**ALBERTA TRANSPORTATION AND  
ECONOMIC CORRIDORS  
GEOHAZARD ASSESSMENT PROGRAM  
PEACE REGION (GRANDE PRAIRIE DISTRICT– NORTH)  
2024 INSPECTION**

Site Number	Location	Name	Hwy	km
PH067	West of Fairview	East Hill Ditch Erosion Section	682:02	13.8-14.1
Legal Description		UTM Co-ordinates (NAD 83)		
Centre 36-81-5-W6		11 N 6214450	E 398000

**PH067-1: HWY 682:02 - HINES CREEK  
2024 INSPECTION PLAN**

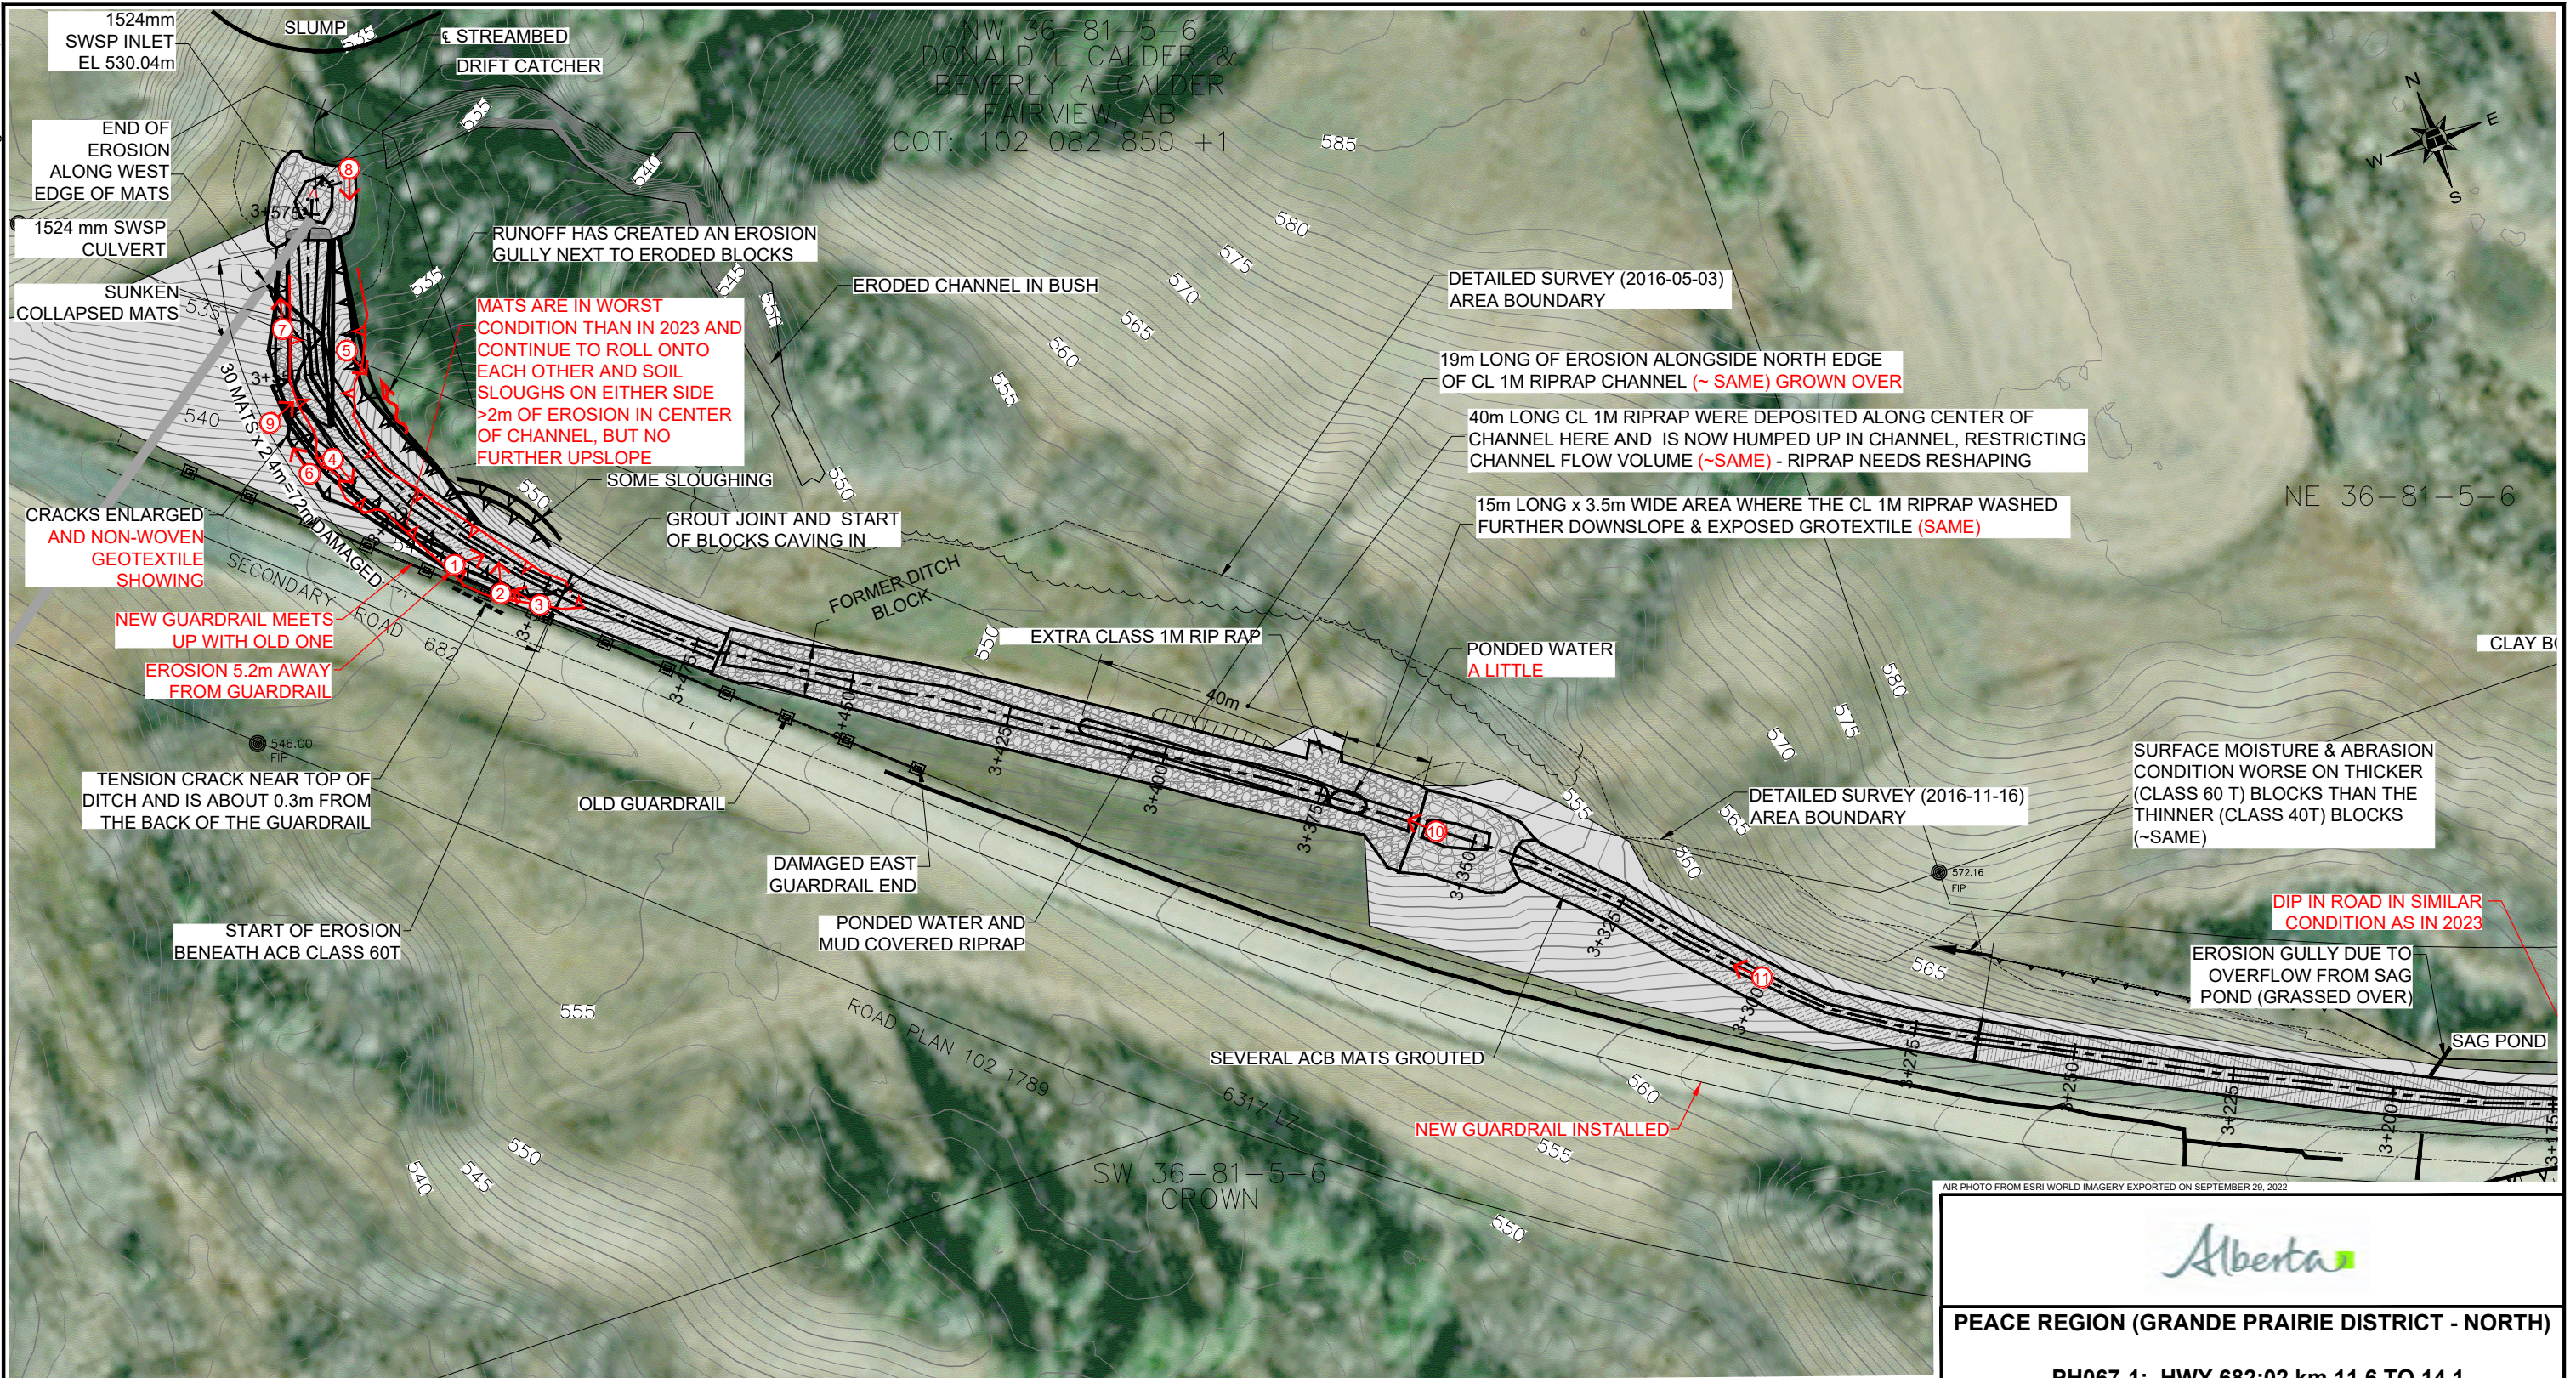
DWG No. 32123-PH067-1-2

- NOTES :**
1. FEATURE LOCATIONS ARE APPROXIMATE
  2. PREVIOUS OBSERVATIONS SHOWN IN BLACK
  3. MAY 7, 2024 FEATURES SHOWN IN RED
  4. ADVANCED ABRASION & SPALLING OF ACB MAT BLOCKS AND MANY BROKEN BLOCKS ALONG CENTER BASE OF CHANNEL; SOME MATS WORSE THAN OTHERS.
  5. HIGHWAY SAND / SALT STAINING ALONG BASE & HIGHWAY SIDE OF ACB MATS IN CHANNEL.

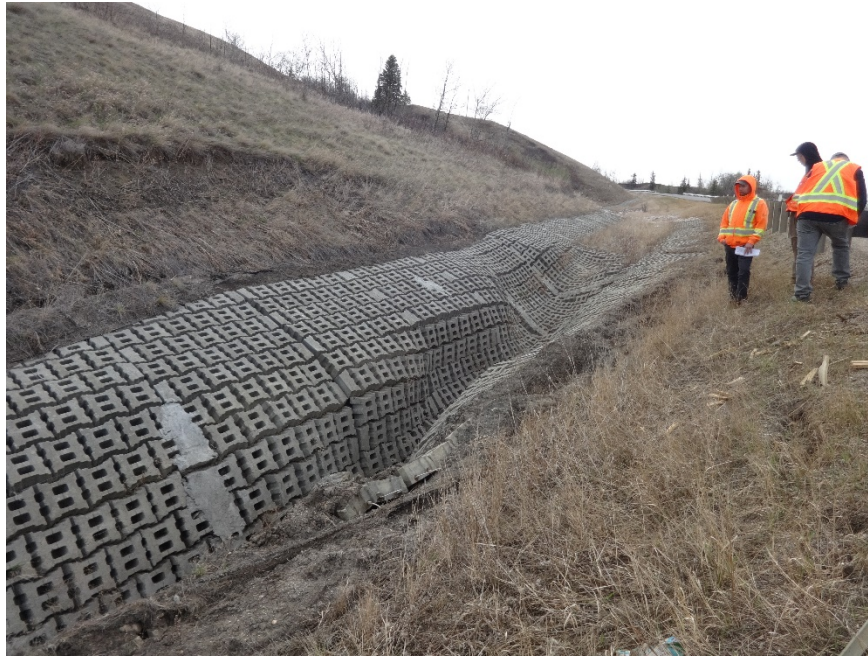
**Photo 1. Looking east along the beginning of the eroded ACB mat area north of the highway.  
Photo credit: Nicole Wilder.**

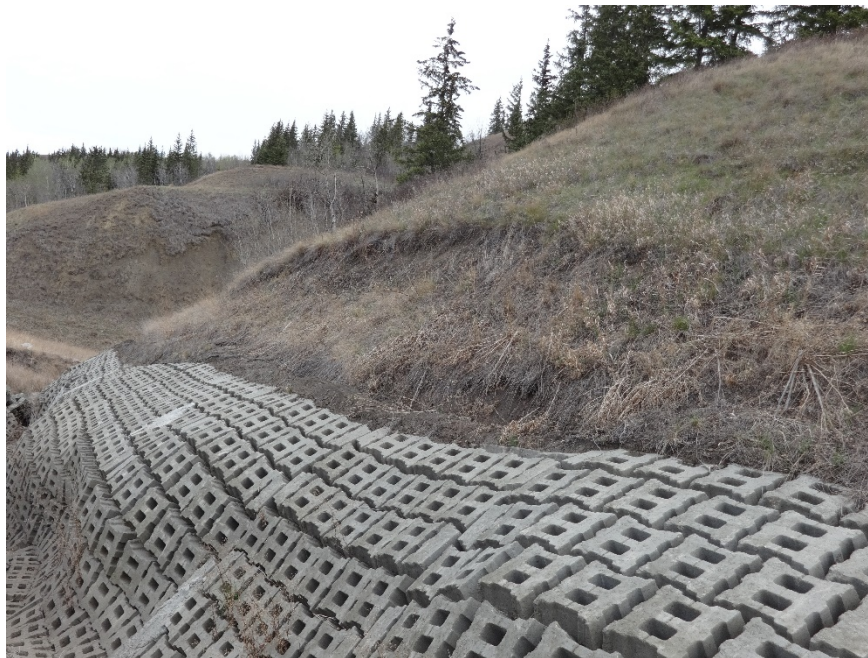
**Photo 2. Looking north along the edge of the eroded ACB mat area. Note the scarp extension  
along the north edge of the mats. Photo credit: Nicole Wilder.**

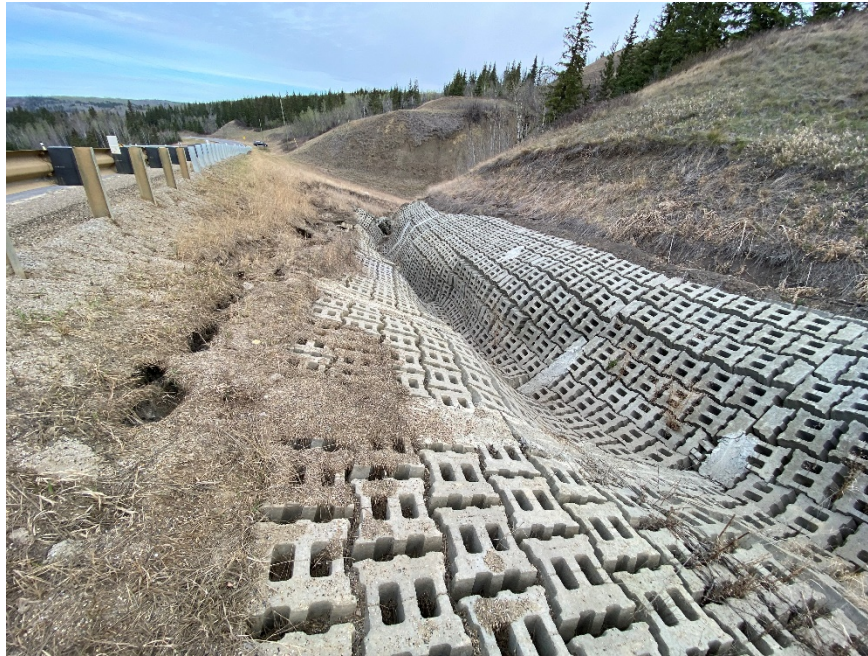
**Photo 3. Looking northwest along the severely damaged ACB mat area and enlarged slide scarp area. Photo credit: Don Proudfoot.**

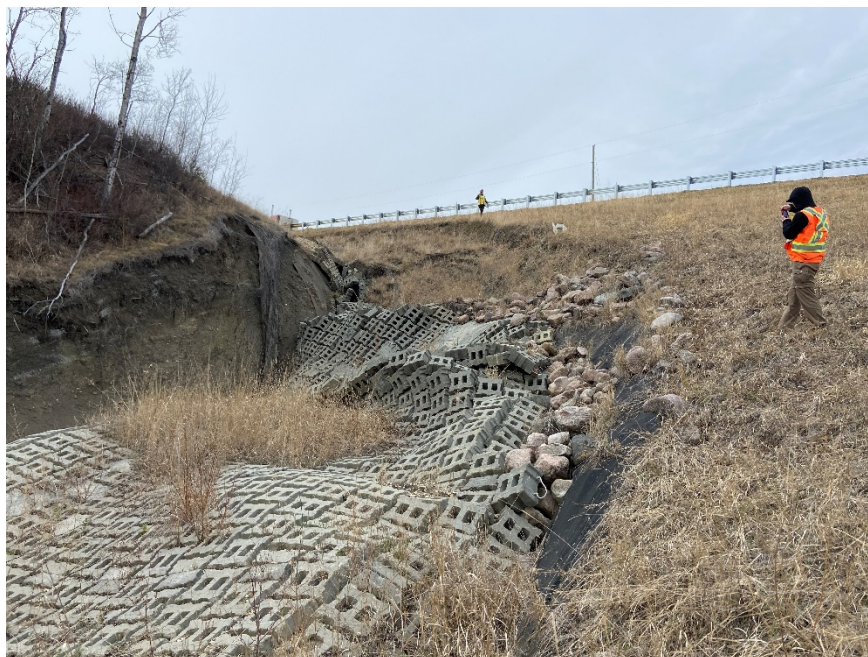
**Photo 4. Looking southeast at the severe erosion through the ACB mats. Note the enlarged erosion and slide developing south of the mats. Photo credit: Nicole Wilder.**

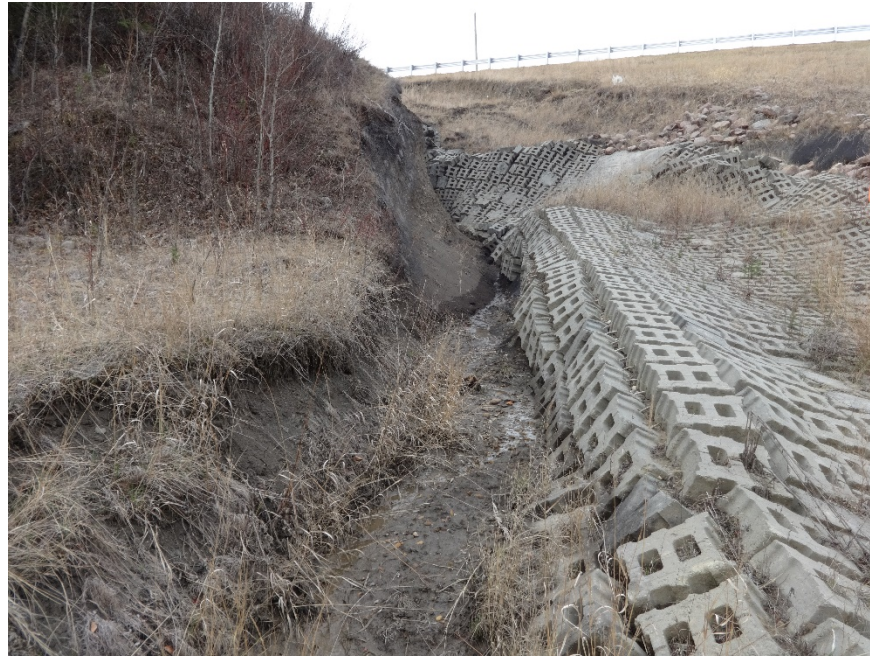
**Photo 5. Looking southeast along the east edge of the eroded ACB mats. Here the mats have slid down into the deeply eroded channel and water flows along here. Photo Credit: Nicole Wilder.**

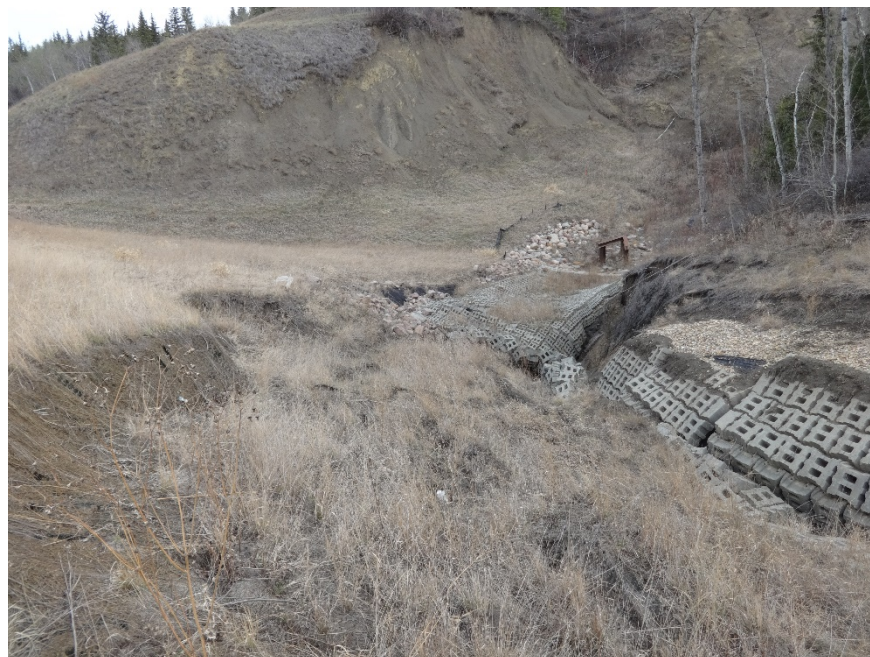
**Photo 6. Looking north along the southwest side of the damaged and eroded ACB mats. Photo Credit: Nicole Wilder.**

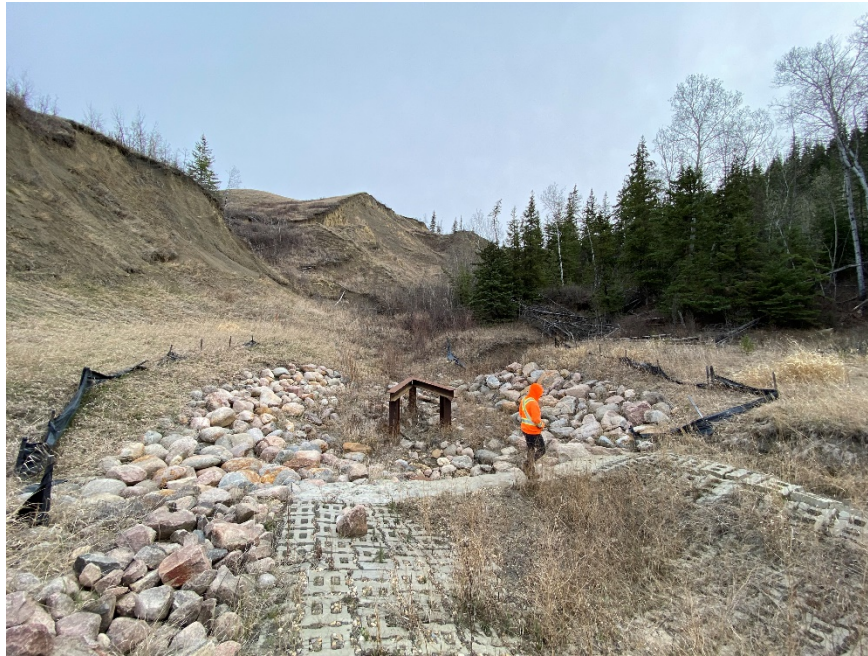
**Photo 7. Looking northwest across the eroded mat area near the bottom of the slope. Photo Credit: Don Proudfoot.**

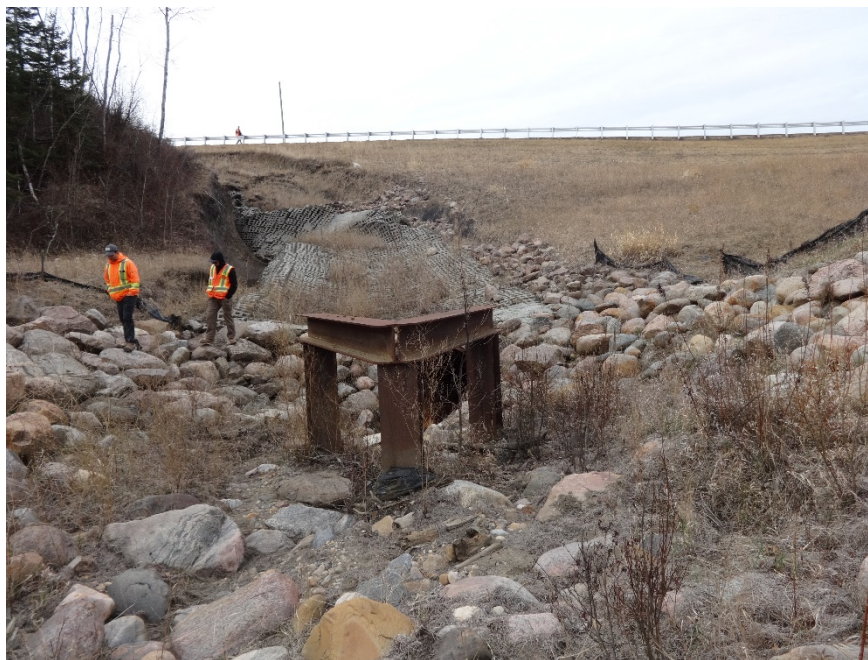
**Photo 8. Looking southwest at the culvert inlet, trash rack and eroded ACB mat area leading to it. Photo Credit: Nicole Wilder.**

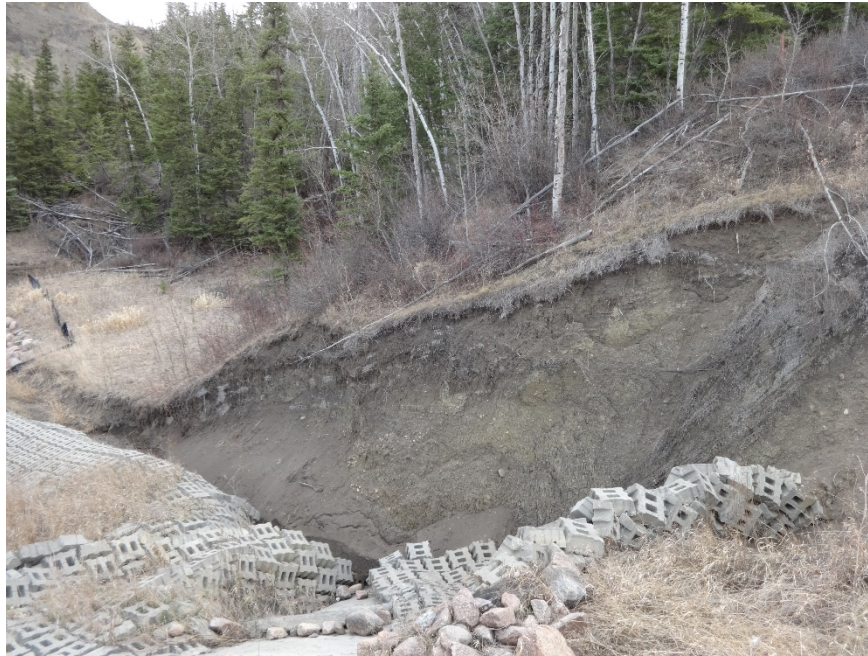
**Photo 9. Looking north at the slumping and infill occurring into the channel upstream of the 1524 SWSP culvert entrance. Photo Credit: Nicole Wilder.**

Consider installing culverts (900 or 1200 mm diameter) in the slumping channel areas upstream of the existing 1524 mm diameter culvert inlet, to allow flow to the existing culvert while minimizing debris and potential blockage.

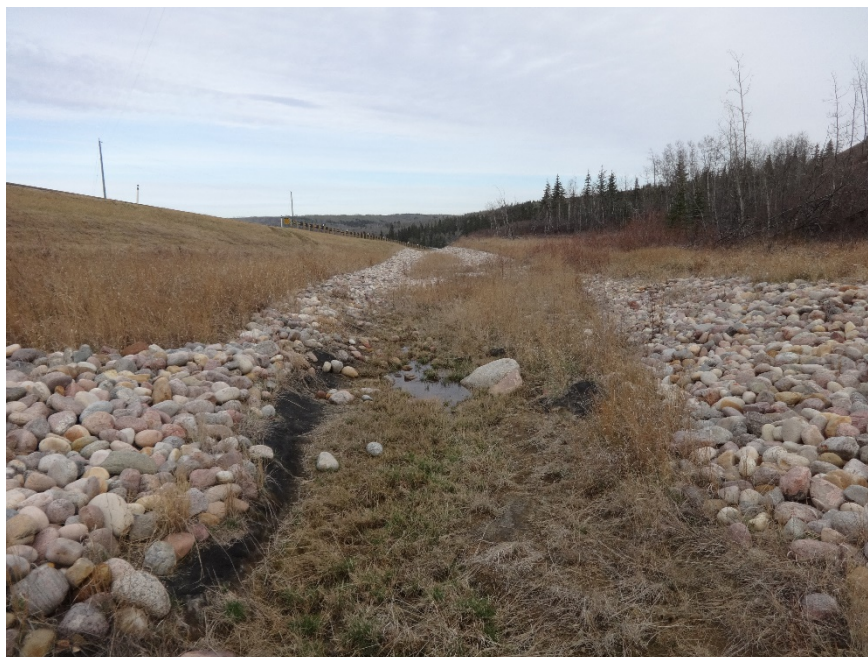
**Photo 10. Looking east at area within riprap that now has mud and grass covering some of the riprap likely from high runoff flow events and ponding afterwards. Photo Credit: Nicole Wilder.**

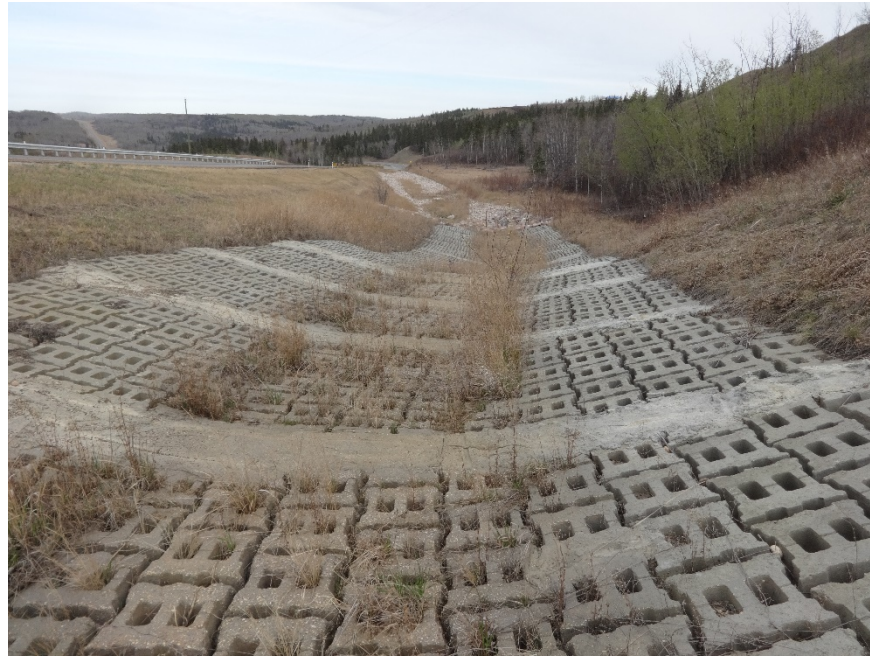
**Photo 11. Looking northwest at the ACB Matting that was previously grouted. Photo Credit: Nicole Wilder.**

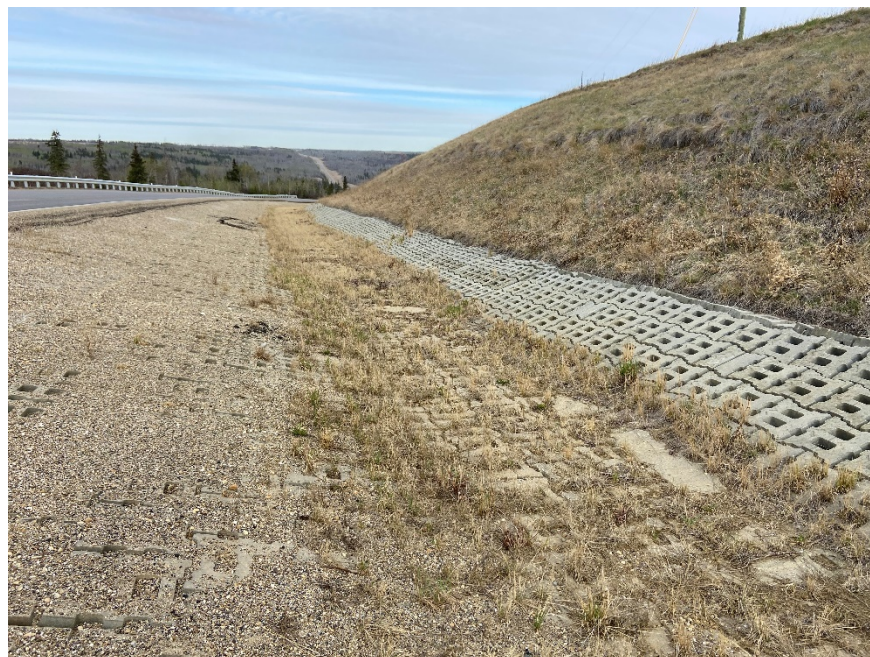
**Photo 12. Looking northwest at the ACB Matting performing well and previously had some willows growing out of them which were cut. Photo Credit: Nicole Wilder.**

Continue cutting or spray the willows that grow in the lined channel with broadleaf pesticide to eliminate the trees from growing larger as their presence, if left unchecked, could impede drainage and cause high flows to erode outside the lined channel

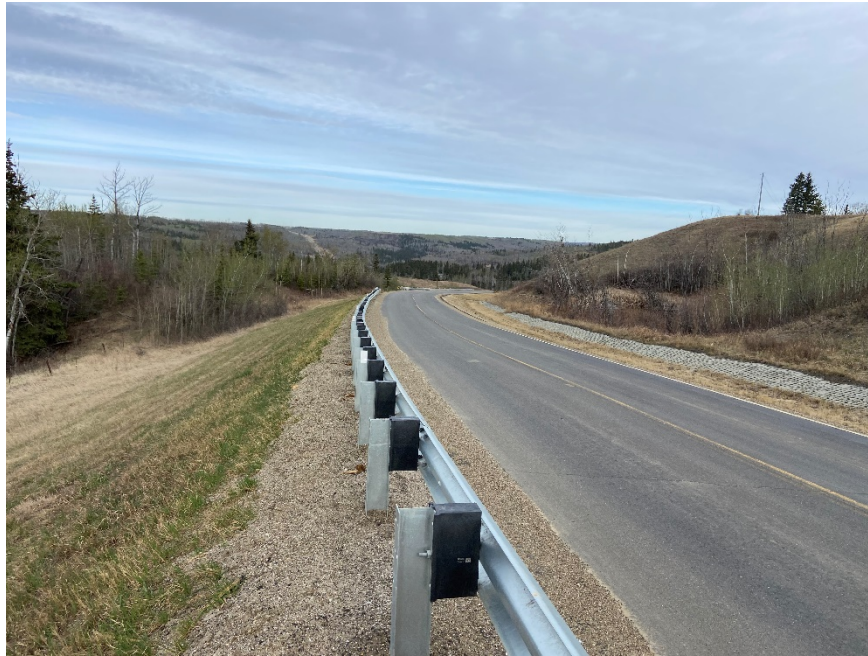
The dip across the highway near the sag pond (first noticed in 2014 ~Sta 3+200), has not gotten any worse this year, however cracks had appeared in 2020 (before the new overlay covered them) and suggests that a landslide might be slowly developing at this location, moving southward.

**Photo 13. Looking northwest towards sag pond and dip in highway. Photo Credit: Nicole Wilder.**

Continue monitoring the slide that appears to be developing across the highway near the sag pond.

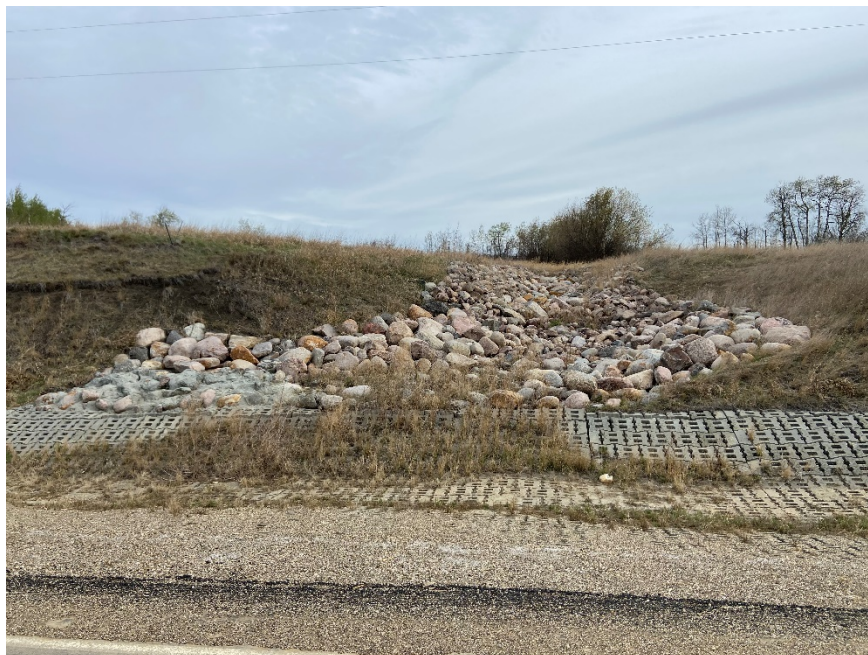
**Photo 14. Looking north at where riprap was previously placed, appears to be in good condition but a scarp has extended to the west of it. Photo Credit: Don Proudfoot.**

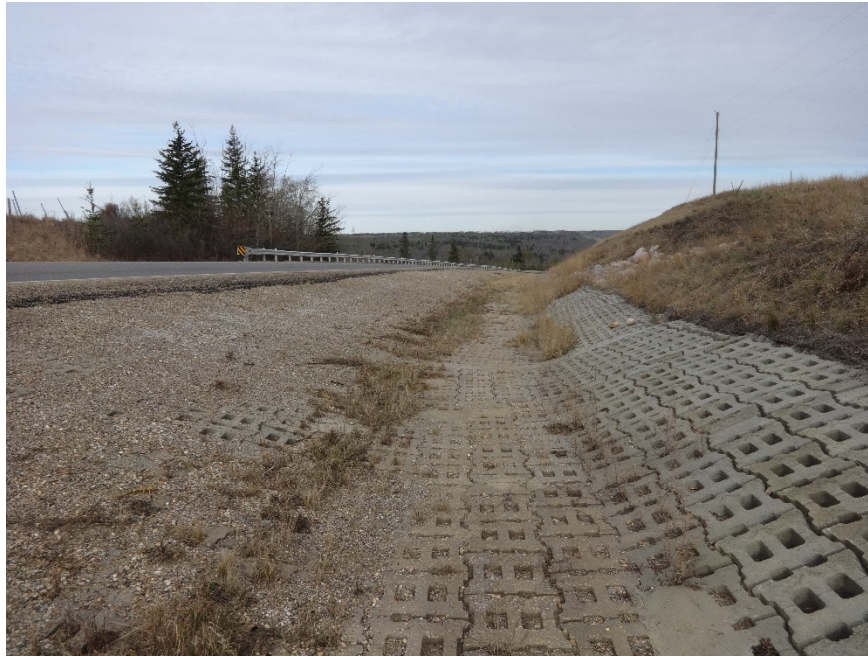
**Photo 15. Looking west at east end of ACB mat lining. Photo Credit: Nicole Wilder.**

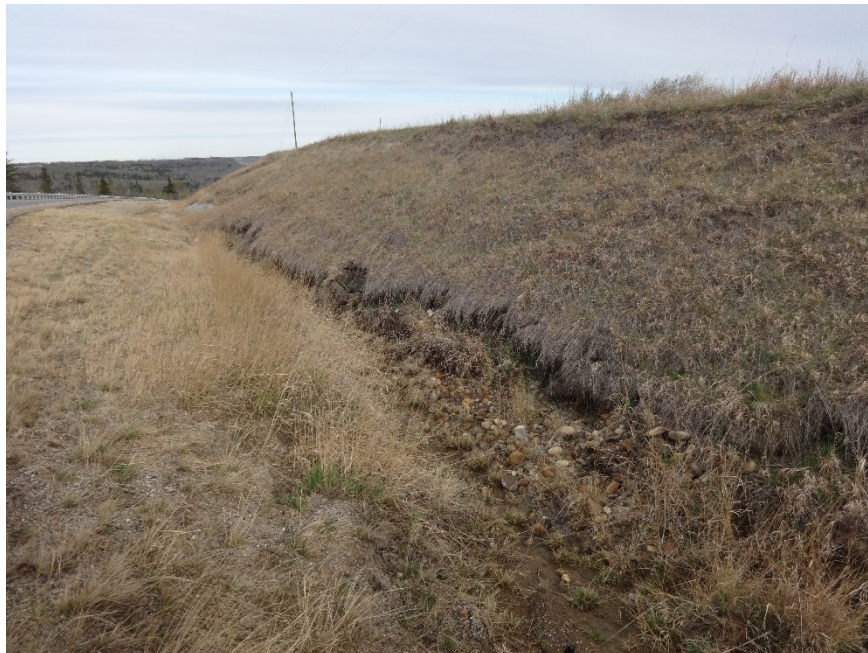
**Photo 16. Looking northwest from the WBL shoulder of Hwy 49:06 towards the east end of the site. Photo Credit: Nicole Wilder.**
