**ALBERTA TRANSPORTATION
GEOHAZARD ASSESSMENT PROGRAM
PEACE REGION – GRANDE PRAIRIE DISTRICT - NORTH
2023 INSPECTION**

Site Number	Location	Name	Hwy	km
PH077-1 and 77-2	West of Fairview	Sites E of Hines Creek Bridge	682:02	12.5-12.8
Legal Description		UTM Co-ordinates (NAD 83)		
NE35-81-5-W6		11V N 6215000	E 396650

**PEACE REGION (GRANDE PRAIRIE DISTRICT - NORTH)
PH077-1 & PH077-2 EAST SIDE OF HINES CREEK BRIDGE
HWY 682:02, km 12.6-12.7**

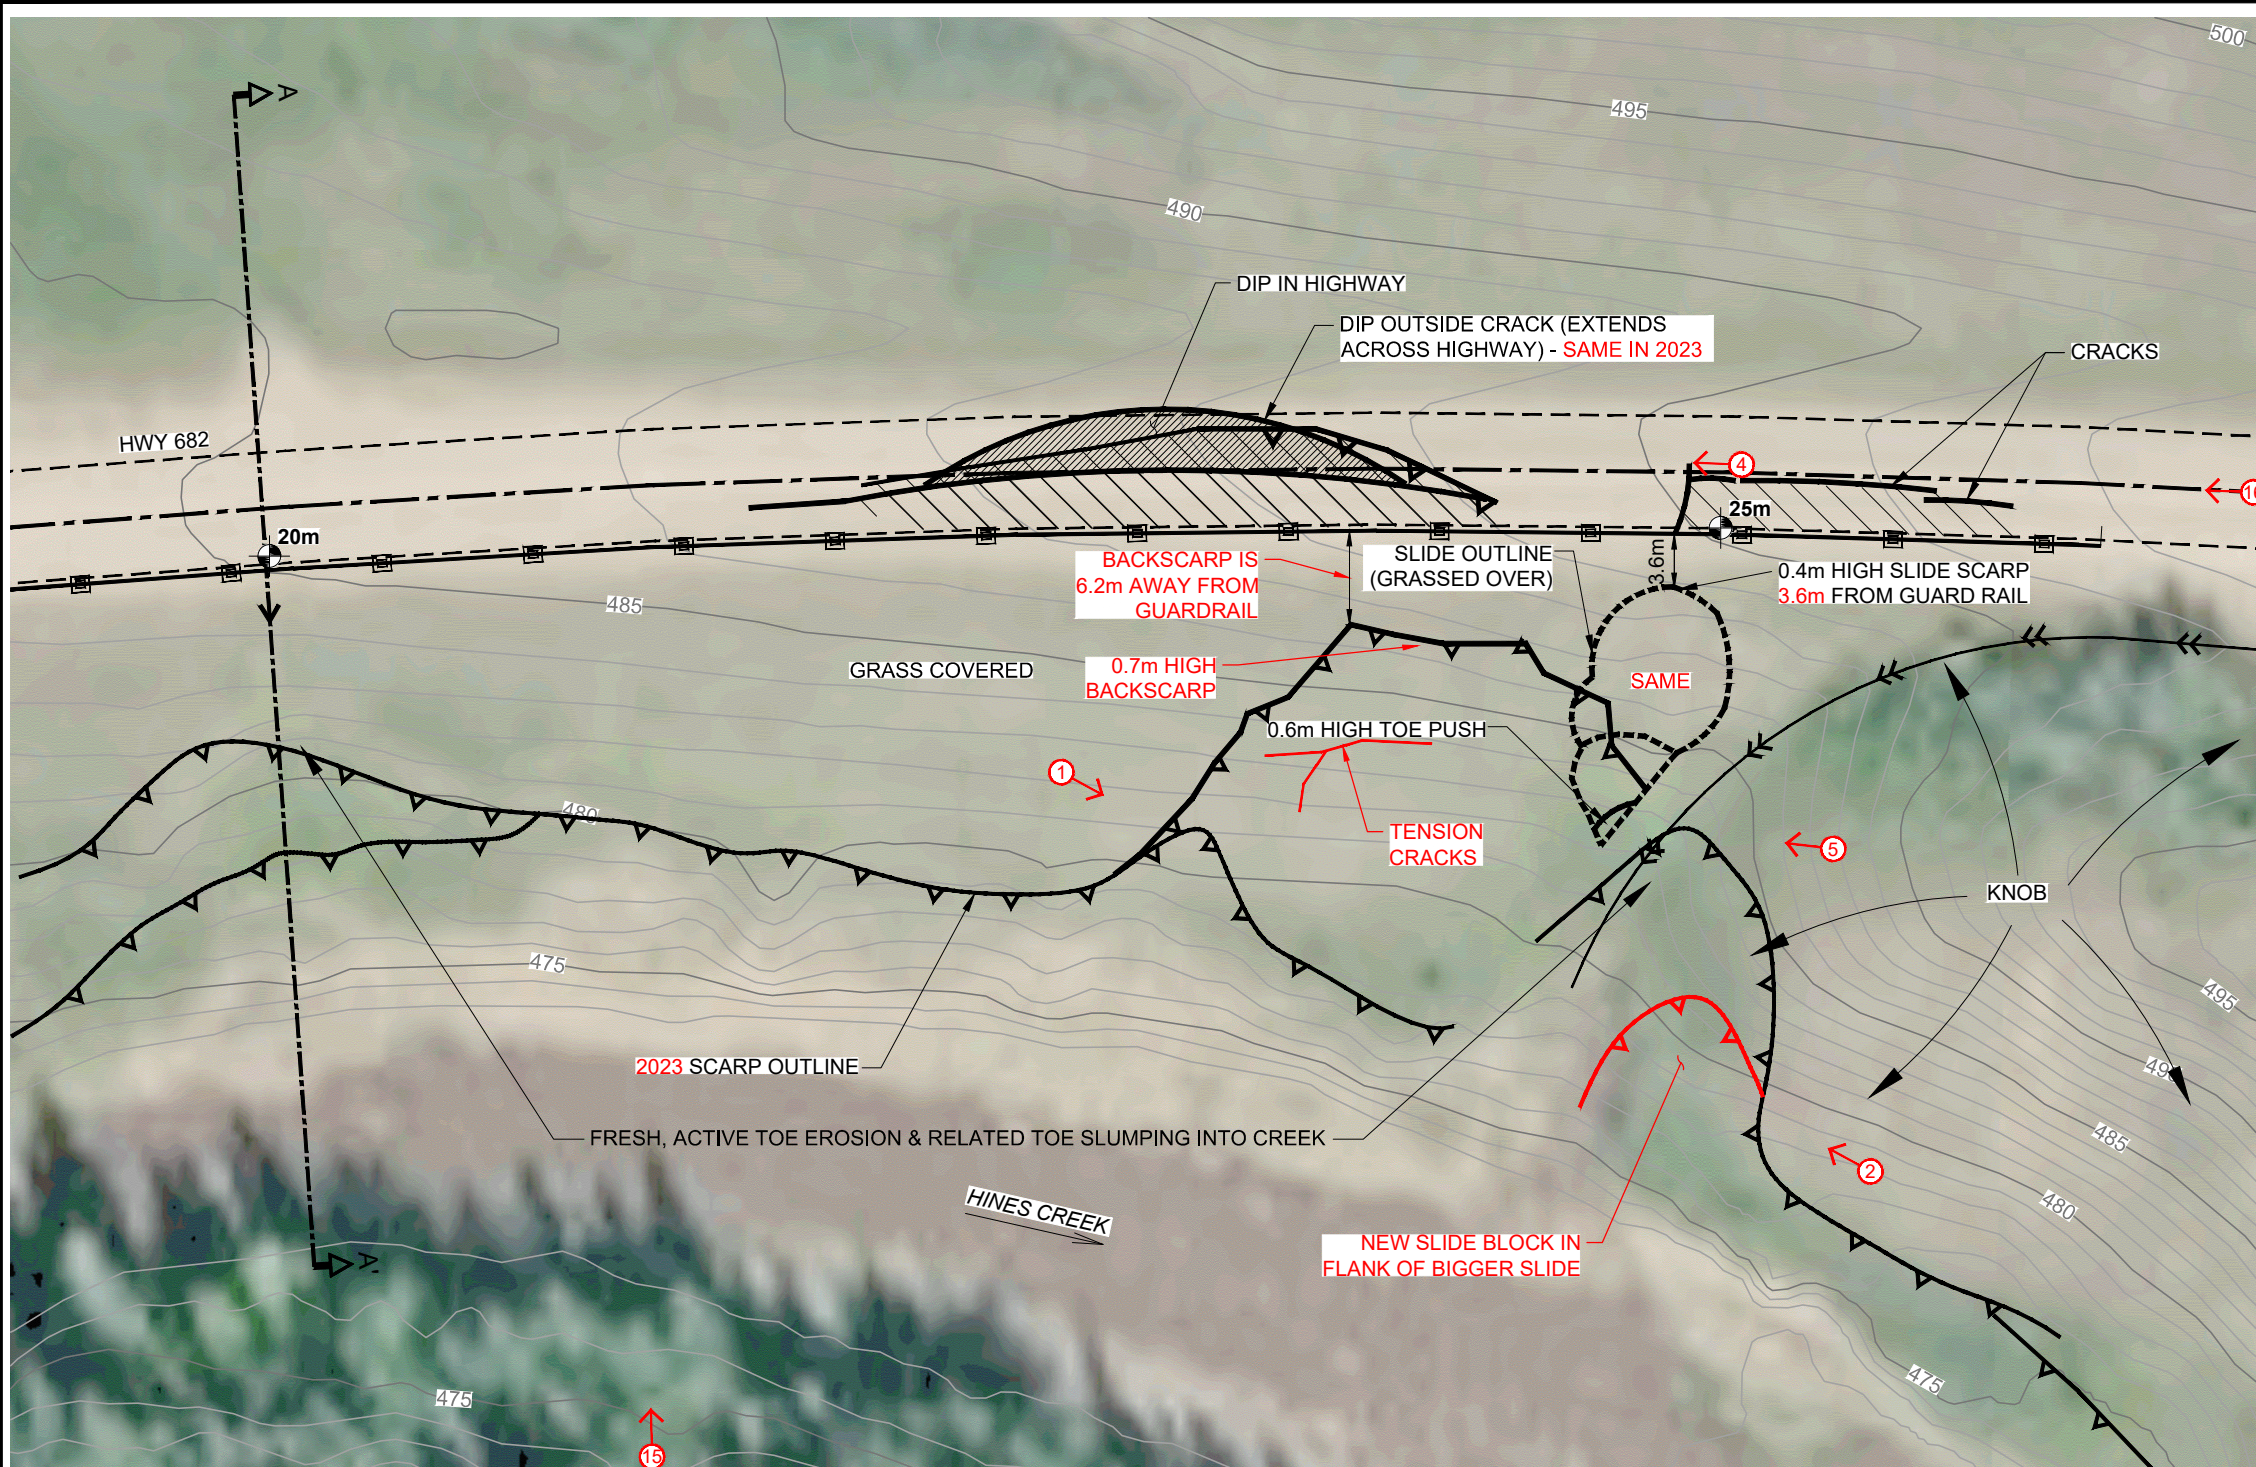
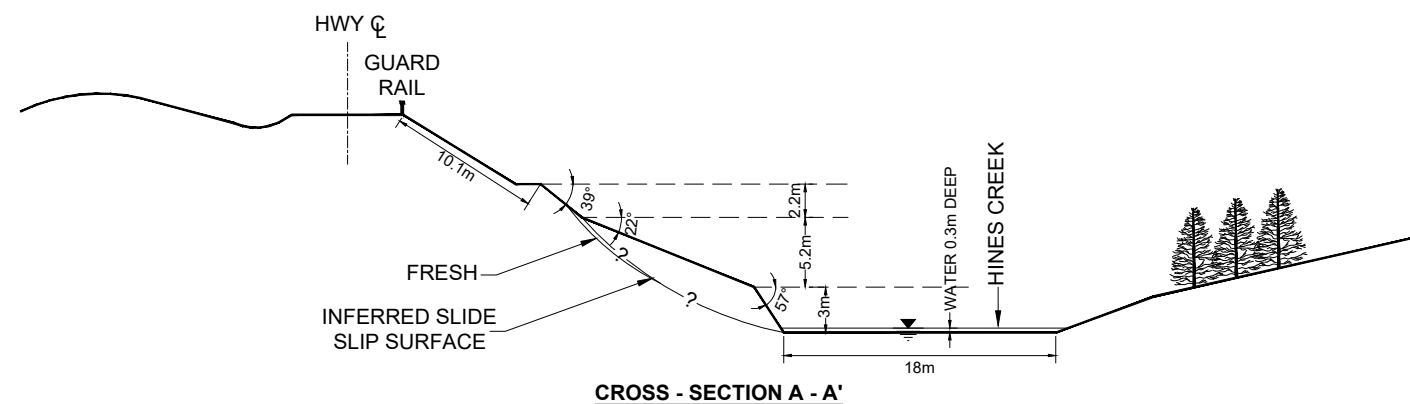
DWG No. 32123-PH077-1-1

1. MAY 30, 2023 OBSERVATIONS SHOWN IN RED.
2. LOCATIONS ESTIMATED WITH HANDHELD GPS.

INSPECTION PLAN - SITE 1

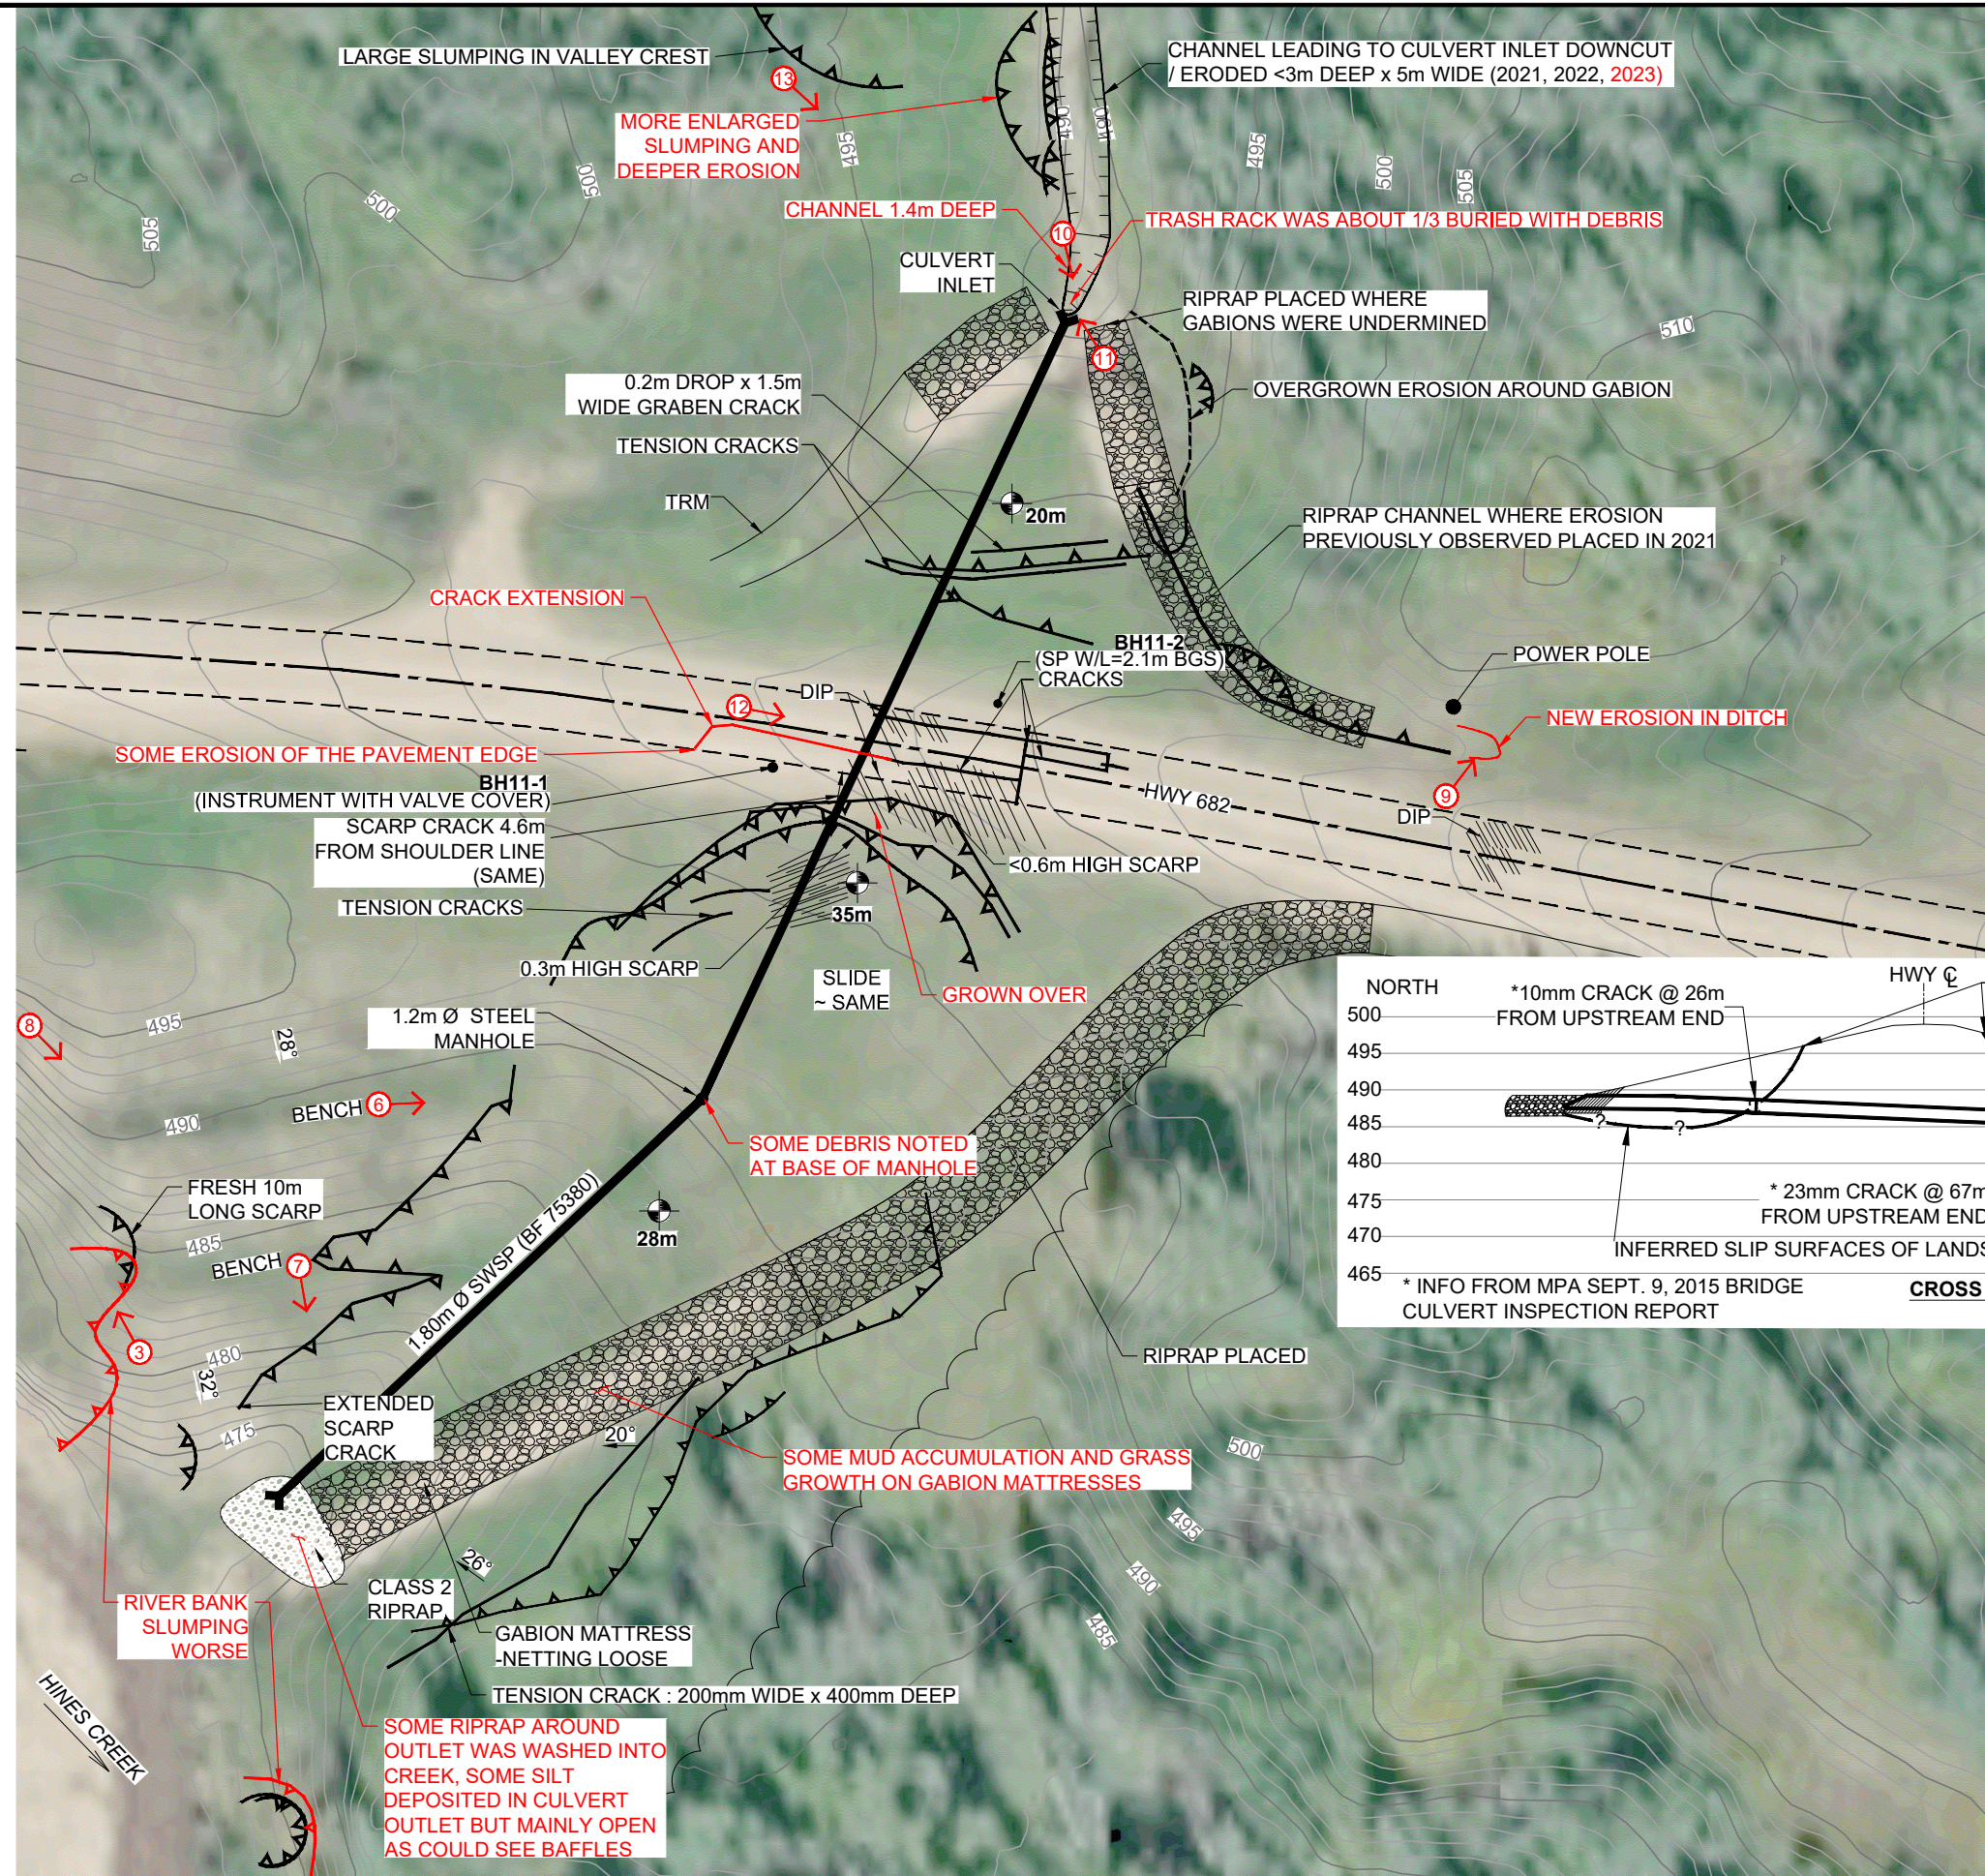
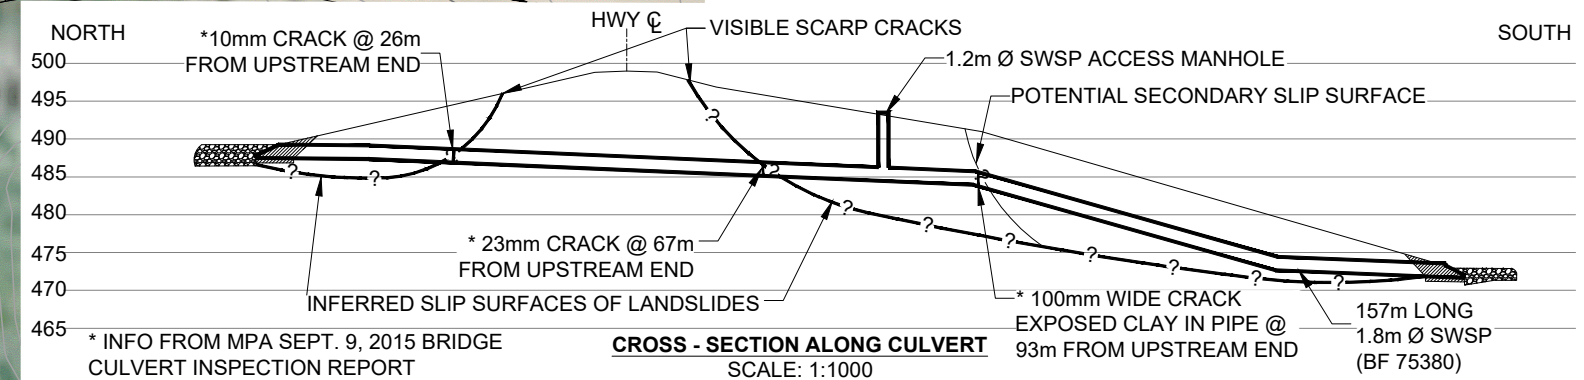
DWG No. 32123-PH077-2-1

- NOTES**
1. SITE RELATIVELY UNCHANGED.
 2. GABIONS LACKING INTERMEDIATE BAFFLES AND LIDS NOT ADEQUATELY TIED.
 3. MAY 30, 2023 OBSERVATIONS SHOWN IN RED.

INSPECTION PLAN - SITE 2

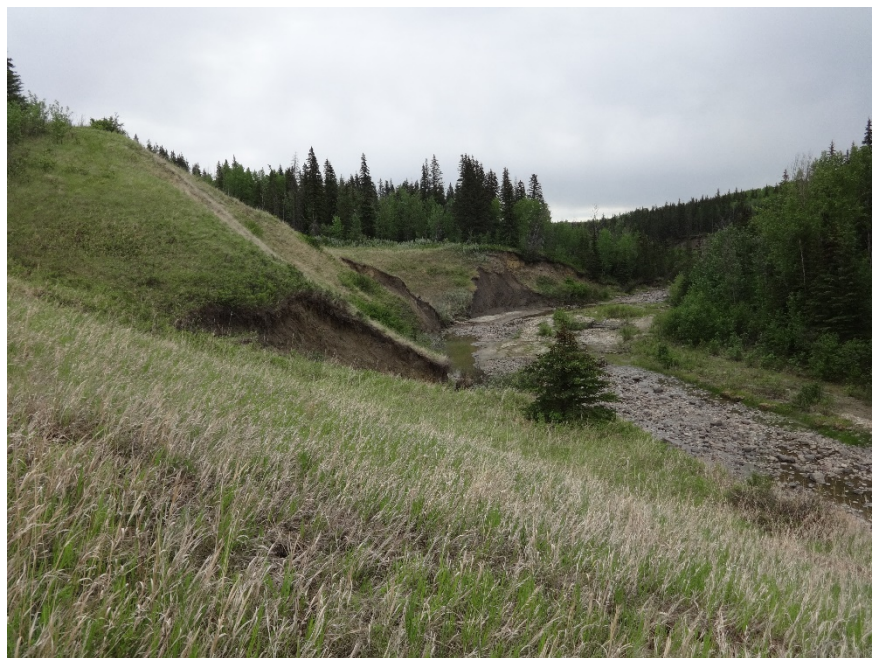
<input checked="" type="checkbox"/> Erosion	<p>At PH077-1, active erosion caused by the creek is occurring at the toe of the slope along the creek's edge.</p> <p>At PH077-2, the TRM south of the highway along the east runoff ditch where previously erosion was observed had been repaired with rip rap lining this ditch and as well as placing riprap on the downstream end of the gabions near the culvert outlet; however, some of this riprap at the base was washed away by the creek.</p>	<input checked="" type="checkbox"/>	<input type="checkbox"/>
<input checked="" type="checkbox"/> Seepage	At PH077-1 the soil within the tension crack within the 35 m wide slide was moist to wet.	<input checked="" type="checkbox"/>	<input type="checkbox"/>
<input checked="" type="checkbox"/> Bridge/Culvert Distress	The upstream end of the 1.8 m diameter SWSP (BF75380) at PH077-2 was about 0.5 m buried with silt and debris at the drift catcher and the outlet did not appear to be visibly damaged at the time of our inspection but was somewhat buried in silt. The 2022 bridge inspection noted that there were distortions and cracks/separations within the culvert (along with low ratings) and that drift and silt should be removed from pipe and drift catcher.	<input checked="" type="checkbox"/>	<input type="checkbox"/>

Photo 1. Looking east at Slide PH077-1 at the erosion along the north side of the Creek. Photo credit: Nicole Wilder.

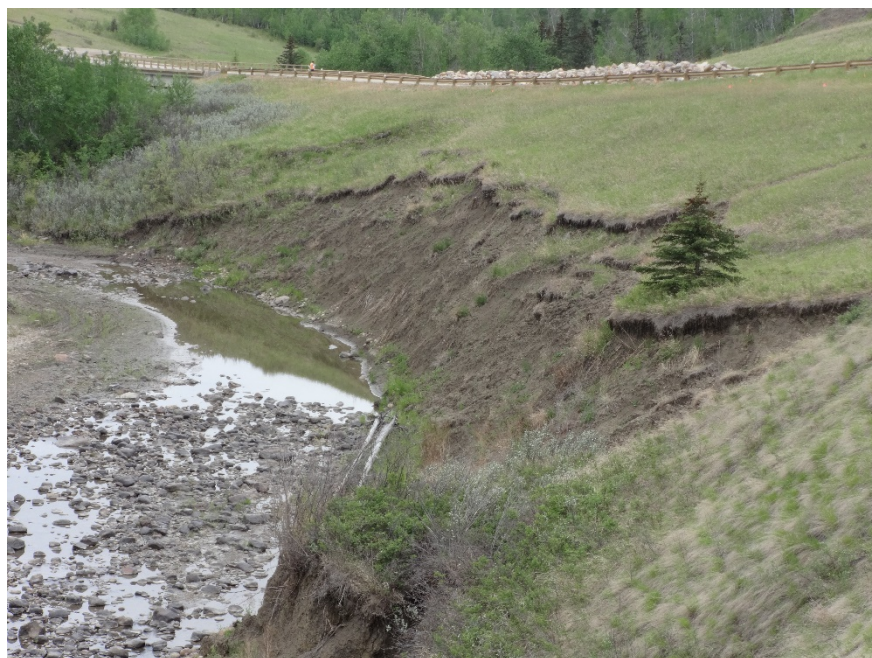
Photo 2. Looking west at the fresh toe slumping above the creek at PH077-1 in the south highway embankment. Photo credit: Nicole Wilder.

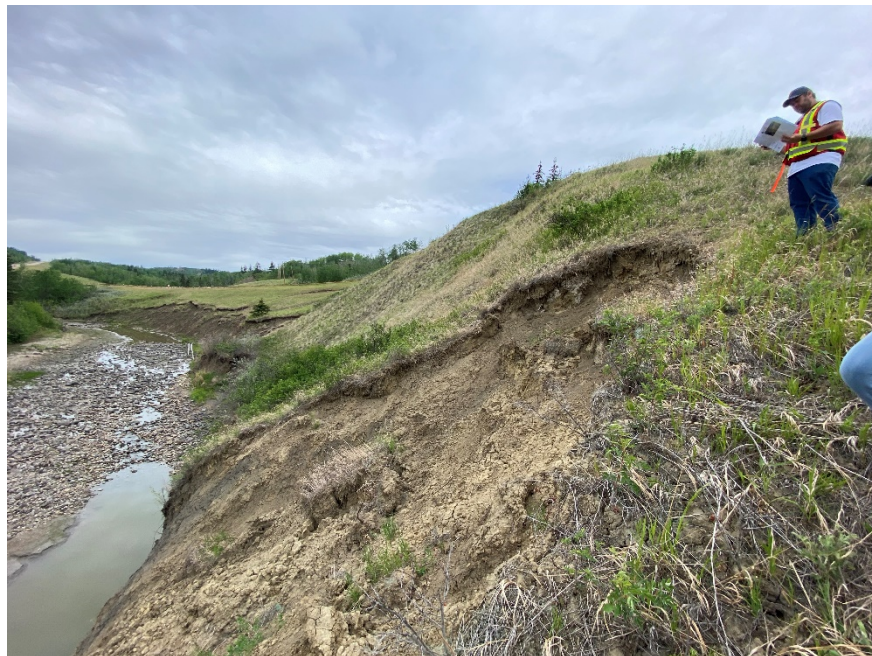
Photo 3. Looking west at area that sloughed into the creek. Photo credit: Don Proudfoot.

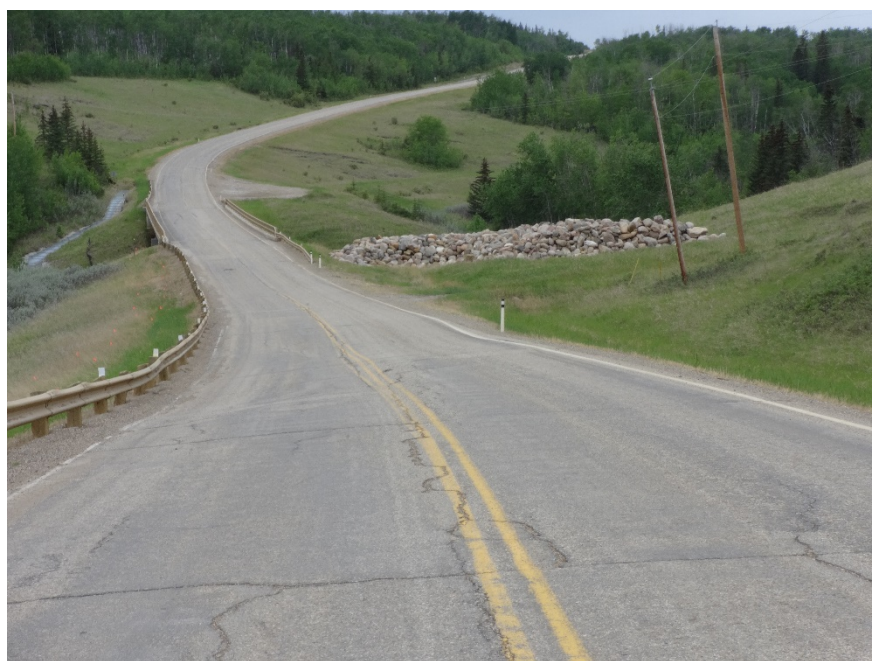
Photo 4. Looking west along the highway at the crack/dip in the highway above the Slide at PH077-1. Photo credit: Nicole Wilder.

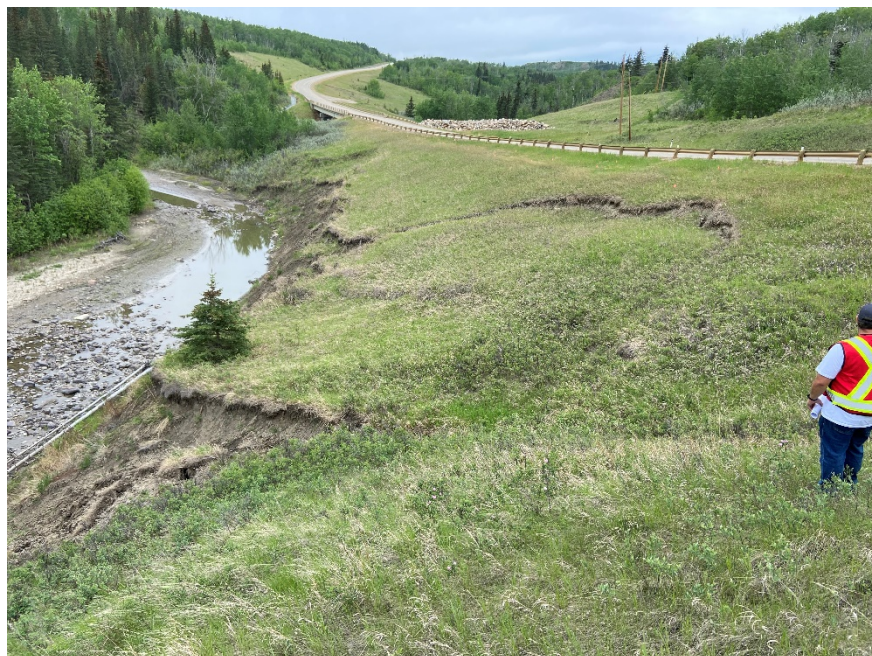
Photo 5. Looking west at new slump that developed west of the knob hill. Photo Credit: Don Proudfoot.

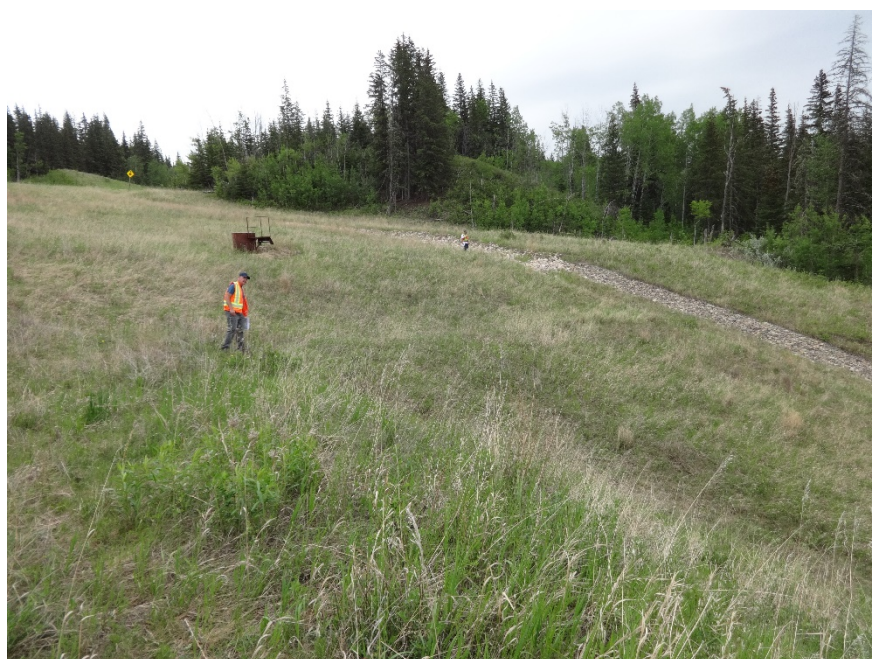
Photo 6. Looking east at riprap swale into the gabion mattress channel of PH077-2. Photo Credit: Nicole Wilder.

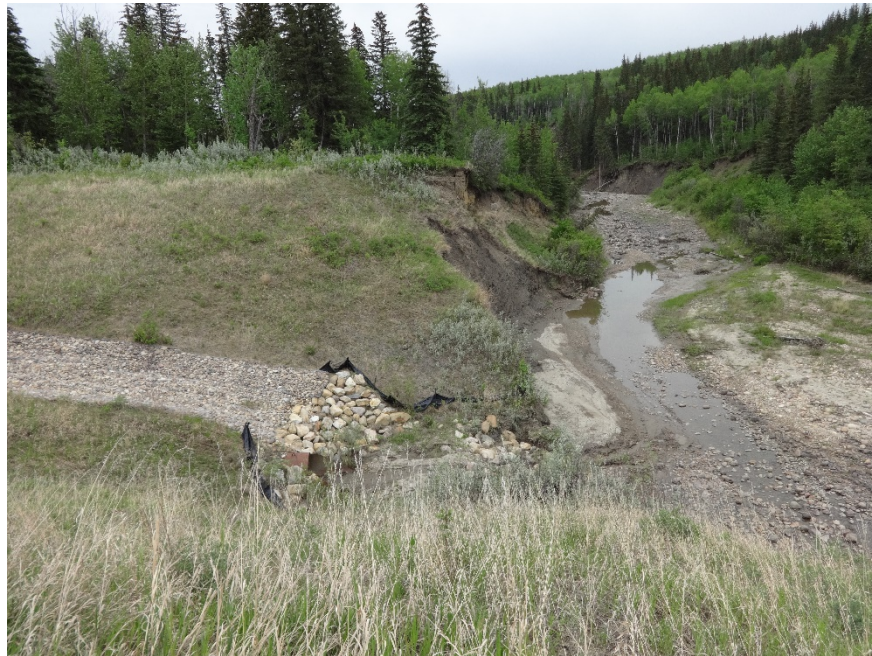
Photo 7. Looking east at the southeast ditch drainage channel of PH077-2, Hines Creek. Photo Credit: Nicole Wilder.

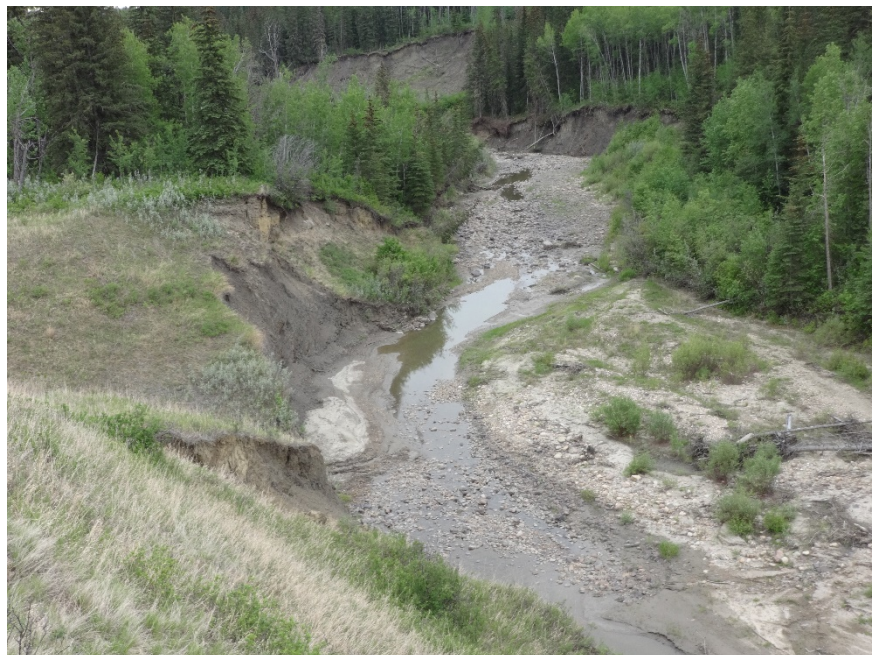
Photo 8. Looking southeast at the river bank slumping near the culvert outlet area of PH077-2. Photo Credit: Nicole Wilder.

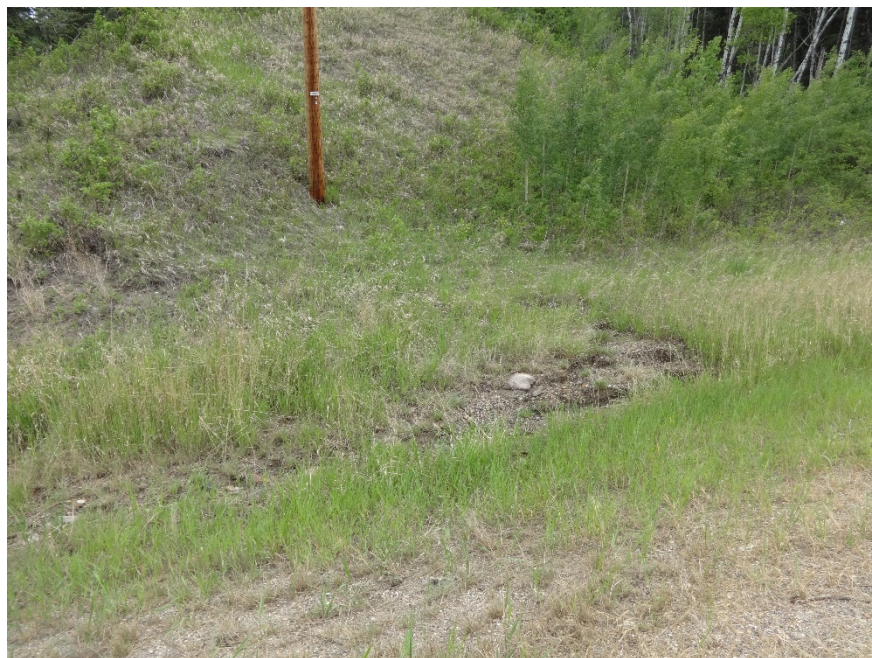
Photo 9. Looking north at new erosion noted upslope from the riprap. Photo Credit: Nicole Wilder.

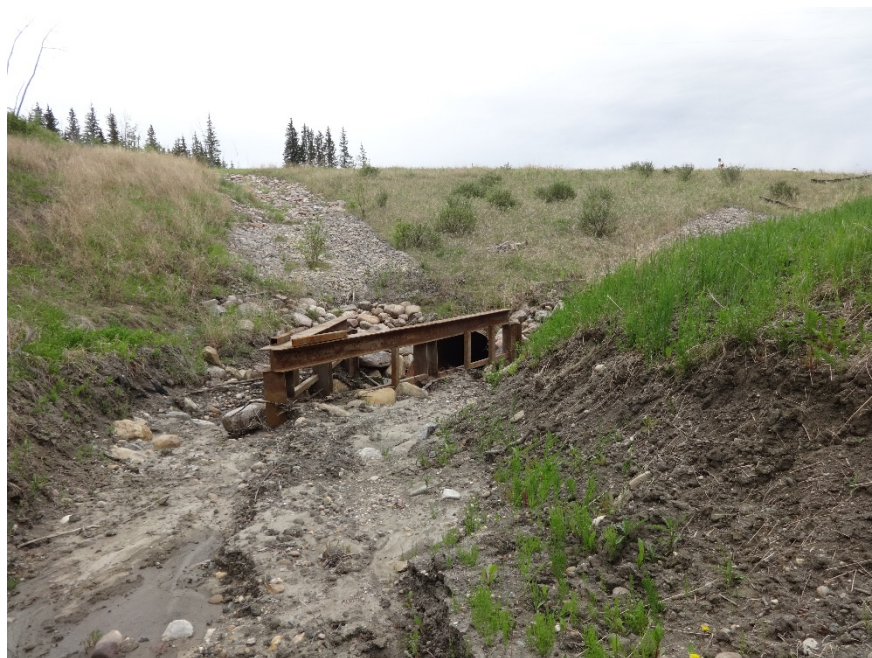
Photo 10. Looking south at the culvert inlet area at PH077-2, the trash rack appeared slightly less full of debris. Photo Credit: Nicole Wilder.

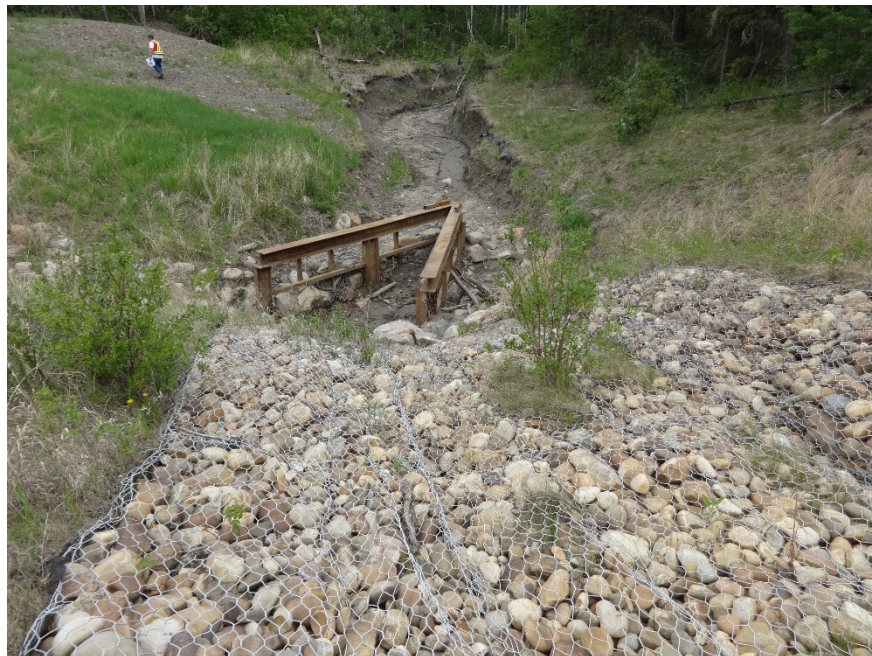
Photo 11. Looking north along the infilled channel leading into the culvert inlet north of the highway at PH077-2. Photo Credit: Nicole Wilder.

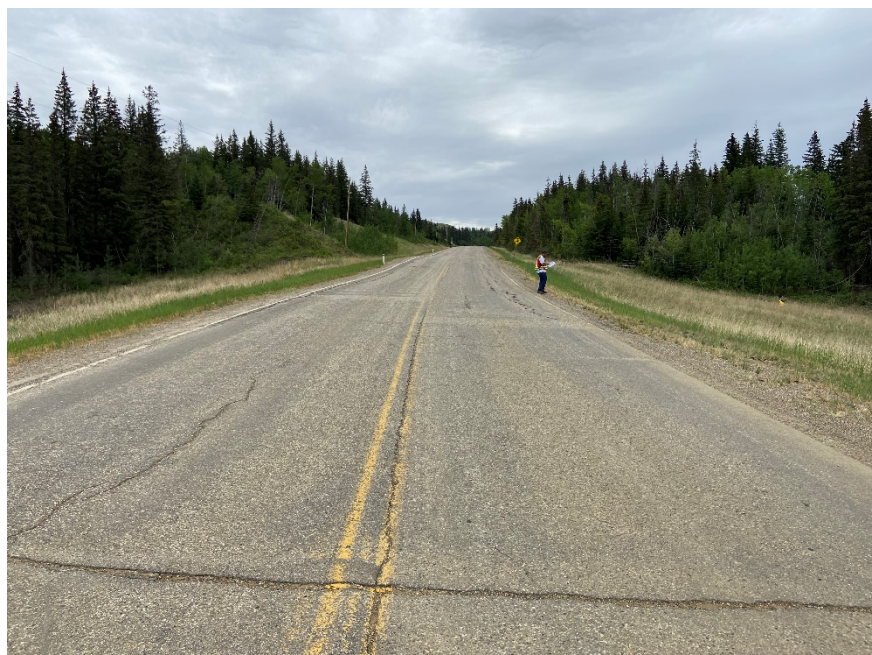
Settlement observed ovetop of the culvert at Site 2, in the form of dips and cracks in the highway could be the result of embankment fill settlement but might also be an indication that the slide movement will eventually retrogress towards the highway or has already.

Photo 12. Looking east at the dip in the highway. Photo credit: Don Proudfoot.

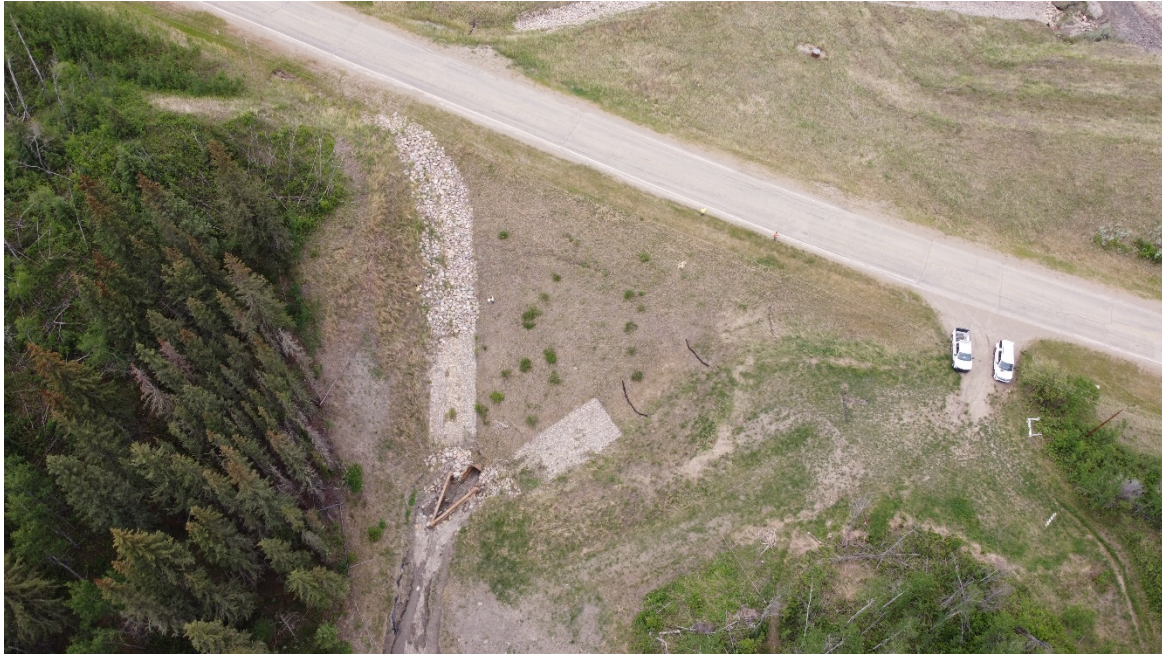
Photo 13. Looking southeast at north sideslope of highway at culvert inlet at PH077-2. Drone Photo Credit: Don Proudfoot.

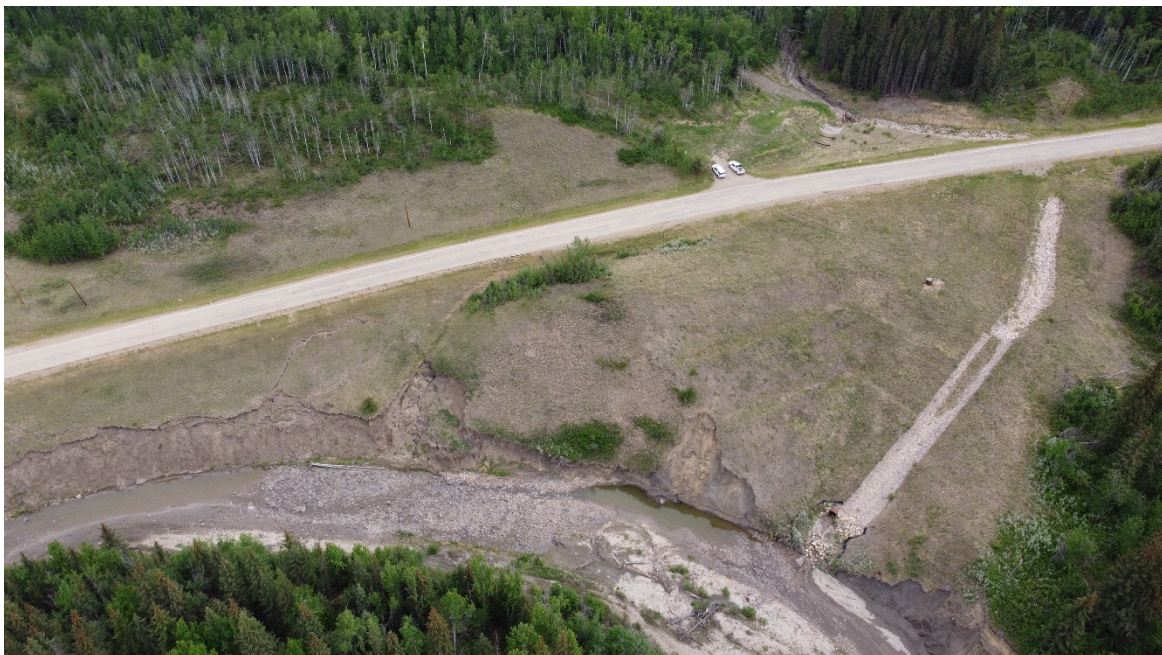
Photo 14. Looking north at Slumping riverbank at PH077-1/2. Drone Photo Credit: Don Proudfoot.

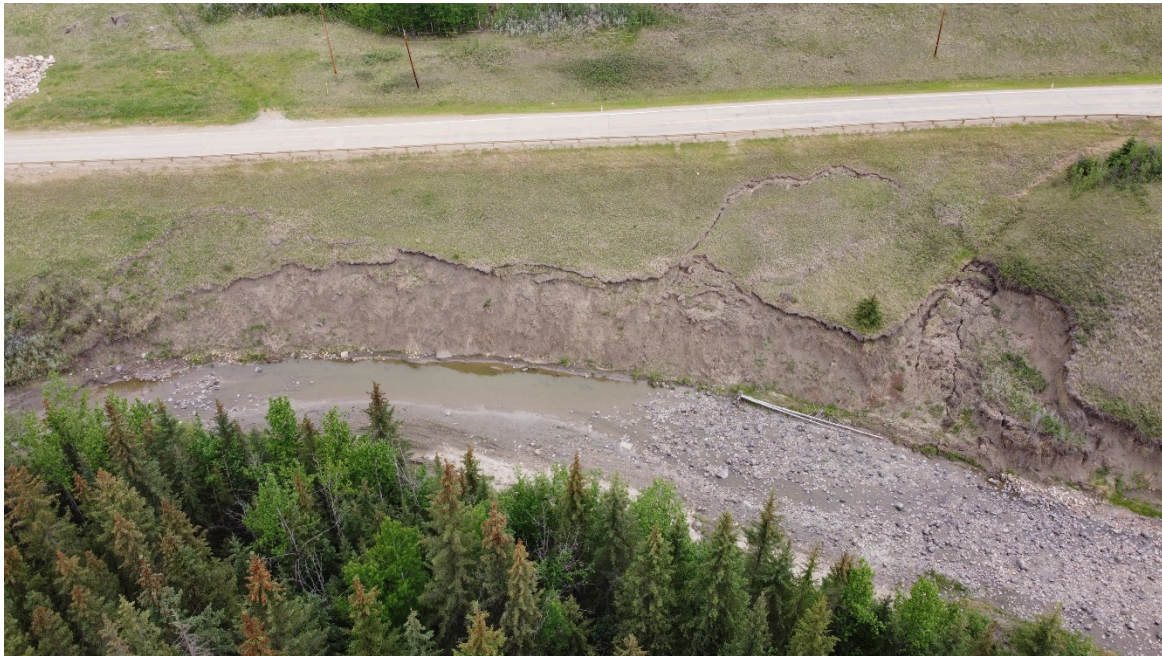
Photo 15. Looking north at slumping riverbank at PH077-1. Drone Photo Credit: Don Proudfoot.

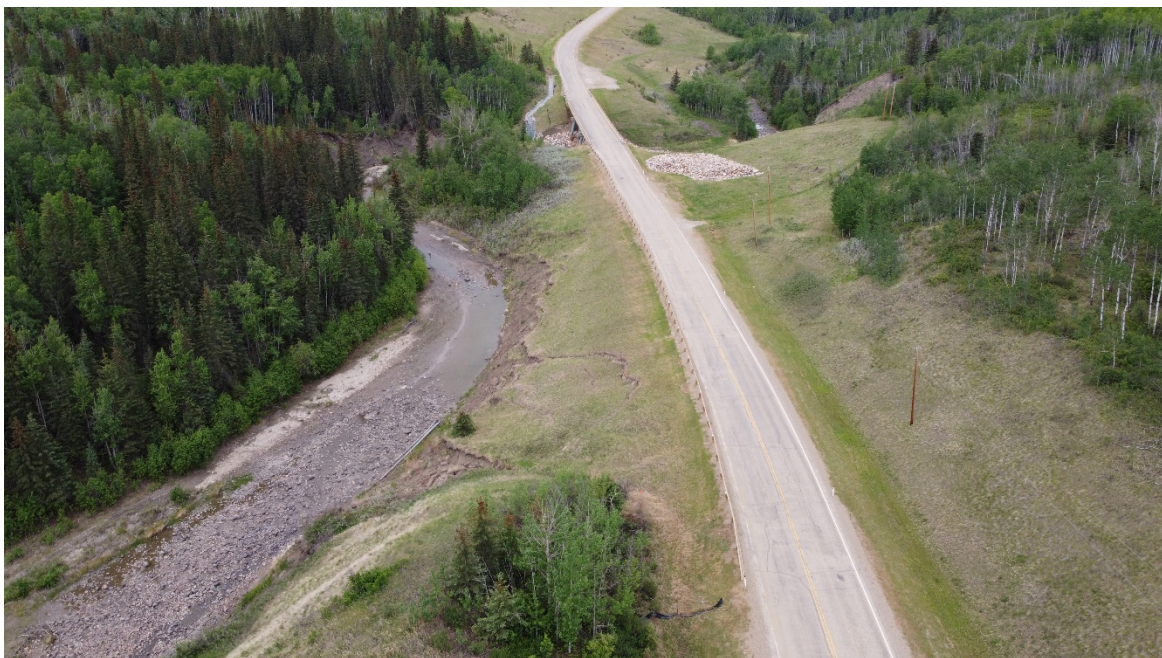
Photo 16. Looking northwest at PH077-2. Drone Photo Credit: Don Proudfoot.
