**ALBERTA TRANSPORTATION AND  
ECONOMIC CORRIDORS  
GEOHAZARD ASSESSMENT PROGRAM  
PEACE REGION – GRANDE PRAIRIE DISTRICT - NORTH  
2024 INSPECTION**

| Site Number | Location | Name | Hwy | km |
|---|---|---|---|---|
| PH077-1 and 77-2 | West of Fairview | Sites E of Hines Creek Bridge | 682:02 | 12.5-12.8 |

| | Date | PF | CF | Total |
|---|---|---|---|---|
| <b>Current Inspection:</b> | May 7, 2024 | 12 | 4 | 48 (PH077-1) |

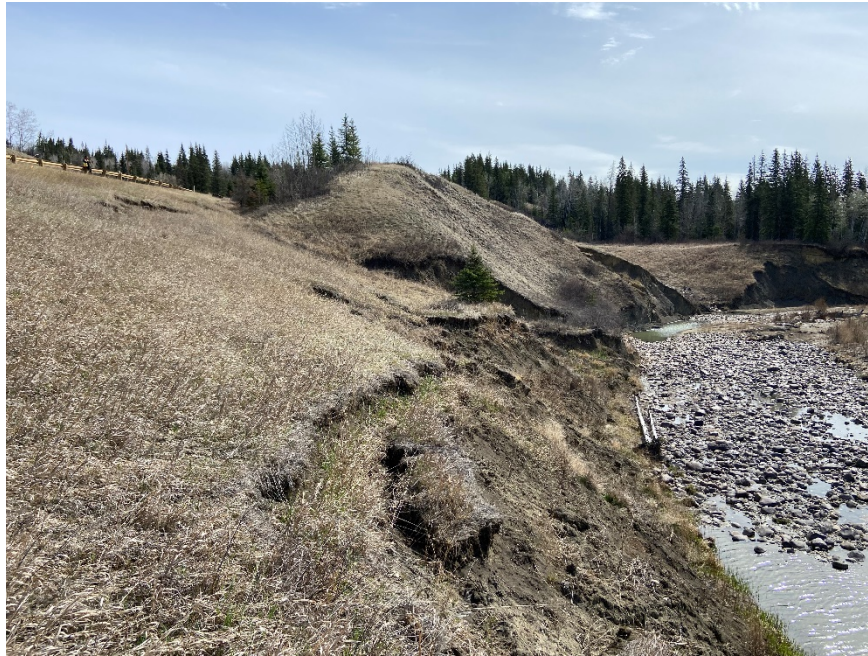
**At PH077-1**, the slide roughly paralleling the creek and highway is a direct result of erosion by Hines Creek and resulting soil loss along the toe of the embankment. The slope will tend to flatten with time due to loss of cohesion in the clay fill embankment material. Therefore, the slide could also gradually enlarge into the driving lanes of the highway surface, and there are already indications of this presumably starting to occur based on the existing cracks and dips in the highway. The smaller 15 m wide and larger 35 m wide slide near the east end of this site may have also been triggered by east ditch runoff erosion, and/or having a slope that is too steep for the composition material of the embankment. Ditch or surface erosion of the slope could also contribute to more rapid slope movements.

**Photo 1. Looking east at Slide PH077-1 at the erosion along the north side of the Creek. Photo credit: Don Proudfoot.**

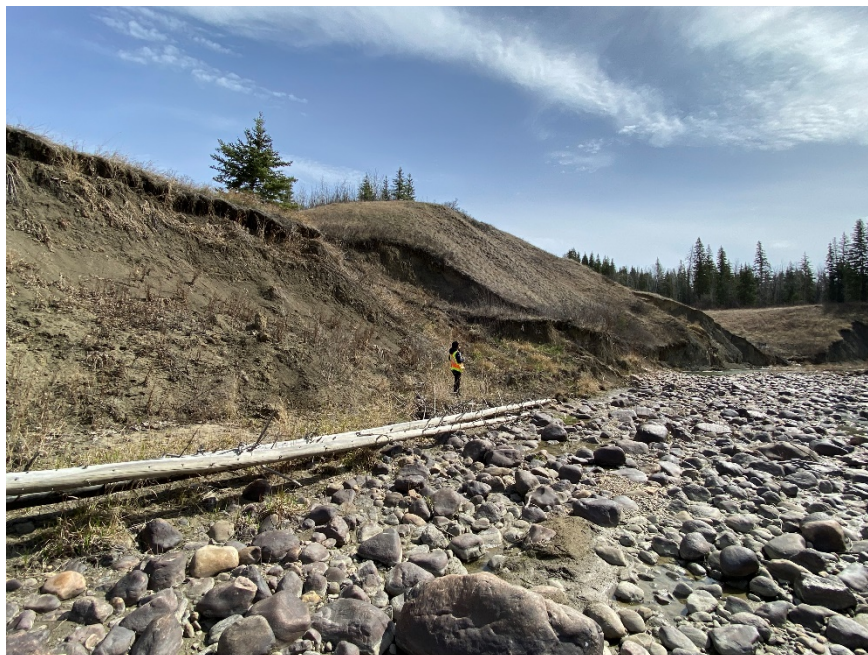
**Photo 2. Looking north east at PH077-1 at the erosion along the north side of the Creek from the creek bed. Photo credit: Don Proudfoot.**

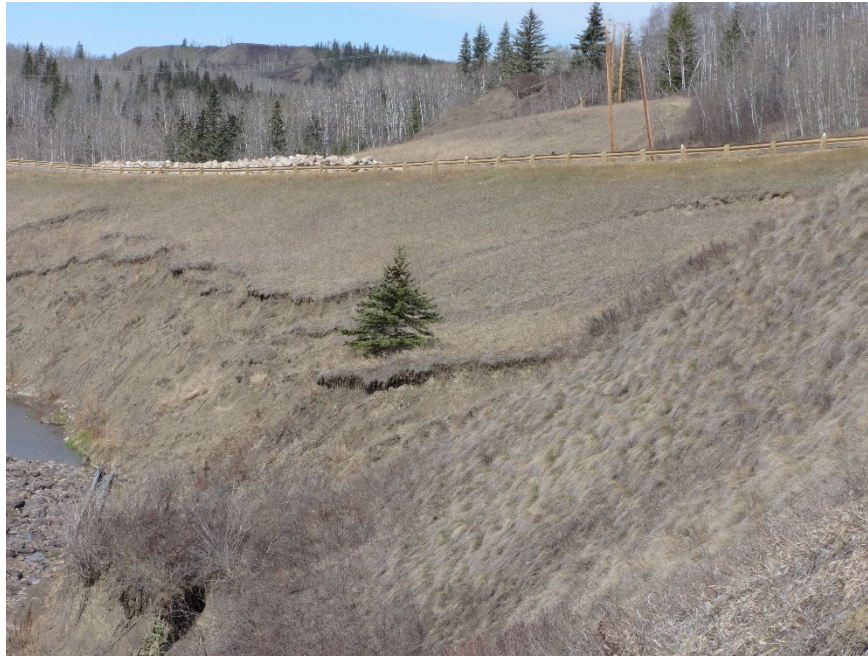
**Photo 3. Looking west at the fresh toe slumping above the creek at PH077-1 in the south highway embankment. Photo credit: Nicole Wilder.**

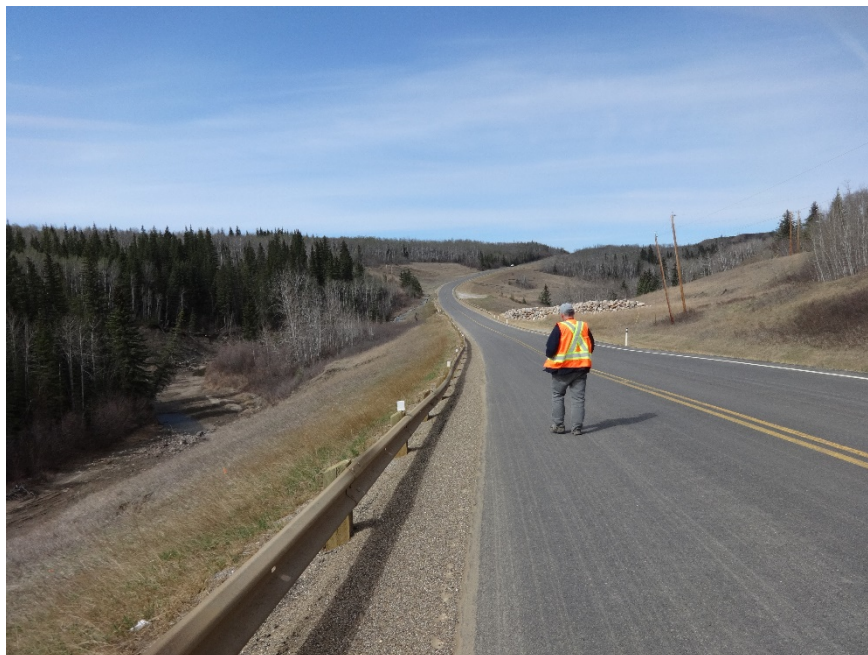
| <input checked="" type="checkbox"/> Pavement Distress | At PH077-1, a 40 m long crack and a 15m long crack (near the east end) existed in the highway and slightly starting to show through the 2023 | <input type="checkbox"/> | <input checked="" type="checkbox"/> |

| | <p>overlay. A noticeable dip exists across a 45 m length of the highway.</p> <p>At PH077-2, cracks are not yet noticeable through the 2023 overlay but a noticeable dip exists across a 40 m length of the highway overtop the SWSP culvert, with another dip existing further east.</p> | | |

**Photo 4. Looking west along the highway at where crack in the highway was (before overlay) above the Slide at PH077-1 The dip is still evident. Photo credit: Nicole Wilder.**

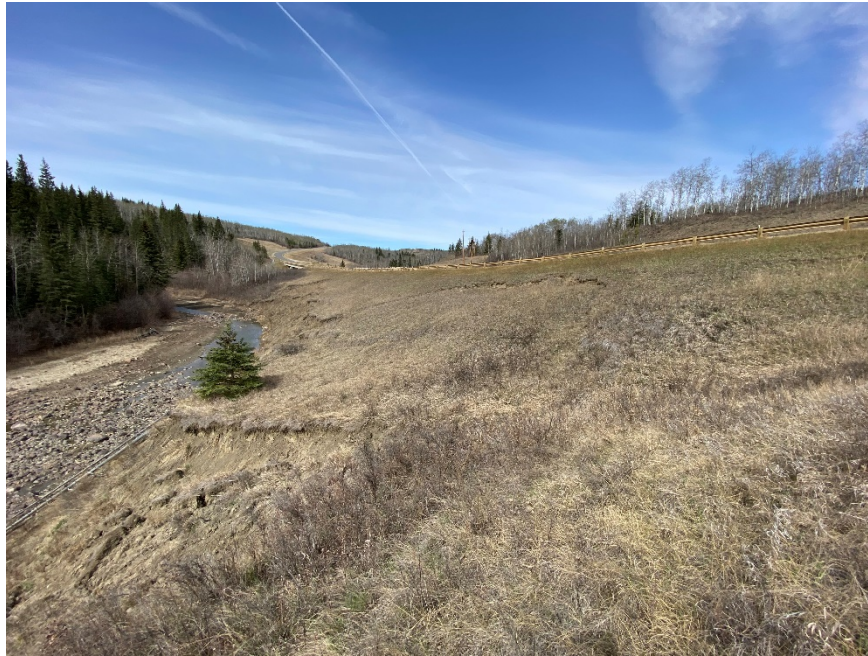
**Photo 5. Looking west at newer slump that developed west of the knob hill. Photo Credit: Don Proudfoot.**

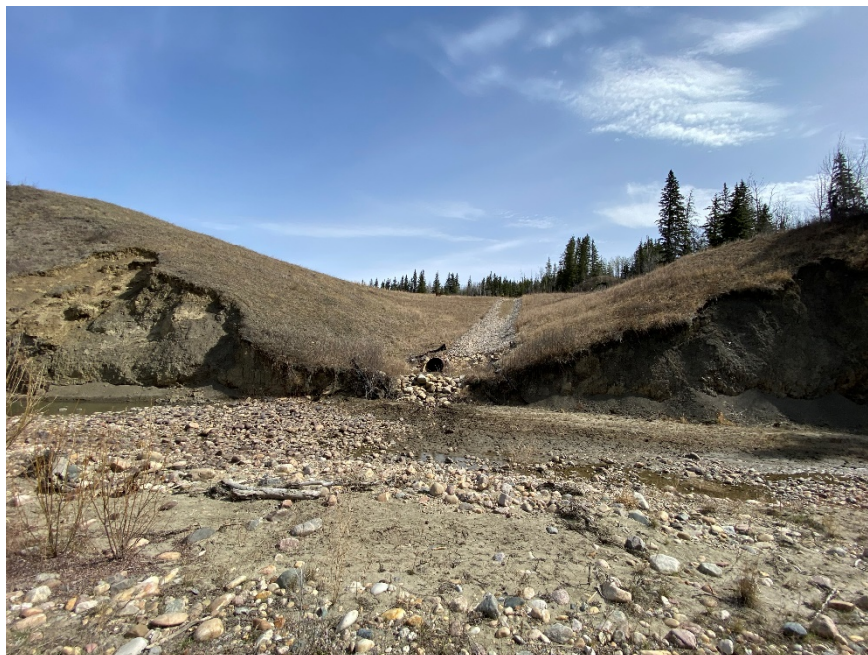
**Photo 6. Looking north at culvert outlet and river bank erosion and sloughing on either side. Photo Credit: Don Proudfoot.**

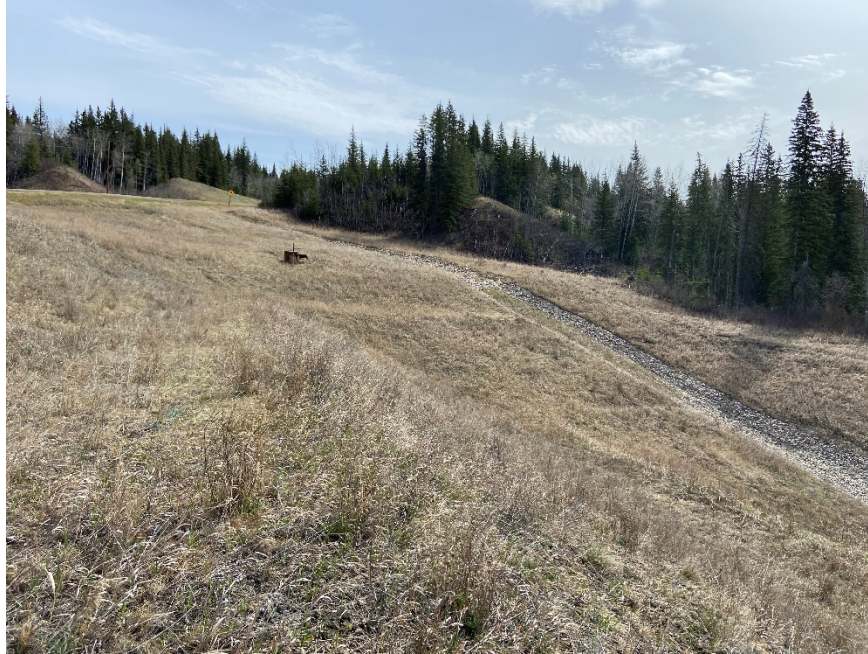
**Photo 7. Looking east at riprap swale into the gabion mattress channel of PH077-2. Photo Credit: Don Proudfoot.**

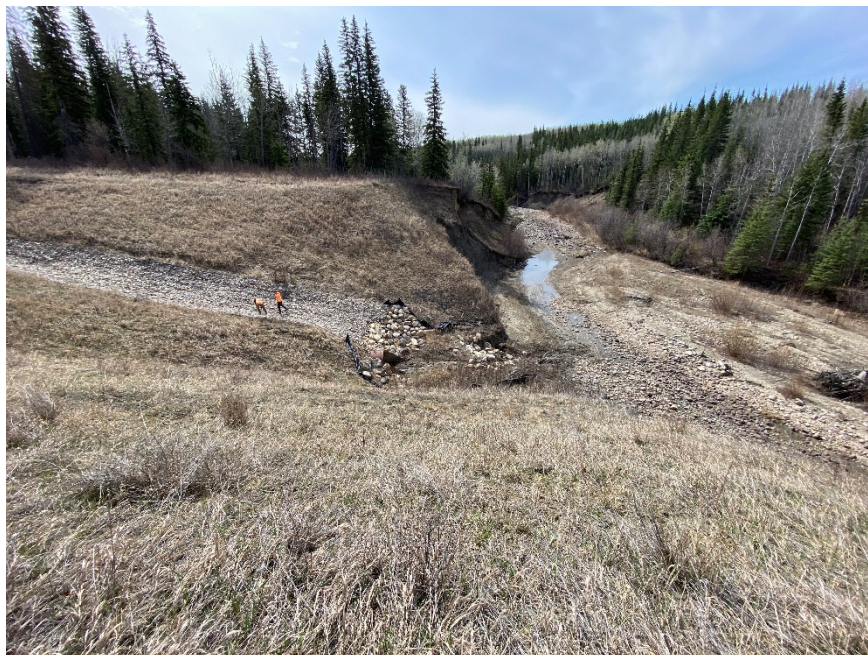
**Photo 8. Looking southeast at the southeast ditch drainage channel of PH077-2, Hines Creek. Photo Credit: Don Proudfoot.**

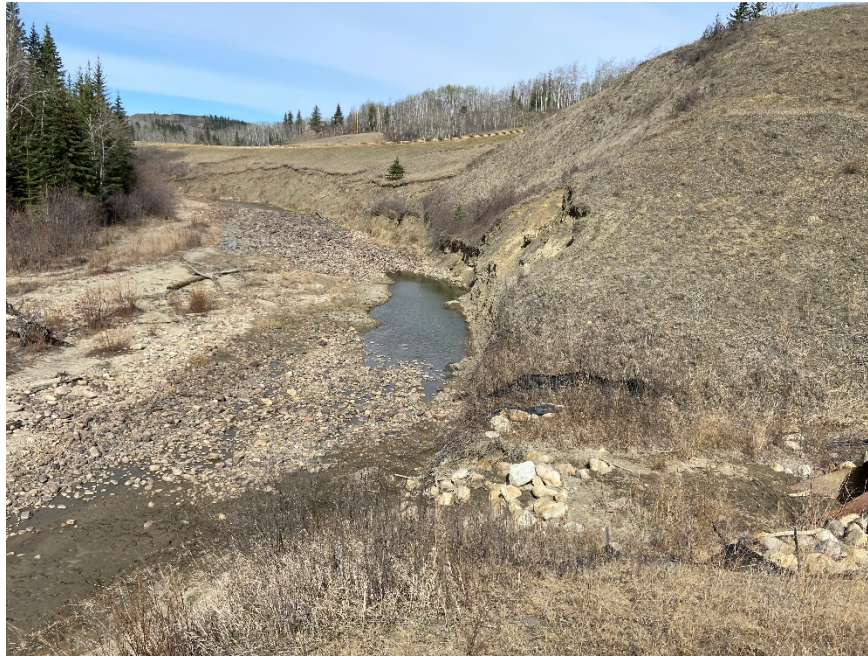
**Photo 9. Looking west at river erosion and culvert outlet area of PH077-2. Photo Credit: Don Proudfoot.**

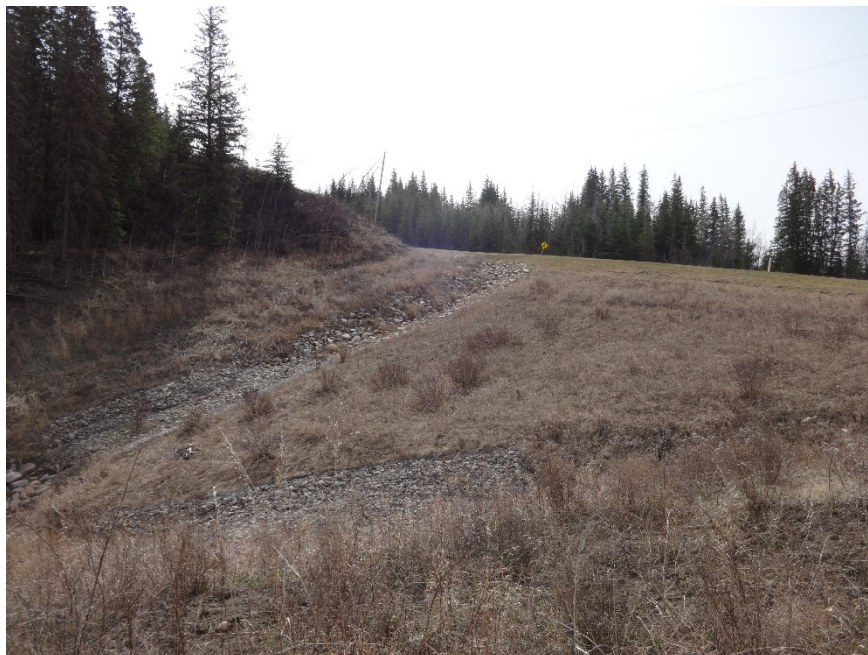
**Photo 10. Looking southeast at the v-shaped ditches on the north side of the highway. Photo Credit: Nicole Wilder.**

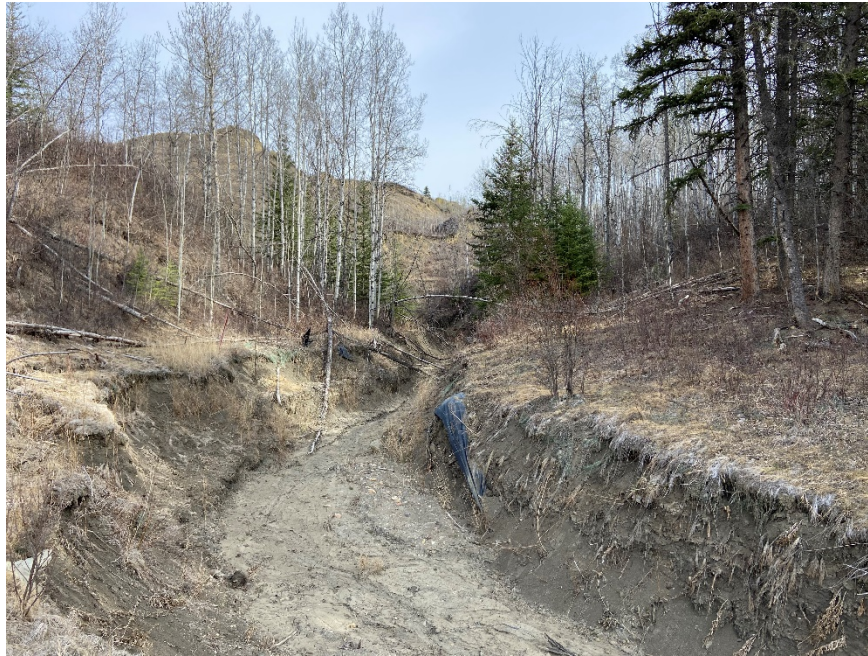
Similarly, cracks in the north embankment slope which previously retrogressed to near the highway also suggest a landslide has developed. This is also supported by a documented crack in the culvert. This landslide was likely triggered by loss of toe support due to erosion caused by the tributary creek. Highway ditch runoff erosion (at the TRM/gabion intersections) may have also been contributing factors.

**Photo 11. Looking north at eroded tributary creek channel leading into the culvert inlet north of the highway at PH077-2. Photo Credit: Don Proudfoot.**

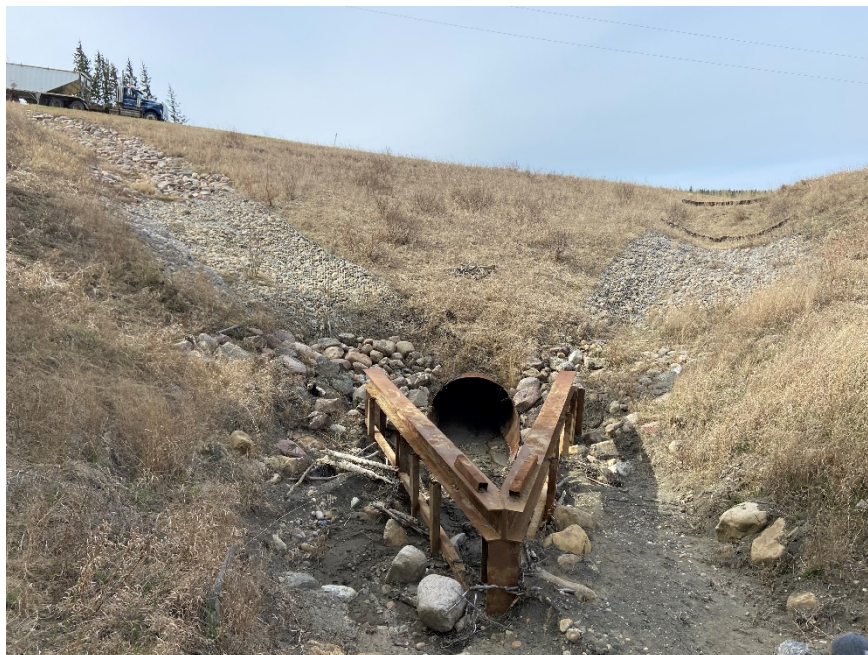
| <input checked="" type="checkbox"/> Bridge/Culvert | The upstream end of the 1.8 m diameter SWSP (BF75380) at PH077-2 was about 0.5 m buried with silt and debris at the drift catcher and the outlet did not appear to be visibly damaged at the time of our inspection but was somewhat buried in silt and had some ice inside. The 2023 bridge inspection noted that the vertical elbow was detaching from pipe, baffles were tearing and there were distortions and cracks/separations within the culvert (along with low ratings) that required struts and plates to be added within the culvert. The report also noted that drift and silt should be removed from pipe and drift catcher. | <input checked="" type="checkbox"/> | <input type="checkbox"/> |

**Photo 12. Looking south at the culvert inlet area at PH077-2, the trash rack appeared half full of debris. Photo Credit: Don Proudfoot.**

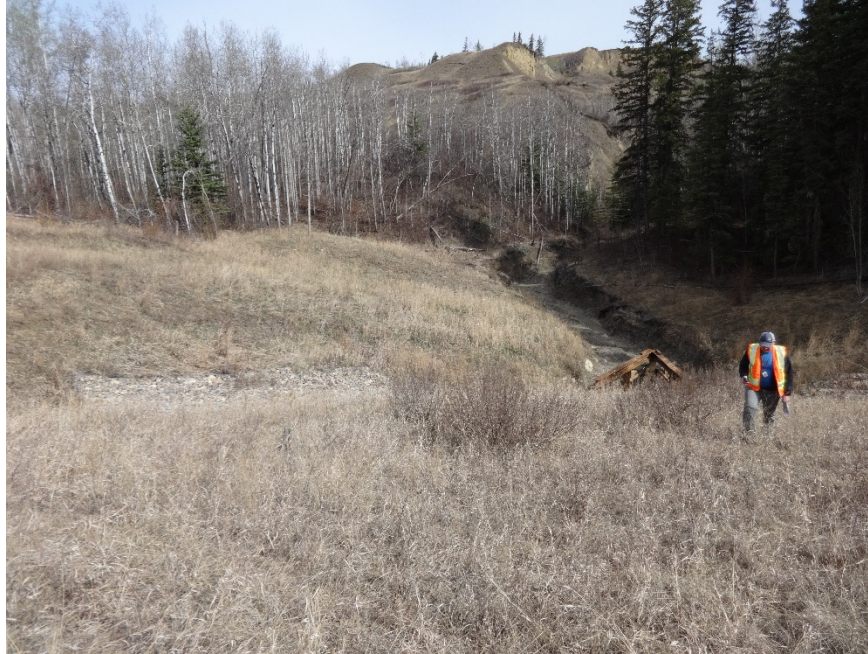
**Photo 13. Looking north at eroded tributary channel, trash rack and upstream slope instabilities north of the highway at PH077-2. Photo Credit: Nicole Wilder.**

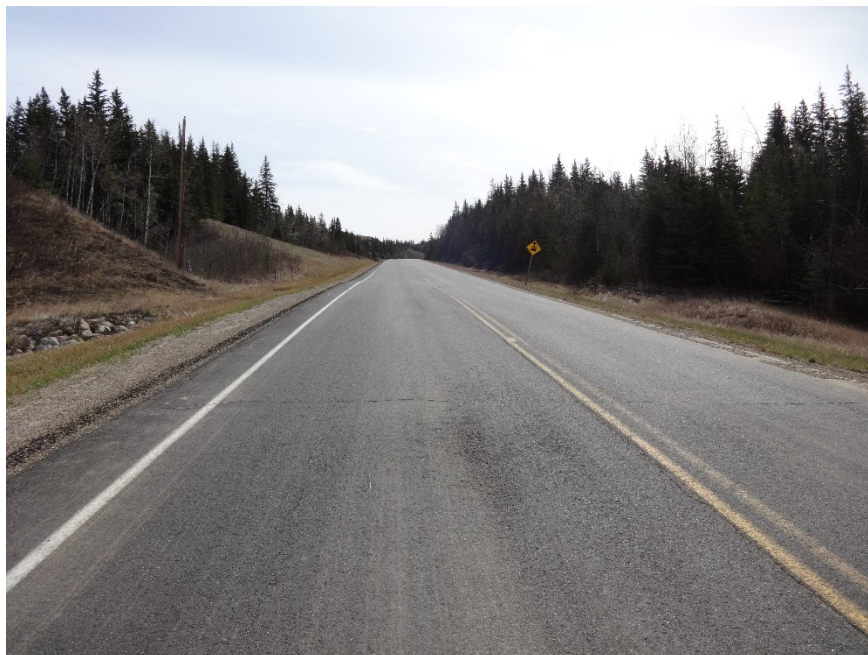
Settlement observed overtop of the culvert at Site 2, in the form of dips and cracks in the highway could be the result of embankment fill settlement but might also be an indication that the slide movement will eventually retrogress towards the highway or has already.

**Photo 14. Looking east at the dip in the highway. Photo credit: Don Proudfoot.**
