Slide Name: (GP 21) SH 719 Henderson Creek (BF 73982)
Inspection Date: June 22, 2004
Inspection By: – Alberta Transportation and EBA Staff listed on Page 1

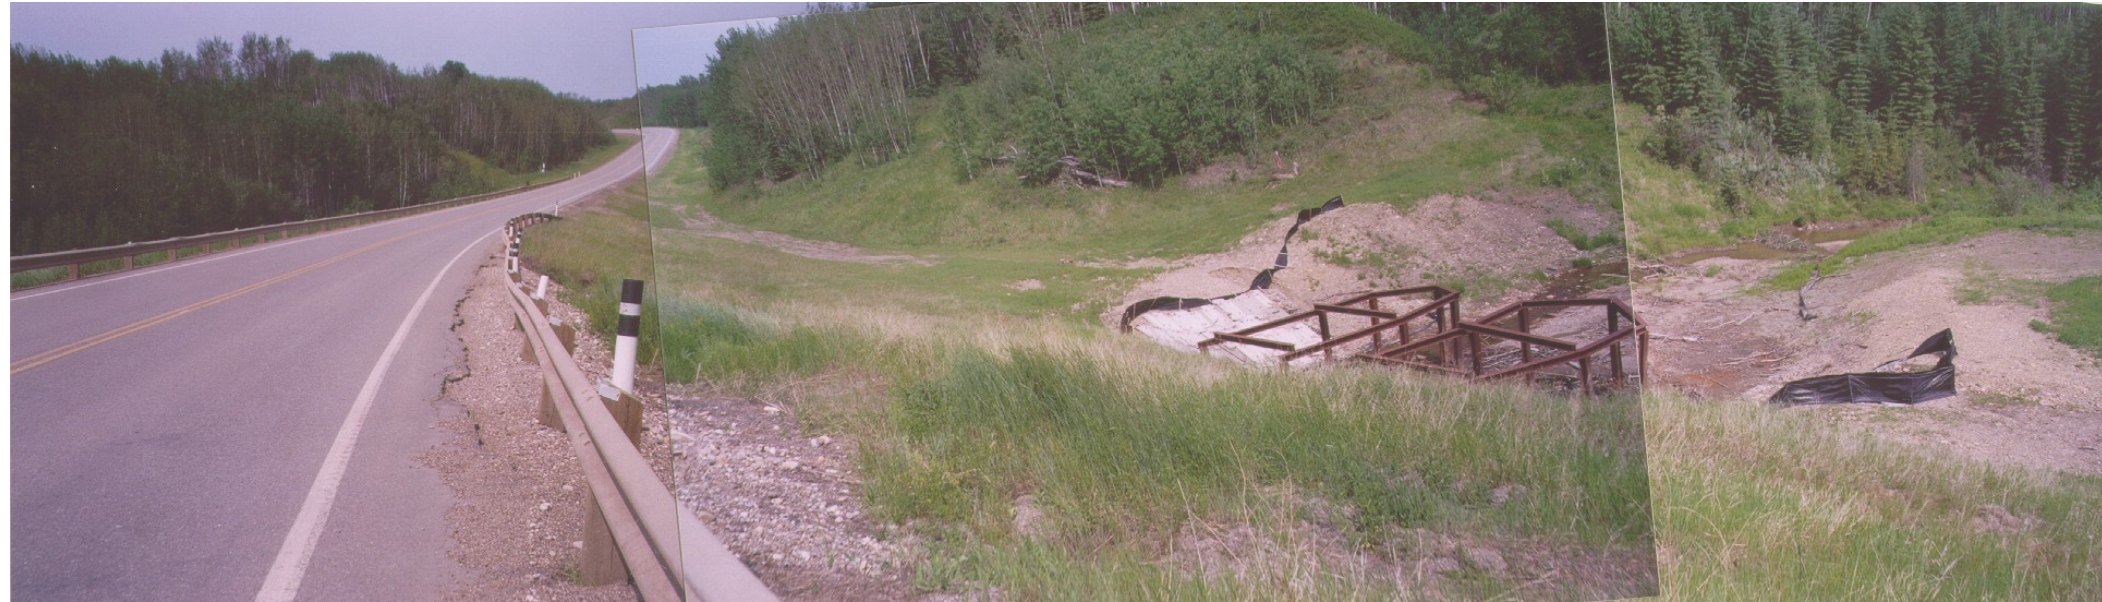
**Photo 1**

- 1) Looking north and upstream
- 2) Drift accumulation at culvert inlet was cleaned out; only minor drift accumulation remaining
- 3) Pre-cast concrete slab installed at toe area
- 4) Shoulder (previous headscarp drop area) infilled with a gravel fillet

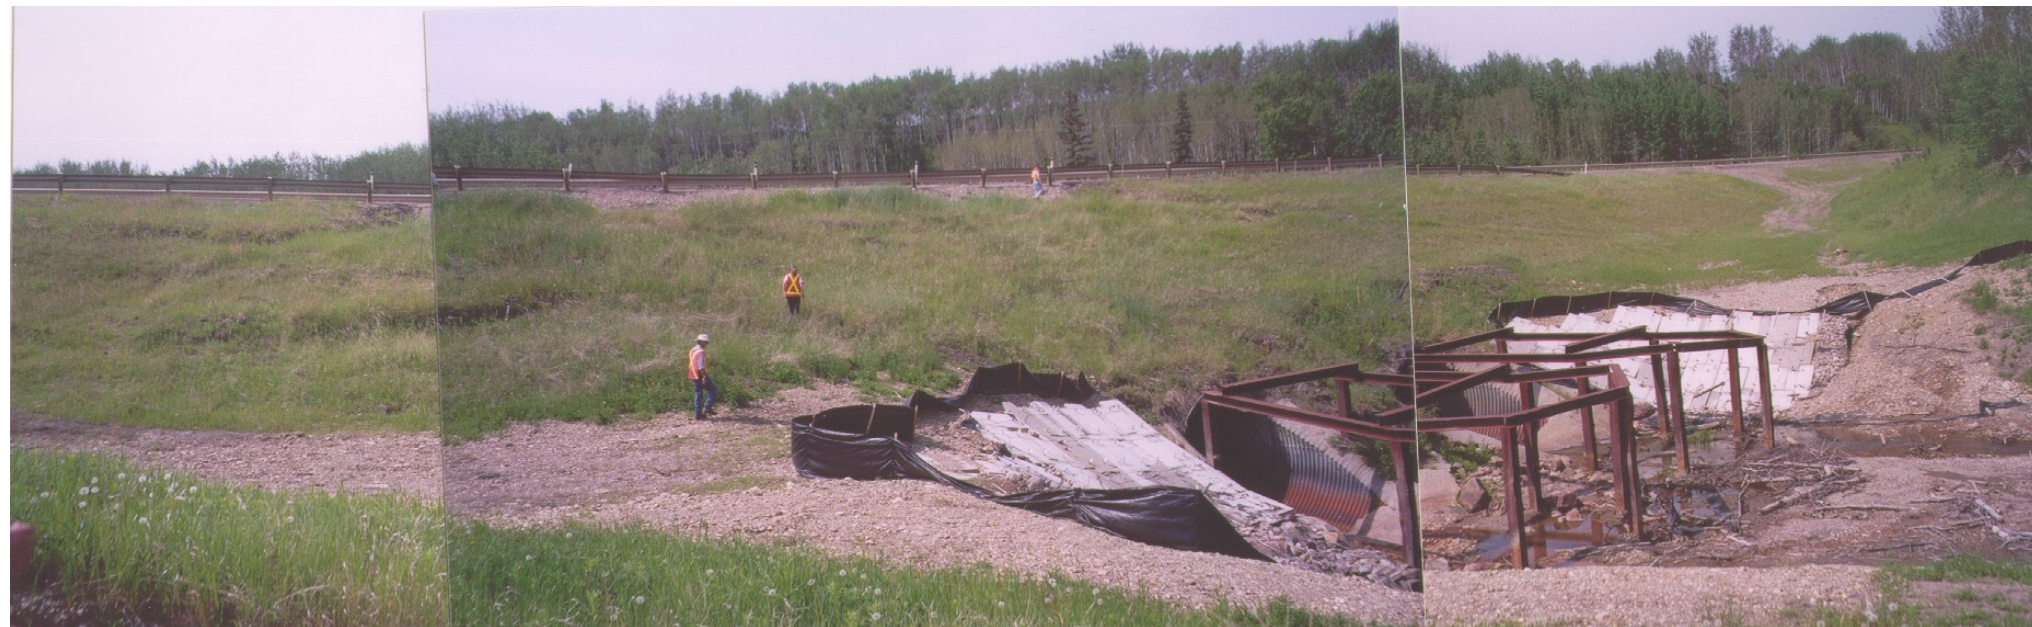
**Photo 2**

Looking west at upstream slope (Slide)

- 1) Recent installation (winter 2003) of armour protection of toe area using precast concrete slabs tied together with wire
- 2) Gabion basket constructed along perimeter sides of the pre-cast concrete slabs

- Visual monitoring of this site should be carried out regularly by maintenance staff.
- The temporary toe protection works (as constructed by AT Bridge Engineering) should be visually monitored for signs of future toe erosion and sliding because the buried organic material was not excavated at the slope toe area.

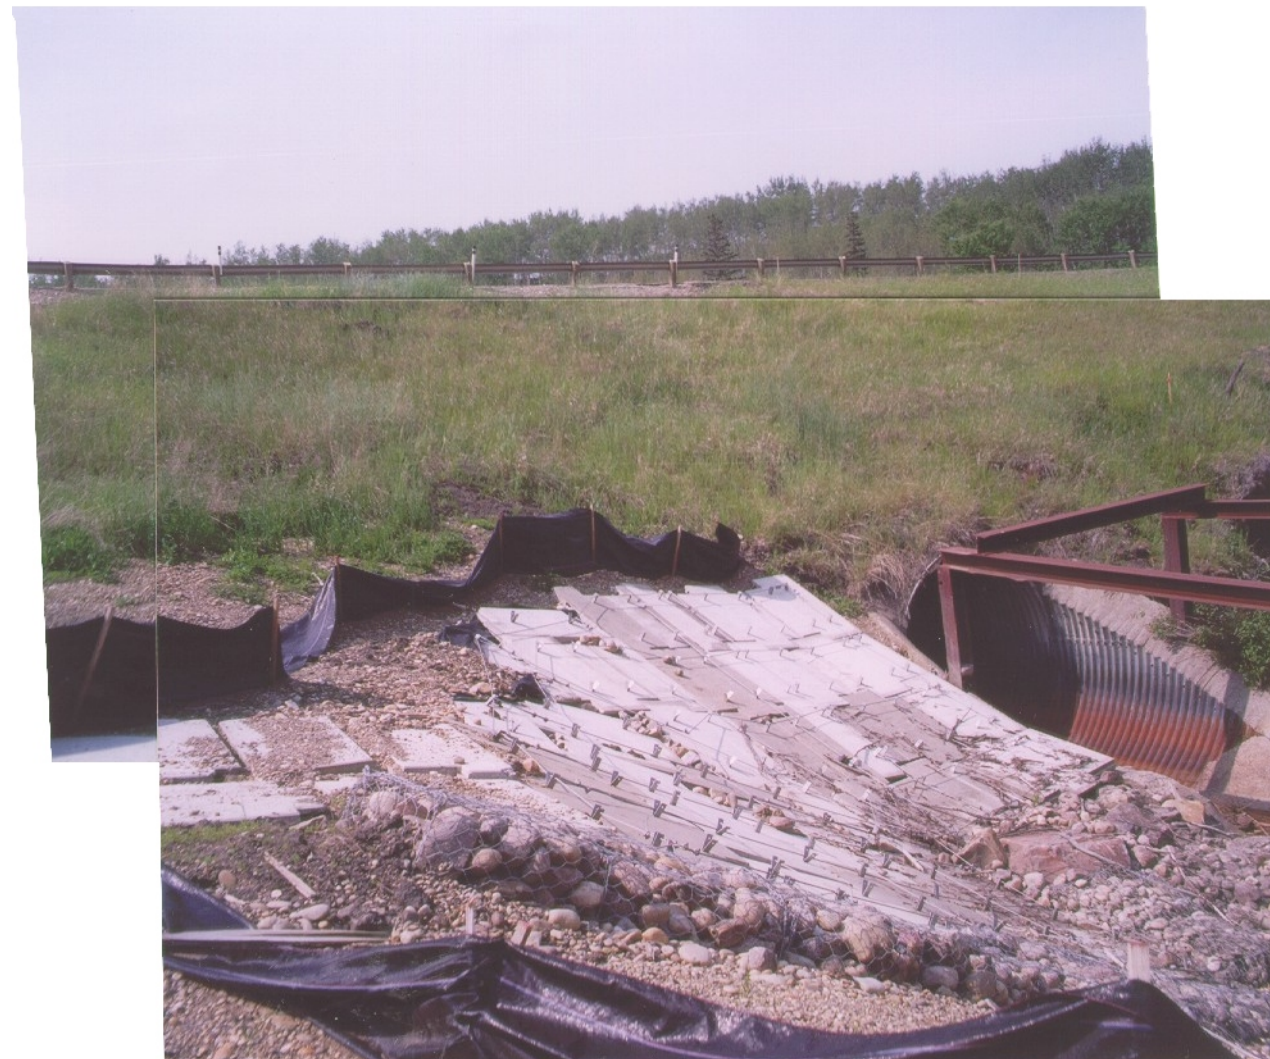
Photo 3

Close-up of toe armour installation of pre-cast concrete slab with gabion basket along its side edges.
