**BRIEF FILE SUMMARY  
(LANDSLIDE RISK ASSESSMENT)**

| 1) | <b>Site (GP21)</b> | SH 719 Henderson Creek Slide (BF73982) |
| 2) | <b>Reference Location along Highway:</b> | SH 719 Approach fill over double culvert (BF73982) |

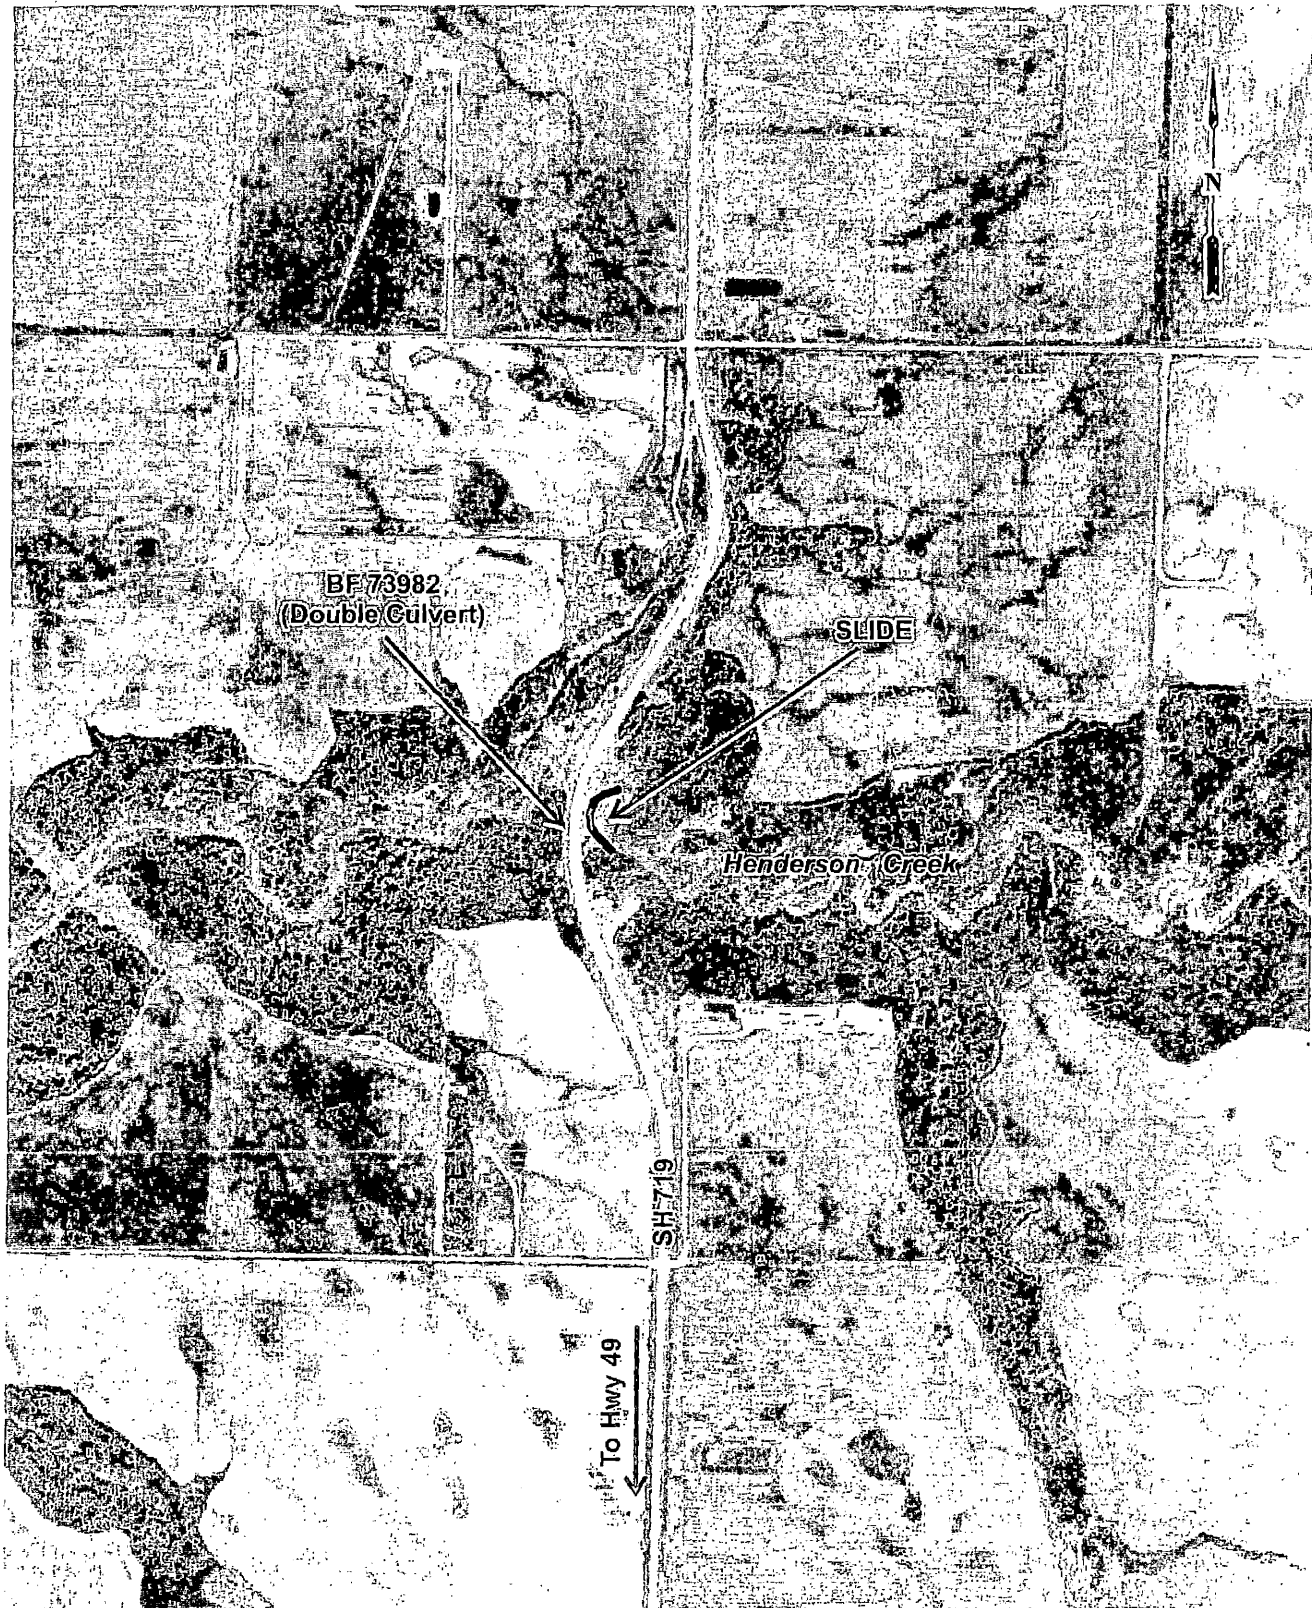
Figure 1

2001 Aerial Photograph
