File: 2012-1002-Callout

Date: Sept 1, 2014

Re: **Call-out Inspection Report** (Currently GP-21a- Erosion of w. ditch of N. Approach)
(Previously GP-21 Slide at previous twin culvert)
Hwy 719:02 at Henderson Creek Bridge
- Erosion distress along
Site (1) west ditch (riprap) down valley along North Approach to bridge
Site (2) east ditch (grassed) down valley along North Approach to bridge

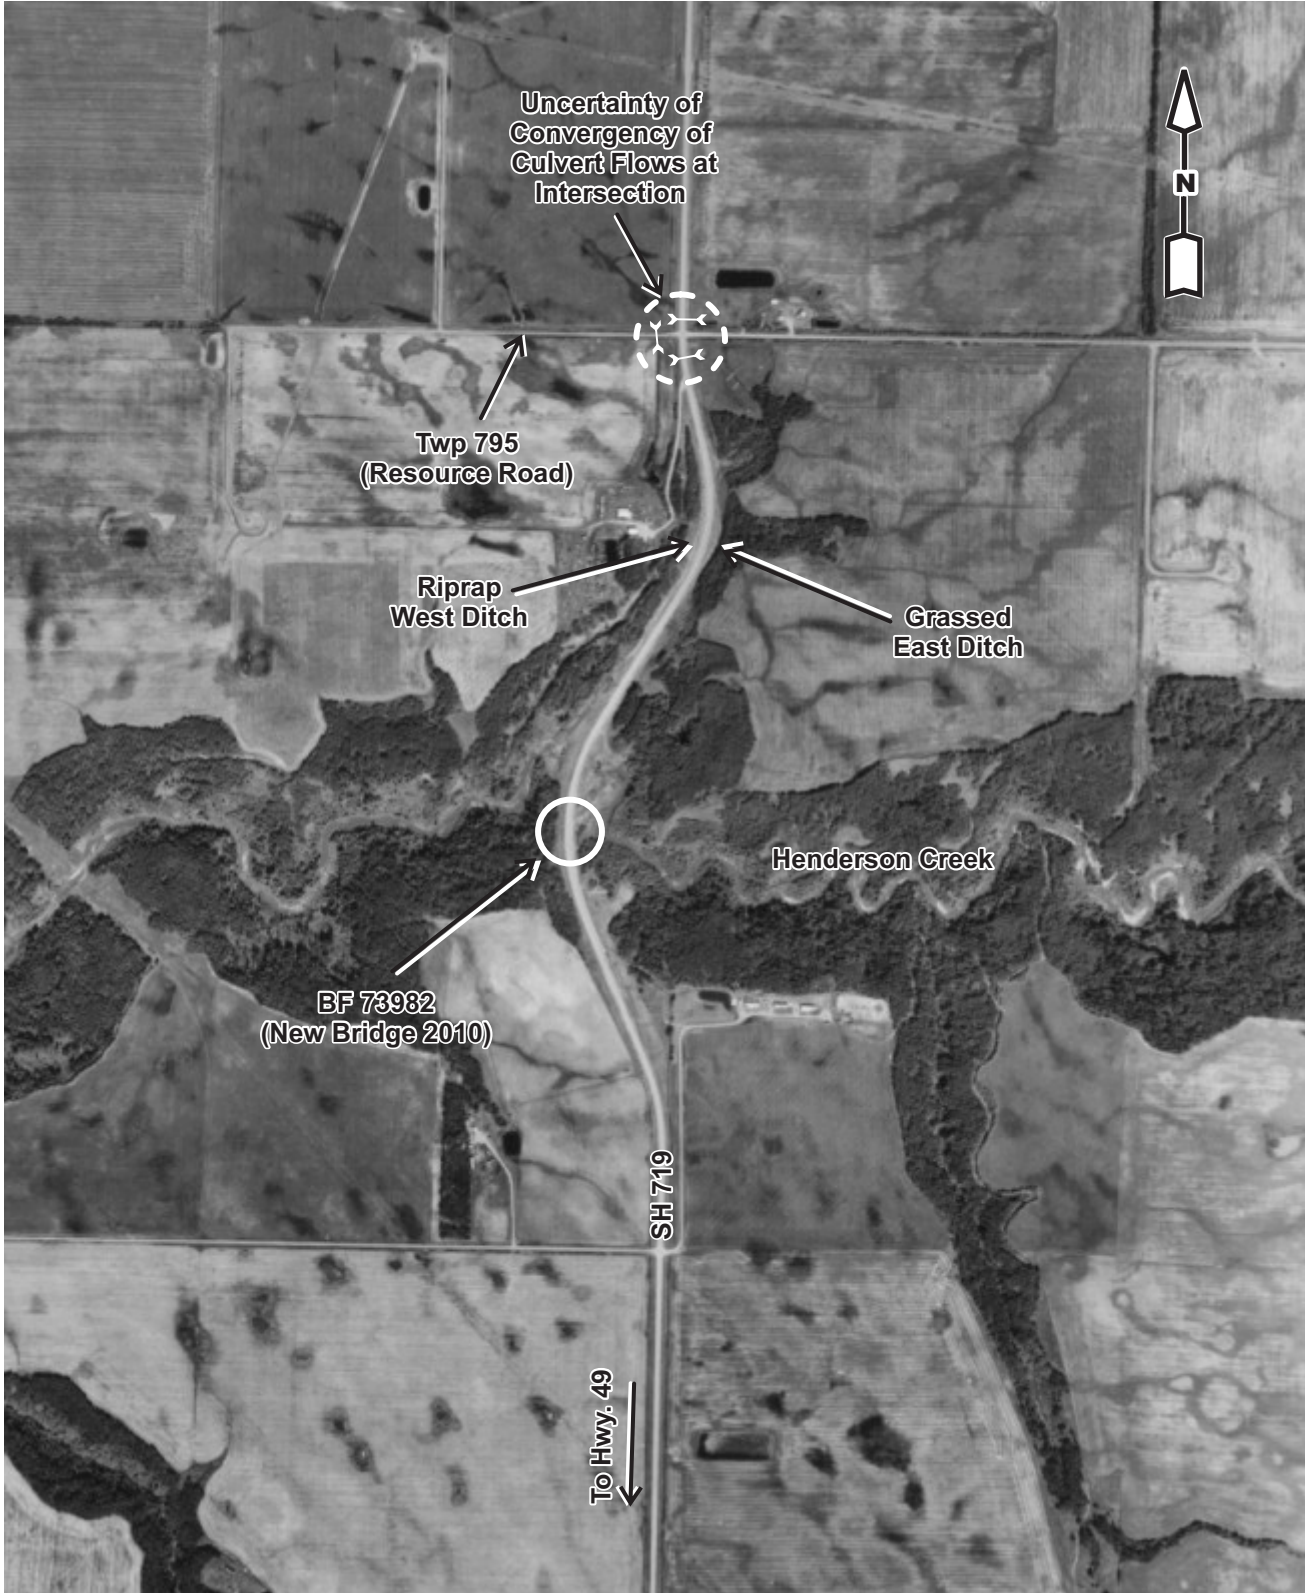
Figure 1
Aerial Photo
Site Location Plan

As indicated in Figure 1 (Site Location Plan), there were two ditches on opposite sides (west and east) of highway descending about 800m distance down the valley slope along its north approach to the new bridge. Along the west ditch, new riprap channel lining and some minor channel trimming-widening were evidently constructed along the west ditch during the 2009-2010 times of new bridge construction. It was apparent some design effort was exerted for such riprap ditch lining constructions (likely constructed as per design). Some areas of west ditch might have been widened to provide channel hydraulic section improvements. Along the opposite east ditch, the ditch was grassed and of narrower channel widths, likely of old vintage untouched ditch conditions (likely old times prior to 2010 bridge construction). In general, it was apparent that no substantial changes were made to the gradeline and channel sections along both ditches along this north downvalley approach (during the 2009-2010 time of new construction of bridge). Thus, the ditch gradeline down this north approach roadway should have remained unchanged overtime.

- As indicated in Figure 1. It was observed that a bundling of the culverts can be located at intersection at valley top (Hwy 719 junction with Twp 795 road) and there may be a likelihood (uncertainty) that excessive flows were converged from the culvert arrangements thereof. This needs to be further investigated.

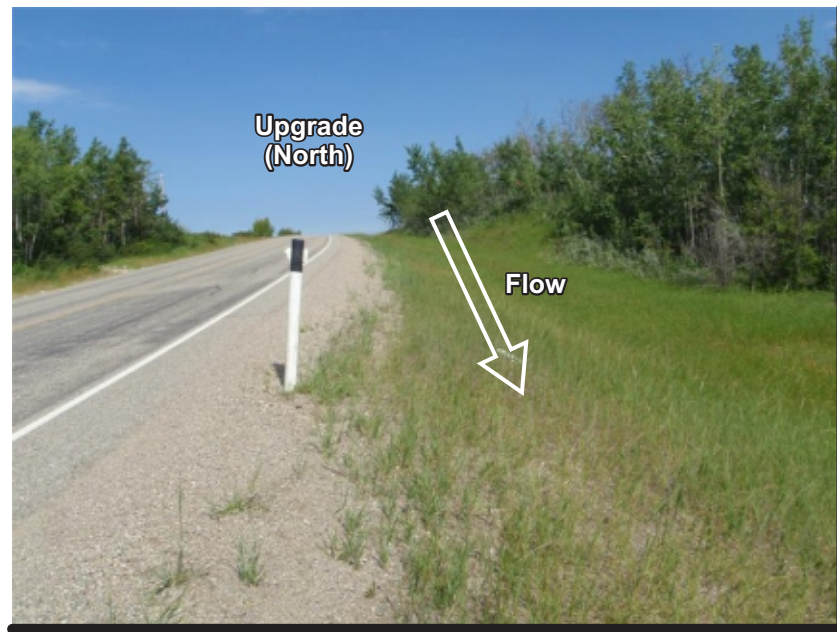
Photo 1

Looking north upgrade towards upland – Highway start its descend of north valley slope

- Ditch not sustaining erosion distress and apparently less flow transmitting along this east ditch
- East (grassed) ditch going down the north slope
- Width bottom grassed ditch is of trapezoidal width at top portion of valley slope

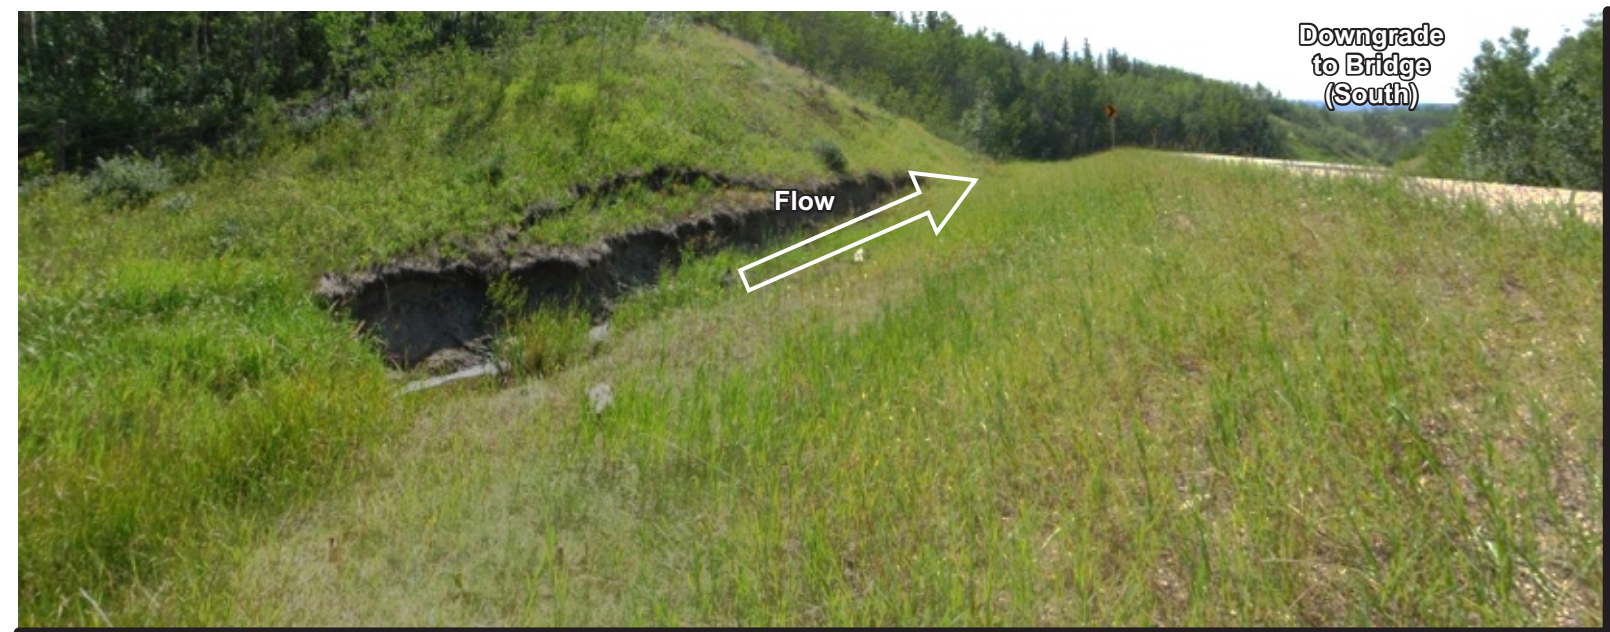
Photo 1a

Looking south downgrade at east (grassed) ditch – upper portion of north valley approach

- Erosion of this grass lining ditch has started already despite a wider ditch section and a gentler grade (at some distance downgrade from top of valley)

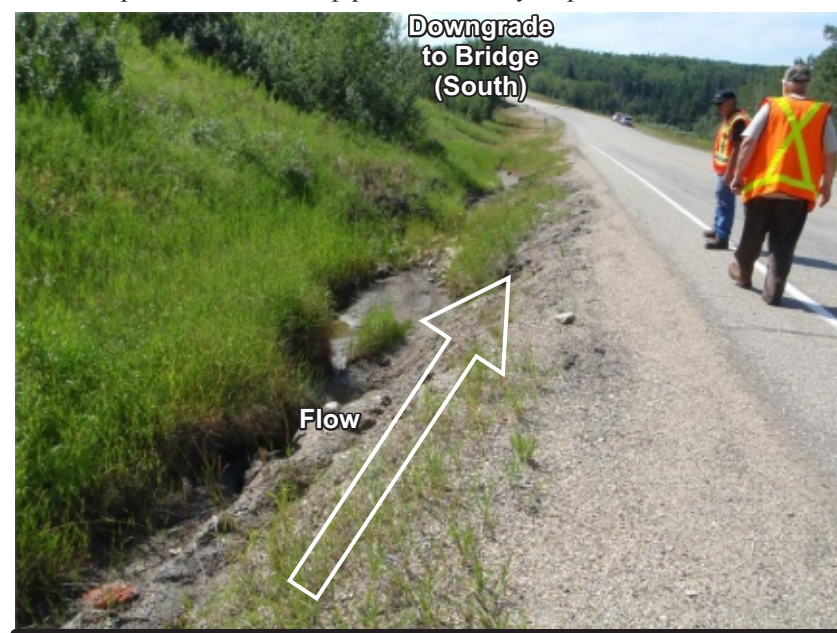
Photo 1b

Looking south downgrade at east (grassed) ditch – descending down north valley approach

- Narrower V ditch and higher cut slope above
- Erosion rilling is occurring (at some distance downgrade from top of valley)

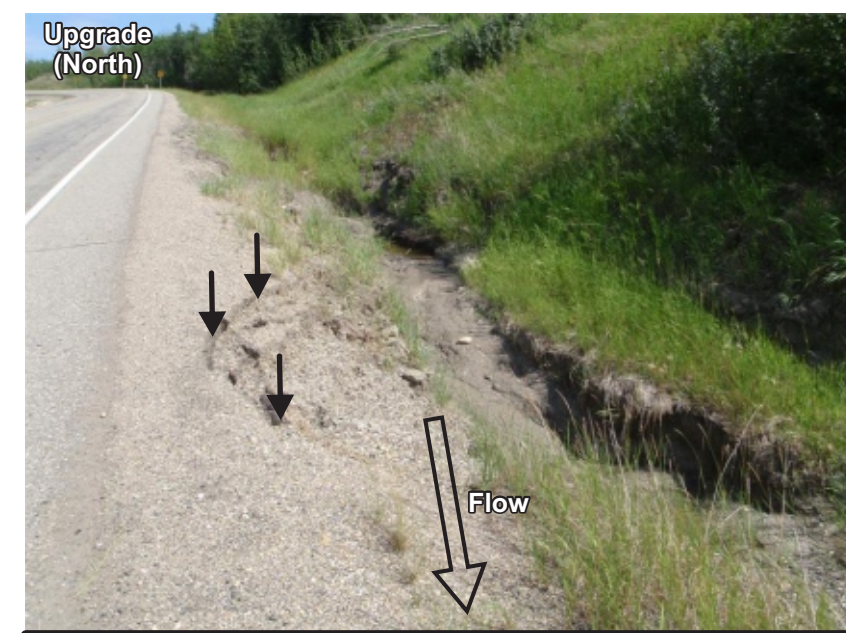
Photo 1c

Looking north upgrade at east (grassed) ditch erosion – descending down north valley approach

- Another upgrade view (reverse of Photo#1b)
- Rilling erosion of ditch (at some distance downgrade from top of valley)

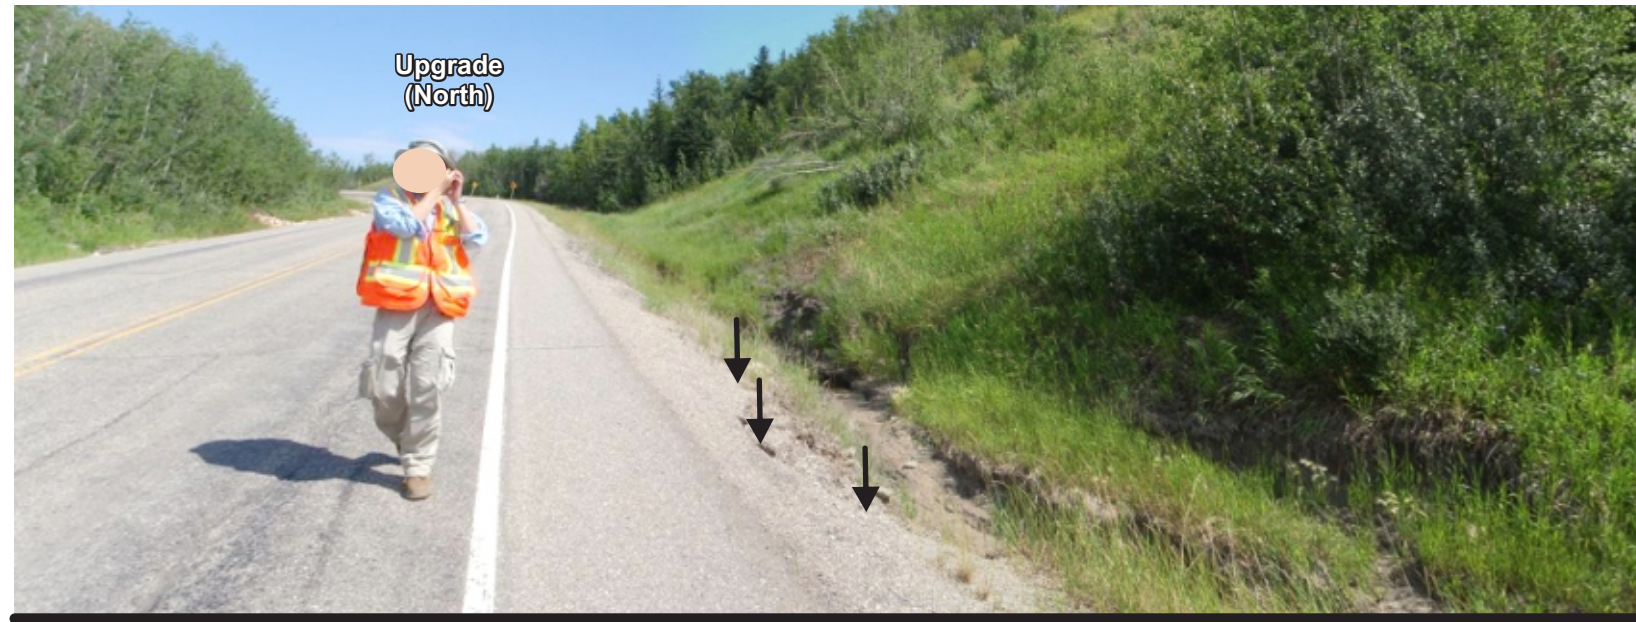
Photo 1d

Looking north upgrade at east (grassed) ditch erosion - Another view

- Sloughing of sideslopes as a result of ditch erosion
- Sloughing of sideslope due to incising erosion rilling of a V ditch
- Sideslope can be pragmatically repaired with benching infill with erosion resistant granular materials

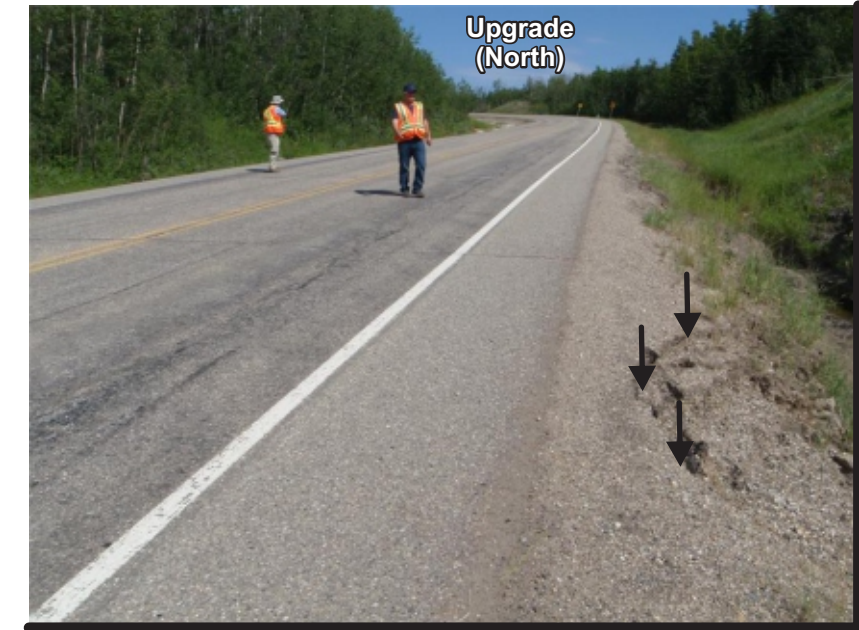
Photo 1e

Looking north upgrade at east (grassed) ditch erosion - Another view

- Sloughing of sideslopes as a result of ditch erosion
- Sloughing of sideslope due to incising erosion rilling of a V ditch
- Sideslope can be pragmatically repaired with benching infill with erosion resistant granular materials

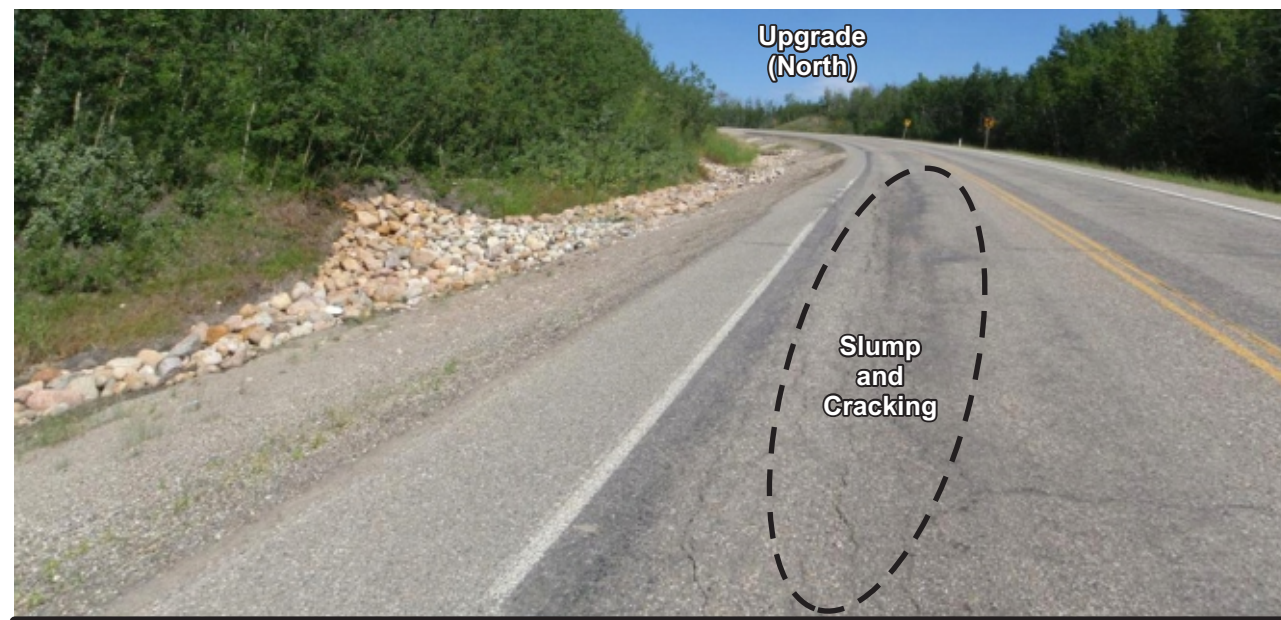
Photo 2

West ditch- Looking north upgrade – a general view of riprap lining ditch

- Channel constructed with riprap (M-1 stone) lining and rock and gabion checks to accept flow
- Ditch of trapezoidal width to increase hydraulic radius to minimise flow erosion energy
- Heavy Industrial Traffic (illegal weights) may have caused rutting subsidence settlement (foundation failure) of pavement structure at locations. A very likely scenario

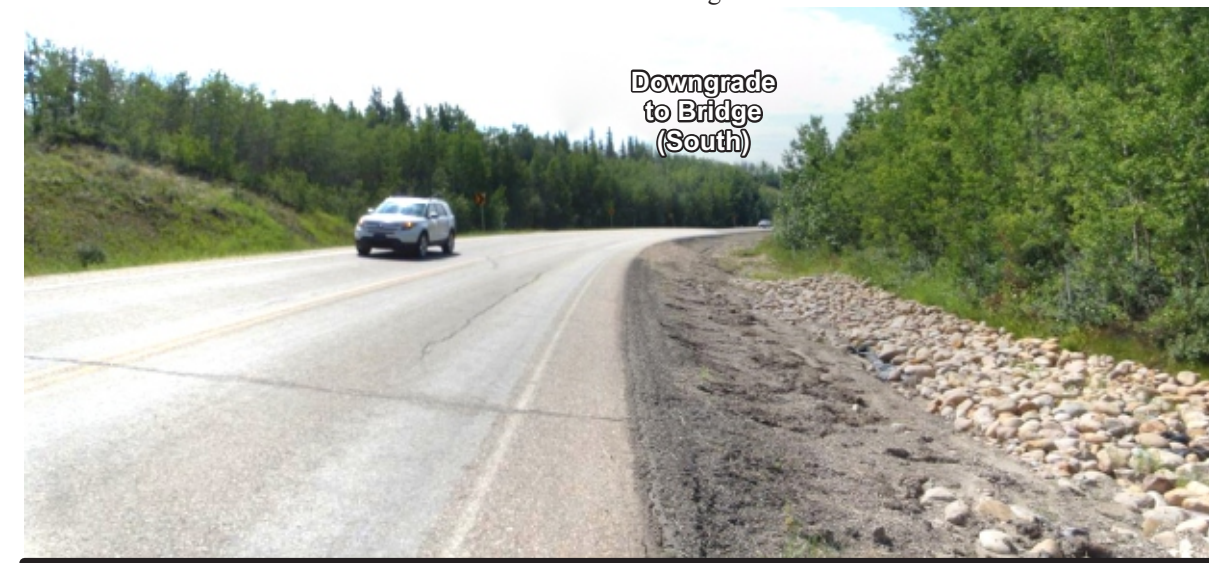
Photo 2a

West ditch with riprap lining and rock and gabion checks – erosion+sideslope sloughing

- Heavy Industrial Traffic (illegal weights) may have caused rutting subsidence settlement (foundation failure) of pavement structure at locations. A very likely scenario.
- Some rilling erosion occurring alongside edge of riprap lining
- Some sloughing of sideslope transgressed up the edge of roadway
- Substantial flow apparently transmitting along this ditch
- Riprap stone mostly of M-1 size; gabion drop structure in fair conditions
- Flow path has shifted out of its intended channel lining channel and flow occurring along weak soil along edge of rock lining

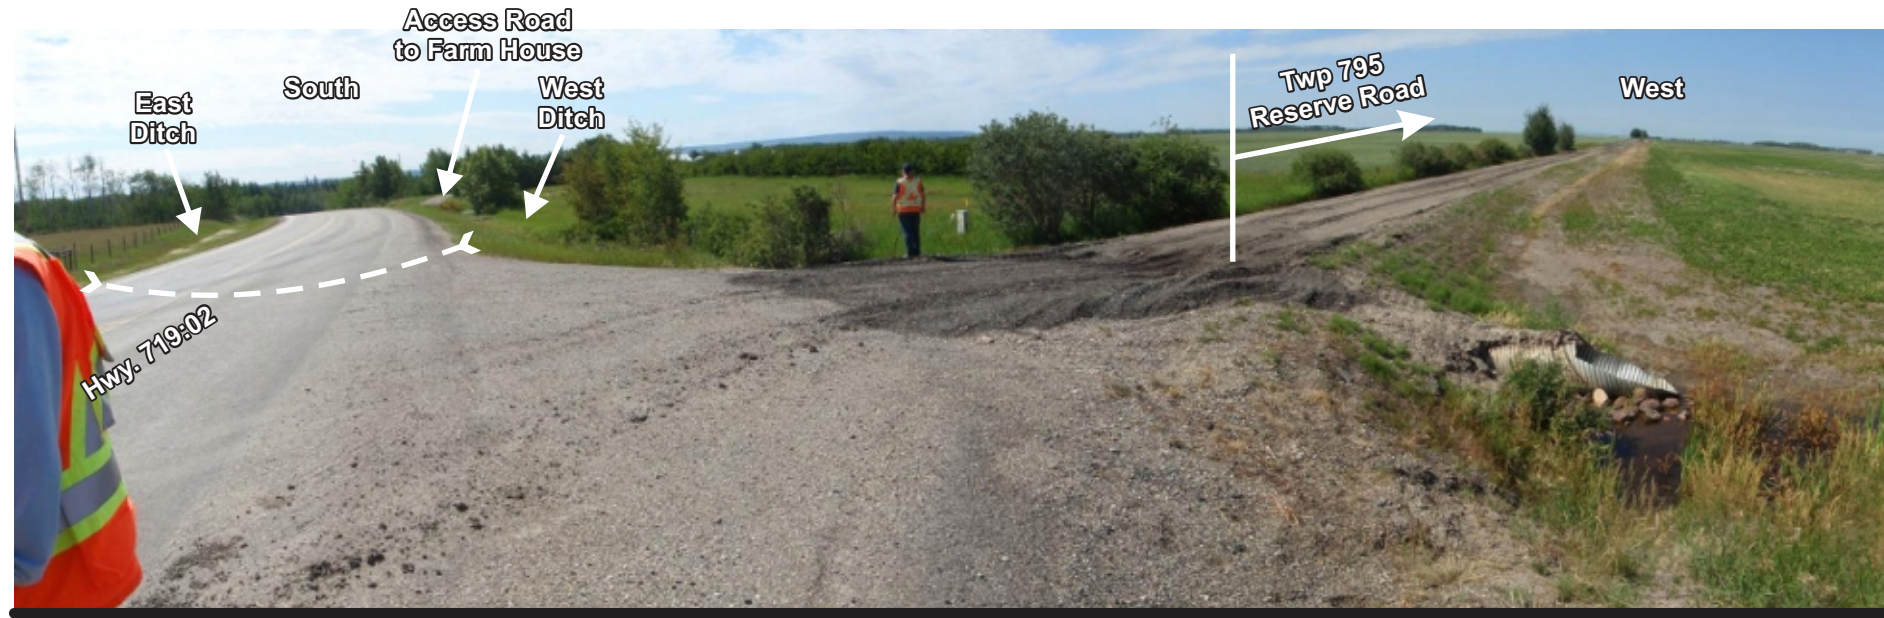
Photo 3

Upland ditch flow convergence can be source of overloading flows to erode onto a ditch (west ditch of Hwy. 719)

- Ditch flow convergence at Intersection at north valley top of Henderson Creek may be problematic culprit to converge high flow amount onto the west ditch
- Culvert layout at Intersection of Hwy 719:02 and Twp 795 Road needs to be reviewed on outflow/onflow distribution from down valley from uplands
- West ditch of Hwy 719:02 likely accepting high flows converged from along Twp 795 road (both from east side and from west side).
- A need to review the convergence of ditch flows down this west ditch of Hwy 719

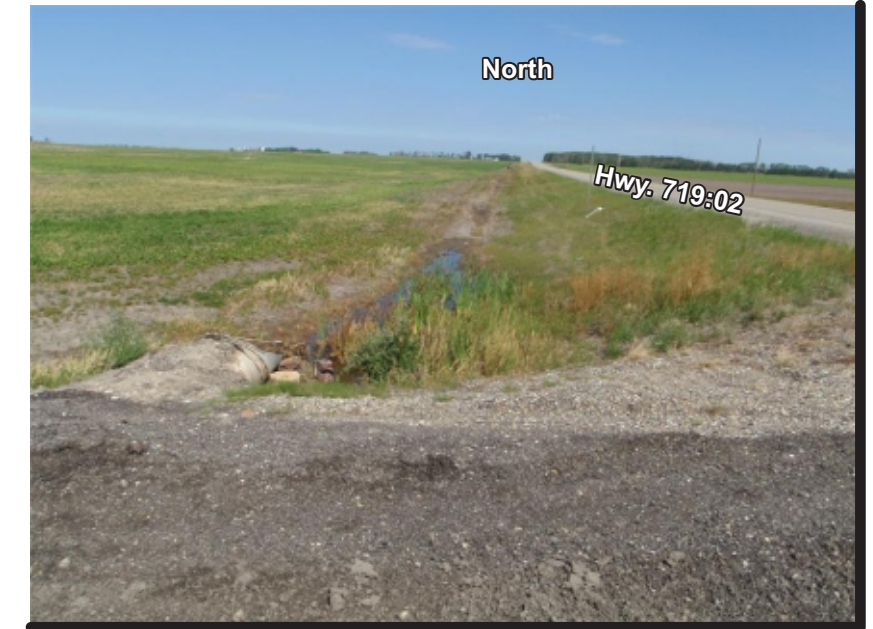
Photo 3a

Twp 795 Resource road (east/west)

- Apparently the damming up waters by Twp 795 Resource road embankment may have converged upland waters to flow into Hwy 719 west ditch
- Need to check any cross drainage culvert constructed along Twp 795 R. road for equalizing flows on its both sides (north to south)

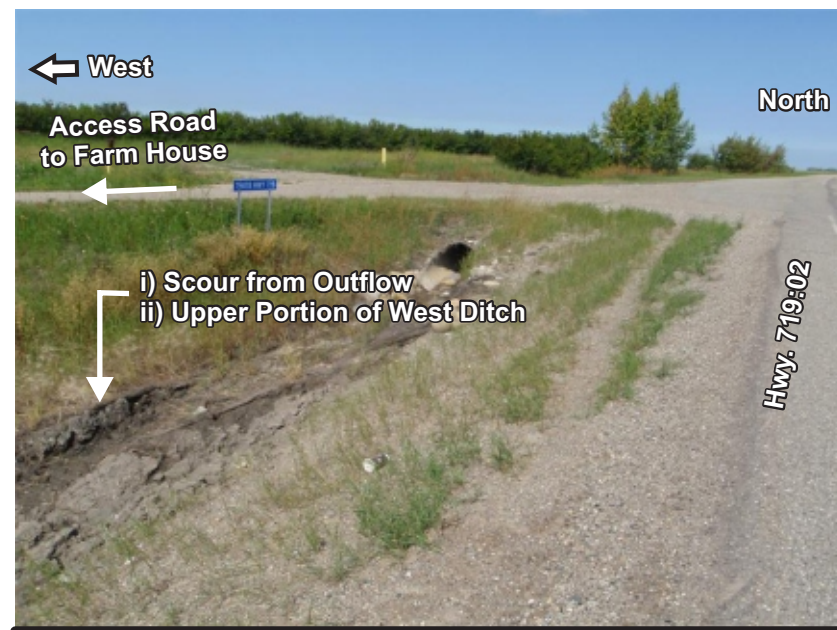
Photo3b

Looking north (at access to farm house) – an access culvert to channel flow onto west ditch

- Culvert apparently under full flow distress to scour flow onto west ditch
- A need to review actual flows accepted onto this west ditch via this culvert

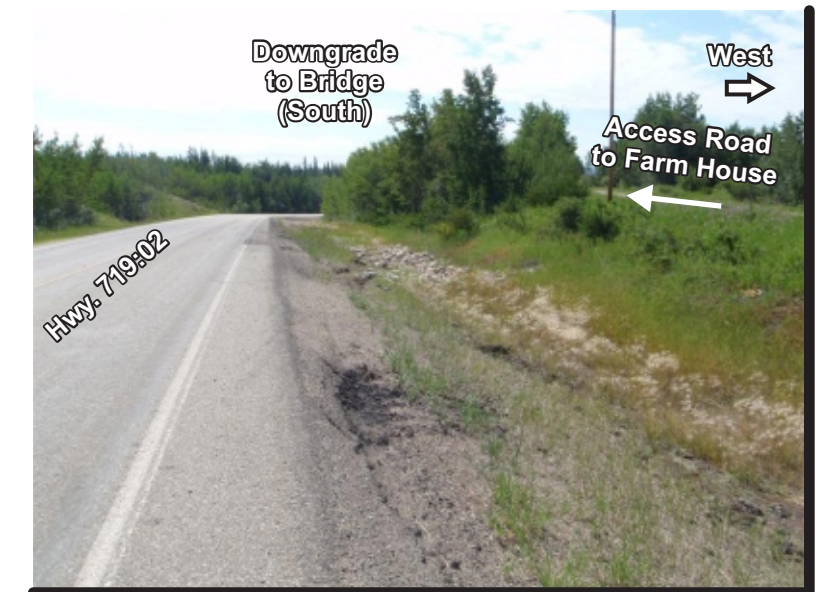
Photo 3d

West ditch at top verge of valley and edge of uplands

- Ditch sideslope sloughing apparent under some erosion scour likely from snow windrow melt erosion effect
- Sideslope distress can be repaired with bench in filling with gravelly erosion resistant material to restore sideslope

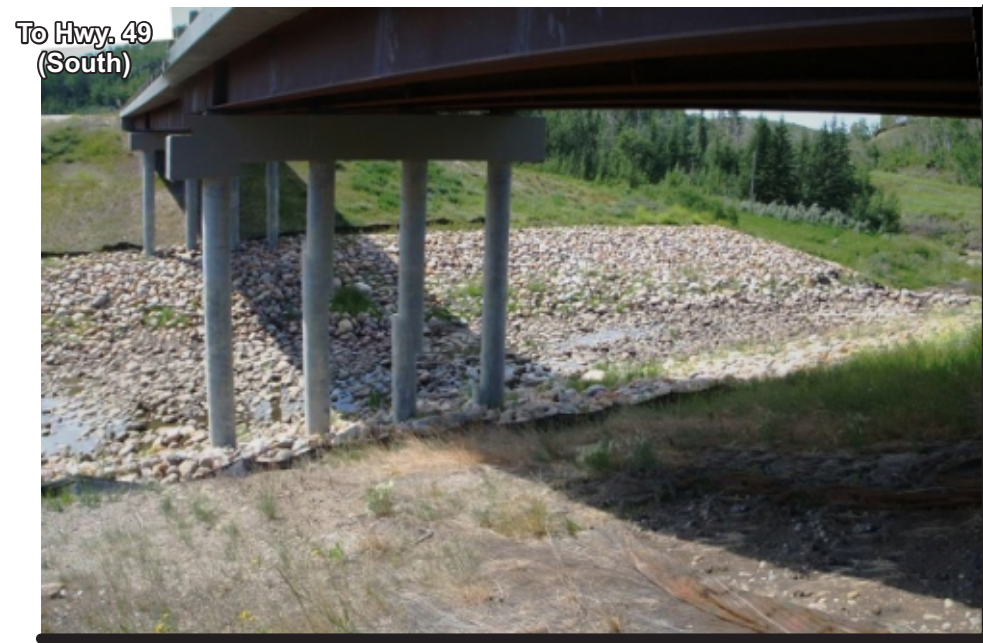
Photo 4

A new bridge (an early 2000 construction)

- New creek channel restored (previous a twin culvert construction) under the new bridge
- Headslope and downflow drains in good conditions

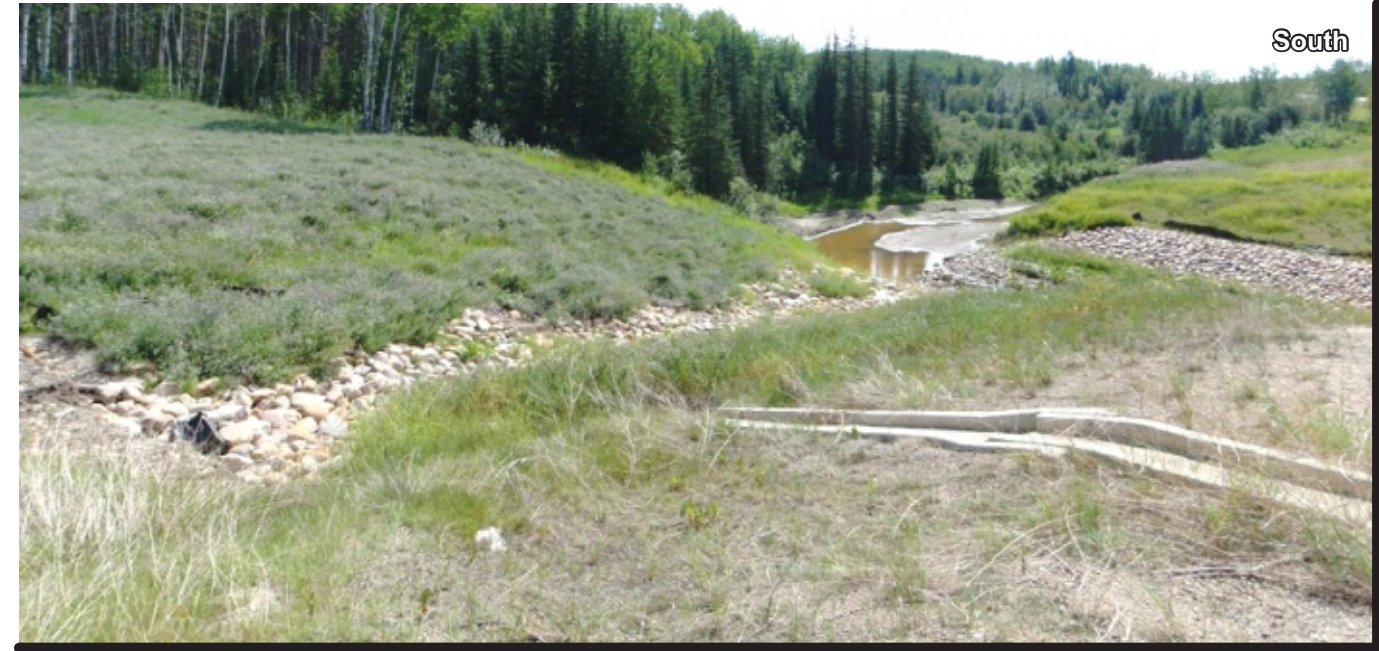
Photo 4a

A new bridge (an early 2000 construction)

- New creek channel restored (previous a twin culvert construction) under the new bridge
- Headslope and downflow drains in good conditions

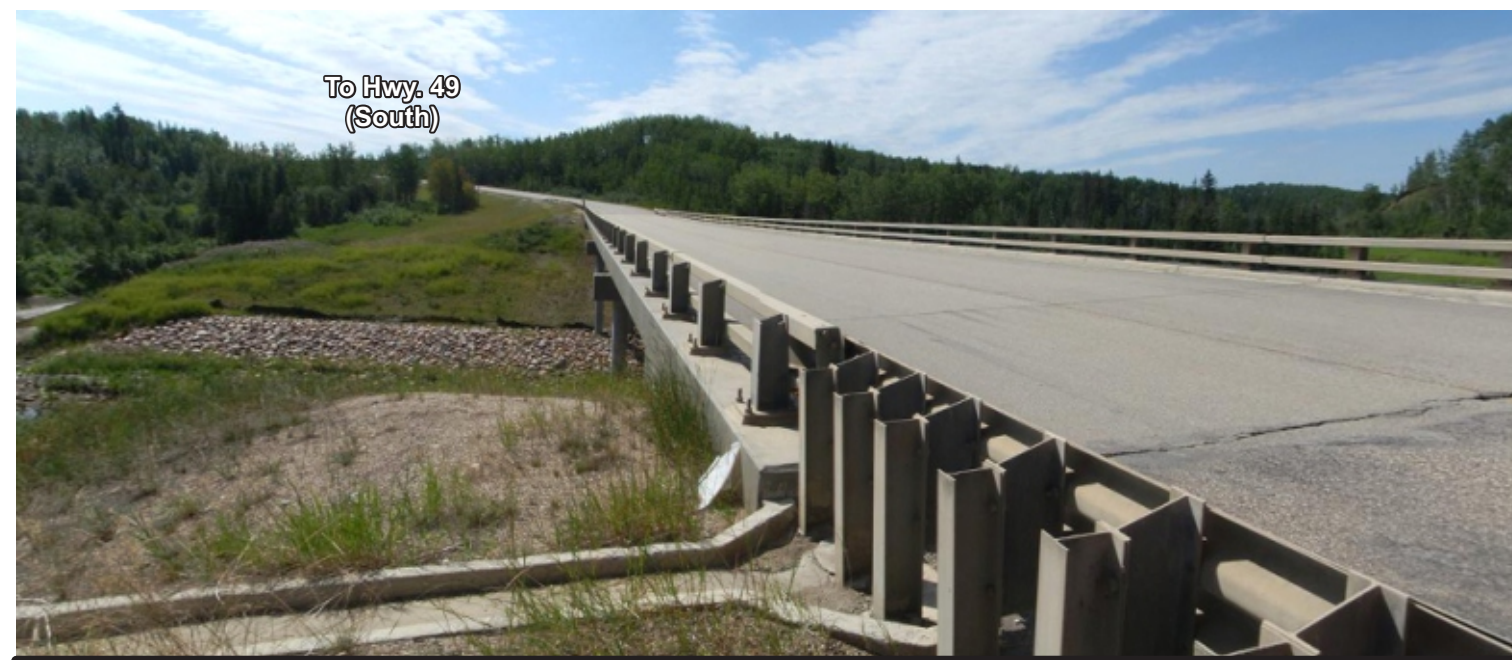
Photo 4a

A new bridge (an early 2000 construction)

- New creek channel restored (previous a twin culvert construction) under the new bridge
- Headslope and downflow drains in good conditions
