June 13, 2023

File No.: 32123

**GEOHAZARD RISK MANAGEMENT PROGRAM  
PEACE REGION – GRANDE PRAIRIE DISTRICT - NORTH  
SECTION D CALL-OUT INSPECTION  
HWY 719:02 KM 4.9 BACKSLOPE FAILURE WITH TOE EROSION**

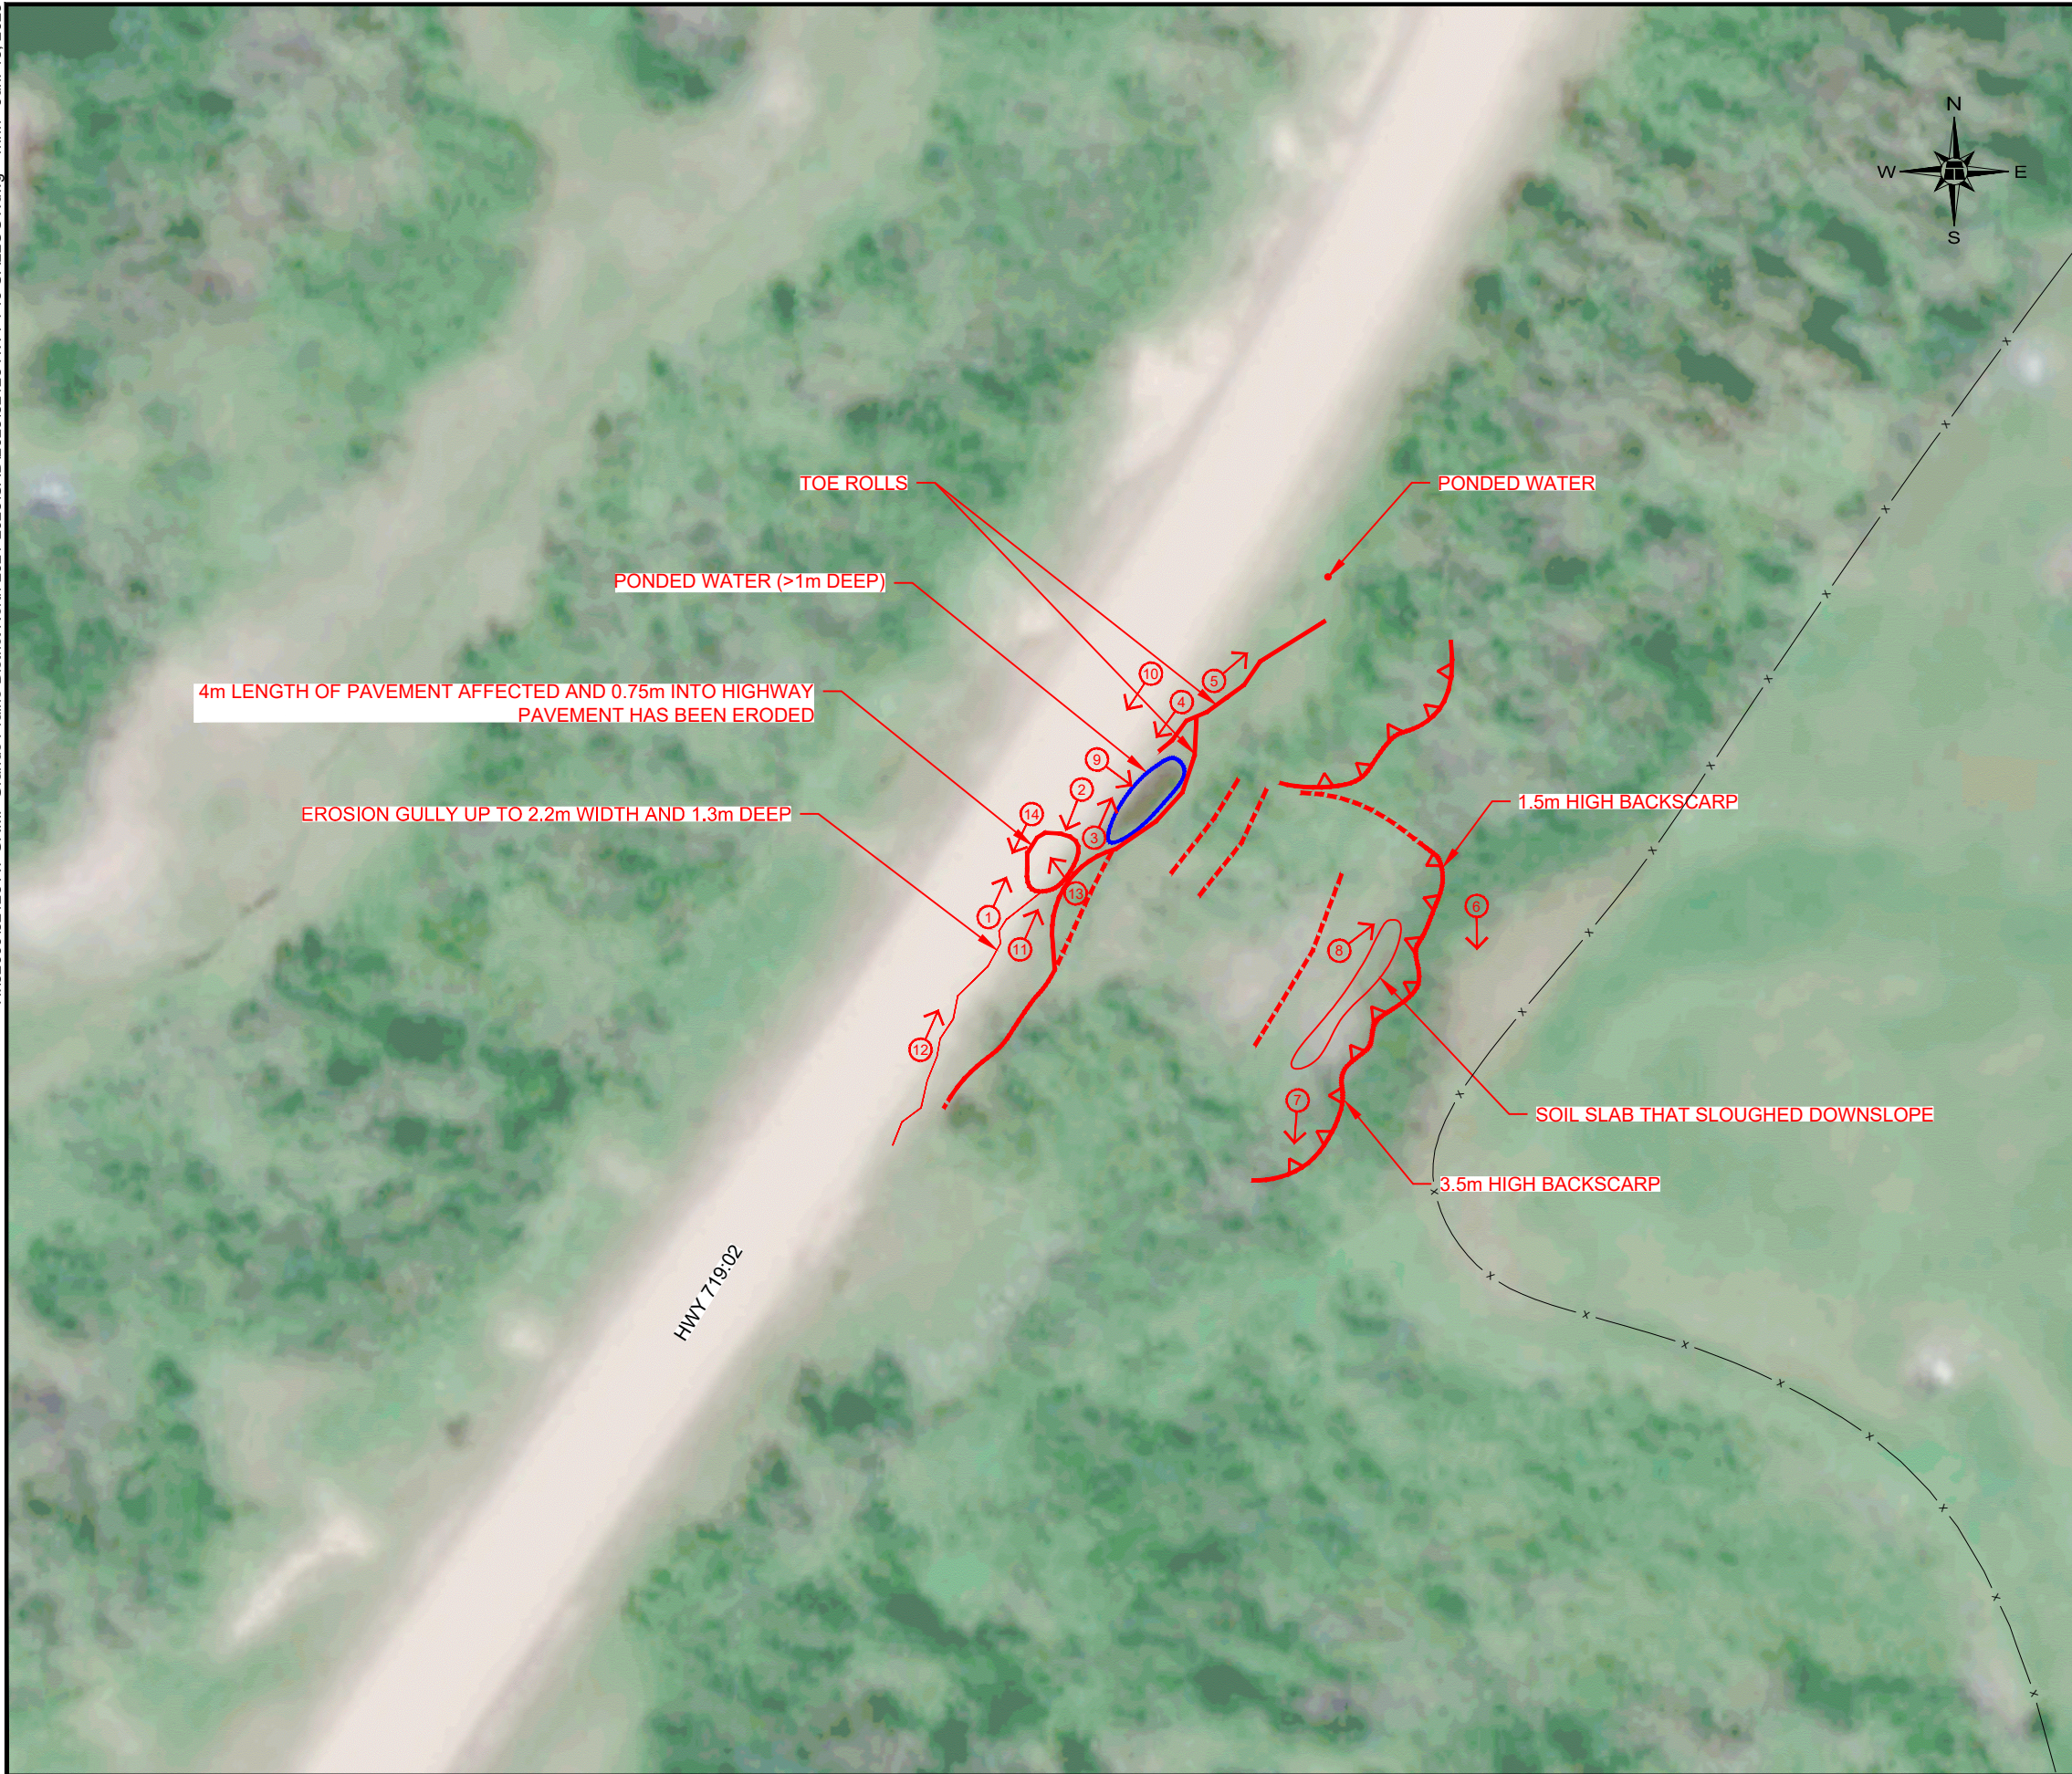
**SITE PLAN**  
**FIGURE 1**

Observations made during the site visit are illustrated on Figure 1, attached. Selected photographs of the site visit are also attached to this letter.

At the time of the call-out inspection, the main slump on the east side of the highway was approximately 65 m in width, 42 m in length down to the ditch with several internal scarp cracks throughout and an area where the pavement edge has eroded. There was a visible toe roll which was between 0.2 m and 0.3 m in height. The slump extended up past the top of the backslope to the crest of the tributary valley, approximately 16 m above the highway. The backslope was inclined at approximately 2H:1V in the slumped zone and the valley slope above the backslope was generally heavily treed with deciduous and coniferous trees. Relatively flat farmland is present in the plateau outside/above the Henderson Creek valley.

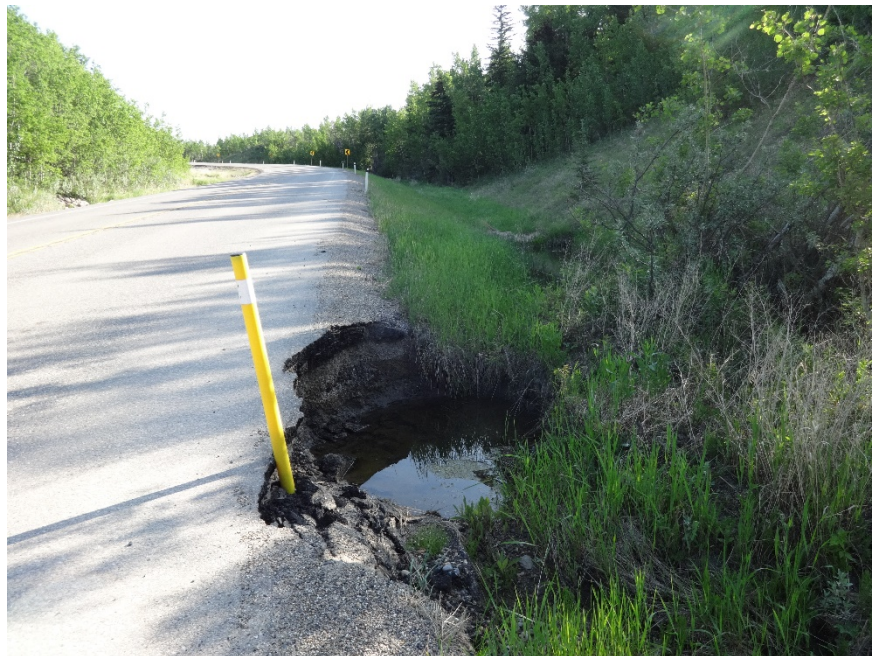
The erosion into the pavement is affecting approximately 4 m in length (measured at the edge of asphalt), was about 75 mm into the asphalt and slightly encroaching into the northbound lane. There appeared to be at least three layers of asphalt exposed in the eroded scarp. There were parallel cracks observed further to the south in the outer wheel path of the north lane but they did not appear to be associated with the toe erosion.

**Photo 1. Looking northeast at where water has eroded the highway. Photo credit: Nicole Wilder.**

In the short to intermediate term, it is recommended that the local MCI slightly grade the highway ditch at the slump location to promote surface drainage and allow the built-up ponded water to drain. To accomplish this, a culvert should be installed parallel to the highway under the landslide mass that is toeing out along the east ditch, extending approximately 90 m from northern to southern flanks, to allow unrestricted flow of surface drainage. Excavated material from the ditch should be placed back over the ditch culvert to form a shallow toe berm. It should be noted that excessive removal of material from the toe of the slope could result in accelerated landslide movement.

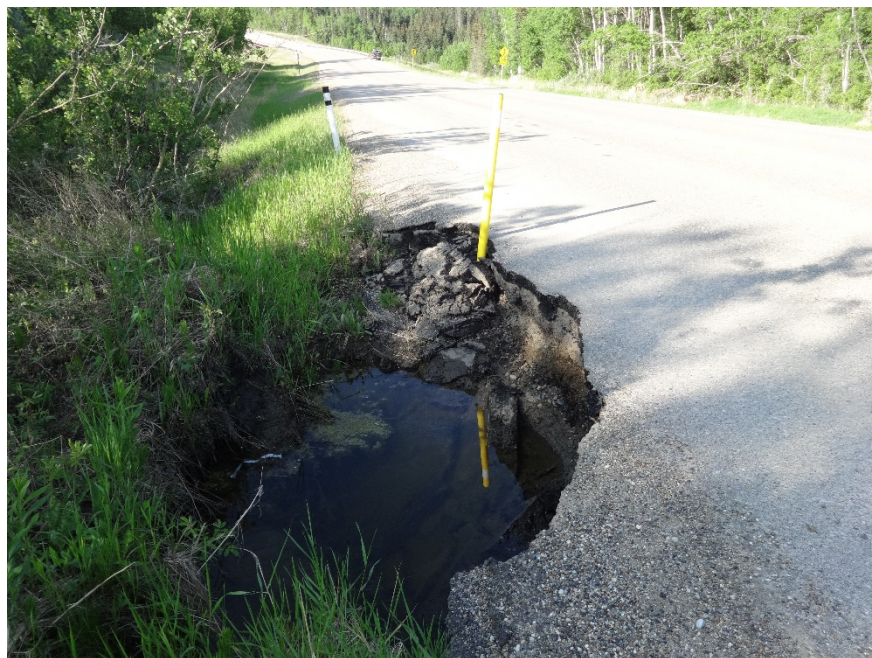
**Photo 2. Looking southwest at where water has eroded the highway. Photo credit: Nicole Wilder.**

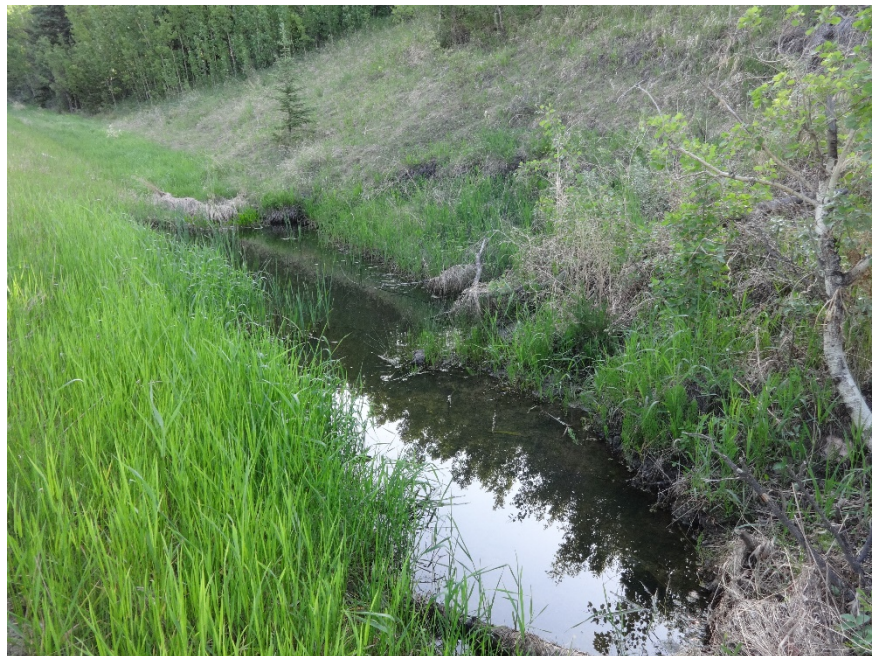
**Photo 3. Looking northeast at where water has ponded north of where pavement was affected. Photo credit: Nicole Wilder.**

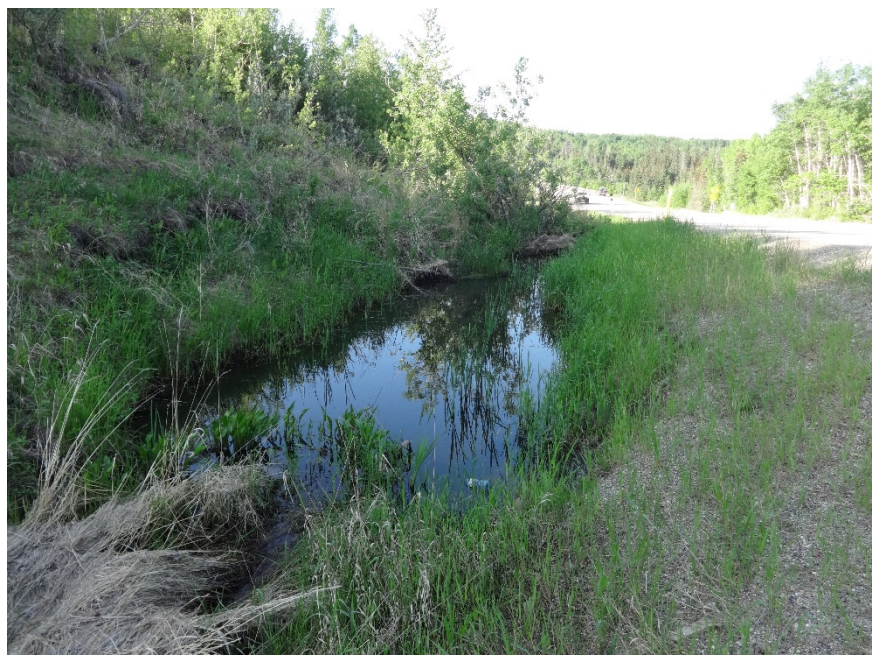
**Photo 4. Looking southwest at where water has ponded north of where pavement was affected. Photo credit: Nicole Wilder.**

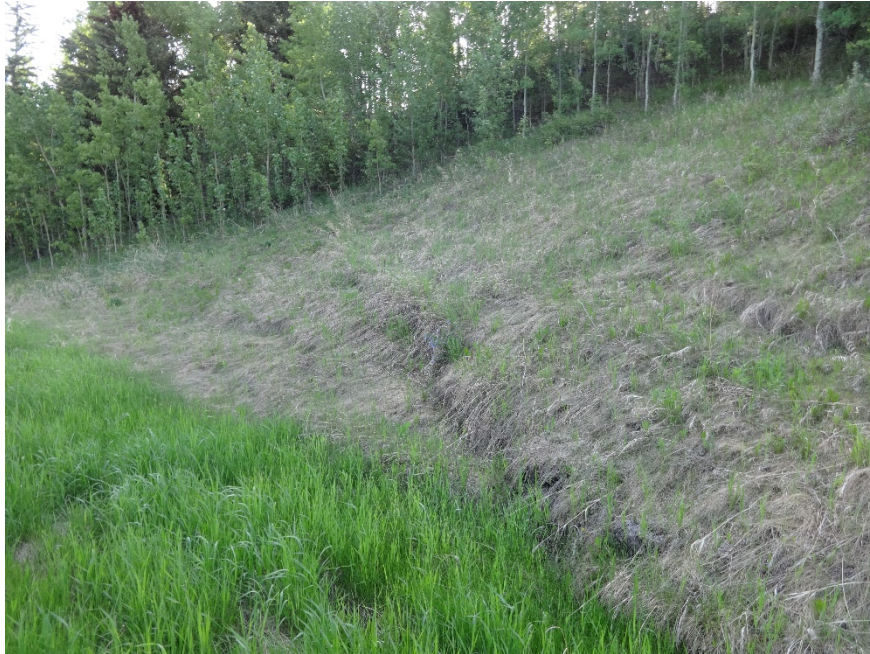
**Photo 5. Looking northeast at where noticeable toe roll is. Photo credit: Nicole Wilder.**

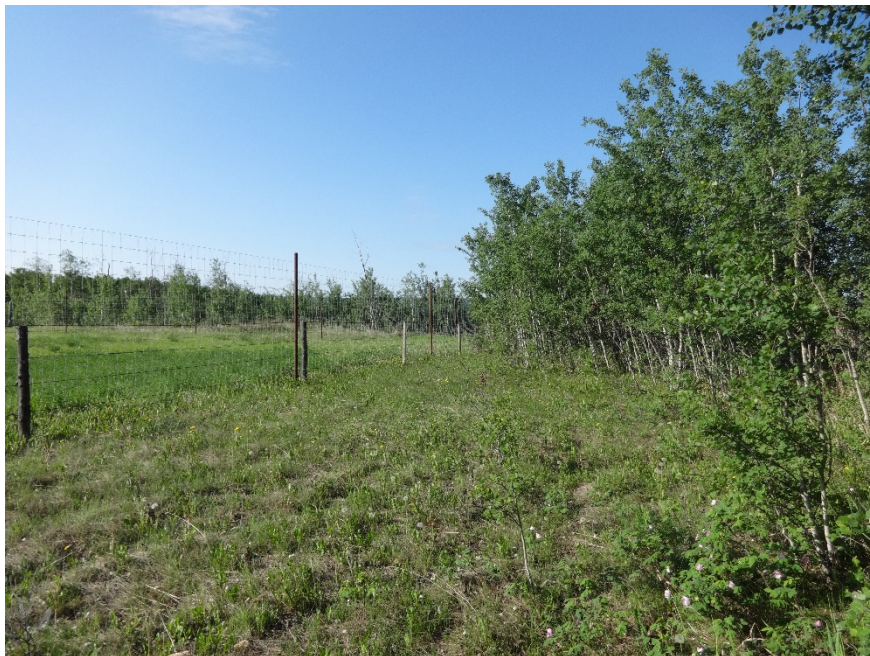
**Photo 6. Looking south at farm fence above the slope failure. Photo credit: Nicole Wilder.**

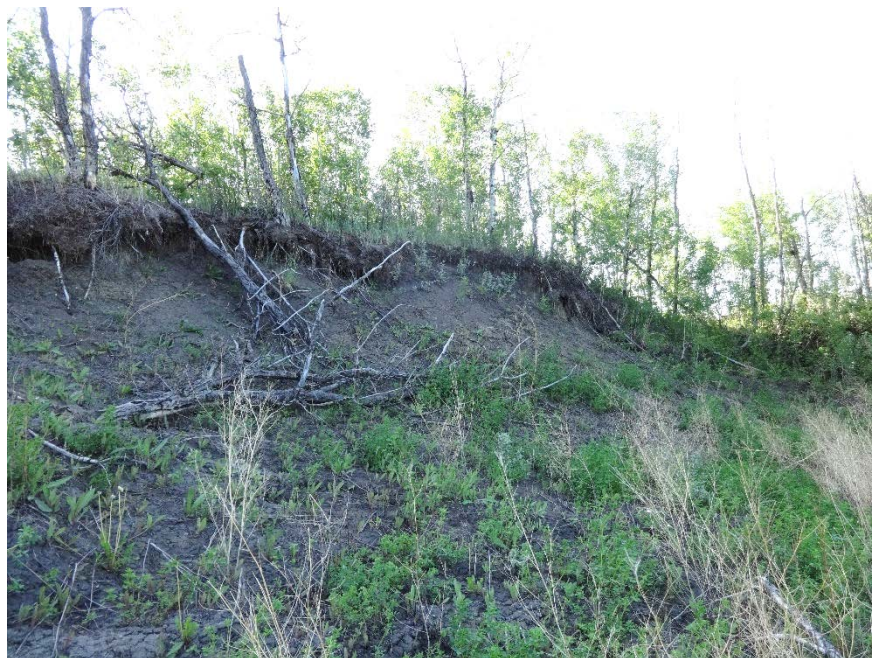
**Photo 7. Looking south at the 3.5 m high backscarp. Photo credit: Nicole Wilder.**

Potential long-term repairs may include cutting back the backslope and tributary valley slope at the landslide location to a flatter inclination, possibly together with the installation of French drains in the flattened slope as well as surface drainage enhancements (like a catchwater ditch at the crest of the slope). Slope flattening would likely require acquisition of additional right-of-way. A detailed topographic survey, a few test holes with standpipe piezometers in them and some slope stability analyses should be undertaken to design the details of suitable long term repair measures.

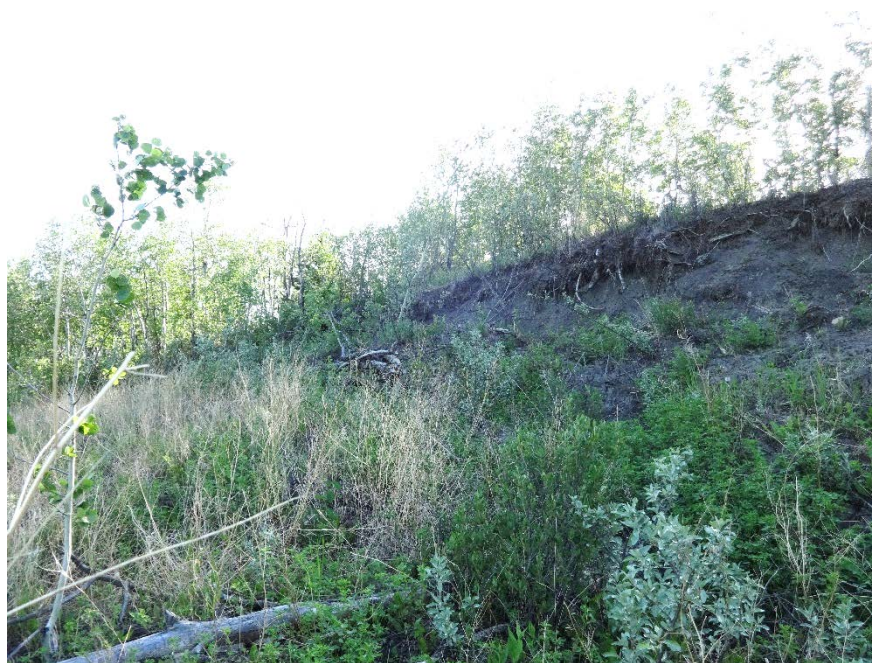
**Photo 8. Looking northeast at 1.5 m high backscarp. Photo credit: Nicole Wilder.**

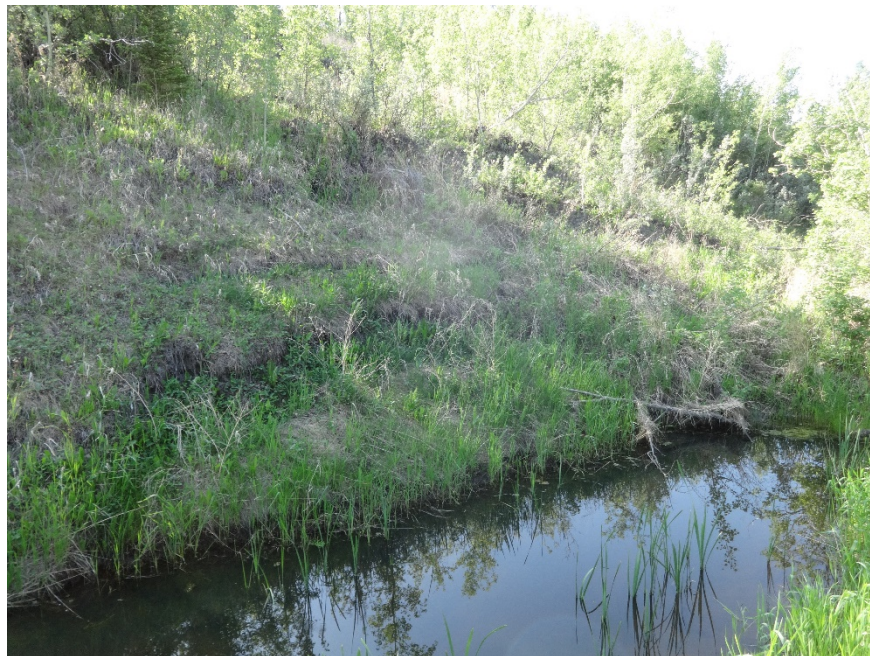
**Photo 9. Looking southeast at scarps above ponded water near toe of the landslide. Photo credit: Nicole Wilder.**

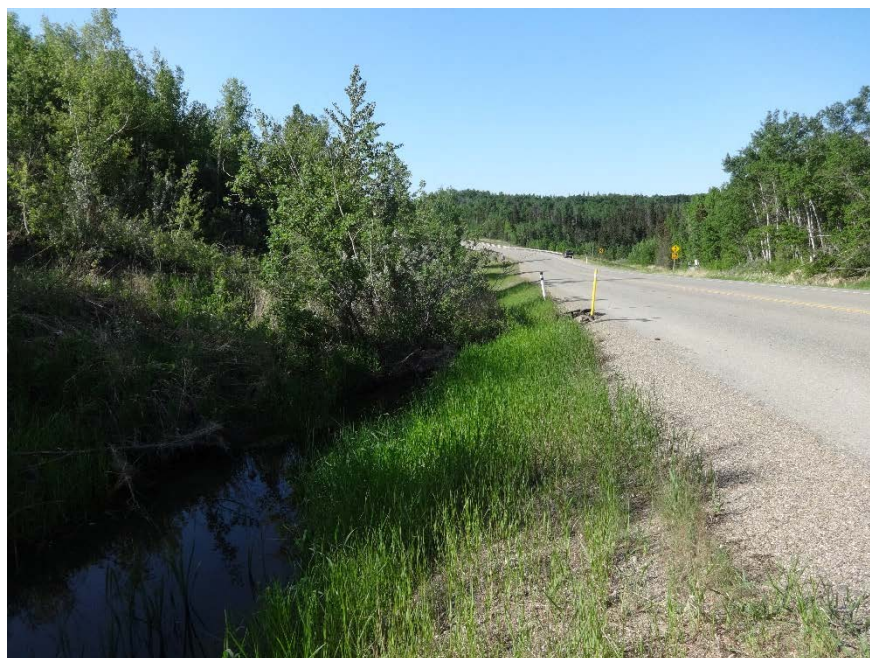
**Photo 10. Looking southwest at highway and yellow marker. Photo credit: Nicole Wilder.**

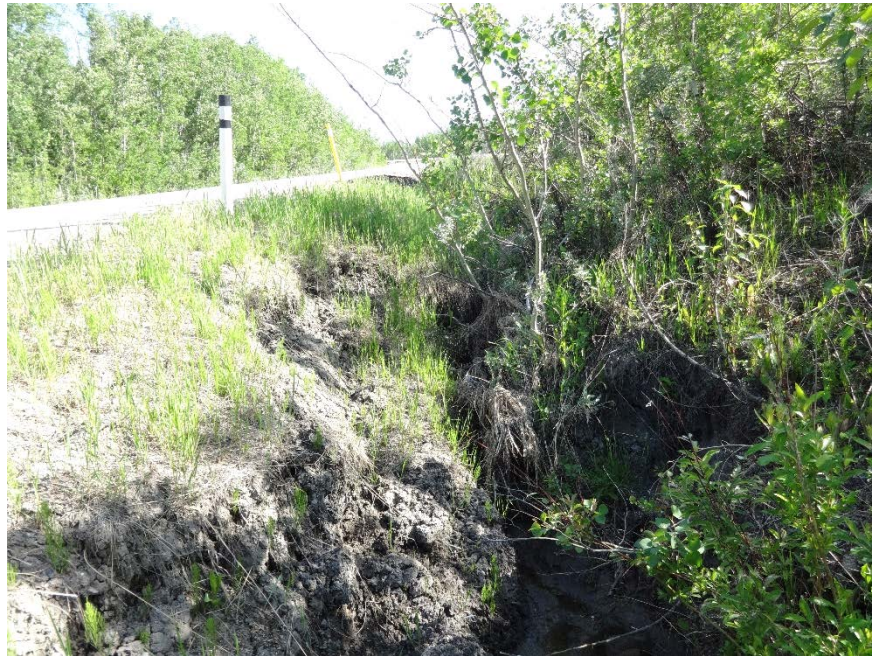
**Photo 11. Looking north at erosion gully just south of where pavement was affected. Photo credit: Nicole Wilder.**

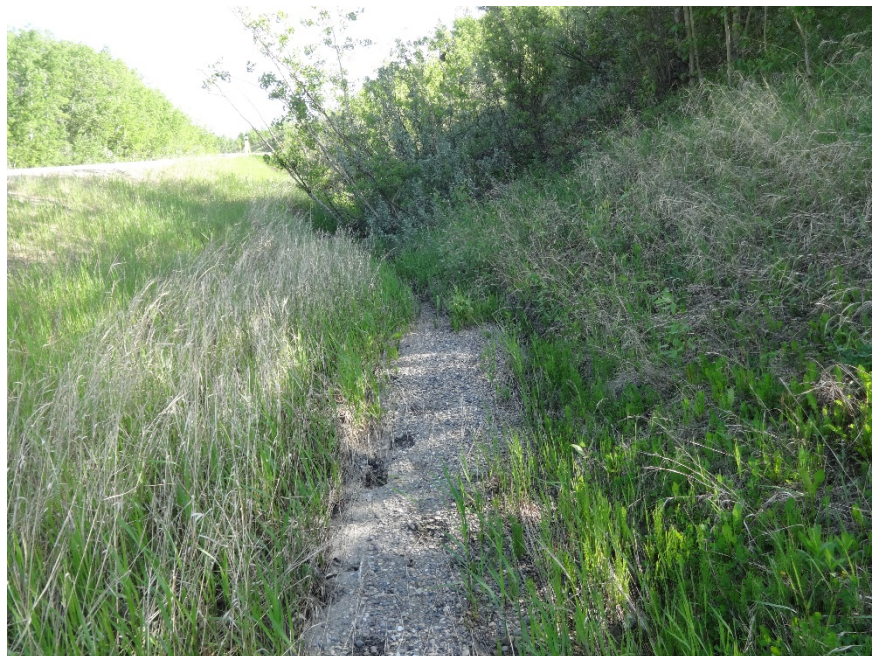
**Photo 12. Looking north at where erosion continues south of main area. Photo credit: Nicole Wilder.**

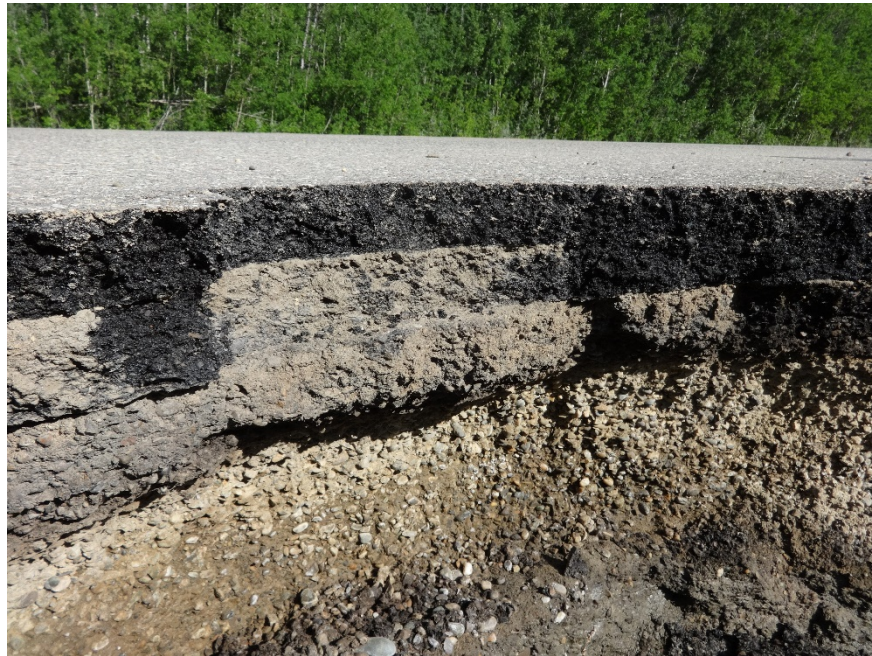
**Photo 13. Looking west at where pavement has been eroded. Photo credit: Nicole Wilder.**

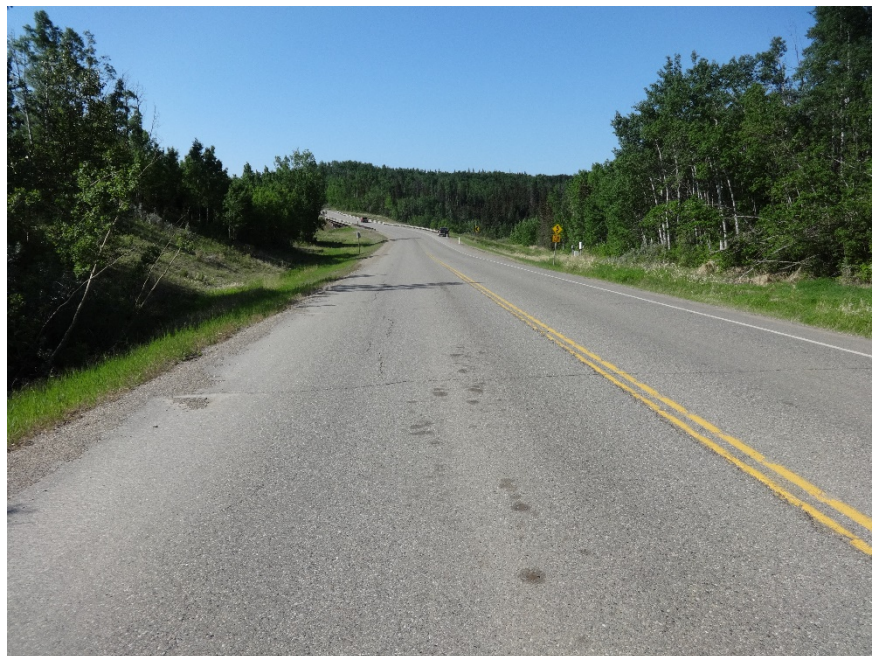
**Photo 14. Looking southwest at highway towards Henderson Creek bridge. Photo credit: Nicole Wilder.**
