**ALBERTA TRANSPORTATION
GEOHAZARD ASSESSMENT PROGRAM
PEACE REGION (GRANDE PRAIRIE DISTRICT - NORTH)
2023 INSPECTION**

Site Number	Location	Name	Hwy	km
PH010	Eureka River South Hill	Sites 1, 2 and 4	726:02	9.8
Legal Description		UTM Co-ordinates (NAD 83)		
NW12/SW13-86-8-W6		11 N 6258319	E 368453

Date	PF	CF	Total
Previous Inspection:	May 16, 2022	13	5	65 – Site 2
		9	4	36 – Site 1
Current Inspection:	June 1, 2023	13	5	65 – Site 2
		9	4	36 – Site 1
Road AADT:	400	Year:		2022
Inspected By:	Barry Meays, Don Proudfoot (Thurber) Rishi Adhikari, Max Shannon (TEC)			
Report Attachments:	<input checked="" type="checkbox"/> Photographs <input checked="" type="checkbox"/> Plans <input checked="" type="checkbox"/> Maintenance Items

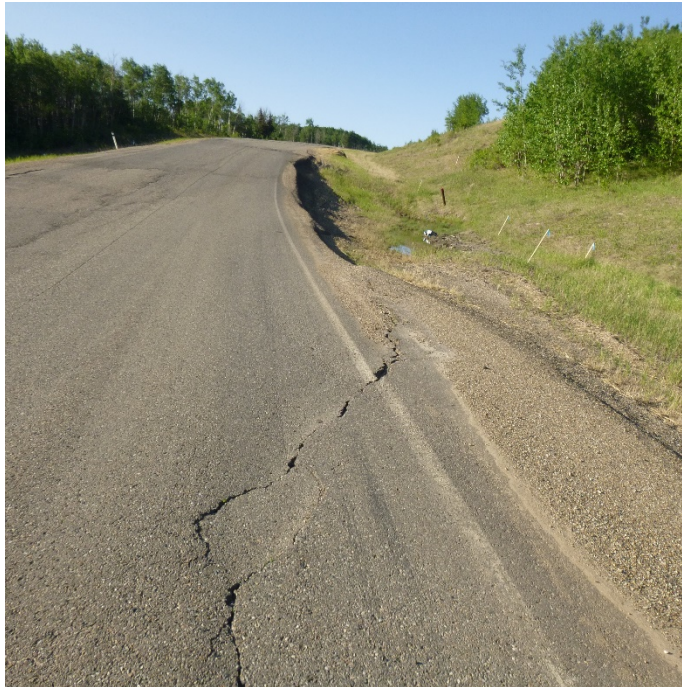
Photo 1 – Looking south at the slide scarp crossing the highway at Site 2, at the dip in the road that extends into the north ditch.

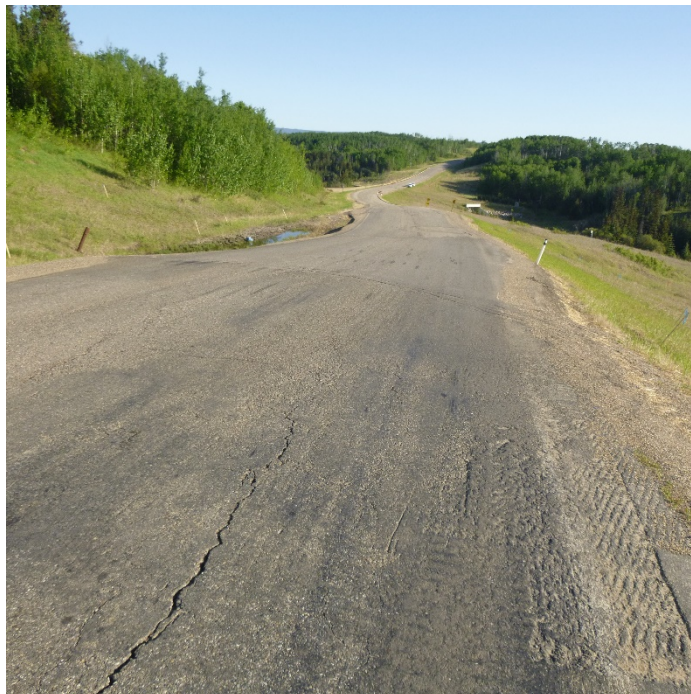
Photo 2 – Looking north from the Slide Site 2 at the milled/patched pavement. Note the fresh, well-defined reflective north end scarp crack extending across the road.

Continue to patch and mill the highway at Sites 2 and 4 as required.

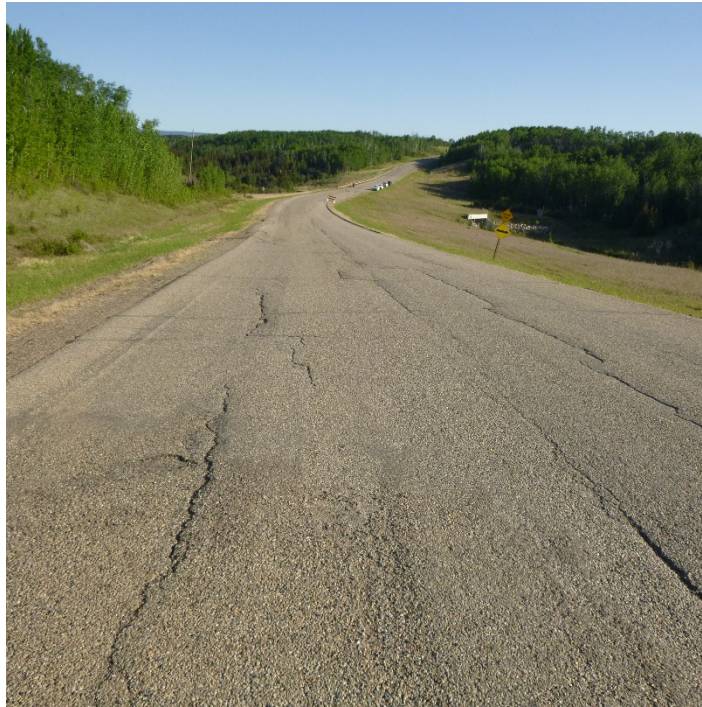
Inclinometer SI08-4 located between Sites 1 and 2 at Site 4 (damaged prior to 2020 readings) was indicating ongoing movements (latest ~8 mm/yr) at 7 to 9 m depth. Patching of the dip and cracks on the pavement in 2015, a more defined slide crack about 50 m long with a dip on the east side of it was observed in 2016, and past visual observations indicating general crack widening, distortion, and on-going sealing in the last few years, suggests a larger slide is developing and moving towards the river.

Photo 3 – Looking north along the fatigued highway pavement across slide Site 4.

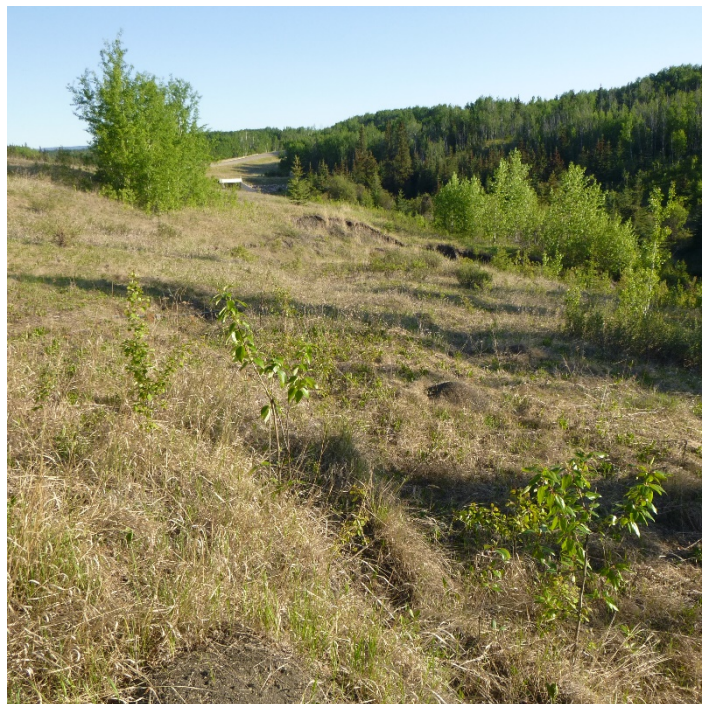
Photo 4 – Looking north along the east highway embankment from the south end of Slide Site 2.

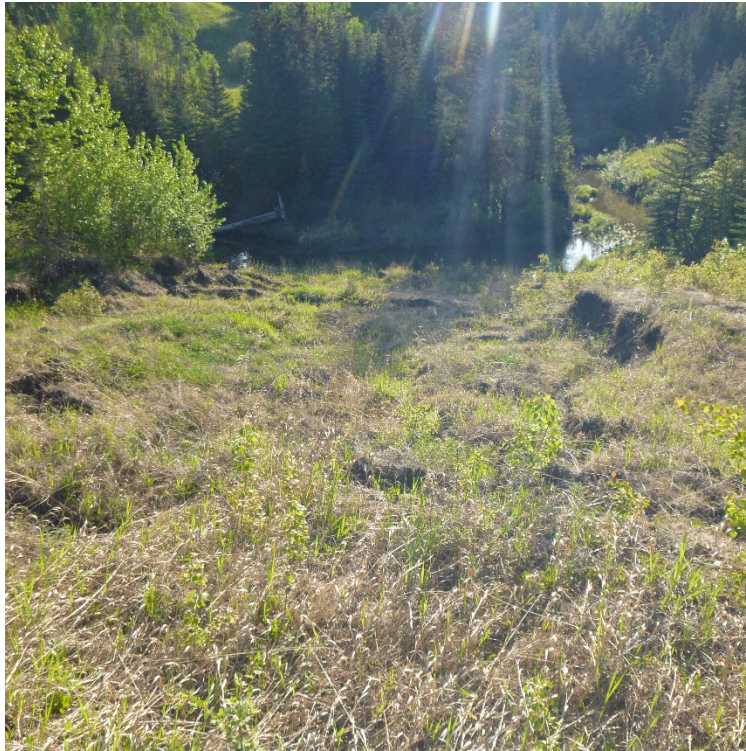
The landslides at the PH010 site were triggered by river erosion along the base of a river valley slope that has been subject to historic landslide movement. The slide movements are occurring in high plastic clay deposits. The landslide at Site 2 is more extensive and mobile than at Site 1, extending all the way up to and through the highway embankment. To date the movements at Site 2 have been dealt with by milling the pavement at the flanks of the slide and adding asphalt patches in the road surface and small earth fills to smooth out dips in the adjacent ditch. However, the additional weight of these fills and the ongoing river erosion at the toe of the slope keeps the landslide in motion. The movement at Site 1 has been slower and so far, the landslide has not retrogressed into the highway at that location.

Photo 5 – Looking southeast at the outside bend of the river, which is causing the most active slumping area at Site 2.

Periodically re-grade the slope below Site 2 to seal the cracks and provide a smoother, more uniform slope from the broken, uneven, and crack infested slope that currently exists.

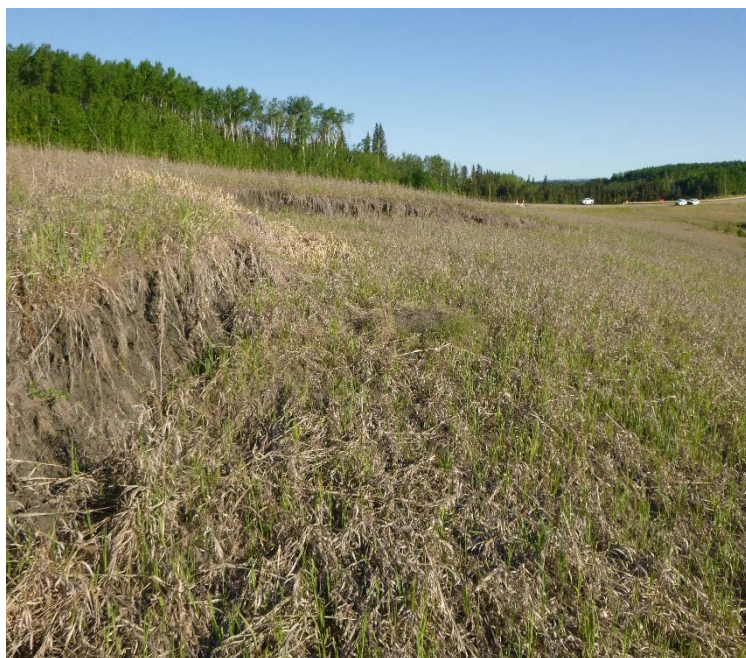
Photo 6 – Looking northwest along the fresh slide scarp/crack of Site 2, from just north of the most active portion of the slide.

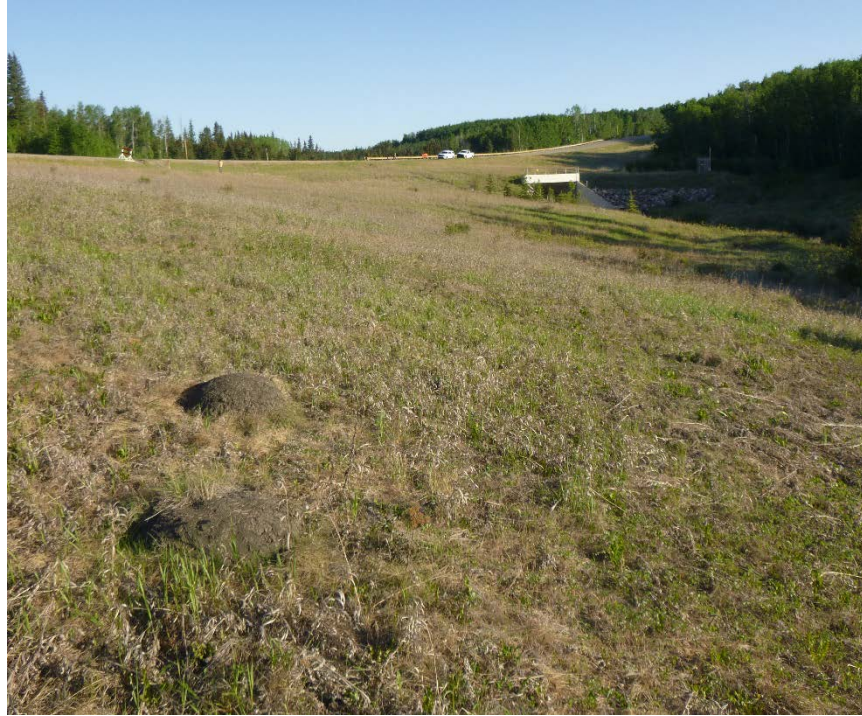
Photo 7 - Looking north across the Site 1 Slide from south of the river. Note the grassed over slide scarp parallel in the background to the highway.

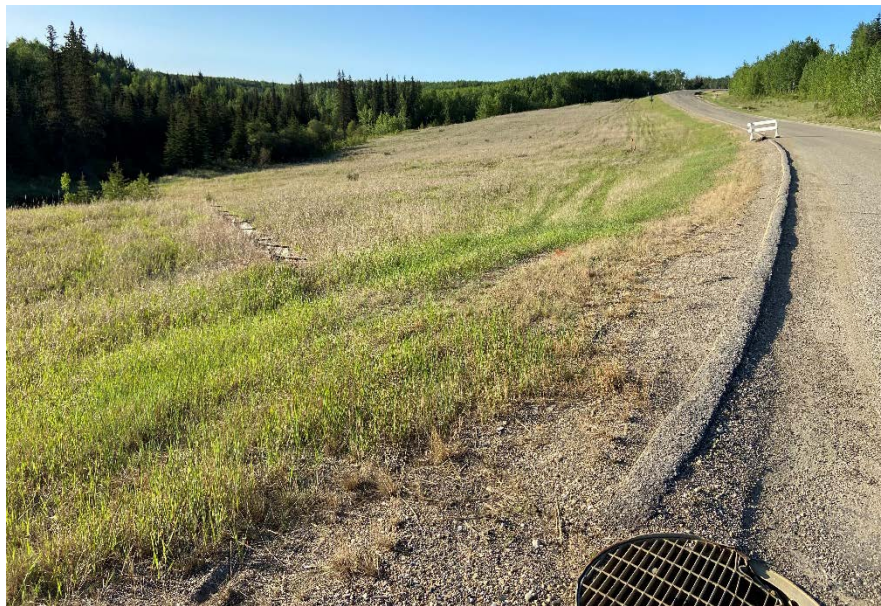
Photo 8 – Looking south from the north end of Site 1 slide. This surface water catch basin manhole on the edge of the highway draining to the half-culvert is to be replaced with a subdrain just off the east highway edge leading to a drop structure and into a smooth-wall steel pipe.

The 800 mm drop manhole, AC curb, and half culvert at Site 1 were removed as part of the above referenced paving contract, and replaced with a subdrain running alongside the east edge of the pavement that drained into a catch basin which in turn was connected to a 300 mm diameter SWSP that outlets at the river. Also as part of this contract, the existing pavement adjacent to Slide 2 was removed over a distance of 120 m, and replaced with a new, smoothed, 520 mm thick pavement structure containing geogrid in the GBC and 0.6 m of re-conditioned subgrade.
