**ALBERTA TRANSPORTATION AND
ECONOMIC CORRIDORS
GEOHAZARD ASSESSMENT PROGRAM
PEACE REGION (GRANDE PRAIRIE DISTRICT - NORTH)
2024 INSPECTION**

| PH010 | Eureka River South Hill | Sites 1, 2 and 4 | 726:02 | 9.8 |

| | Date | PF | CF | Total |
|---|---|---|---|--|
| Current Inspection: | May 8, 2024 | 7 13 9 | 5 3 4 | 35 – Sites 2, 4 at Hwy 39 – Sites 2, 4 D/S of Hwy. 36 – Site 1 |

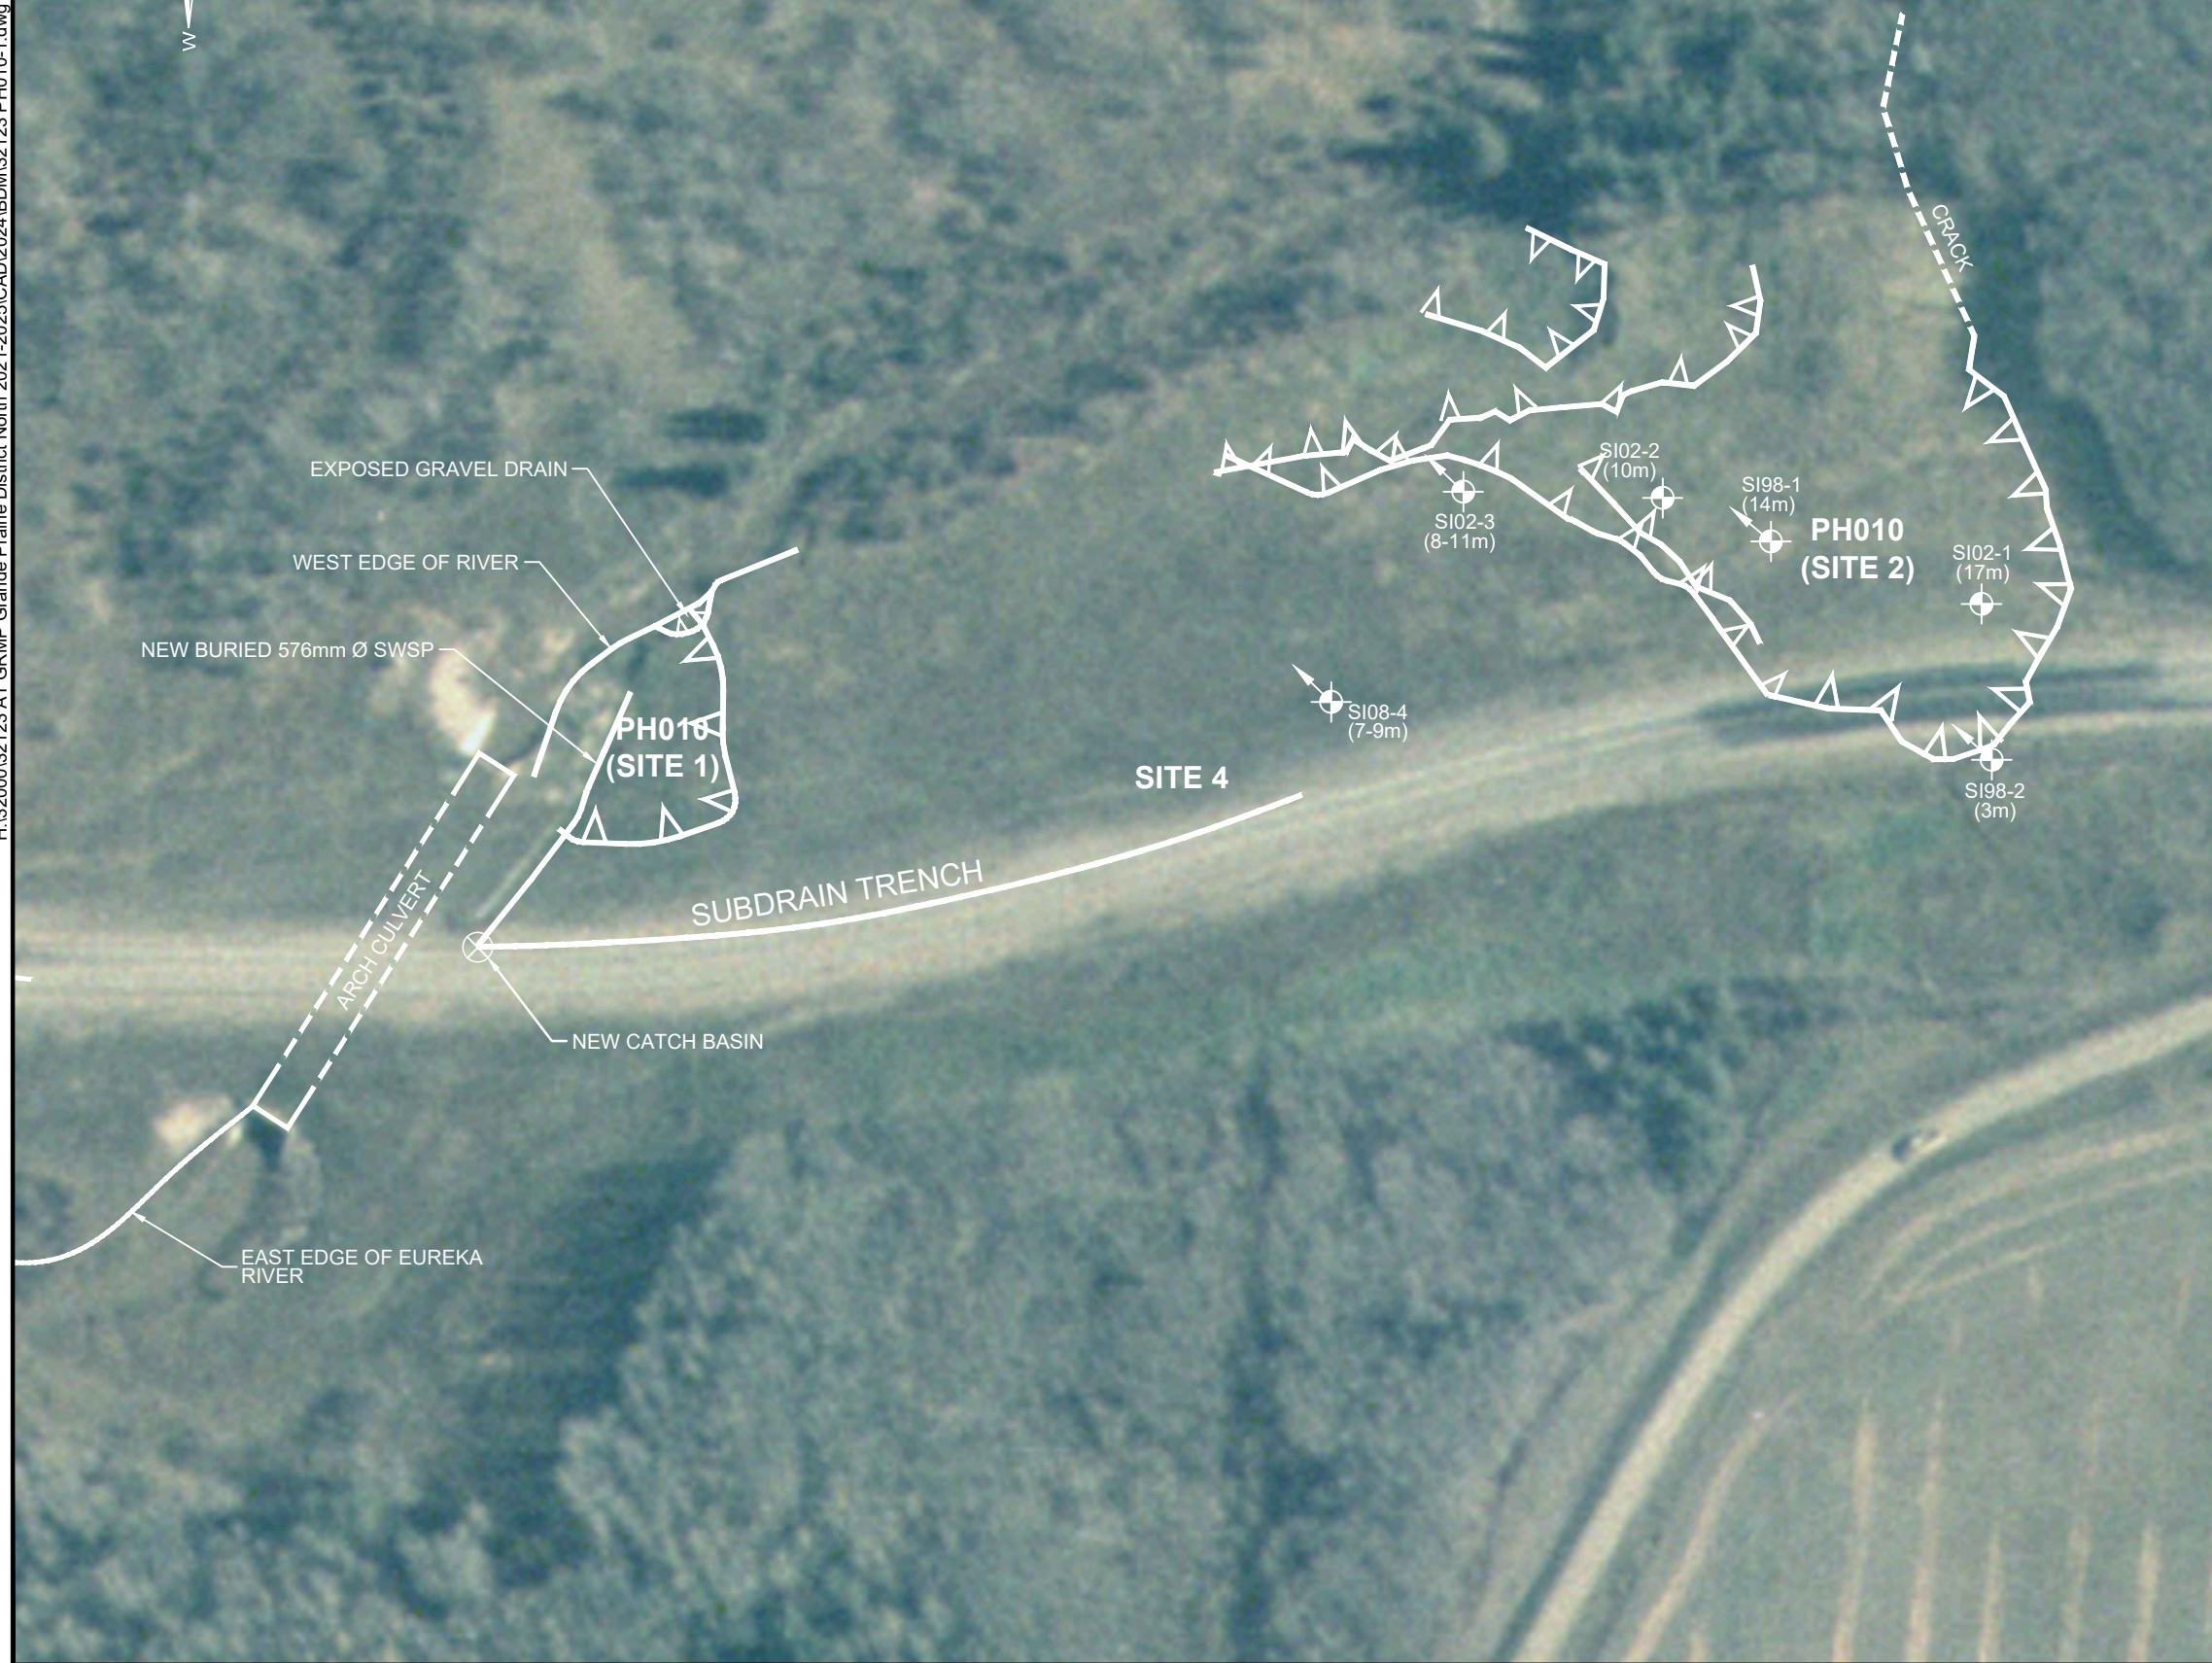
DWG No. 32123-PH010-1

| <input checked="" type="checkbox"/> Slope Movement | Slide 2 continues to move at a fast rate further downslope of the highway activated by river erosion at the outside bend of the River. The highway pavement at Site 4 (between Sites 1/2) was good due to the 2023 overlay. Site 1 was unchanged this year. | <input checked="" type="checkbox"/> |
| <input checked="" type="checkbox"/> Erosion | West edge of riverbank below Site 2 (severe); Vehicle track ruts and erosion gully alongside new TRM placement on west side of hwy at Site 2 (moderate); Exposed gravel drain outlet formed a slump at Site 1 (moderate); West ditch opposite Slide 1 (slight). | <input checked="" type="checkbox"/> |

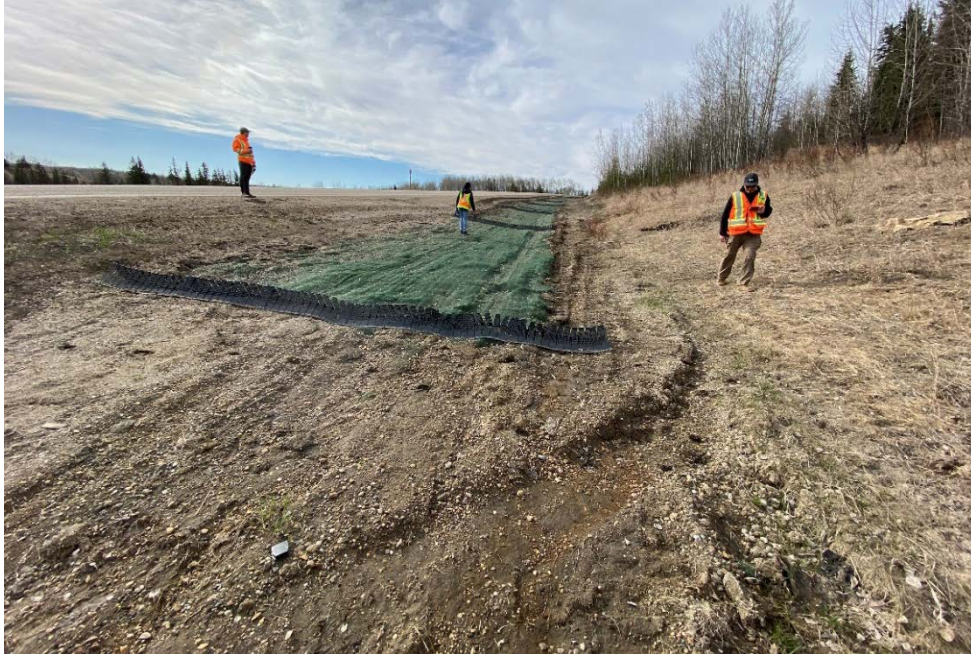
Photo 1 – Looking south along the west ditch at the east end of the TRM placement at Site 2.

At Site 2, one additional roll (30 m length) of TRM and ditch barriers should be extended northwards along the west ditch to protect it from erosion. Also, the TRM and ditch barriers along the north ditch should be extended a bit further up the west backslope, as bare soil and some erosion from recent surface flow was observed.

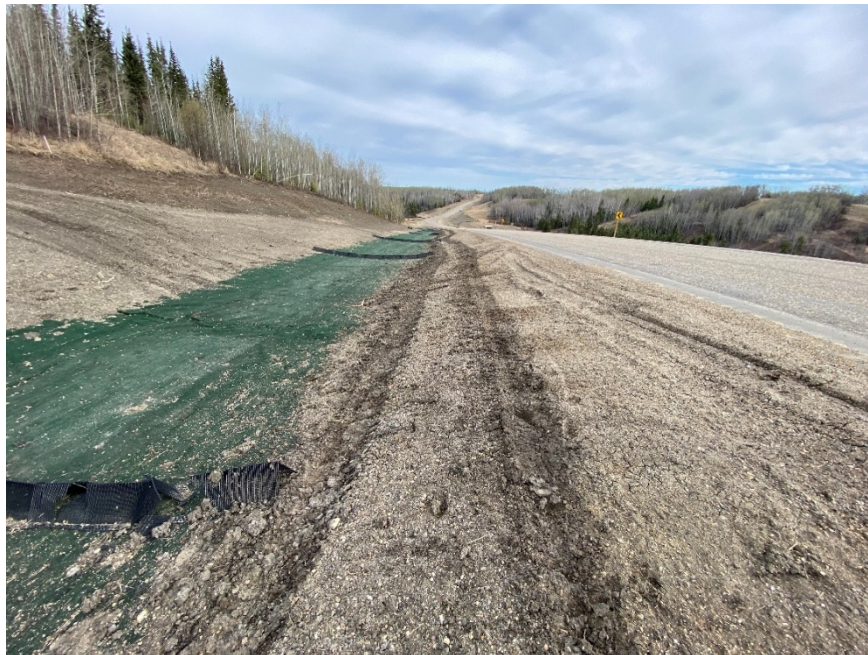
Photo 2 – Looking north along the west ditch of Site 2, at vehicle track ruts that caused damage to the ditch barriers.

The silt fence installed along the outside boundary of the Site 2 repair under the last years aforementioned contract, should either be keyed in the ground surface or removed (perhaps as part of the contract warranty work). Similarly, the vehicle track ruts in the west ditch of Site 2 should be graded and the damaged ditch barriers replaced.

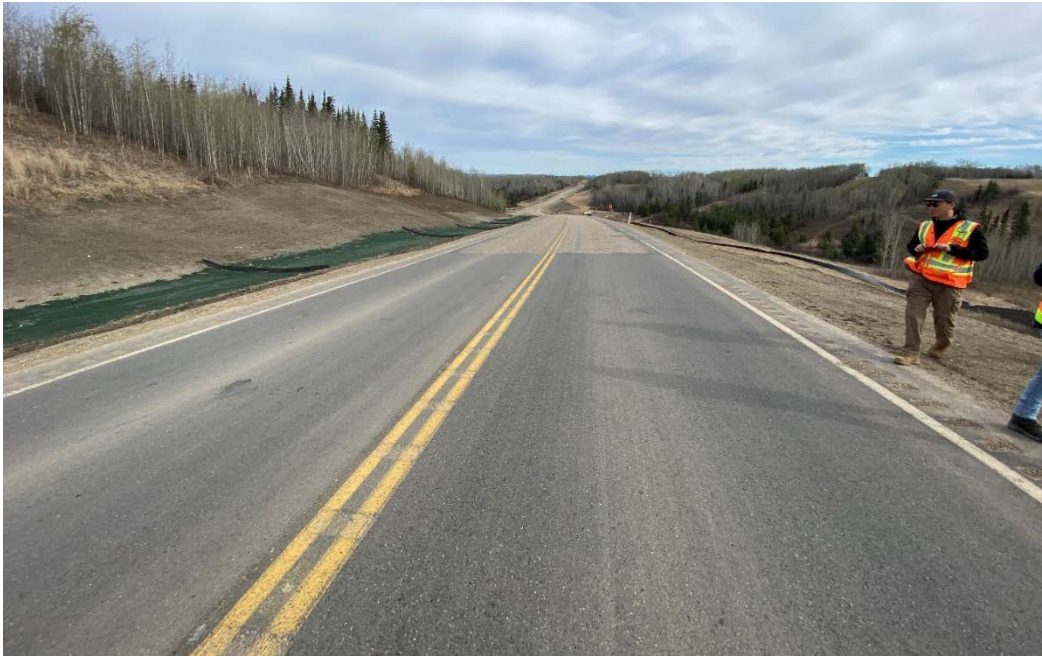
| <input checked="" type="checkbox"/> Pavement Design | After resurfacing a segment that included geogrid placement, in conjunction with the 2023 Hwy 726 overlay, the pavement is in excellent condition with no visible signs of distress. | <input type="checkbox"/> |

Photo 3 – Looking north along the freshly paved highway surface that was constructed over Lightweight Geofam fill at Site 2.

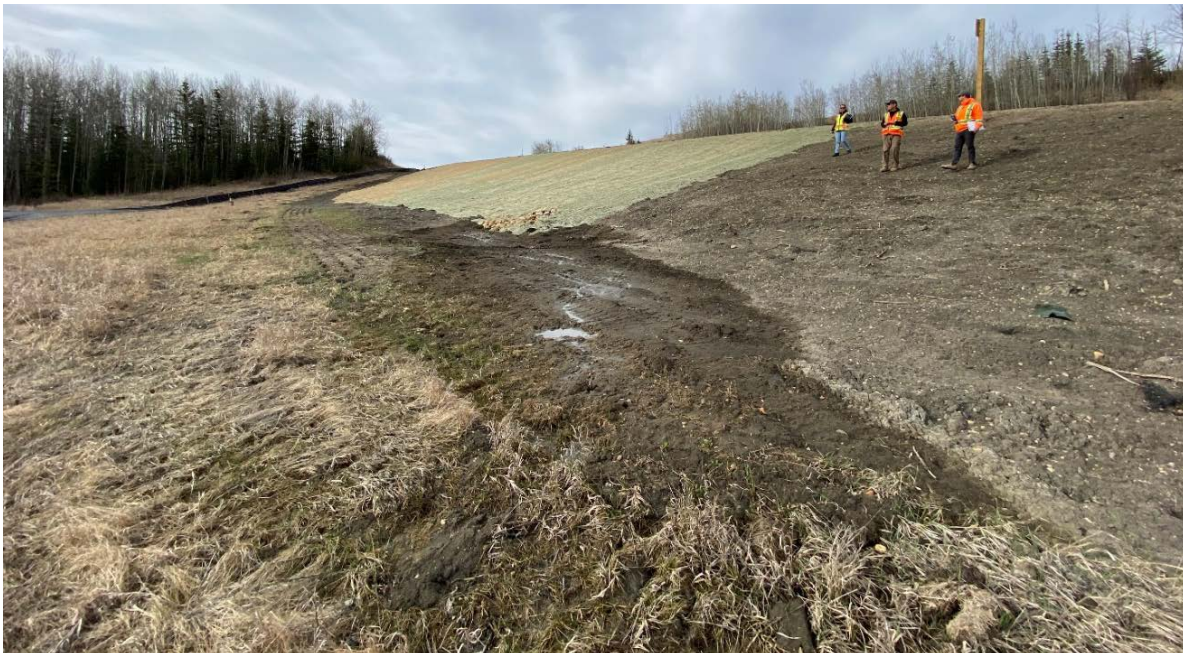
| <input checked="" type="checkbox"/> Seepage | From the subdrain outlet at Site 2, from the backslope west of the hwy at Site 4, and from the exposed gravel drain at Site 1. | <input type="checkbox"/> |

Photo 4 – Looking south along the east sideslope at steady seepage from the new subdrain outlet constructed beneath the new Lightweight Geofam fill at Site 2.

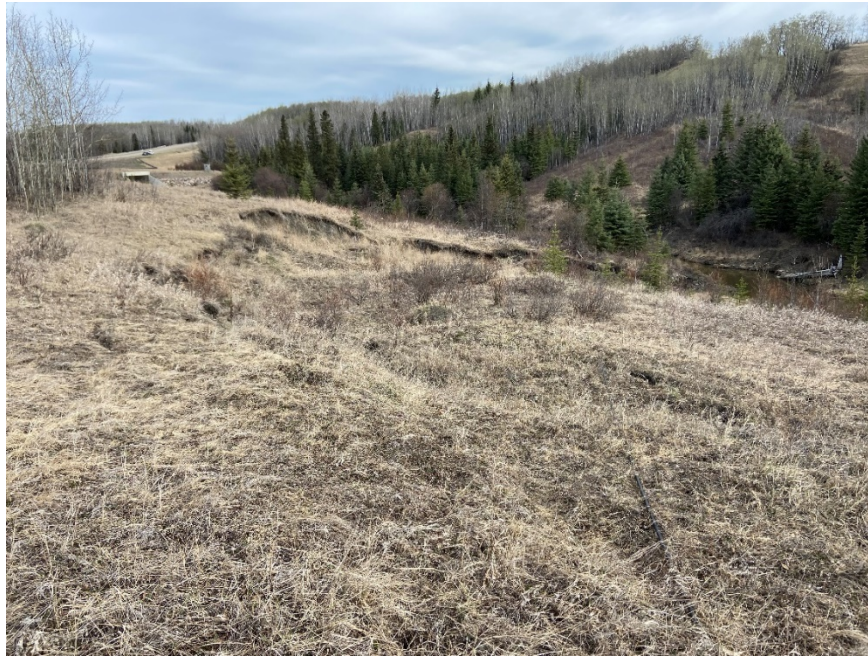
Photo 5 – Looking north along the east highway embankment from the south end of Slide Site 2.

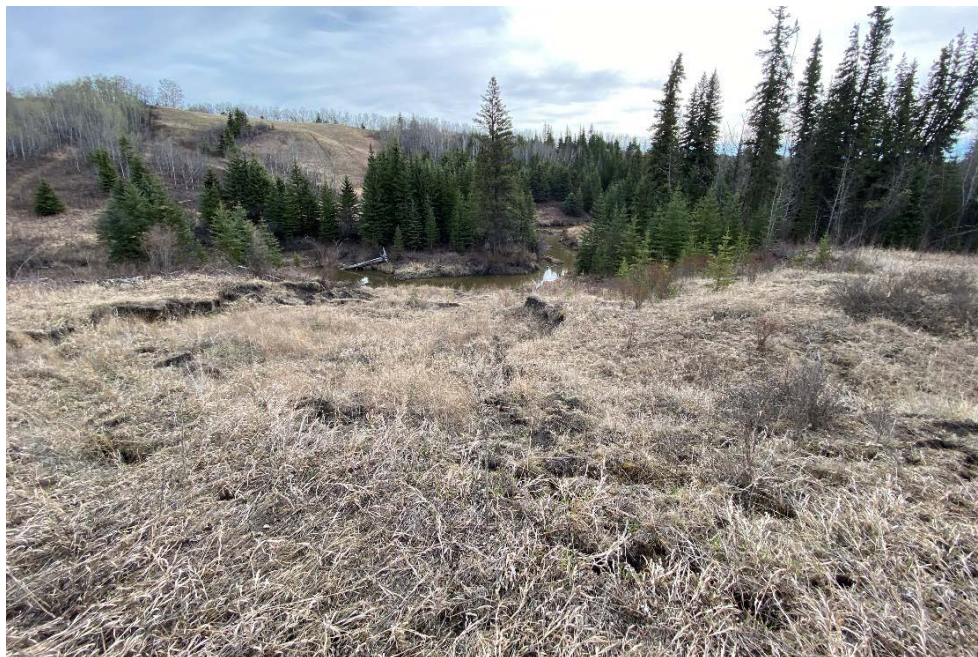
Photo 6 – Looking east at the outside bend of the river, which is causing the most active slumping area at Site 2.

Periodically re-grade the slope below Site 2 to seal the cracks and provide a smoother, more uniform slope from the broken, uneven, and cracked slope that currently exists.

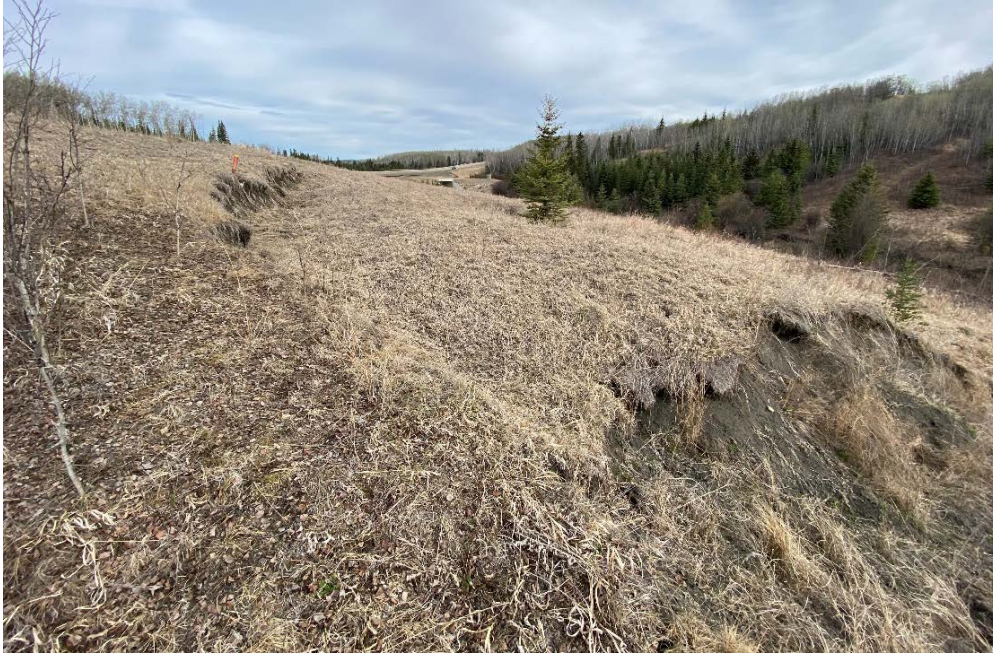
Photo 7 – Looking northwest along the active slide scarp/crack of Site 2, from just north of the most active portion of the slide.

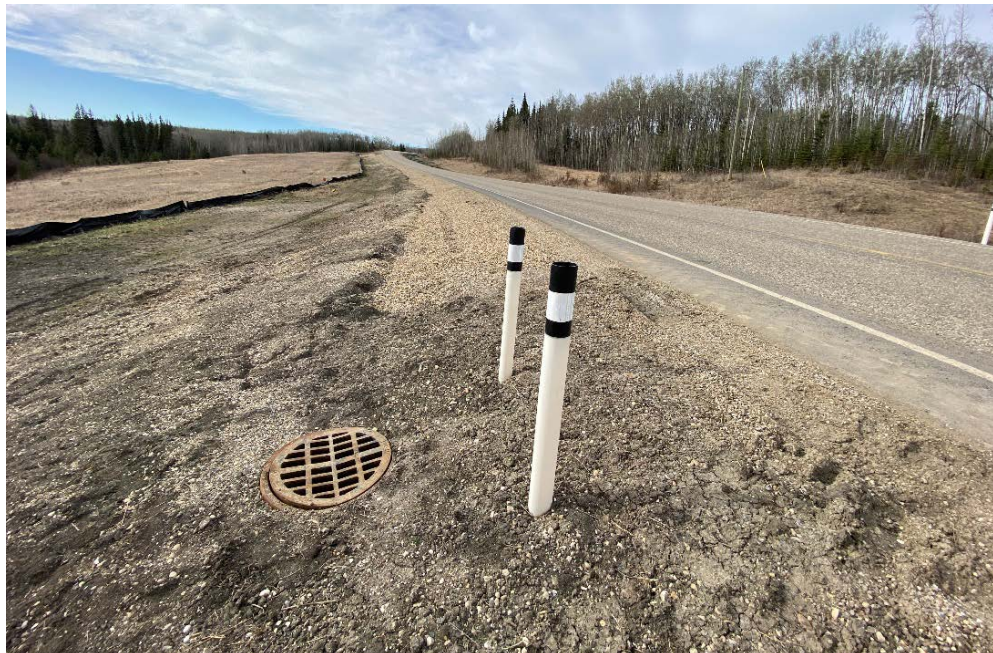
The movement at Site 1 has been slower and so far, the landslide has not retrogressed into the highway at that location. The 800 mm drop manhole, AC curb, and half culvert at Site 1 were removed as part of the above referenced paving contract, and replaced with a subdrain running alongside the east edge of the pavement that drains into a catch basin which in turn was connected to a 300 mm diameter SWSP that outlets at the river.

Photo 8 – Looking south from the north end of the Site 1 slide at the new surface water catch basin manhole that captures surface runoff from the new subdrain further south along the east edge of the highway, that drains into a smooth-wall steel pipe outletting further east. This replaced the previously existing AC curb/Manhole/Half-Culvert system.

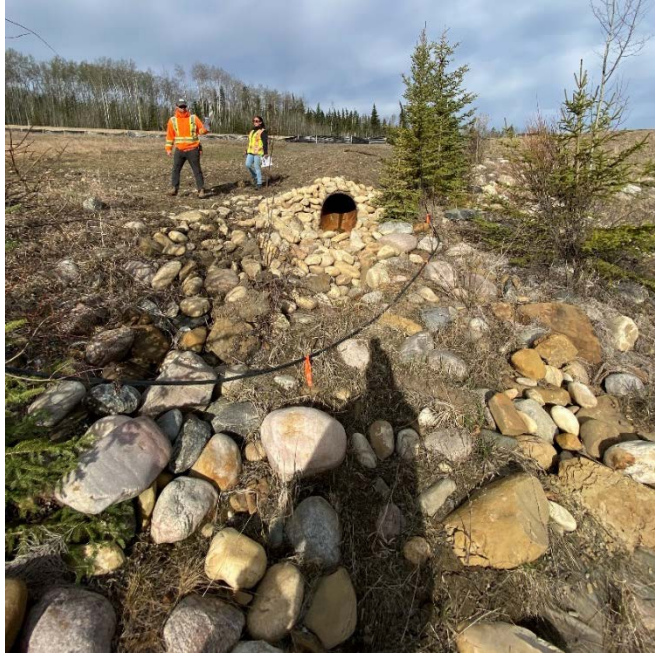
Photo 9 – Looking northwest at the new SWSP outlet (Site 1). Note the re-routed Telus cable at ground surface.

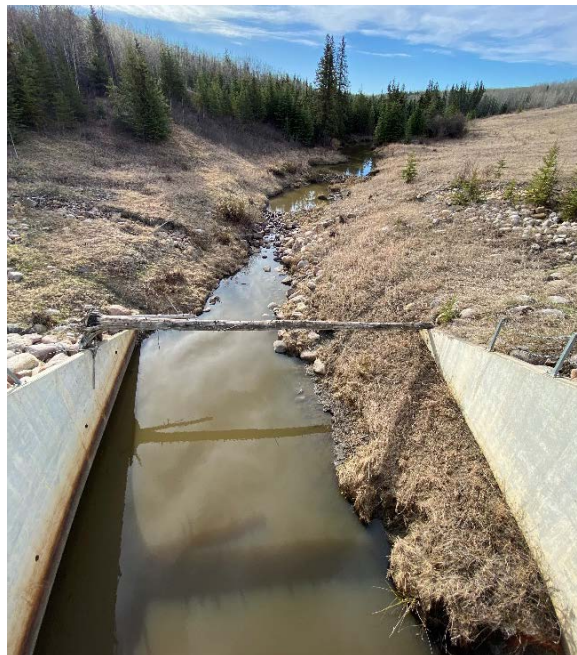
Photo 10 – Looking southeast along the Eureka River from the arch culvert inlet (Site 1).
