**ALBERTA TRANSPORTATION  
GEOHAZARD ASSESSMENT PROGRAM  
PEACE REGION (GRANDE PRAIRIE DISTRICT- NORTH)  
2023 INSPECTION**

Site Number	Location	Name	Hwy	km
PH026	Eureka River North Hill	Sites #3, #5 and #6	726:02	10.1
Legal Description		UTM Co-ordinates (NAD83)		
SW13/SE14-86-8-W6		11 N 6258740	E 368408

Date	PF	CF	Total
<b>Previous Inspection:</b>	May 16, 2022	13	4	52 (Site 3)
		9	5	45 (Sites 5 and 6)
<b>Current Inspection:</b>	June 1, 2023	13	4	52 (Site 3)
		9	5	45 (Sites 5 and 6)
<b>Road AADT:</b>	400	<b>Year:</b>	2022	
<b>Inspected By:</b>	Barry Meays, Don Proudfoot (Thurber) Rishi Adhikari, Max Shannon (TEC)			
<b>Report Attachments:</b>	<input checked="" type="checkbox"/> Photographs <input checked="" type="checkbox"/> Plans <input checked="" type="checkbox"/> Maintenance Items

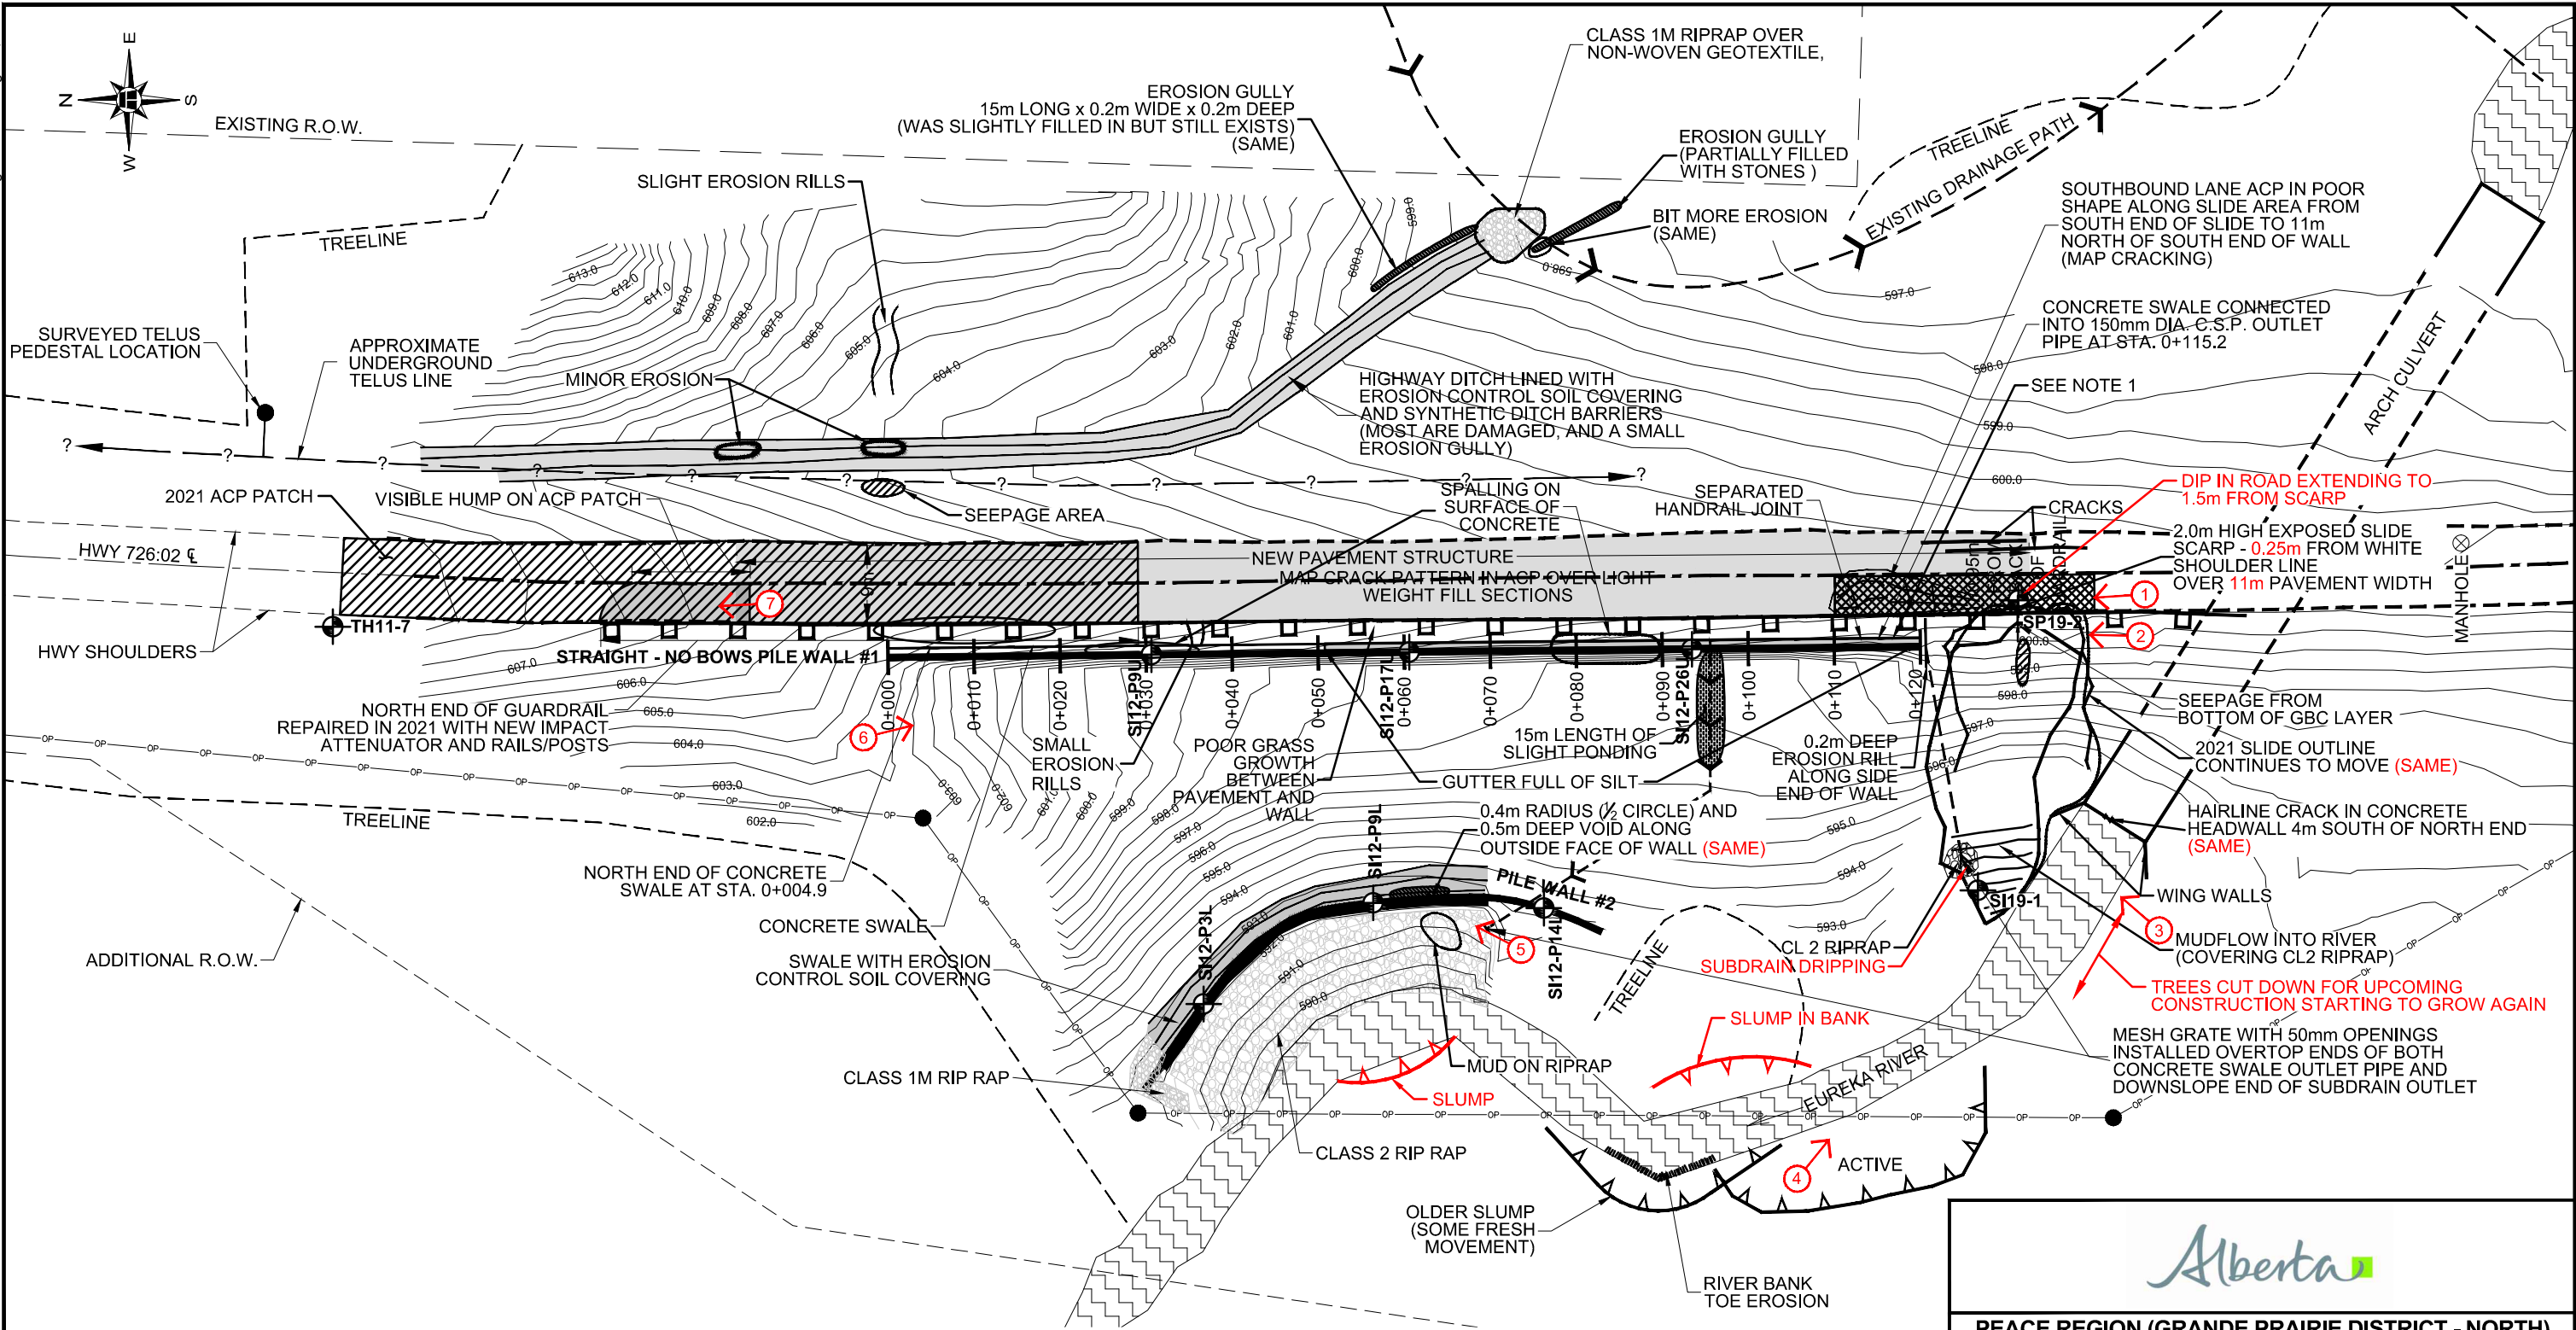
**DWG No. 32123-PH026-1-3**

- NOTES:**
- 1. GUTTER GRATE IS LOOSE AND GUTTER IS FULL OF DIRT AND NEEDS CLEANING (AT MAINTENANCE).
  - 2. CONDITIONS ON JUNE 1, 2023 SHOWN IN RED.
  - 3. REFER TO DWG NO. 32123 PH026-1-7 AND -PH026-1-8 FOR LATEST SLIDE DETAILS.

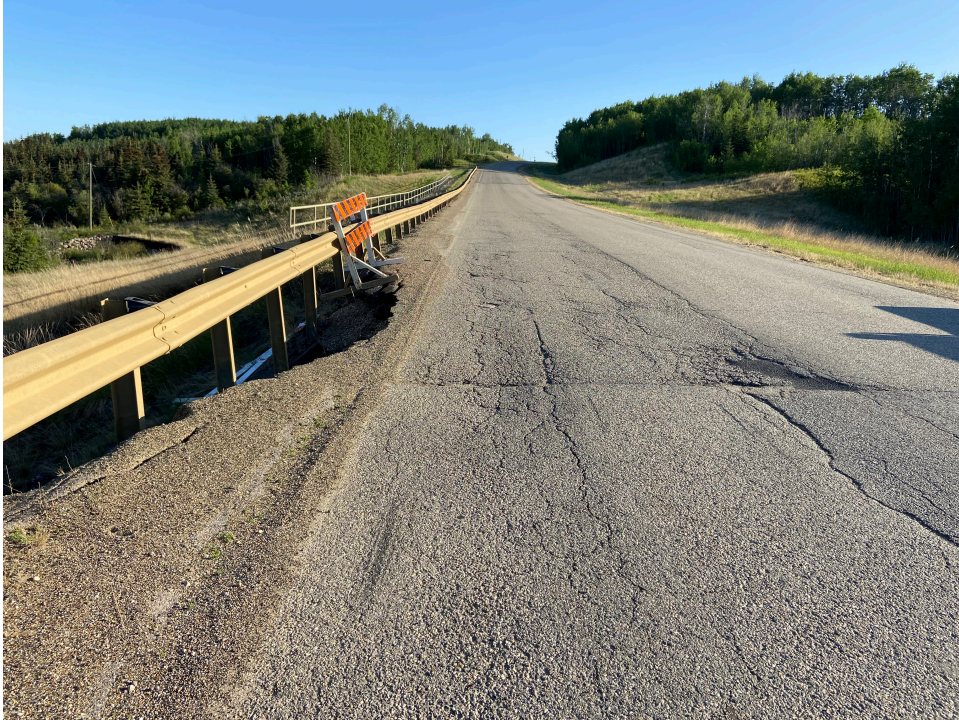
The seepage from the pavement GBC observed in 2016 south of the upper pile wall and ongoing weathering of the fill are the likely causes of the slide that occurred south of the upper pile wall in 2017. The seepage likely saturated the GBC and embankment fill with time, which created a weak soil mass that eventually failed, carrying the material down into the river.

Photo 1 – Looking north along the highway south of the upper pile wall at the landslide that developed at Site 3.

- Excavated the slumped material in the west highway embankment, and disposed of the material outside and away from the valley crests. Installed a drainage geosynthetic and a subdrain system along the base of the excavated slump. Sheet piles were installed along the slide toe and adjacent to the arch culvert, to minimize river inflow and to provide support for excavation adjacent to it, while temporary sheet piles were installed adjacent to the highway/pile wall for excavation support and removed after backfilling. The subdrains were extended through the lower portion of the re-built slope to outlet on the riprap adjacent to the river. Additional Class 2 riprap was installed along the toe of the repaired area adjacent to the river to prevent future toe erosion. The new highway embankment was re-built using compacted gravel to re-establish the existing slope and to surround the subdrains.

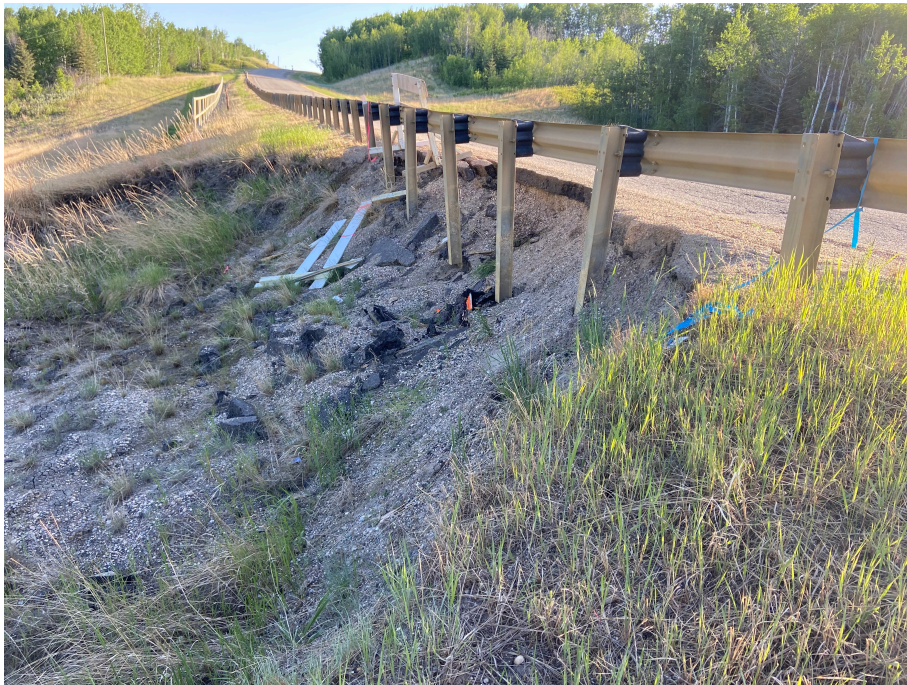
Photo 2 – Looking north at the slide scarp that has extended into the SB shoulder to within 0.25 m of the white line beyond the south end of the upper pile wall at Site 3.

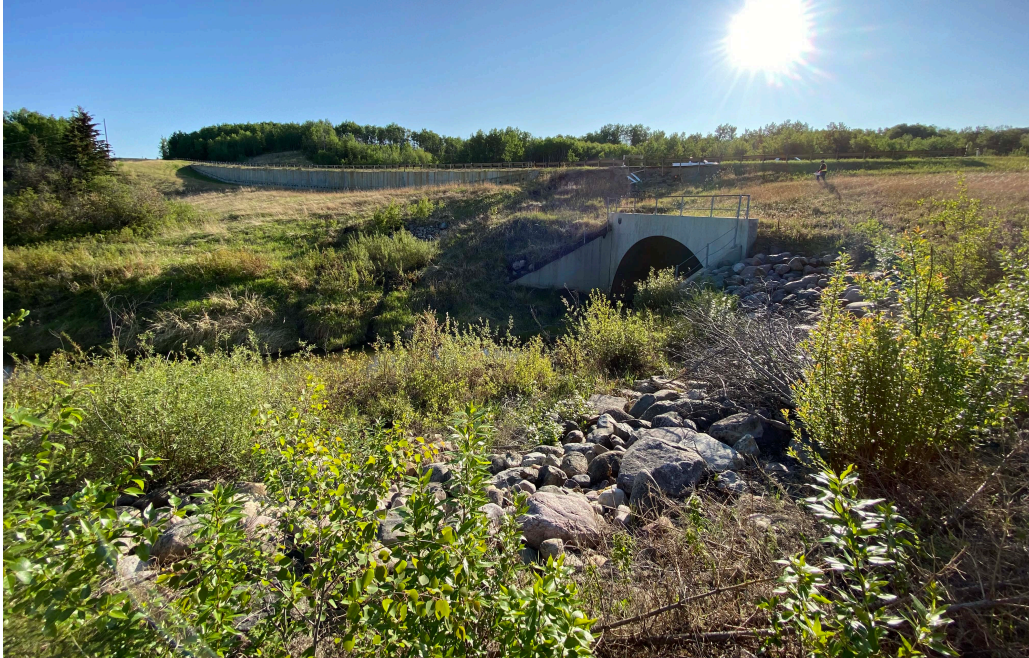
Photo 3 – Looking northeast at the slide that pushed debris against and around the arch culvert outlet headwall at Site 3. Note the cut trees growing again on the south side of the arch culvert.

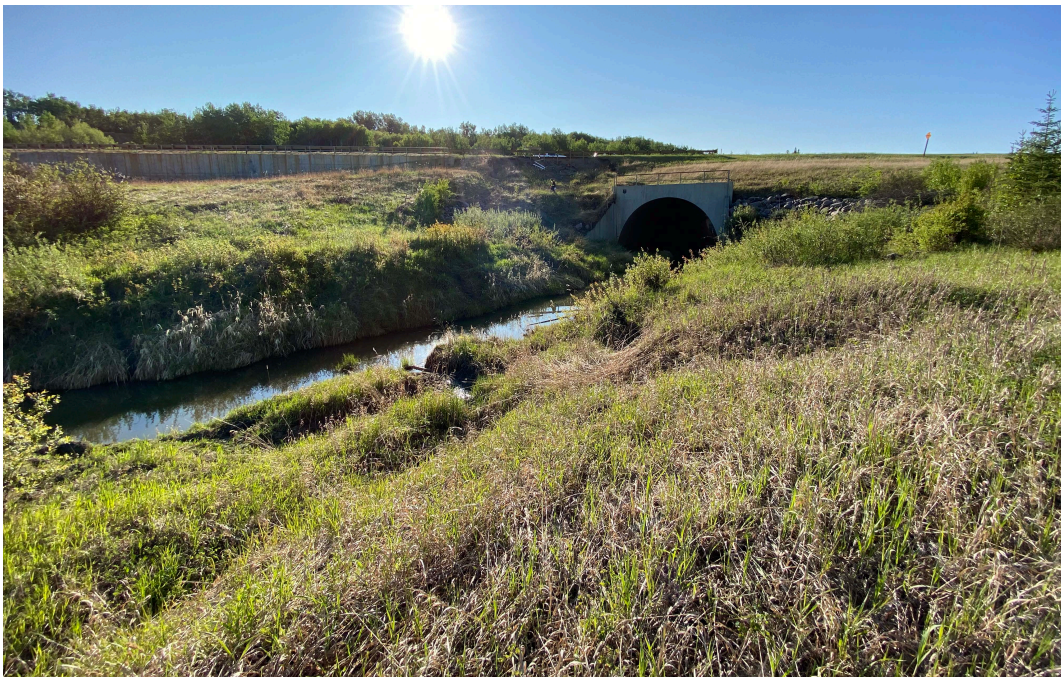
Photo 4 – Looking east at the body and scarp face of the slide between the south end of the pile wall and the arch culvert at Site 3.

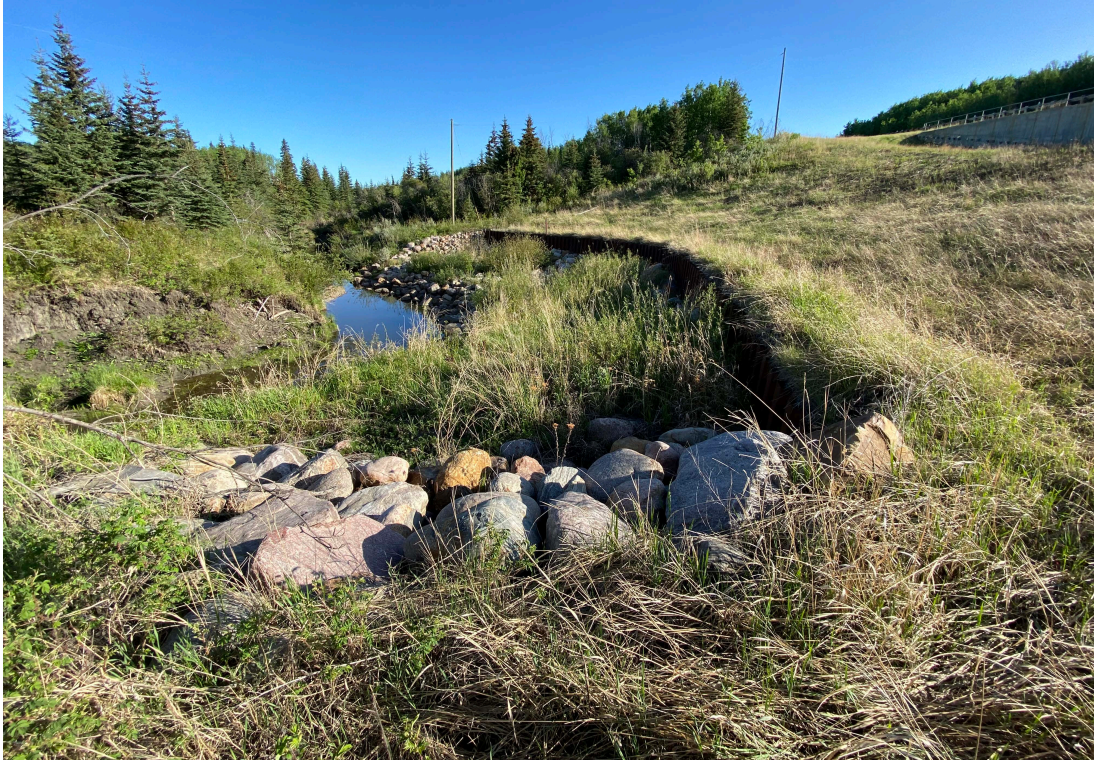
Photo 5 – Looking north at the lower pile wall area and riprap behind it at Site 3.

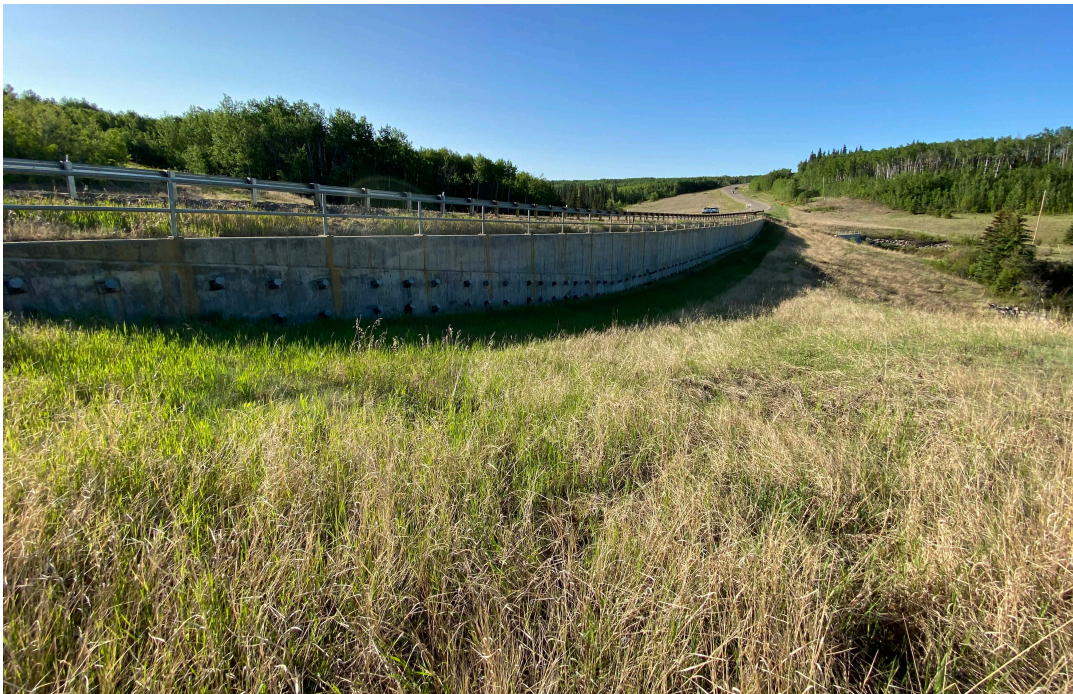
The exposed concrete along the top of the upper pile wall is spalling. This was attributed to weaker than design strengths on this material, for which the contractor was penalized for low strengths at that time.

Photo 6 - Looking south along the upper pile wall and downslope embankment at Site 3.

- 1) Clean the gutter of soil/debris buildup under the handrail adjacent to the west side of the highway, and securely fasten the loose gutter grate.
- 2) The spalled concrete on the surface of the upper pile wall should be repaired by placing a proper concrete sealant over the entire exposed surface to prevent any further degradation.
- 3) A steel sleeve could be installed over the gap in the handrail.

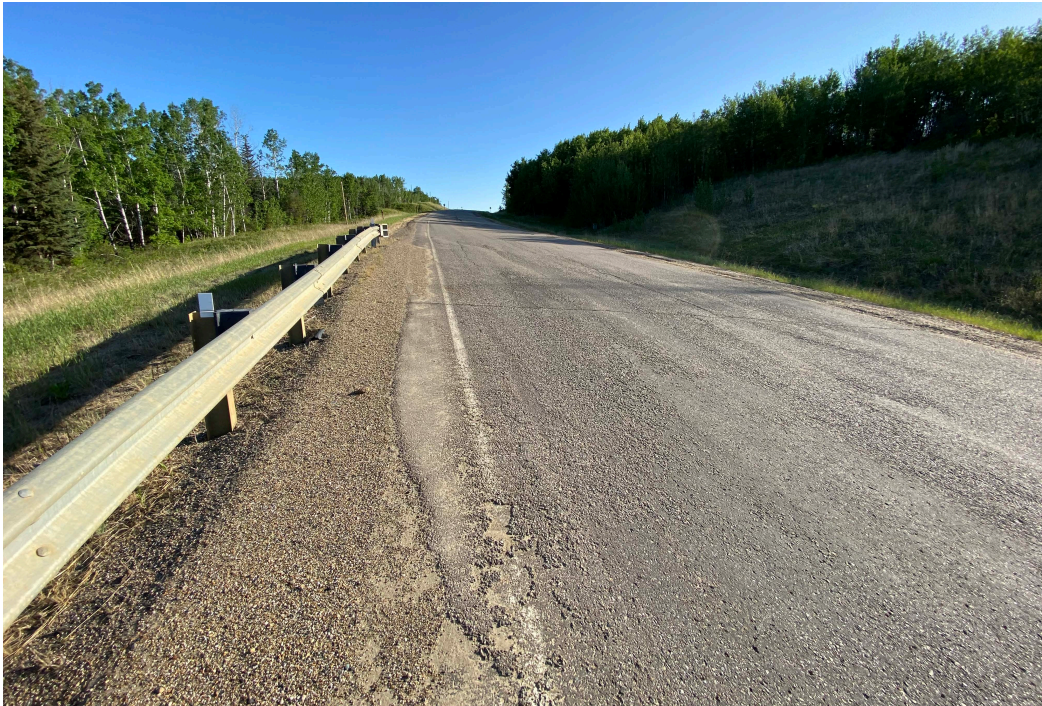
Photo 7 – Looking north along the highway at the north end of the guardrail and former patching at Site 5.

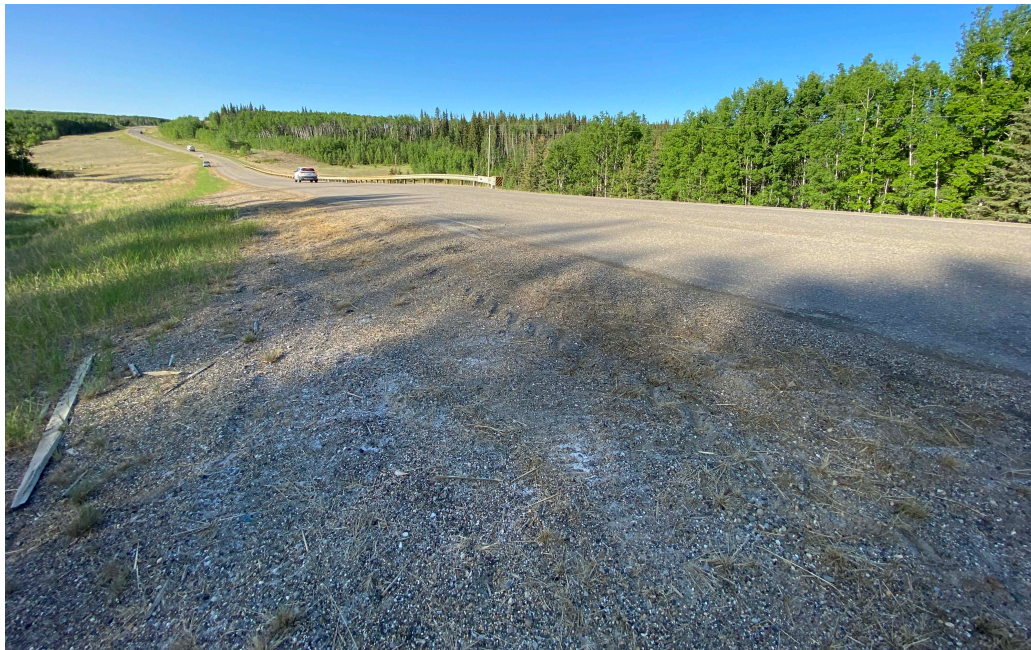
Photo 8 - Looking south along the highway from the south end of the scarp of Site 5.

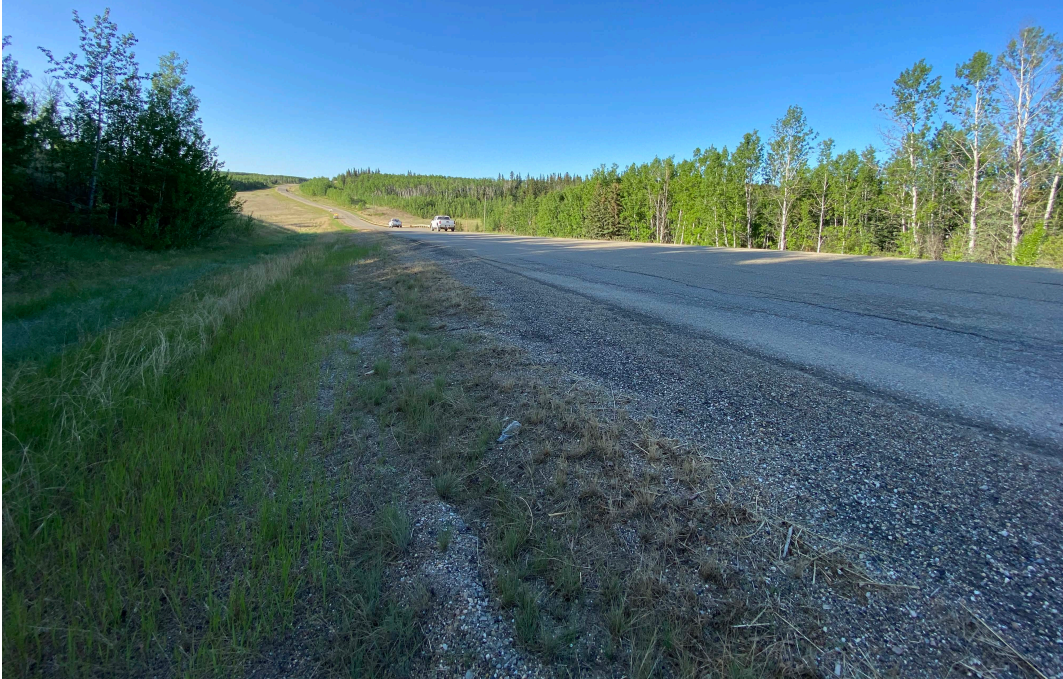
Photo 9 - Looking south along the highway at the subsidence in the NB driving lane and shoulder at Site 5.

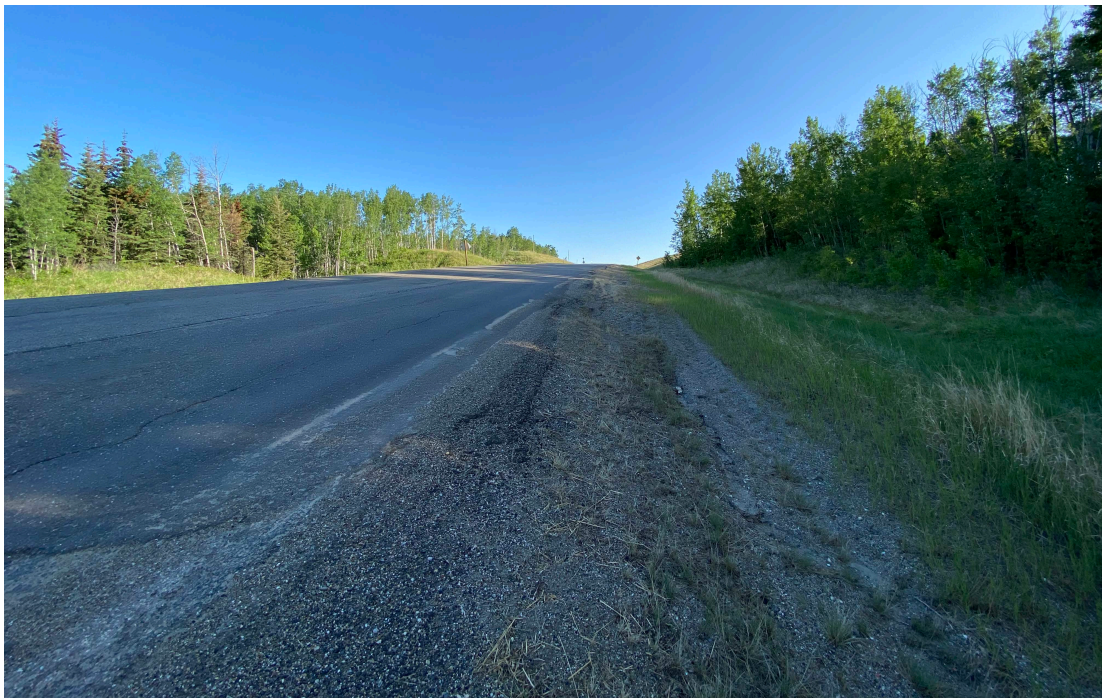
Photo 10 - Looking north along the east highway edge at where the slide scarp crosses the highway at Site 6.
