**ALBERTA TRANSPORTATION AND
ECONOMIC CORRIDORS
GEOHAZARD ASSESSMENT PROGRAM
PEACE REGION (GRANDE PRAIRIE DISTRICT - NORTH)
2024 INSPECTION**

Site Number	Location	Name	Hwy	km
PH026	Eureka River North Hill	Sites #3, #5 and #6	726:02	10.1
Legal Description		UTM Co-ordinates (NAD83)		
SW13/SE14-86-8-W6		11 N 6258740	E 368408

2024 PH026 INSPECTION PLAN

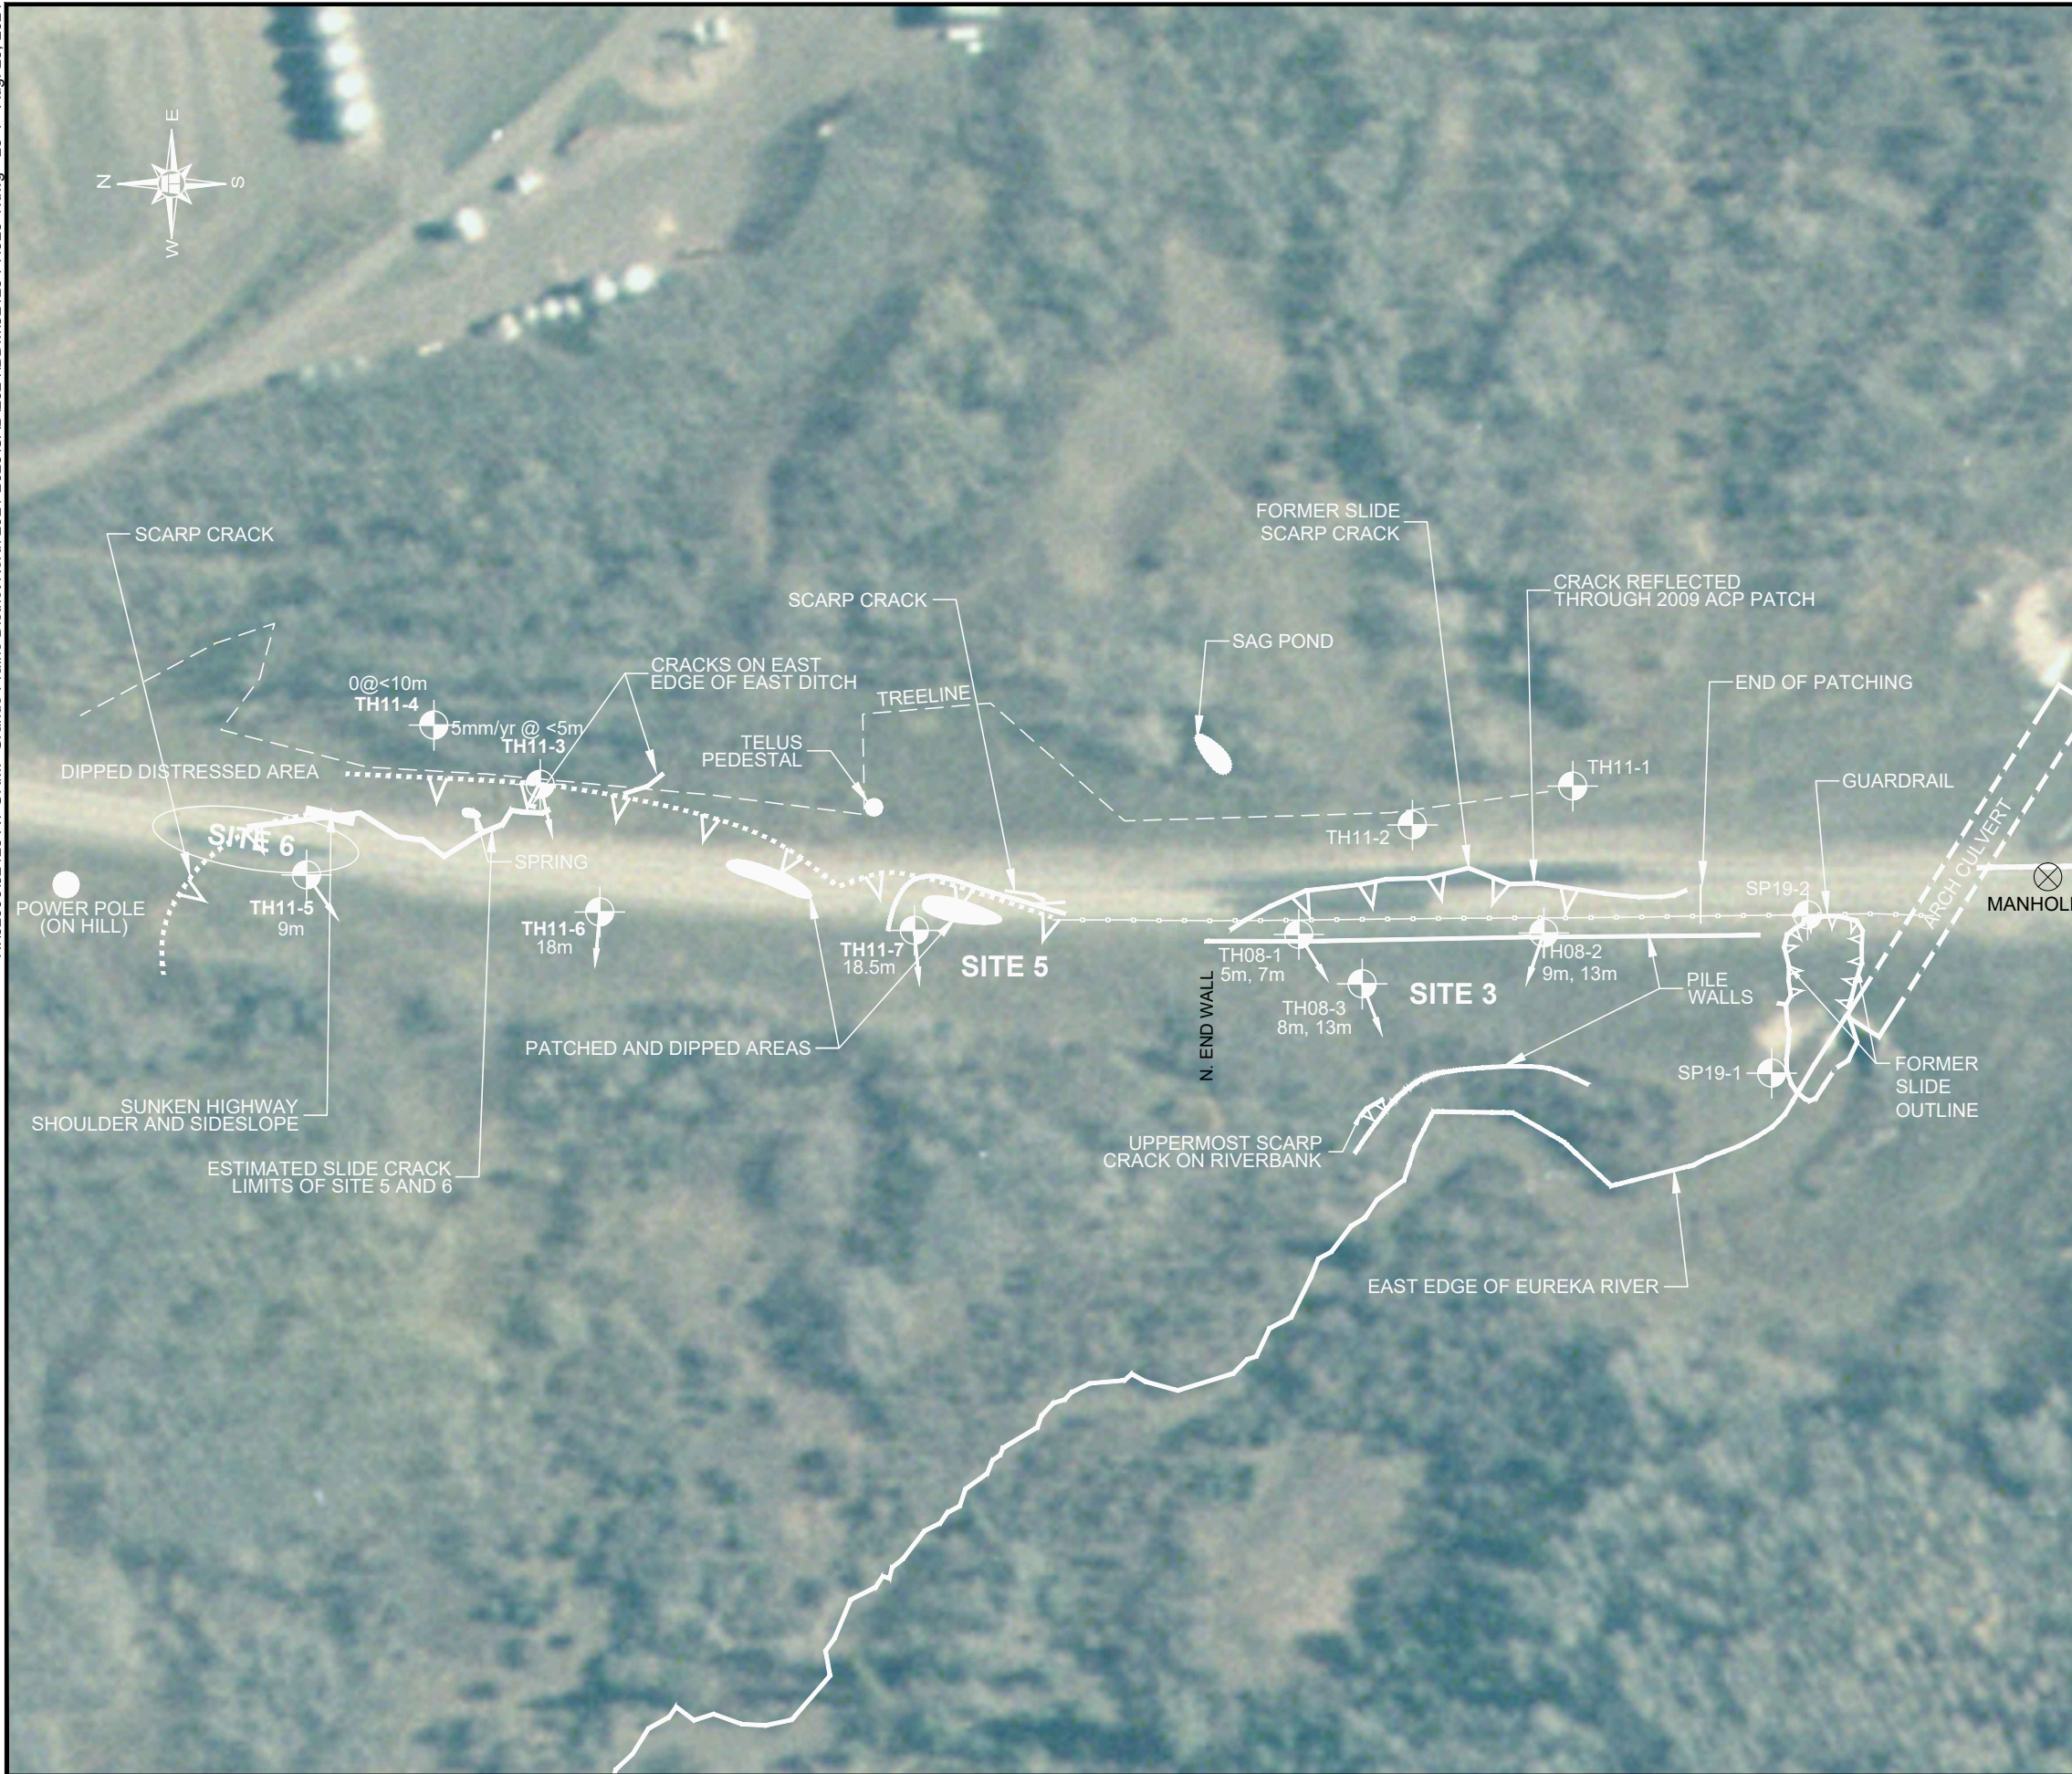
DWG No. 32123-PH026-1

1. SLIDE FEATURES RECORDED USING A HAND HELD GPS.
2. SITE 5 AND SITE 6 MAY OUTLINE THE EDGE OF A SINGLE SLIDE SPANNING BETWEEN THE TWO AREAS.
3. FOR UPDATED CRACKS / PATCHES, SEE DWG No. 32123-PH026-2 TO 32123-PH026-4.

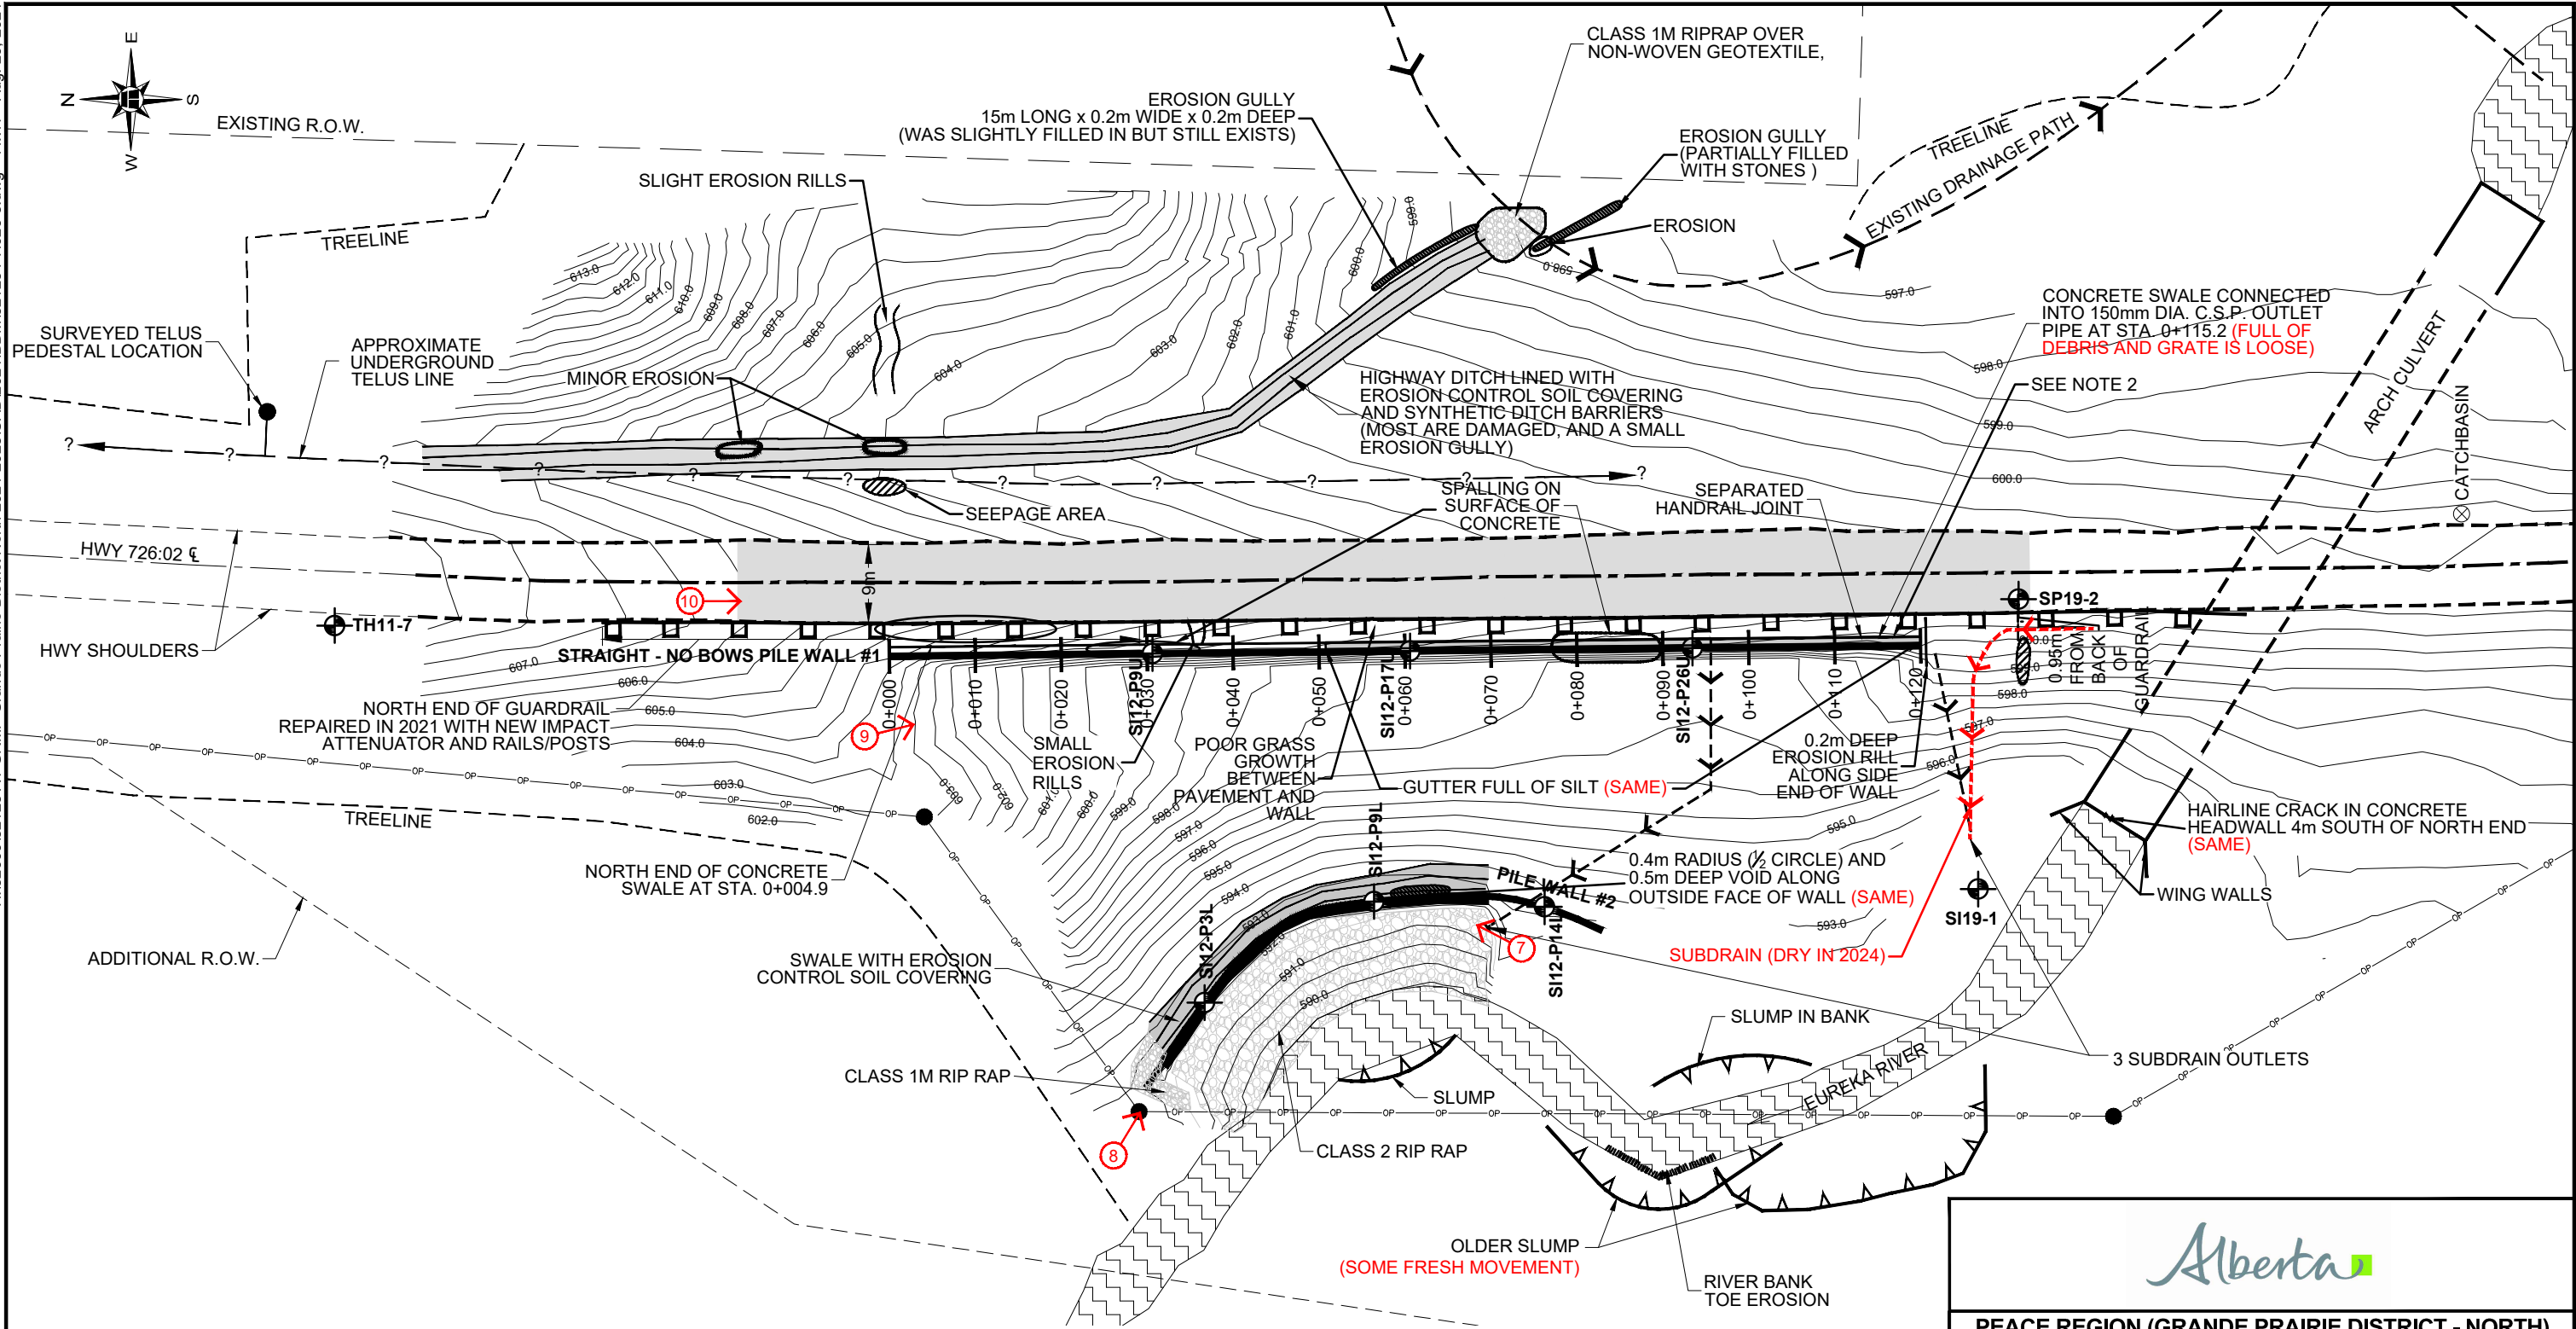
DWG No. 32123-PH026-3

- NOTES:**
- CONDITIONS ON MAY 8, 2024 SHOWN IN RED.
 - GUTTER GRATE IS LOOSE AND GUTTER IS FULL OF DIRT AND NEEDS CLEANING (AT MAINTENANCE).
 - HIGHWAY 726:02 WAS OVERLAYED IN FALL OF 2023.
 - REFER TO DWG NO. 32123 PH026-4 FOR ADDITIONAL DETAILS OF 2023 SLIDE REPAIRS BETWEEN ARCH CULVERT AND UPPER PILE WALL.

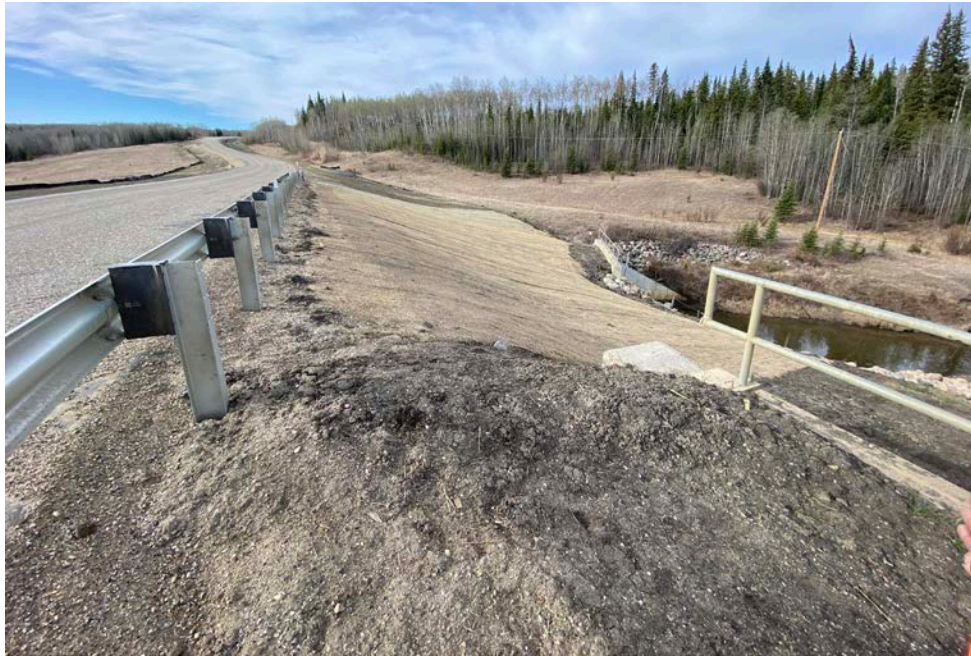
Also as part of this Paving Contract #21542, TEC approved repairs as undertaken by Thurber in the 2023 detailed design and tender, to the Site 3 slide that occurred between the upper pile wall and bridge culvert, which consisted of: Excavated the slumped material in the west highway embankment, and disposed the material outside and away from the valley crests; Installed a drainage geosynthetic and a subdrain system along the base of the excavated slump; Installed sheet piles along the slide toe and adjacent to the arch culvert, to minimize river inflow and to provide support for excavation adjacent to it; Installed temporary sheet piles adjacent to the highway/pile wall for excavation support (which were removed after backfilling); Extended the subdrains through the lower portion of the re-built slope to outlet on the riprap adjacent to the river; Installing additional Class 2 riprap along the toe of the repaired area adjacent to the river to prevent future toe erosion; Re-built the new highway embankment using compacted gravel to re-establish the existing slope and to surround the subdrains; and then completed with Topsoil Replacement, Seeding, and Soil Coverings. Based on our 2024 inspection, these repairs appear to have stabilized this smaller landslide area.

Photo 1 – Looking south along the west highway embankment south of the upper pile wall at the 2023 landslide repairs at Site 3.

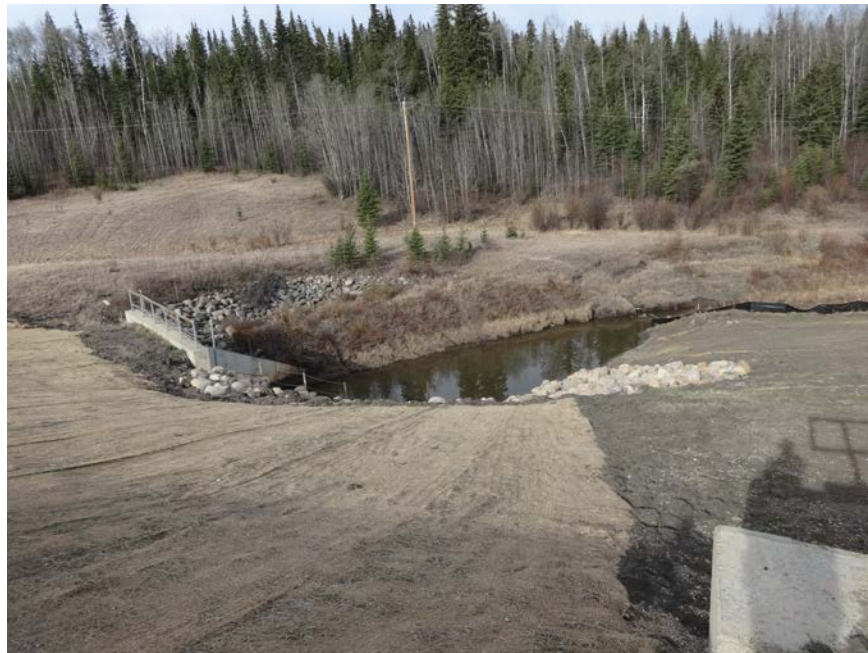
Photo 2 – Looking west at the slide repairs and arch culvert outlet from the south end of the upper pile wall at Site 3. Note the bank slump on the outside bend of the river.

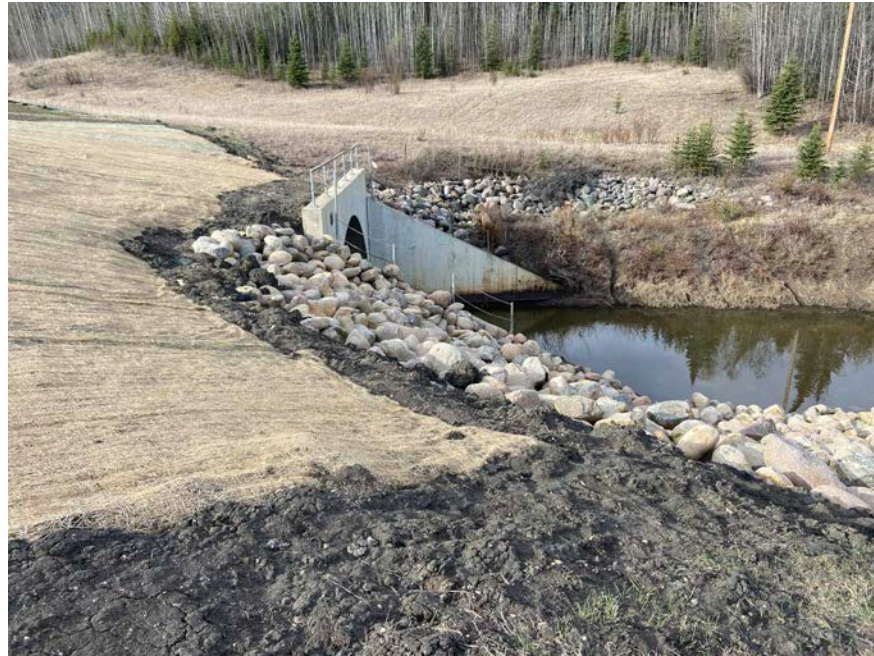
Photo 3 – Looking southwest at the lower slide repairs and arch culvert at Site 3.

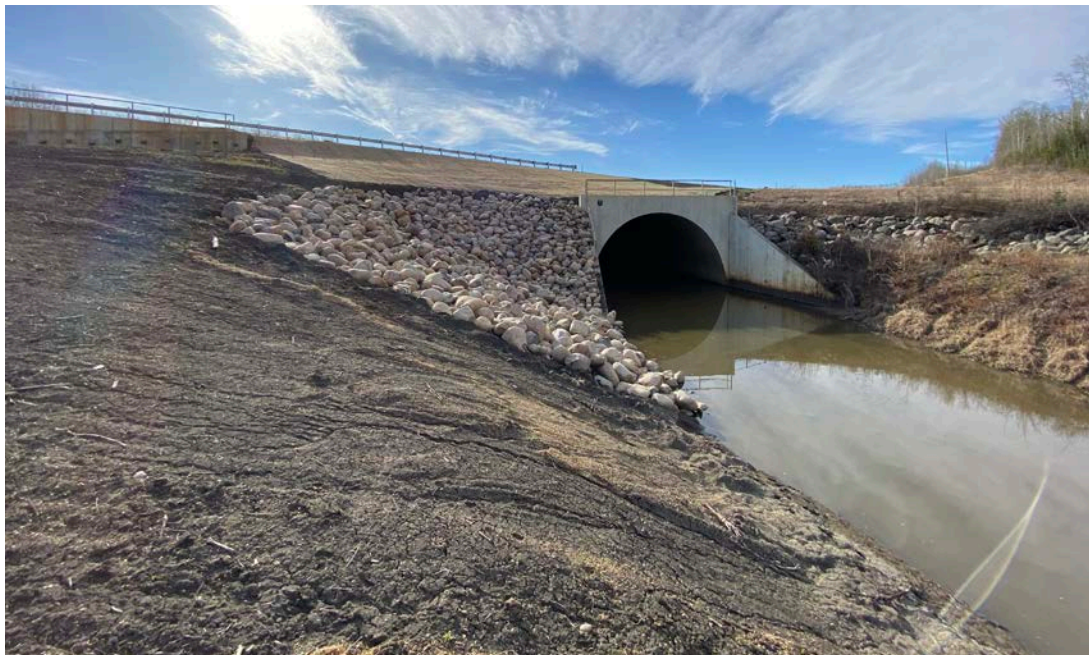
Photo 4 – Looking southeast at the slide repairs and the arch culvert outlet area at Site 3.

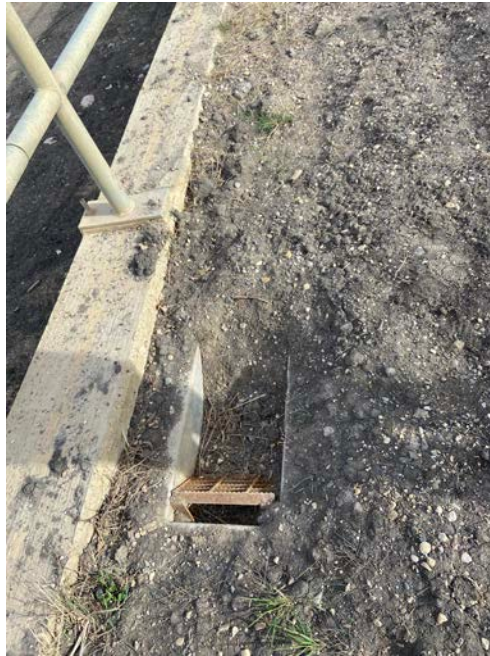
<input checked="" type="checkbox"/> Other	Maintenance issues that require attention: loose gutter grate and silt/debris filled concrete gutter. The exposed concrete on the top of the upper pile wall is spalling. The handrail was separated at one location on the pile wall. Also, there was minimal grass growth on the west embankment around the 2023 slide repair area.	<input checked="" type="checkbox"/>
---	---	-------------------------------------

Photo 5 – Looking north at the top of pile wall gutter drain and loose cover plate at site 3. This needs to be cleaned.

- 1) Clean the gutter of soil/debris buildup under the handrail adjacent to the west side of the highway, and securely fasten the loose gutter grate.
- 2) The spalled concrete on the surface of the upper pile wall should be repaired by placing a proper concrete sealant over the entire exposed surface to prevent any further degradation.
- 3) A steel sleeve could be installed over the gap in the handrail.
- 4) Install a grate that was missing on the subdrain outlet from the 2023 slide repairs performed between the pile wall and bridge culvert.

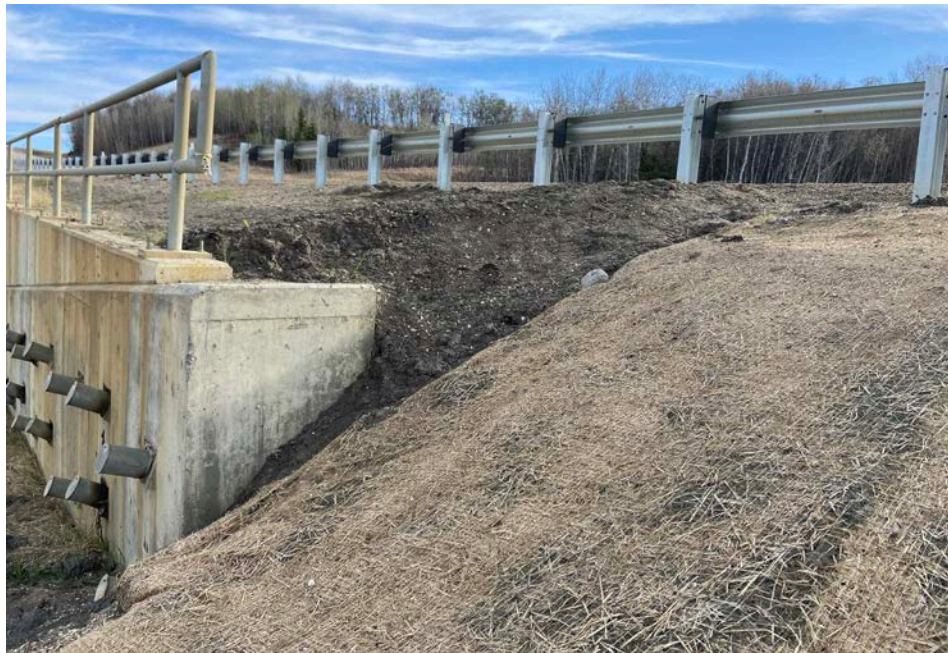
Photo 6 – Looking north at the south end of the pile wall at Site 3. If runoff begins to develop at this area, it will need to be built up with additional clay infill, then topsoiled/seeded/covered.

Consider covering the slope in between the pavement and the upper wall with hand placed asphalt, as there is sparse grass growth here and some rilling has formed.

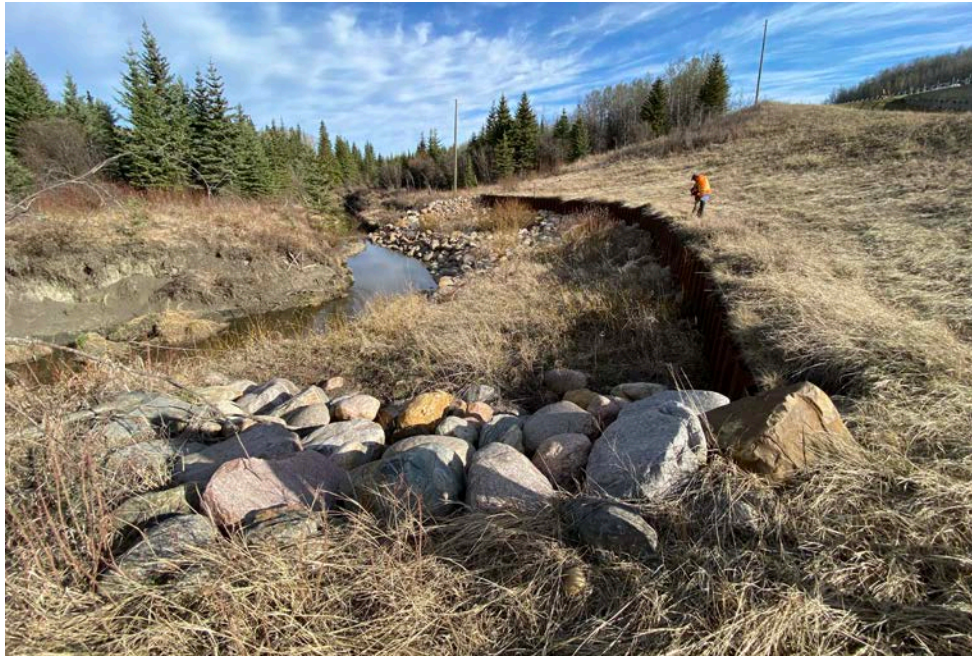
Photo 7 – Looking north at the lower pile wall area at Site 3, the riprap behind it, and the river.

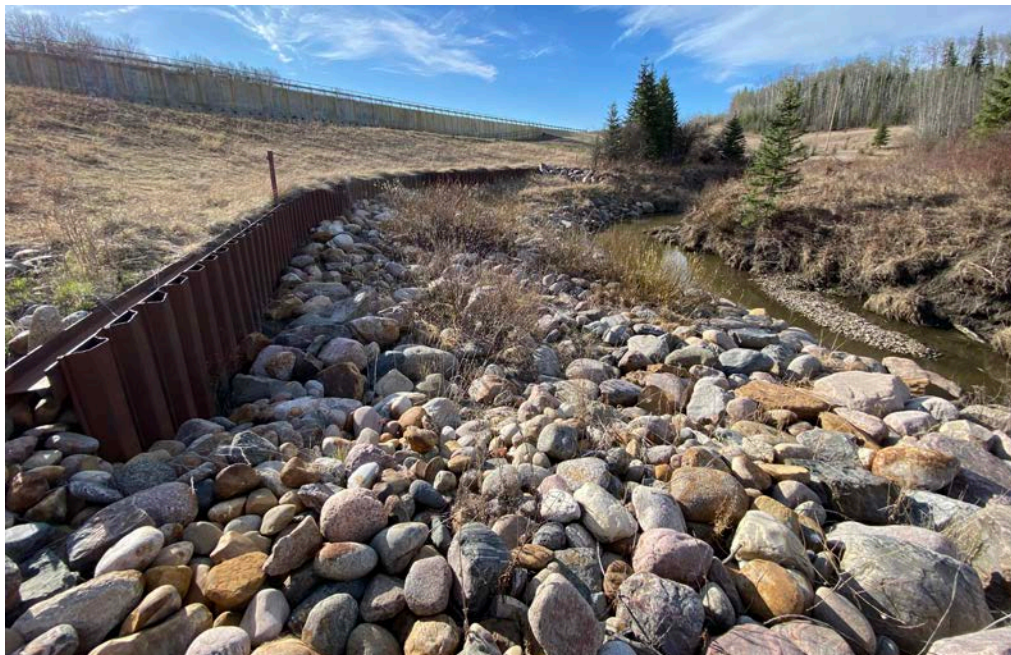
Photo 8 – Looking south along the lower pile wall, riprap, and river at Site 3.

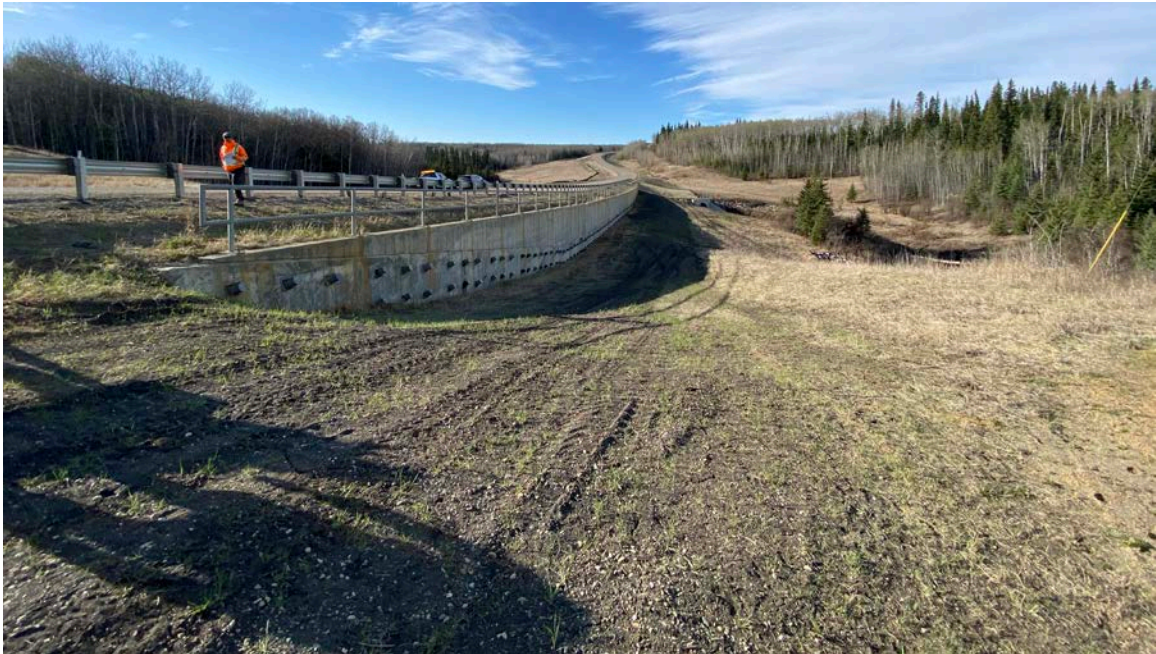
Photo 9 - Looking south along the upper pile wall and downslope embankment at Site 3.

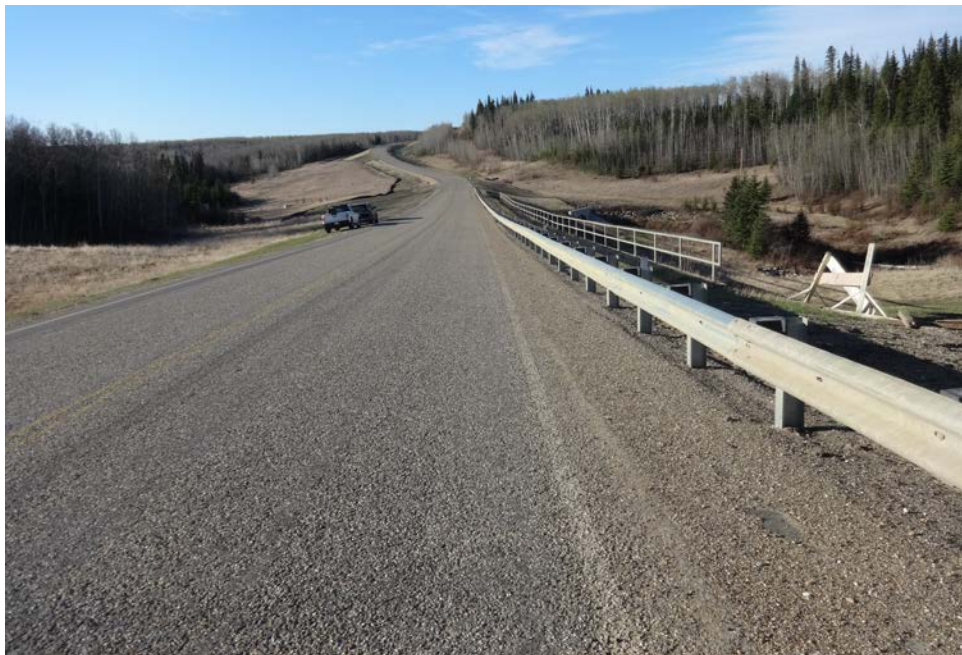
Photo 10 – Looking south along the highway from the north end of the pile wall of Site 3.

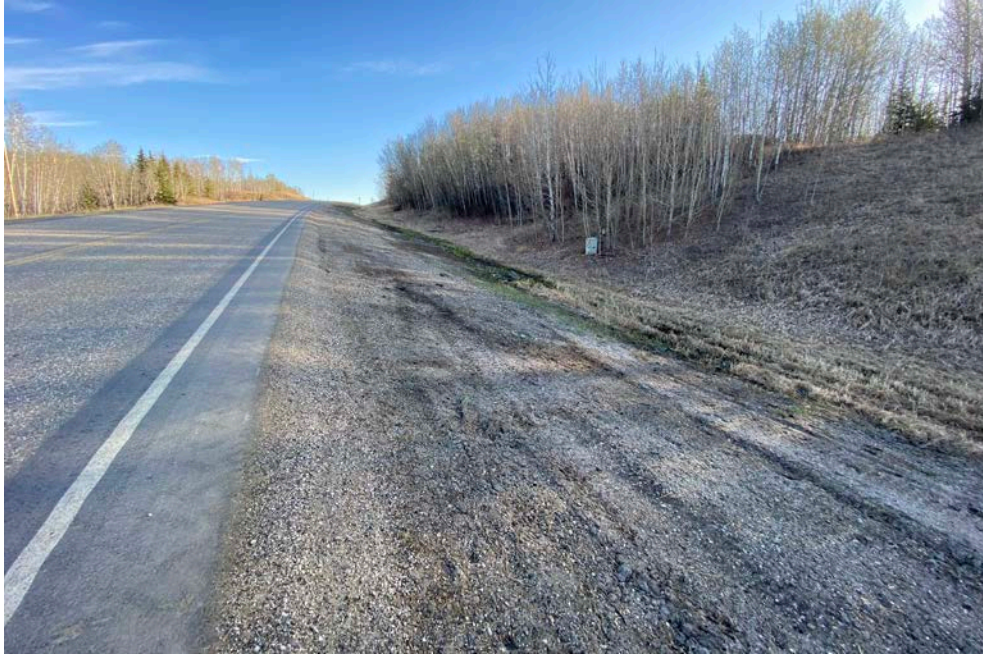
Slide features at/between Sites 5 and 6 have not changed significantly over the last few years. The inclinometers installed in 2011 (SI's 11-5, -6 and -7, which were previously showing movements in the order of 15 to 25 mm/year) had all sheared off by 2015, while SI's 11-3 and 11-4 which are located very near the top of the slide scarp show negligible movement. This indicates creep movements are occurring at both Sites 5 and 6, in addition to between them, at depths as deep as 18.5 m below ground surface. This more closely defines the slide boundary between Sites 5 and 6 and outlines the edge of a single larger slide moving towards the river.

Photo 11 - Looking north along the highway and east ditch from the south end of the scarp of Site 5.

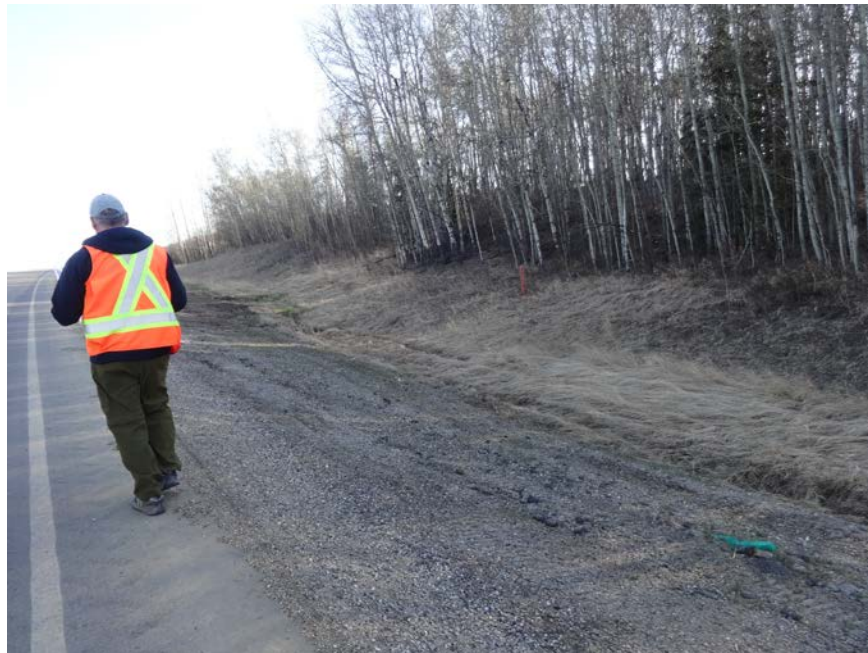
Photo 12 - Looking north along the east ditch at SI 11-3, where the slide scarp runs along the ditch between Sites 5 and 6.

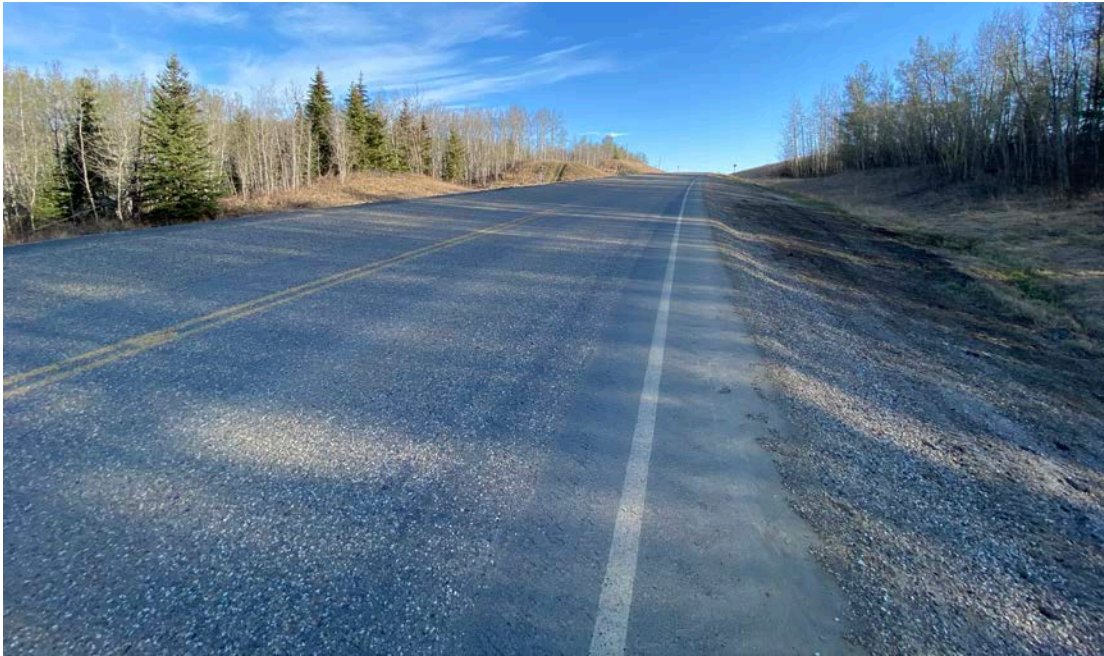
Photo 13 - Looking north along the east highway edge where the slide scarp crosses the highway at Site 6.

The major highway re-alignment is still considered the best long-term recommendation, since the slip surfaces at Sites 5 and 6 are too deep to stabilize with a cost-effective pile wall.

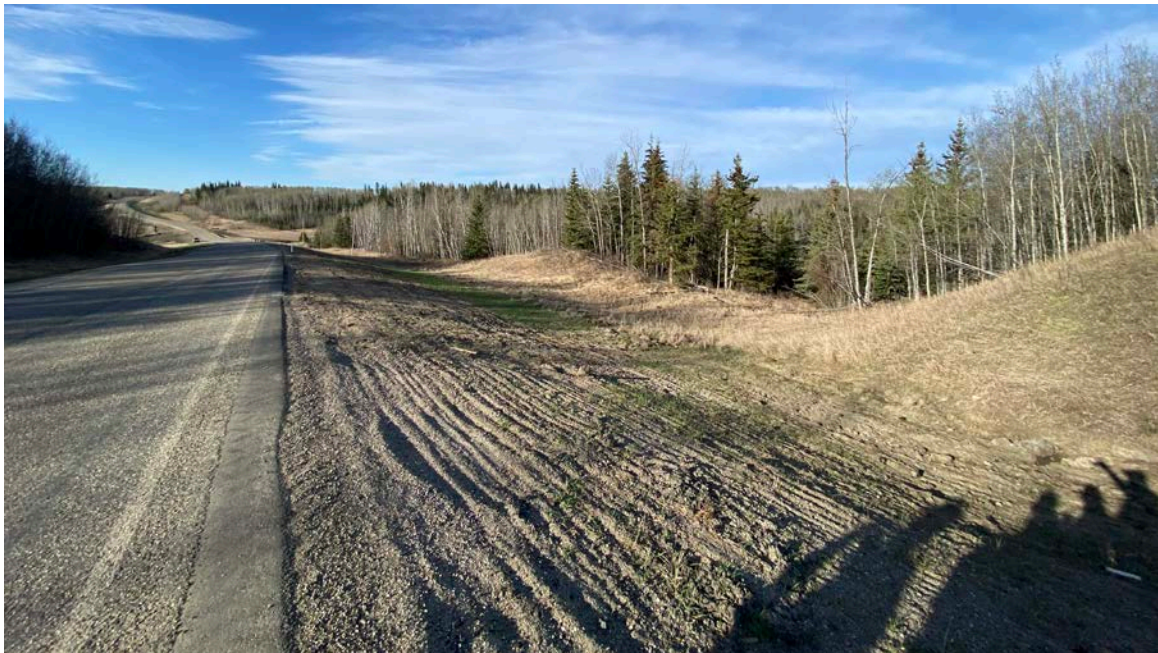
Photo 14 - Looking south along the west side of the highway where the slide scarp crosses at Site 6.
