ALBERTA TRANSPORTATION AND
ECONOMIC CORRIDORS GRMP
GRANDE PRAIRIE REGION –
(GRANDE PRAIRIE NORTH)
INSTRUMENTATION MONITORING - SPRING 2024

Site Number	Location	Name	Hwy	km
PH026	HWY 726:02 km 9.91, 10.30	North Eureka River Slide	726:02	Km 9.9, 10.3
Legal Description: 8-14-86-8 W6		UTM Co-ordinates		
		11U E 368433	N	6258811

Current Monitoring:	27-May-2024	Previous Monitoring	13-Oct-2023
Instruments Read By:	Mr. Niraj Regmi, G.I.T and Mr. Nixson Mationg, of Thurber

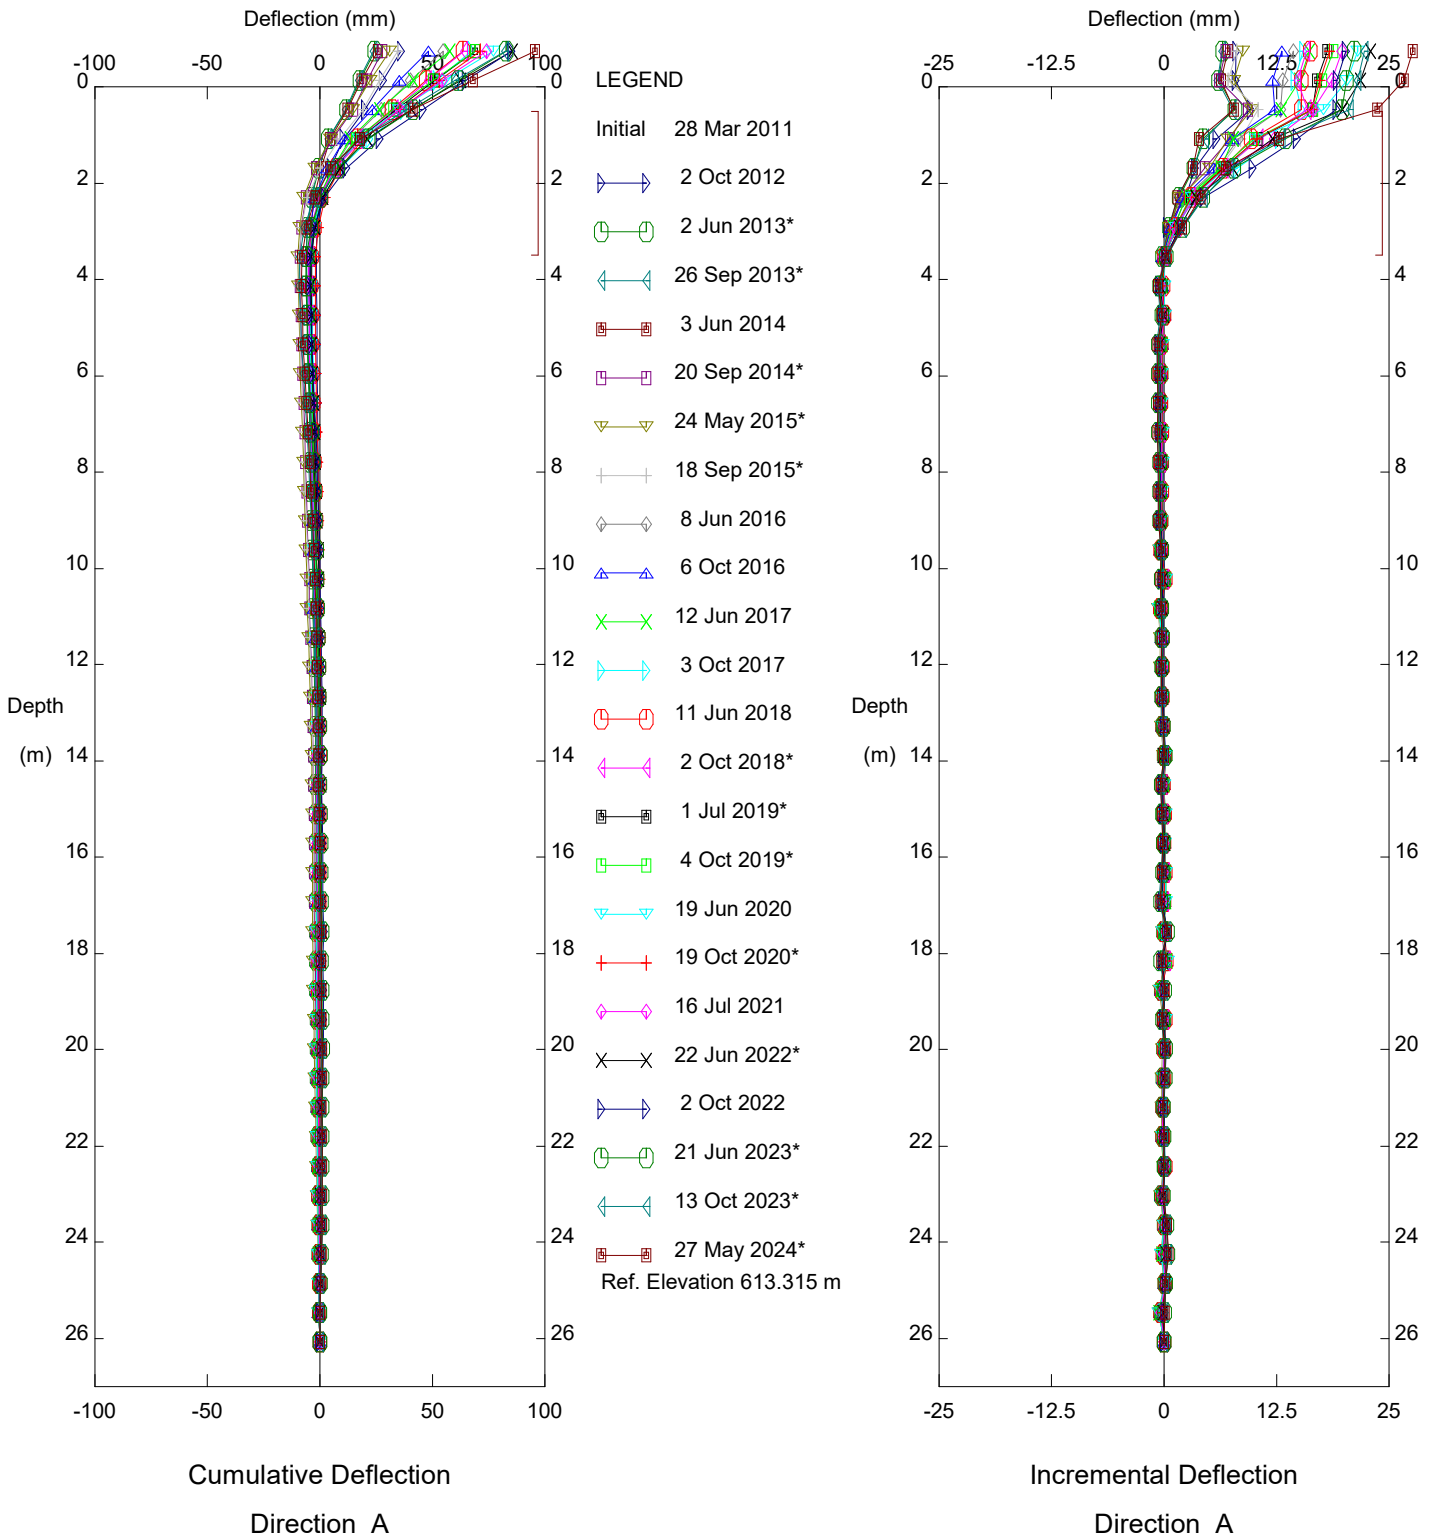
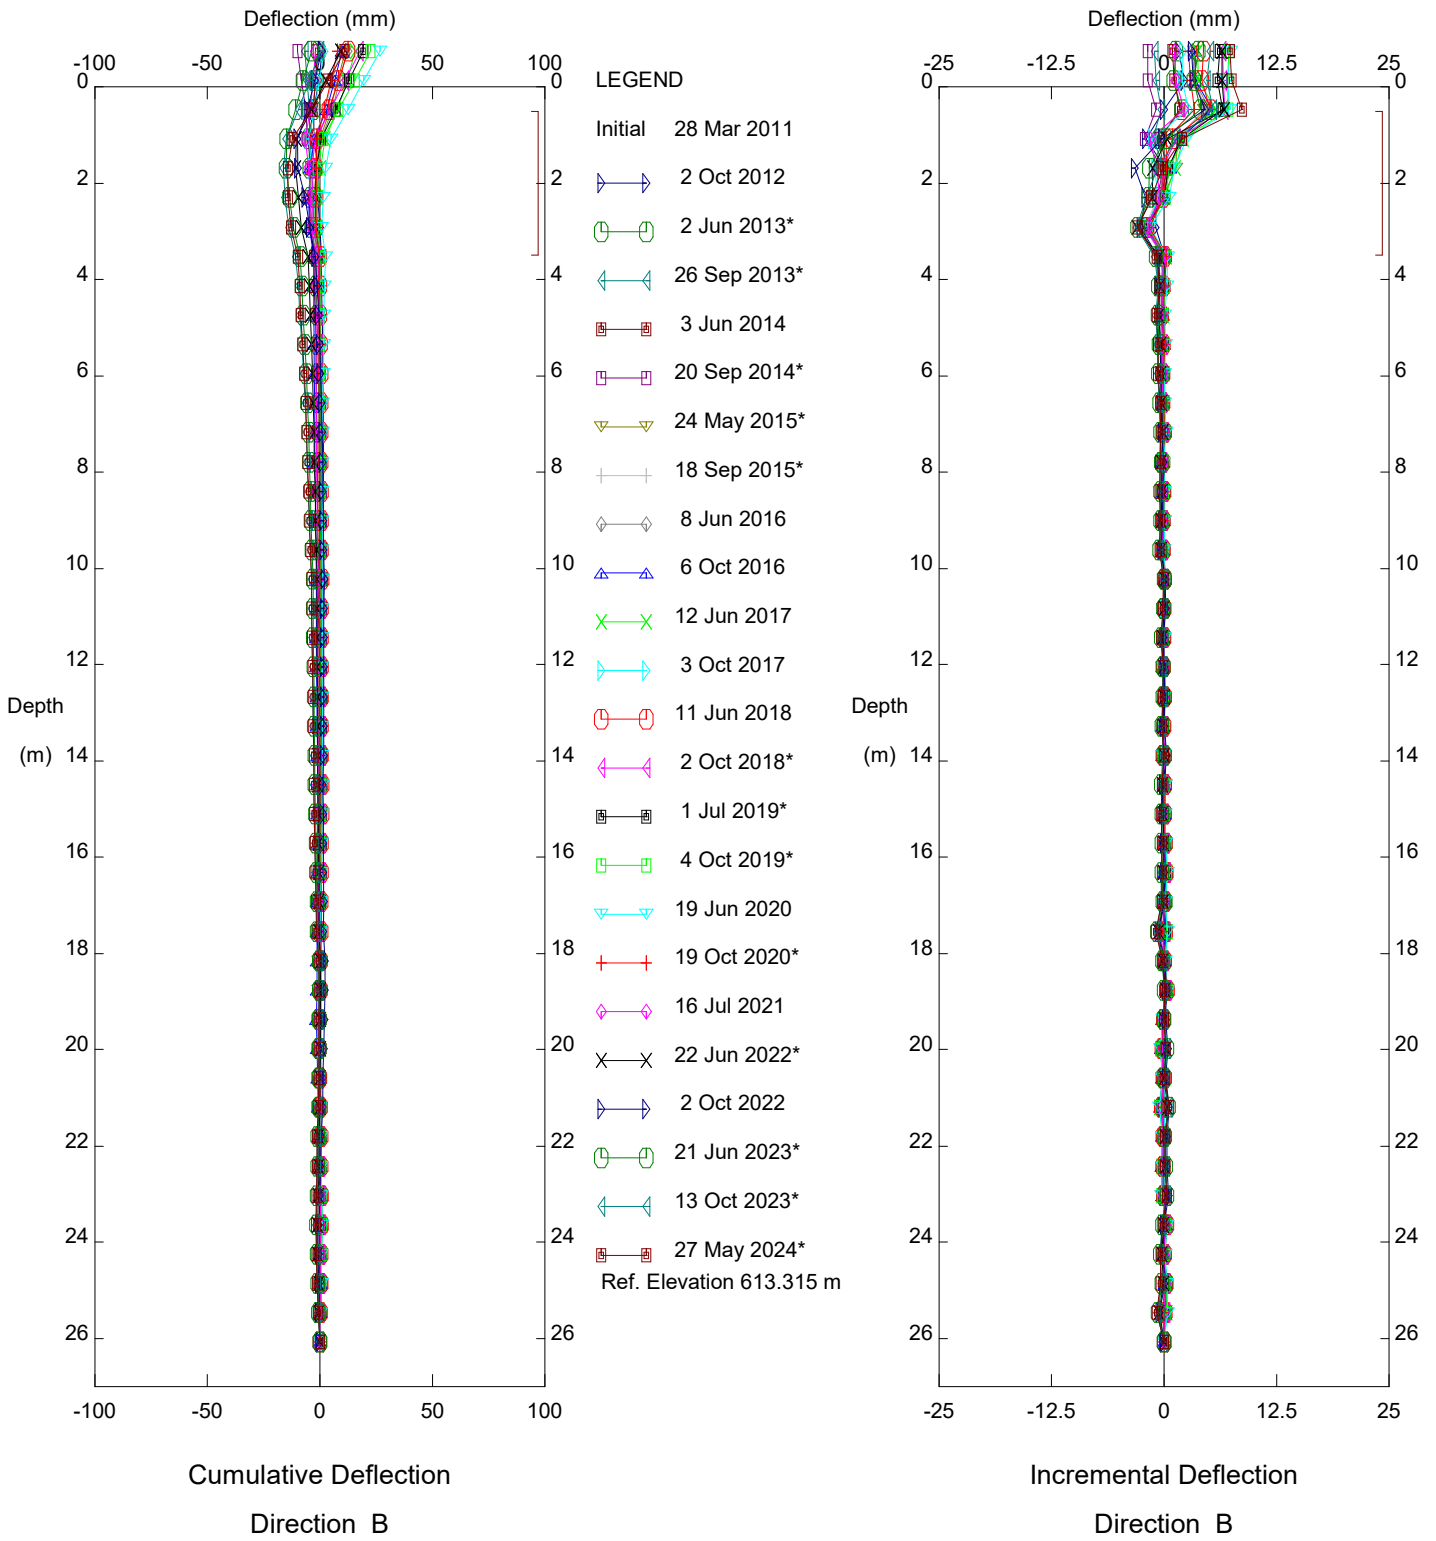
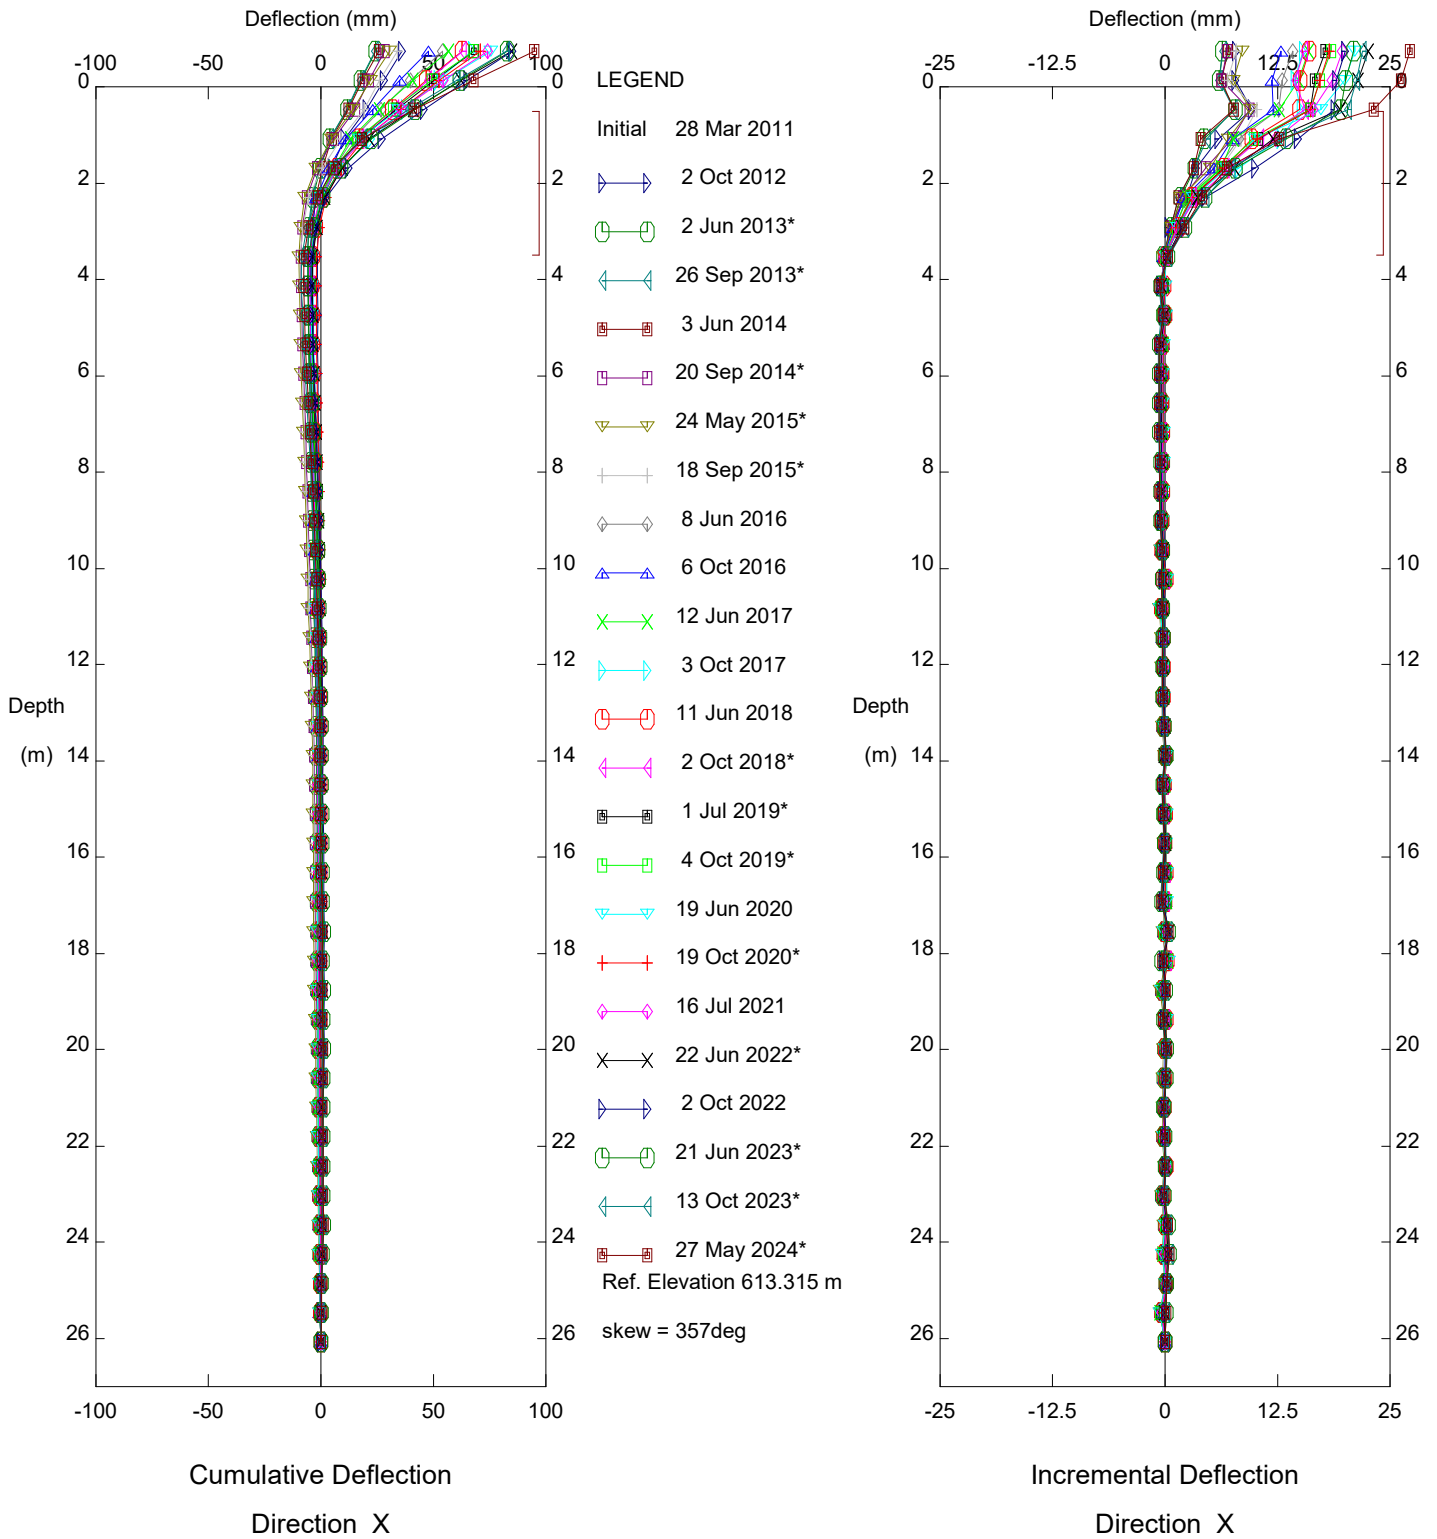
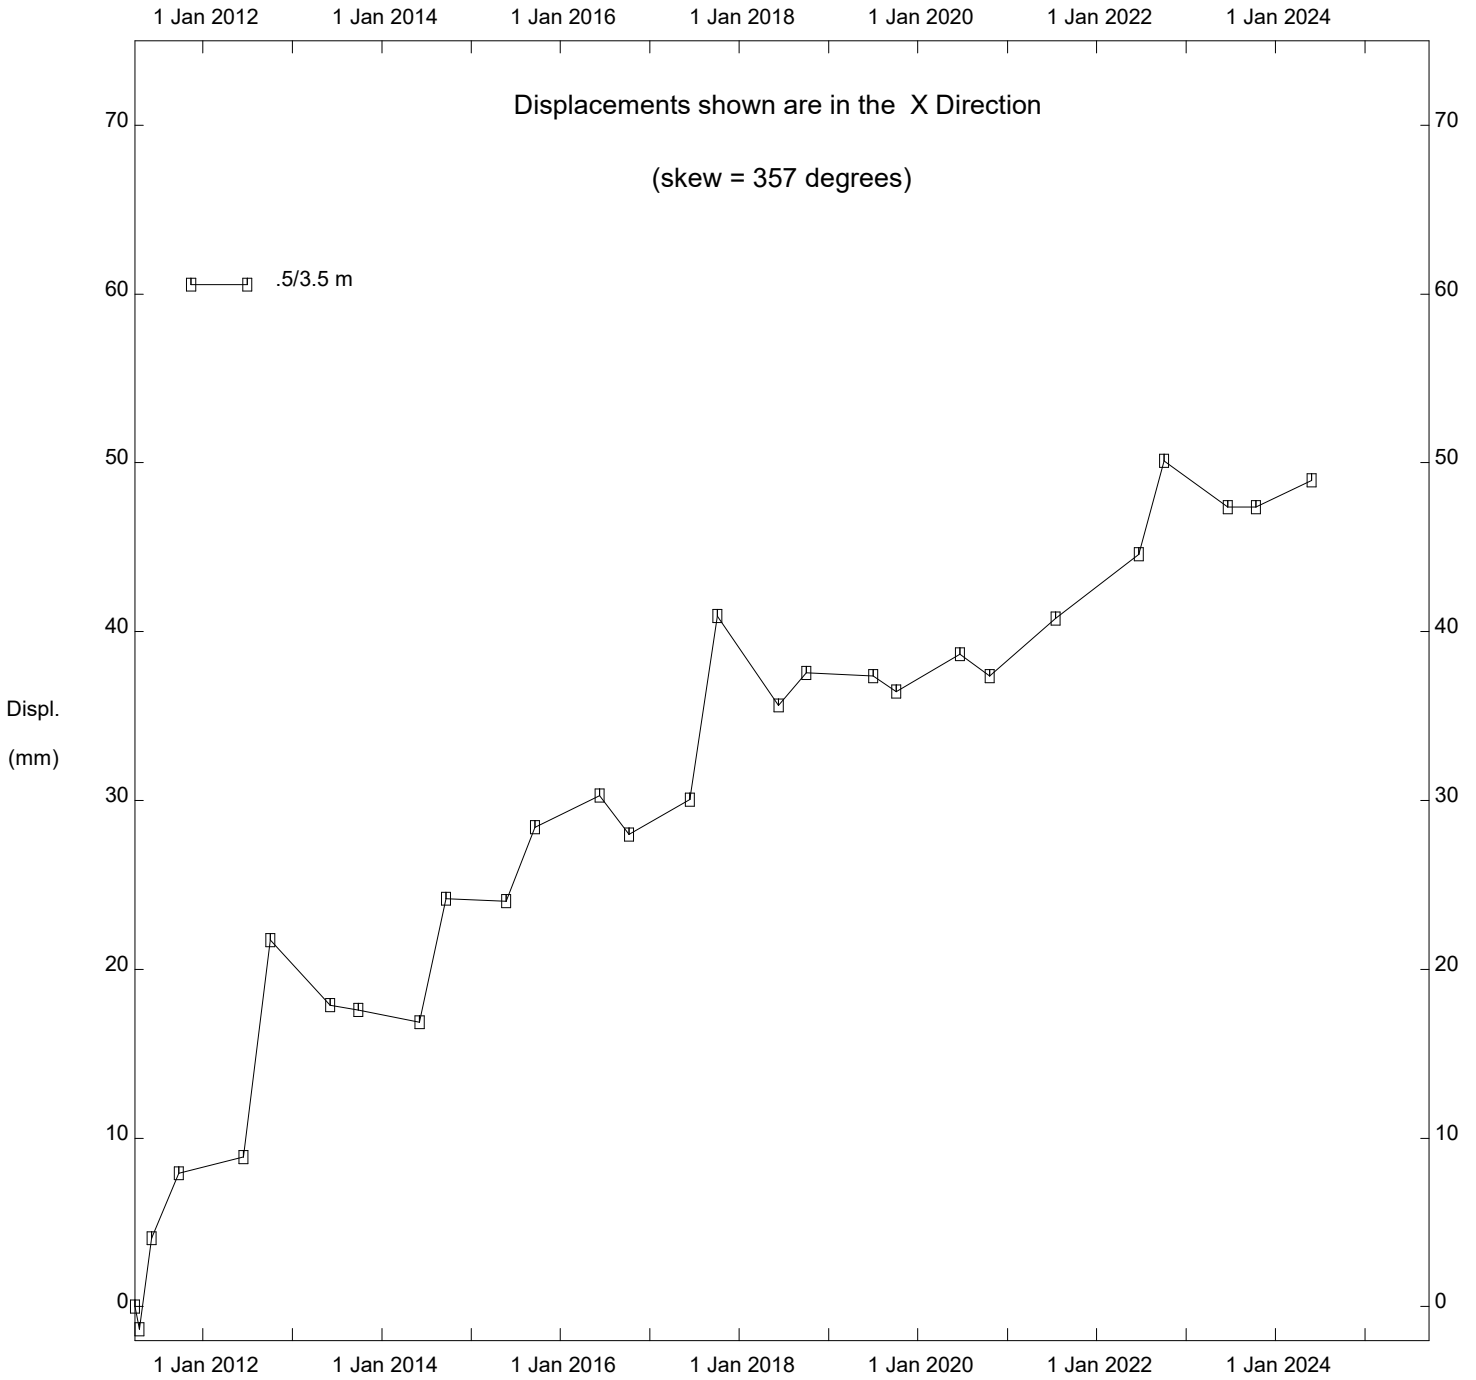
Hwy 726:02 Eureka River, PH026, Inclinometer SI11-3

Discussion	
Zones of New Movement:	None
Interpretation of Monitoring Results:	<p>Slope inclinometer SI11-3 showed a rate of movement of 2.6 mm/yr over 0.5 m to 3.5 m depth since the fall of 2023 readings. This rate of movement has held more or less steady since 2013.</p> <p>SI11-4 continued to show no discernible movement.</p> <p>Slope inclinometers SI12-P9U, SI12-P17U, SI12-P26U were installed in the upper wall.</p> <p>Since the fall of 2023, SI12-P9U has shown barely discernible movement. The total pile head movement to date has been 15.9 mm in the upslope direction of about 2 mm of movement has occurred since 2014.</p>

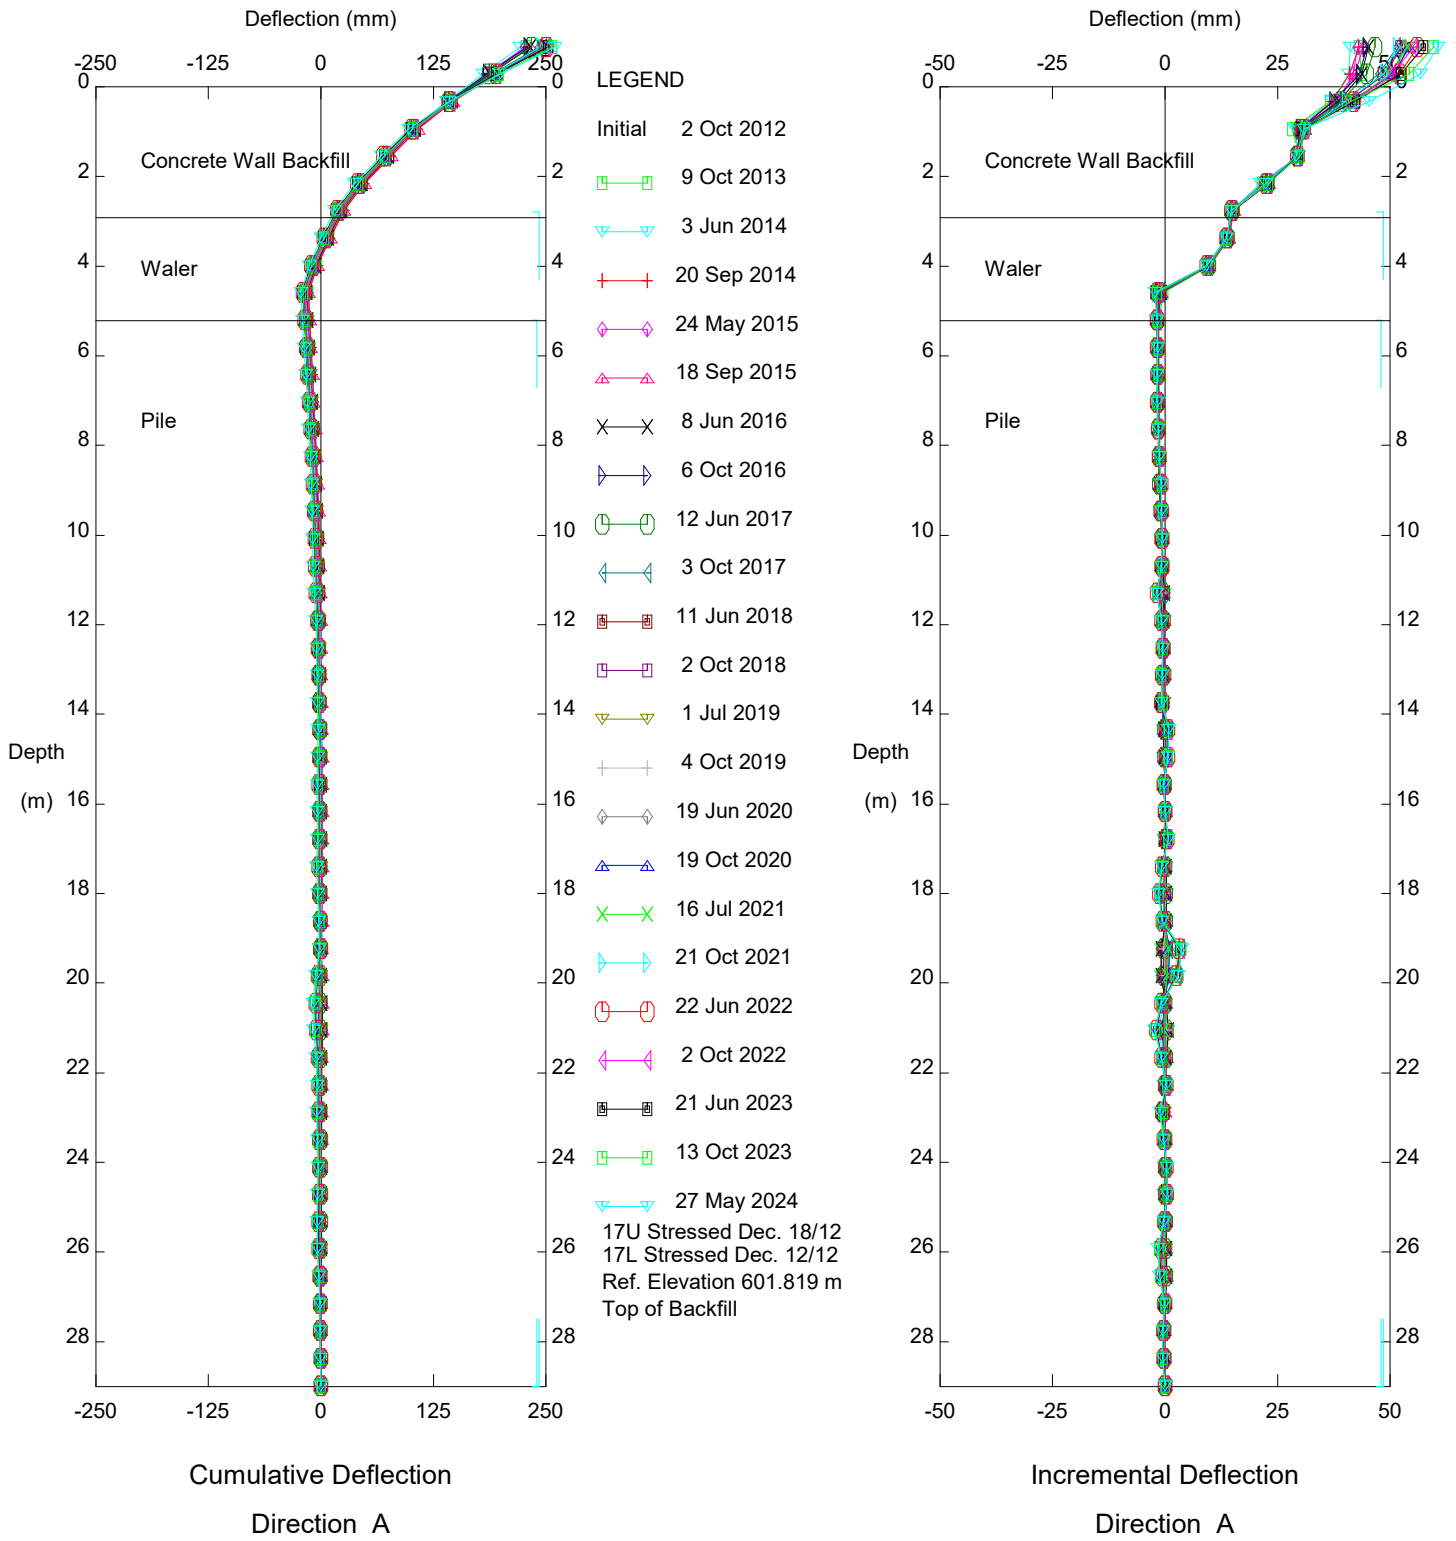
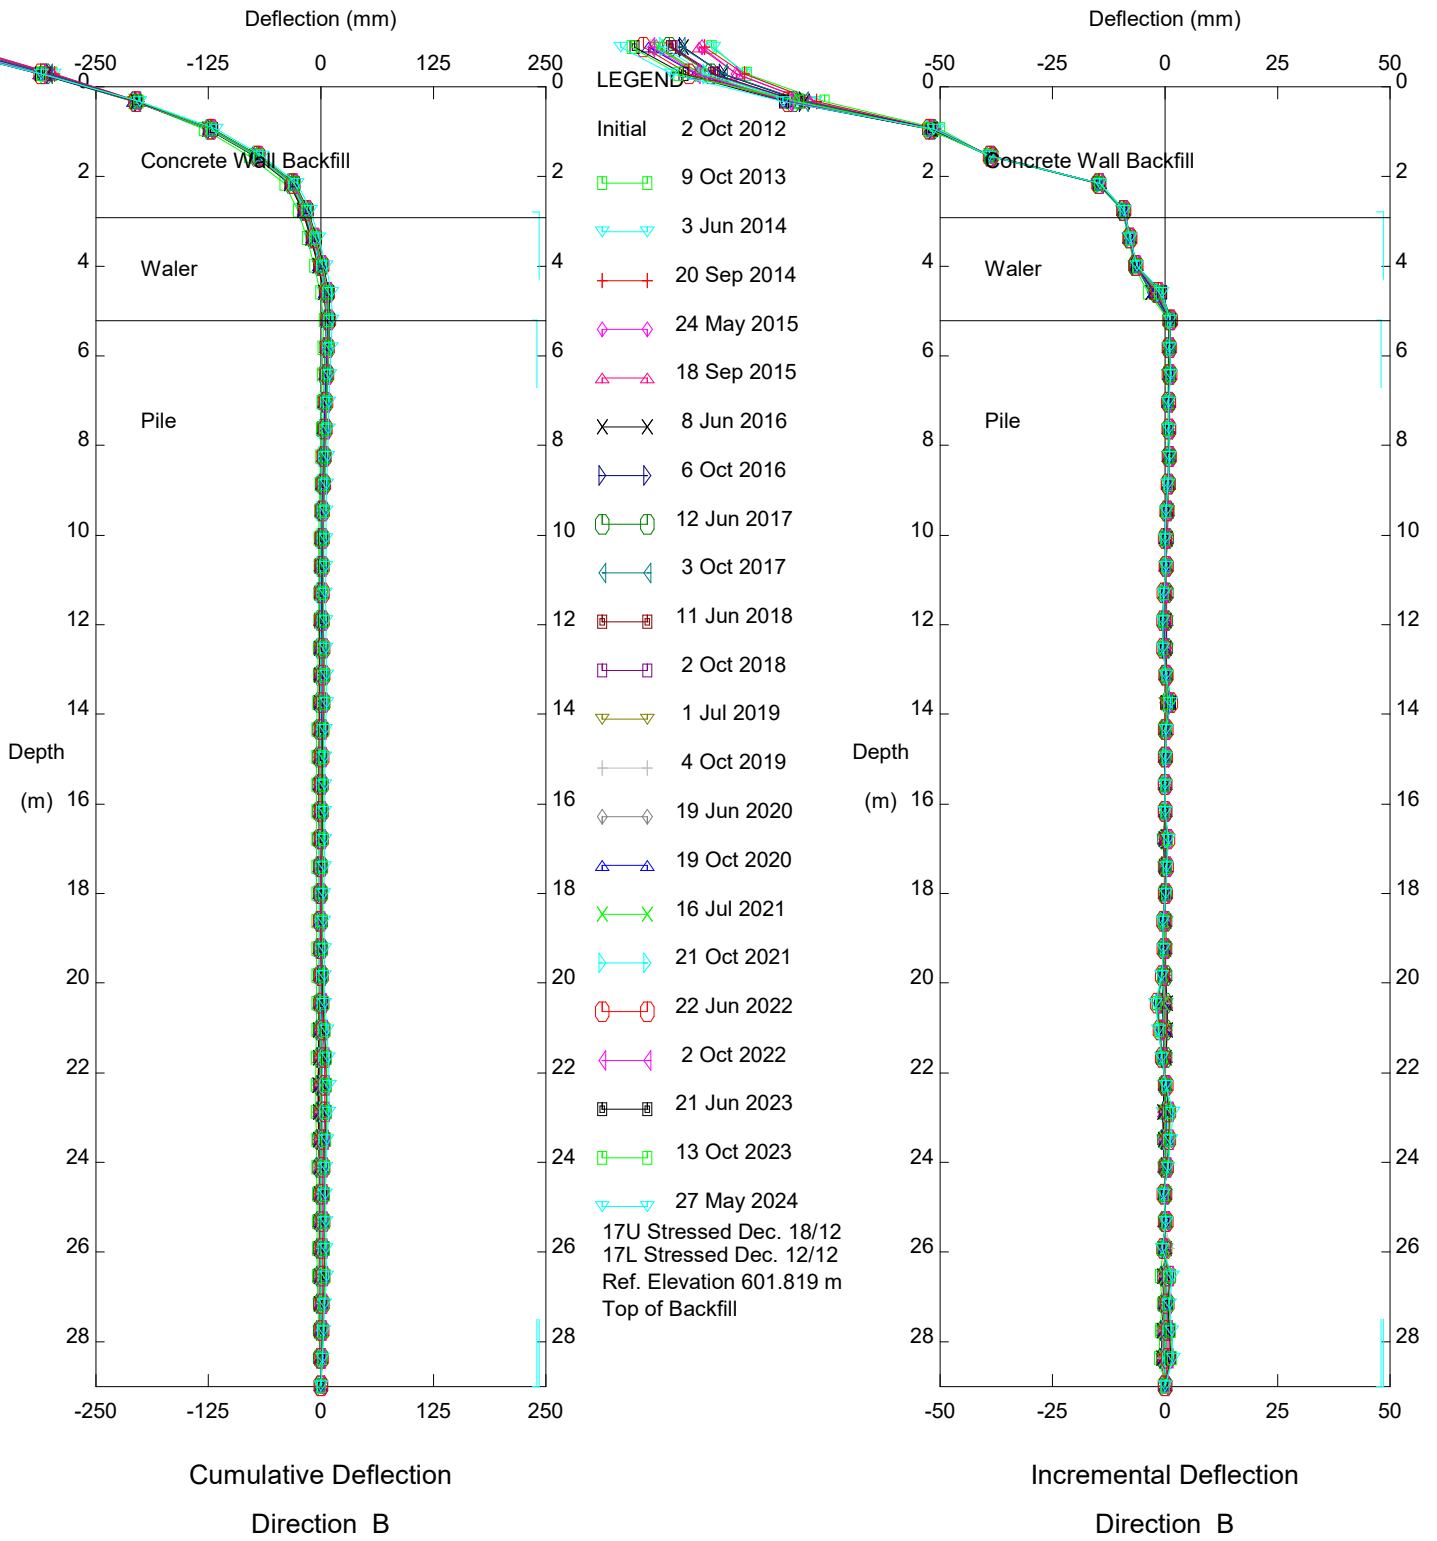
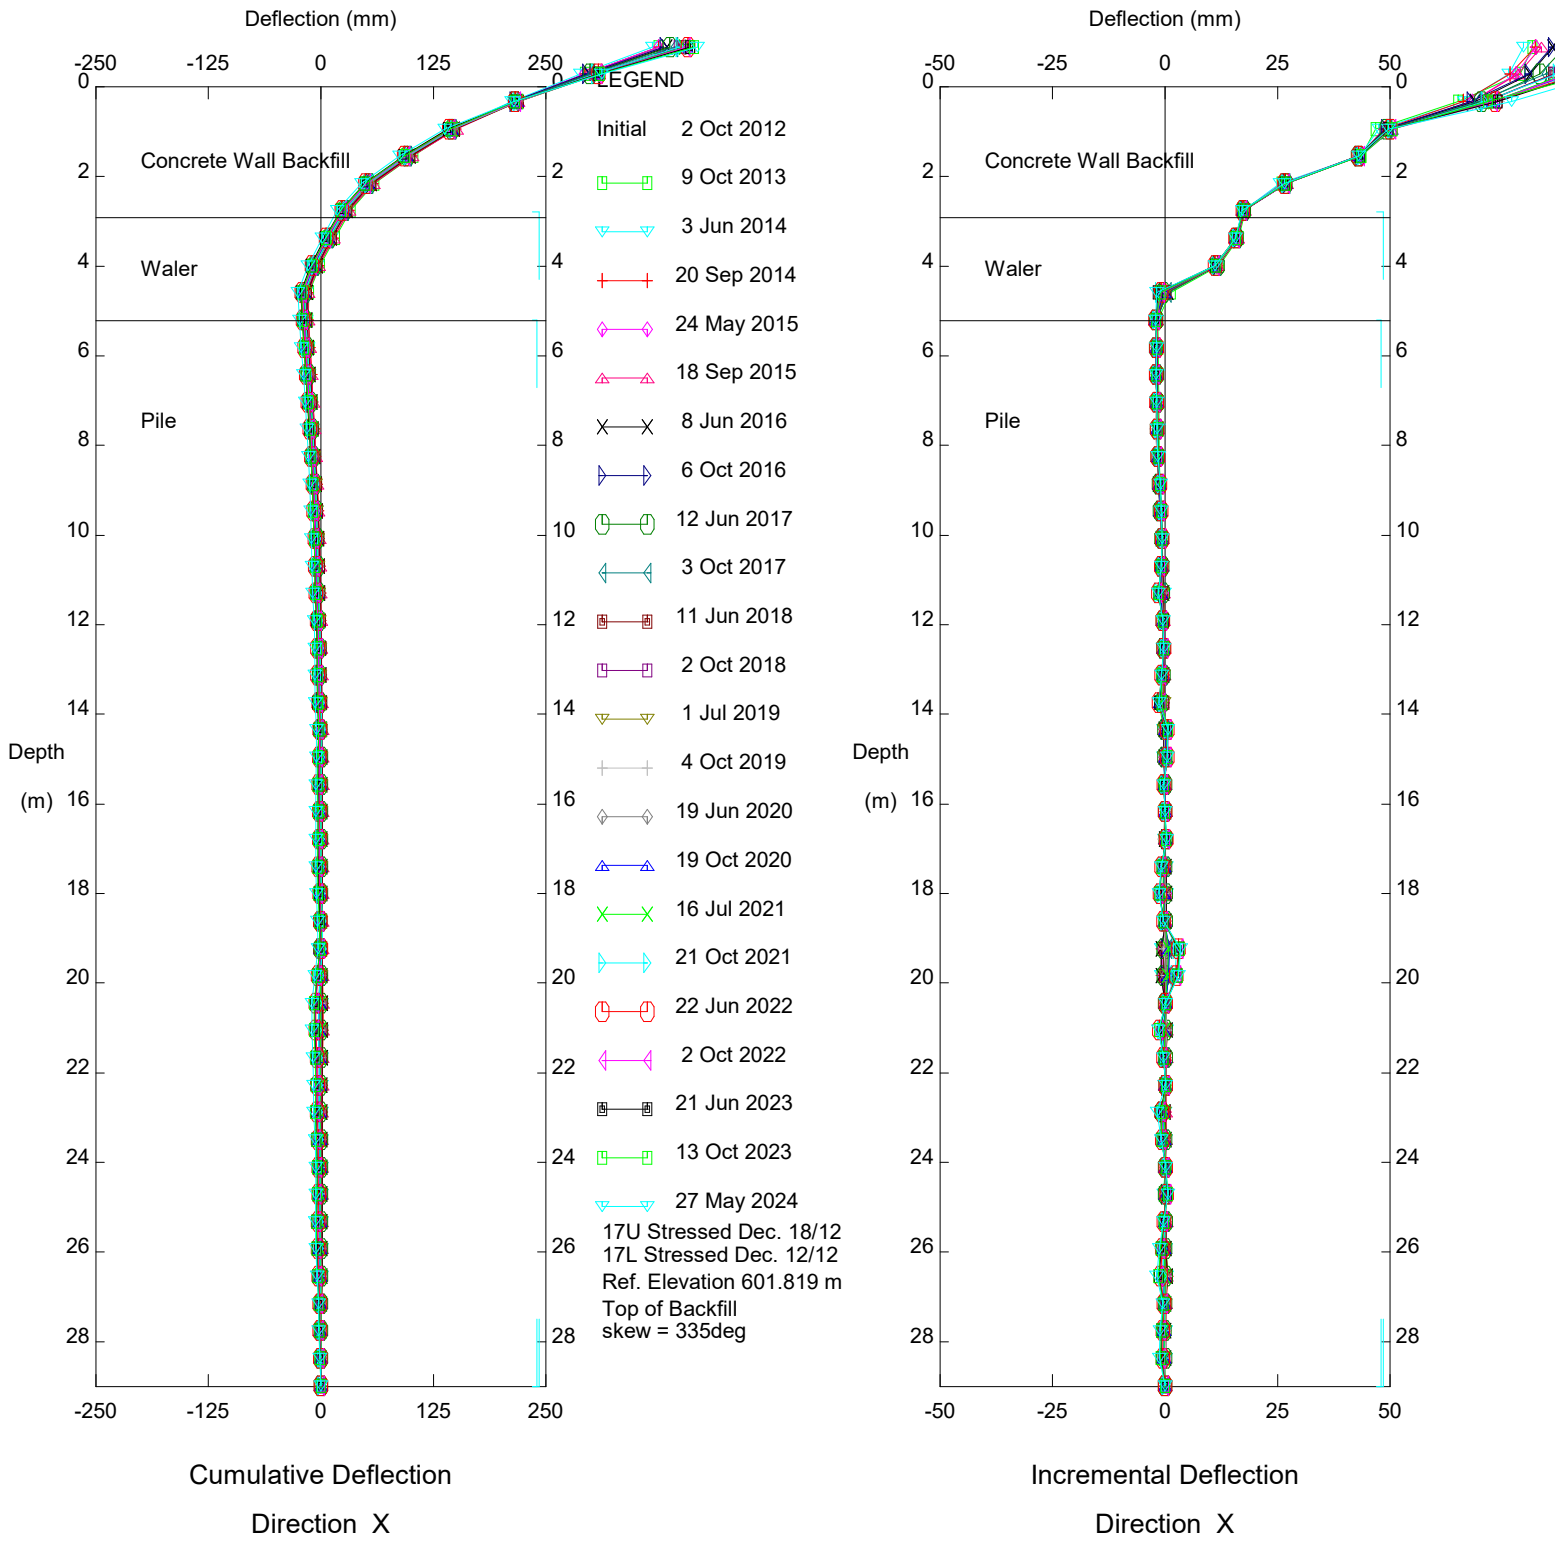
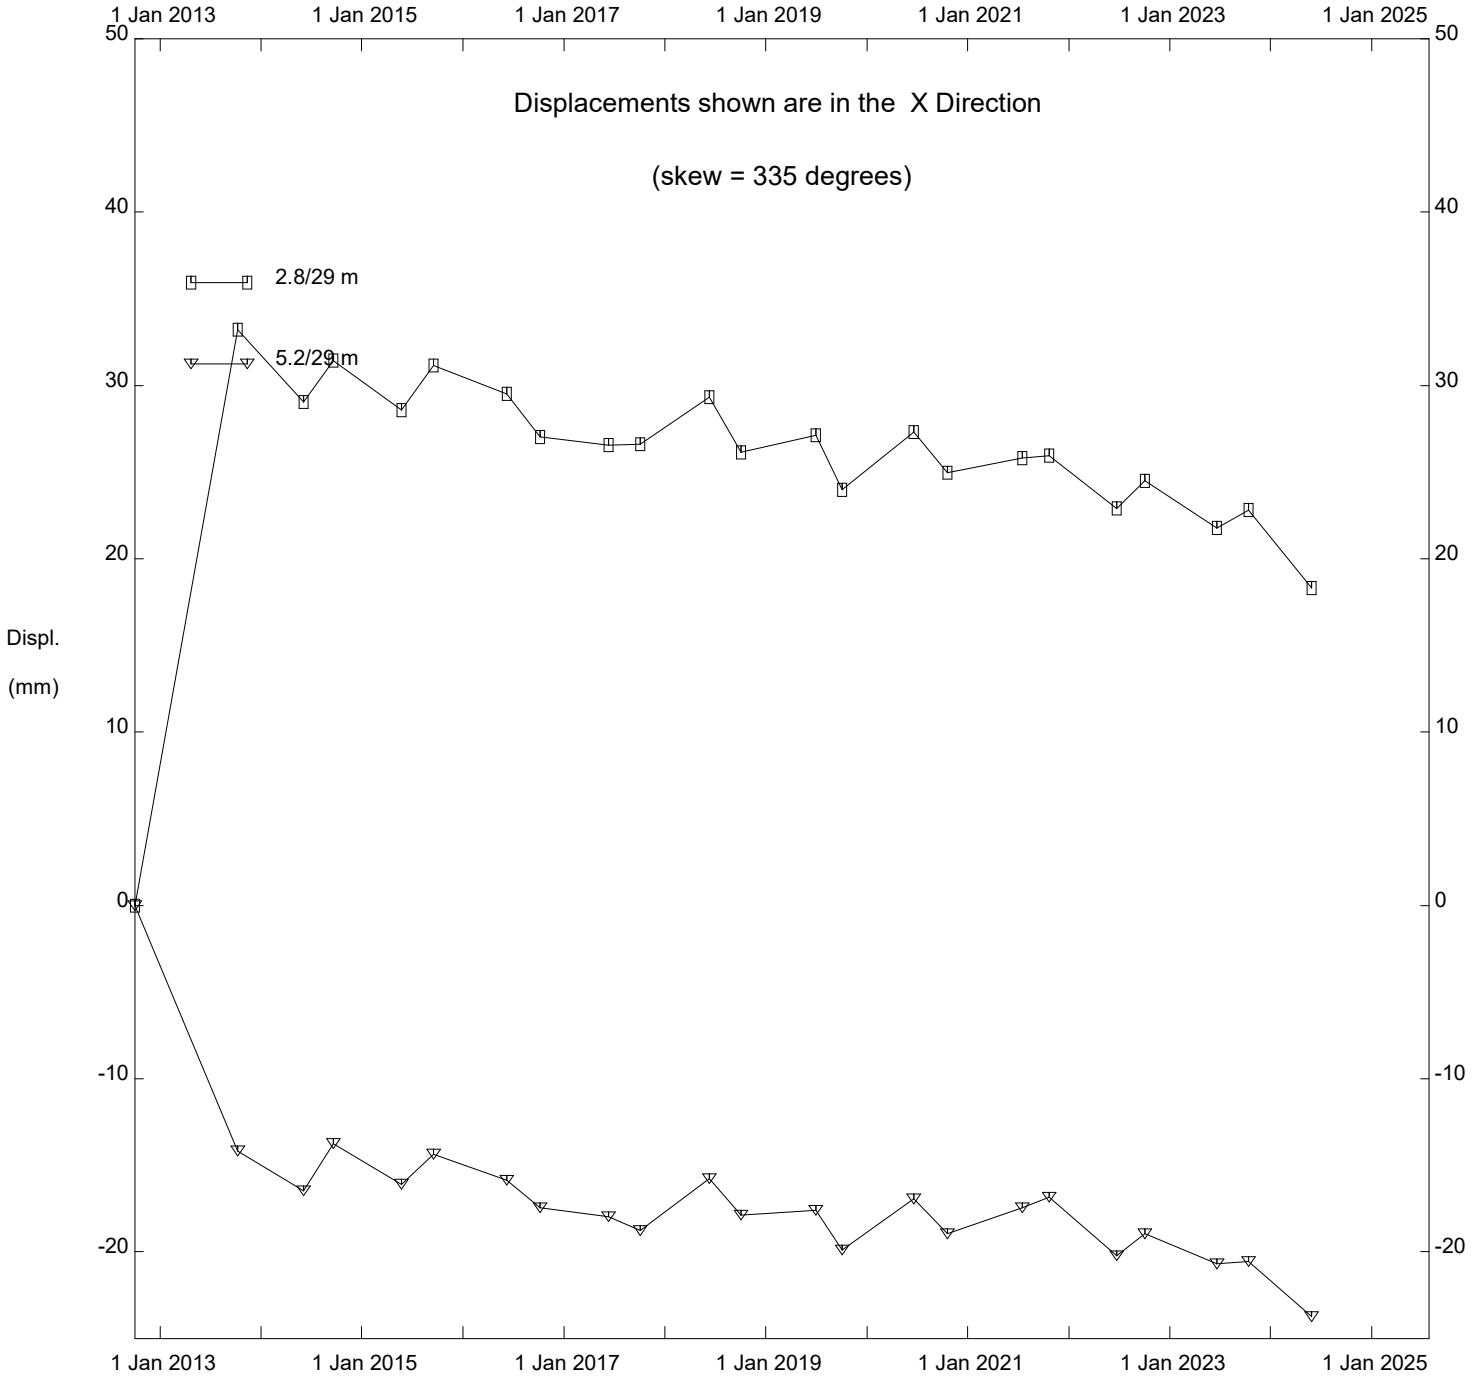
PH026 Eureka River Upper Wall, Inclinator SI12-P17U

<p>SI12-P17U showed discernible movement. The total pile head movement to date has been 23.7 mm in the upslope direction of which about 8 mm of movement has occurred since 2014.</p> <p>SI12-P26U showed a rate of movement of 0.7 mm/yr over the length of the pile and waler from 2.5 m to 26.3 m depth and a rate of movement of 0.9 mm/yr over the length of the pile only from 4.9 m to 26.3 m depth. The total pile head movement to date has been 19.1 mm in the upslope direction of which about 7 mm has occurred since 2014.</p> <p>Slope inclinometers SI12-P3L, SI12-P9L and SI12-P14L were installed in the lower wall.</p> <p>SI12-P3L has shown a total pile head movement of 13.4 mm towards the river since installation, with no discernible movement since the fall of 2023 readings. SI12-P9L has shown a total pile head movement of 20.7 mm in the downslope direction since installation, with no discernible movement over the length of the pile since the fall of 2023 readings. SI12 P14L has shown a total pile head movement of 5.0 mm in the downslope direction since installation, with no discernible movement since the fall of 2023 readings.</p> <p>Since the previous readings in the fall of 2023, the groundwater level in pneumatic piezometer PN11-3 decreased by 0.46 m. Vibrating wire piezometer VW11-7 showed an increase in groundwater level of 0.04 m since the fall of 2023 readings.</p> <p>Since the fall of 2023, the load cells showed decreases in the measured load, ranging from 0.86 kN in VC1763 (anchor 26) to 2.94 kN in VC1759 (anchor 50U). The current readings on the load cells varied from 172.79 kN in VC1762 (anchor 77U) to 223.85 kN in VC1764 (anchor 27U). The anchor design load was 300 kN and the anchors were locked off at 240 kN.</p> <p>The load cells all showed a general trend of dropping load for the first 4 years after completion of construction. Since around 2018, anchors 26L, 27U and 50U have shown a trend of slowly increasing load, while Anchors 50L, 76L and 77U have continued to show a trend of decreasing load, although at a reduced rate compared to the initial period after completion of construction. This trend of diverging load trends is unlikely to be a concern for now but if it continues there may be a concern for the load sharing of the wall structure, which could overstress the wall.</p> <p>Initially, the load cells showed a gradual decrease in measured load since they were locked off. However, over the past several years, the load cell readings have been levelling off, indicating the pile wall may be reaching a point of equilibrium. (see comment for above paragraph)</p> <p>The instrument readings at this site indicate that the landslide repairs at this site have been successful in stabilizing the slope movements.</p>

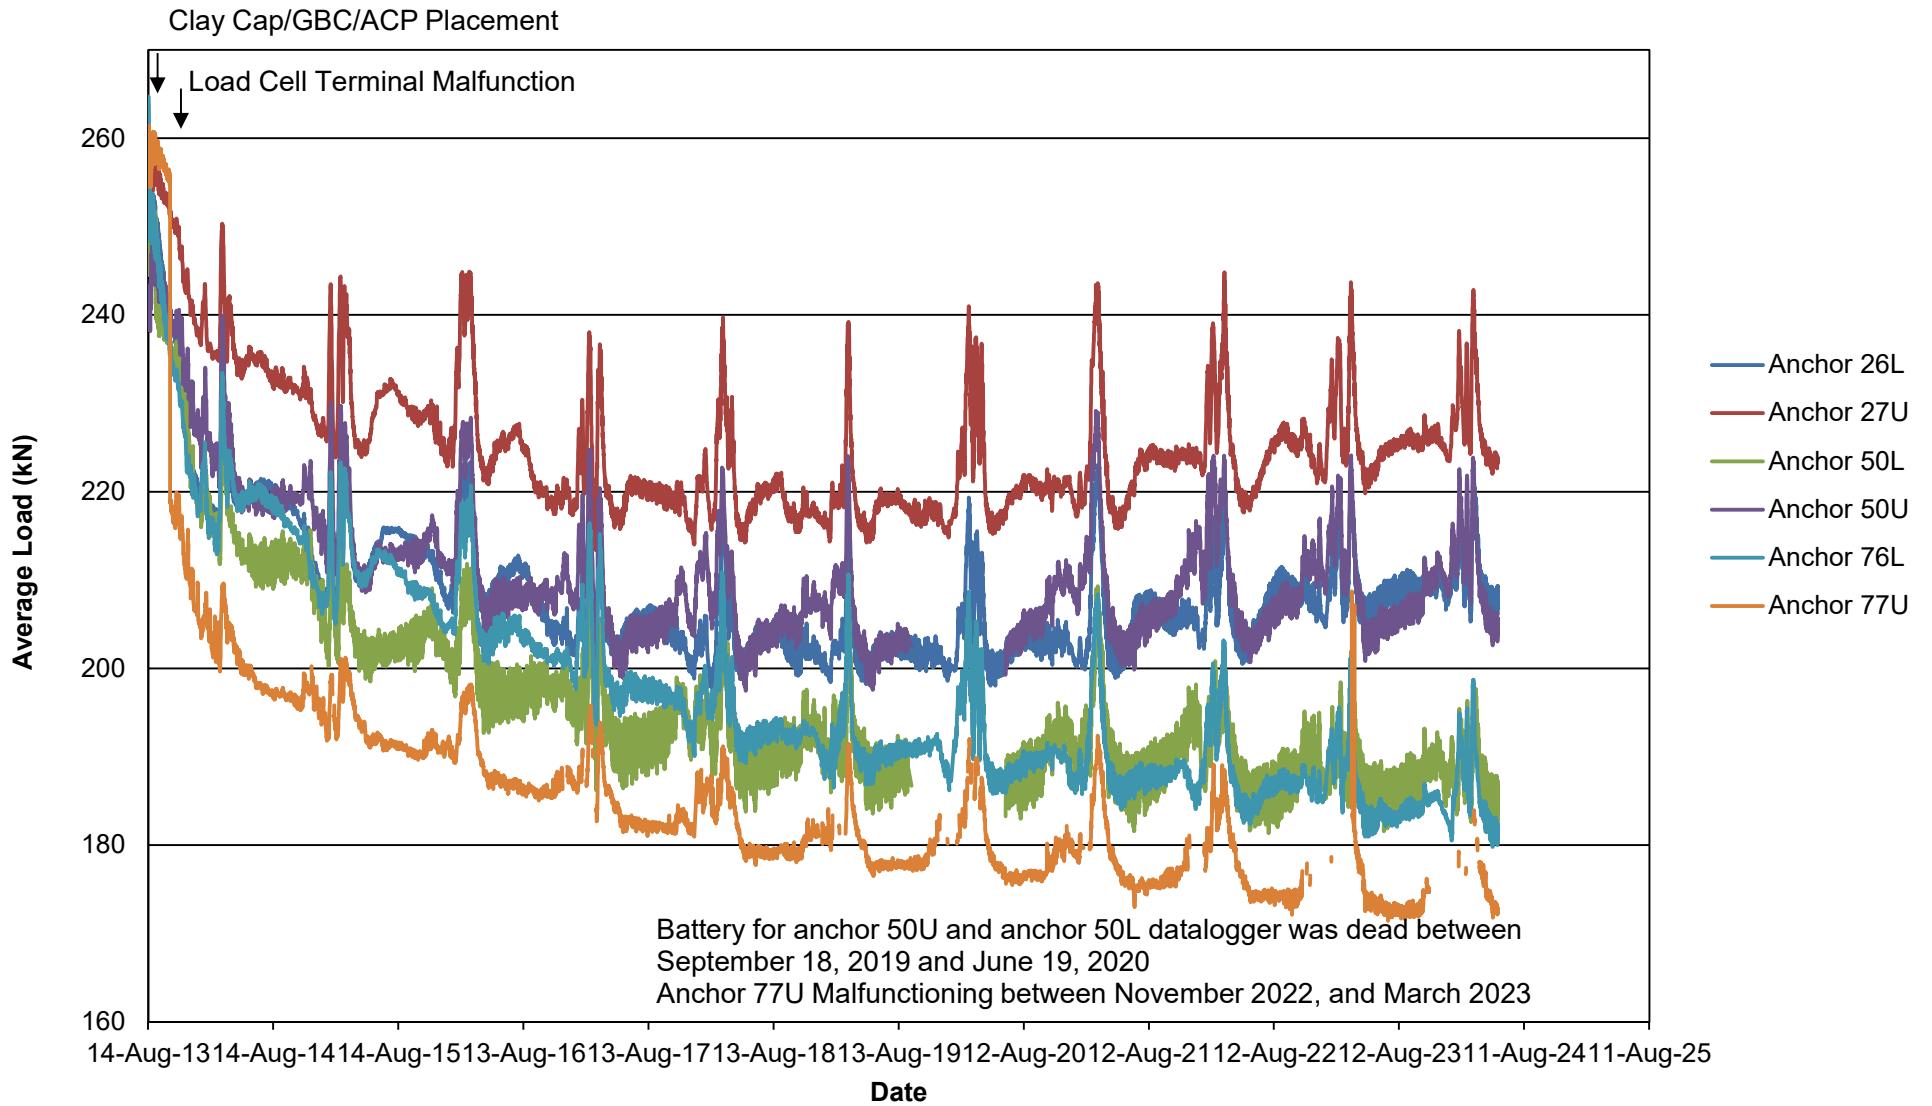
FIGURE PH026-3
LOAD CELL DATA FOR HWY 726:02 UPPER PILE WALL ANCHORS

As of October 16, 2013, at 9:59 one of the vibrating wires in VC1762 (anchor 77U) has stopped working. The measured force is an average of two vibrating wires instead of three

The battery for the datalogger for load cells VC1759 and VC1760 was dead between September 18, 2019 and June 19, 2020. No data was collected between those dates.
