File No.: 32123

**ALBERTA TRANSPORTATION AND ECONOMIC CORRIDORS GRMP (CON0022165)
PEACE REGION (GRANDE PRAIRIE DISTRICT – NORTH)
INSTRUMENTATION MONITORING RESULTS – FALL 2023**

SITE GP014: HWY 733:04, BAD HEART RIVER

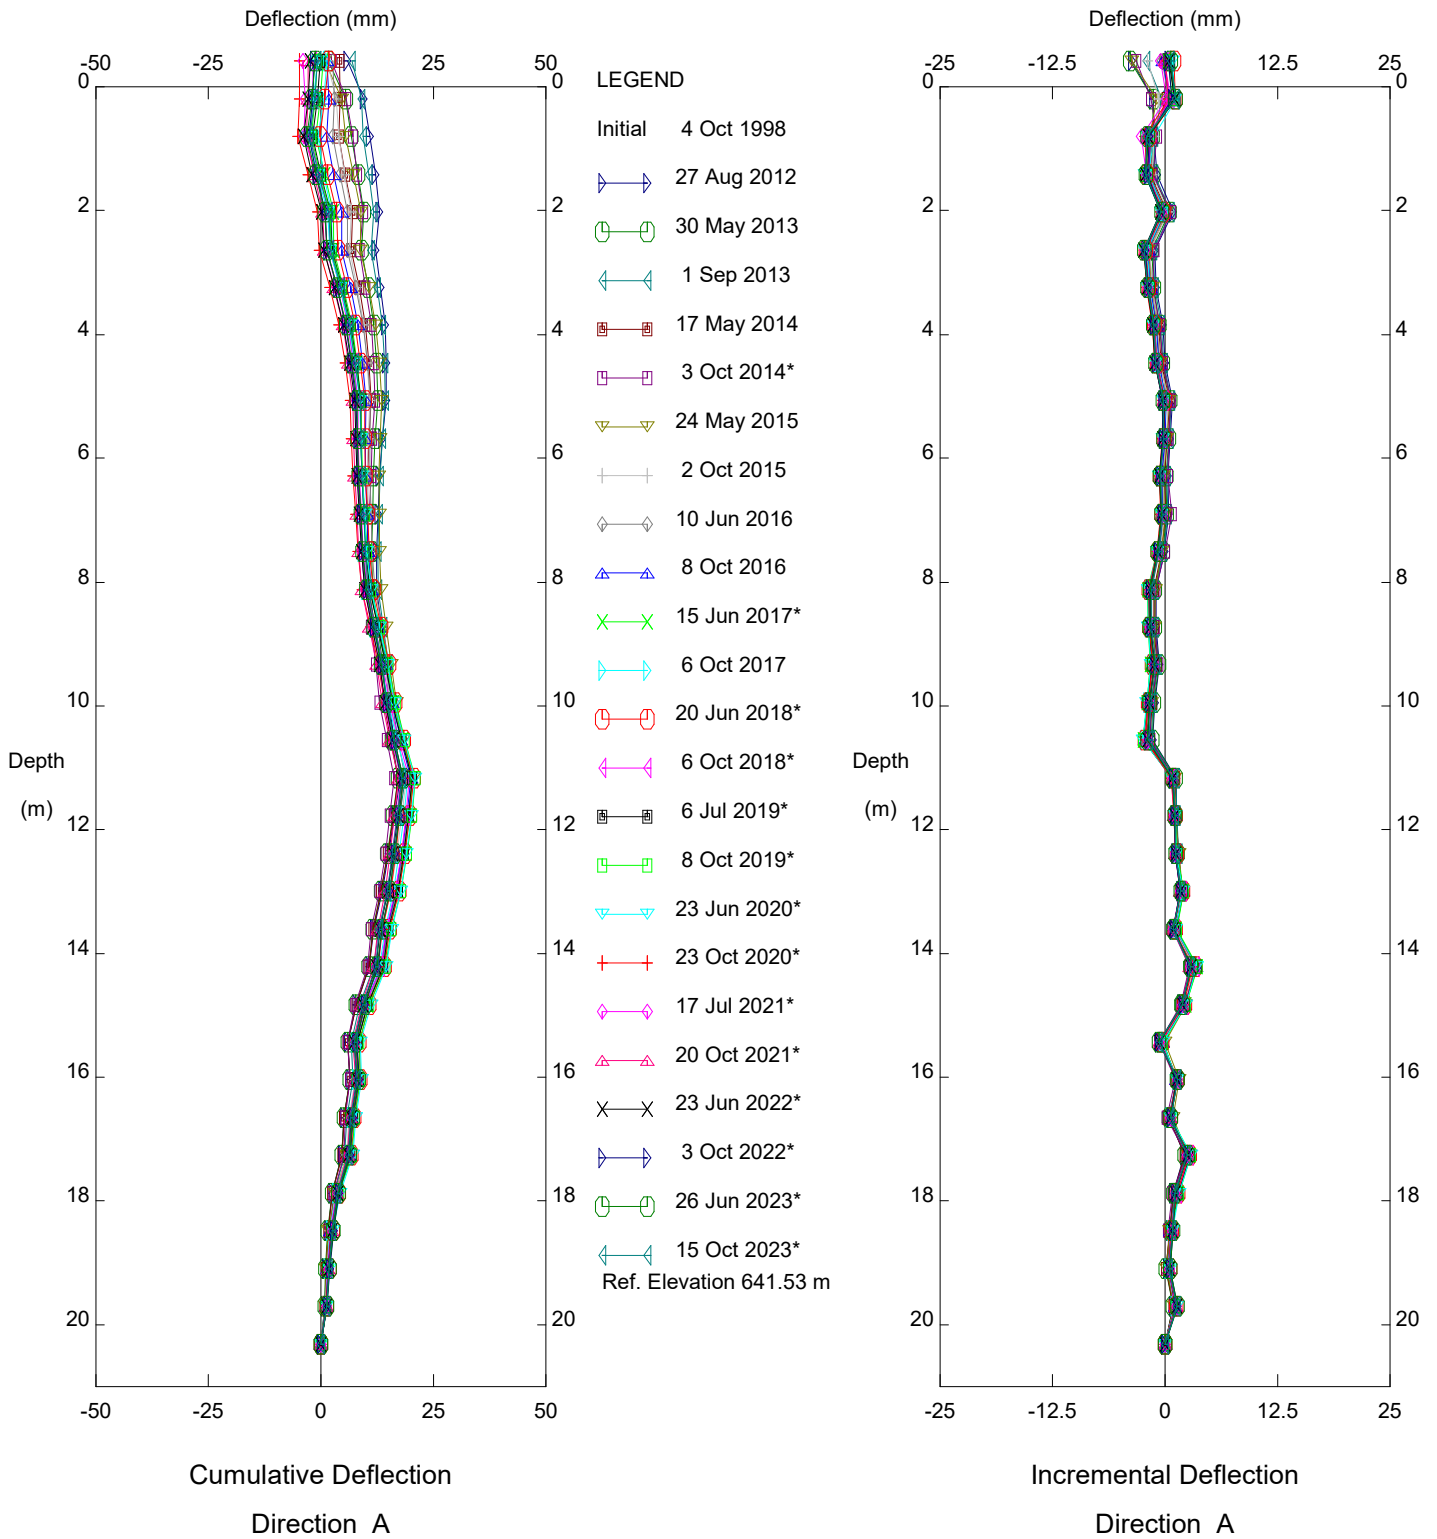
GP014 Bad Heart River South Slide, Inclinometer SI98-7

Slope inclinometer SI98-7 continued to show no discernible movement. It is possible that this SI is not deep enough to measure the slip surface related to the observed cracks in the pavement uphill from its location.

Since the instrumentation readings at this site show relatively minimum changes over several years of monitoring, we recommend reading the instrumentation at this site every two years; thus, the next set of readings should be in 2025.

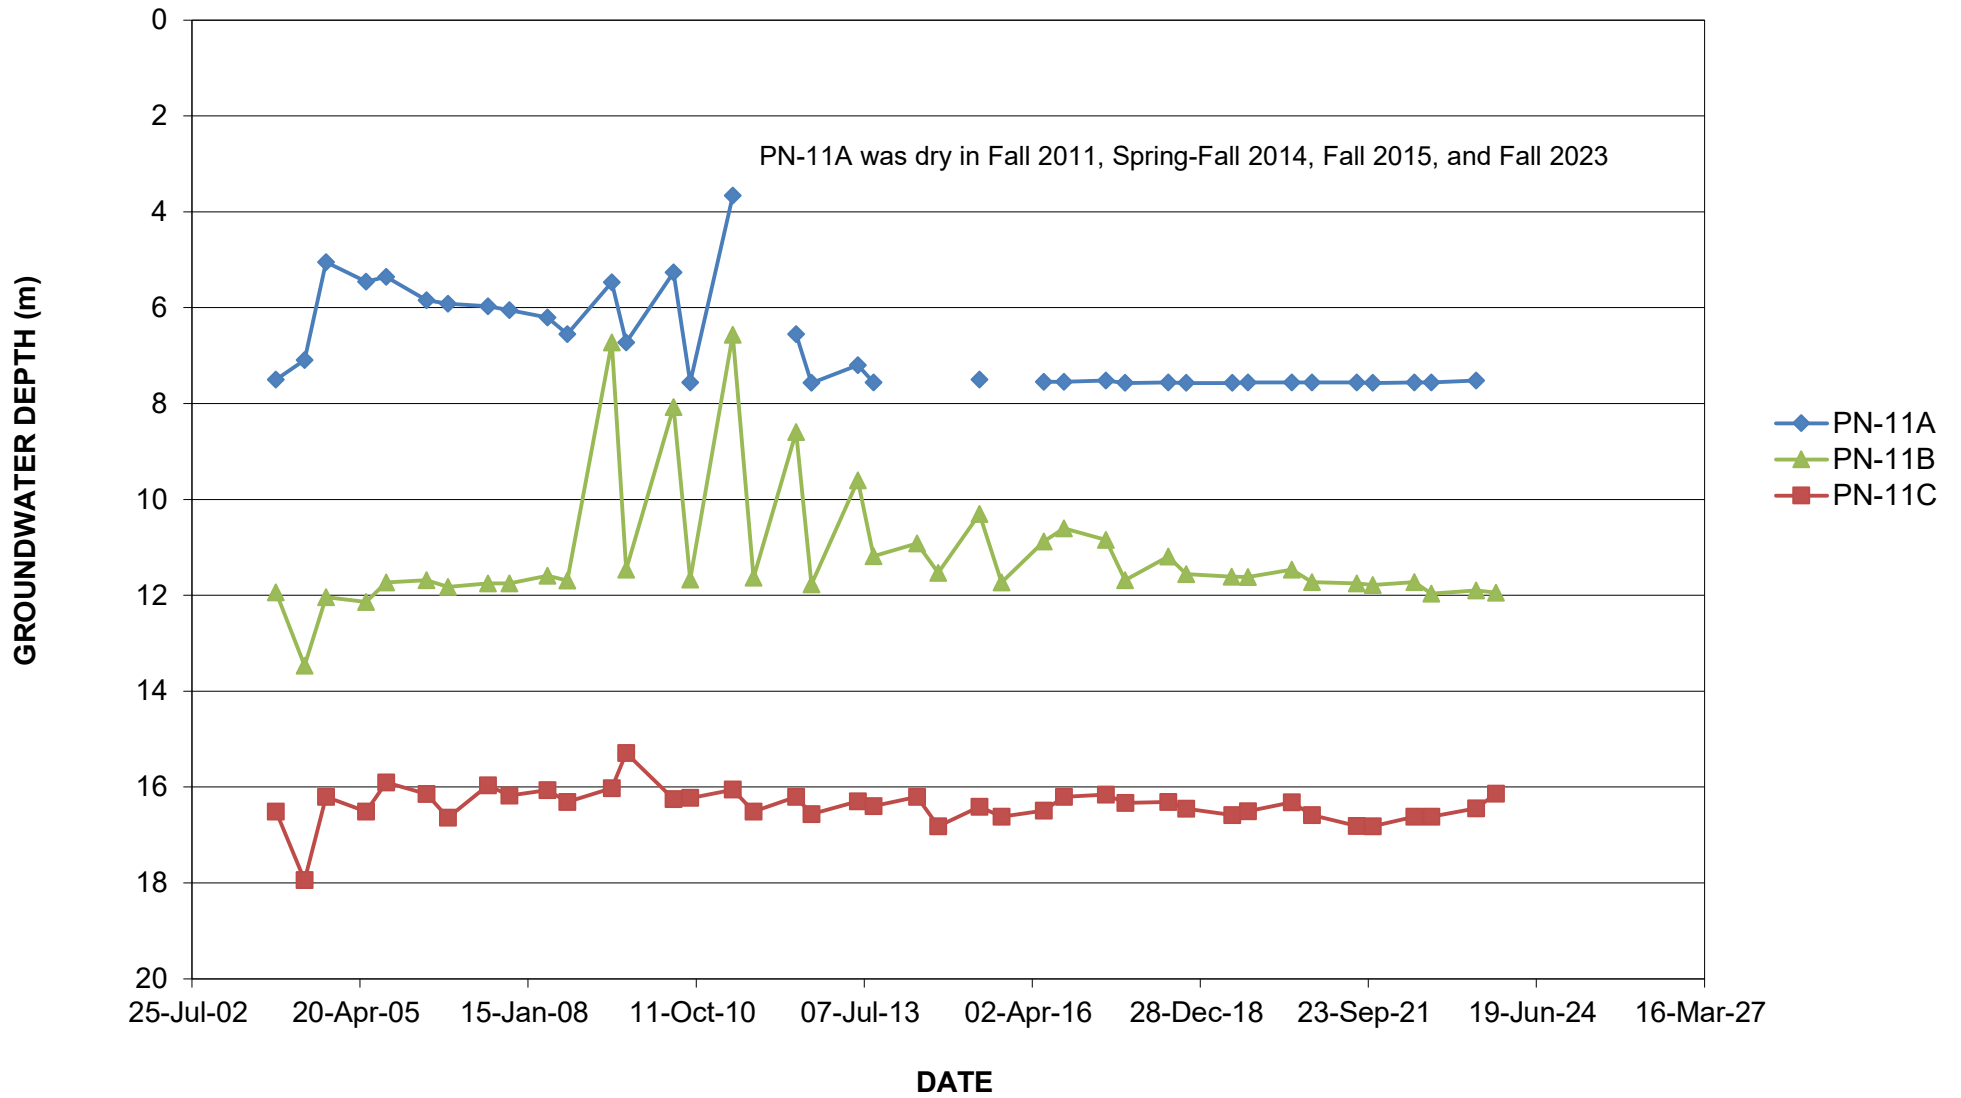
**FIGURE GP014-2
PIEZOMETRIC DEPTHS FOR HWY 733:04, BAD HEART RIVER**

Pneumatic piezometer PN-11A was dry during the spring of 2023 readings. PN-11B showed a decrease in groundwater level of 0.05 m since the spring of 2023 readings. PN-11C showed an increase in groundwater level of 0.30 m since the spring of 2023 readings. Pneumatic piezometer results are summarized in Table GP014-2 and are plotted in Figures GP014-1 (by elevation) and GP014-2 (by depth) in Appendix A.
