July 14, 2023 File No.: 32123

ALBERTA TRANSPORTATION AND ECONOMIC CORRIDORS GRMP (CON0022165) PEACE REGION (GRANDE PRAIRIE DISTRICT – NORTH) INSTRUMENTATION MONITORING RESULTS – SPRING 2023

SITE GP014: HWY 733:04, BAD HEART RIVER

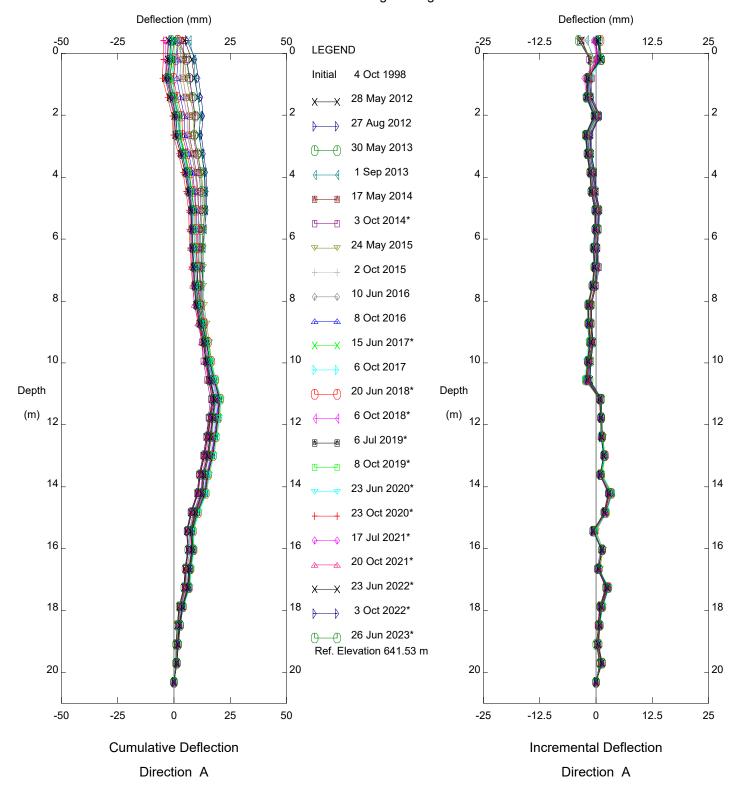
GP014 Bad Heart River South Slide, Inclinometer SI98-7

Zones of new movement were not observed in SI98-7 since the previous readings in the fall of 2022.

Slope inclinometer SI98-7 continued to show no discernible movement.

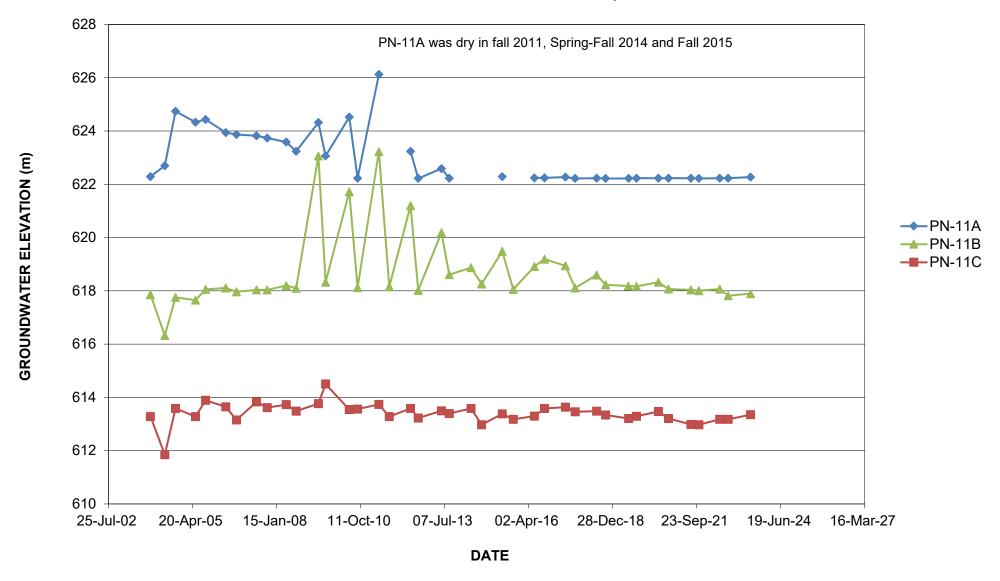
FIGURE GP014-1
PIEZOMETRIC ELEVATIONS FOR HWY 733:04, BAD HEART RIVER

Pneumatic piezometers PN-11A, PN-11B and PN-11C showed increases in groundwater level of 0.04 m, 0.07 m and 0.18 m, respectively, since the fall of 2022 readings. Pneumatic piezometer results are summarized in Table GP014-2 and are plotted in Figures GP014-1 (by elevation) and GP014-2 (by depth) in Appendix A.
