**ALBERTA TRANSPORTATION AND ECONOMIC CORRIDORS  
GEOHAZARD ASSESSMENT PROGRAM  
PEACE REGION GRANDE PRAIRIE DISTRICT - NORTH  
2024 INSPECTION**

Site Number	Location	Name	Hwy	km
GP031	South slope of the Peace River Valley near the Shaftesbury ferry crossing	Shaftesbury Slide, South Site	740:02	49.3
Legal Description		UTM Co-ordinates (NAD 83)		
LSD 4-9-82-23-W5M		11U N 6 216 300	E 466 120

Date	PF	CF	Total
<b>Previous Inspection:</b>	May 19, 2023	11	3	33
<b>Current Inspection:</b>	May 6, 2024	11	3	33
<b>Road AADT:</b>	80		<b>Year:</b>	2023
<b>Inspected By:</b>	Don Proudfoot, Nicole Wilder (Thurber) Robert Senior, Rocky Wang(TEC)			
<b>Report Attachments:</b>	<input checked="" type="checkbox"/> Photographs		<input checked="" type="checkbox"/> Plans	<input checked="" type="checkbox"/> Maintenance

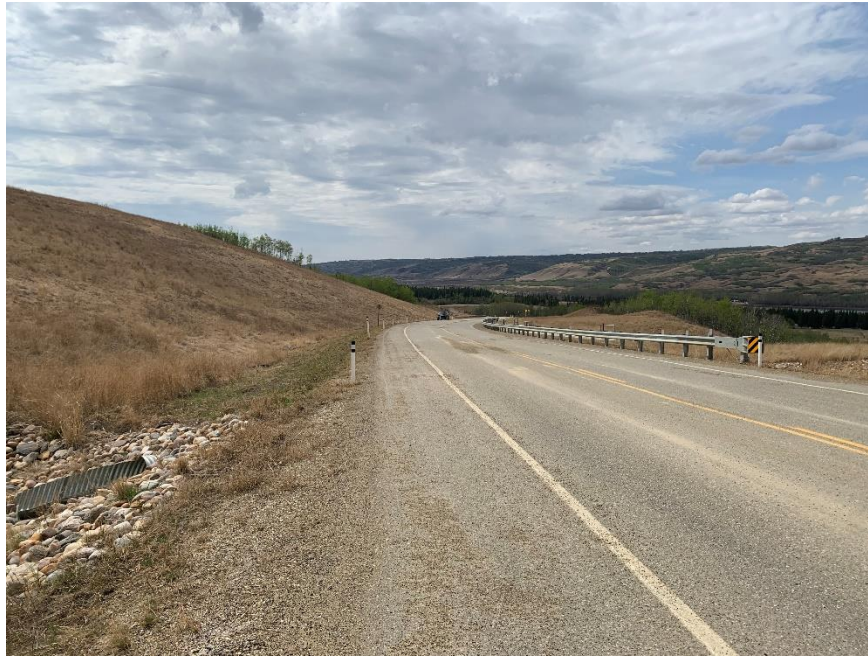
**Photo 1. Looking west from Sta. 49+250.**

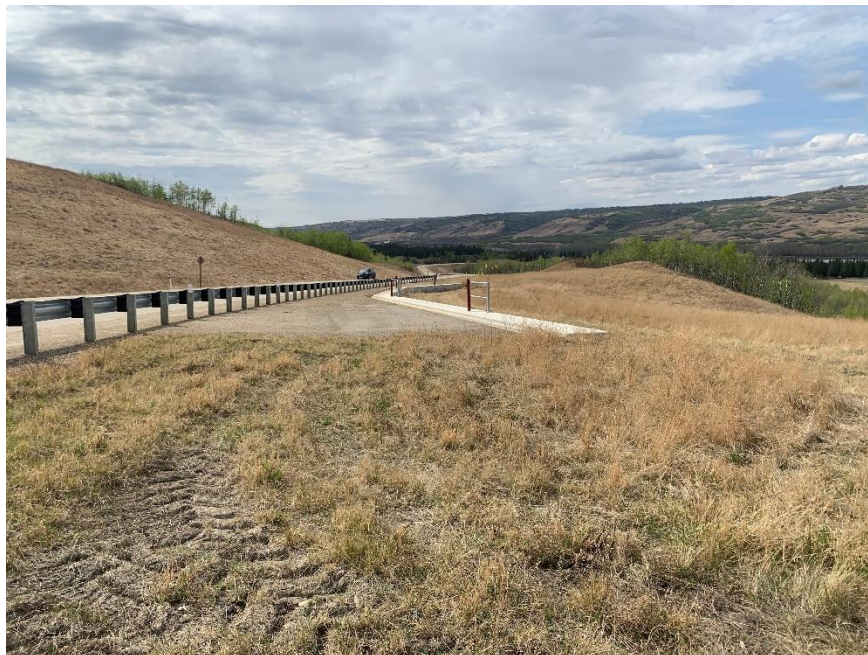
The remedial measures appear to be performing well to date. Pile deflections are all within expected ranges and the global stability of the toe berm and backslope slopes look good. Grass growth is well established on the site and the erosion prevention measures appear to be working.

**Photo 2. Looking west at pile wall alignment.**

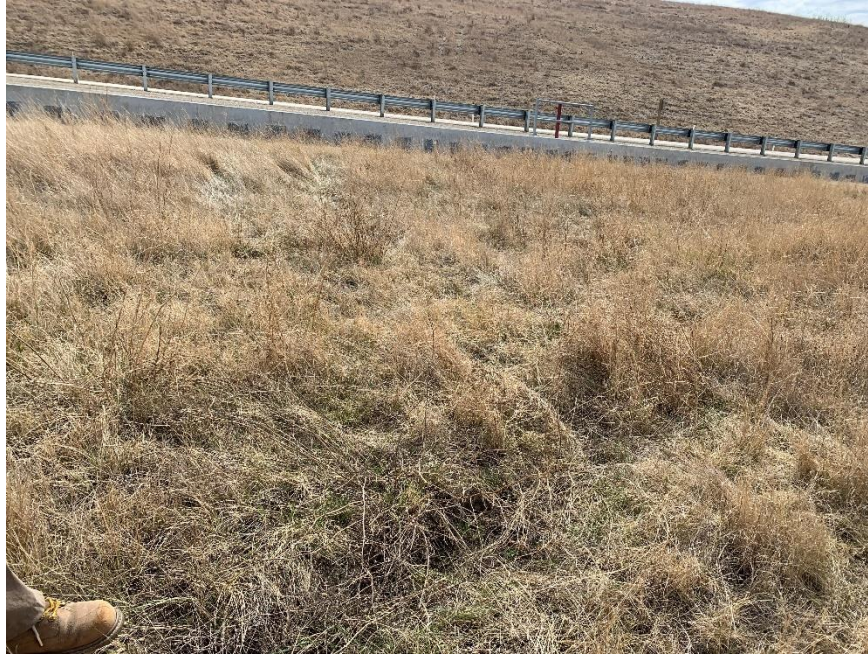
The slide crack downslope of the wall appears to be near the same location as the backscarp of the original slide. In its failed state the slide mass was broken and loose and it is believed that the slide mass has crept downslope as it tightens and consolidates against the toe berm. The piles were designed to protect the road from this creep movement if a significant gap and differential across the crack do not occur. The design assumed a maximum unsupported cantilever of 4m from the top of water to the slip

**Photo 3. Looking at landslide backscarp crack downslope of pile wall.**

SLIDE CRACK WITH UP TO 0.2m DROP

If further deformation of the slope below the wall occurs it would be beneficial to due some grooming of the area to avoid ponding of surface water and to fill the scarp crack with some clay or topsoil to limit seepage of precipitation runoff into the slip surface of the slide.

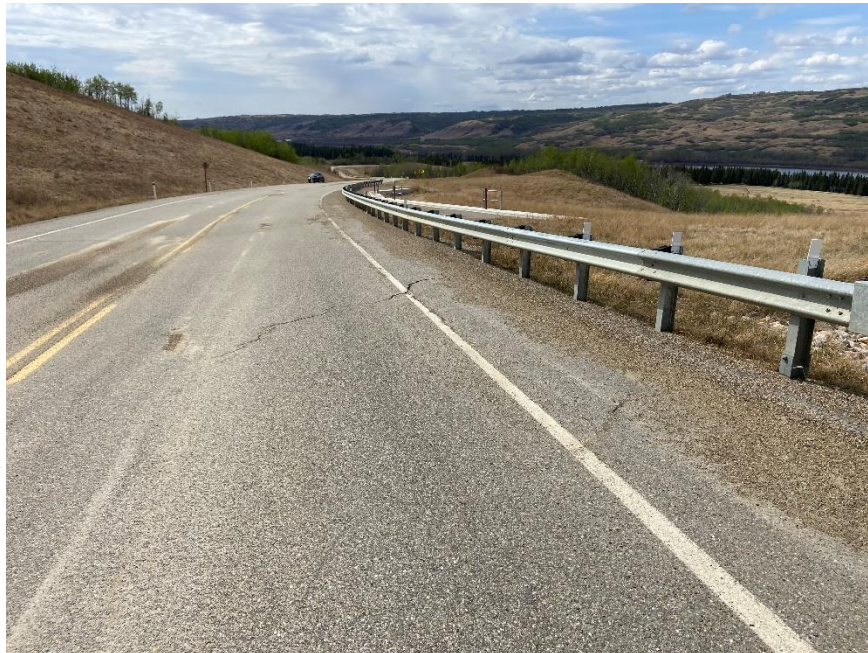
There is an active landslide within the bush area to the east of the repair. More details about this slide were recorded during the recent visit and it appears to be very active. The new cracks in the highway at the east end of the wall and the dip in the road at Station 49+170 are located above this active slide and might indicate that the slope above the slide is straining due to the loss of support in the slope, which might ultimately lead to the slope failure extending to the road level at this location in the future. For this reason, the risk level for the site was increased previously.

**Photo 4. Looking west at diagonal cracks in road pavement.**

TWO CRACKS:  
A = 1.3m LONG, 2mm WIDE  
B = 5.9m LONG, 5mm WIDE

If the active landslide in the bush to the east of the repair continues to affect the road some future remedial measures will be required and might involve extending the width of the toe to the east and potentially shifting the highway into the backslope at this location. Excess material from the previous repair was stockpiled over the former gravel pit north of Range Road No. 234 and could be used for the toe berm extension.

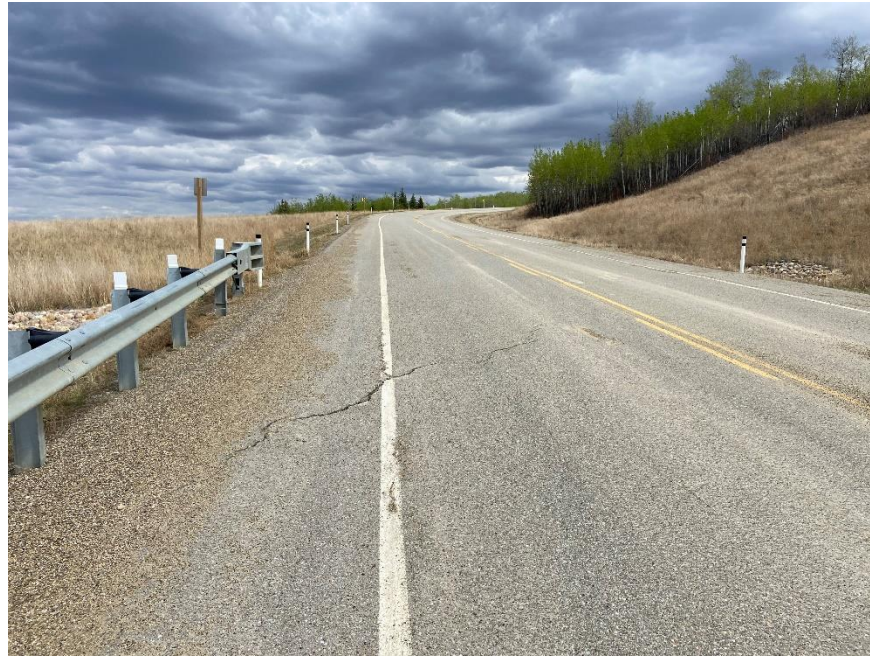
**Photo 5a. Looking southeast at diagonal cracks in road pavement.**

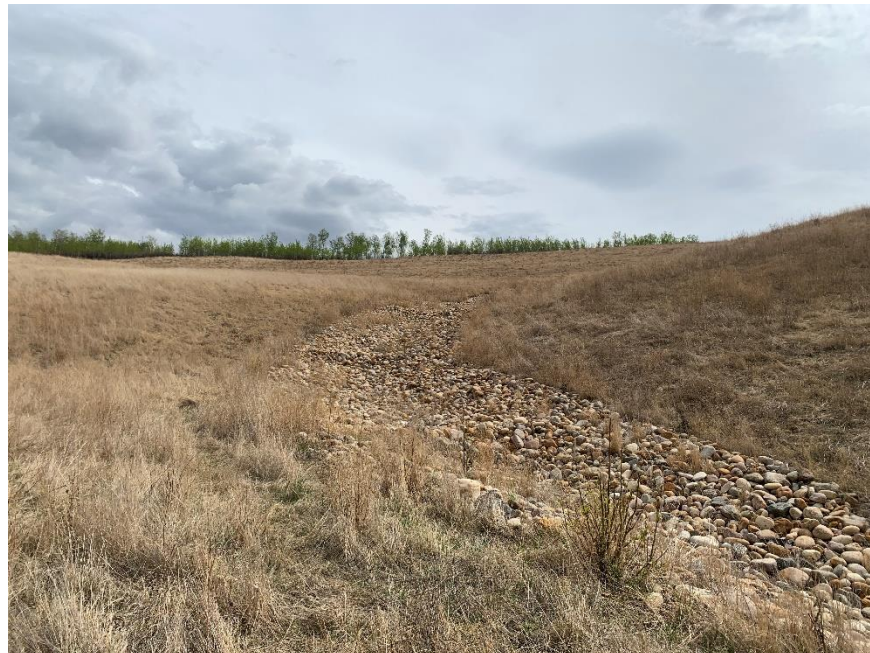
**Photo 6. Looking northwest at west riprap channel.**

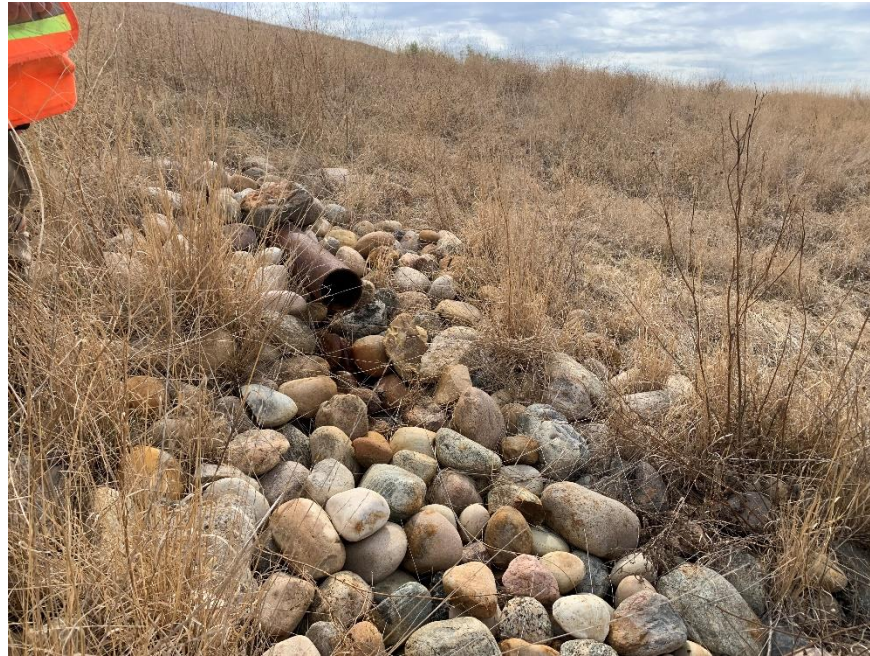
<input checked="" type="checkbox"/> Seepage	There was a steady drip coming from the drainpipe indicating the presence of groundwater, indicating that the drainpipe is performing as per design.	<input type="checkbox"/>
<input checked="" type="checkbox"/> Bridge/Culvert	The inlet and outlet of a centreline culvert are blocked by silt and erosion /slumping, respectively	<input checked="" type="checkbox"/>
<input type="checkbox"/> Other		<input type="checkbox"/>

**Photo 7. Looking at steady drip from drain pipe.**

STEADY DRIP FROM DRAIN PIPE; SAME

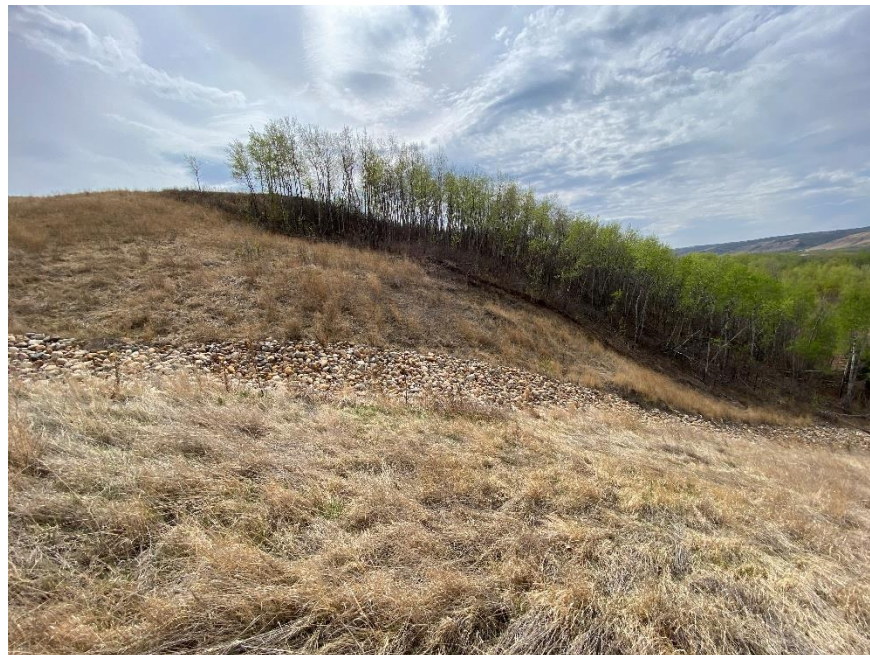
The slump located above the west riprap channel is likely located in weak native material that had been pre-sheared during landslide events prior to construction. This slump has not changed since the previous visit in 2023.

**Photo 8. Looking west at slump in cut slope. It hasn't changed since the last inspection.**

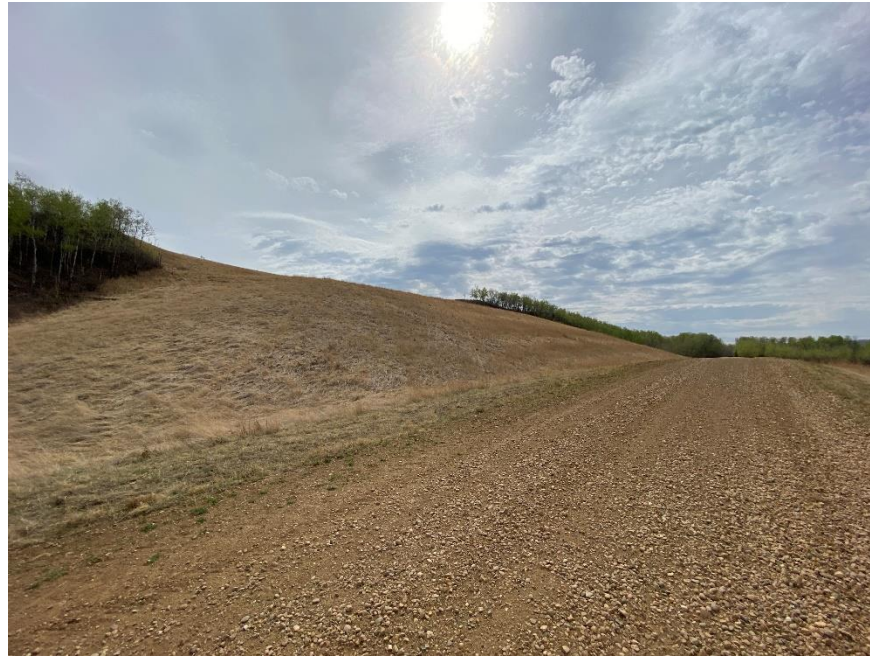
**Photo 9. Looking southwest along the county road on the toe berm.**

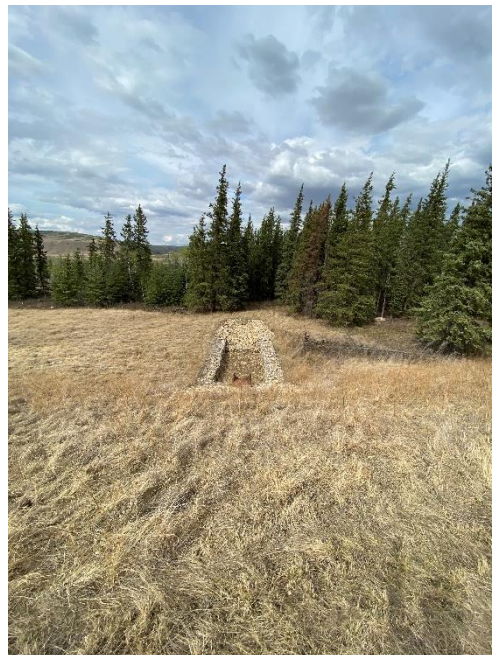
**Photo 10. Looking north at drop pipe outlet.**

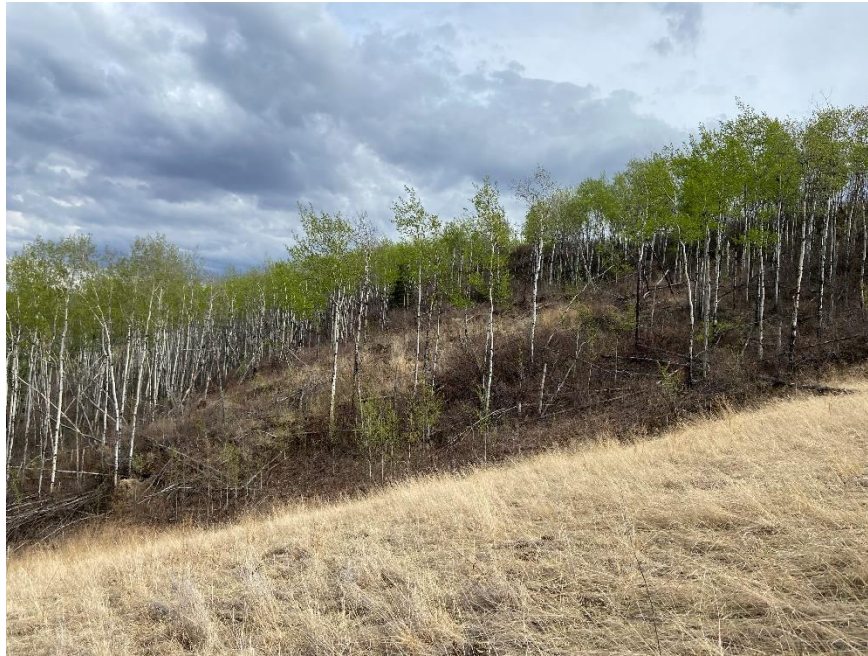
**Photo 11. Looking southeast at the active landslide in the bush east of the toe berm.**

NATURAL SLIDE IN BUSH; WITH SOME TILTED TREES

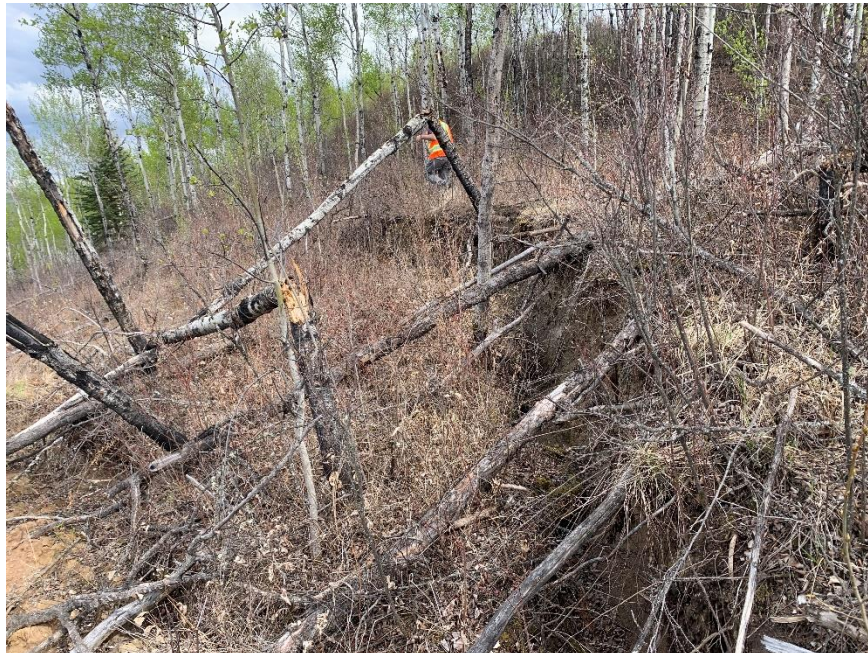
**Photo 12. Looking east along the backscarp of the slide in the bush.**

BACKSCARP HEIGHT VARIES FROM 1.4m TO 0.8m

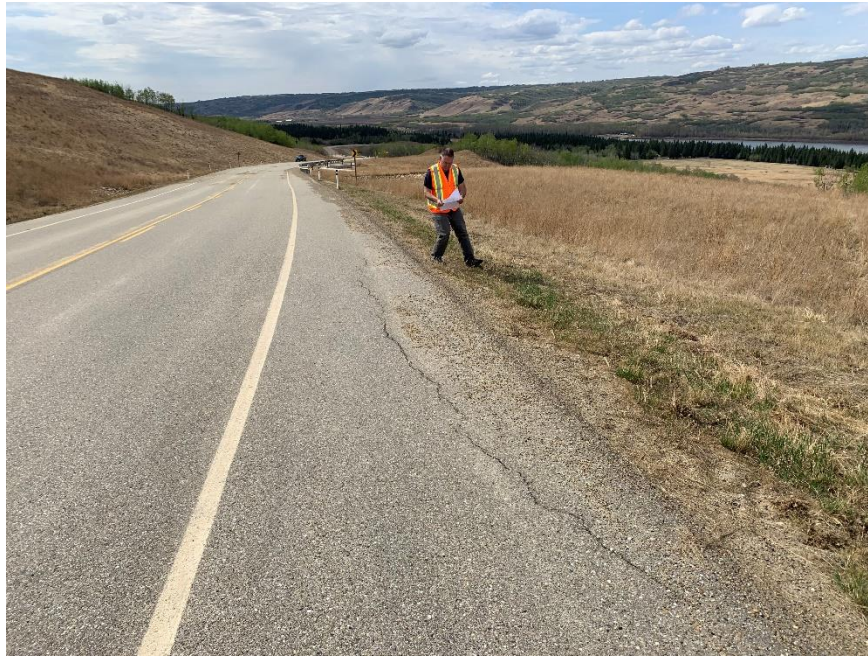
**Photo 13. Looking west at arc shaped cracks in highway shoulder.**

4 ARC SHAPED CRACKS IN SHOULDER UP TO 5 mm WIDE POSSIBLY DUE TO SETTLEMENT ALONG POORLY PACKED SHOULDER

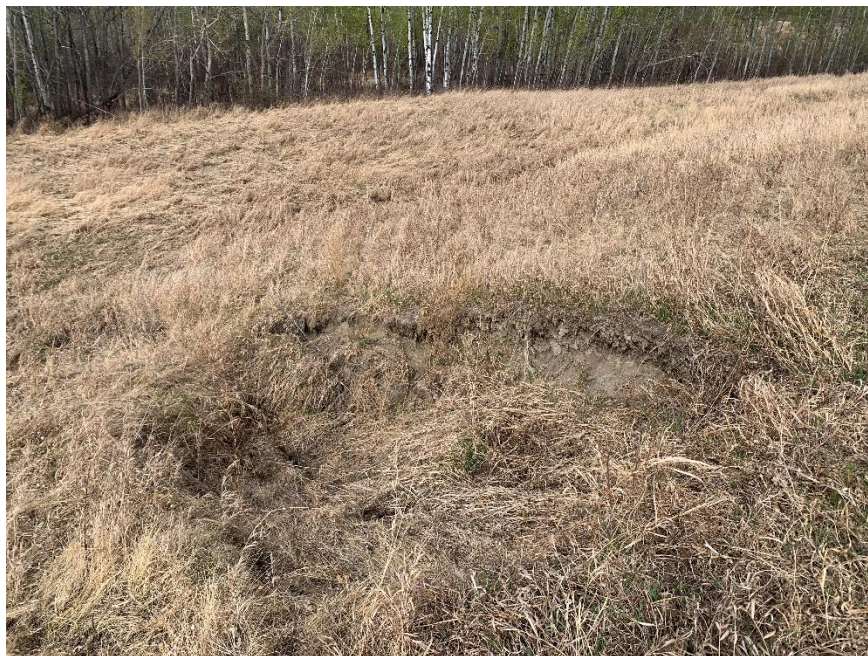
**Photo 14. Looking north at eroded/slumping outlet of centreline culvert**

SMALL SLUMP AT OUTLET OF CENTERLINE CULVERT; MORE EROSION AND RETROGRESSION. POSSIBLE BREAK IN PIPE WITH SINKHOLE. CULVERT OUTLET NOT VISIBLE. **GROWN A BIT MORE SINCE LAST VISIT**

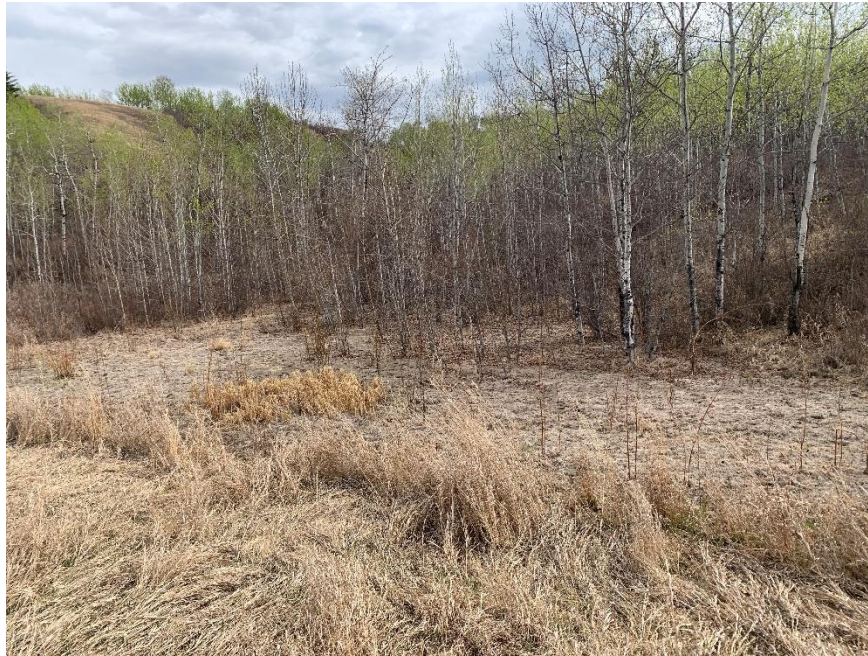
**Photo 15. Looking south at the silted-up inlet area of the centreline culvert near Sta. 49+460.**

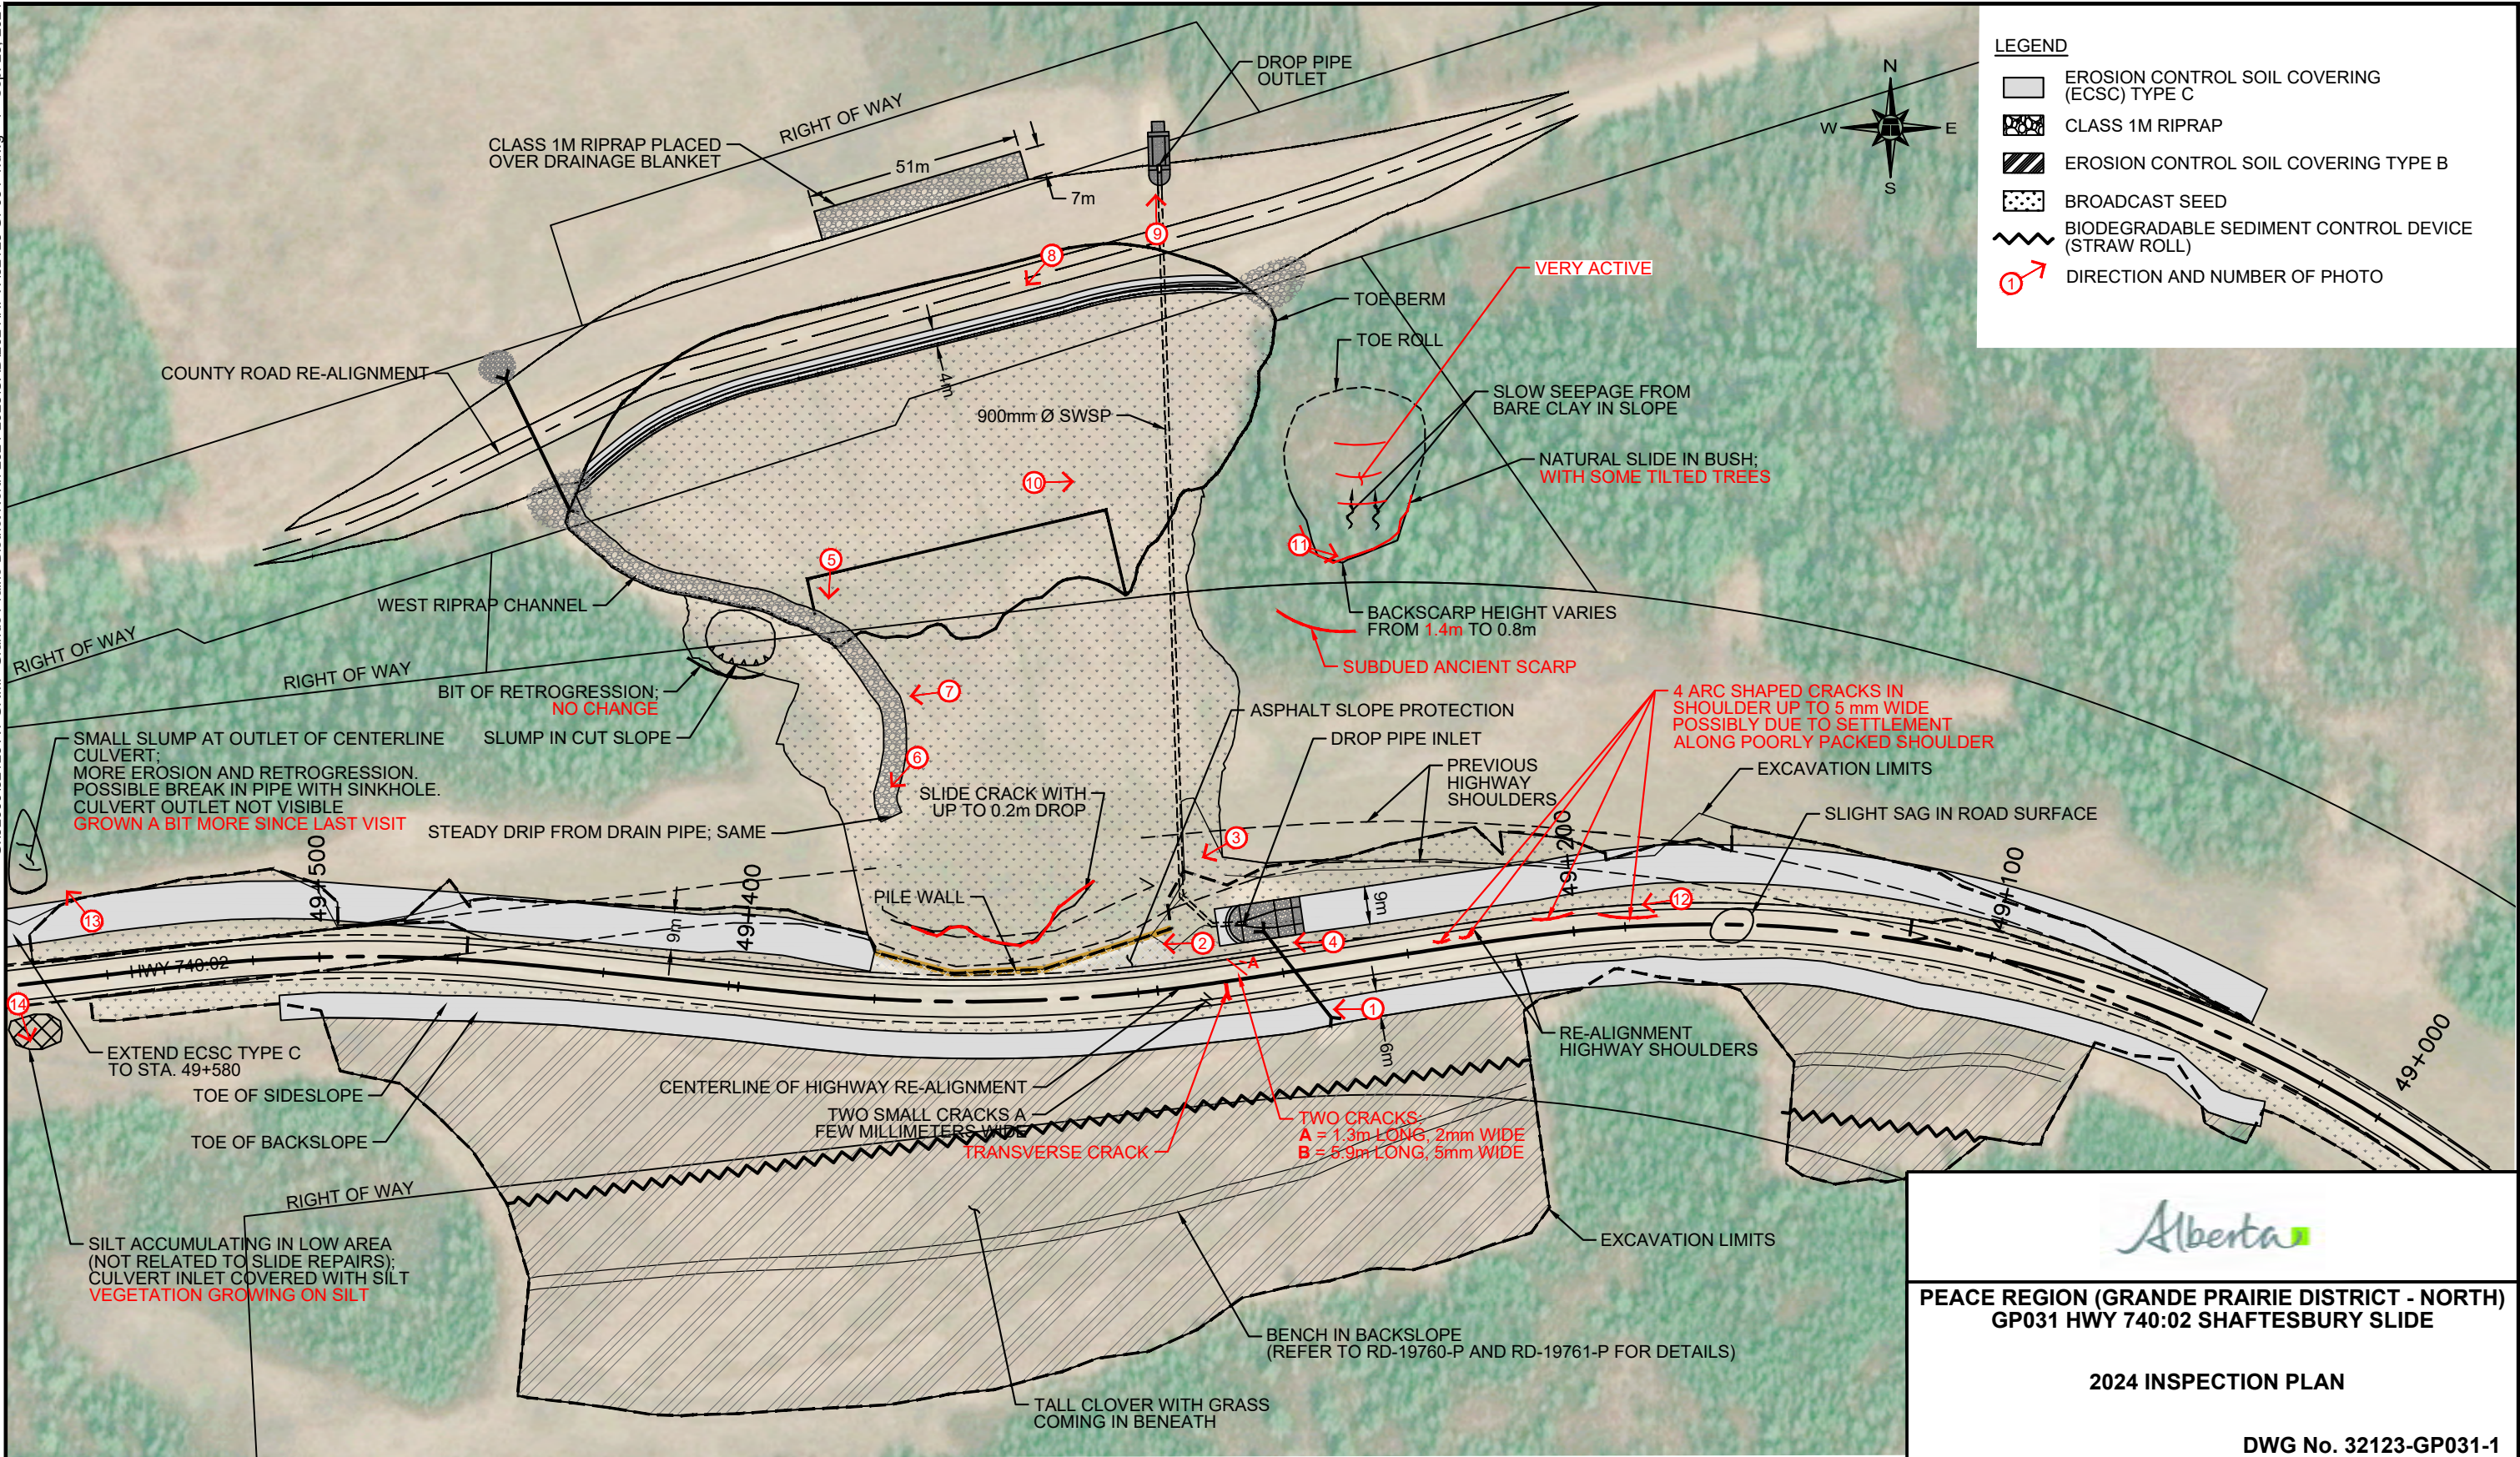
DWG No. 32123-GP031-1

BIT OF RETROGRESSION; **NO CHANGE**
