**ALBERTA TRANSPORTATION  
GEOHAZARD ASSESSMENT PROGRAM  
PEACE REGION-GRANDE PRAIRIE  
2016 INSPECTION REPORT**

Site Number	Location	Name	Hwy	km
GP039-1	Colquhoun Creek Crossing	Ditch Erosion (12 km's S. of Laglace)	724:04	13.349
Legal Description		UTM Co-ordinates		
SE¼ 04-073-08 W6M		11U E 363186	N 6129337

**PEACE REGION (GRANDE PRAIRIE) 2016  
GP39-1: HWY 724:04 km 13.349 DITCH EROSION  
(12 km SOUTH OF LA GLACE)**

**2016 INSPECTION FIGURE**

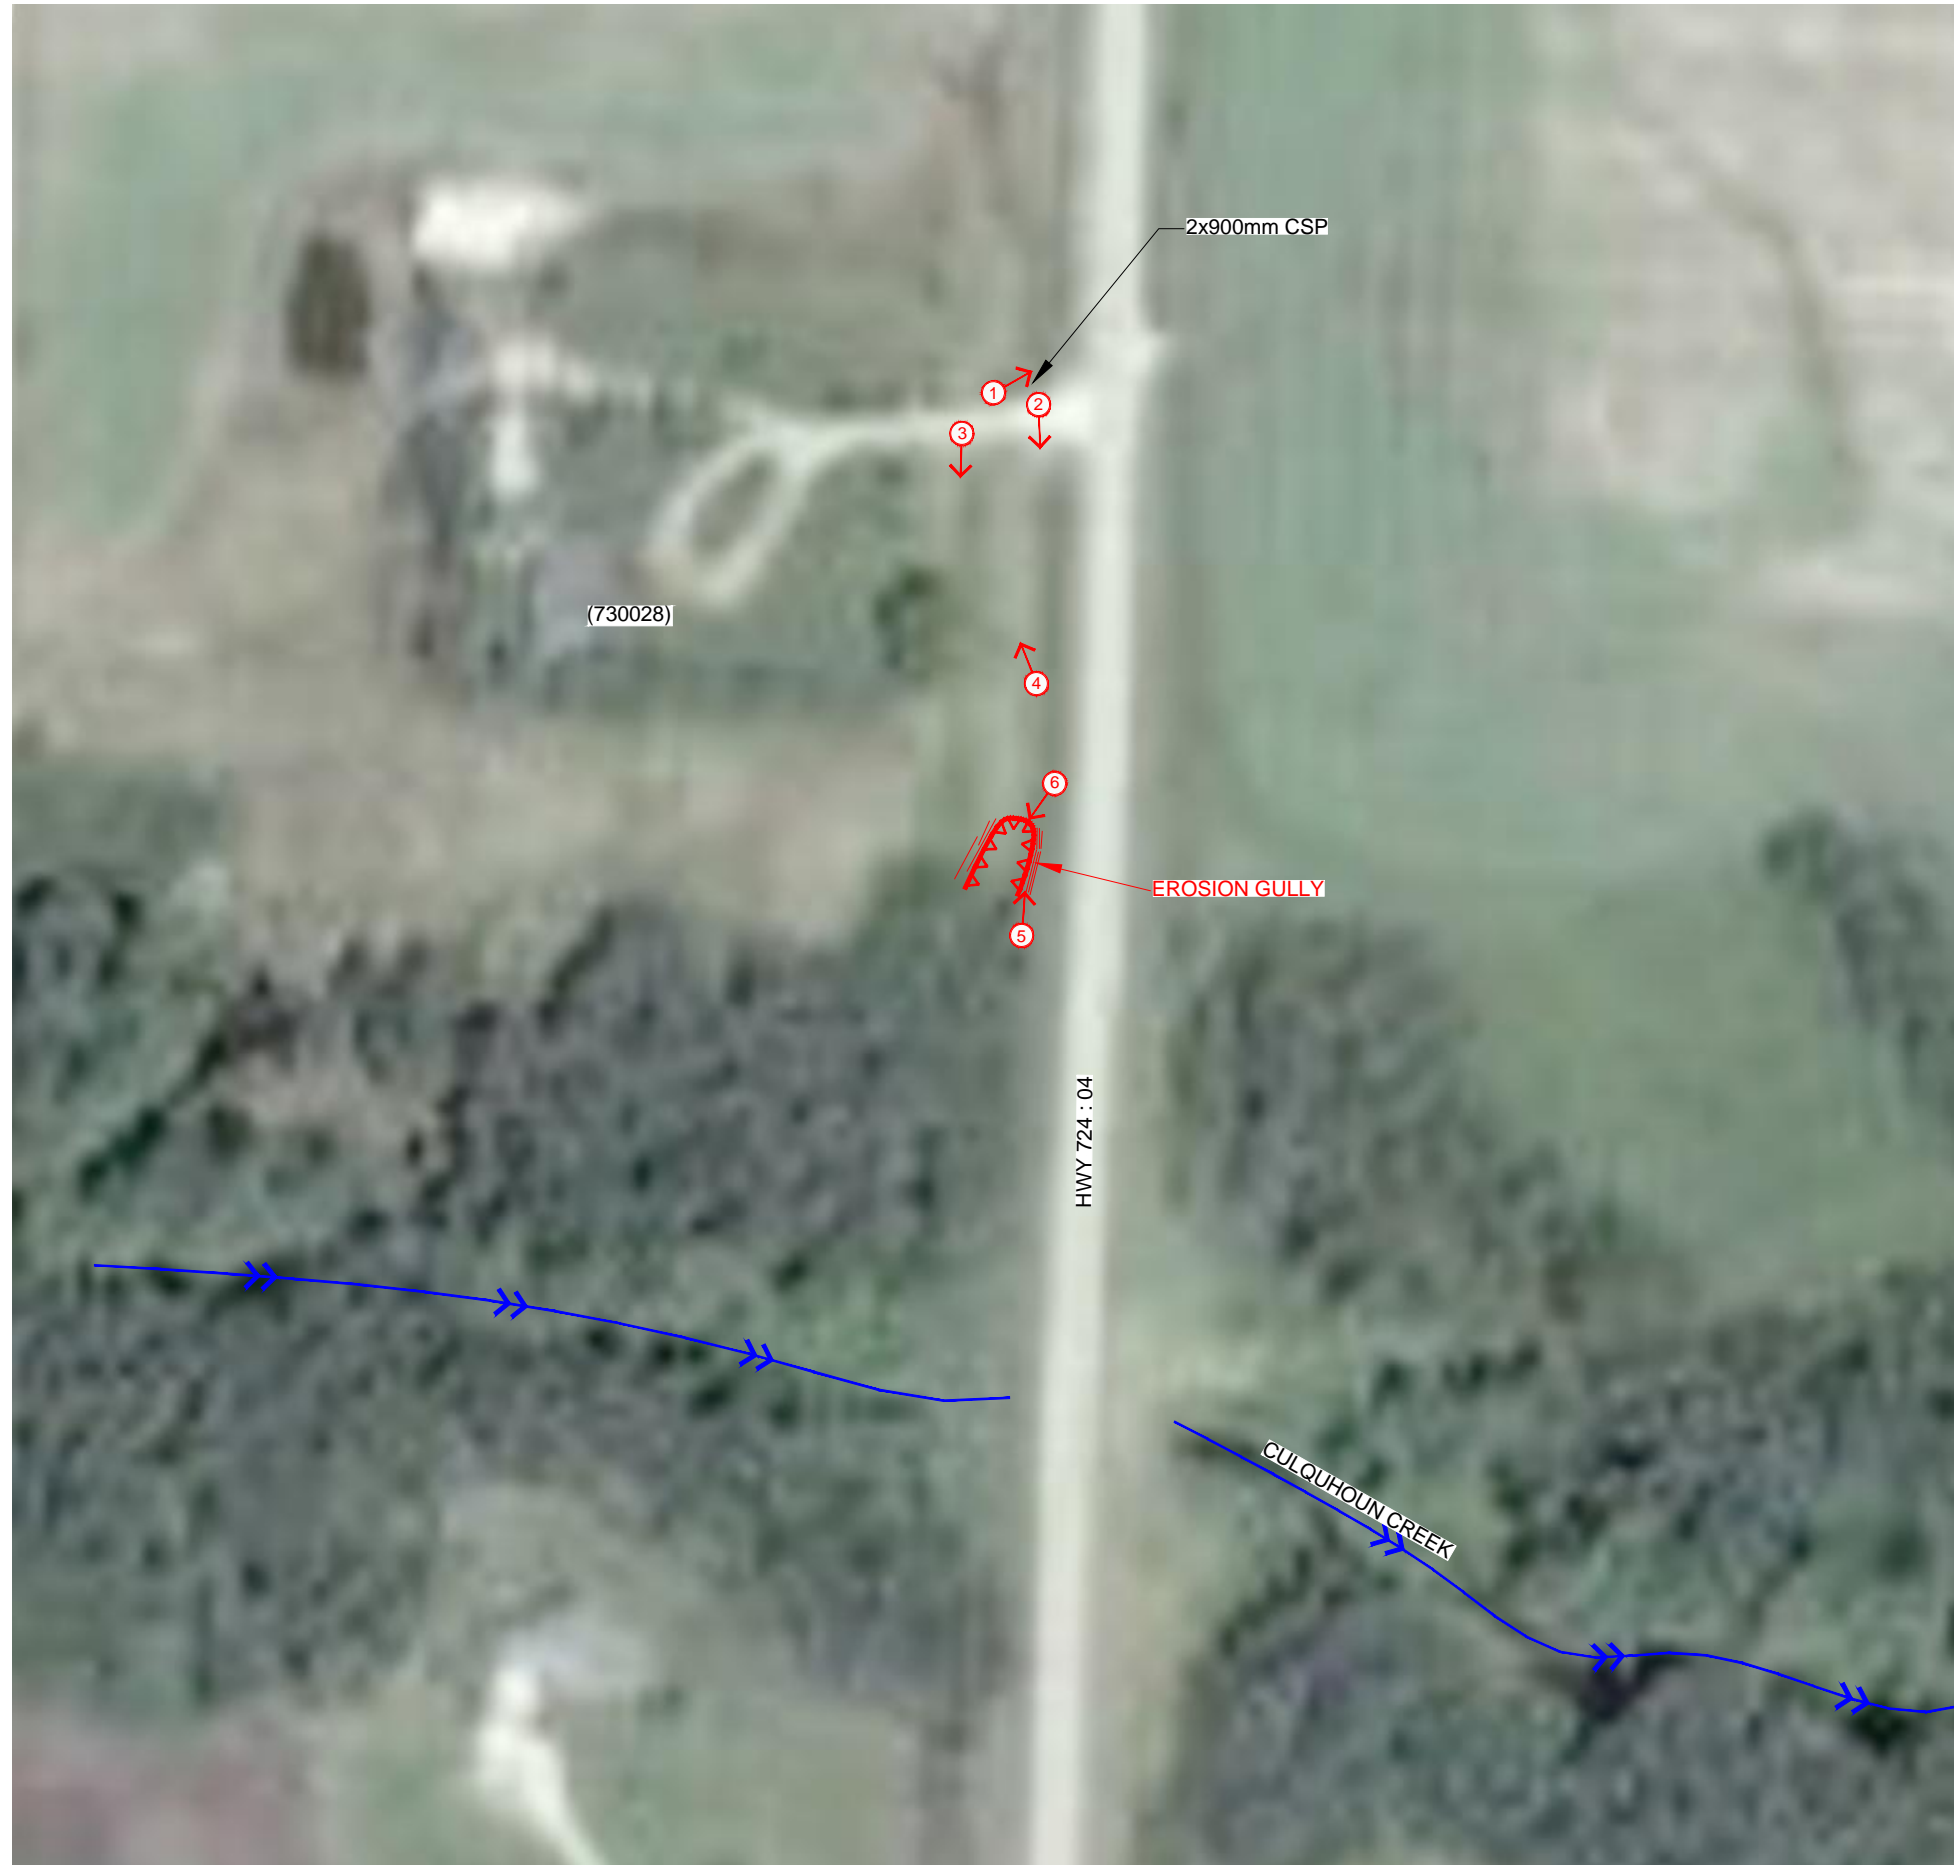
**DWG No. 13353-GP39-1-1**

<b>Primary Site Issue:</b>	An erosion gully has formed at the crest of the Culquhoun Creek north valley slope along the SBL ditch and is retrogressing into the limits of the privately owned land at No.730028 Hwy 724:04.		
<b>Dimensions:</b>	The erosion gully is about 30 m long, 2 m in width, and 1m to 2m in depth.		
<b>Maintenance:</b>	Some sand appears to have been dumped into the backscarp in attempt to backfill the erosion gully.		
<b>Observations:</b>	<b>Description</b>	<b>Worsened?</b>	
<input type="checkbox"/> Pavement Distress		<input type="checkbox"/>	
<input type="checkbox"/> Slope Movement		<input type="checkbox"/>	
<input checked="" type="checkbox"/> Erosion	Erosion gully has formed at the interface between the Hwy 724:04 SBL ditch and the crest of the Culquhoun Creek north valley slope.	<input checked="" type="checkbox"/>	
<input type="checkbox"/> Seepage		<input type="checkbox"/>	
<input type="checkbox"/> Bridge/Culvert Distress		<input type="checkbox"/>

The erosion gully did not appear to have adverse impact on the highway embankment at the time of this Call-out. However, the backscarp of the erosion gully is retrogressing to privately owned land adjacent the SBL of the roadway.

The weak and soft material should be excavated from the erosion gully and an armoured channel lined with permanent erosion control measures, such as gabion mattresses, should be constructed as soon as practical in order to avoid conflict with the land owner.

Excavate erosion gully and rebuild channel with permanent erosion control measures.	\$20,000 to \$30,000
---	-------------------------

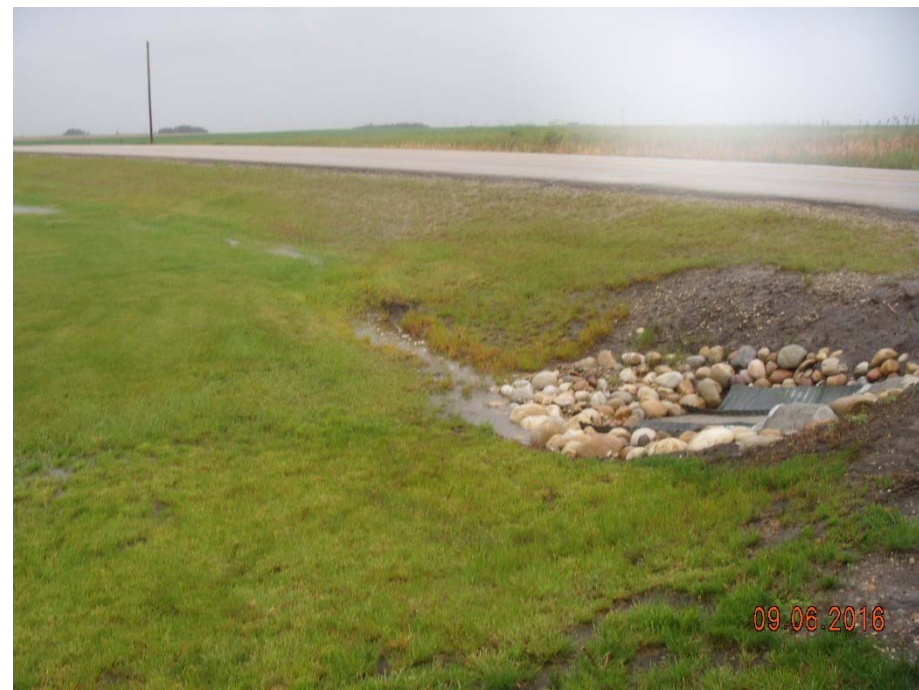
**Photo 1.**  
Looking northeast from the private driveway at 130028 Hwy 724 to the inlet of double barreled 900 mm CSP culverts in the SBL ditch.

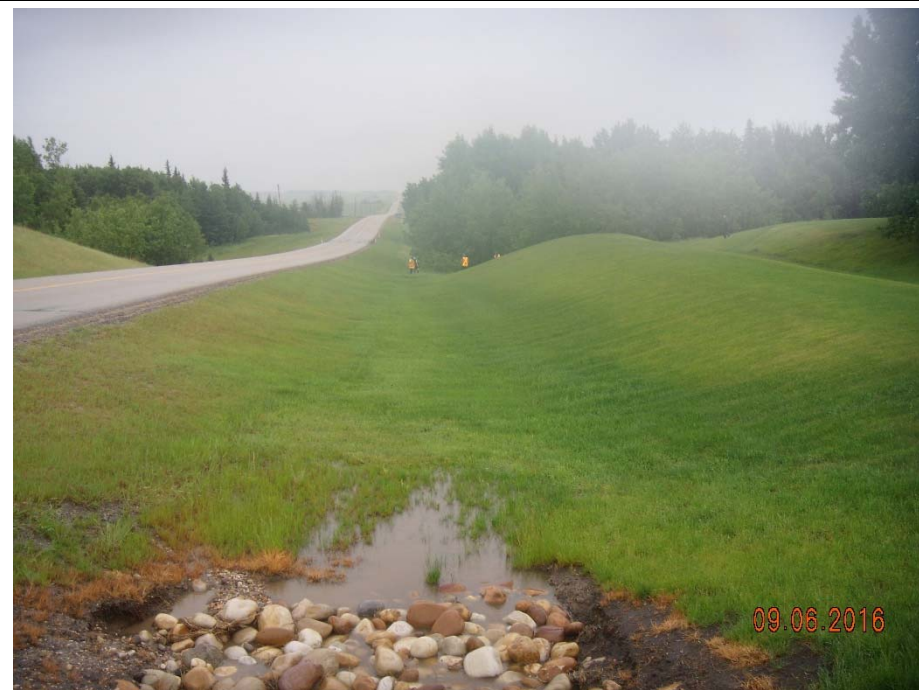
**Photo 2.**  
Looking south from the private driveway at 130028 Hwy 724 above the outlet of the culverts along the SBL ditch.

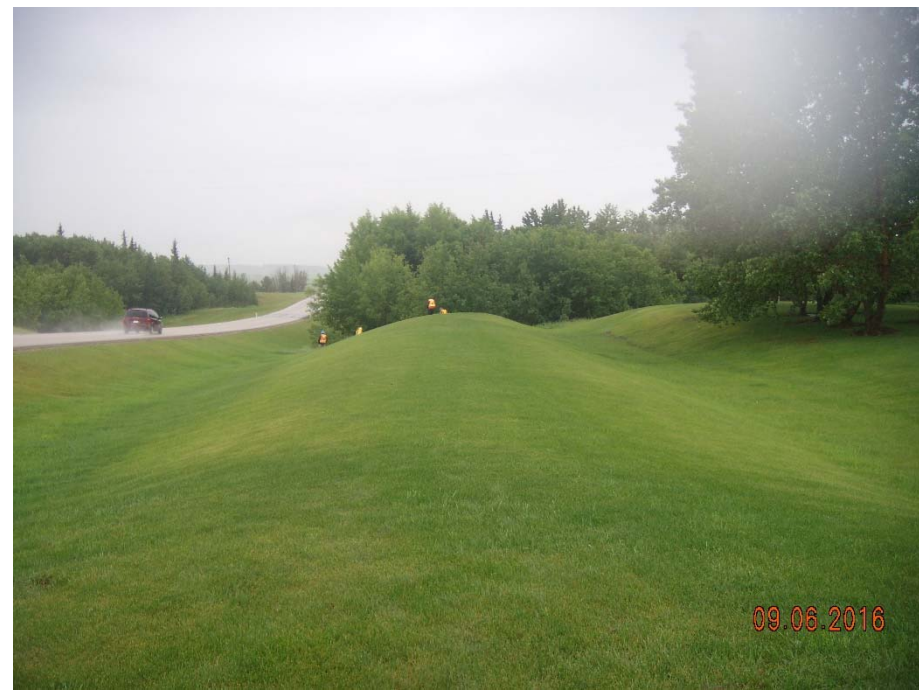
**Photo 3.**  
Looking south from private driveway at 130028 Hwy 724 along the berm west of SBL ditch.

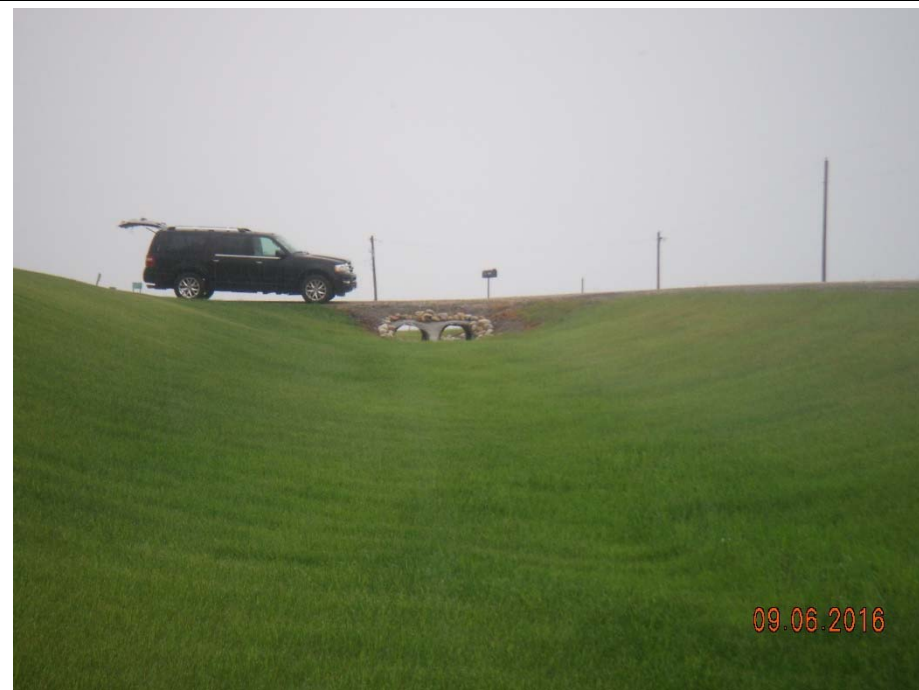
**Photo 4.**  
Looking north from the the tree line in te SBL ditch towards the culverts under the private driveway at 130028 Hwy 724.

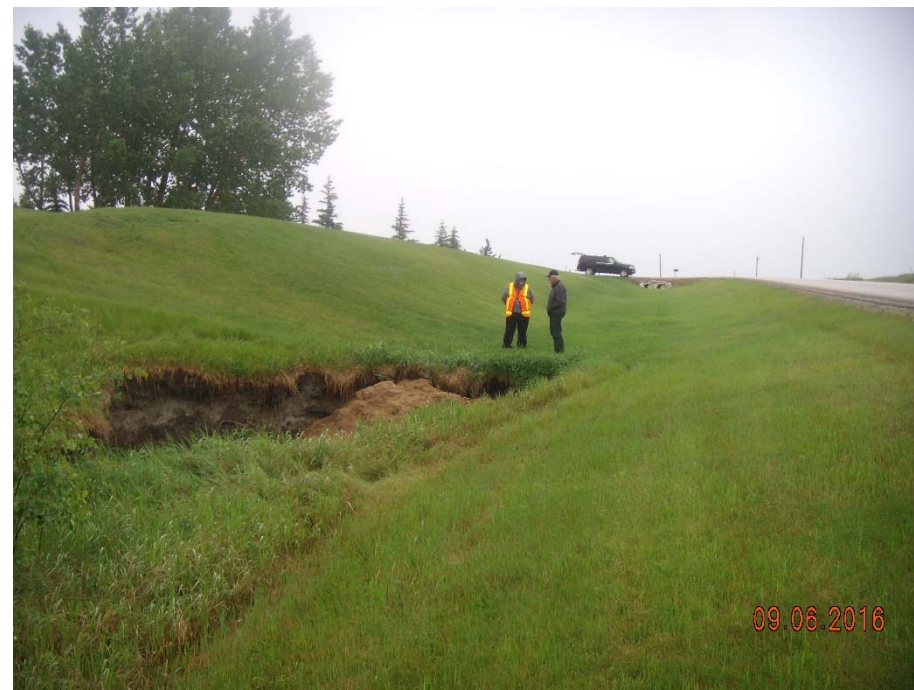
**Photo 5.**  
Looking northwest from the sideslope of the SBL of Hwy 724:04 at erosion gully that has formed at the crest of the Culquhoun Creek north valley slope.

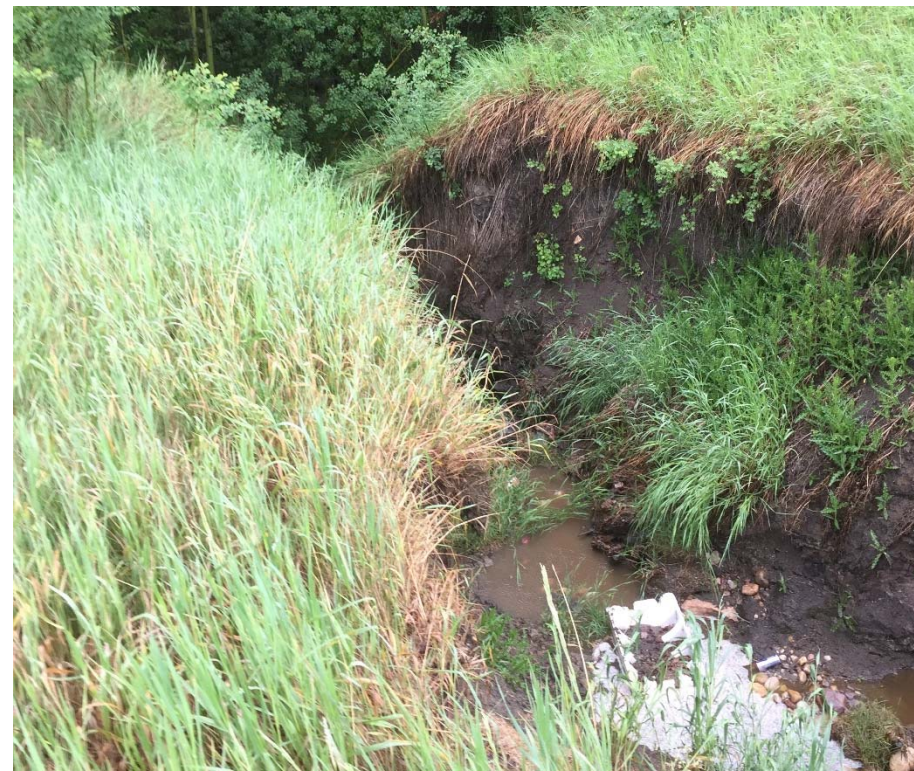
**Photo 6.**  
Looking southwest from the crest of the Culquhoun Creek north valley slope along the erosion gully. Some additional erosion and retrogression has occurred since 2014.
