**CON0022166 Peace Region
(Grand Prairie – South) GRMP**

GP017 - Hwy 40:34, km 26.7

Call-Out Report

CON0022166 Peace Region (Grande Prairie – South) GRMP
GP017 – Hwy 40:34, km 26.7
Call-Out Report

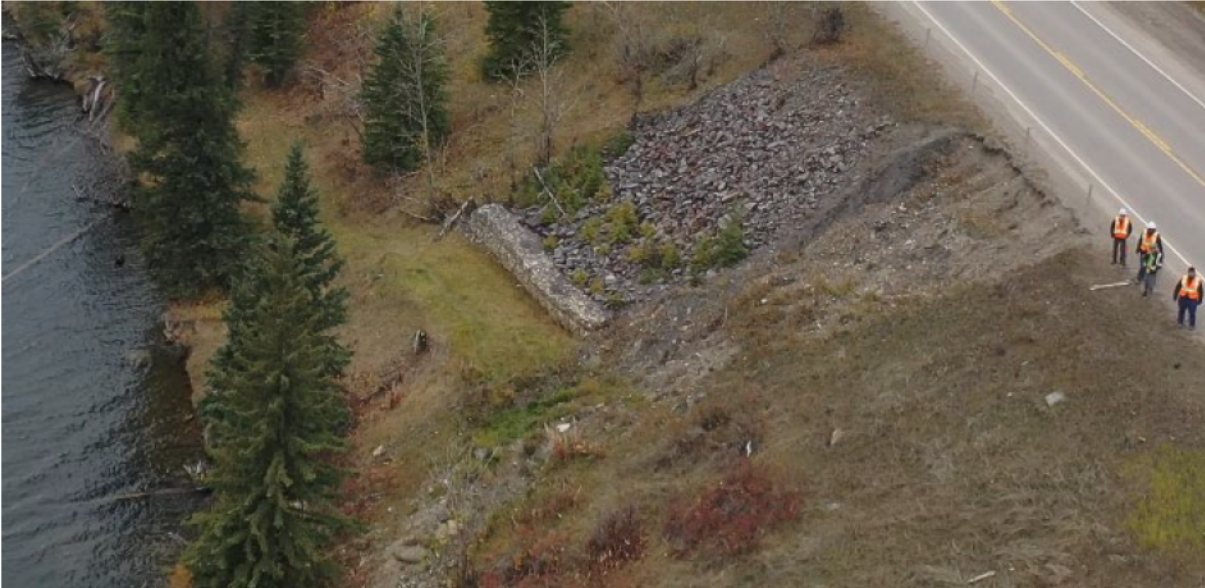
- A centreline culvert was not seen during the site inspection.
- The portion of the slope that failed is grassed without tree cover (Photo 1). The grassed-portion of the slope extends for approximately 70 m to the east. A few dead trees are present on the sliver-fill surface.

- Photo 1** Oblique UAV view of GP017 site showing 2001 repair and recent failure. Photo taken October 12, 2021, facing west. The trail at the toe of the slope is used for the Great Canadian Death Race.

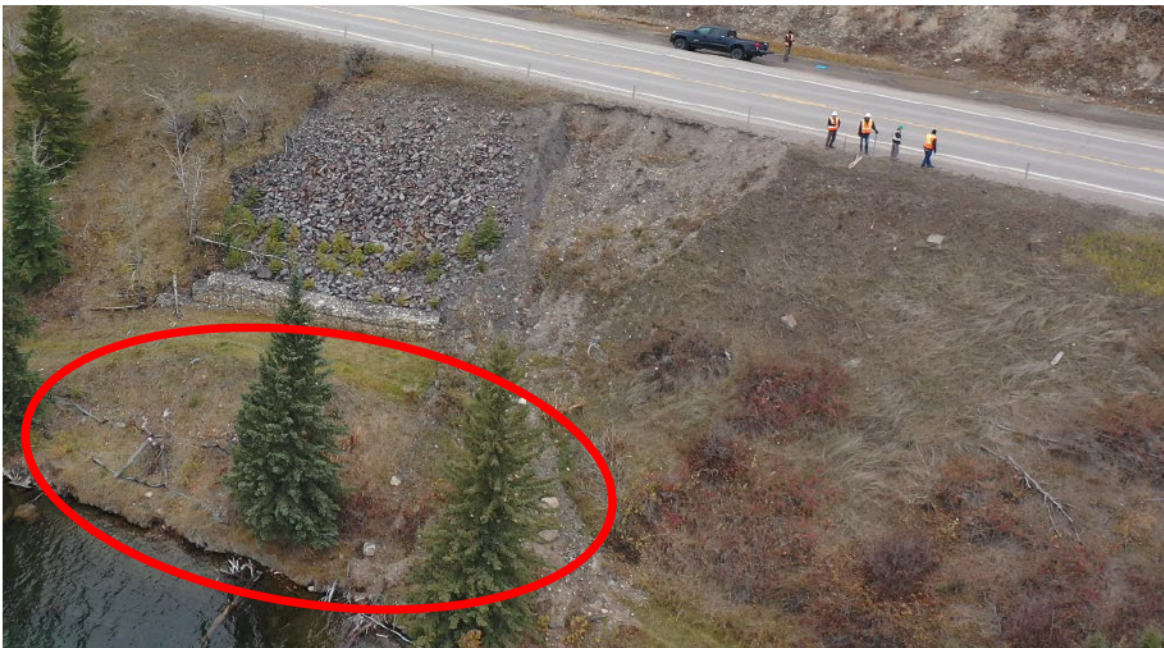
- The slope failure is approximately 15 m wide at the edge of the pavement and 4 to 6 m wide near the gabion wall (the slope failure is wider at top of slope than at bottom, as shown in Photo 2).

- A berm of fill (or a graded stockpile) appears to have been constructed at the base of the slope below the gabion wall (Photo 2). The trail has been routed up and over the berm of fill. The berm appears to be stable and well-vegetated. Silt fence placed during 2002 construction is partially in place in a deteriorated state at the toe of the berm.

- Photo 2** Oblique UAV view of GP017 site showing 2001 repair and recent failure. Photo taken October 12, 2021, facing northwest. The slope below the gabion wall appears built up (red circle). Eroded material from the slide mass is being transported across the trail towards the lake.

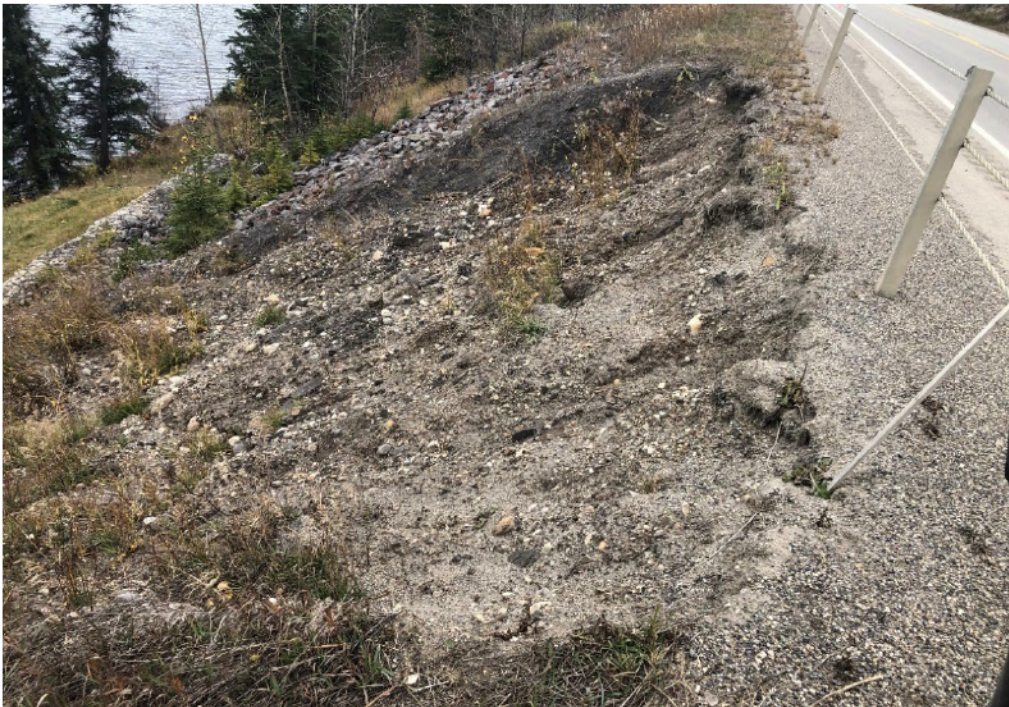
Photo 3 Crest of embankment slope, recent slide area, and 2001 repair. Photo taken on October 12, 2021, facing west.

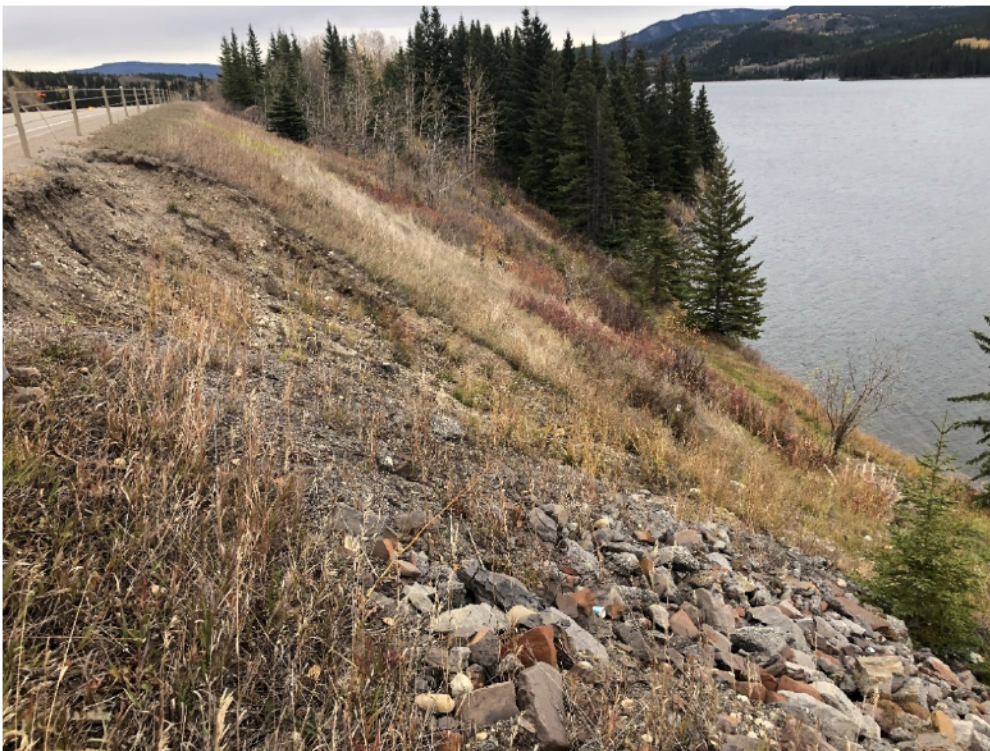
Photo 4 Crest of embankment slope near 2001 repair and recent failure. Photo taken on October 12, 2021, facing east.

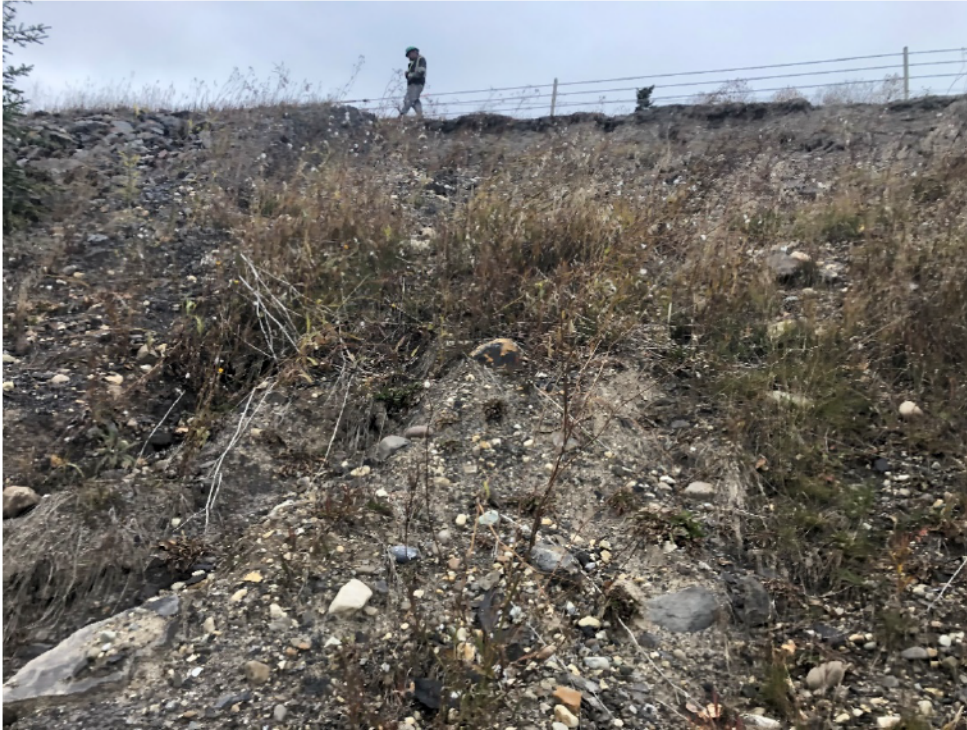
- The highway has a crown opposite the slide. Surface water runoff from the pavement appears to be flowing onto the slide and eroding the slide surface (Photo 5). Eroded materials are being carried downslope towards the lake (Photo 2).

- Probability Factor – A rating of 9 was selected for the site because the slope failure/erosion area is an unvegetated steep slope with erodible materials exposed and with rills forming on the lower parts of the slope. The site appears to be actively eroding.

Photo 5 Rills are forming on the lower portion of the slide from surface water runoff flowing over the edge of pavement and onto the slide mass. Photo taken on October 12, 2021, facing north.

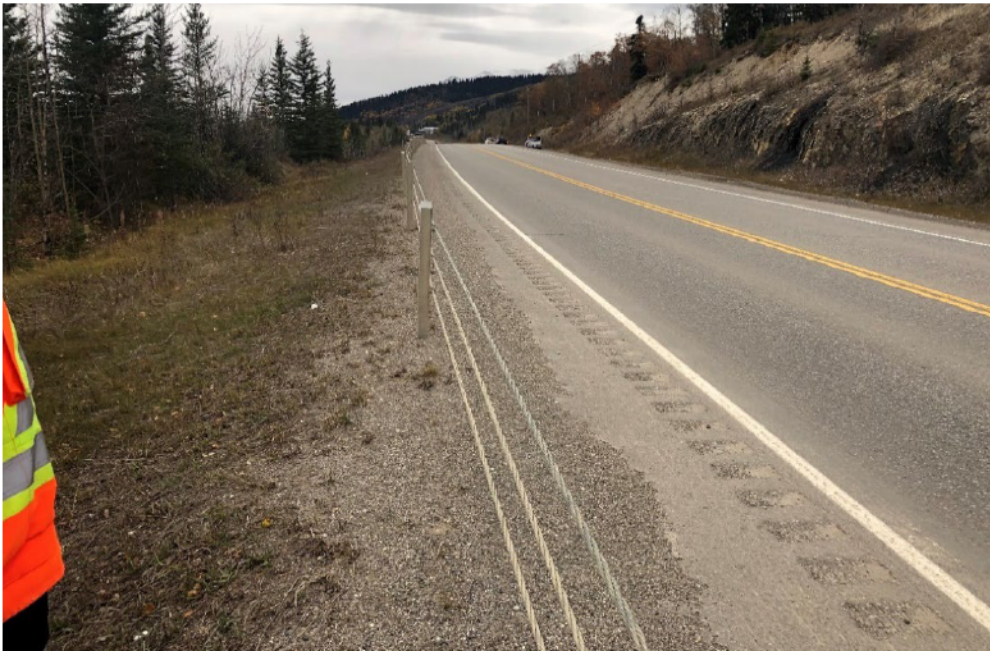
Photo 6 Location to the east of site where the trail is close to the highway. Bedrock outcrop in upslope ditch approximately 100 m to the east of the site. Photo taken on October 12, 2021, facing west.
