**ALBERTA TRANSPORTATION  
GEOHAZARD ASSESSMENT PROGRAM  
PEACE REGION – GRANDE PRAIRIE DISTRICT  
2020 CALL OUT**

<b>Site Number</b>	<b>Location</b>	<b>Name</b>	<b>Hwy</b>	<b>km</b>
Call Out	W of Grande Cache	Backslope Mudflows	40:34	35.0
<b>Legal Description</b>		<b>UTM Co-ordinates (NAD 83)</b>		
Km 35.0: SE32-56-8-W6		11U N 5,973,287	E 358,670

**PEACE REGION (GRANDE PRAIRIE)  
CALLOUT: HWY 40:34 km 35**

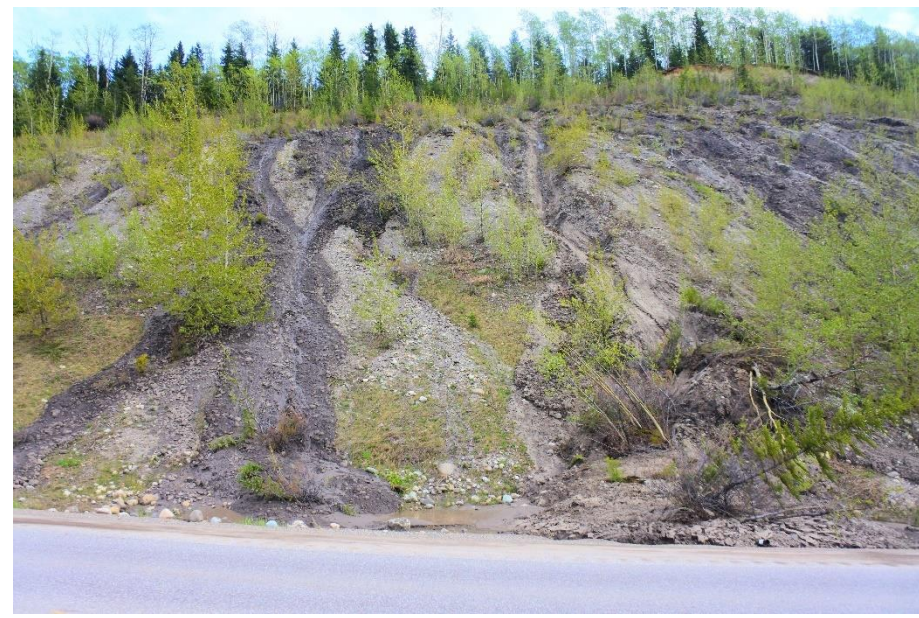
**Photo 1.**  
Looking southeast  
at shallow  
landslides/mudslide  
s down the  
backslope.

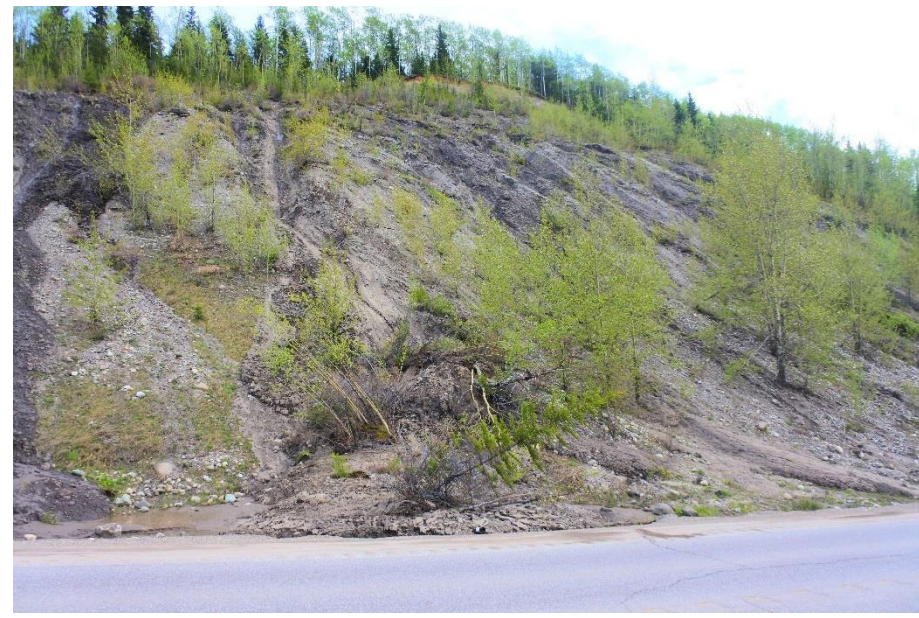
**Photo 2.**  
Looking south at  
shallow  
landslides/mudslide  
s and accumulation  
of debris near base  
with trees still  
growing on mass  
that slid.

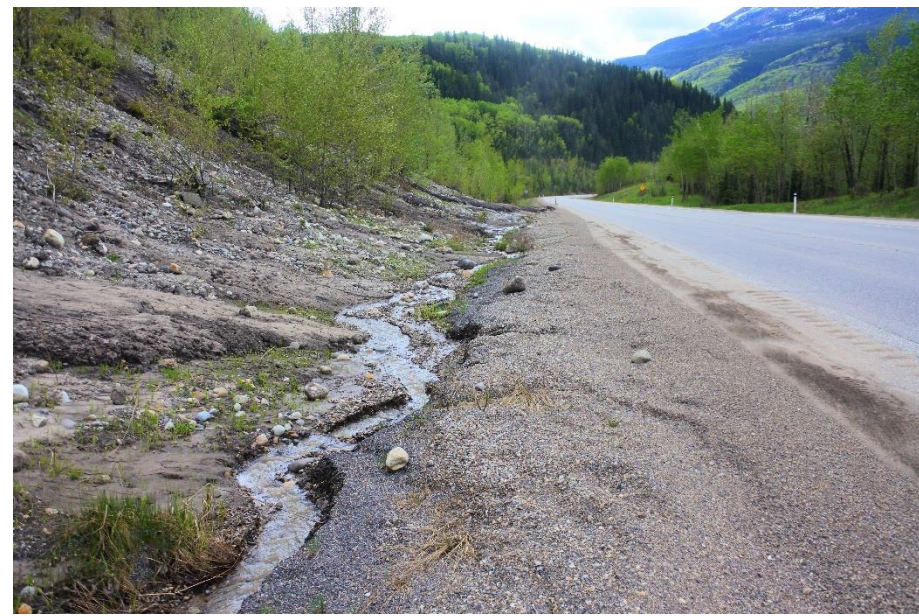
**Photo 3.**  
Looking southwest at east ditch and erosion that runoff is cutting down around the debris accumulation.

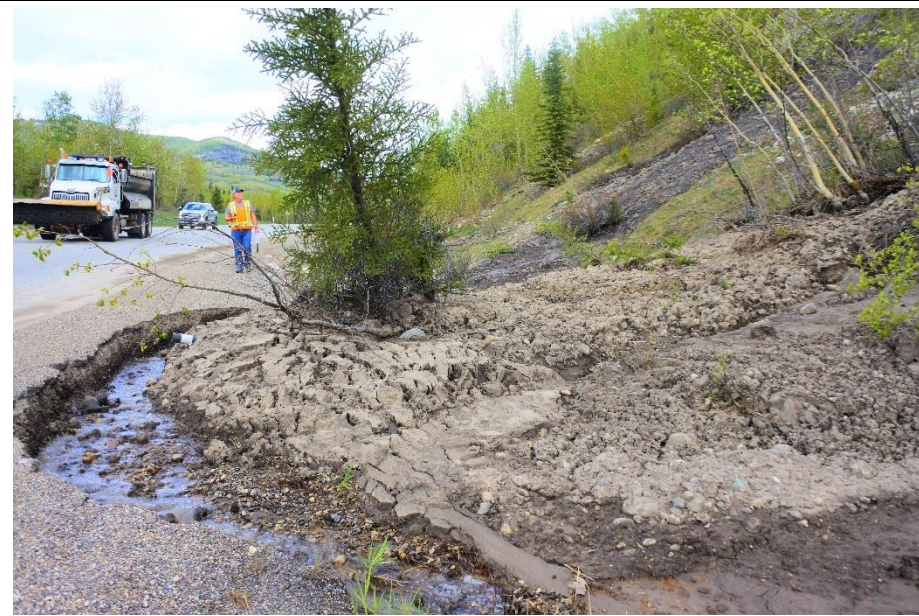
**Photo 4.**  
Looking northeast at debris which slid down into east ditch and erosion is cutting it's way down around it.

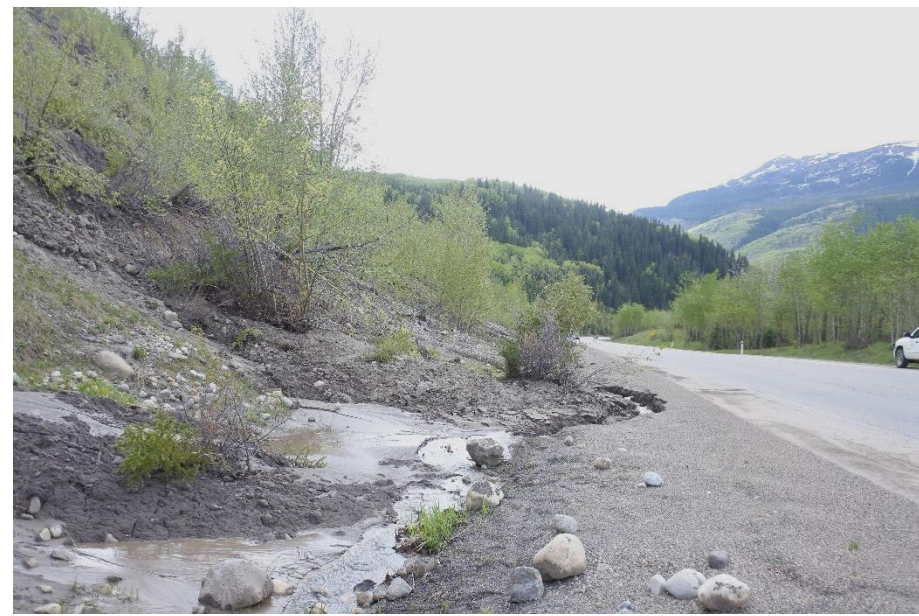
**Photo 5.**  
Looking southwest  
at east ditch further  
upslope where  
debris flow is  
saturated and has  
trees still growing.

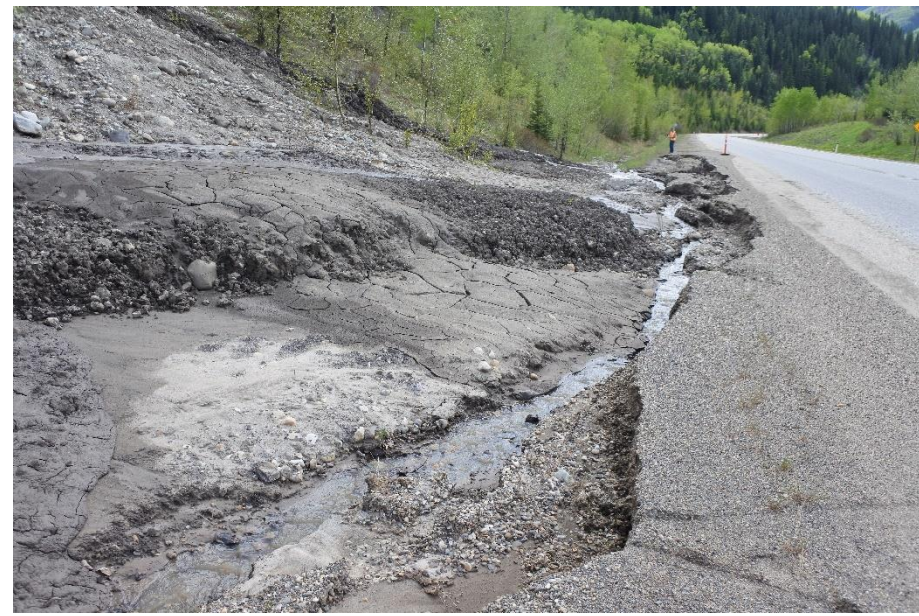
**Photo 6.**  
Looking southwest  
at east ditch further  
downslope at  
erosion cutting into  
the highway  
shoulder.

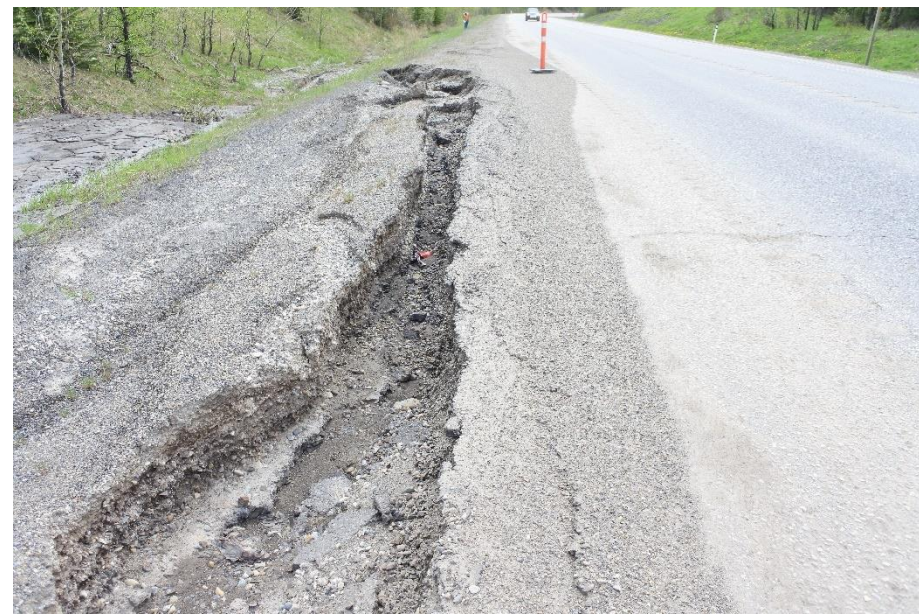
**Photo 7.**  
Looking southwest  
at east ditch further  
downslope at  
erosion cutting into  
the highway  
shoulder.

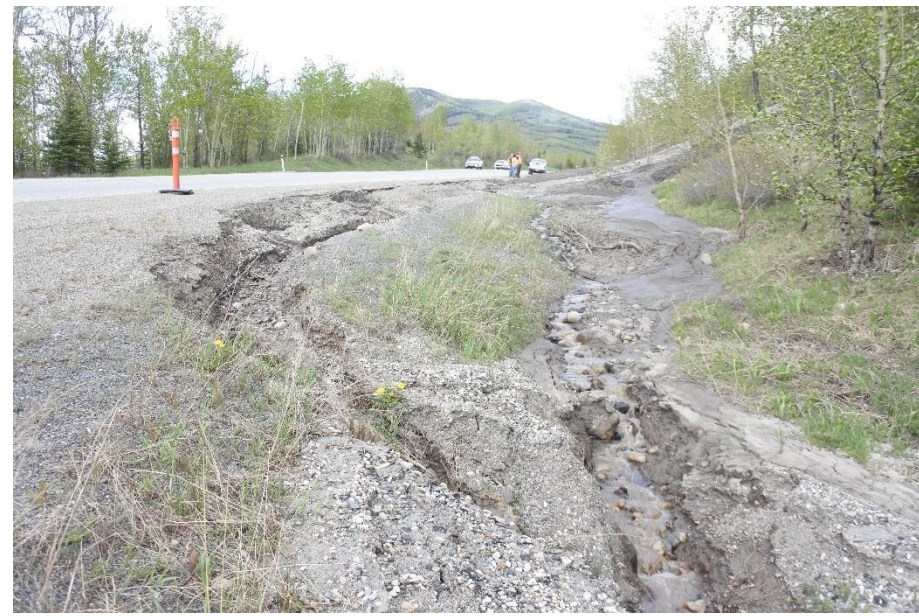
**Photo 8.**  
Looking northeast  
at east ditch further  
downslope at  
erosion cutting into  
the highway  
shoulder and  
delineator has been  
placed.

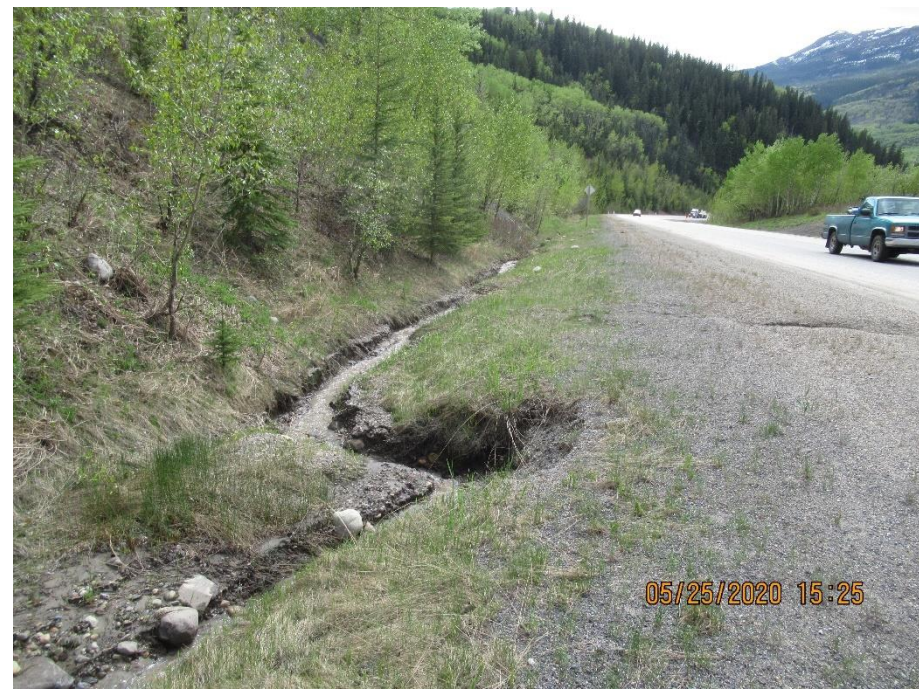
**Photo 9.**  
Looking southwest  
at east ditch at the  
southmost portion  
of the site erosion.

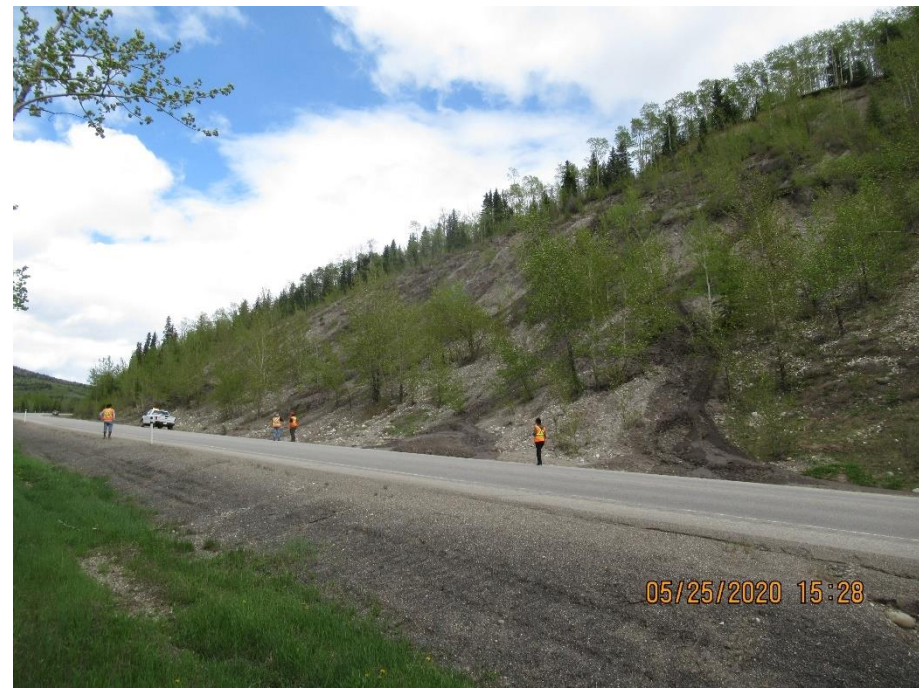
**Photo 10.**  
Looking northeast  
at backslope from  
across highway 40.
