**PEACE REGION
(GRANDE PRAIRIE DISTRICT – SOUTH) GRMP**

SITE INSPECTION FORM

SITE NUMBER AND NAME: GP041 Ditch Erosion North of Grande Cache		HIGHWAY & KM: 40:34, 32.405	PREVIOUS INSPECTION DATE: July 21, 2021	INSPECTION DATE: June 12, 2023
LEGAL DESCRIPTION: SE 04-57-08-W6M	NAD 83 COORDINATES: UTM Northing Easting 11 5973931 360755		RISK ASSESSMENT: PF: 10 CF: 3 TOTAL: 30	
AVERAGE ANNUAL DAILY TRAFFIC (AADT): 1,480 (north) & 1,520 (south) (Reference No. 70000104, 2022)			CONTRACT MAINTENANCE AREA (CMA): 504

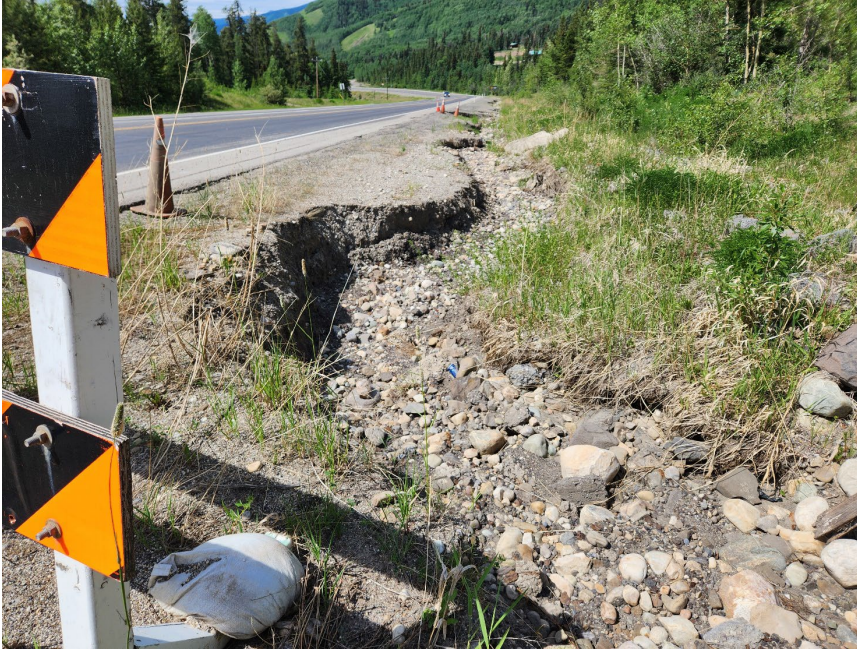
- Photo 1** Erosion feature in north (westbound) ditch of Hwy 40:34 at WP294. Note erosion approximately 1.2 m from edge of pavement which is approximately 1.0 m to 1.2 m deep. Photo taken June 13, 2023, facing northwest.

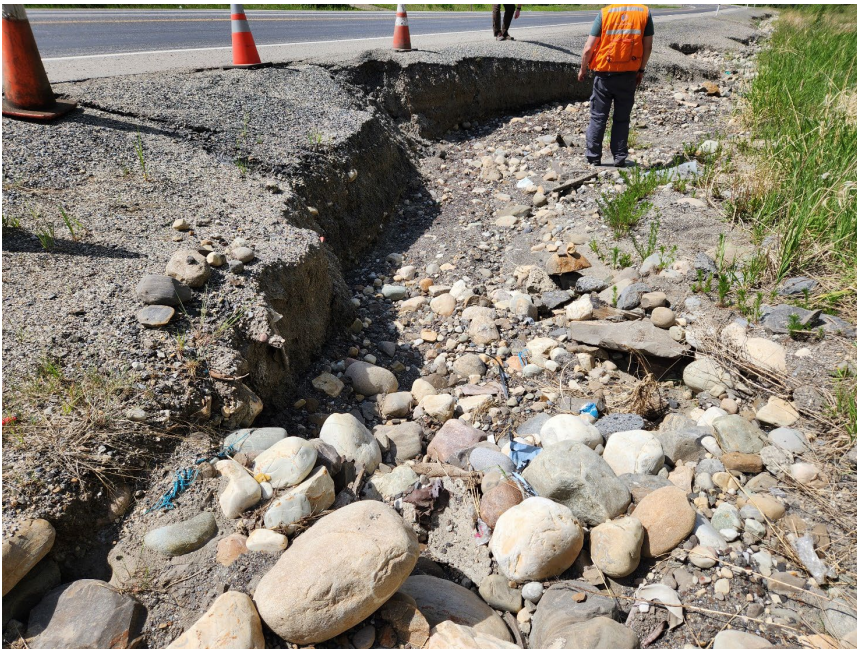
ITEM	CONDITION EXISTS		DESCRIPTION AND LOCATION	NOTICABLE CHANGE FROM LAST INSPECTION	
	YES	NO		YES	NO
Pavement Distress	X		Erosion has progressed to edge of pavement at WP293.	X	
Slope Movement		X	None observed at time of 2023 inspection.		X
Erosion	X		Erosion ongoing in north (westbound) ditch of highway alongside section repaired in 2006 as described below.	X	
Seepage		X	None observed at time of 2023 inspection.		X
Culvert Distress		X	No culverts observed by KCB.		X

- Photo 2** Erosion feature in north (westbound) ditch of Hwy 40:34 at WP293. Note erosion at edge of pavement which is approximately 1.0 m to 1.2 m deep. Photo taken June 13, 2023, facing northwest.

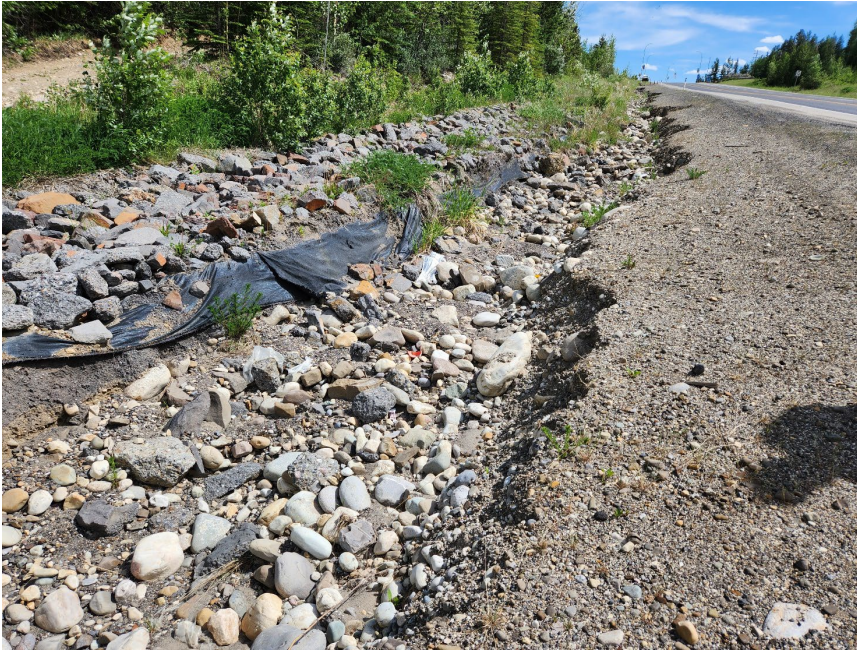
COMMENTS
An erosion feature was repaired in 2006 by placing riprap on a woven geotextile separating medium. The riprap was conglomerate from a nearby quarry and has since experienced various degrees of breakdown due to the matrix material for the conglomerate being sandstone with variable resistance to freeze-thaw particle breakdown. Sometime afterwards (at least once since 2013) limestone or greywacke riprap from a nearby quarry was placed on the 2006 repair to augment the riprap armoring where conglomerate riprap had deteriorated due to freeze-thaw action.
An erosion feature has since formed alongside the riprap due to surface water flow bypassing the riprap, potentially due to inadequate riprap/channel freeboard and snow clearing activities as described below. Also, the riprap armoured ditch was constructed above the toe of the highway embankment, leaving a secondary unarmoured channel for water to flow in closer to the highway.

Photo 3 Erosion feature in north (westbound) ditch of Hwy 40:34. Note exposed geotextile and riprap particles in ditch, some of which are subrounded and composed of conglomerate, and limestone, or greywacke from a nearby quarry. Photo taken June 13, 2023, facing southwest.

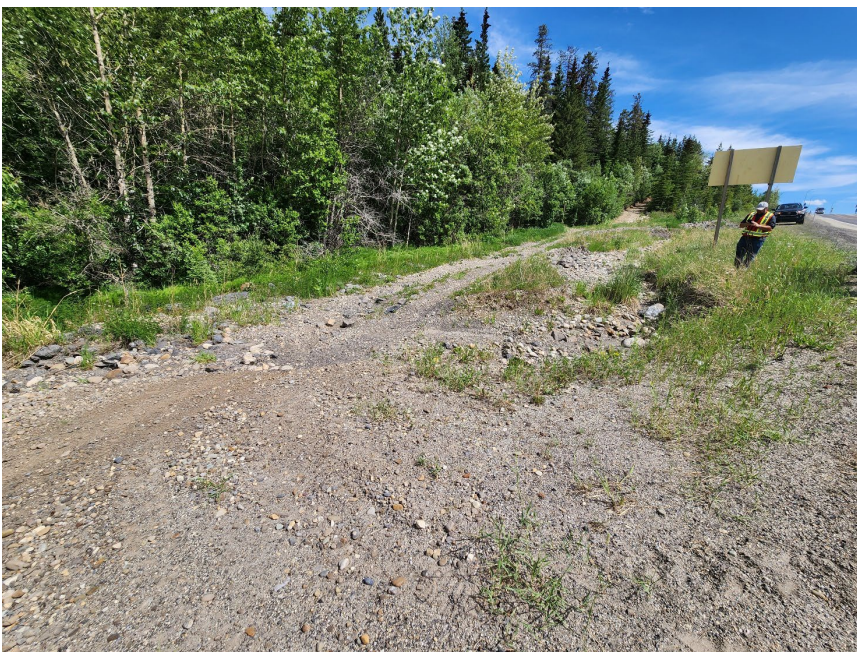
Photo 4 Erosion feature in north (westbound) ditch of Hwy 40:34 at WP295. Note recreational trail/road across erosion feature. Photo taken June 13, 2023, facing southeast.
