SITE INSPECTION FORM

SITE NUMBER AND NAME: GP036 Rockfall 2.0 km South of McIntyre Mine		HIGHWAY & KM: 40:36, 12.061	PREVIOUS INSPECTION DATE: June 14, 2022	INSPECTION DATE: June 12, 2023
LEGAL DESCRIPTION: NW 04-58-08-W6M	NAD 83 COORDINATES: UTM Northing Easting 11 5984469 359856		RISK ASSESSMENT: PF: 16 CF: 5 TOTAL: 80	
AVERAGE ANNUAL DAILY TRAFFIC (AADT): 780 (north) & 980 (south) (Reference No. 25592, 2022)			CONTRACT MAINTENANCE AREA (CMA): 504

PROJECT	PEACE REGION (GRANDE PRAIRIE DISTRICT-SOUTH) GEOHAZARD RISK MANAGEMENT PROGRAM	
TITLE	Site Plan GP036 - Rockfall 2.0 km South of McIntyre Mine Hwy 40:36, km 12.061	
SCALE	PROJECT No.	FIG No.
1:1,500	A05116A01	1

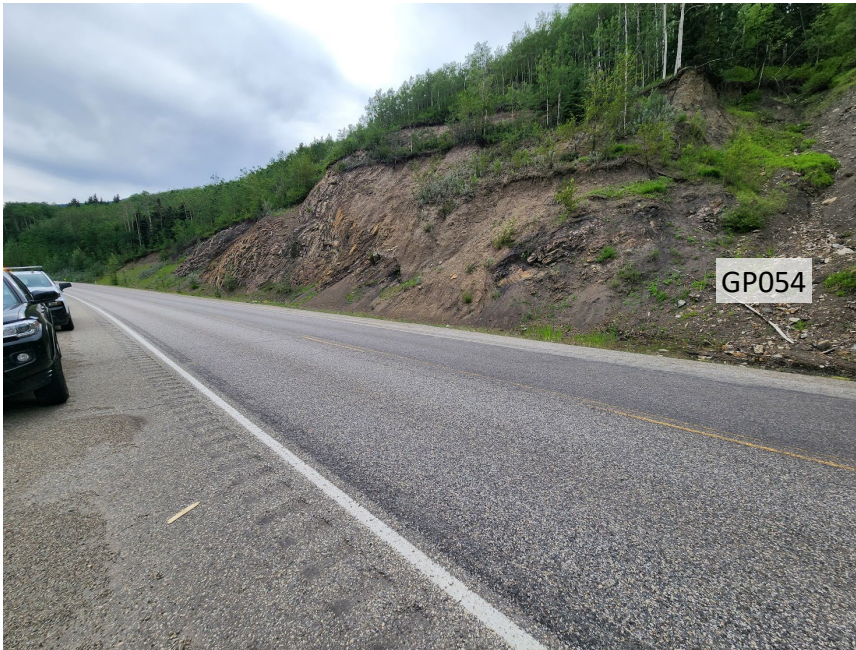
- Photo 1** Rock slope along west side of Hwy 40:36 near southern site limit. Note soil infilling of possible fault feature and GP054 km 12.1 debris flow site on right/east. Photo taken June 12, 2023, facing northwest.

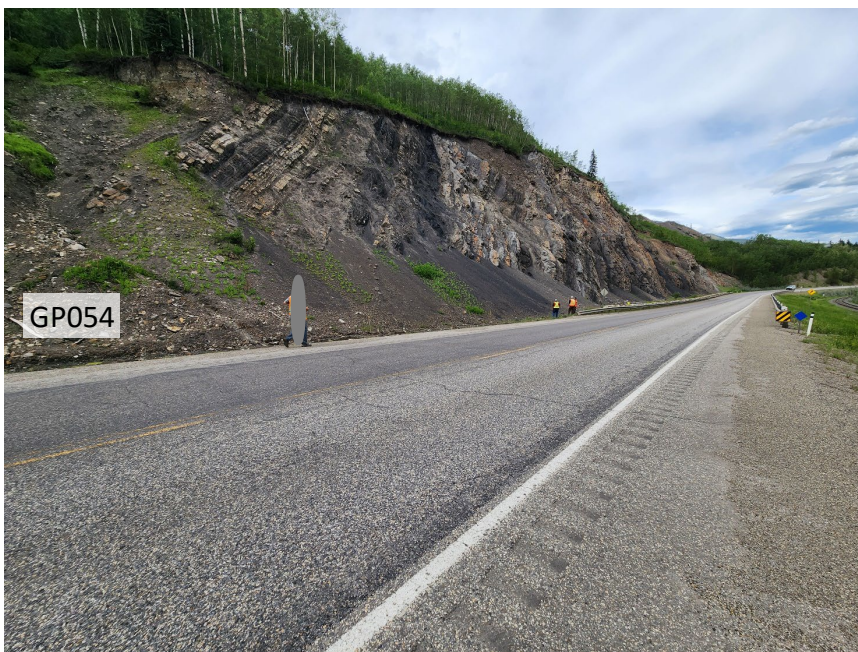
- Photo 2** Rock slope along west side of Hwy 40:36. Note GP054 km 12.1 debris flow site on left/west. Photo taken June 12, 2023, facing northwest.

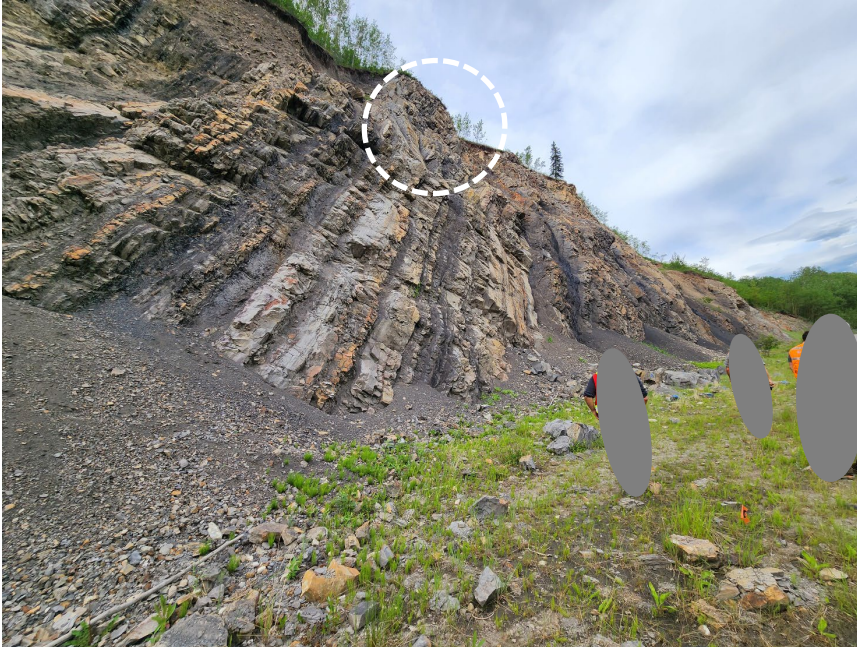
Photo 3 Rock slope along west side of Hwy 40:36. Note talus material mainly from coal seams and rockfall particles in highway ditch and potential rock block on upper slope (circled in white, see photo below). Photo taken June 12, 2023, facing northwest.

- Short-term
 - Clean highway ditch regularly to maintain rockfall storage volume (i.e., keep ditch as wide and deep as possible to retain material within the ditch) and reduce the potential for material reaching the highway. A buried gas line and fiber optics cable along the ditch limits the depth the ditch can be excavated or cleaned out. Estimated cost: approximately \$25,000 to \$40,000.

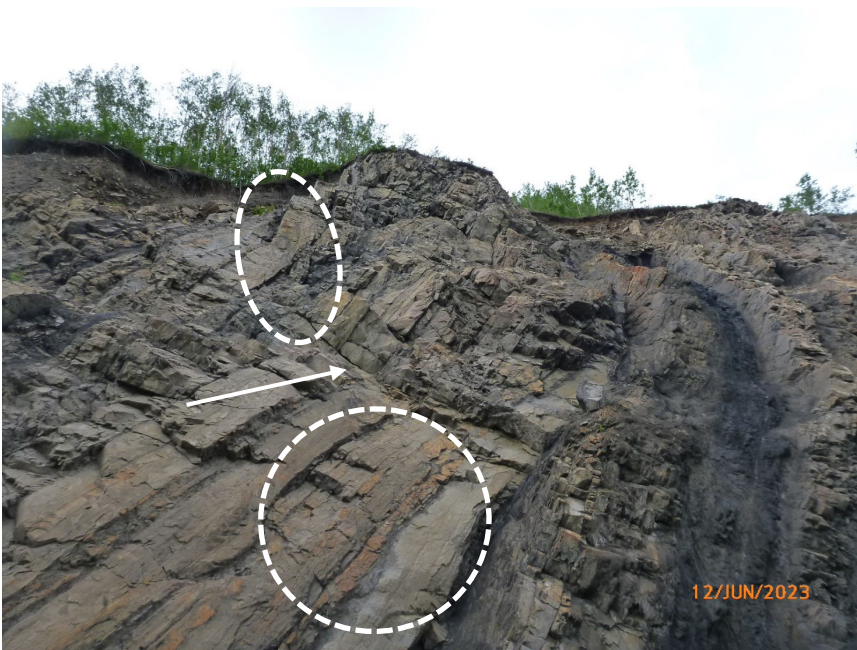
Rock mass consists of beaded and sheared sedimentary rocks, with coal seams which are weathering faster. Faster weathering of the coal results in the undermining of more competent rocks, which results in overhanging blocks and particles with little support that eventually fall, and the deposition of talus cones/slopes at the toe of the coal seams with occasional adjacent lateral rock block piles/cones. Cubical shaped rockfall particles appear to be rolling and bouncing down the talus cones bringing them closer to the highway (i.e., the talus cones act like chutes for rockfall particles). Whereas flat platy shaped rockfall particles appear to get hung up in the talus.
Several hanging rock blocks with some close to falling, including one potentially large rock block. A bedrock discontinuity “plane” (distorted and non-planar) appears to underlie the large rock block. Along the north side of the large rock block is a layer of fractured rock and a coal seam which is weathering faster than the rest of the slope. The discontinuity between the undulating discontinuity and the large rock block appears to be dilated. Continued weathering of the coal seam could result in loss of confinement, resulting in overstressing the remainder of the attachments for the large rock block to the slope, causing a large rockfall event that would likely cover the section of highway below.

Photo 4 Potential rock block on upper slope shown in previous photo. Note dilated or open joints below rock block (indicated with white arrow), joints or shear planes to left and below rock block (circled in white), and rock and coal to right of rock block which is eroding. Photo taken June 12, 2023, facing northwest.

- Long-term:
 - The rockfall hazards should be further studied to assess the effectiveness of rock slope stabilization mitigations such as bolting, trim blasting, shotcrete, and attenuation mesh, which should be completed with scaling. This work is underway, and a site investigation was completed by KCB in May 2023 to support design work. Estimated cost: approximately \$700,000 to \$850,000 for 70% mesh and approximately \$100,000 to \$200,000 for scaling.

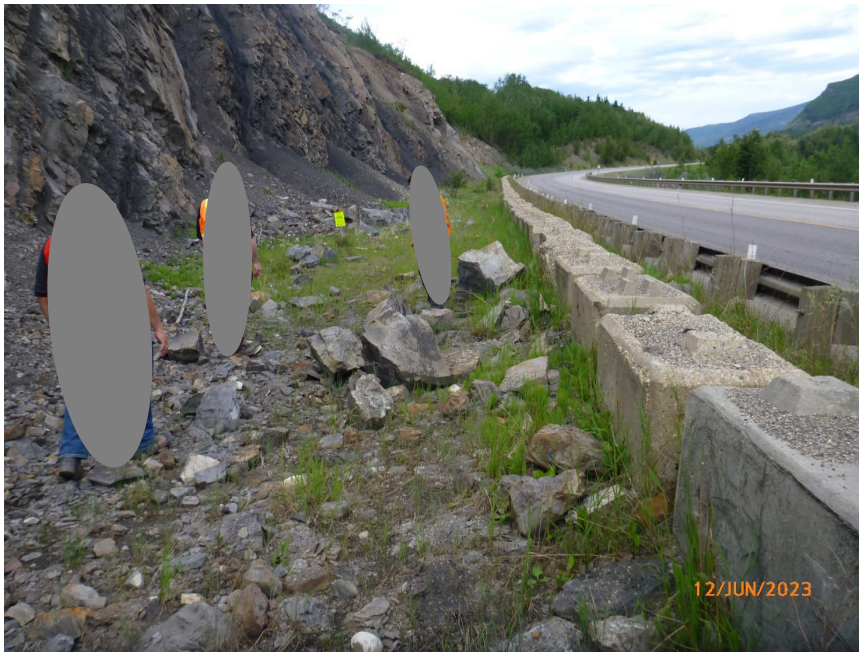
Photo 5 Rockfall particles in west ditch of Hwy 40:36. Note yellow sign indicating location of high-pressure natural-gas pipeline. Photo taken June 12, 2023, facing northwest.

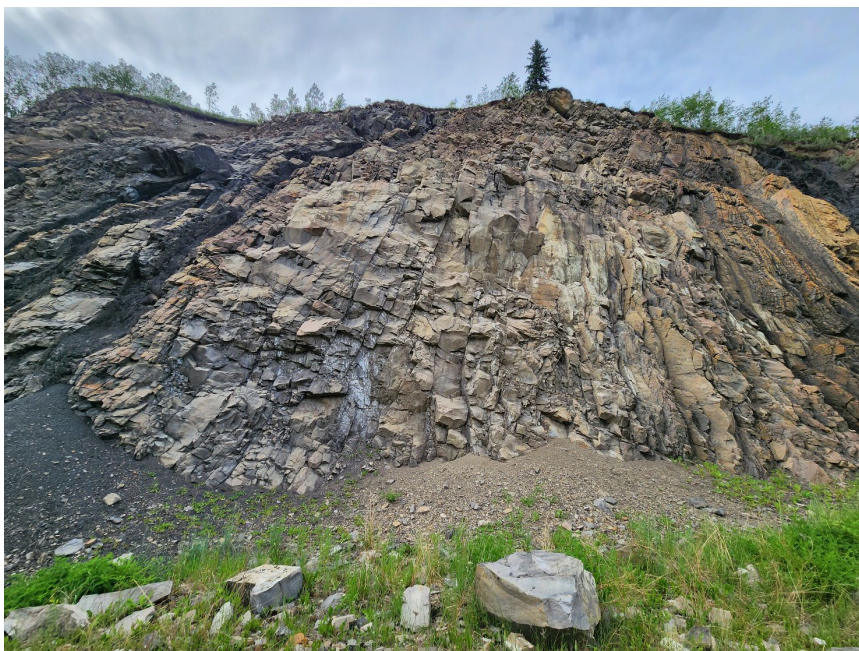
Photo 6 Rock slope along west side of Hwy 40:36. Note near-vertical bedding orientation of bedrock. Photo taken June 12, 2023, facing northwest.

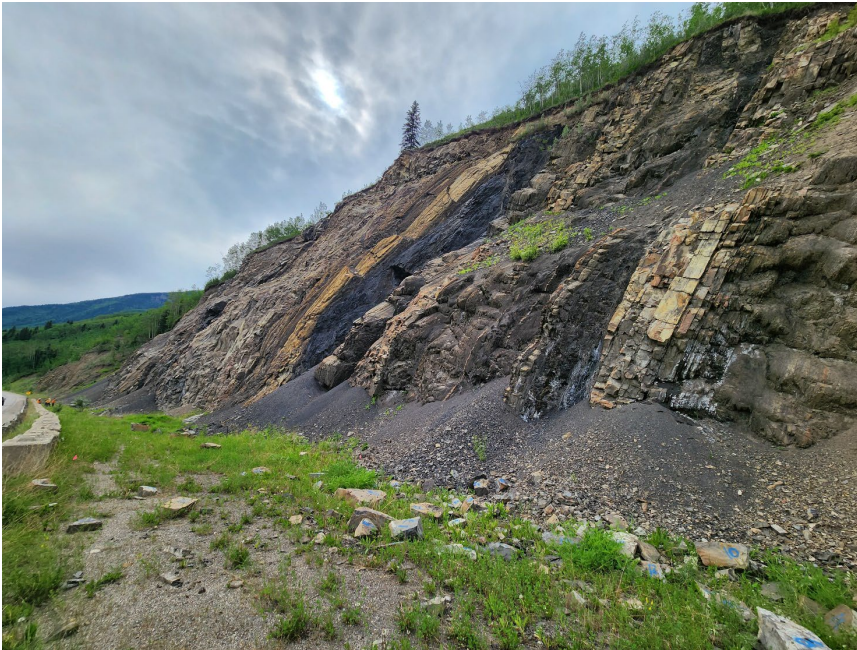
Photo 7 Rock slope along west side of Hwy 40:36. Note talus material mainly from coal seams and rockfall particles in highway ditch. Photo taken June 12, 2023, facing southwest.

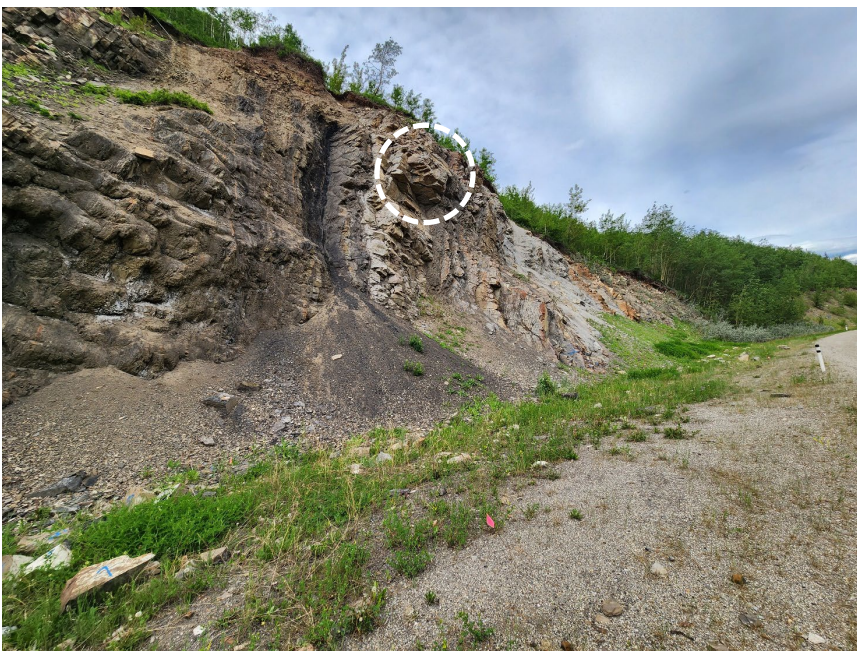
Photo 8 Rock slope along west side of Hwy 40:36 near northern site limit. Note hanging rock block (circled in white). Photo taken June 12, 2023, facing northwest.

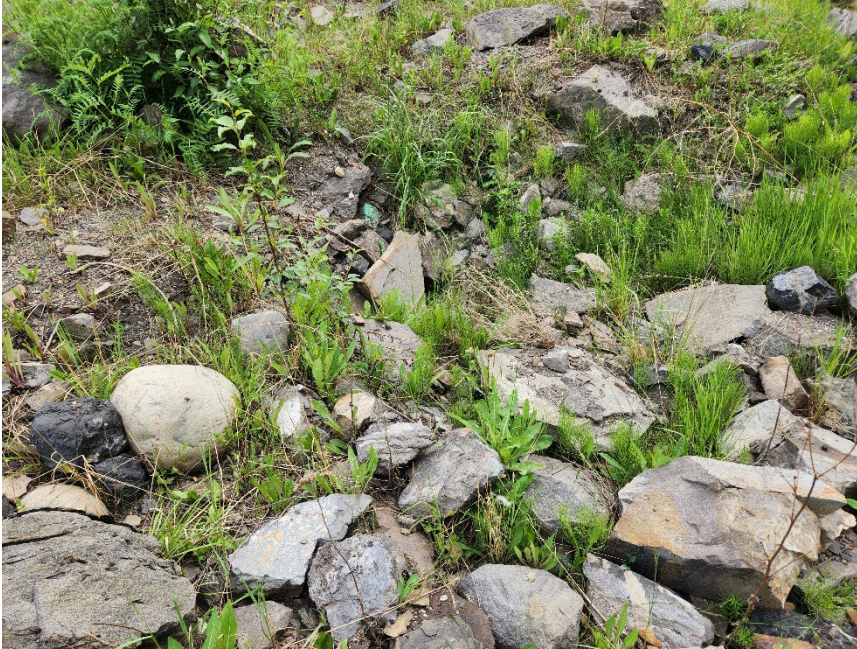
Photo 9 Culvert inlet in west ditch of Hwy 40:36 partially blocked with rockfall particles. Some rockfall particles removed from culvert inlet by KCB by hand during 2023 inspection. Photo taken June 12, 2023, facing southeast.

- Some of the concrete lock blocks are deteriorating and have been damaged by rock strikes. They will eventually need to be replaced.
 - Inlet of culvert which is blocked with rockfall particles should also be cleaned to maintain ditch flow.

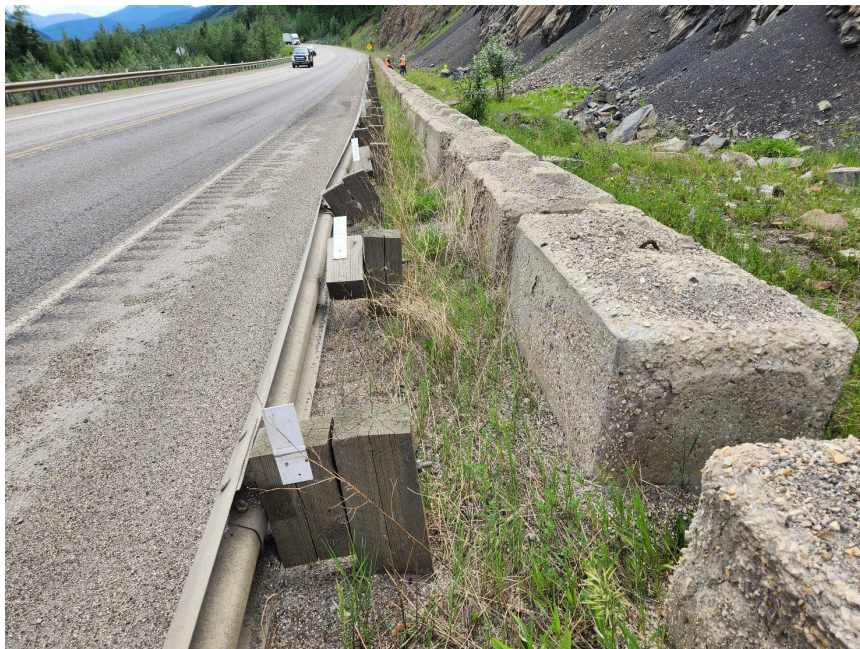
Photo 10 Segment of guardrail deflected and pushed towards southbound traffic from rockfall strike. Note lock blocks are deteriorating. Photo taken June 12, 2023, facing southwest.
