**PEACE REGION  
(GRANDE PRAIRIE DISTRICT – SOUTH) GRMP**

**SITE INSPECTION FORM**

| <b>SITE NUMBER AND NAME:</b><br>GP036 Rockfall 2.0 km South of McIntyre Mine | | <b>HIGHWAY &amp; KM:</b><br>40:36, 12.061 | <b>PREVIOUS INSPECTION DATE:</b><br>June 12, 2023 | <b>INSPECTION DATE:</b><br><b>June 10, 2024</b> |

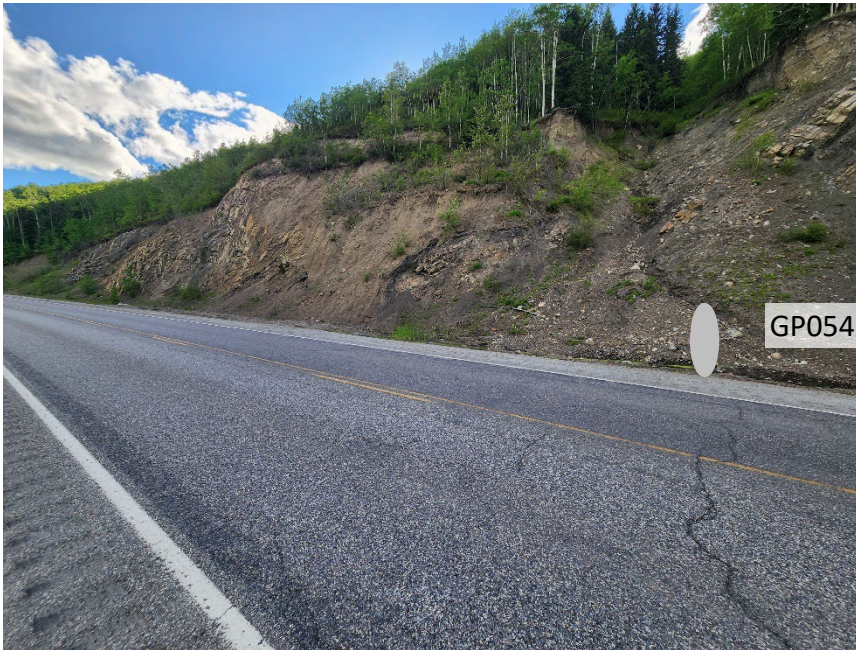
| <b>COMMENTS</b> |
|--|
| Possible fault structure located between rock slopes that is infilled with soil (Photo 1). |

**Photo 1** Rock slope along west side of Hwy 40:36. Note soil infilling of possible fault feature and GP054 km 12.1 debris flow site on right. Photo taken June 10, 2024, facing southwest

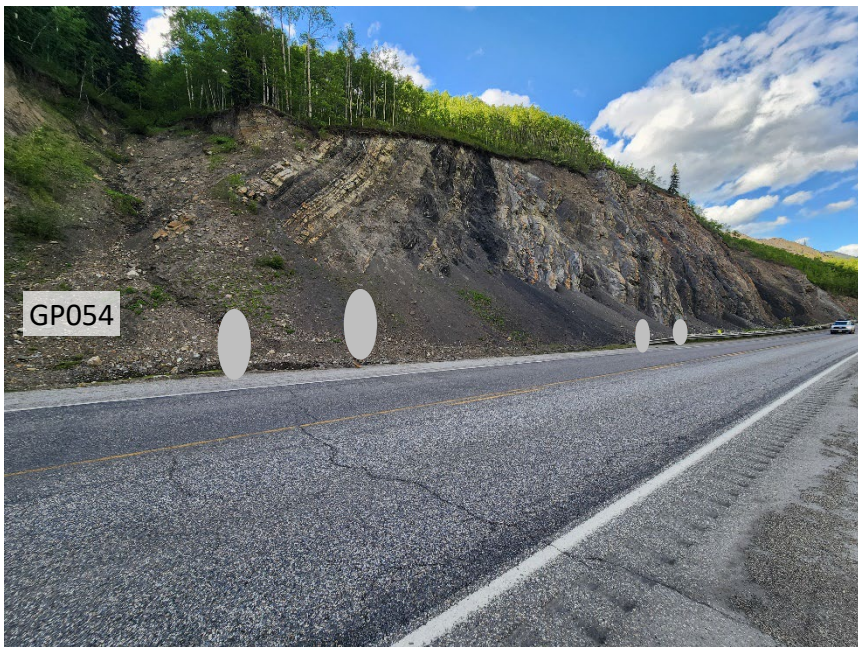
**Photo 2** Rock slope along west side of Hwy 40:36. Note GP054 km 12.1 debris flow site on left and talus material mainly from coal seams in ditch. Photo taken June 10, 2024, facing northeast.

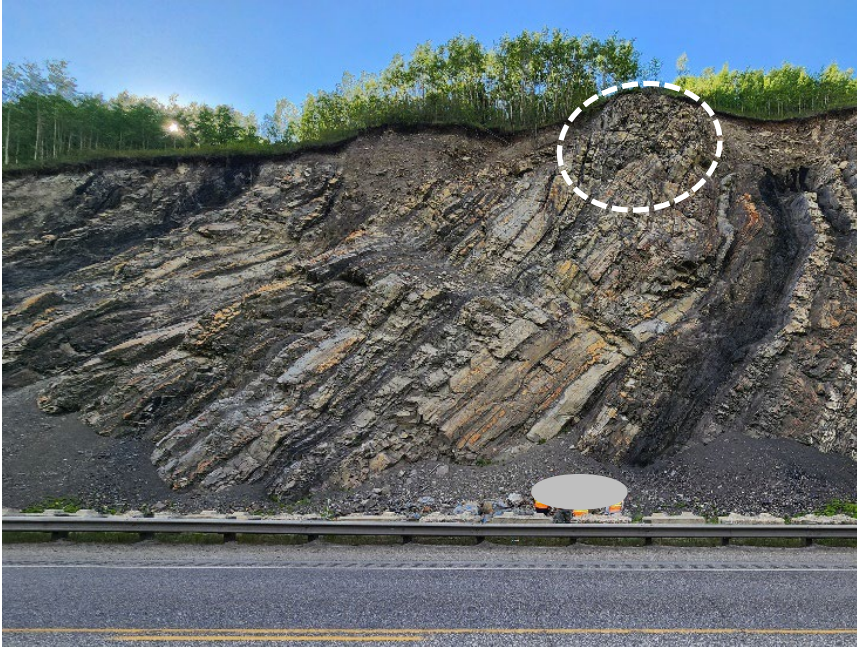
| <b>COMMENTS</b> |
|--|
| Brow of rock slope is treed with a relatively thin layer of soil (Photo 3). |
| Several hanging rock blocks with some close to falling, including one potentially large rock block (Photos 3, 4, and 8). A bedrock discontinuity “plane” (distorted and non-planar) appears to underlie the large rock block (Photo 4). Along the north side of the large rock block is a layer of fractured rock and a coal seam which is weathering faster than the rest of the slope. The discontinuity between the undulating discontinuity and the large rock block appears to be dilated. Continued weathering of the coal seam could result in loss of confinement, resulting in overstressing the remainder of the attachments for the large rock block to the slope, causing a large rockfall event that would likely cover the section of highway below. |

**Photo 3** Rock slope along west side of Hwy 40:36. Note potential rock block on upper slope (circled in white, see photo below) and thin layer of soil at crest of slope. Photo taken June 10, 2024, facing northwest.

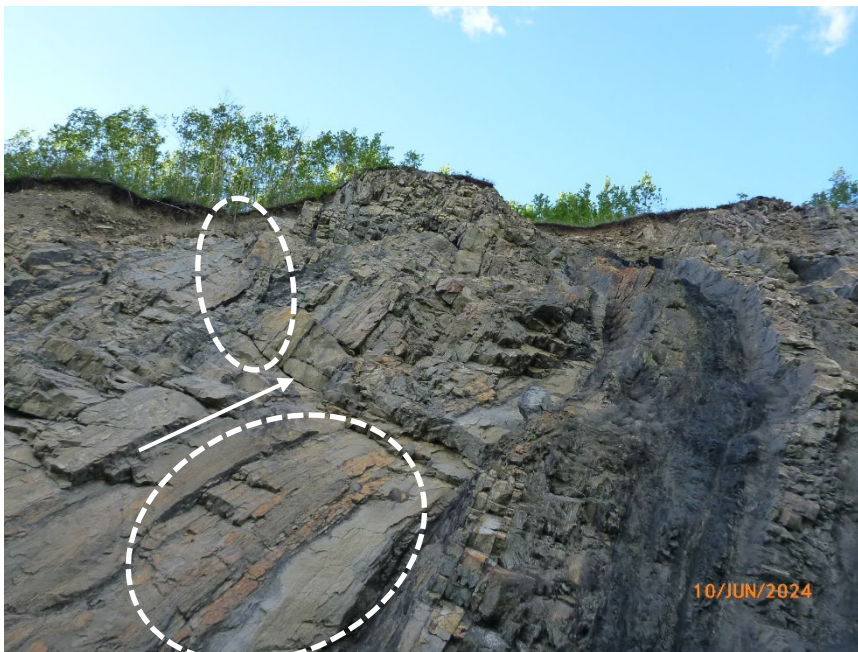
**Photo 4** Potential rock block on upper slope shown in previous photo. Note dilated or open joints below rock block (indicated with white arrow), joints or shear planes to left and below rock block (circled in white), and rock and coal to right of rock block which is eroding. Photo taken June 10, 2024, facing northwest.

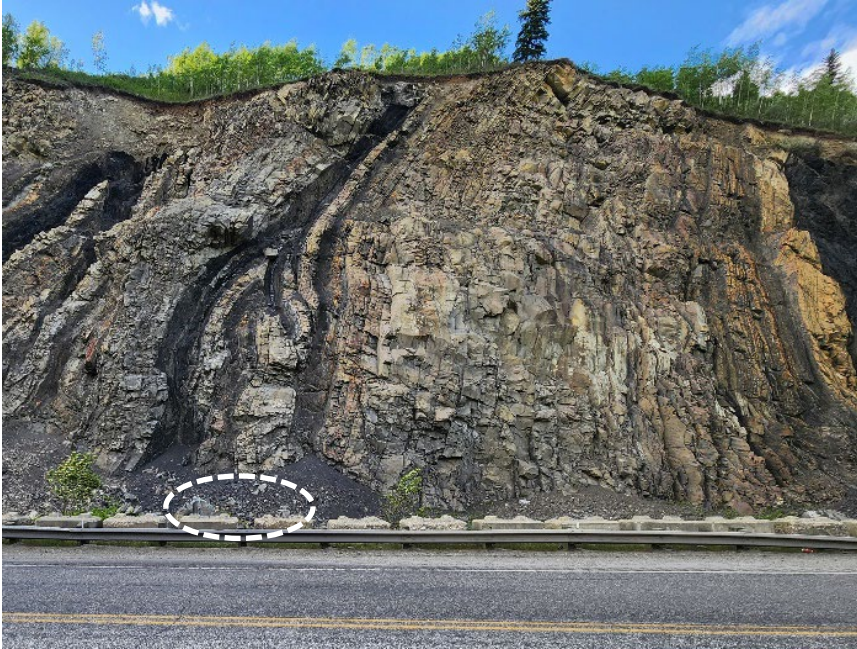
| ITEM | CONDITION EXISTS | | DESCRIPTION AND LOCATION | NOTICABLE CHANGE FROM LAST INSPECTION | |
|---|---|---|--|---|---|
| Slope Movement | X | | Previously fallen rockfall particles and talus materials between toe of slope and lock blocks on west side of highway (Photo 5). Some rockfall particles on east side of highway, but they may have been cleaned off highway (Photo 12). Since previous inspection, two large rockfall particles near middle of site (up to 1.5 m x 1.0 m x 0.8 m) (Photos 4 and 5) and one rockfall event near north end of site (Photos 8 and 9) which likely occurred in June 2023 after a heavy rainfall event. Relaxations of joints on rock slope appeared to be increasing. | X | |

**Photo 5** Rock slope along west side of Hwy 40:36. Note two large particles circled in white (see next photo) which fell between 2023 and 2024 inspections, and near-vertical bedding orientation of bedrock. Photo taken June 10, 2024, facing northwest.

- Short-term:
  - Clean highway ditch regularly to maintain rockfall storage volume (i.e., keep ditch as wide and deep as possible to retain material within the ditch) and reduce the potential for material reaching the highway. A buried gas line and fiber optics cable along the ditch limits the depth the ditch can be excavated or cleaned out. Estimated cost: approximately \$25,000 to \$40,000.

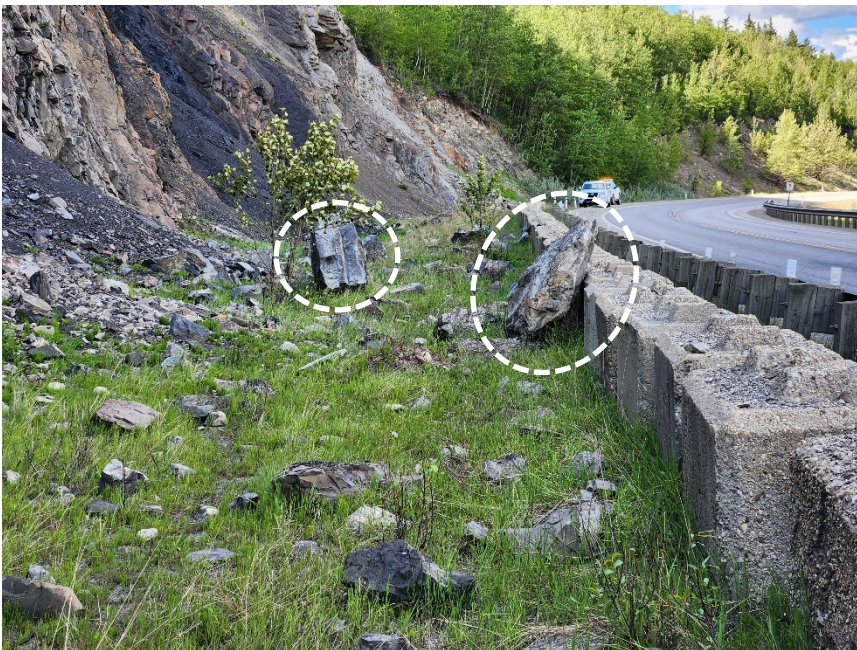
**Photo 6** Rockfall particles in ditch on west side of Hwy 40:36. Note two larger particles circled in white fell between 2023 and 2024 inspections. Photo taken June 10, 2024, facing northeast.

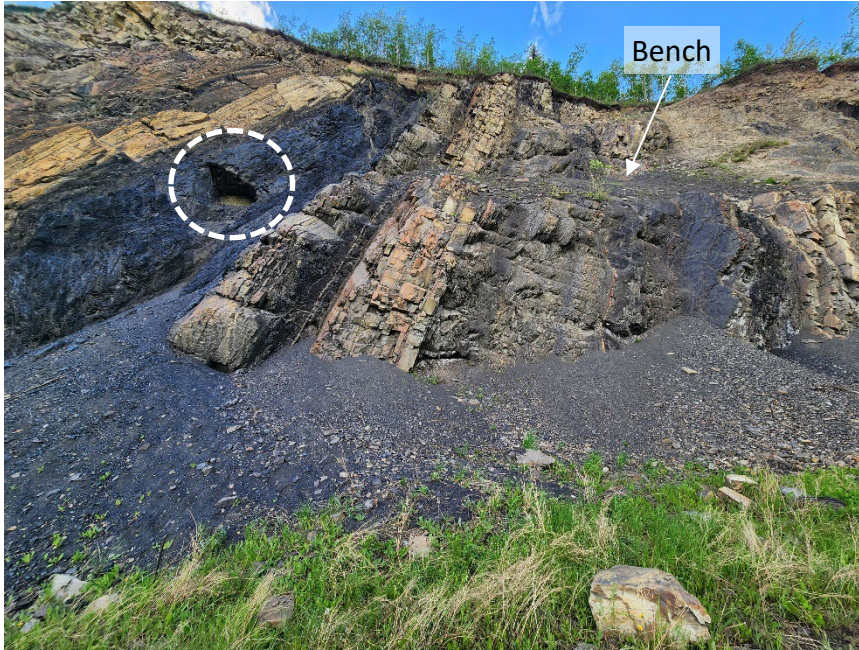
| <b>COMMENTS</b> |
|--|
| Mid-slope ledges and talus cones/slope could potentially bounce/launch/roll rockfall particles out onto highway (Photo 7). |
| Decommissioned coal mine shaft entrance approximately midway up rock slope (Photo 7). |

**Photo 7** Rock slope along west side of Hwy 40:36. Note talus material mainly from coal seams in ditch, bench which could launch rockfall particles from mid slope, and decommissioned coal mine shaft entrance (circled in white). Photo taken June 10, 2024, facing north.

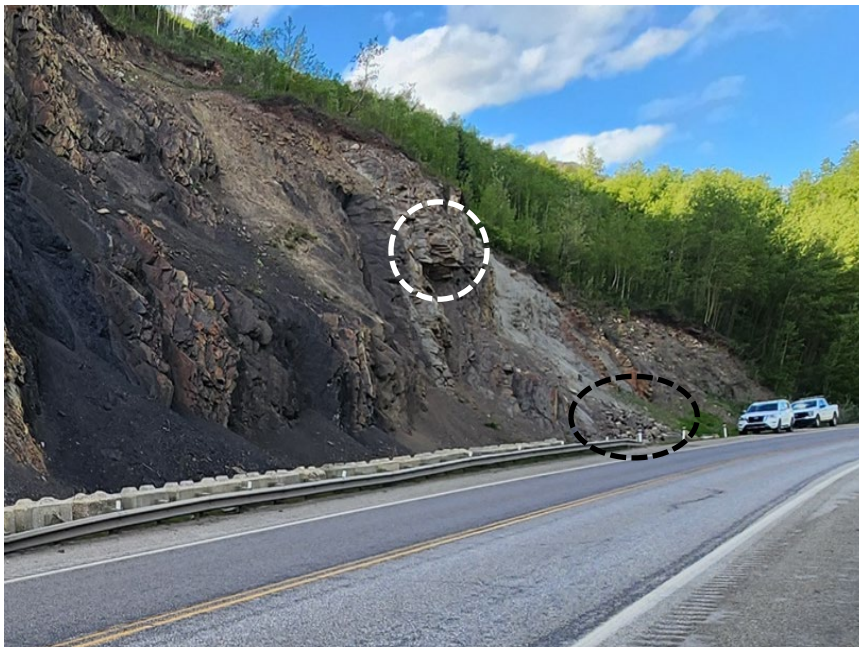
**Photo 8** Rock slope along west side of Hwy 40:36 near north end of site. Note hanging rock block (circled in white) and rockfall that occurred between 2023 and 2024 inspections (circled in black, see next photo). Photo taken June 10, 2024, facing north.

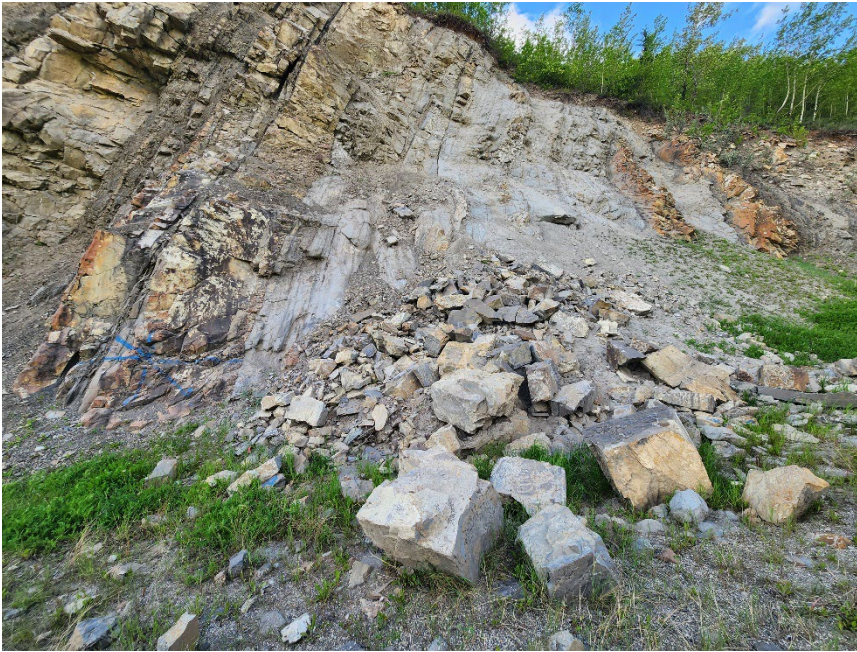
**Photo 9**      **Rockfall at north end of site that occurred between 2023 and 2024 inspections near north end of site. Photo taken June 10, 2024, facing northwest.**

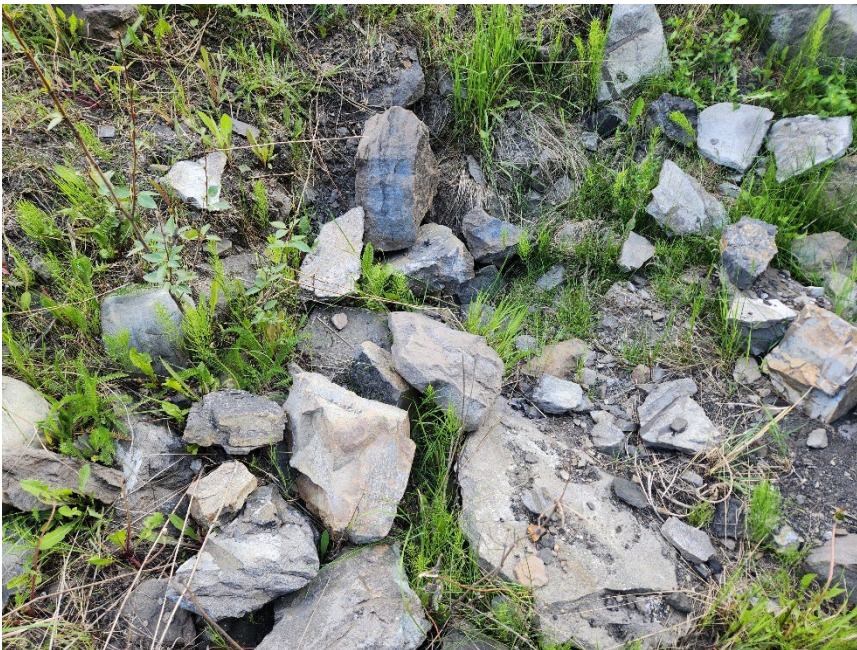
| ITEM | CONDITION EXISTS | | DESCRIPTION AND LOCATION | NOTICABLE CHANGE FROM LAST INSPECTION | |
|---|---|---|--|---|---|
| Culvert Distress | X | | Culvert inlet on west side of highway partially blocked with rock fall particles (Photo 10). Some rockfall particles removed by KCB during 2024 inspection by hand. | X | |

**Photo 10**      **Culvert inlet in ditch on west side of Hwy 40:36 partially blocked with rockfall particles. Some rockfall particles removed from culvert inlet by KCB by hand during 2024 inspection. Photo taken June 10, 2024, facing southeast.**

- Some of the concrete lock blocks are deteriorating and have been damaged by rock strikes. They will eventually need to be replaced.
  - Inlet of culvert which is blocked with rockfall particles should also be cleaned to maintain ditch flow.

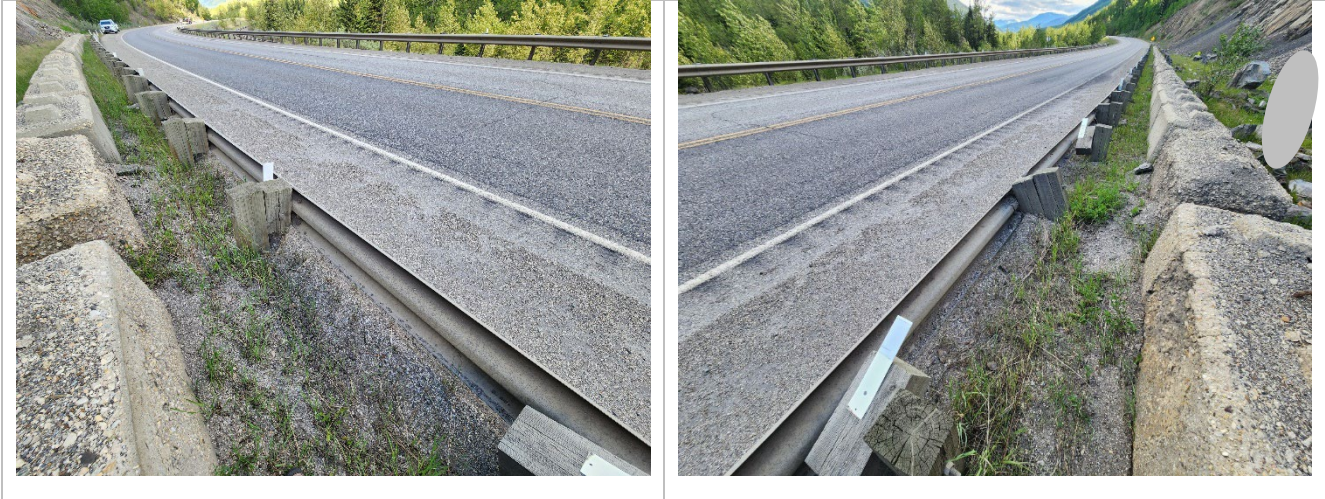
| ITEM | CONDITION EXISTS | | DESCRIPTION AND LOCATION | NOTICABLE CHANGE FROM LAST INSPECTION | |
|---|---|---|--|---|---|
| Pavement Distress | | X | None observed at time of 2024 inspection (Photo 11). | | X |

| <b>COMMENTS</b> |
|--|
| Segment of guardrail deflected and pushed towards south/westbound traffic from rockfall strike (Photo 11). |

**Photo 11** Pavement surface of Hwy 40:36. Note segment of guardrail deflected and pushed towards southbound lane from rockfall strike and lock blocks are deteriorating. Photos taken June 10, 2024, facing northeast and northwest, respectively.

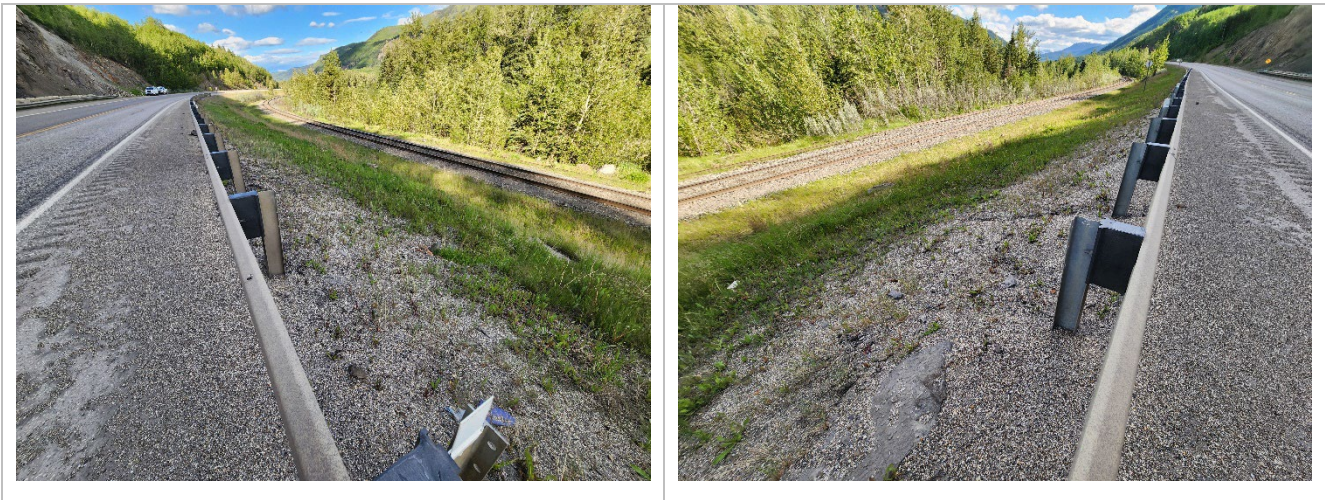
**Photo 12** East side of Hwy 40:36. Some rockfall particles on east side of highway but they may have been cleaned off highway. Photos taken June 10, 2024, facing northeast and northwest, respectively.
