**ALBERTA TRANSPORTATION AND  
ECONOMIC CORRIDORS GRMP  
GRANDE PRAIRIE REGION –  
(GRANDE PRAIRIE SOUTH)  
INSTRUMENTATION MONITORING - SPRING 2024**

Site Number	Location	Name	Hwy	km
GP042	HWY 40:36	GP042 Landslide Repairs	40:36	Km 37.4 to 38.2
<b>Legal Description:</b> 15-16-59-6 W6		<b>UTM Co-ordinates</b>		
		11U E 379994	N	5997080

<b>Current Monitoring:</b>	30-May-2024	<b>Previous Monitoring</b>	27-Jun-2023
<b>Instruments Read By:</b>	Mr. Niraj Regmi, G.I.T and Mr. Nixson Mationg, of Thurber		
<b>Instruments Read During This Site Visit</b>			
<b>Slope Inclinometers (SIs):</b> SI22-W2, SI22-W3, SI22-W4, SI22-W5, SI22-W6, SI22-W7	<b>Pneumatic Piezometers (PN):</b> N/A	<b>Vibrating Wire Piezometers (VW):</b> VW20-S1, VW20-S3, VW20-DS1A, VW20-DS1B, VW20-DS2A, VW20-DS2B, VW20-DS3, VW20-DS6A, VW20-D3, VW20-D4	<b>Standpipe Piezometers (SP):</b> N/A
<b>Load Cell (LC):</b> N/A	<b>Strain Gauges:</b> N/A	<b>SAA:</b> SAA22-P15	<b>Others:</b>

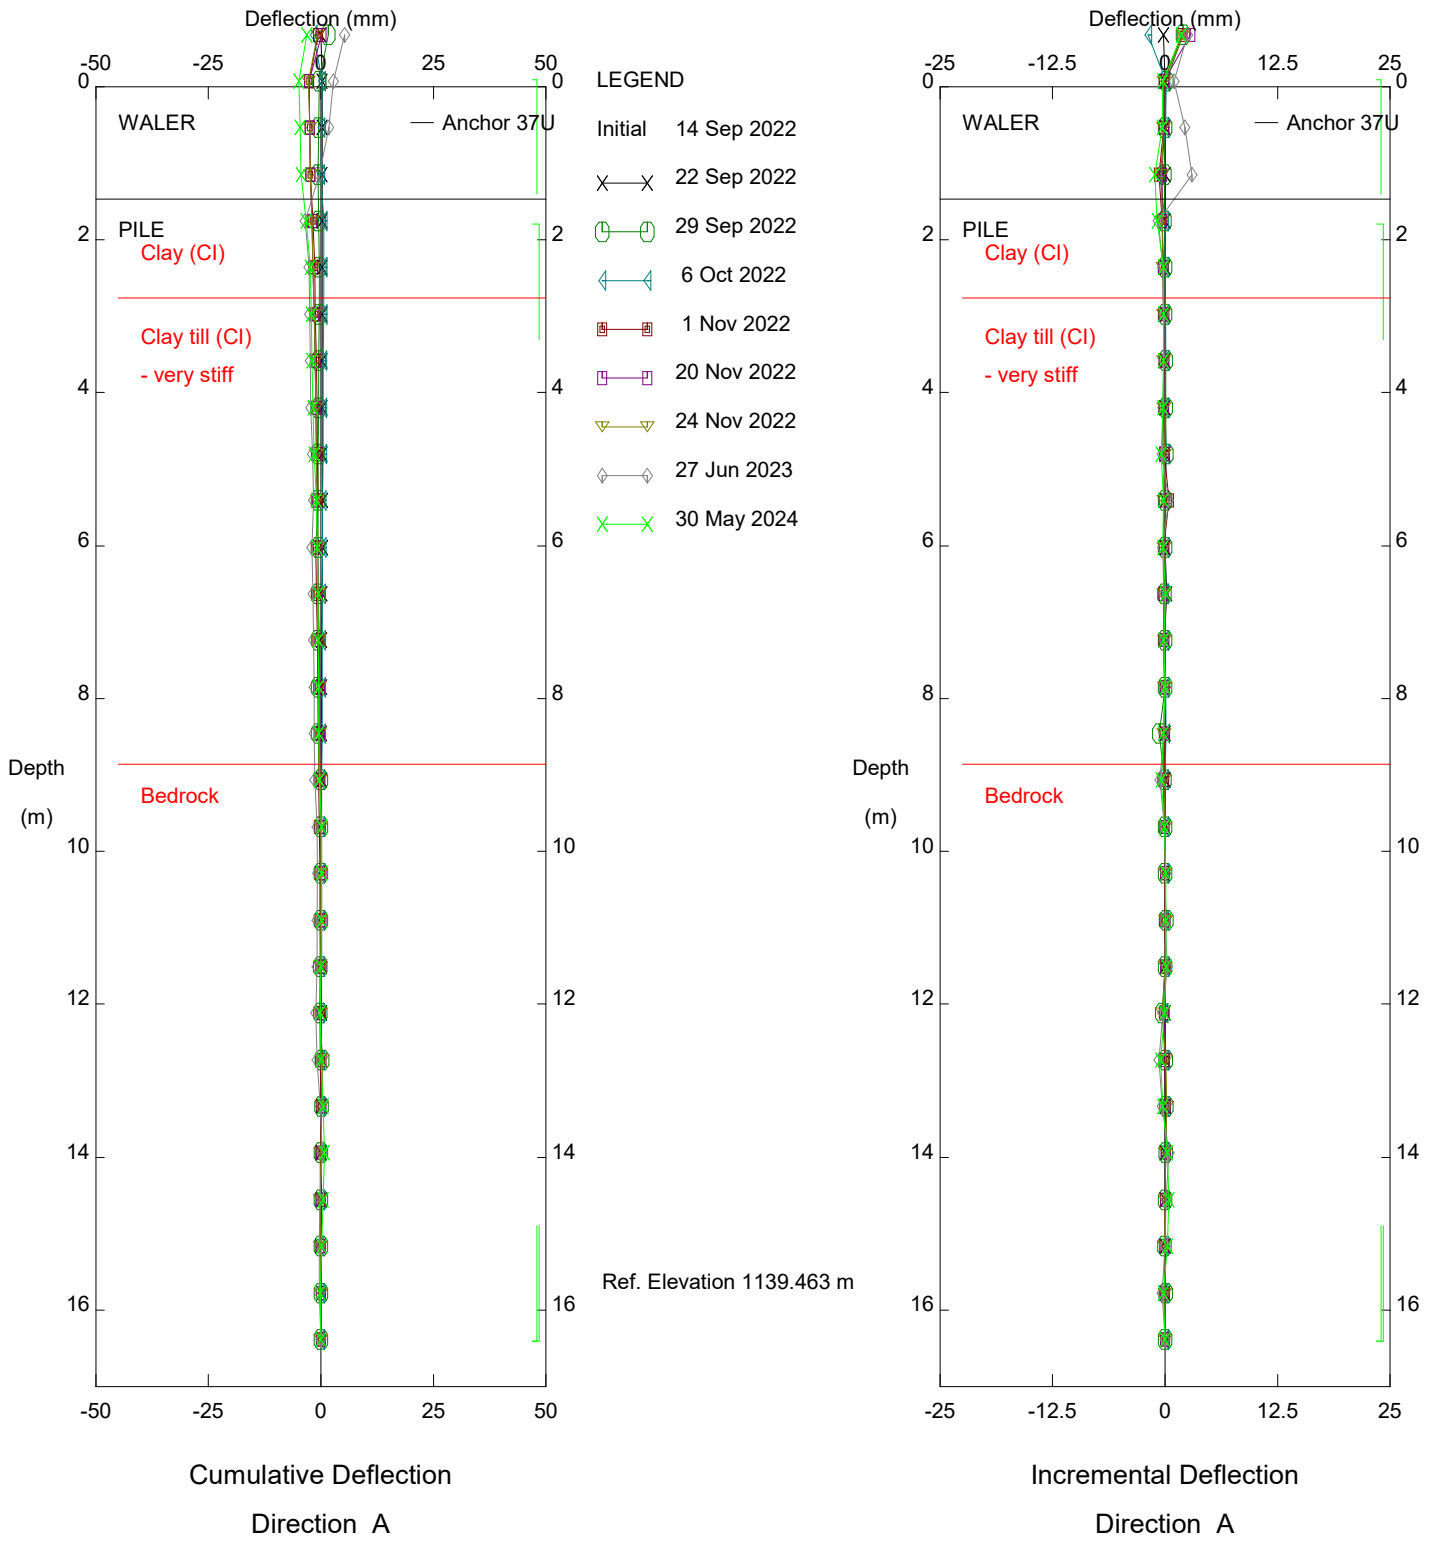
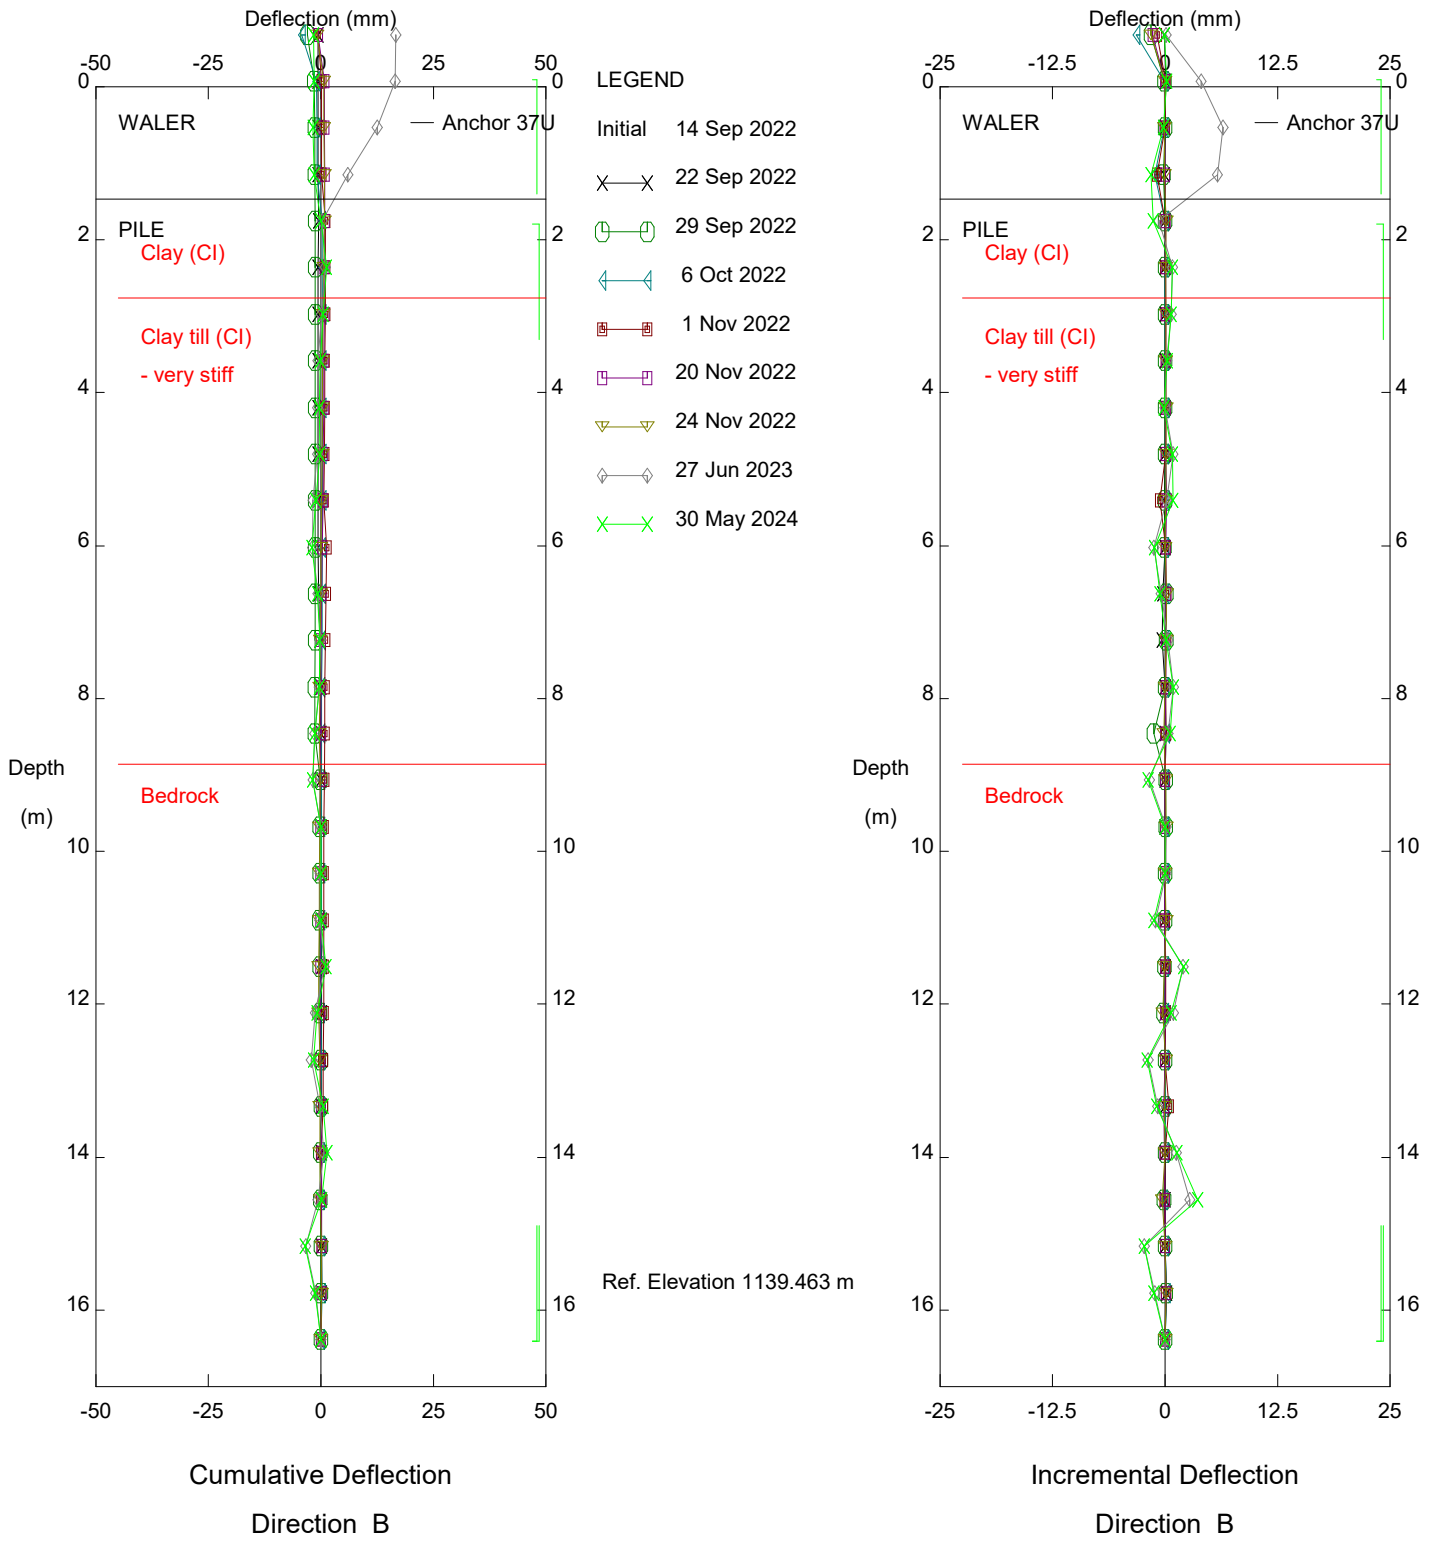
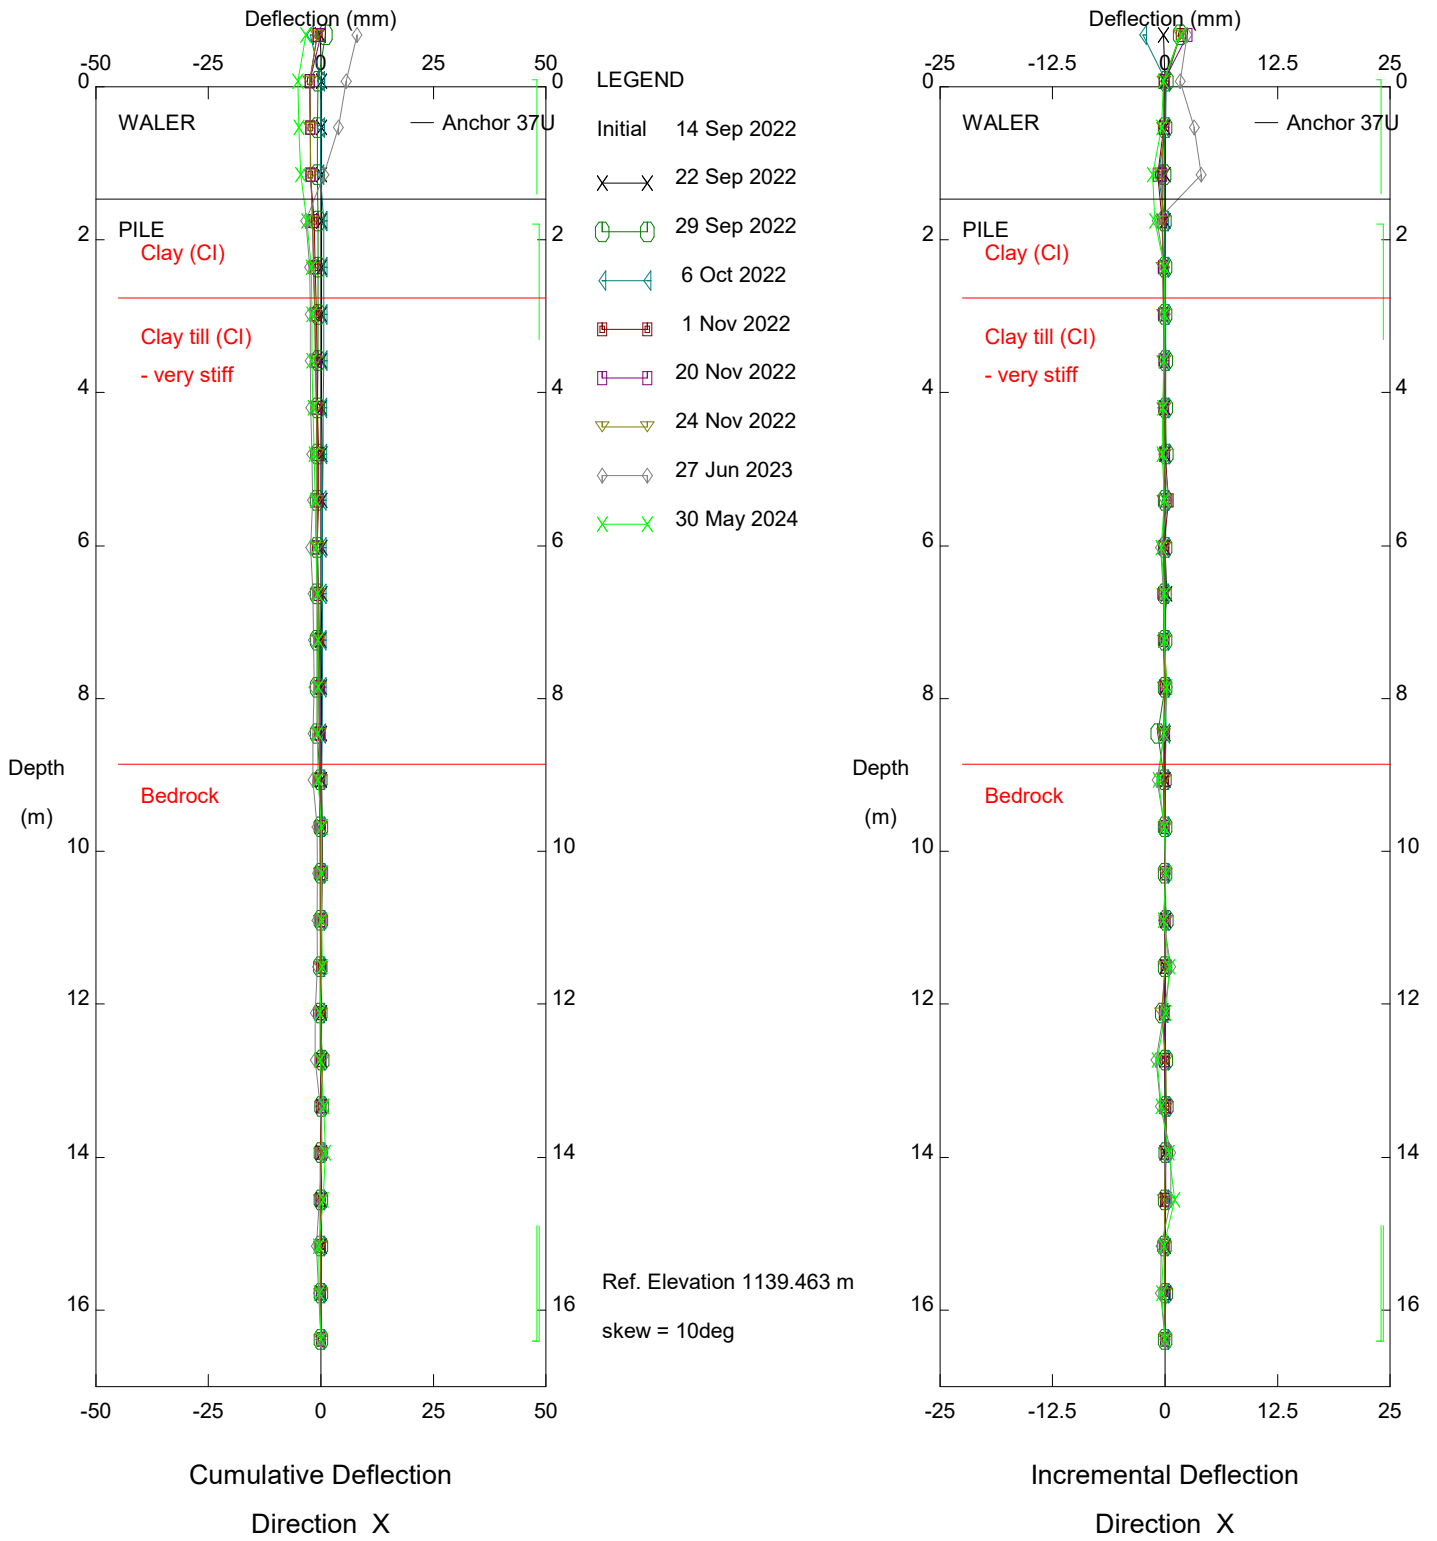
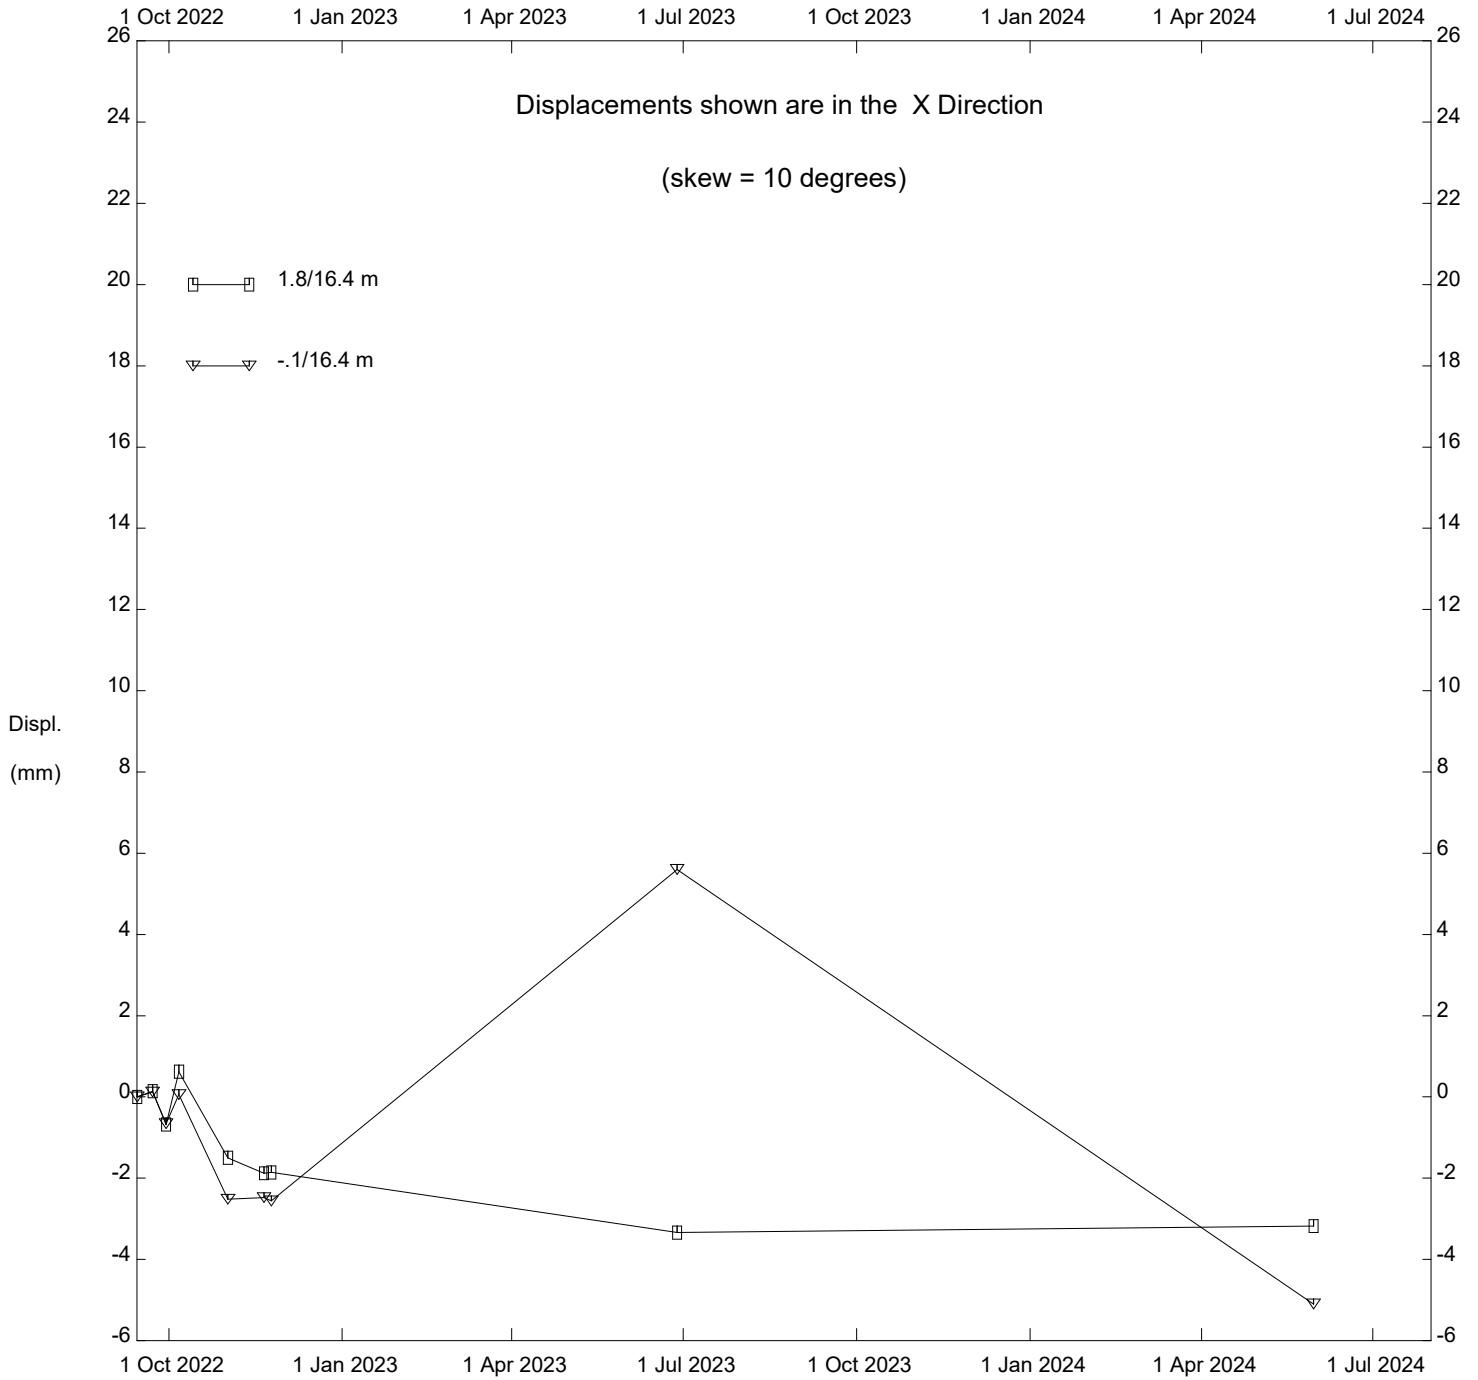
GP042 Slope Stabilization, Inclinometer SI22-W2

<b>Discussion</b>	
<b>Zones of New Movement:</b>	None
<b>Interpretation of Monitoring Results:</b>	<p>SI22-W2 and SI22-W3, installed in Pile Wall 1, show total cumulative pile head movements of 3.2 mm and 1.6 mm, respectively, in the upslope direction. The upslope movements measured in these instruments likely reflects the effect of locking off the anchors.</p> <p>SI22-W4, SI22-W5 and SI22-W6, installed in Pile Wall 2, show total cumulative pile head movements of 0.2 mm, 4.3 mm and 7.0 mm, respectively, in the downslope direction. These instruments show current movement rates over the piles ranging between no discernible movement in SI22-W4 to 3.5 mm/yr in SI22-W6.</p> <p>SI22-W7 in Pile Wall 3 shows a total cumulative pile head movement of 1.9 mm in the downslope direction. The current rate of movement in SI22-W7 is 1.5 mm/yr, corresponding to an increase in rate of movement of 3.4 mm/yr since the previous readings on June 27, 2023.</p> <p>SAA22-P15 has shown a cumulative movement of 0.4 mm in the upslope direction over the length of the pile since it was initialized. SAA22-P15 showed no discernible movement since the previous readings on June 27, 2023. SAA22-P15 showed a trend of higher cumulative movement during the 2023 to 2024 winter months, before returning to a similar cumulative movement as spring 2023.</p>

<p>The pile head movements are all currently well within the design deflection limits for the wall.</p> <p>The downloaded data from the datalogger was missing readings between June 27 to October 18, 2023.</p> <p>The load cells showed decreases in measured load of between 2.19 kN in VC2419 (anchor 15U) to 5.40 kN in VC2420 (anchor 15L) since the previous readings on June 27, 2023. The load cells showed a trend of slowly decreasing, before reaching minimums in January 2024, and slowly increasing until May 2024. All of the anchor loads are still well below their SLS design loads.</p> <p>The active piezometers were last read on June 27, 2023. The piezometers showed changes in groundwater level ranging from a decrease of 0.52 m at VW20-DS2B to an increase of 0.22 m at VW20-DS1B. The current reading at VW20-DS1B, located downslope of the highway and south of the pile walls, is currently showing the highest groundwater level measured in the instrument since it was initialized.</p>
