Alberta Transportation
Main Floor, Provincial Building
9621 96 Avenue
Peace River, Alberta
T8S 1T4

CON0022166 Peace Region (Grande Prairie South) GRMP
Hwy 40:36 rockfall, km 8.395 to 17.161
Call-Out Report

This call-out report was prepared for AT under Contract No. CON0022166. KCB's site observations, assessments, and recommendations for short-term and long-term remedial actions are presented in this report.

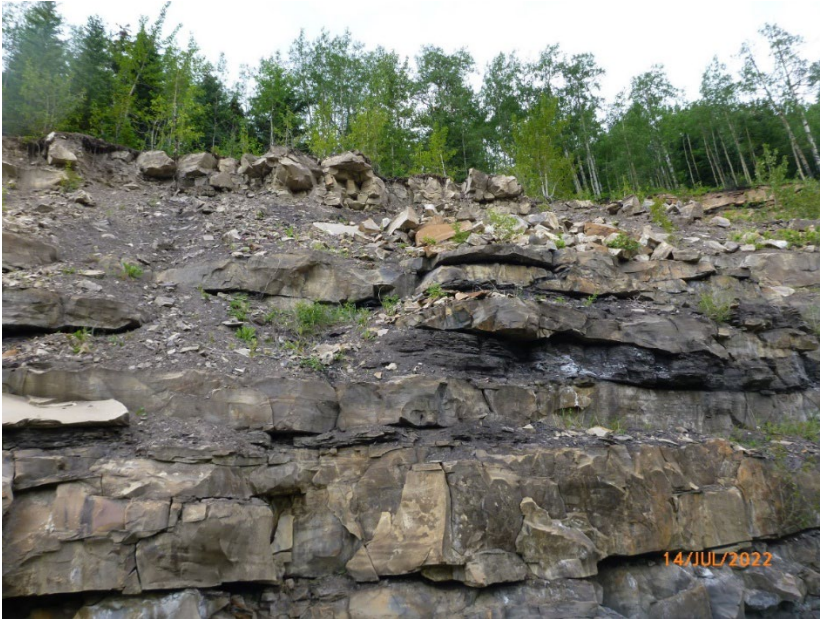
- At the south end of the slope (Photo GP049-I-1) the rock slope below the bench (4 to 8 m above the highway is deteriorating to an approximate 45°-degree slope with several pieces overhanging. The formation of a scree (sand and gravel surfacing on the rock slope has obscured the type of bedrock that is weathering) might be allowing energy dissipation for some rockfall blocks to be attenuated, but some particles (non-“platy” particles) are rolling off the slope and down into the ditch.

Photo GP049-I – 1 Rock mass at GP049-I site is has near horizontal bedding planes. Brow of rock slope has overhanging blocks that should be scaled. Photo taken July 14, 2022, facing west.

- ◆ *The slope should be scaled to remove loose particles.*
- Rockfall particles were observed within 1 m of the edge of pavement (Photo GP049-I-2). There are some rockfall particles in the ditch but the ditch bottom is not blocked yet.

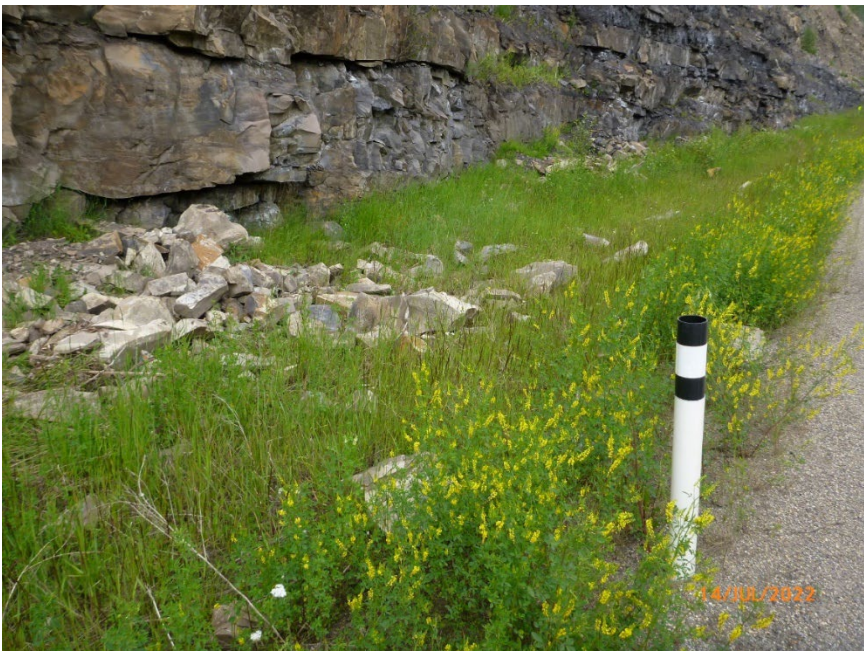
Photo GP049-I – 2 Rockfall in ditch has reached the edge of the highway. Photo taken July 14, 2022, facing northwest.

- ◆ *The ditch should be cleaned of rockfall particles, scree, and talus.*
- Not all of the upper slope above the mid-slope bench could be viewed from the highway, but it appears in the drone videos taken in spring 2022 to be of similar quality to the rest of the upper slope. Overhanging blocks of bedrock and loose particles were visible in the upper slope (Photo GP049-I-3). The upper slope appeared to be a dilated, weak rock mass.

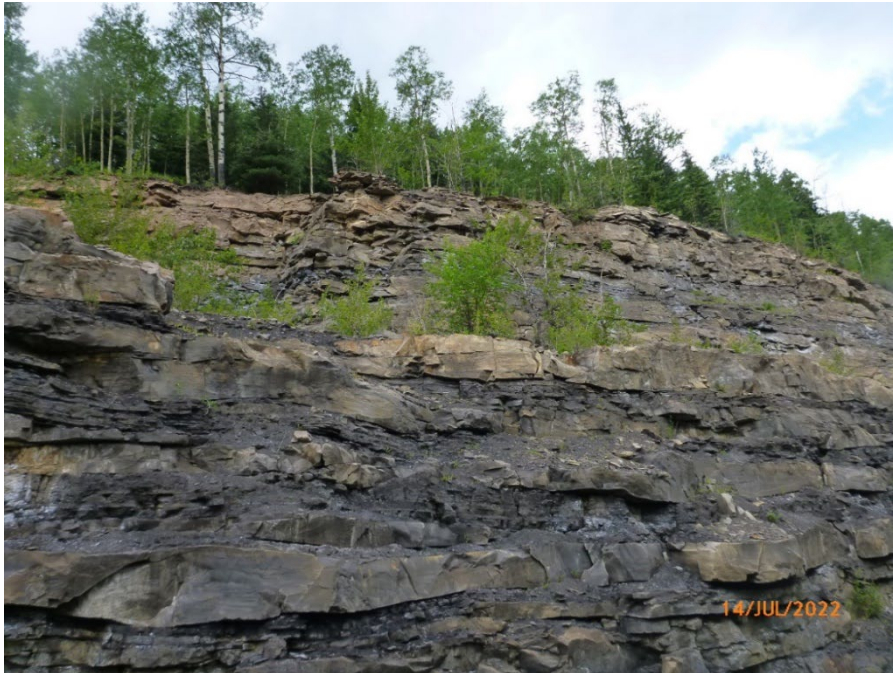
Photo GP049-I – 3 Higher portion of rock slope above mid-slope bench sparsely vegetated with small trees. Note overhanging blocks on upper slope above bench that should be scaled. Photo taken July 14, 2022, facing west.

- ◆ *The upper rock slope should be scaled to remove loose particles. However, we believe the entire rock slope will continue to deteriorate so regular scaling will be required in the future. An attenuation drape (i.e., fine mesh covering of the slope) would confine the path of rockfall and dissipate energy through drape friction and promoting contact with the rock slope.*

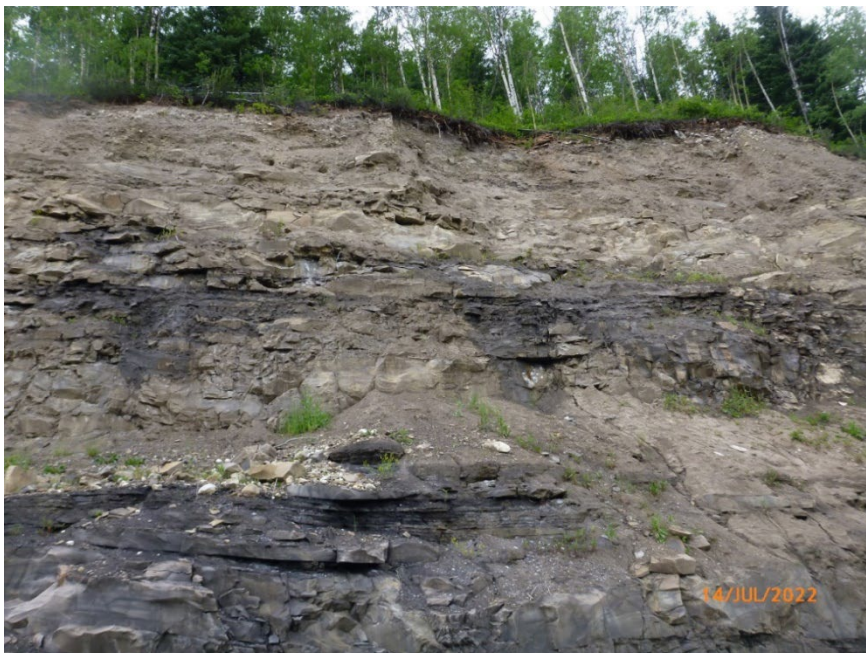
- Soil is exposed at the brow of the slope (Photo GP049-I-4) and appears to be a till material that contains cobbles and boulders which presents additional rockfall hazards.

Photo GP049-I – 4 Soil at brow of slope at north end of -I site contains cobbles and rock mass looks reasonably competent. This location could be addressed with an attenuating drape. Photo taken July 14, 2022, facing west.

- ◆ *An attenuation drape could mitigate the rockfall hazard from the soil at the brow of the slope.*

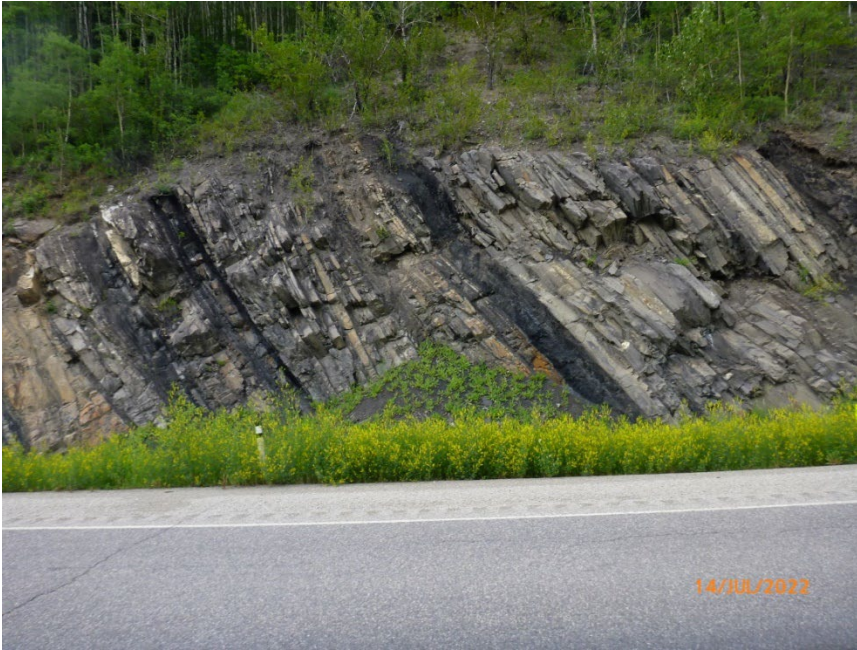
- The rock slope is approximately 250 m long and approximately 10 m high.
- The bedrock structure is different than the -I site in that the bedrock planes are inclined 45° to 60°, dipping generally to the north or northeast (Photo GP049-II-1 and -2). The bedding layers in the bedrock appear to be thinner than at the -I site. Some of the bedding layers in the bedrock mass are coal seams. The quality of the bedrock and condition of the rock slope appears to be better at the -II site than at the -I site.

Photo GP049-II – 1 Rock mass structure is different than at GP049-I site (inclined bedding, 45° to 60°), 400 m to the north of the GP049-I site. Photo taken facing west on July 14, 2022.

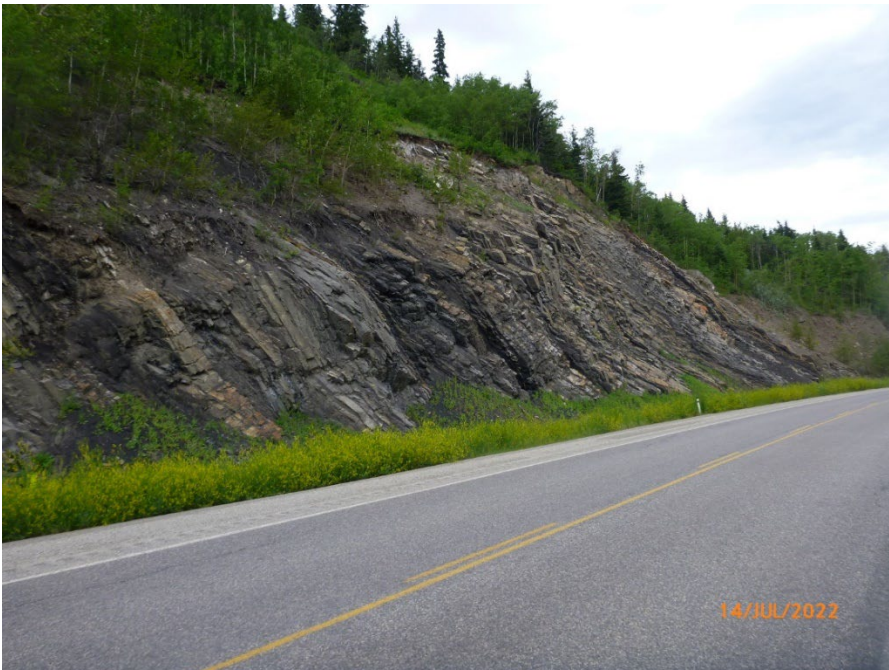
Photo GP049-II – 2 Higher rock slope at north end of GP049-II site. Some overhanging particles where inclined bedding planes have been undermined by historical rock falls or construction blasting. Photo taken facing northwest on July 14, 2022.

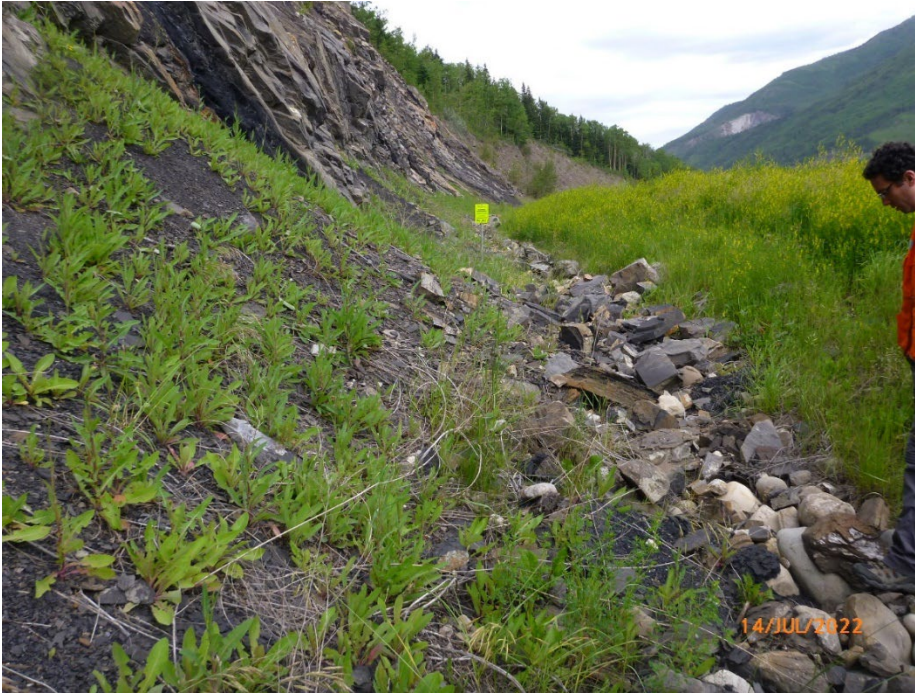
- The coal seams appear to be weathering faster than the adjacent bedrock seams which causes undermining of the overlying bedrock which then generates rockfall (Photo GP049-II-3 and -4). The talus slopes of deteriorated coal and fine-grained particles allows some rockfall particles to roll to the toe of the talus slope and up the highway slope towards the pavement.

Photo GP049-II – 3 Ditch at GP049-II is approximately 10 m wide and 1.5 m deep and appears to be containing most rock fall particles. Tall vegetation obscures seeing rockfall particles near edge of pavement. Note buried pipeline marker in ditch. Photo taken facing north on July 14, 2022.

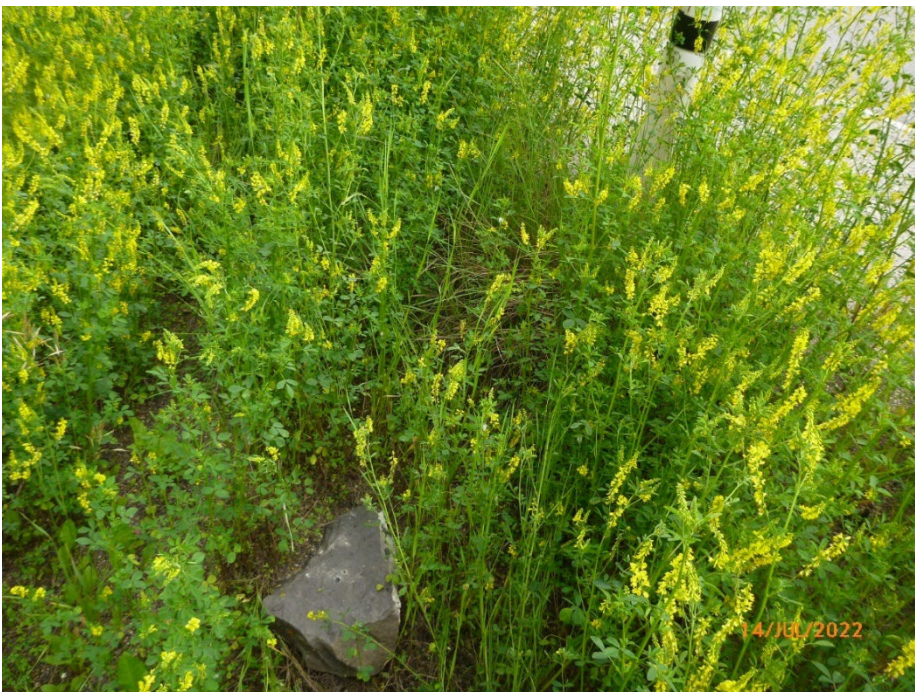
Photo GP049-II – 4 One of three observed rockfall particle 0.3 m x 0.2 m x 0.1 m located within 1.0 m from edge of pavement.

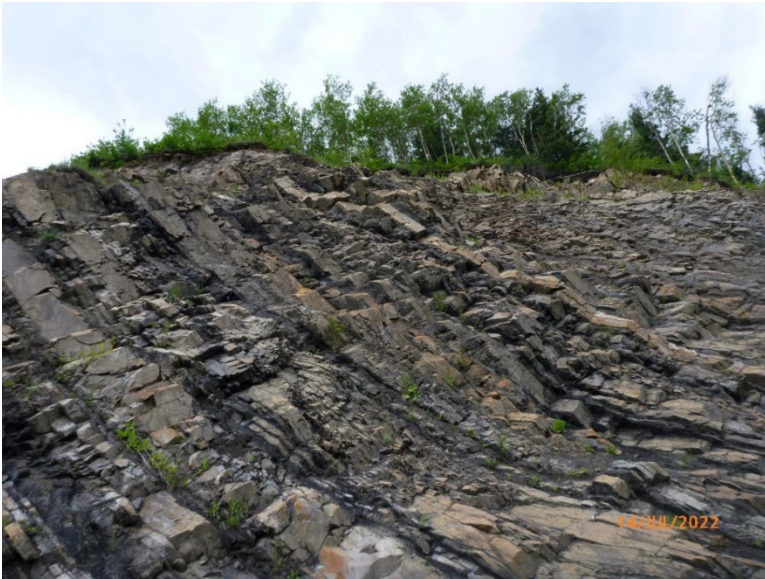
- The orientation of bedding planes and the orientation of the slope is such that weathering of more fractured and thinly bedded layers of bedrock lead to undermining of more competent, thicker layers of bedrock, creating potential for future rockfall events (GP049-II-5).

Photo GP049-II – 5 Undermining of more competent bedrock layers created by weathering and erosion of less competent bedrock layers creates rockfall hazard on the entire slope. One source of rockfall blocks is located near brow of slope, located above a large rockfall block (1.2 m x 1.2 m x 0.3 m) located 3 m from pavement edge. Brow of slope has bedrock that has dilated joints and potential for large blocks of rock to detach. Photo taken July 14, 2022, facing west.

- ♦ *The slope should be scaled to remove the hazard posed by loose particles that could become future rockfall events.*
- The brow of the slope at its highest point appears to be bedrock with more widely spaced discontinuities with dilated joints, with potential to generate rockfall events. This part of the slope is immediately above where a rockfall particle 1.2 m x 1.2 m x 0.3 m was located within 1.0 m of the edge of pavement (Photo GP049-II-5)

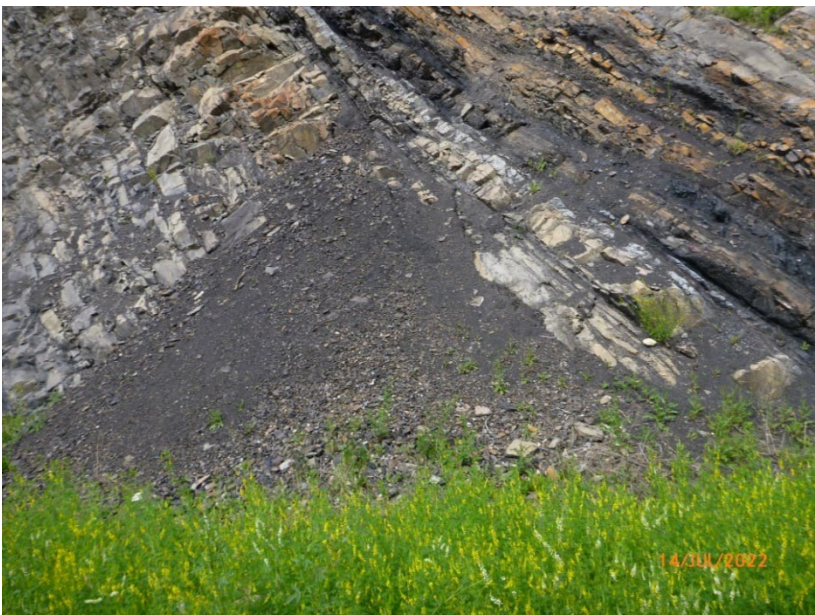
Photo GP049-II – 6 Talus cone located below zone of interbedded highly fractured rock and coal. Coal appears to weather/erode creating a talus cone, leaving overlying bedding planes of more competent rock unsupported, creating some rockfall hazard. Photo taken July 14, 2022, facing west.

- ♦ *The coal seams could be shotcreted to mitigate weathering and exacerbation of existing rockfall hazard.*

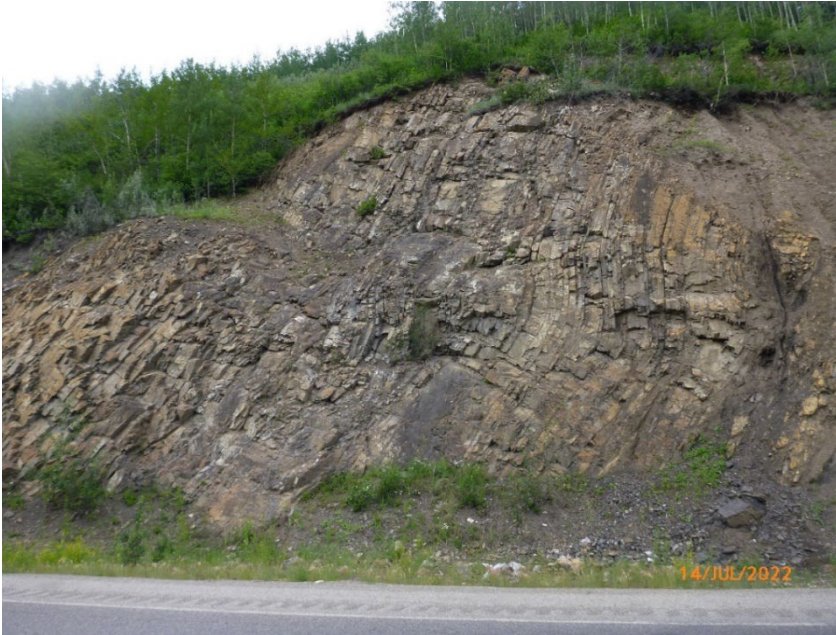
- Soil with cobbles and coarse gravels (and possibly boulders) is present at the brow of the slope in various locations (Photos GP036-1, -6, -7, -8, and -14). The larger particles in the soil mass are a hazard that could generate future rockfall events from the crest of the slope.

Photo GP036 – 1 Rock slope at south end of GP036 site. Rockfall activity does not reach the road at this site. Note soil infilling of possible fault feature at right of photo. Photo taken July 14, 2022, facing northwest.

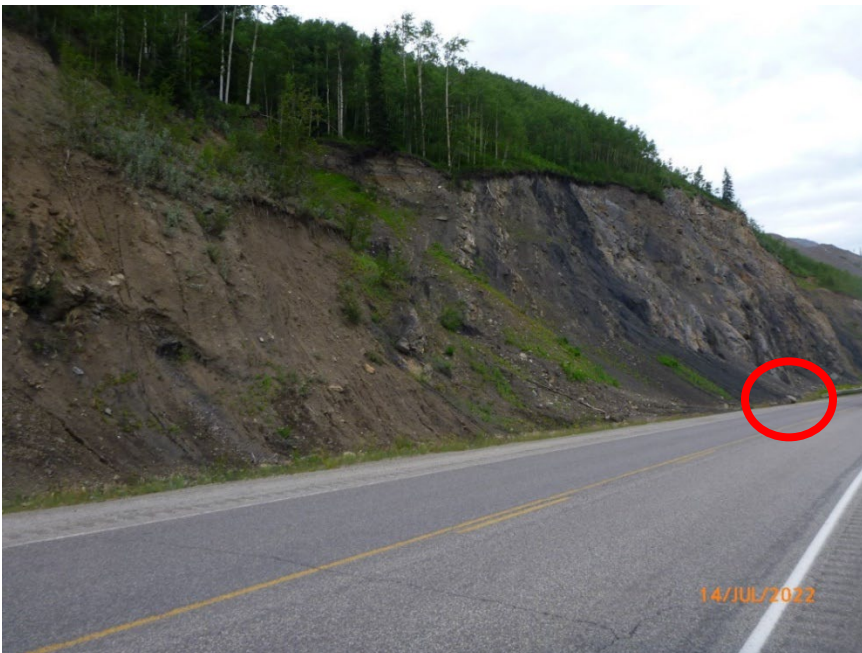
Photo GP036 – 2 Soil-infilled possible fault structure between rock slopes. South end of north part of site shown in this photo. Largest rock fall in July 2022 rainfall and rockfall event is shown by red circle. Photo taken July 14, 2022, facing northwest.

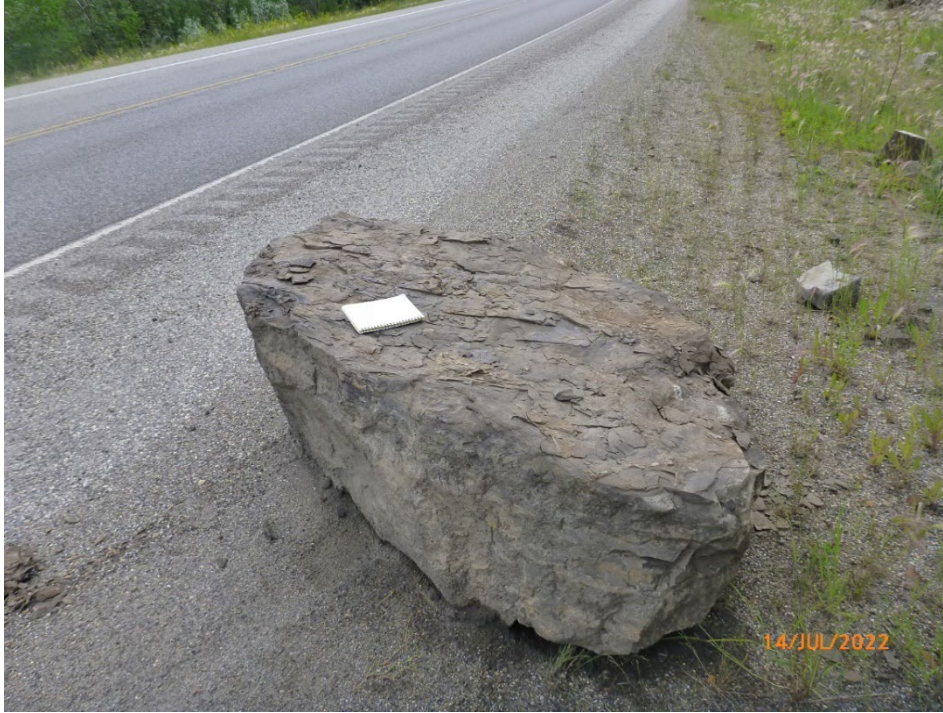
- ♦ *The ditch should be cleaned of rockfall particles and talus cones.*
- Evidence of surface water drainage over the slope face was observed. Small rills were eroded into fine-grained talus cones (Photo GP036-3).

Photo GP036 – 3 Largest rockfall particle from July 2022 rainfall event (0.6 m x 1.5 m x 1.2 m). Rockfall particle fell at southern limit of guardrail and was pushed to this location off road. Photo taken July 14, 2022, facing southwest.

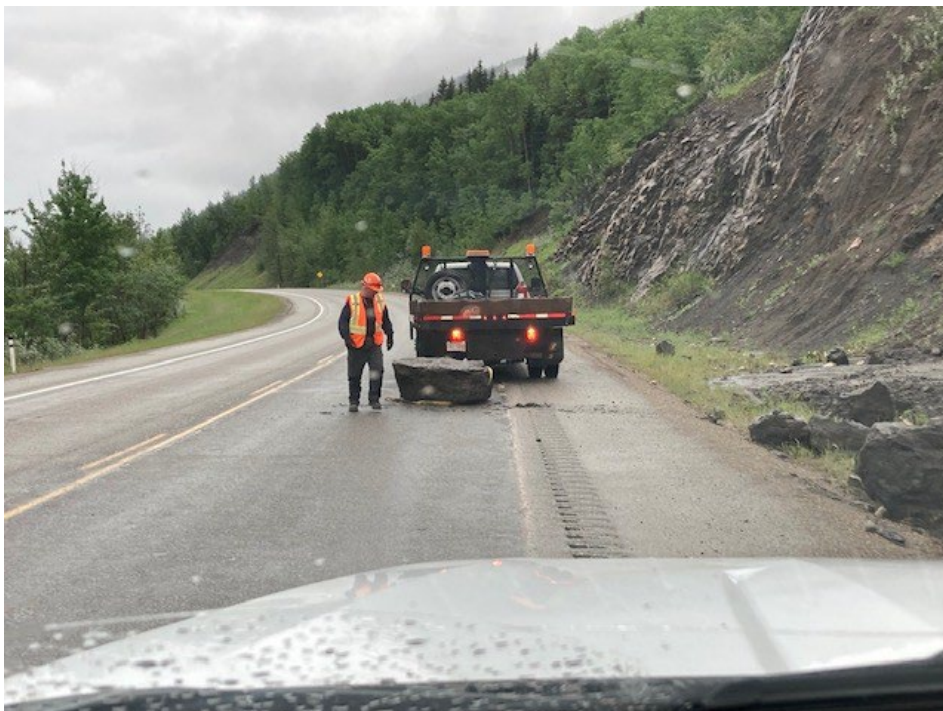
Photo GP036 – 4 June 29, 2022 rockfall on the highway. Photo taken July 29, 2022, facing southwest by AT.

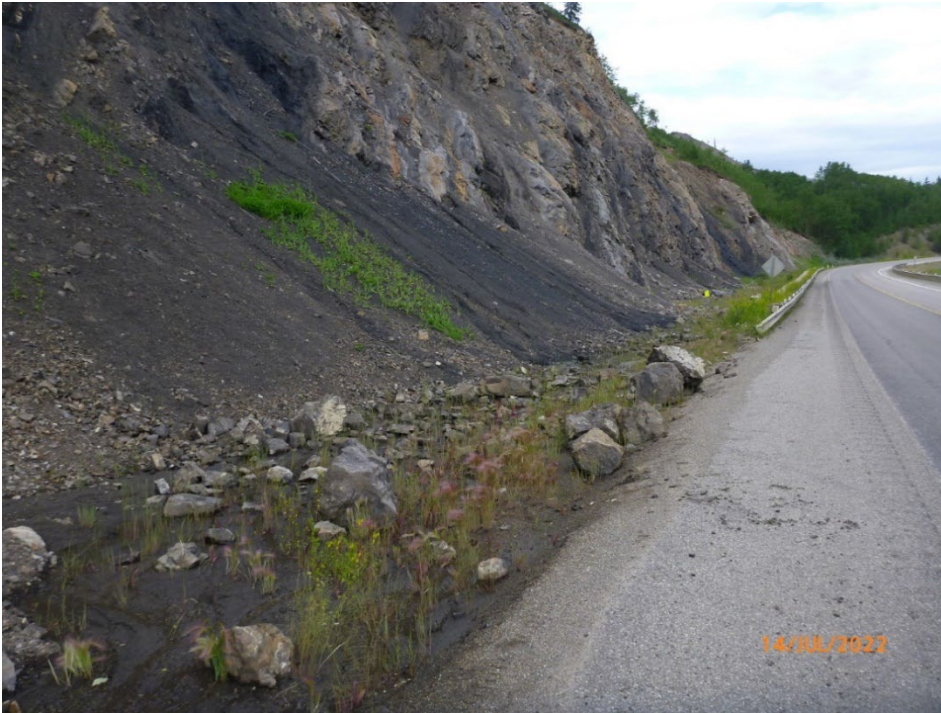
Photo GP036 – 5 **Collection of rockfall blocks at south limit of north rock slope near southern limit of guard rail. Photo taken July 14, 2022, facing northeast.**

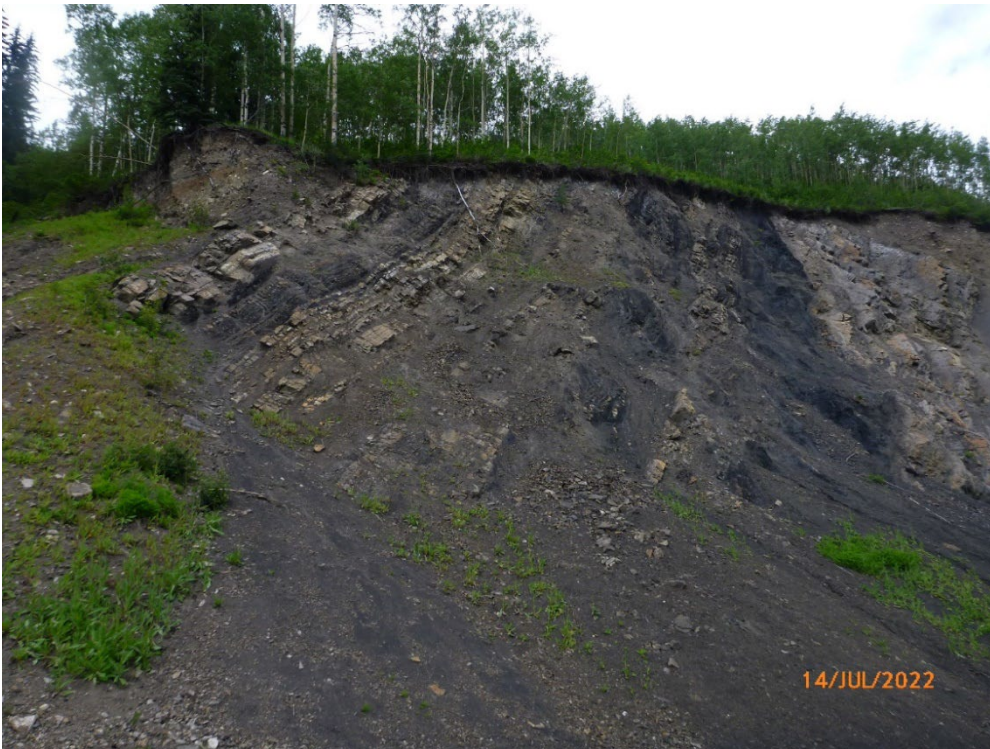
Photo GP036 – 6 **Upper part of north slope above June 29, 2022 rockfall event show in Photo GP036 – 4. Photo taken July 14, 2022, facing northwest.**

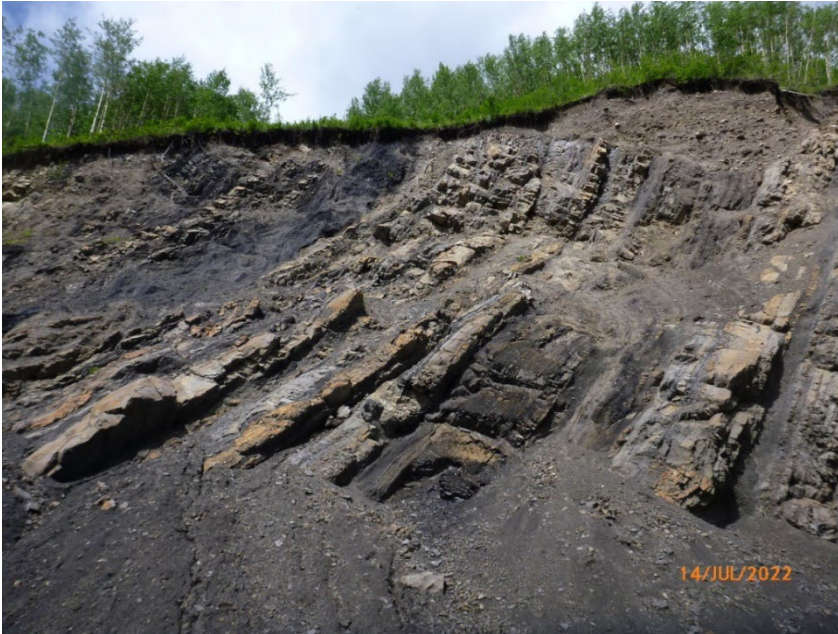
- Weaker bedrock units (such as coal, but also more closely fractured or weak bedrock) are eroding faster than the surrounding more competent bedrock. In some cases the weathering has created deep channels (0.5 m to 1.0 m deep) in the bedrock surface. These “channels” become preferential pathways for smaller particles (sand, gravel, cobbles) to be funneled down. Talus slopes are accumulating at the base of the weathered “channels” (Photos GP036-7, -8, -10, and -11).

Photo GP036 – 7 Upper slope, progressing to the north. Note gravel deposit at brow of slope. Note also weathering and removal of weaker rock units (such as coal) which is creating some overhangs and loss of confinement for the rock slope face, leading to rockfalls. Photo taken July 14, 2022, facing northwest.

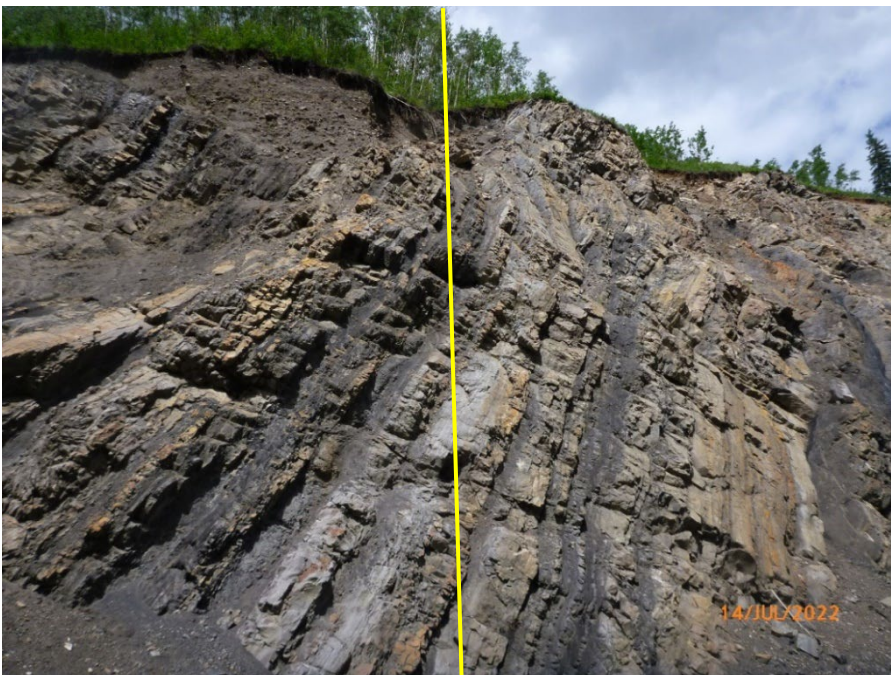
Photo GP036 – 8 Upper slope. Yellow line shows north limit of photo -6. Note uneven weathering of rock slope face which is creating overhangs and rockfall potential as well as preferential fall paths for smaller rockfall particles. Photo taken July 14, 2022, facing northwest.

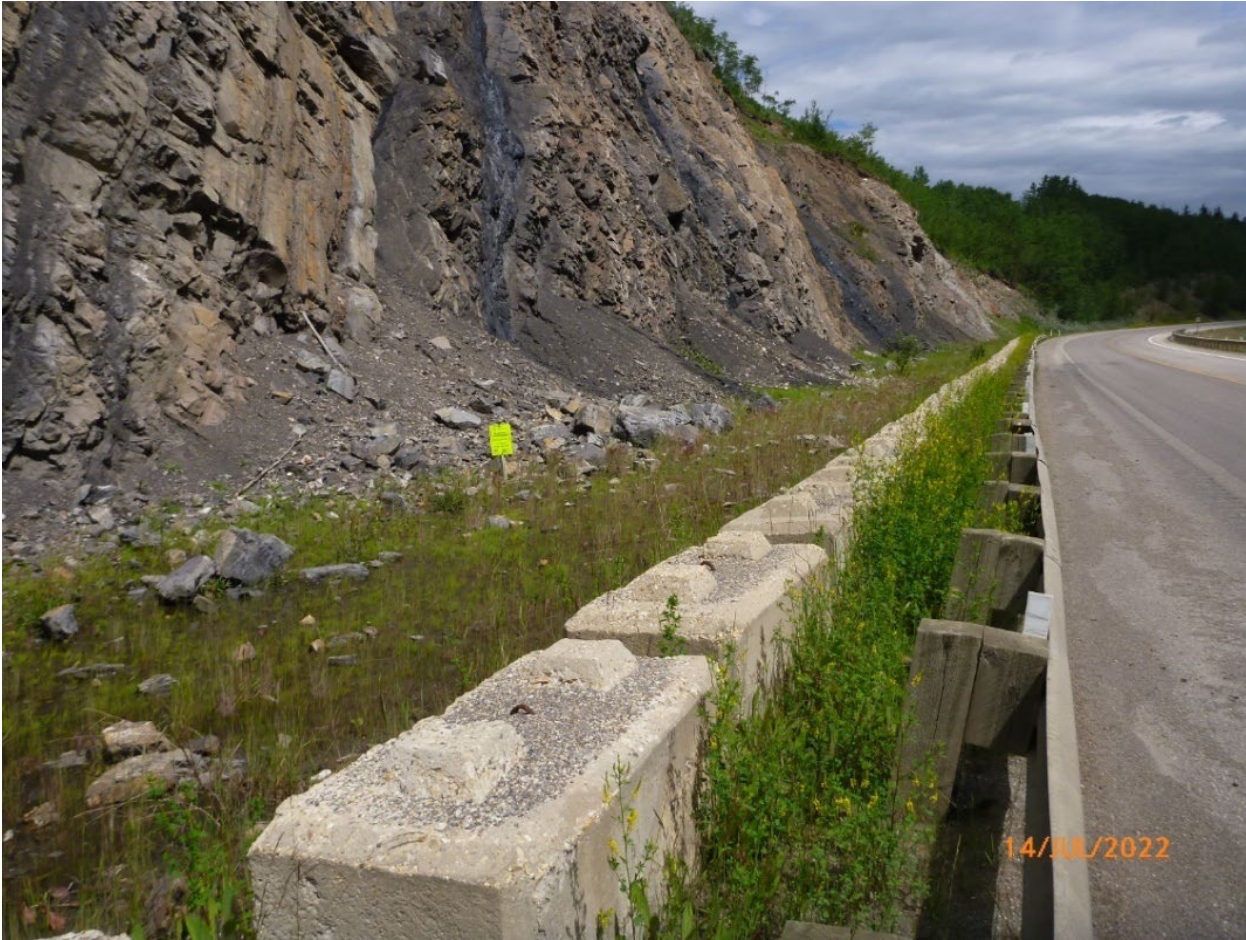
- Historic rockfall activity at the GP036 site resulted in AT installing a row of lock blocks at the edge of the highway and then installing a guardrail to address the hazard associated with the lock blocks (Photo GP036-9). The guardrail has been impacted by direct strikes of rockfall events indicating the combination of lock/block height, ditch width, and ditch depth is not adequate to contain rockfalls from hitting the highway surface.

Photo GP036 – 9 **Portion of slope with deteriorating lock blocks and guard rail at edge of pavement. Note weathering coal seams, rockfall particles in ditch, and pipeline marker at toe of slope. Photo taken July 14, 2022, facing northeast.**

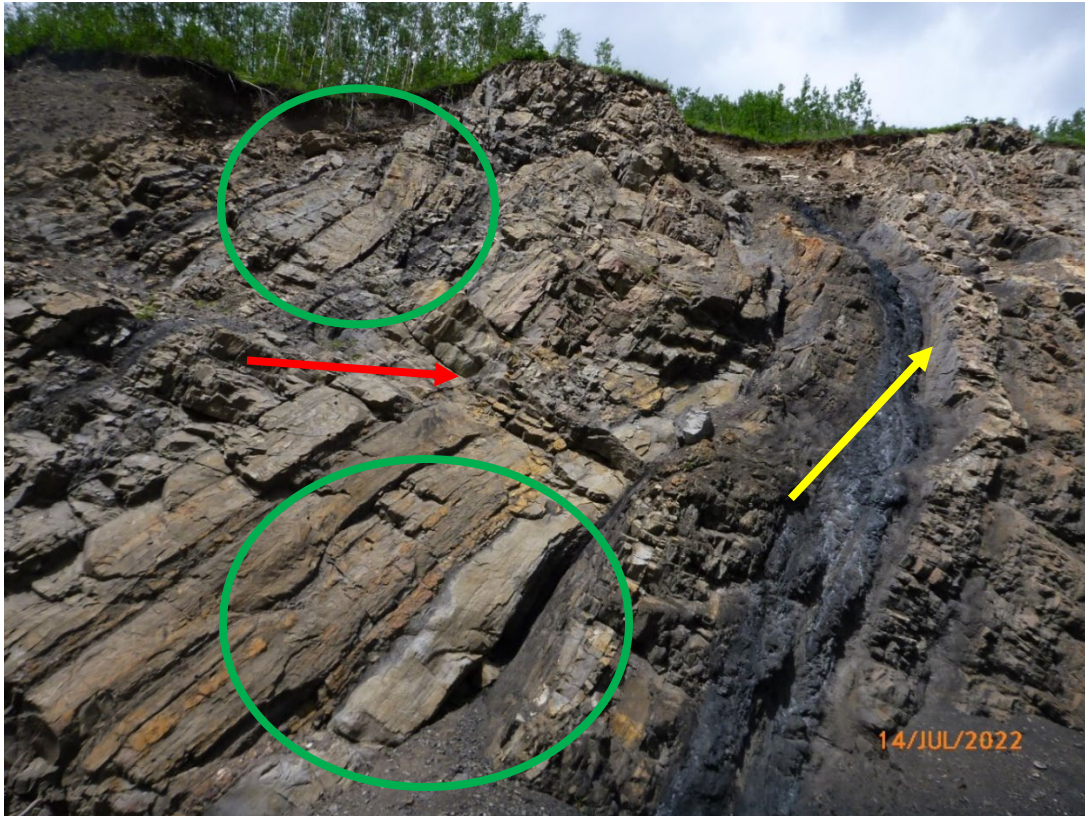
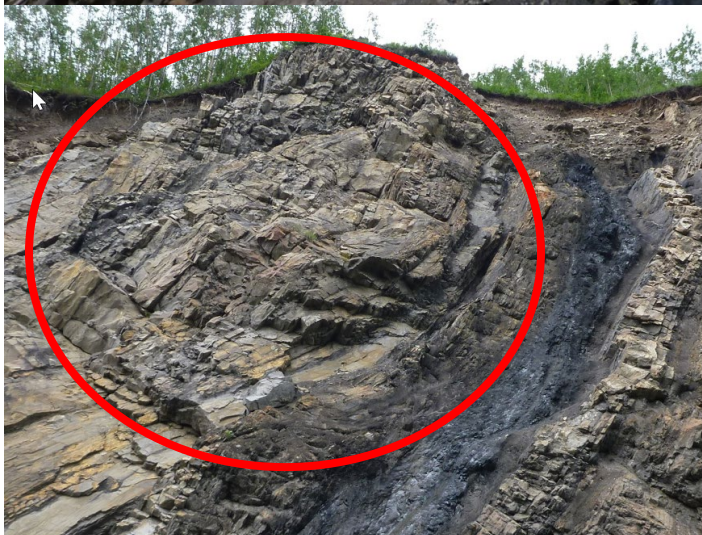
- A potentially large rock block that could be a future rockfall hazard was identified on the slope (Photo GP036-10). A bedrock discontinuity “plane” (distorted and non-planar, as

previously discussed) appears to underlie a large block of rock with some overhang. The north side of the large rock block is a layer of fractured rock and a seam of coal which is weathering faster than the rest of the slope. The discontinuity between the undulating discontinuity and the block of rock appears to be dilated. Continued weathering of the coal seam could result in loss of confinement, resulting in overstressing the remainder of the attachments for the large block to the slope, causing a large rockfall event that would likely bury the entire highway.

Photo GP036 – 10 Potential rock block on upper slope that could be further undermined by weathering of soft rock and coal seams. Some dilated (open) joints at toe. Red arrow indicates dilated joint. Green circles indicate bedrock joint or shear plane on left and below the rock block that could be behind the rock block. Yellow arrow indicates soft rock and coal seams that are weathering and eroding which could unload the north side of the rock block and cause a large rockfall event. Red circle in inset photo shows extent of rock block. Photo taken July 14, 2022, facing northwest.

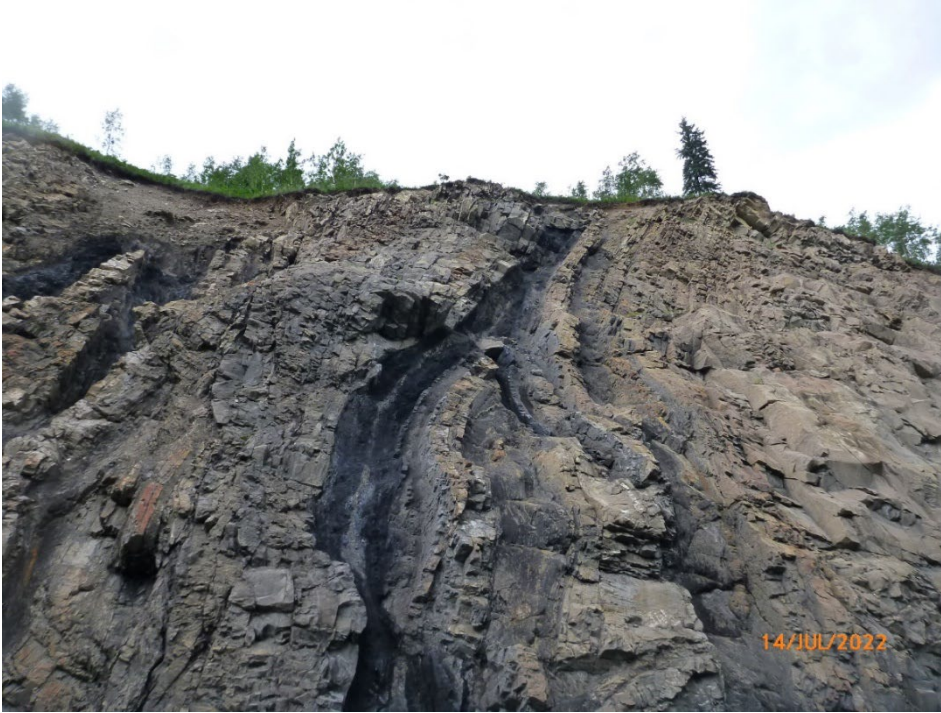
Photo GP036 – 11 Additional coal seams and soft rock layers that have weathered and eroded, leaving blocks of rock unsupported. Photo taken July 14, 2022, facing northwest.

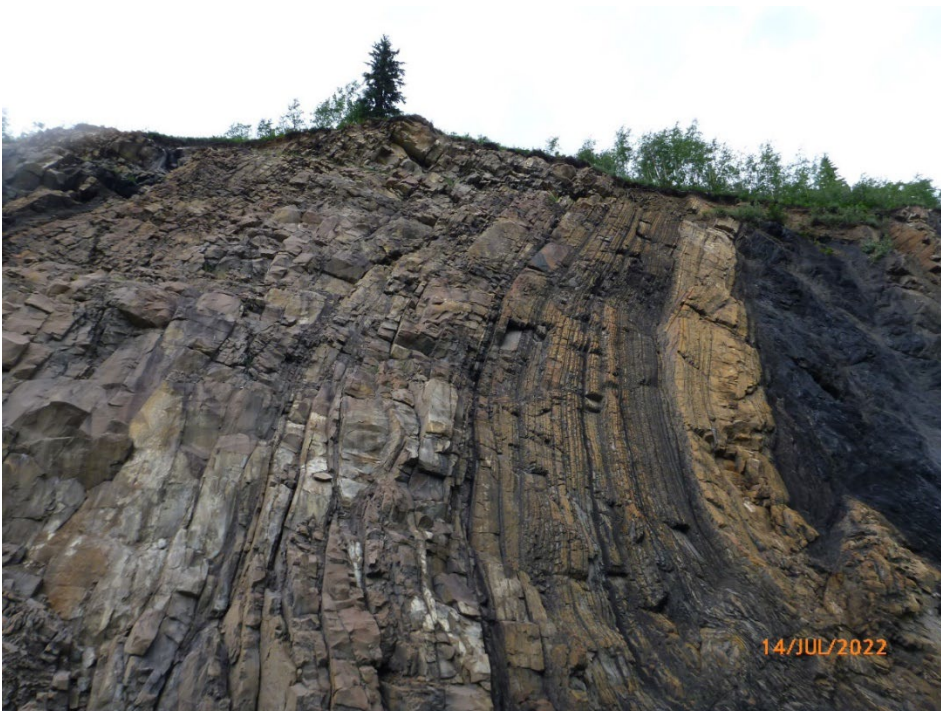
- The north part of the slope appears to be more competent bedrock with less weathering and deterioration. The coal seam with the adit exposed mid-point of the slope also appears to be more competent and is not weathering at the same rate as other coal seams on the GP036 slope (Photo GP036-12 and -13).

Photo GP036 – 12 More competent section of rock slope between coal seams (adit coal seam is to the right (north)). Photo taken July 14, 2022, facing northwest.

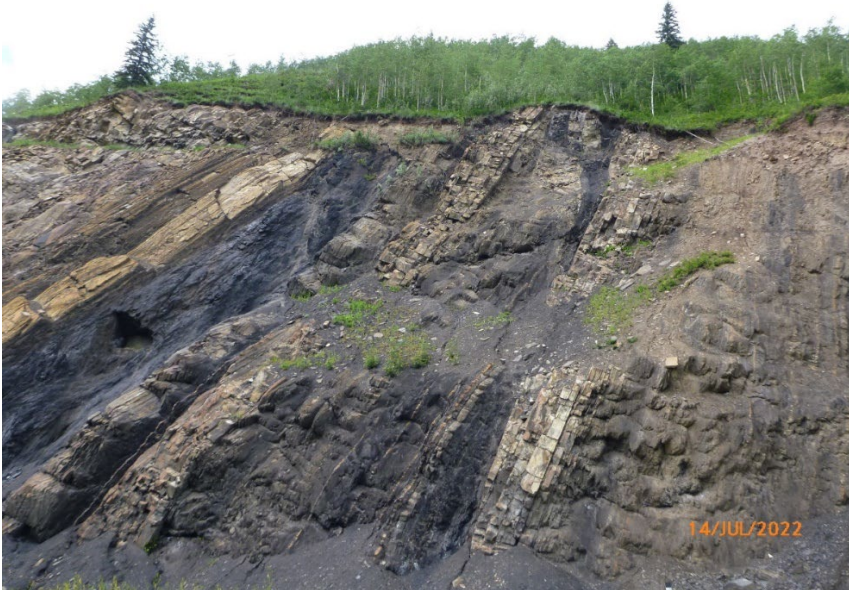
Photo GP036 – 13 Rock slope to the north of coal seam adit. Photo taken July 14, 2022, facing northwest.

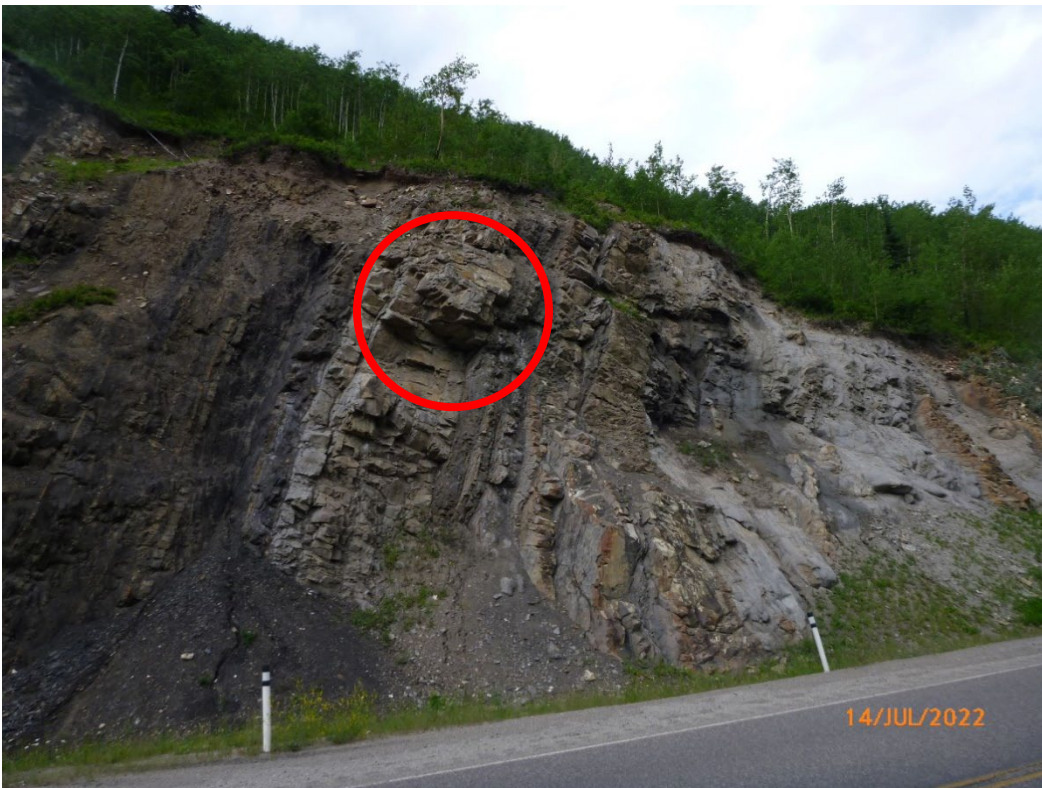
Photo GP036 – 14 Rock slope at north limit of rock cut slope. Red circle indicates overhang in upper third point of slope (shown in Photo -15). Photo taken July 14, 2022, facing northwest.

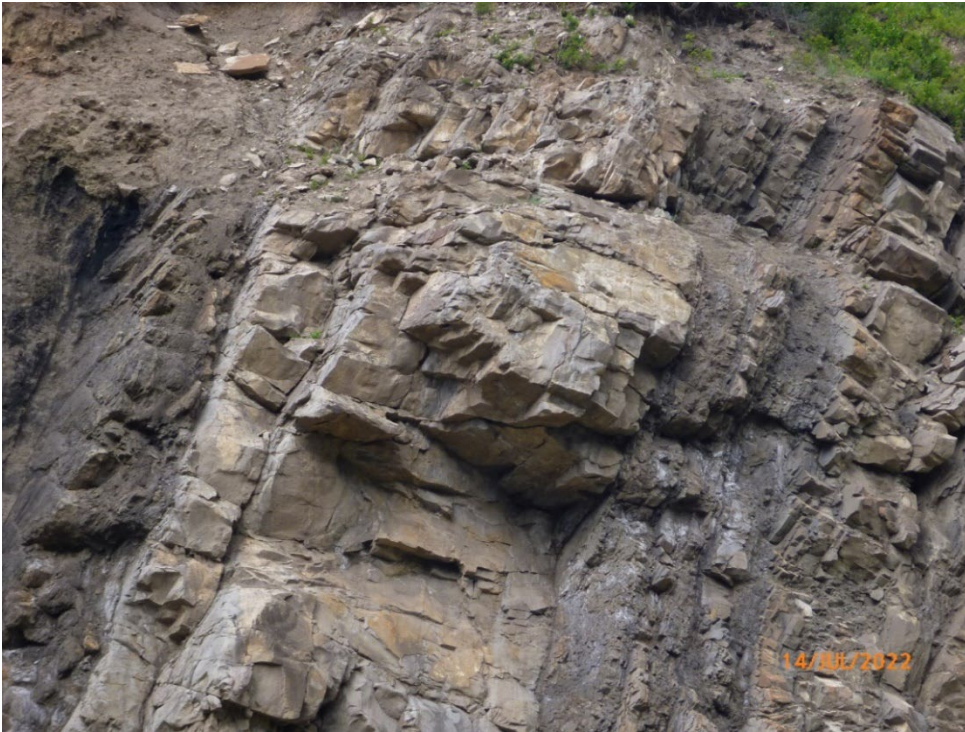
Photo GP036 – 15 Overhang at upper third of slope shown in Photo 13. Photo taken July 14, 2022, facing northwest.

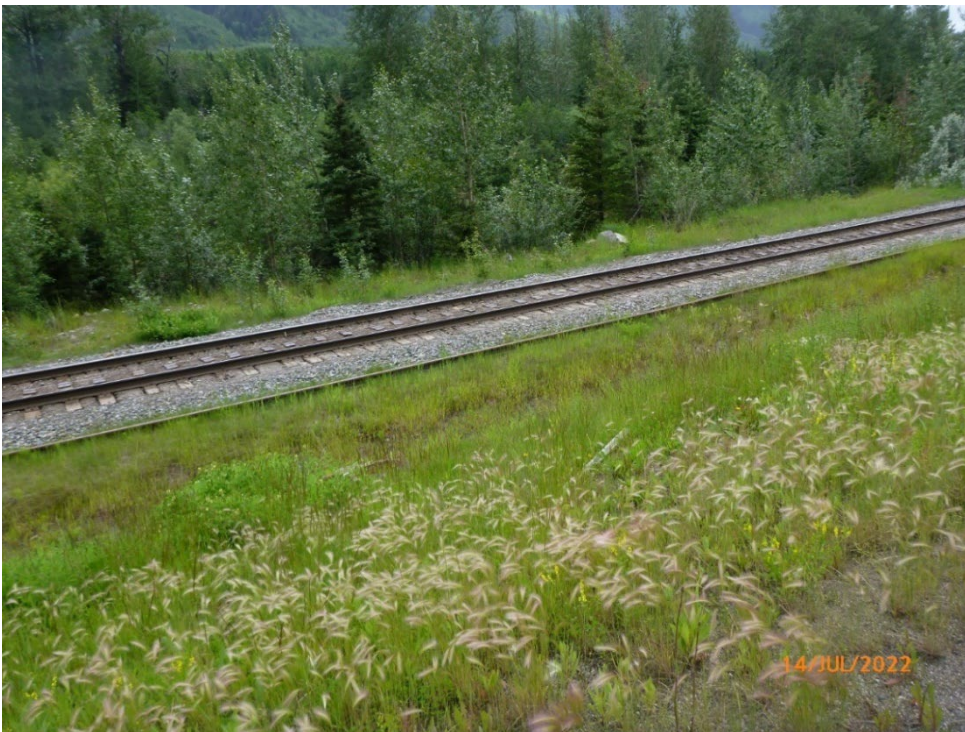
Photo GP036 – 16 Large blocks of rock that appear to have rolled downhill past the railway tracks. Photo taken July 14, 2022, facing south.

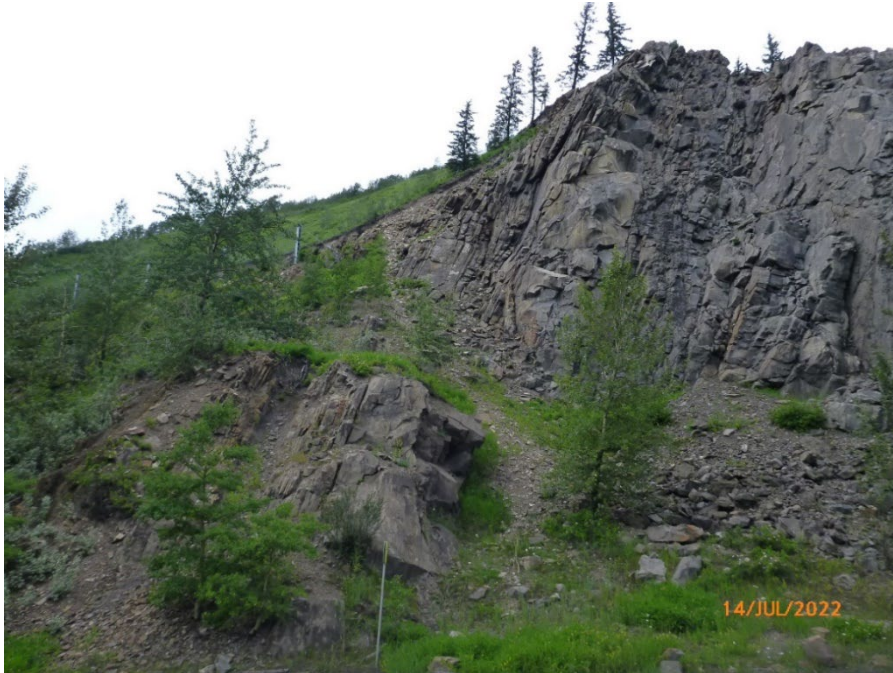
Photo Rockfall Fence Site 1

- Some rockfall blocks were noted in the ditch below a zone of closely bedded and fractured bedrock that has preferentially weathered with time (Photos Rock Fall Fence -1 and -2).
 - ♦ *The slope should be scaled and the ditch cleaned of rockfall blocks.*

**Rock slope north of GP049 downslope of mine rockfall fence.
Photo taken July 14, 2022, facing northwest.**

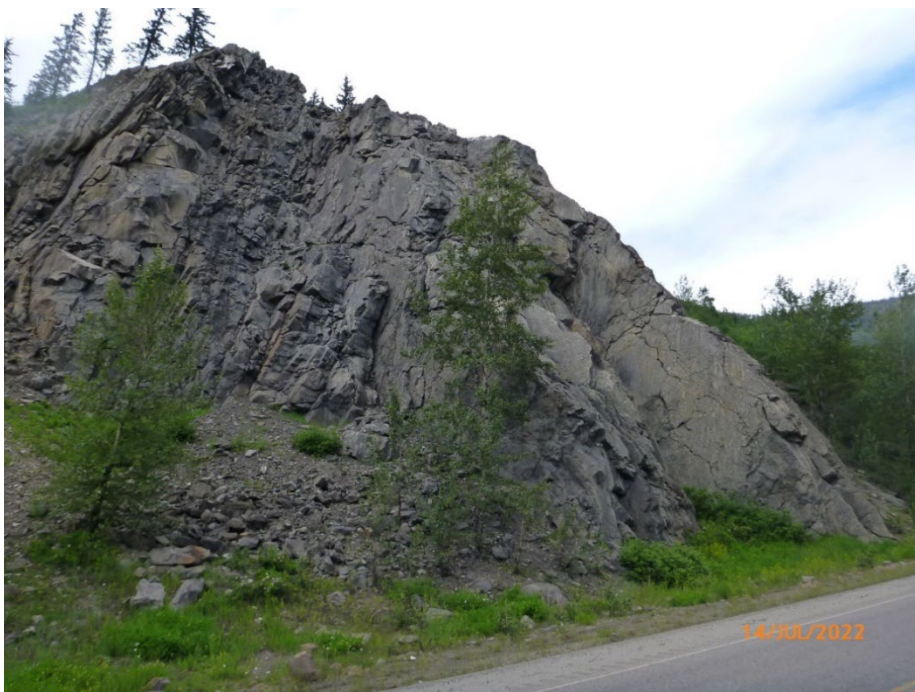
Photo No Site Number 2

Rock slope north of GP049 downslope of mine rockfall fence. Several overhanging rock blocks are present on the more fractured zones of this rock slope. Photo taken July 14, 2022, facing north.

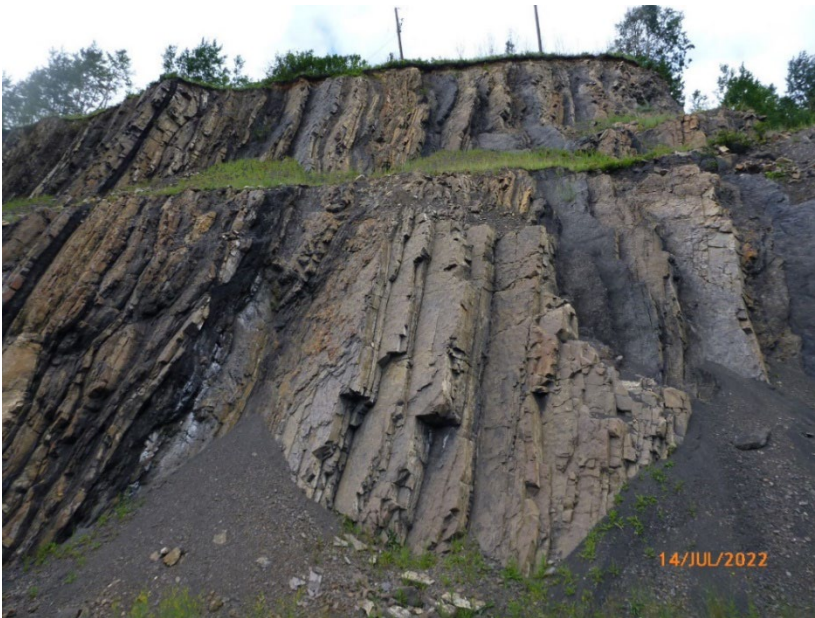
- The bedrock structure at this site consists of near vertical bedding planes (dip estimated between 70° to 80°) dipping to the south to southwest (Photo GP053-I-1 and -2). The rock mass appears to have relatively tight bedding planes but the rock mass is fractured perpendicular to the bedding planes which generates rockfall events.

Photo GP053-I – 1 Typical rock slope with uneven weathering of bedding planes. Weathering of weak, fractured or coal seams is causing stronger seams to be undermined. Deeper troughs preferentially funnel rockfall particles into talus cones. Note talus cones on mid-slope bench which could launch rockfall from upper part of slope. Photo taken July 14, 2022 facing northwest.
