Alberta Transportation
Main Floor, Provincial Building
9621 96 Avenue
Peace River, Alberta
T8S 1T4

CON0022166 Peace Region (Grande Prairie South) GRMP
Hwy 40:36 rockfall, km 8.395 to 17.161
Call-Out Report

This call-out report was prepared for AT under Contract No. CON0022166. KCB's site observations, assessments, and recommendations for short-term and long-term remedial actions are presented in this report.

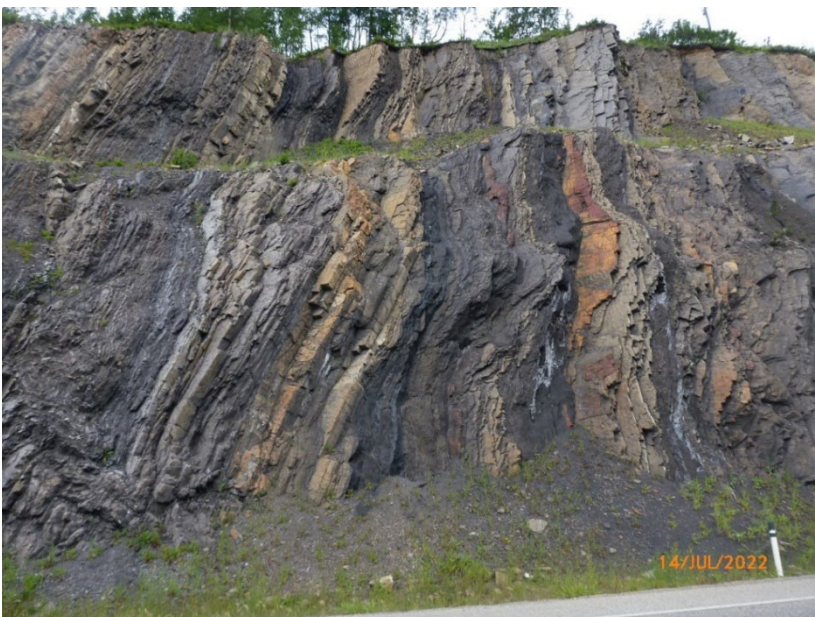
- The bedrock structure at this site consists of near vertical bedding planes (dip estimated between 70° to 80°) dipping to the south to southwest (Photo GP053-I-1 and -2). The rock mass appears to have relatively tight bedding planes but the rock mass is fractured perpendicular to the bedding planes which generates rockfall events.

Photo GP053-I – 2 Rock slope with relatively even weathering of bedding planes. Note talus cones on mid-slope bench which could launch rockfall from upper part of slope. Photo taken July 14, 2022, facing northwest.

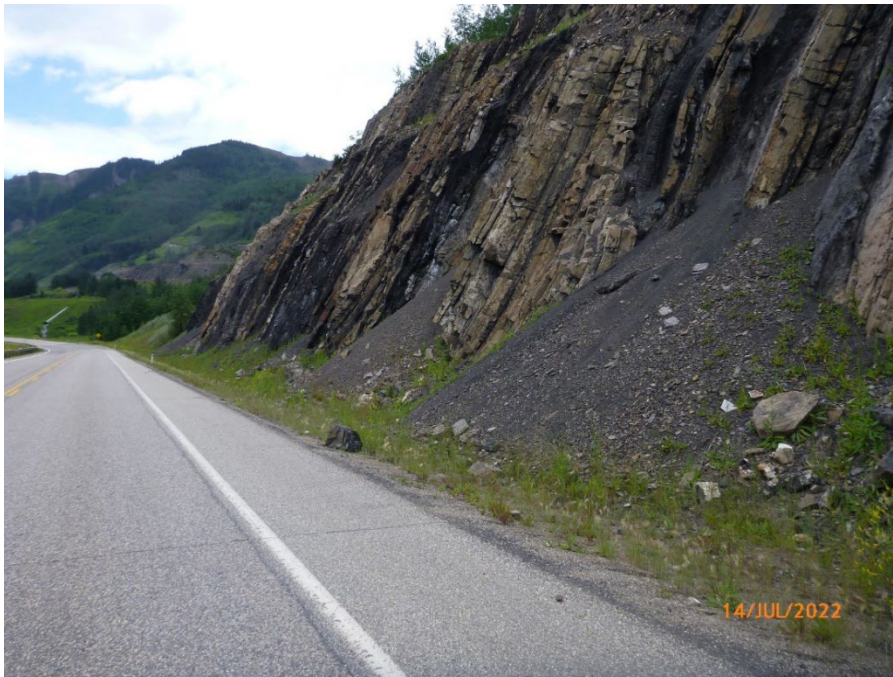
- Talus cones of fine-grained material (sand and gravel) and rockfall particles were observed in the ditch (Photo GP053-I-3).
- The bedrock structure changes in the north part of the -I slope to a gentle fold with dip of approximately 20°, dipping to the southeast towards the highway (Photo GP053-I-4).

**Photo GP053-I – 3 Talus cones and rockfall particles in ditch and close to edge of pavement.
Photo taken July 14, 2022, facing southwest.**

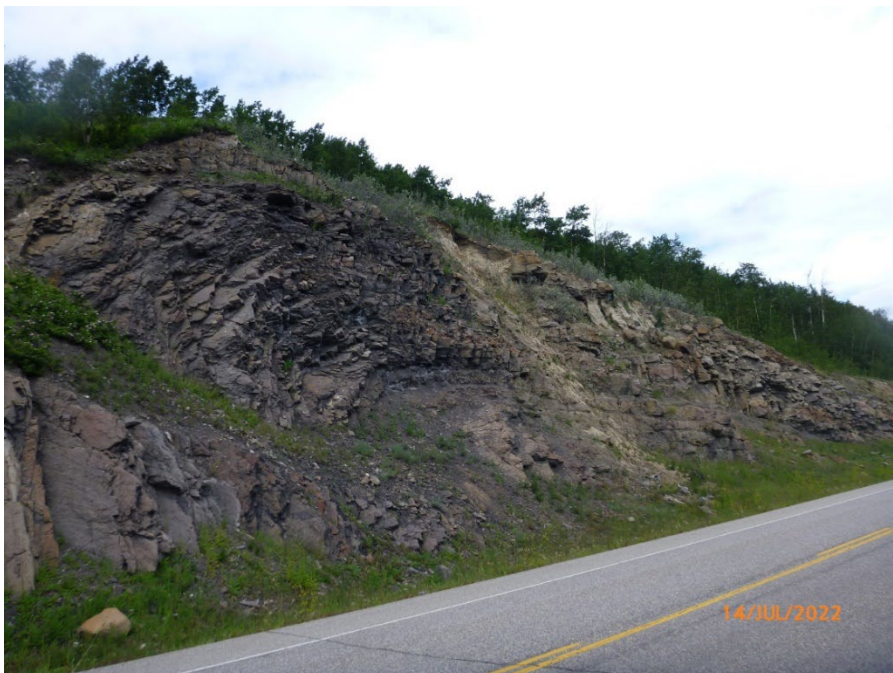
Photo GP053-I – 4 Different (second) structure of bedrock with different orientation of bedding planes. Note non-planar distortion of bedding planes in a gentle fold. The near vertical bedding plane bedrock structure shown in Photos GP053-2 is located at the lower lefthand corner of this photo. Photo taken July 14, 2022, facing northwest.

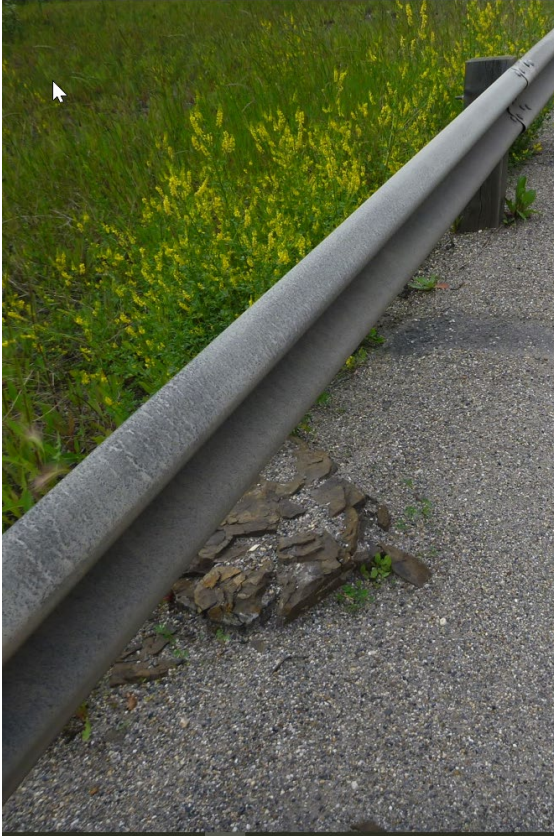
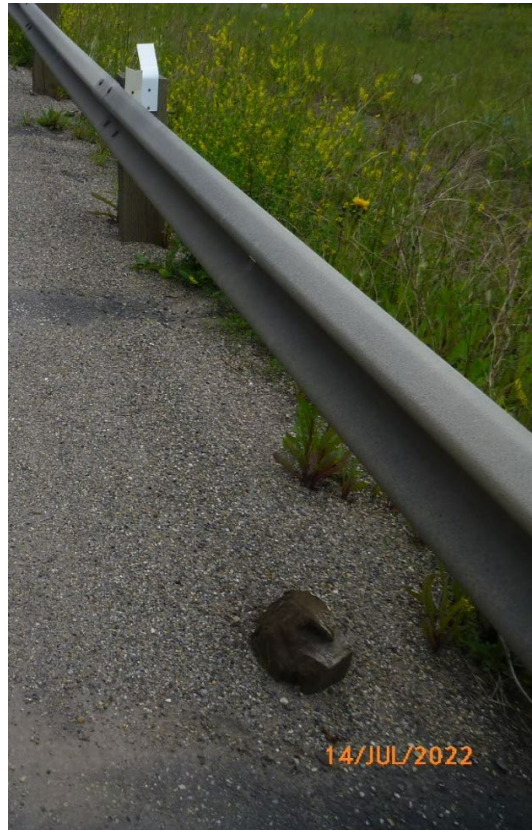
Photo GP053-I – 5 Rockfall particles under guardrail on opposite side of the highway from rock slope. Photos taken July 14, 2022, facing southwest and northeast respectively.

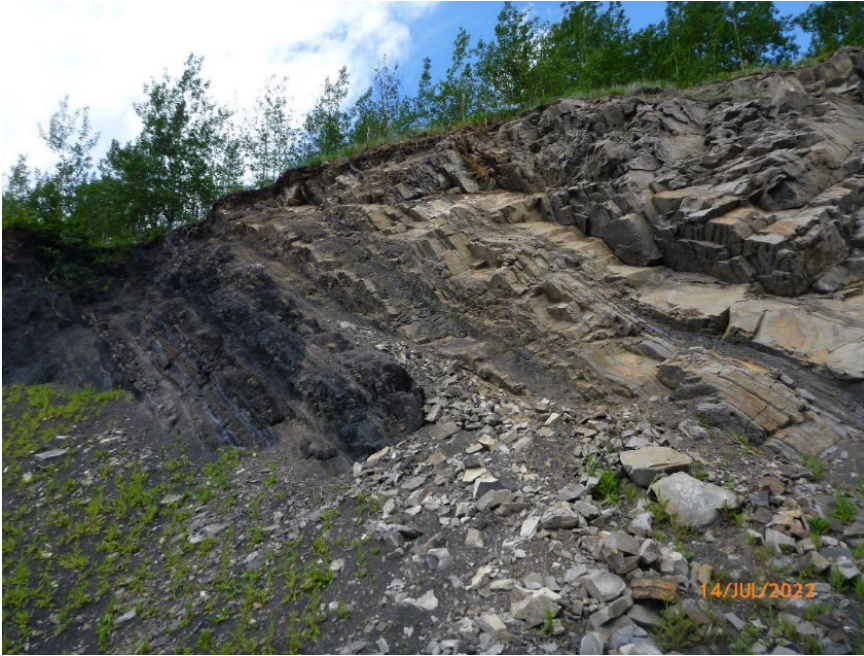
Photo GP053-II – 1 Different structure (third) of bedrock with different orientation of bedding planes. Note overhangs forming on south side of bedding planes caused by previous rockfall. Photo taken July 14, 2022, facing northwest.

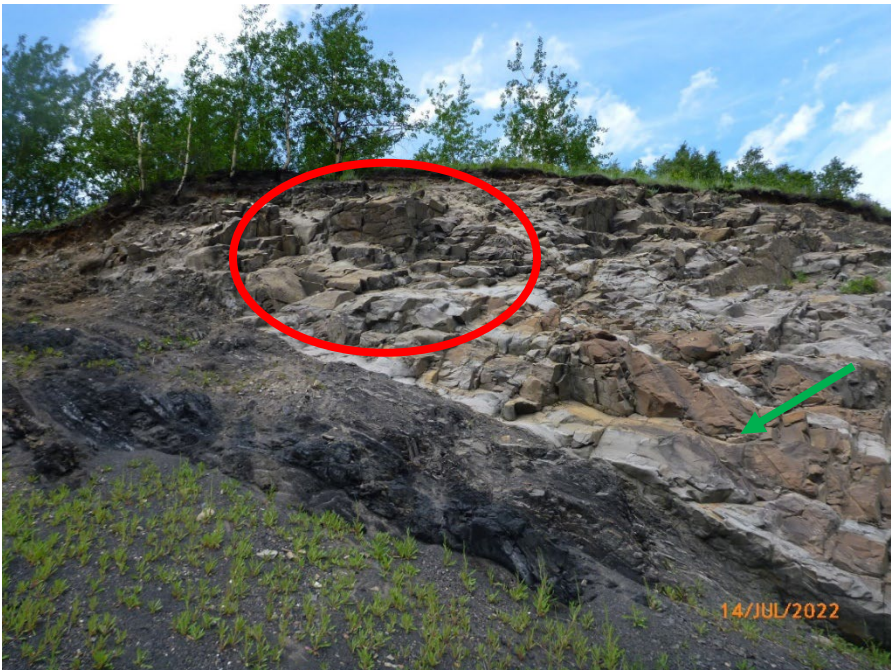
- Only one area of the rock slopes (GP053-II) viewed during the call-out inspection showed any sign of drill and blast method being used (i.e., half-barrel patterns in the rock slope). This is likely due to post-construction deterioration of the bedrock slopes after construction. Although it cannot be proven, KCB's experience with blasting is that the drill and blast excavation of the rock slope may have damaged the rock slope, leaving it more prone to post-construction deterioration. Weaker or more fractured bedrock slopes exposed to concentrated runoff or groundwater seepage discharge would have eventually deteriorated even with careful drill and blast excavation techniques being used. The condition of the GP049-I and GP053-III slopes could indicate that weaker or blast-damaged materials were removed during construction.

Photo GP053-II – 2 Rock slope with half barrels (green arrows) from rock cut blasting. Red circle indicates dilating bedrock joints in an overhang near top of slope. Photo taken July 14, 2022, facing northwest.

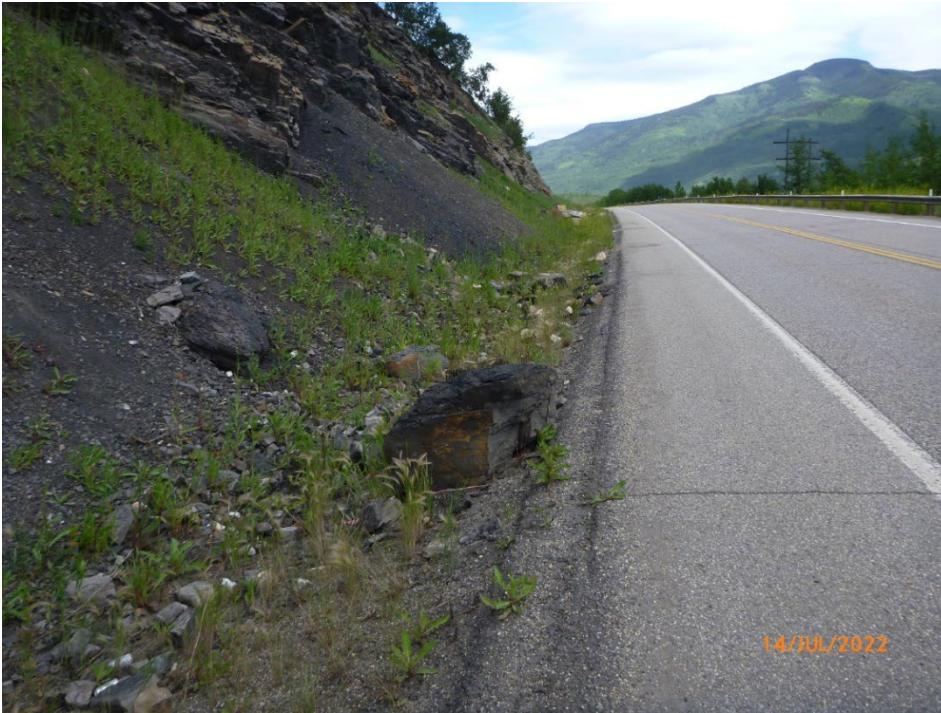
Photo GP053-II – 3 Ditch with talus slopes and rockfall particles. Photo taken July 14, 2022, facing northeast.

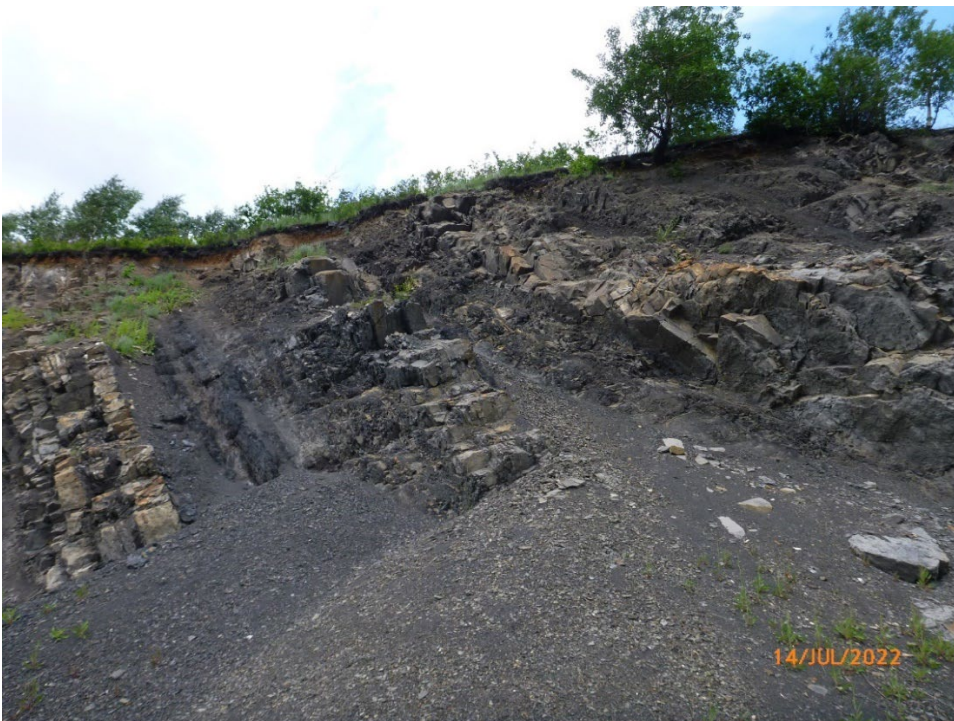
Photo GP053-II – 4 Weathered and eroded soft or highly fractured rock and coal seams are being eroded to create overhanging rock blocks which then become rock fall. Note trees at brow of slope. Photo taken July 14, 2022, facing northwest.

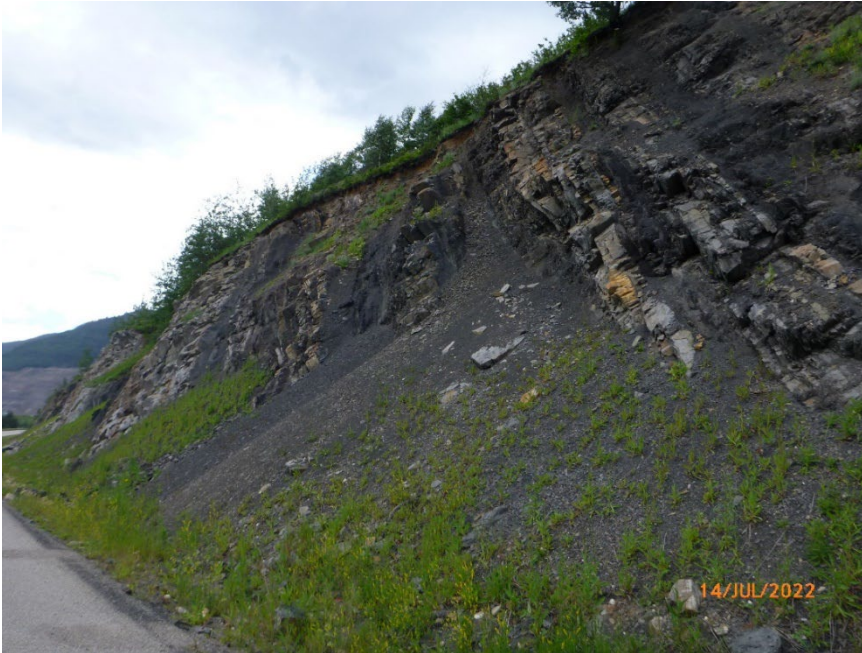
- Small rockfill particles, 0.5 m or less, were observed near the guardrail on the opposite side of the highway (Photo GP053-II-5).
 - ♦ *The slope should be scaled and the ditch cleaned of rockfall blocks and talus material.*

Photo GP053-II – 5 Section of slope that is weathering and eroding with zones of more competent rock elevated above the slope. The loss of support for the more competent rock layers eventually leads to rockfall. Photo taken July 14, 2022, facing southwest.

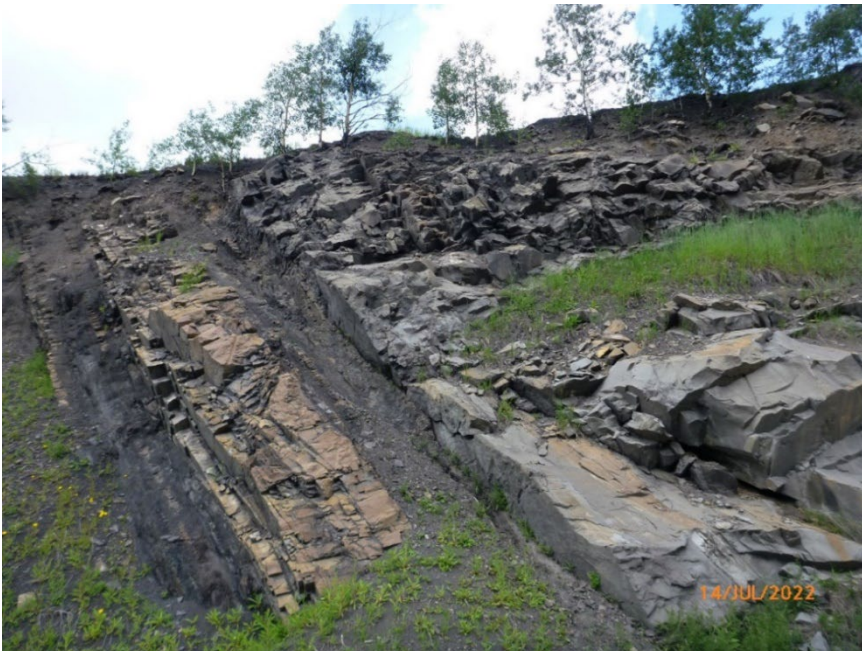
Photo GP053-II – 6 More competent, more massive layers of bedrock that are undermined do not experience as much rockfall or slope deterioration upon erosion of soft rock and coal seams. A mine access road is located behind the crest of the slope as shown in Figure 7. Photo taken July 14, 2022, facing northwest.

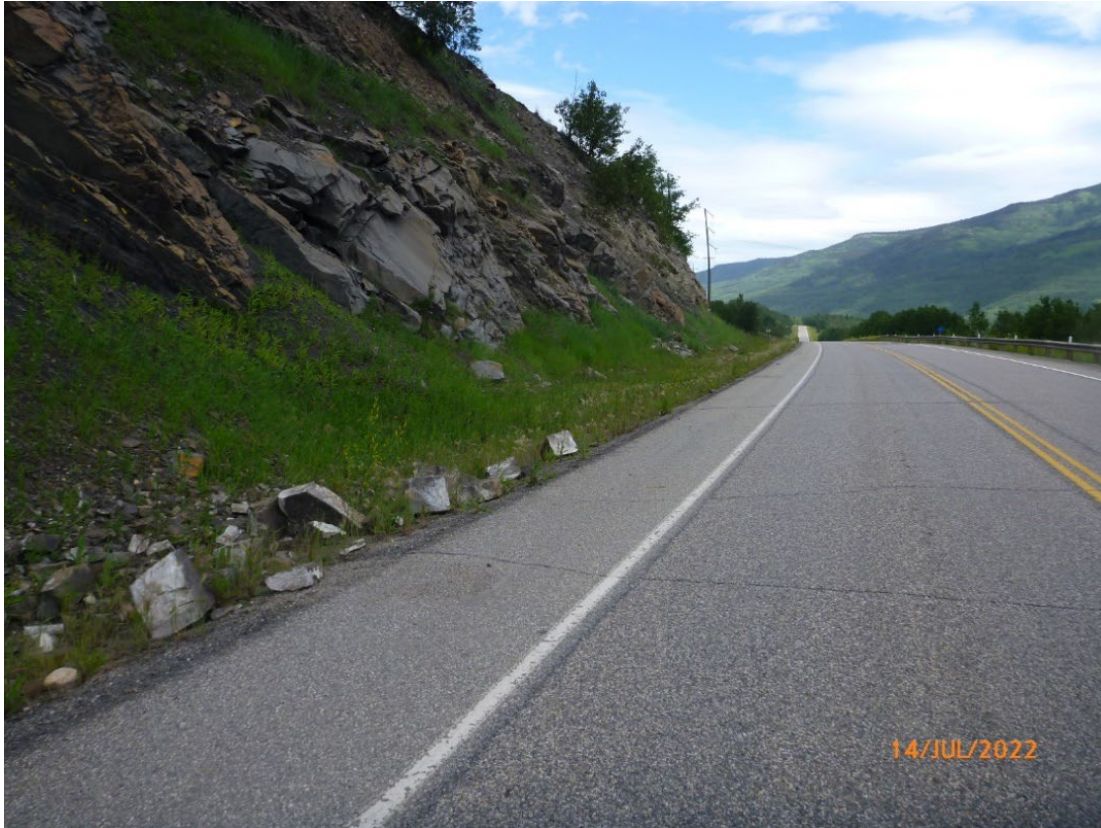
Photo GP053-II – 7 Talus slopes and rock blocks in the ditch. The rock blocks in the ditch appear to get closest to the highway by rolling down the talus slope. Photo taken July 14, 2022, facing northeast.

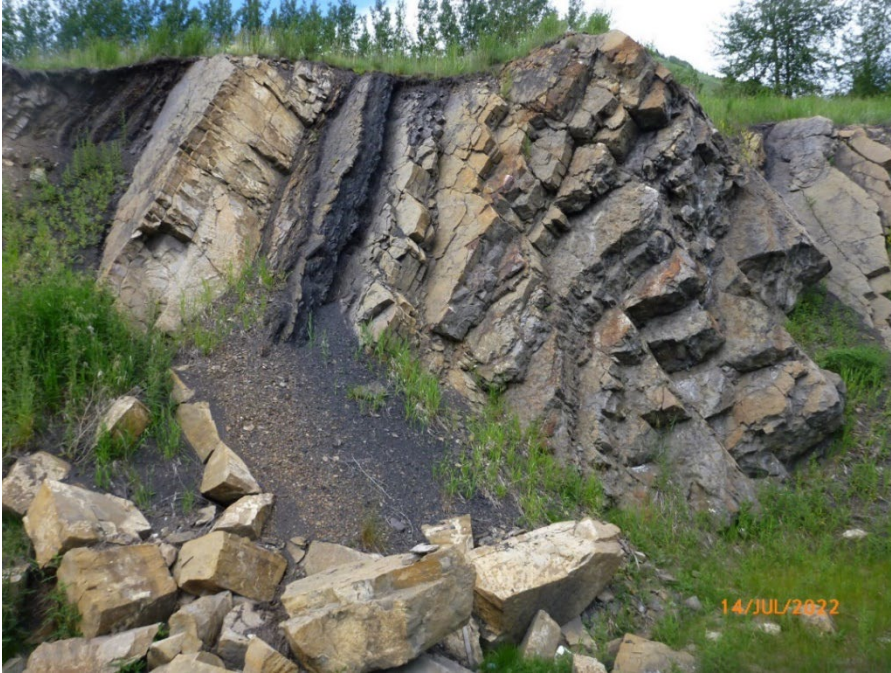
- The rock slope is approximately 100 m long and approximately 4 m to 5 m high.
 - The bedrock structure is different at this site from the previous sites with steeply dipping bedding planes (estimated 60 to 70°) dipping to the south. The bedding planes vary from a few centimeters thick to over 1 m thick. More fractured or possibly blast damaged zones appear to have been removed, likely during construction, leaving an uneven slope surface (Photos GP053-III-1 and -2).

Photo GP053-III – 1 Low rock cut at north end of GP053 site. Rock slope is generating rockfall but height of slope and depth and width of ditch are containing rockfall particles. Note that orientation of bedding planes is different from previous zones of the GP053 site. Photo taken July 14, 2022, facing northwest.

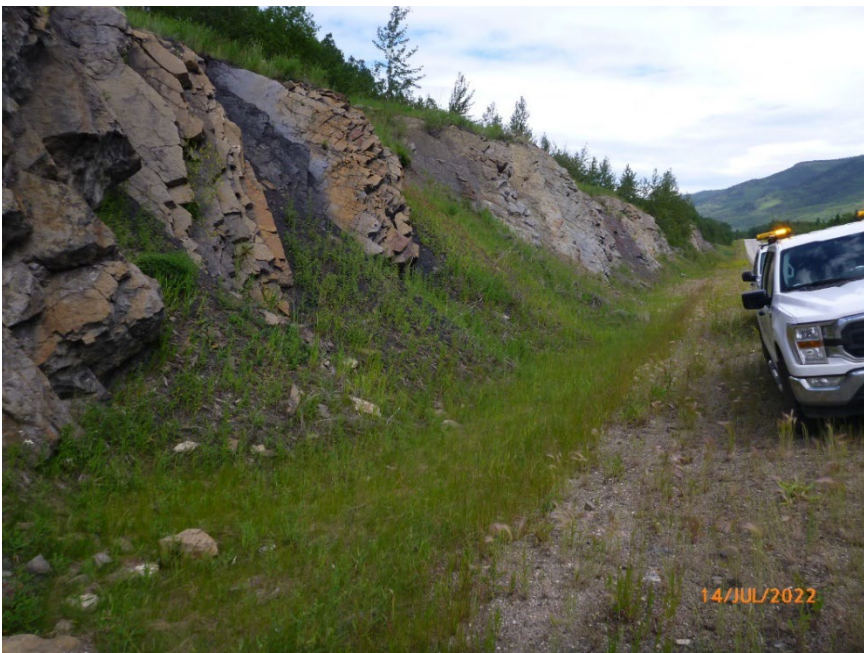
Photo GP053-III – 2 Rock slope and ditch with few rockfall particles. Photo taken July 14, 2022, facing northeast.
