**PEACE REGION  
(GRANDE PRAIRIE DISTRICT – SOUTH) GRMP**

**SITE INSPECTION FORM**

<b>SITE NUMBER AND NAME:</b> GP007 Wanyandie Road Slide		<b>HIGHWAY &amp; KM:</b> 40:36, 29.339	<b>PREVIOUS INSPECTION DATE:</b> June 14, 2023	<b>INSPECTION DATE:</b> <b>June 12, 2023</b>
<b>LEGAL DESCRIPTION:</b> NW 02-59-07-W6M NE 02-59-07-W6M	<b>NAD 83 COORDINATES:</b> UTM Northing Easting 11 5993890 372875		<b>RISK ASSESSMENT:</b> PF: 9 CF: 8 TOTAL: 72	
<b>AVERAGE ANNUAL DAILY TRAFFIC (AADT):</b> 421 (north) & 424 (south) (Reference No. 60403650, 2022)			<b>CONTRACT MAINTENANCE AREA (CMA):</b> 504

**PRIMARY SITE ISSUE:** Deep-seated landslide (or nested slides) along north valley slope of the Smoky River. Hwy 40:36 fill placed in a cut and side-hill arrangement across slide area. Slide movement affecting both lanes of highway.

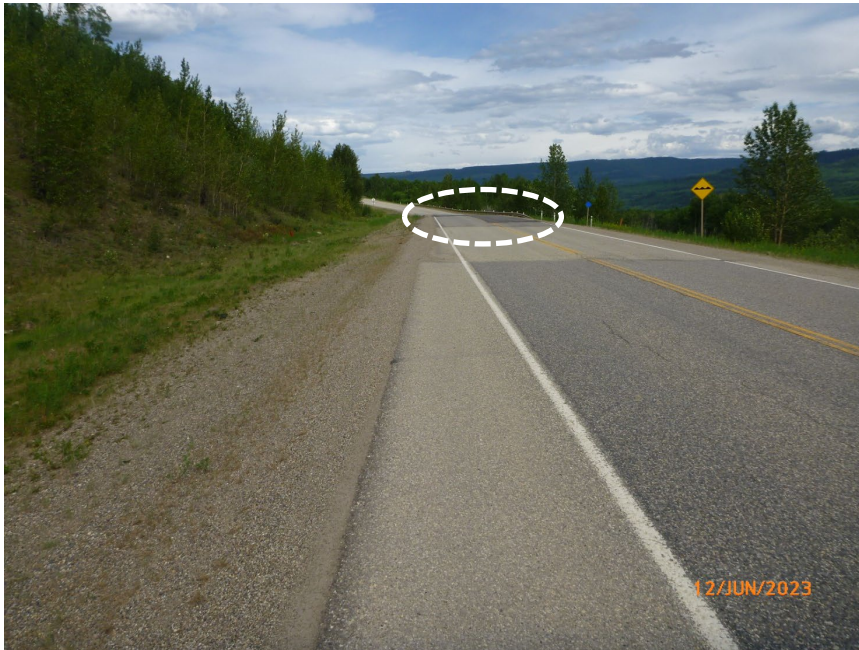
- Photo 1** Pavement surface of Hwy 40:36 at western site limit near Wanyandie Road intersection. Note recent pavement patch on Hwy 40:36 (circled in white). Photo taken June 12, 2023, facing east.

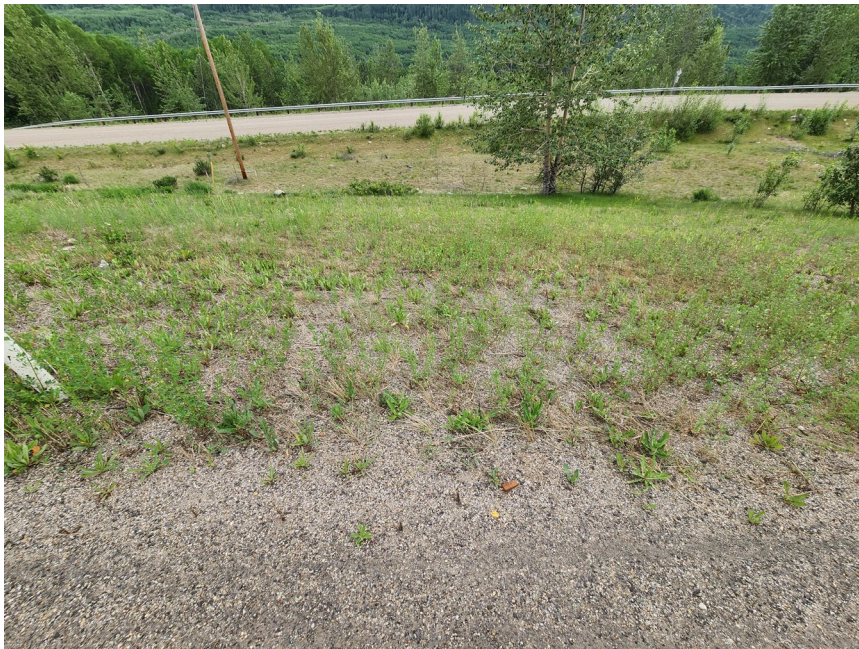
- Photo 2** South embankment slope of Hwy 40:36 above Wanyandie Road at western site limit. Note recent pavement patch on Hwy 40:36 (circled in white). Photo taken June 12, 2023, facing east.

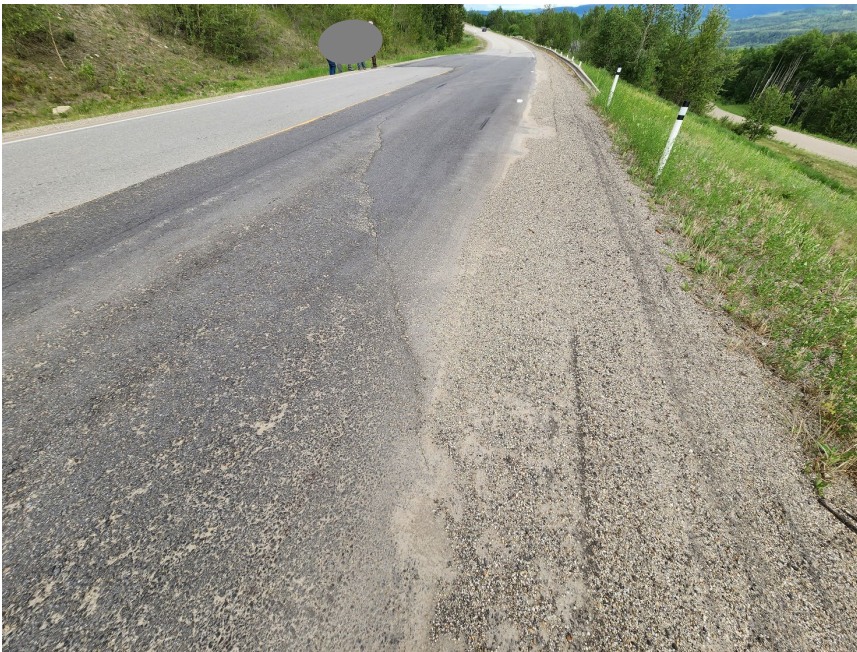
**Photo 3** Cracking and settlement of recent pavement patch in eastbound (south) lane of Hwy 40:36 near western site limit. Photo taken June 12, 2023, facing east.

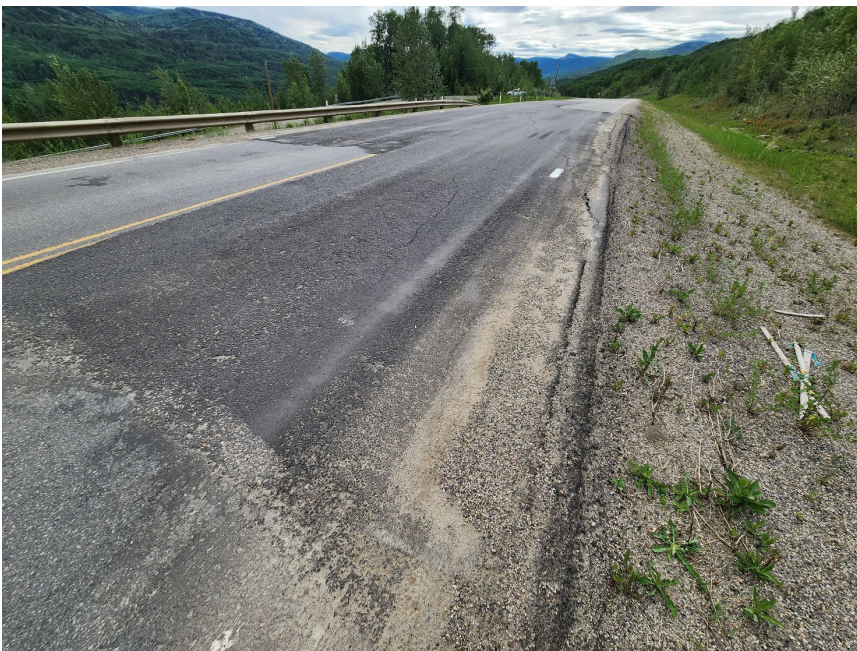
**Photo 4** Cracking and settlement of recent pavement patch in both lanes of Hwy 40:36 near western site limit. Photo taken June 12, 2023, facing west.

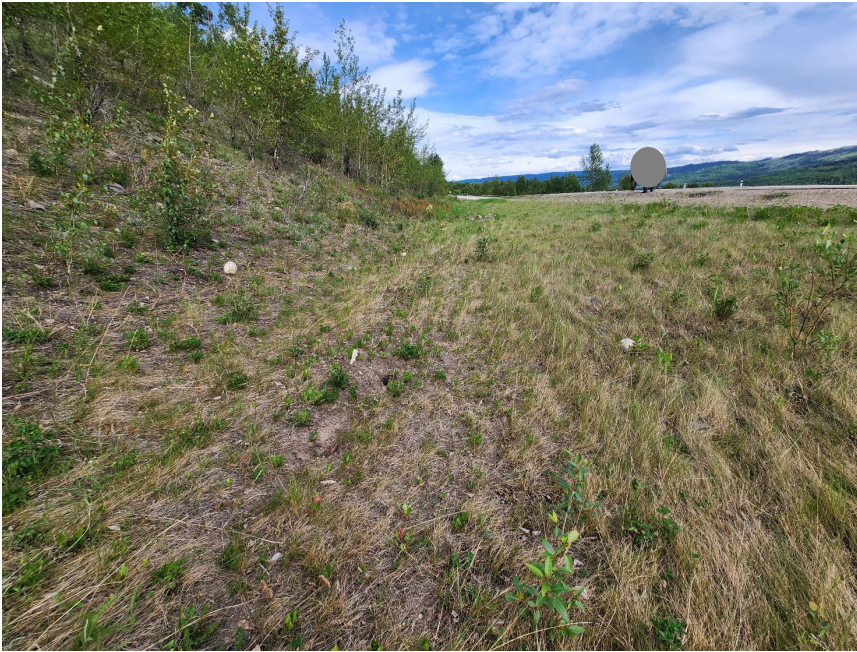
**Photo 5** North ditch of Hwy 40:36 at western site limit near Wanyandie Road intersection. Photo taken June 12, 2023, facing east.

- Upslope/north ditch is wet and poorly drained. Tire tracks also left in bottom of ditch by drill rig in spring of 2022. Ditching improvements needed in upslope/north ditch to improve drainage to west and divert water from slide area. KCB prepared a "sketch" design package for a highway maintenance contractor (HMC) repair, which is expected to be completed in summer or fall 2023. Repair consists of ditch grading and excavation of new deeper ditch channel. Estimated cost: approximately \$100,000.

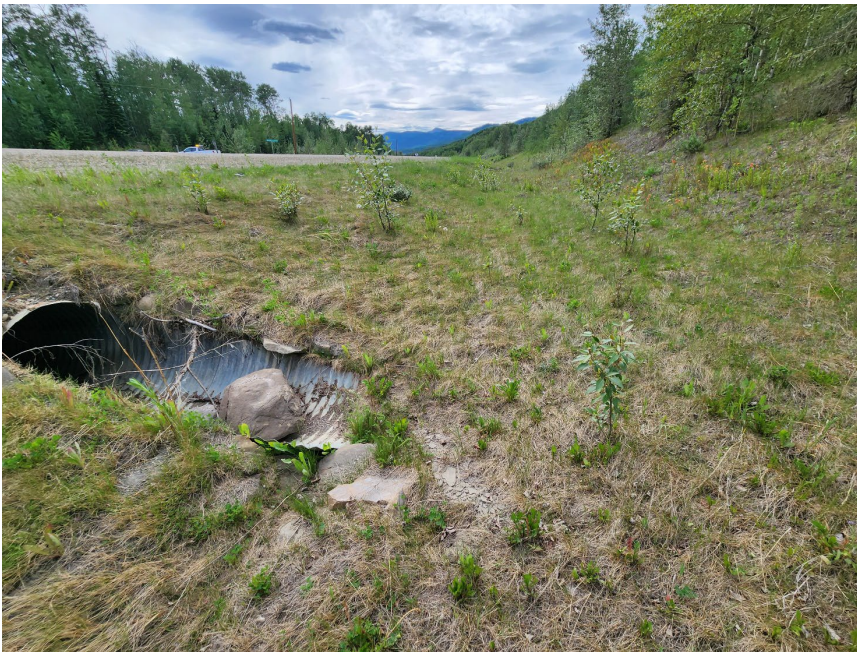
**Photo 6** North ditch of Hwy 40:36 at western site limit near Wanyandie Road intersection. Note boulder-sized rock particle (approximate diameter 0.3 m) in culvert inlet. Photo taken June 12, 2023, facing west.

- Rock particle in culvert inlet should be removed as part of this work to re-establish culvert flow capacity.
- Most of the slide mass is not instrumented and the available LiDAR data indicates slide terrain extends well above/north of the highway where there are no instruments. Interferometric Synthetic Aperture Radar (InSAR) monitoring could be used to further study the slide and assess how the slope is moving and over what extent, which would be useful if TEC adopts a strategy where the impact of sliding at the site is managed with road repairs. Estimated cost: approximately \$50,000 to \$100,000 per year for InSAR.

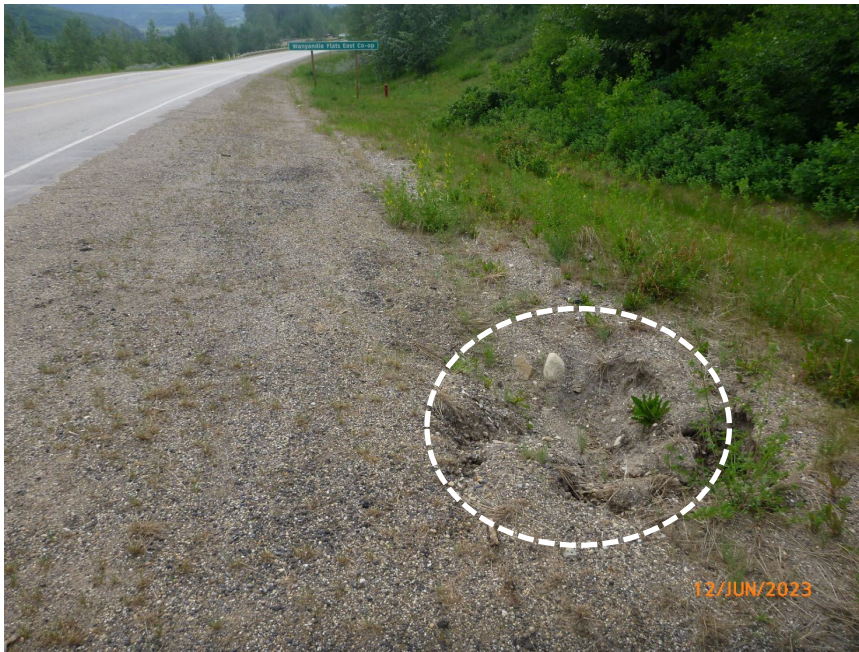
**Photo 7** Sinkhole along fiber optics line (circled in white) in north ditch of Hwy 40:36 near WP301. Photo taken June 12, 2023, facing west.

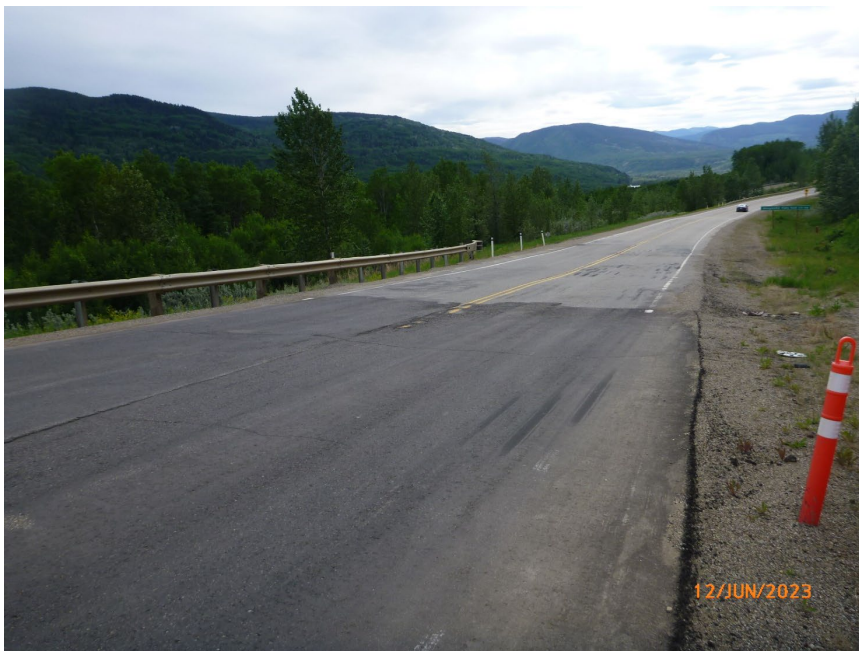
**Photo 8** Start of recent pavement patch on Hwy 40:36 at eastern site limit. Photo taken June 12, 2023, facing southwest.

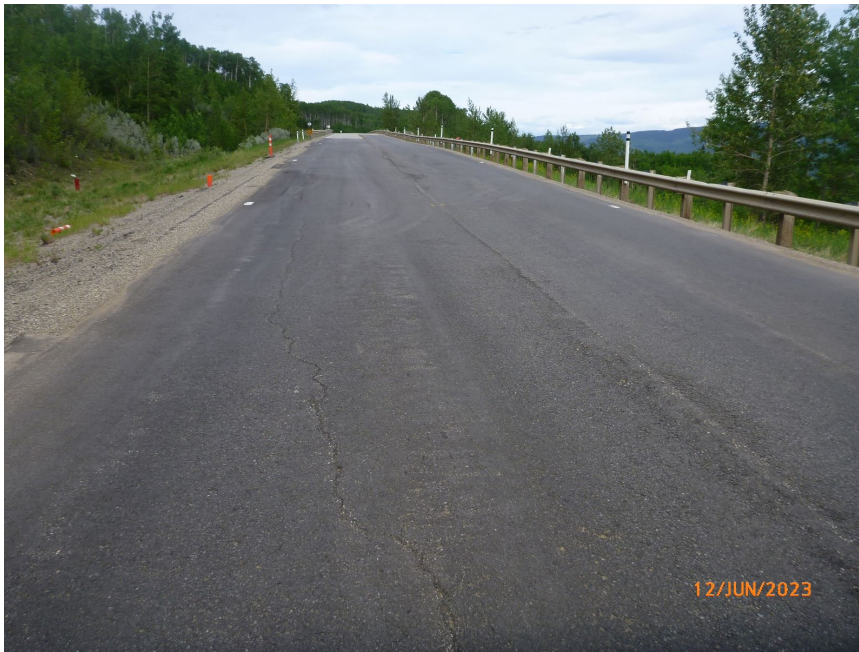
**Photo 9** Recent pavement patch on Hwy 40:36 at eastern site limit. Note crack in eastbound (north) lane. Photo taken June 12, 2023, facing west.

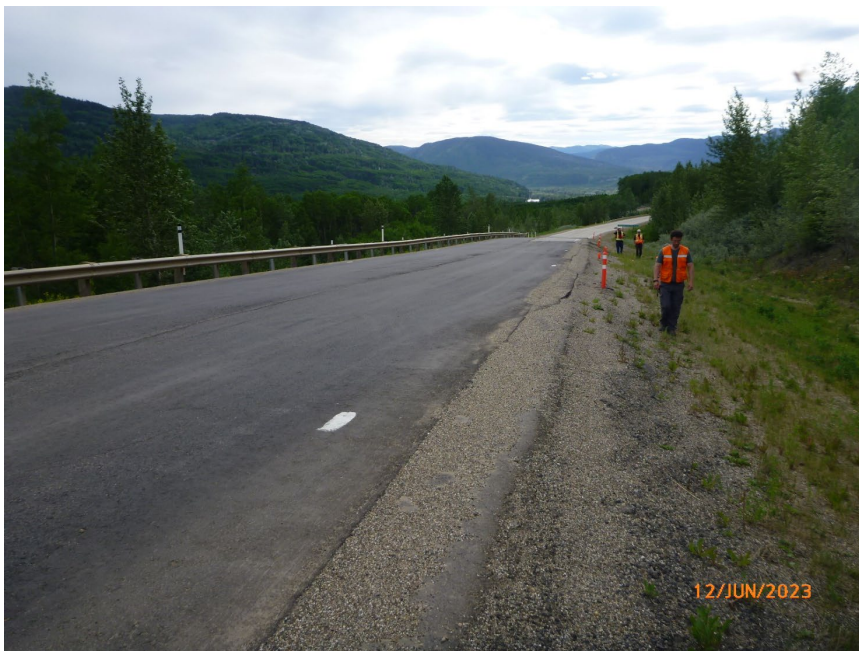
**Photo 10** Recent pavement patch on Hwy 40:36 at eastern site limit. Photo taken June 12, 2023, facing west.

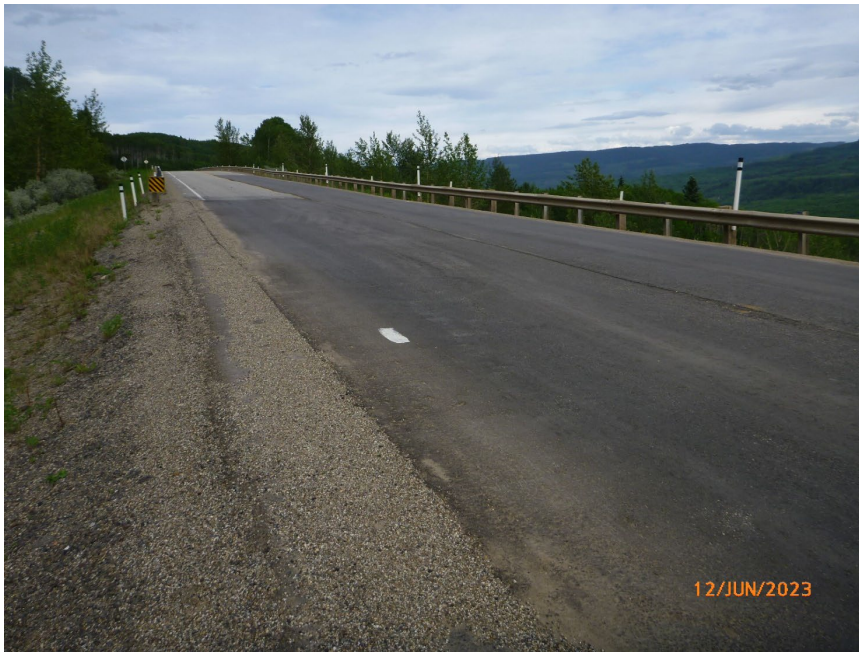
**Photo 11** Recent pavement patch on Hwy 40:36 at eastern site limit. Photo taken June 12, 2023, facing southeast.

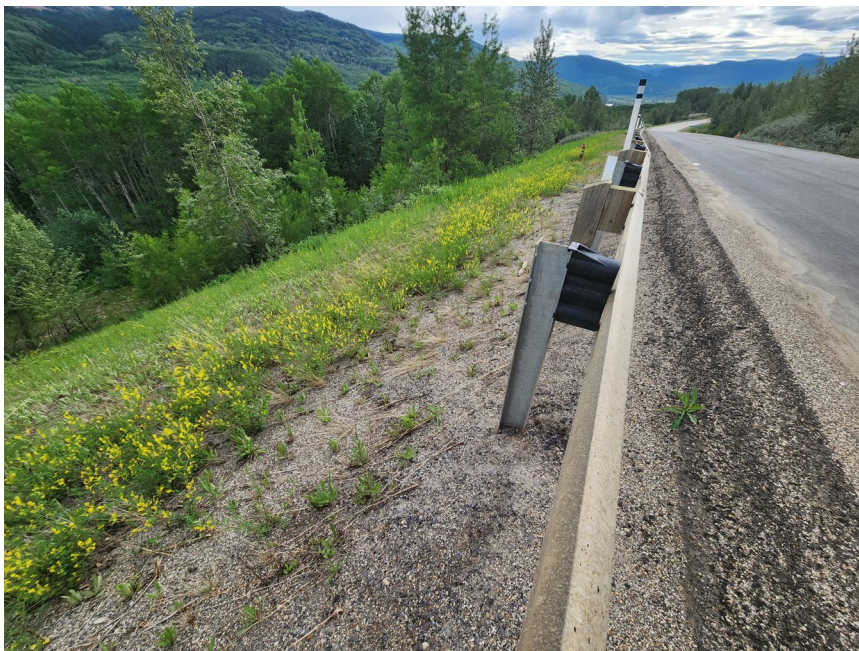
**Photo 12** South embankment slope of Hwy 40:36 at eastern site limit. Photo taken June 12, 2023, facing southwest.
