**PEACE REGION
(GRANDE PRAIRIE DISTRICT – SOUTH) GRMP**

SITE INSPECTION FORM

SITE NUMBER AND NAME: GP007 Wanyandie Road Slide		HIGHWAY & KM: 40:36, 29.339	PREVIOUS INSPECTION DATE: June 12, 2023	INSPECTION DATE: June 10, 2024
LEGAL DESCRIPTION: NW 02-59-07-W6M NE 02-59-07-W6M	NAD 83 COORDINATES: UTM Northing Easting 11 5993890 372875		RISK ASSESSMENT: PF: 9 CF: 8 TOTAL: 72	
AVERAGE ANNUAL DAILY TRAFFIC (AADT): 430 (north) & 437 (south) (Reference No. 60403650, 2023)			CONTRACT MAINTENANCE AREA (CMA): 504

TITLE
 Site Plan
 GP007 - Wanyandie Road Slide
 Hwy 40:36, km 29.339

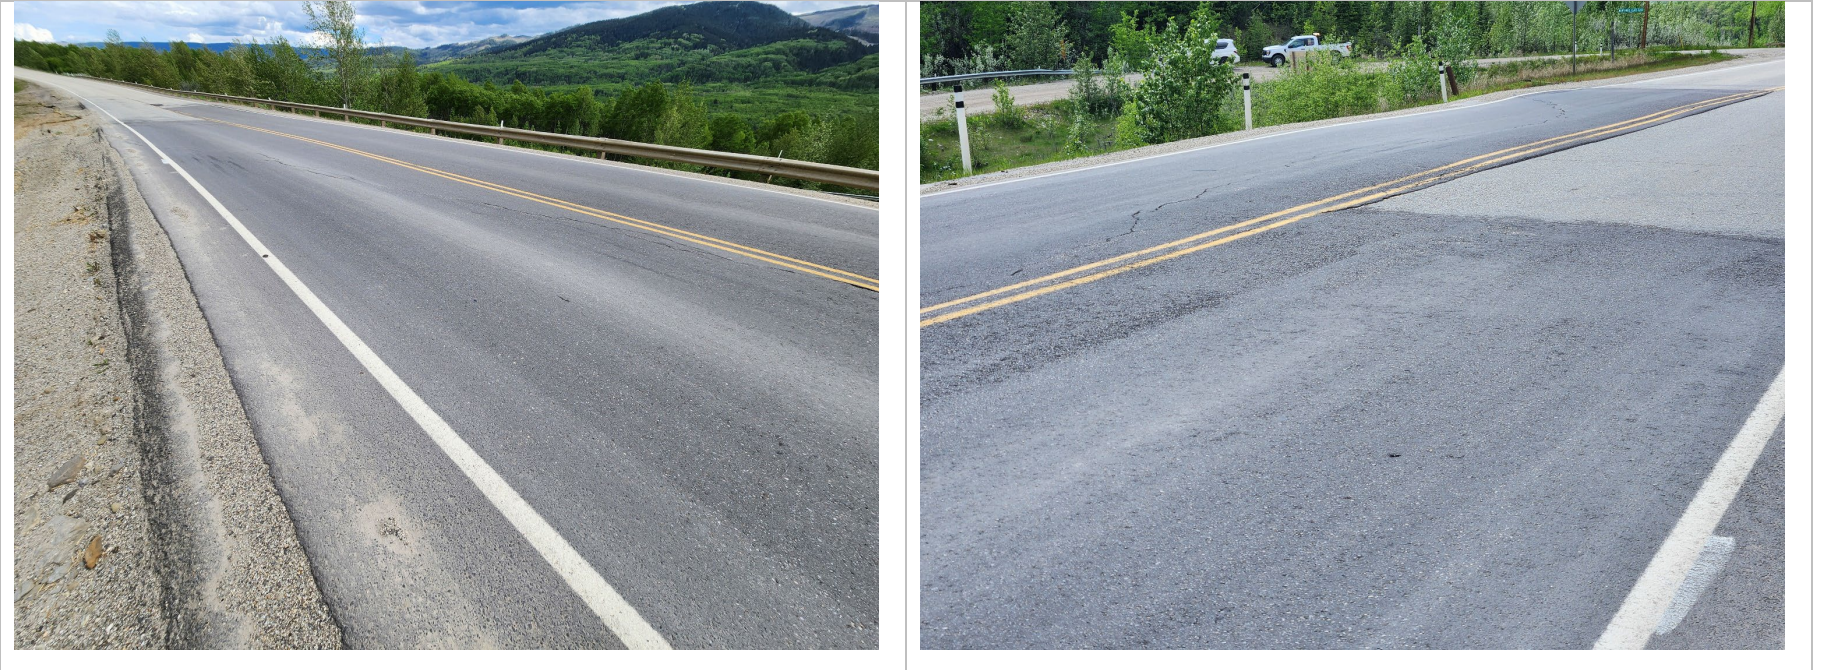
Photo 1 Cracking and settlement across Hwy 40:36 in recent pavement patch at west end of GP007 site. Photos taken June 10, 2024, facing southeast and southwest, respectively.

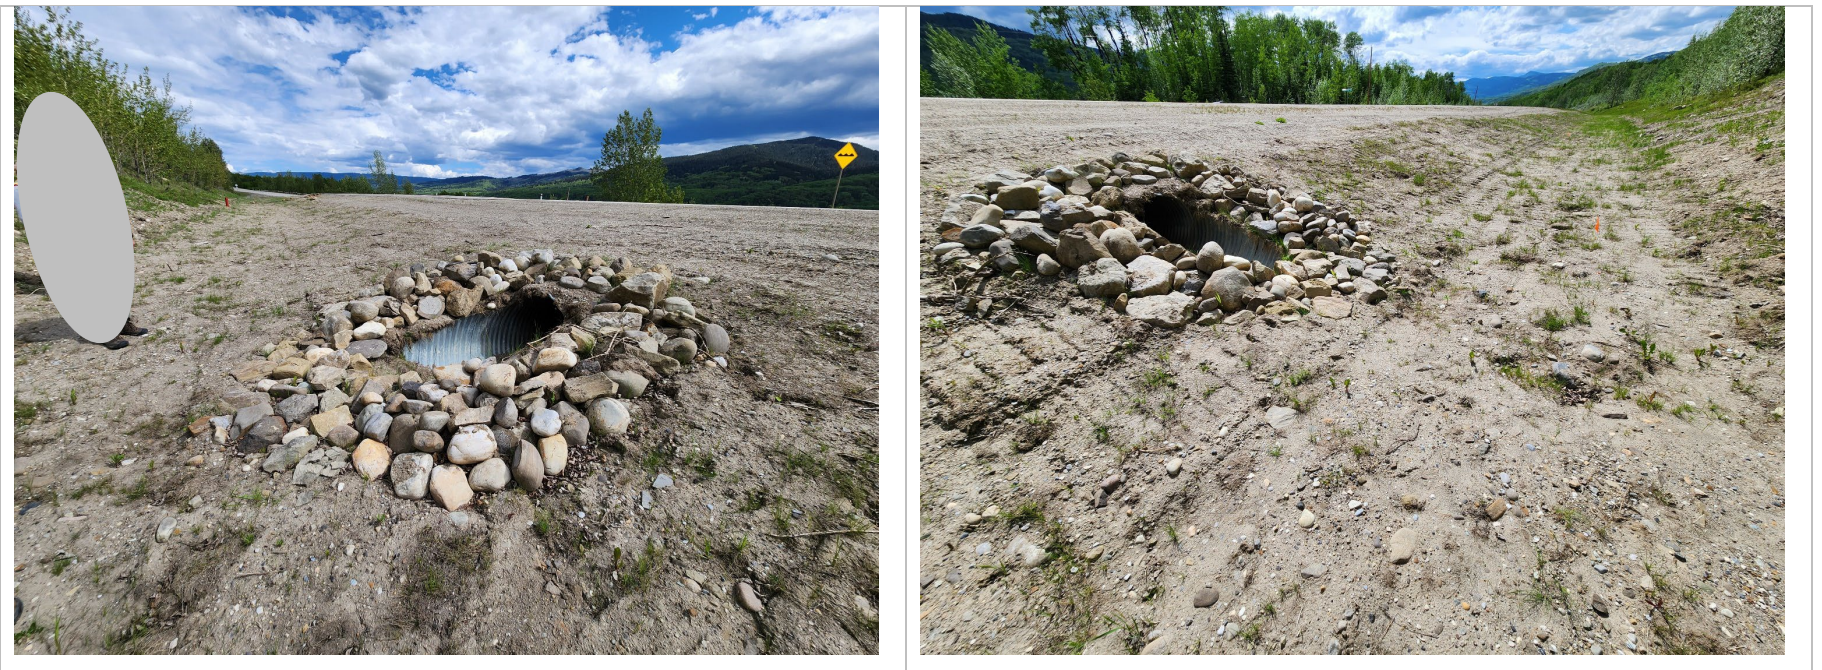
Photo 2 Ditch on north side of Hwy 40:36 near west end of GP007 site. Ditch was regarded in fall 2023. Photos taken June 10, 2024, facing southeast and southwest, respectively.

- Portion of north highway ditch at west end of site regraded in fall 2023 has not re-vegetated and there are pieces of unsecured and piled up rolled erosion control product (RECP) in the ditch (Photos 2 and 3). The RECP should be re-anchored or replaced, and the area seeded again. Estimated cost: \$10,000 to \$20,000.

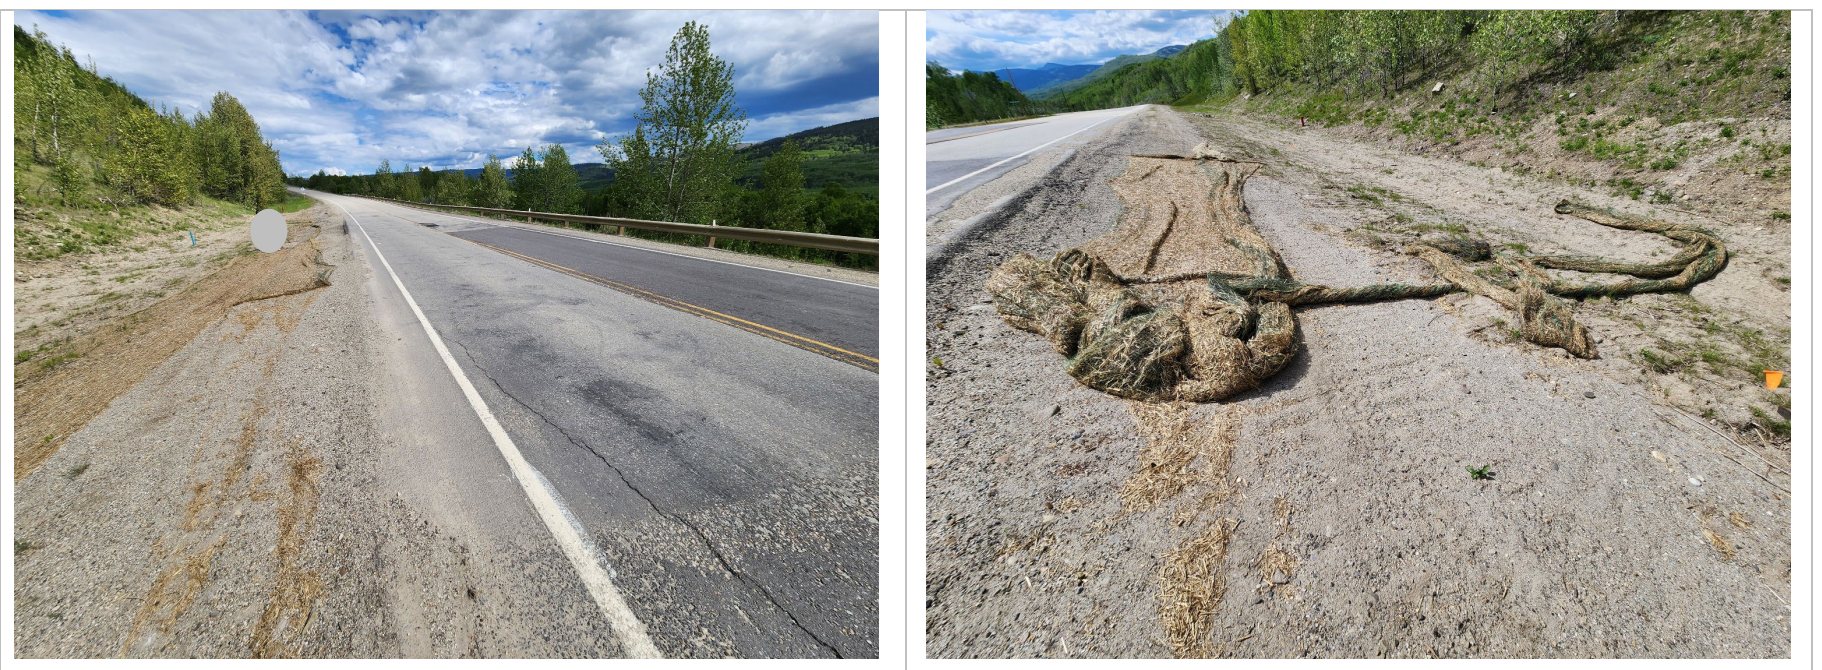
Photo 3 Ditch on north side of Hwy 40:36 near west end of GP007 site. Ditch was regarded in fall 2023. Note rolled erosion control product unsecured from ground. Photos taken June 10, 2024, facing east and west, respectively.

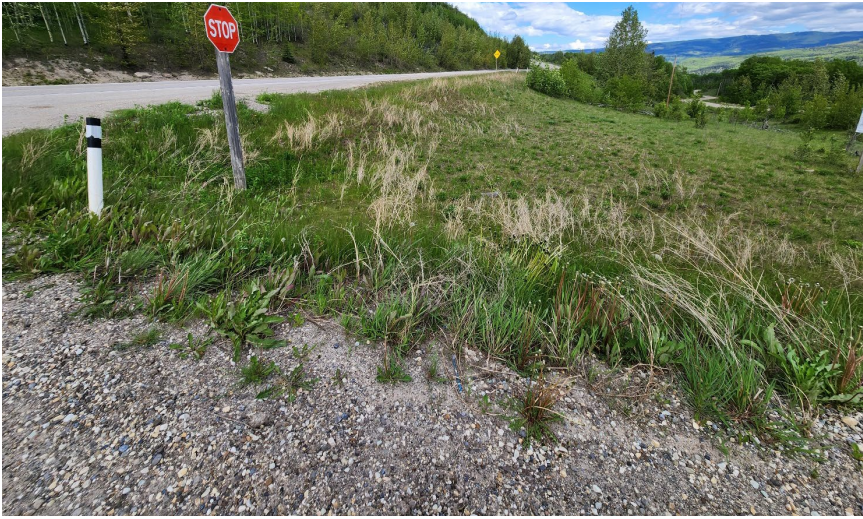
Photo 4 South side of Hwy 40:36 near west end of GP007 site. Photo taken June 10, 2024, facing northeast.

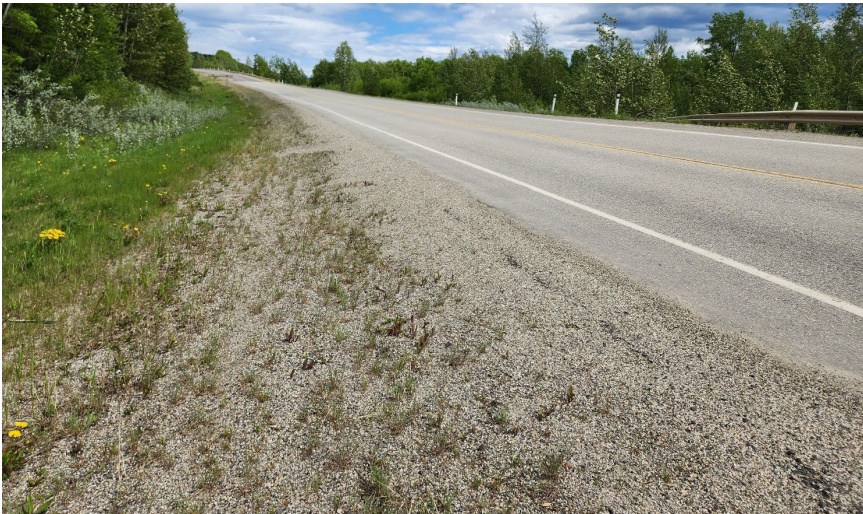
Portions of landslide that appear most active coincide with areas of high fill (below/adjacent to Wanyandie Road intersection and deep gully at eastern site limit). Slide relatively inactive near middle of site (Photo 5) and above highway.
Less active portions of slide above/north of highway may not be as influenced by fill placement or water infiltration into slide scarps at highway level. However, without any changes to the slide or highway geometry, continued movement of the lower portions of the slide or prolonged periods of wet weather causing groundwater levels to rise could eventually result in movements further upslope.
Sinkholes observed along upslope/north highway ditch, which appear to correspond with the location of a fiber optics line.
The area downslope/south of Hwy 40:36 was not visited during the 2024 inspection, but the following was previously observed by KCB in 2022: <ul style="list-style-type: none"> • A series of ridges and troughs on the slope, which are visible in historic air photos and the bare-earth light detection and ranging (LiDAR) data. It was discussed that the ridges and troughs could be the result of blocks sliding and eroding overtime becoming more dome shaped. Generally, no pattern to ridges and troughs. • A pond of water located on the mid-slope. As well as other wet spots on the slope, and ponded and flowing water in two locations on former Wanyandie Road. Note pore pressures/water levels recorded in PN-3, located along former Wanyandie Road, were above ground surface before the instrument became inoperable in 2011.

Photo 5 Pavement surface and north side of Hwy 40:36 near middle of GP007 site. Photo taken June 10, 2024, facing east.

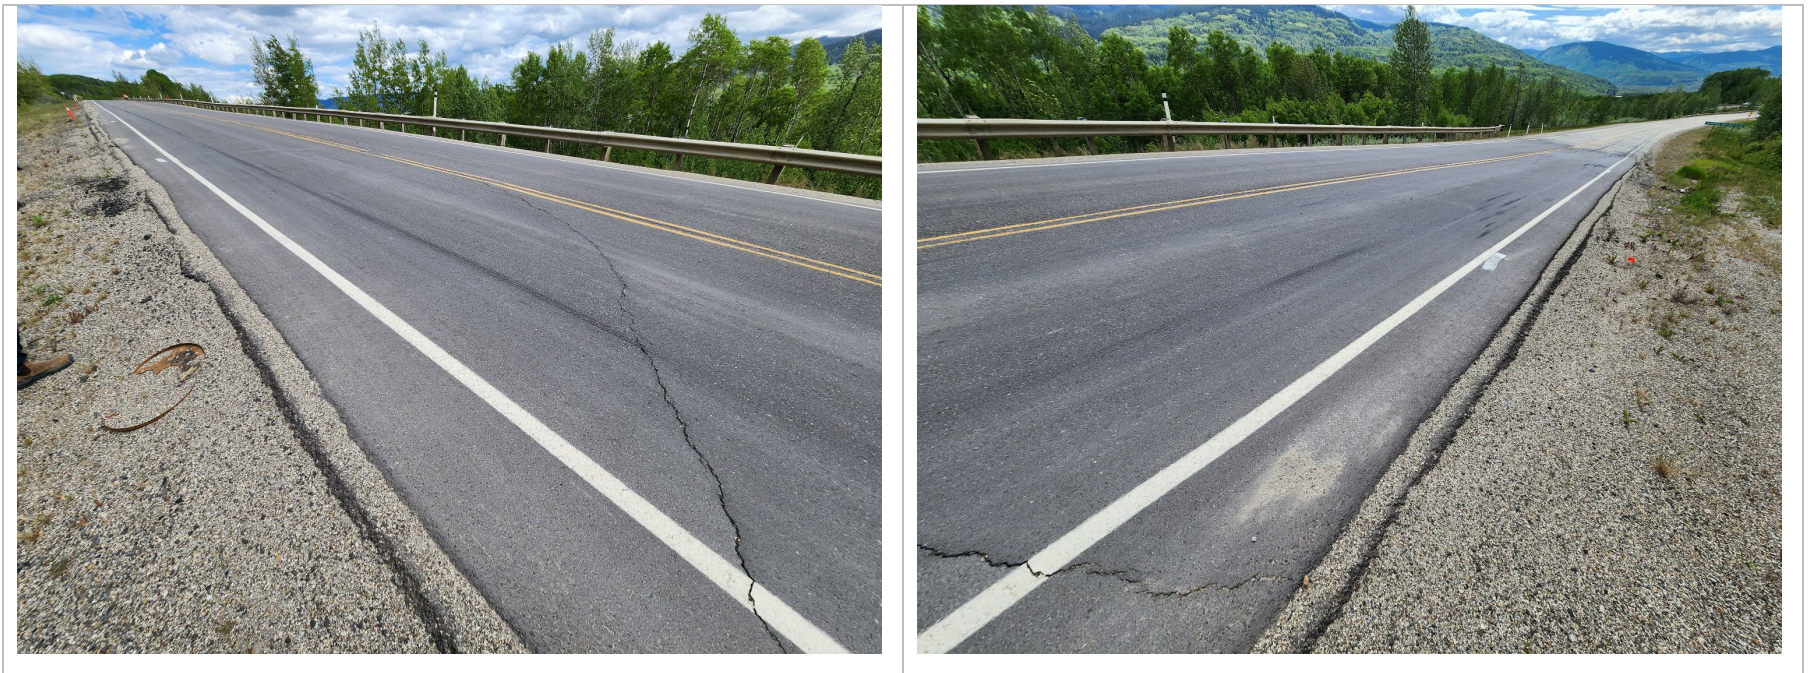
Photo 6 Cracking and settlement across Hwy 40:36 near west end of recent pavement patch at east end of GP007 site. Photos taken June 10, 2024, facing southeast and southwest, respectively.

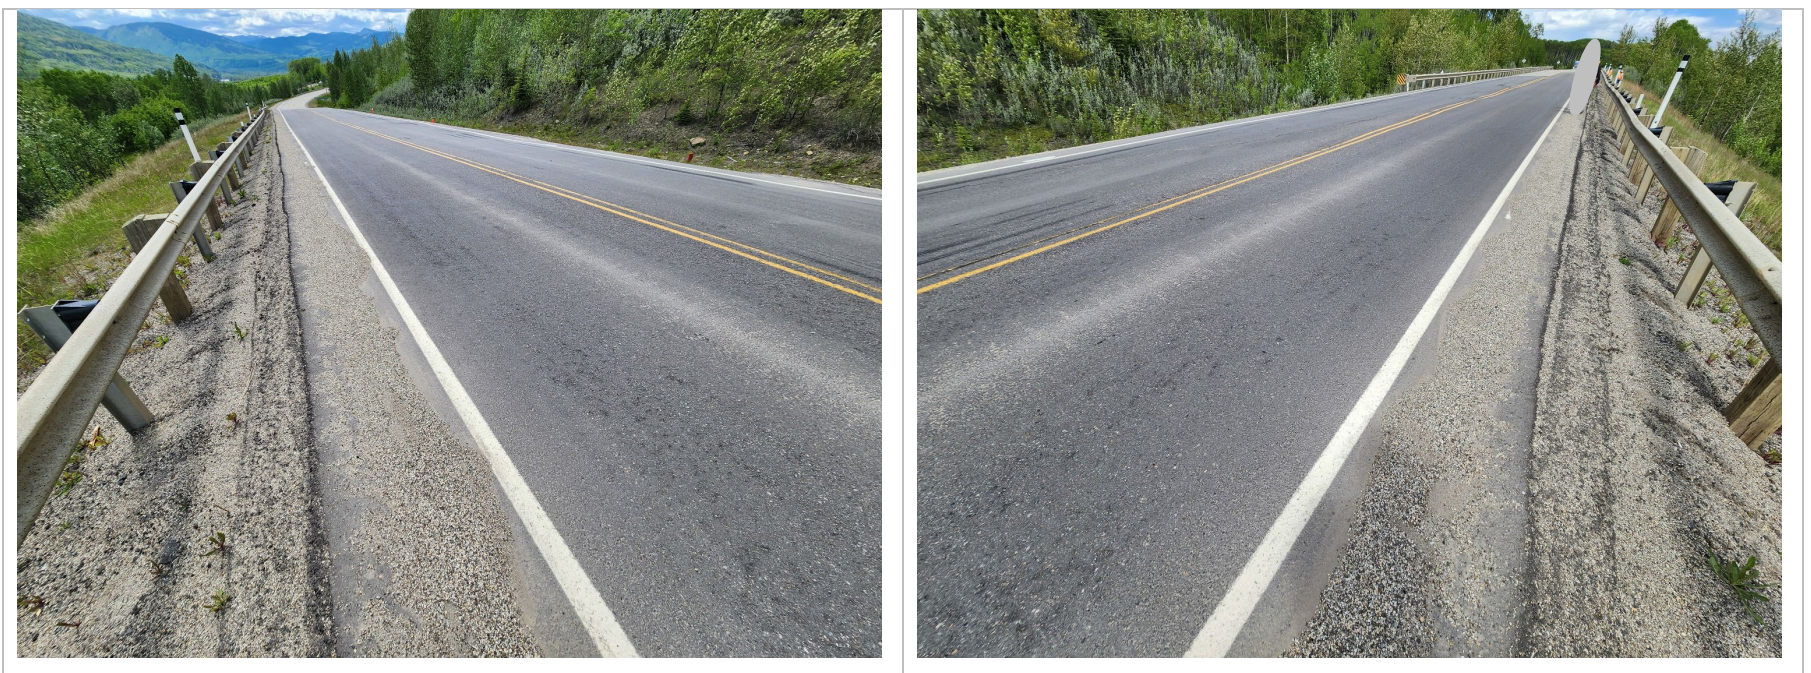
Photo 7 Cracking and settlement across Hwy 40:36 near middle of recent pavement patch at east end of GP007 site. Photos taken June 10, 2024, facing west and northeast, respectively.

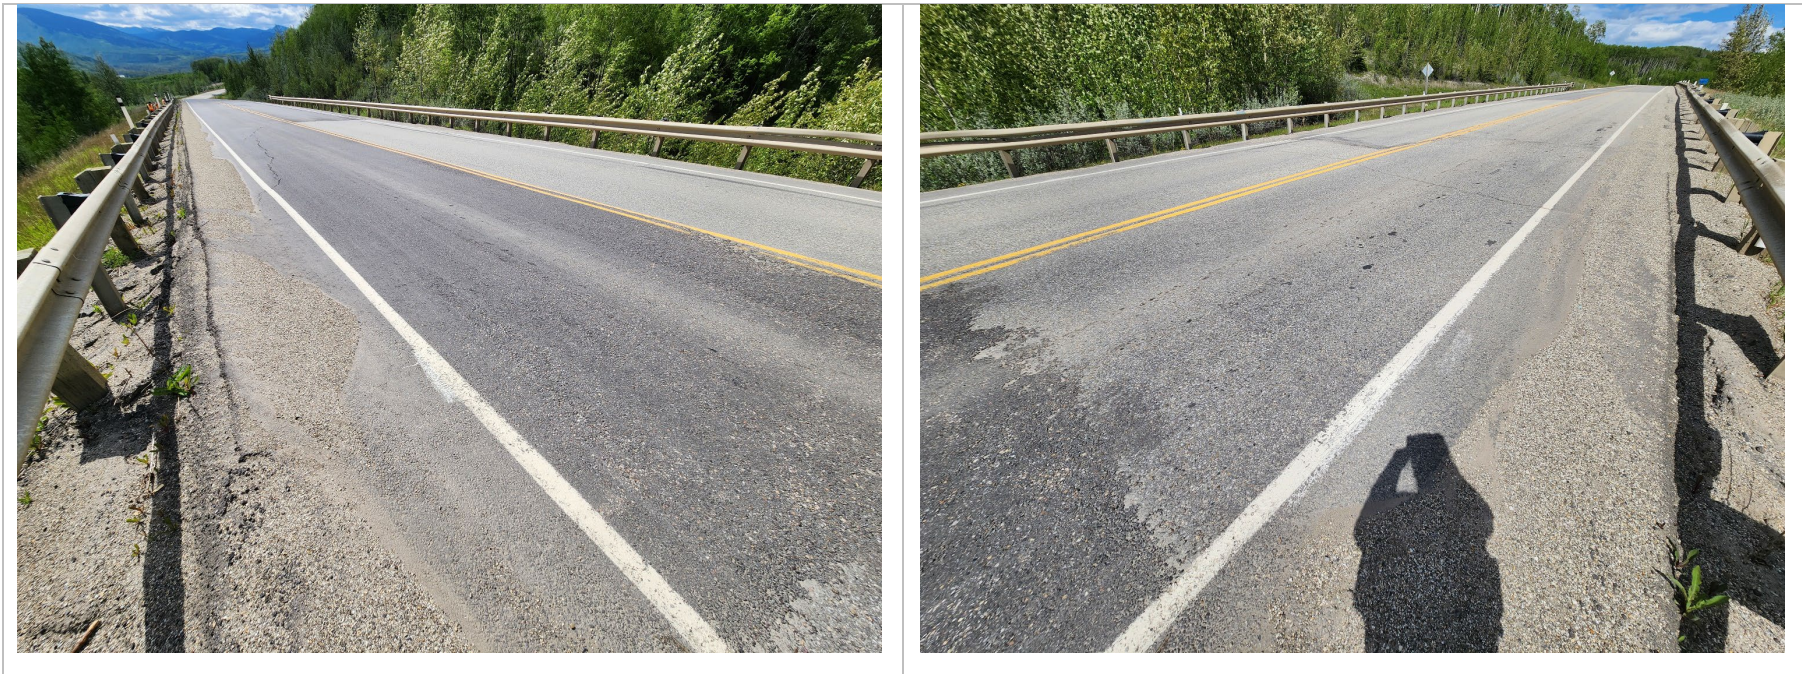
Photo 8 Cracking and settlement across Hwy 40:36 near east end of recent pavement patch at east end of GP007 site. Photos taken June 10, 2024, facing west and northeast, respectively.

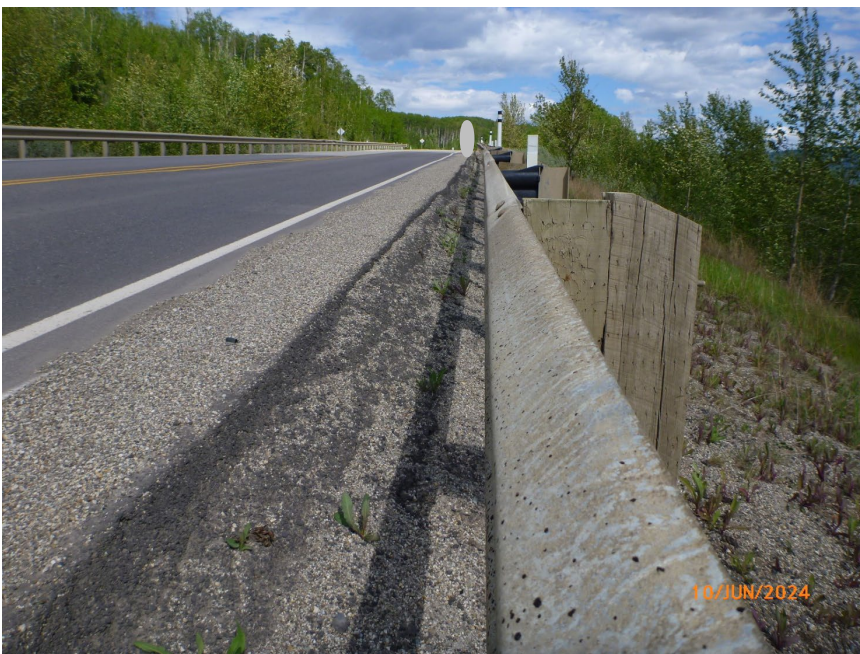
Photo 9 Guardrail on south side of highway at east end of site is low and located far from highway. Photo taken June 10, 2024, facing east.

- Guardrail on south side of highway at east end of site is low (approximately 0.5 m above pavement surface) and located too far from highway (approximately 0.6 m from edge of pavement) and may not redirect motorist back onto highway (Photo 9). There is also an approximate 0.9 m drop below guardrail that could trap a tire and some guardrail rail posts that are unsupported. Guardrail should be moved closer to pavement surface. Estimated cost: \$20,000 to \$40,000 depending on the length.

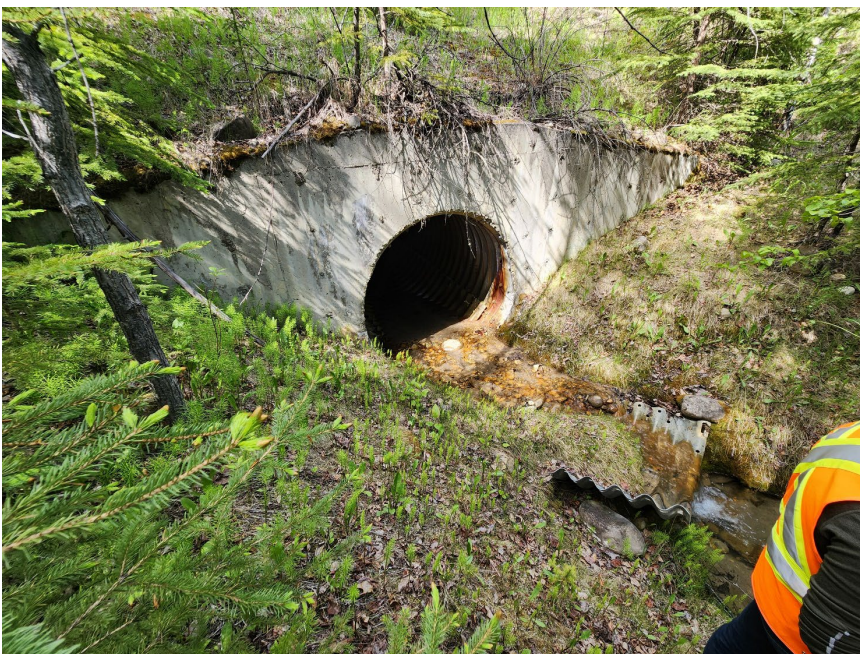
COMMENTS
Slope upslope and downslope of highway is landslide terrain.
Highway crosses deep gully/ravine and bridge-sized culvert (BF80699) at east end of site (Photo 10).
High fills located at western (Photo 4) and eastern flanks of slide with lower side-hill fills in middle of slide area.
Cracking observed in pavement surface at west and east ends of site as follows: <ul style="list-style-type: none"> • At west end of site (Photo 1): cracking across both lanes through recent pavement patch to north shoulder, which was similar to previous inspection. Some skid marks observed in both lanes.. • At east end of site (Photos 6 to 8): cracking and settlement across both lanes through recent pavement patch, which was more noticeable than previous inspection. SI20-03 downslope of this sheared between the fall of 2023 and spring of 2024 readings. Some skid marks observed in westbound lane. <ul style="list-style-type: none"> ○ It is noted that while preparing this report a call-out inspection was completed in August 2024 due to increased pavement distress at the east end of the site, including a circular depression or sinkhole along highway centerline. Additional observations will be documented in the call-out inspection report to be issued in fall 2024. ○ Ongoing movement at east end of site could eventually impact bridge-size culvert (BF80699) (Photo 10).

Photo 10 Outlet of culvert at east end of GP007 site. Photo taken June 10, 2024, facing northeast.
