July 15, 2024

## CON0022166 Peace Region (Grande Prairie District – South) GRMP Instrumentation Monitoring Site GP007; H40:36, km 29.339 Wanyandie Road Slide Section C – 2024 Spring Readings

Hwy 40:36, km 29.339

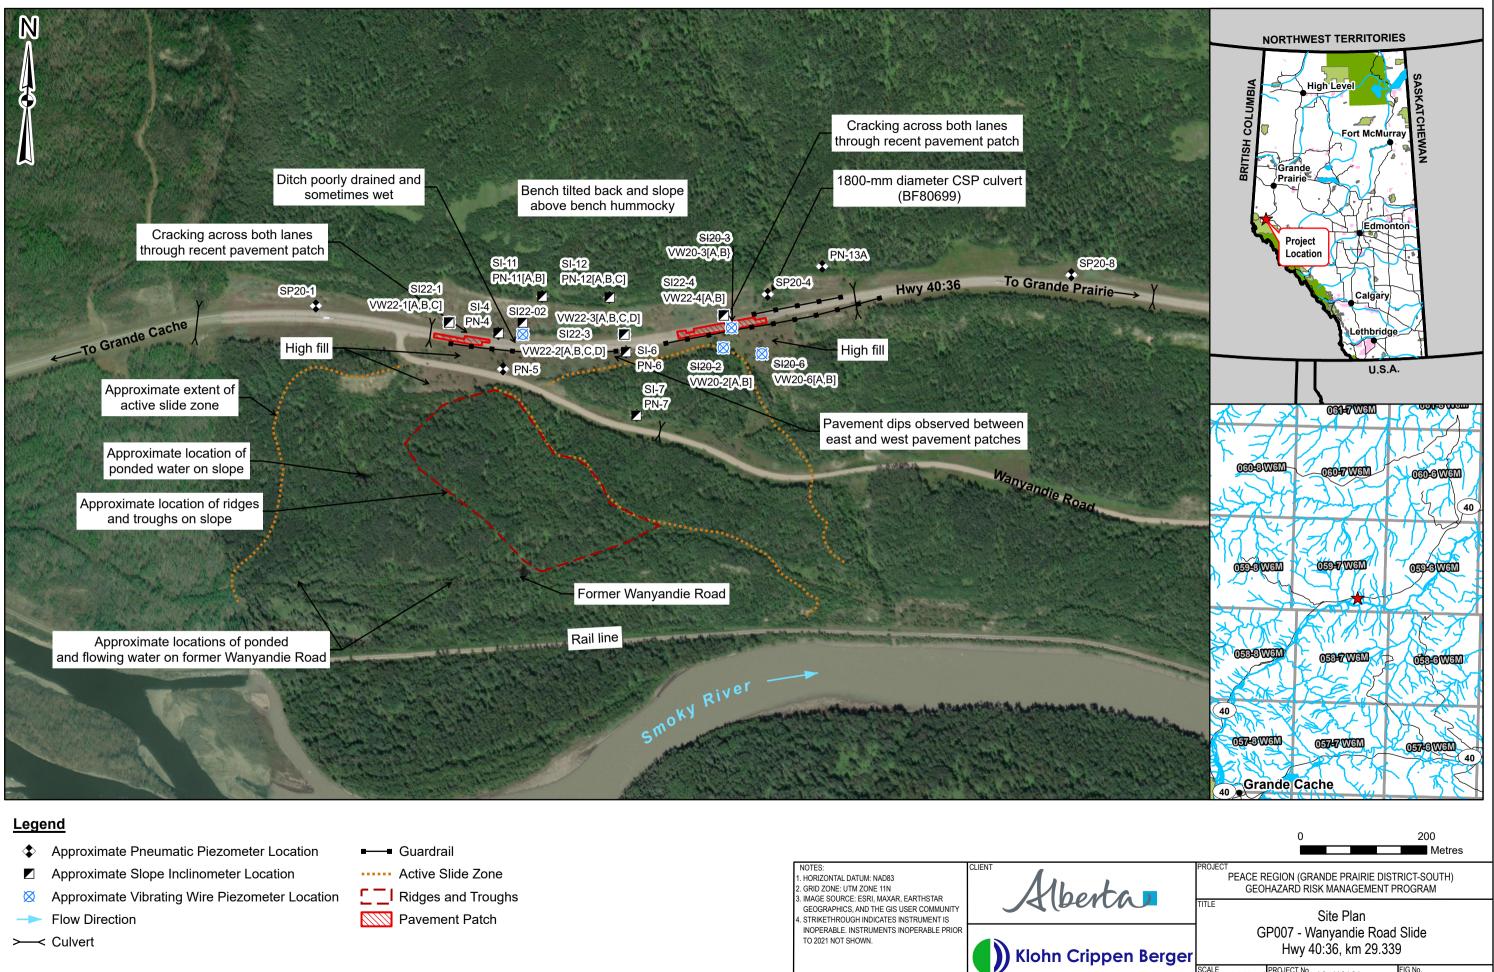
ppen Berger		1111 10:00, 111 20:000	, ,
	<sup>SCALE</sup> 1:6,000	PROJECT №. A05116A01	FIG No. 1

Based on the surface expression of the 2005 bare-earth LiDAR data and historic air photos, the most active slide terrain is located downslope of Hwy 40:36 and Wanyandie Road at the western site limit as shown on Figure 1. In 2022, a series of ridges and troughs were observed, which could be the result of blocks sliding and eroding overtime with vegetation growth, becoming more rounded. The direction of movement recorded in SI98-2 and SI98-5 was towards the area of ridges and troughs before they sheared.

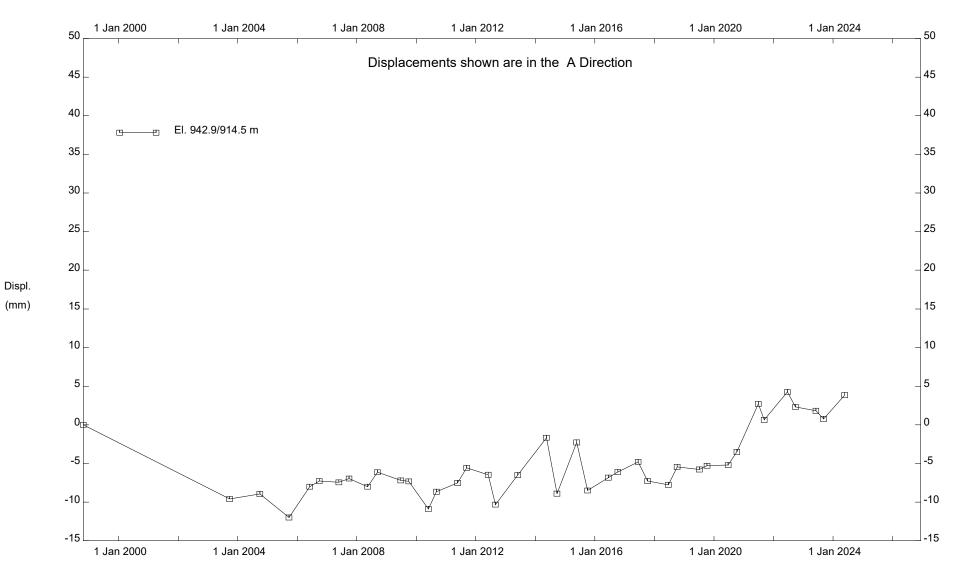
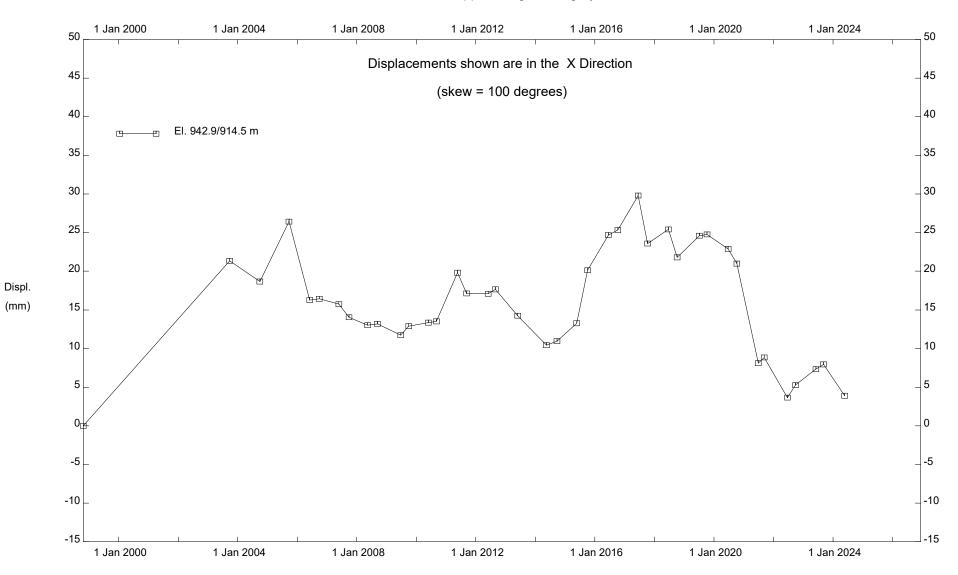
GP007; H40:36, Wanyandie Road Slide, Inclinometer SI98-07

Near the middle of the site, no discernible movement has been recorded in SI98-6, SI98-7, SI03-11, or SI03-12 since installation. However, some possible movement may have been recorded in SI98-7 at an approximate depth of 8.5 m (elevation 935 m) and distributed movement along the entire length of SI03-11. As discussed in Section 1.1, SI98-6, SI03-11, and SI03-12 also may not have been installed deep enough. SI98-6 is located along the south (northbound) shoulder of the highway, SI03-11 and SI03-12 are located above the highway along the backslope, and SI98-7 is located below the highway along Wanyandie Road.

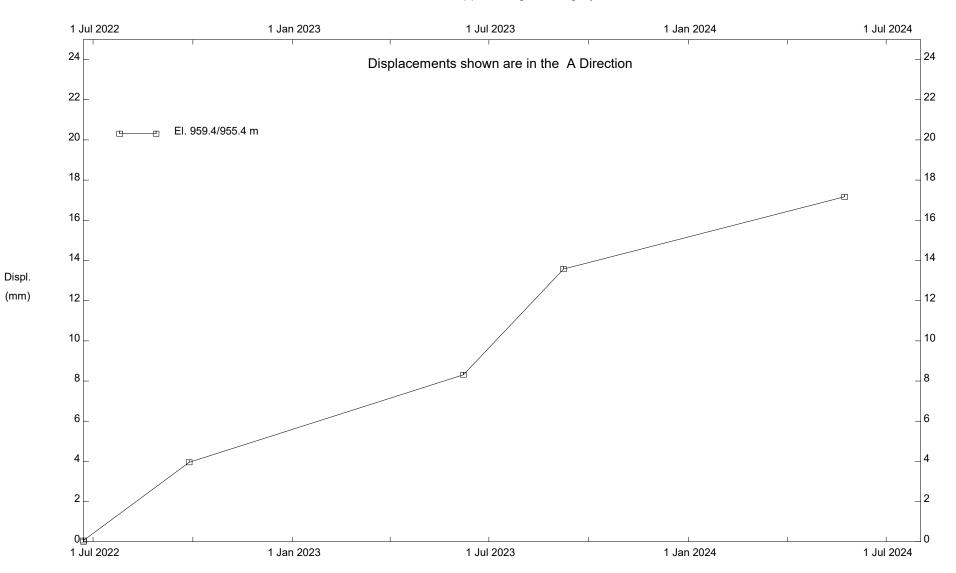
Peace Region - Grande Prairie South, Inclinometer SI22-02

In May 2022, two deeper SIs (SI22-2 and SI22-3) were installed in the north (westbound) highway ditch to assess if there were deeper failure planes in the middle of the site. SI22-2 has recorded distributed movement from an approximate depth of 6.6 m to 10.6 m below ground surface (elevation 959.4 m to 955.4 m) which is confined to the colluvium/till unit. SI22-3 appears to have recorded post-installation casing settlement/flexure at approximately 6 m below ground surface, which may be caused by grout loss in a more granular zone in the colluvium unit.

overall rate of 8.9 mm/year. Movement at this elevation appears to be localized to this instrument, as it has not been recorded in SI98-4 or SI03-11, located west and north of SI22-2, respectively. Ground cracking has been observed in the north (westbound) highway ditch during previous site visits, and fluctuations in recorded movement rate may be attributed to seasonal variations in precipitation or freshet infiltration.

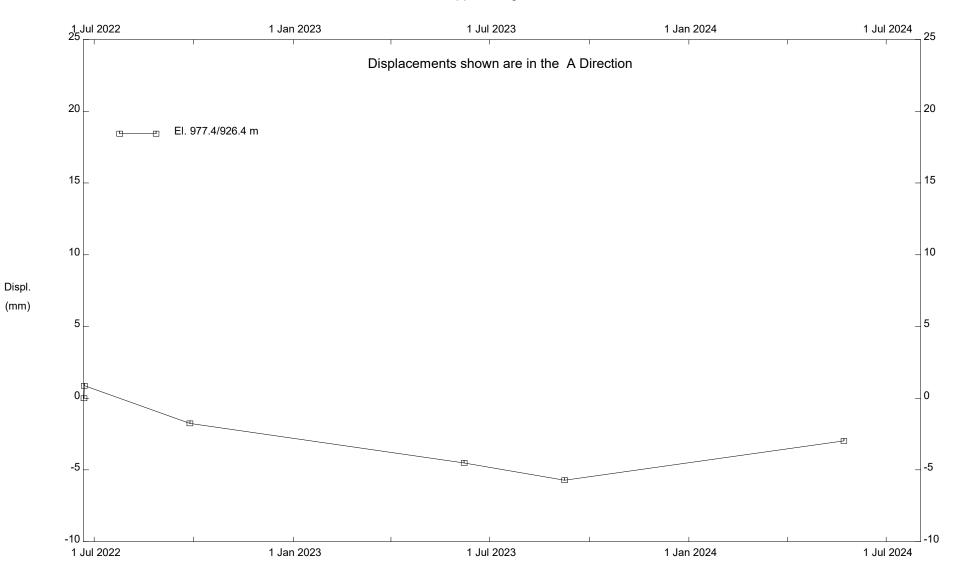
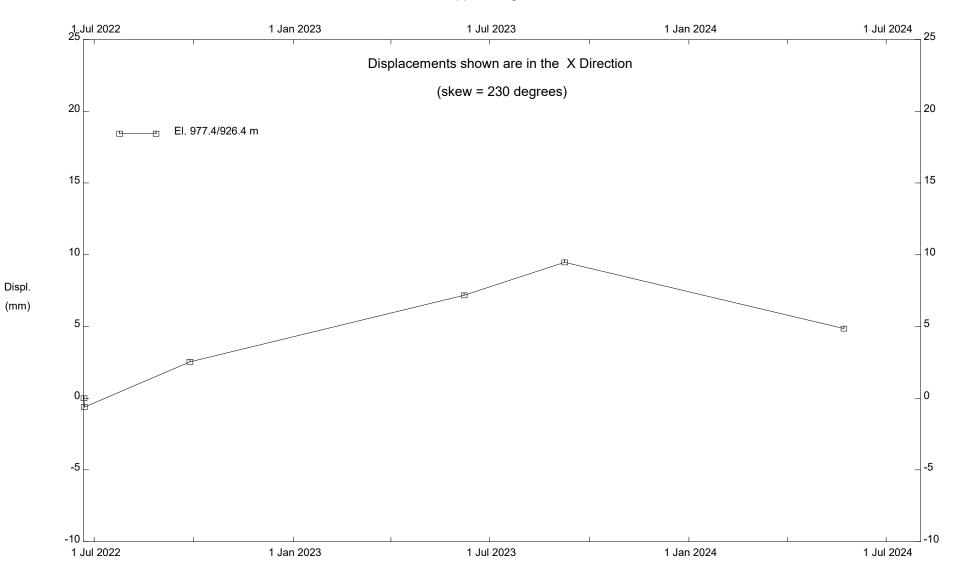
GP007; H40:36, Wanyandie Road Slide, Inclinometer SI22-04

In May 2022, a deeper SI (SI22-4) was installed to assess if a deeper failure plane was present at the eastern extent of the site. Distributed movement is being recorded along the entire length of the instrument (i.e., from near ground surface to the base of the instrument) since installation, with no discrete movement zones.

As of the spring of 2024, SI20-2, SI20-3, and SI20-6 have sheared at an approximate elevation of 956.5 m, 956.2 m, and 940.0 m, respectively, with an overall resultant towards the south to southeast. The movement recorded in these instruments appears to be in response to ground loading by the high fill at this location in the ravine on the east side of the site and is below the water level recorded in nearby SP20-4 (between elevation 957.5 m and 958.0 m). There could be seasonal weakening due to rising and falling groundwater levels. Alternatively, the extent of valley-wall instability could be such that natural slope movements have A- and B-direction components due to the shape of the basal failure plane, potentially more stable zones, or other unknown factors. Since these instruments were terminated in clay till (not bedrock), a deeper SI (SI22-4) was installed by KCB in 2022 into bedrock to assess if deeper movements are occurring at this location. Distributed movement has been recorded along almost the entire depth of SI22-4 at an overall approximate rate of 2.5 mm/year, but no discrete zones of movement have been recorded.
