December 2, 2024

#### CON0022166 Peace Region (Grande Prairie District – South) GRMP Instrumentation Monitoring Site GP007; H40:36, km 29.339 Wanyandie Road Slide Section C – 2024 Fall Readings

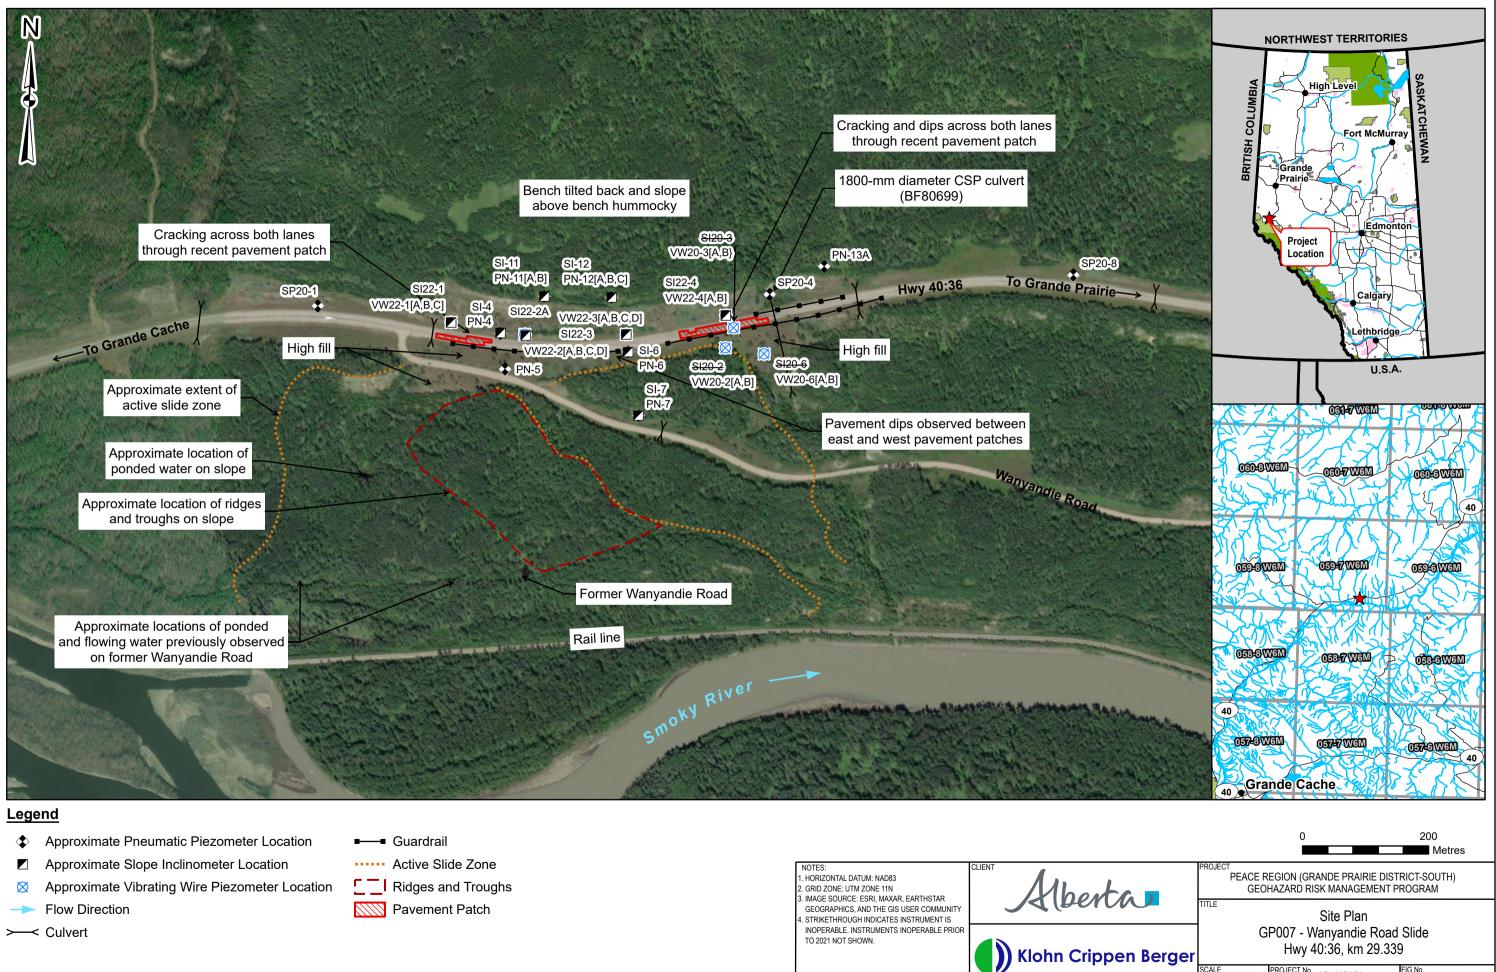
pen Berger	11wy <del>1</del> 0.30, km 23.303						
	<sup>SCALE</sup> 1:6,000	PROJECT No. A05116A01	FIG No. 1

Based on the surface expression of the 2005 bare-earth LiDAR data and historic air photos, the landslide appears most active downslope of Hwy 40:36 and Wanyandie Road at the west end of the site as shown on Figure 1. In 2022, a series of ridges and troughs were observed, which could be the result of blocks sliding and eroding overtime with vegetation growth, becoming more rounded. The direction of movement recorded in SI98-2 and SI98-5 was towards the area of ridges and troughs before they sheared.

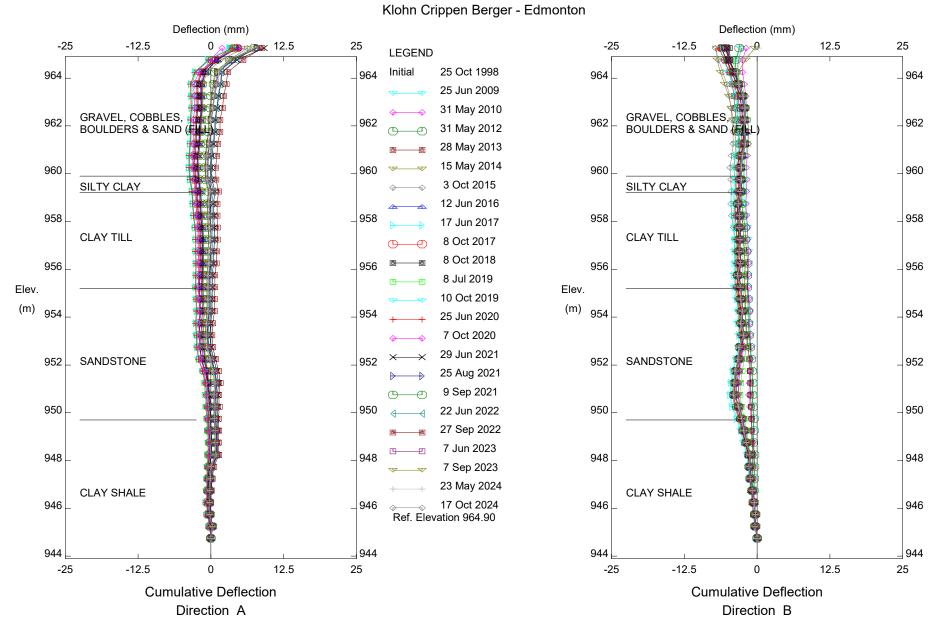
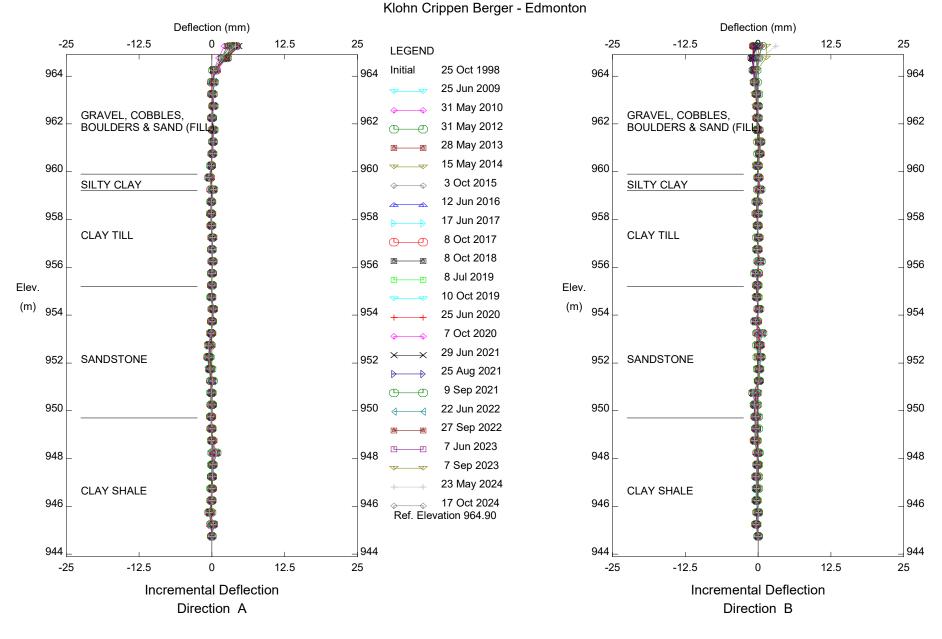
GP007; H40:36, Wanyandie Road Slide, Inclinometer SI98-04

As discussed above, no discernible movement has been recorded in SI98-4 installed upslope of SI98-5 or SI98-6 near the middle of the landslide, but these instruments may not have been installed deep enough. Three deeper SIs (SI22-1, SI22-2, and SI22-3) were installed and anchored in bedrock by KCB in 2022 near the west end and middle of the site to assess if deeper movements are occurring at these locations. No discernible movement has been recorded in SI22-1 or SI22-3 (excluding potential post-installation casing settlement/flexure). Distributed movement has been recorded in SI22-2 from an approximate depth of 6.6 mbgs to 10.6 mbgs (elevation 959.4 m to 955.4 m) at an overall rate of less than 10 mm/year. Movement at this elevation appears to be localized to this instrument, as it has not been recorded in SI98-4 or SI03-11, located west and north/upslope of SI22-2, respectively. Ground cracking has been observed in the north highway ditch during previous site visits, and fluctuations in recorded movement rate may be attributed to seasonal variations in precipitation or freshet infiltration.

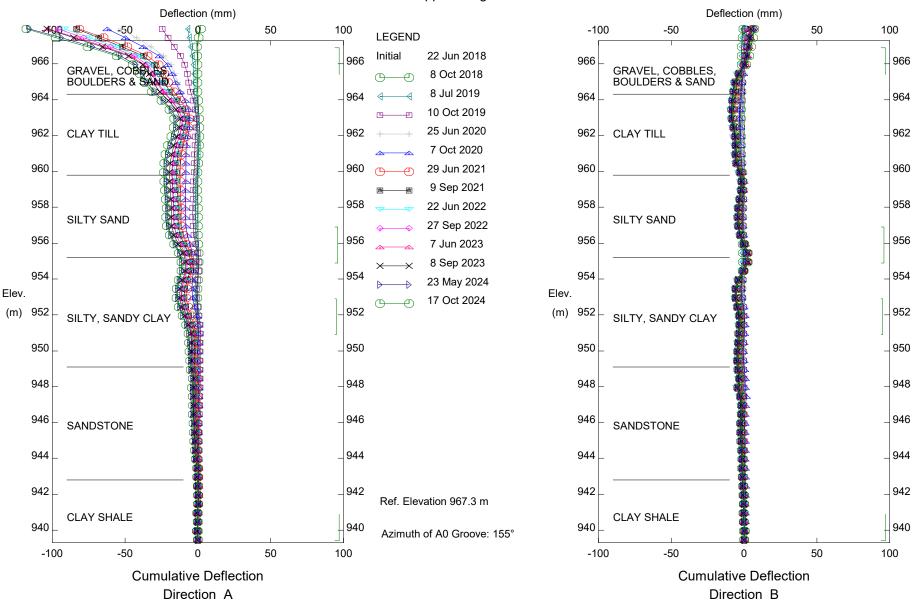
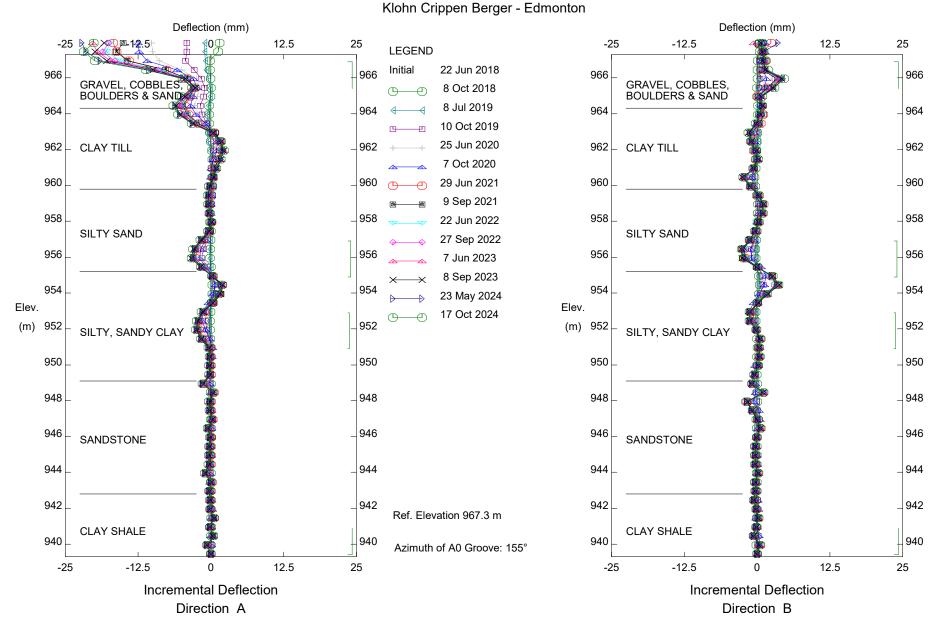
GP007; H40:36, Wanyandie Road Slide, Inclinometer SI98-06

It is noted that the data for SI98-6, SI98-7, and SI03-12 is noisy and difficult to interpret. Based on the absolute plots for these instruments, SI98-6 has kinks in the casing at an approximate depth of 11.9 m and 13.9 m below ground surface (mbgs), and SI98-7 and SI03-12 are tilted approximately 1.3 m and 1.5 m in the A direction, respectively. SI98-12 has also been re-sleeved twice (i.e., had a small-diameter casing installed in it) (dates unknown).

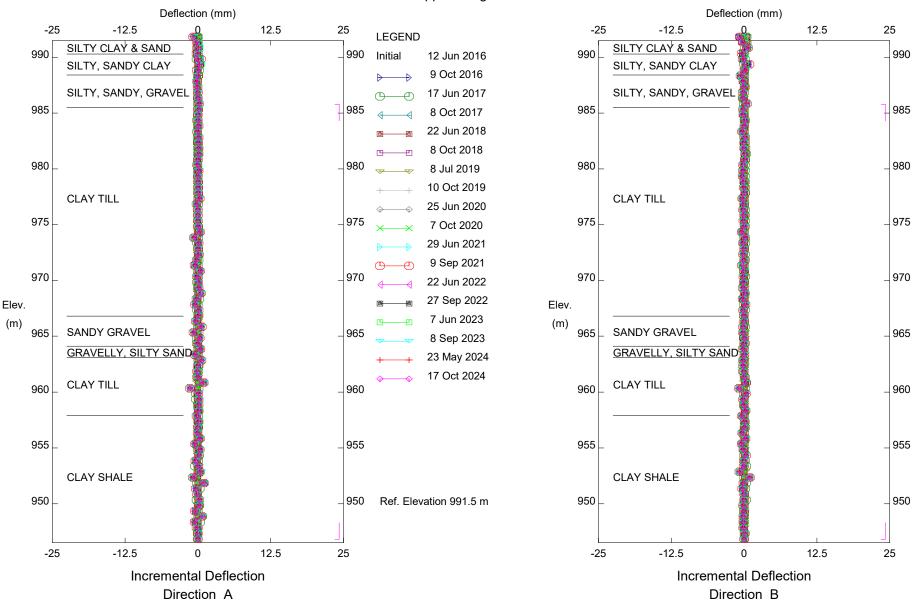
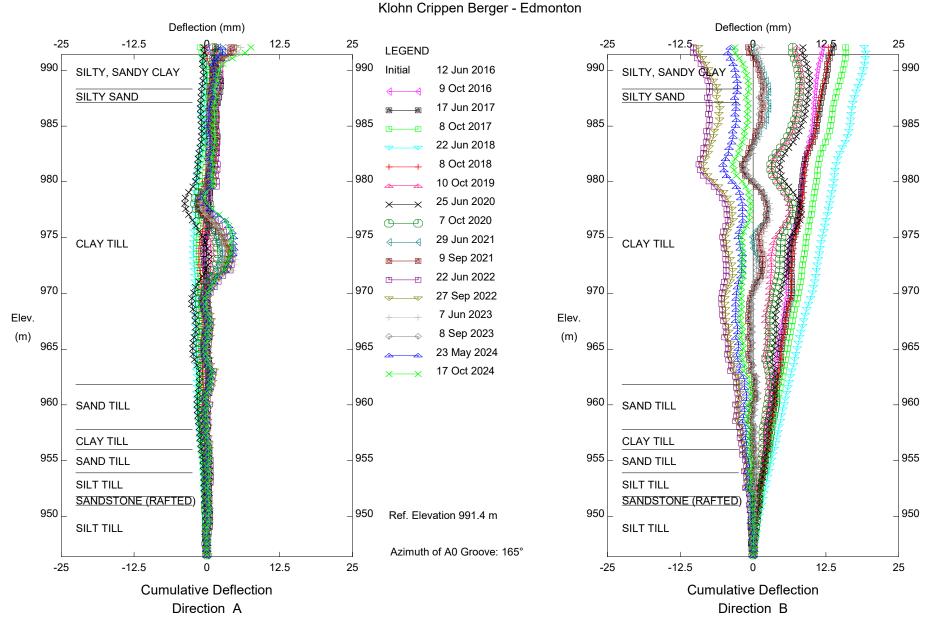
GP007; H40:36, Wanyandie Road Slide, Inclinometer Sl03-11

<sup>4</sup>A large data shift was previously recorded in SI03-11 between the May 2015 and June 2016 readings when the SI reading equipment was changed by the previous consultant. The data obtained by KCB is consistent with the data obtained after June 2016, so the instrument was re-initialized to the June 2016 reading.

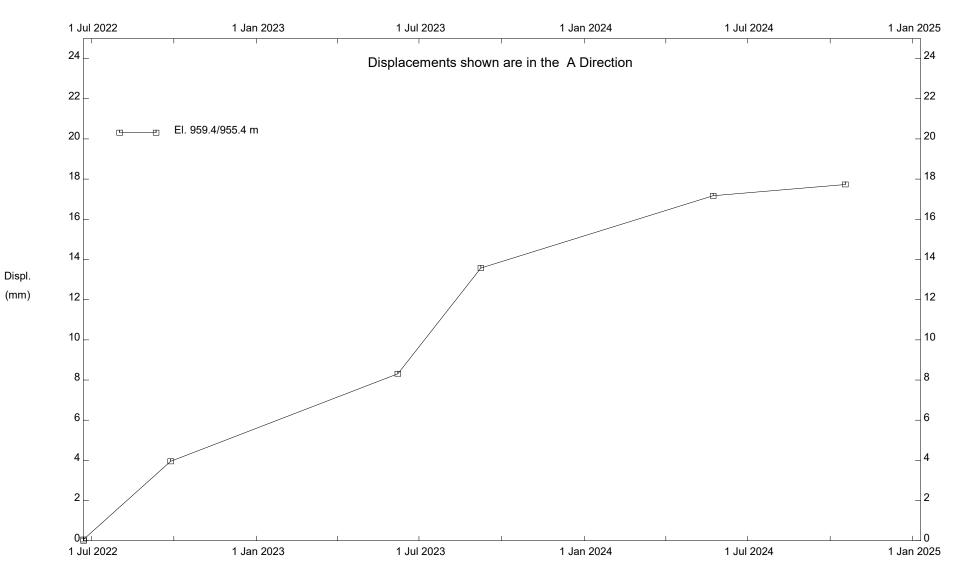
Peace Region - Grande Prairie South, Inclinometer SI22-02

As discussed in Section 1.1, SI98-6, SI03-11, and SI03-12 may not have been installed deep enough. In May 2022, two deeper SIs (SI22-2 and SI22-3) were installed in the north highway ditch to assess if deeper movements are occurring near the middle of the site. Distributed movement has been recorded in SI22-2 from an approximate depth of 6.6 mbgs to 10.6 mbgs (elevation 959.4 m to 955.4 m), which is confined to the colluvium/till unit, and post-installation casing settlement/flexure has been recorded in SI22-3 to an approximate depth of 6 mbgs, which may be caused by grout loss in a more granular zone in the colluvium unit.

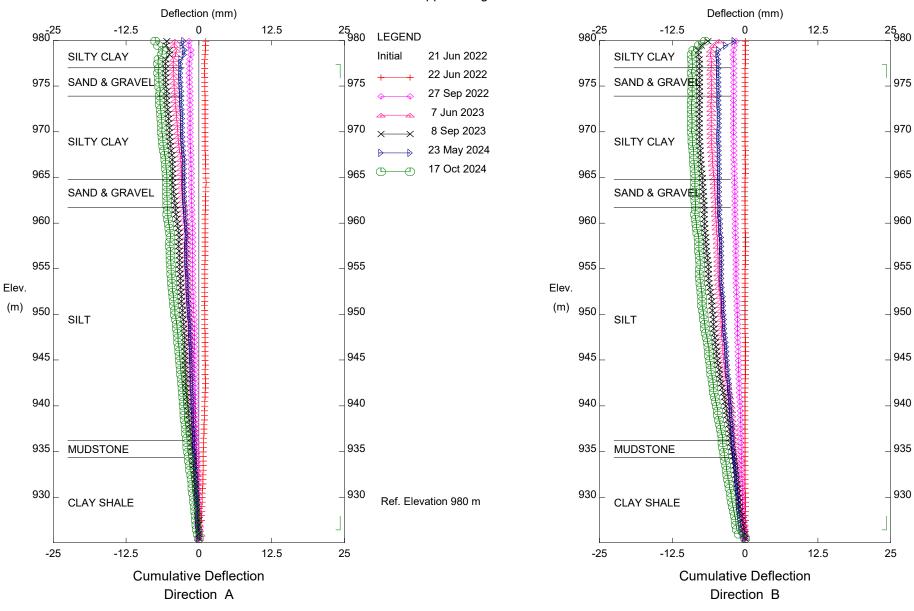
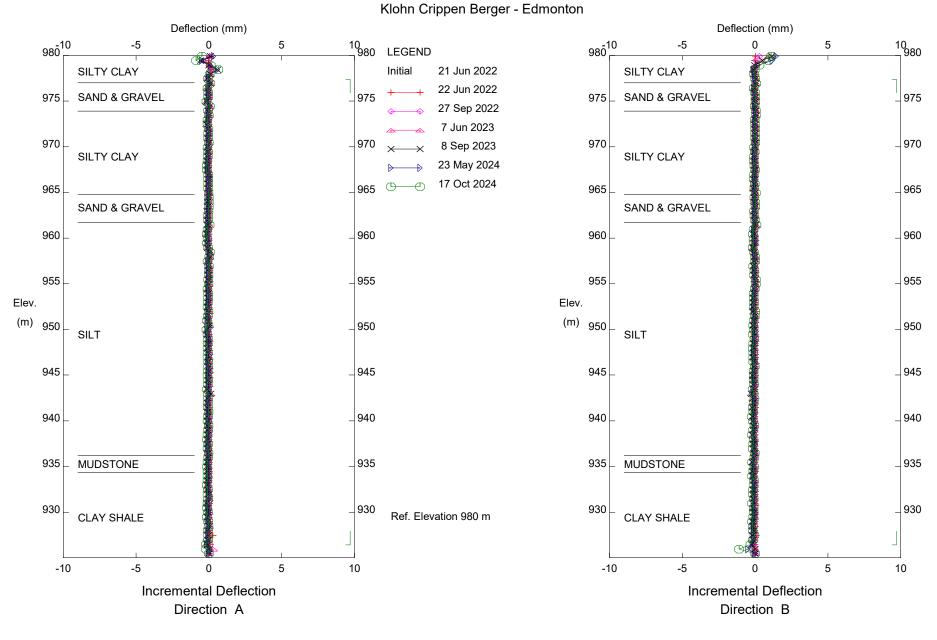
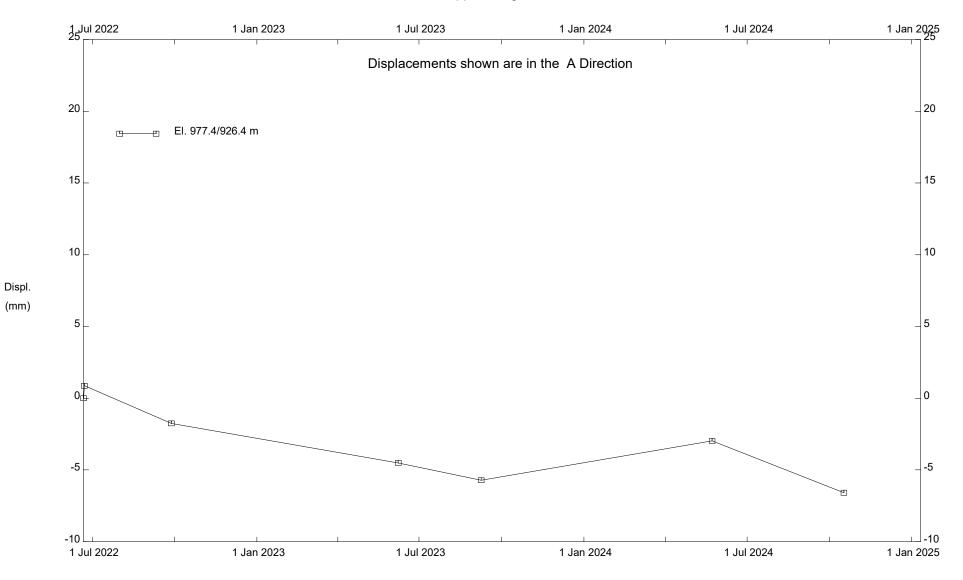
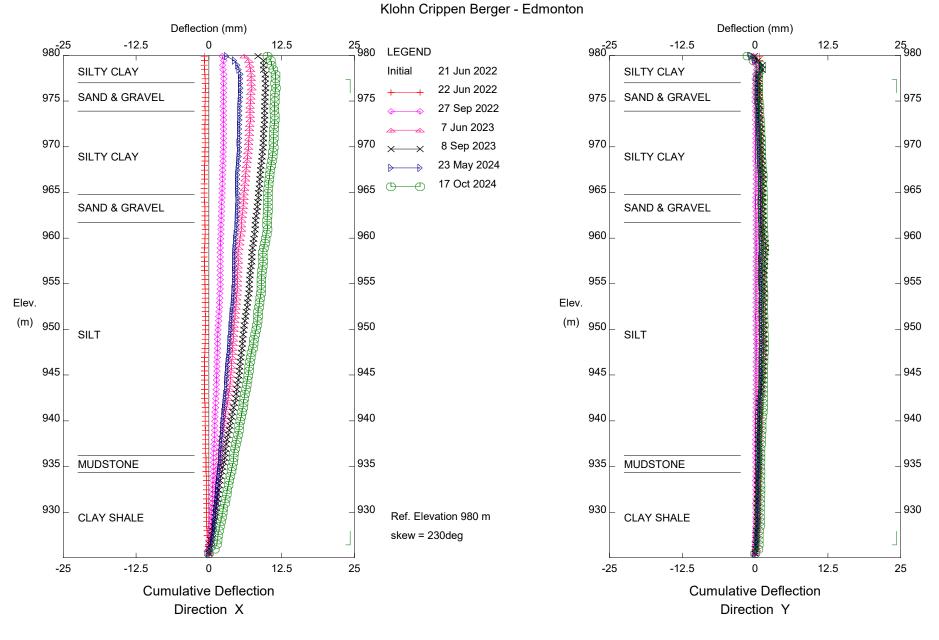
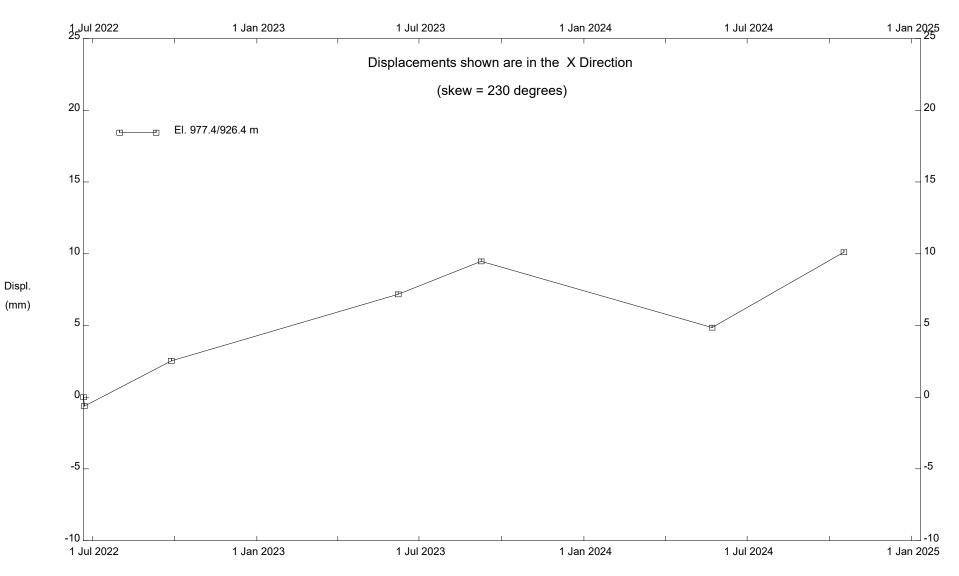
GP007; H40:36, Wanyandie Road Slide, Inclinometer SI22-04

In May 2022, a deeper SI (SI22-4) was installed on the north side of the highway to assess if deeper movements are occurring at the east end of the site. Distributed movement is being recorded along the entire length of the instrument (i.e., from near ground surface to the base of the instrument) since installation, with no discrete movement zones.

southeast. The movement recorded in these instruments appears to be in response to ground loading by the high fill at this location in the ravine on the east side of the site and is below the water level recorded in nearby SP20-4 (between elevation 957.5 m and 958.0 m). There could be seasonal weakening due to rising and falling groundwater levels. Alternatively, the extent of valley-wall instability could be such that natural slope movements have A- and B-direction components due to the shape of the basal failure plane, potentially more stable zones, or other unknown factors. Since these instruments were anchored in clay till (not bedrock), a deeper SI (SI22-4) anchored in bedrock was installed by KCB in 2022 to assess if deeper movements are occurring at this location. Distributed movement has been recorded along almost the entire depth of SI22-4 at an overall approximate rate of less than 5 mm/year, but no discrete zones of movement have been recorded.
