**PEACE REGION
(GRANDE PRAIRIE DISTRICT – SOUTH) GRMP**

SITE INSPECTION FORM

SITE NUMBER AND NAME: GP008 Road Surface Slumping (2.5 km North of McIntyre Mine)		HIGHWAY & KM: 40:36, 16.365 and 17.139	PREVIOUS INSPECTION DATE: June 14, 2022	INSPECTION DATE: June 10, 2024
LEGAL DESCRIPTION:	NAD 83 COORDINATES:		RISK ASSESSMENT:	
	UTM	Northing	Easting	
SE 15-58-08-W6M	11	5986982	362802	West Slide: PF: 8 CF: 4 TOTAL: 32
SW 14-58-08-W6M	11	5987018	363134	Middle Slide: PF: 8 CF: 4 TOTAL: 32
SW 14-58-08-W6M	11	5987028	363196	East Slide: PF: 8 CF: 5 TOTAL: 40
NW 14-58-08-W6M	11	5987195	363778	ATCO Slide: PF: 8 CF: 4 TOTAL: 32
AVERAGE ANNUAL DAILY TRAFFIC (AADT): 820 (East) & 820 (West) (Reference No. 70000788, 2023)			CONTRACT MAINTENANCE AREA (CMA): 504

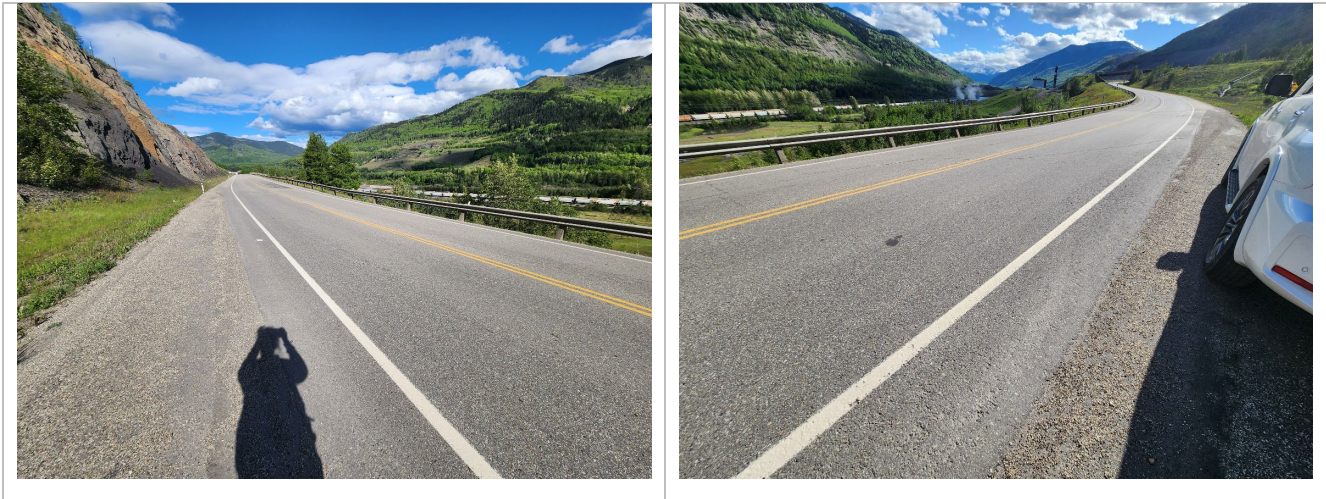
West Slide (Photos 1 and 2):

- Cracking in northbound lane that extends diagonally on either end across both lanes of highway.
- There appears to be a subtle dip or low spot in pavement surface just west of slide.

Photo 1 Cracking in pavement surface of Hwy 40:36 at east slide area. Photos taken June 10, 2024, facing southeast and southwest, respectively.

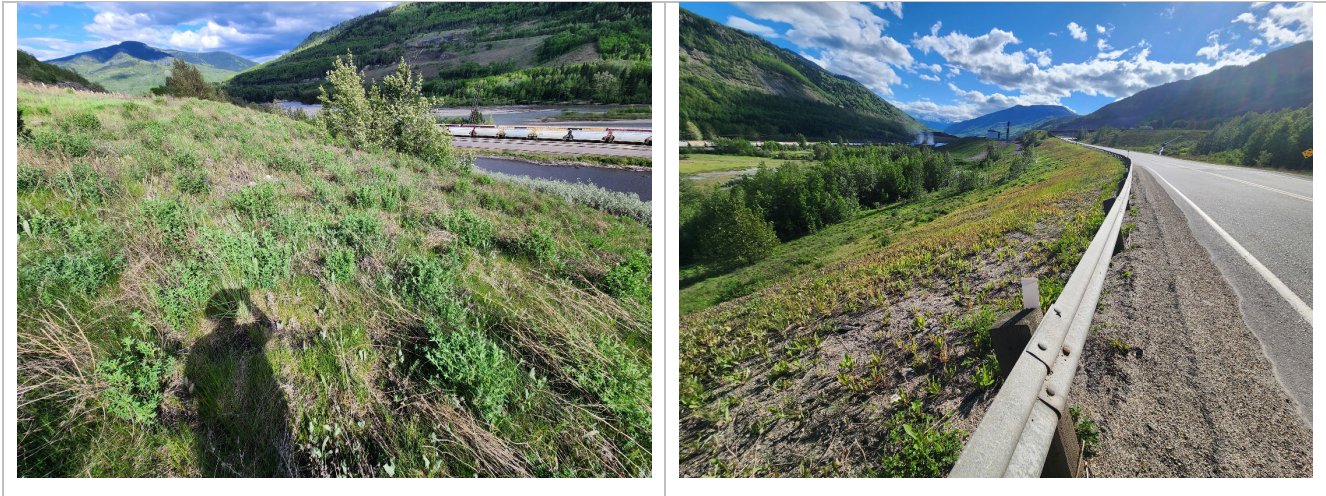
Photo 2 Slope on south side of Hwy 40:36 at west slide area. Photos taken June 10, 2024, facing southeast and southwest, respectively.

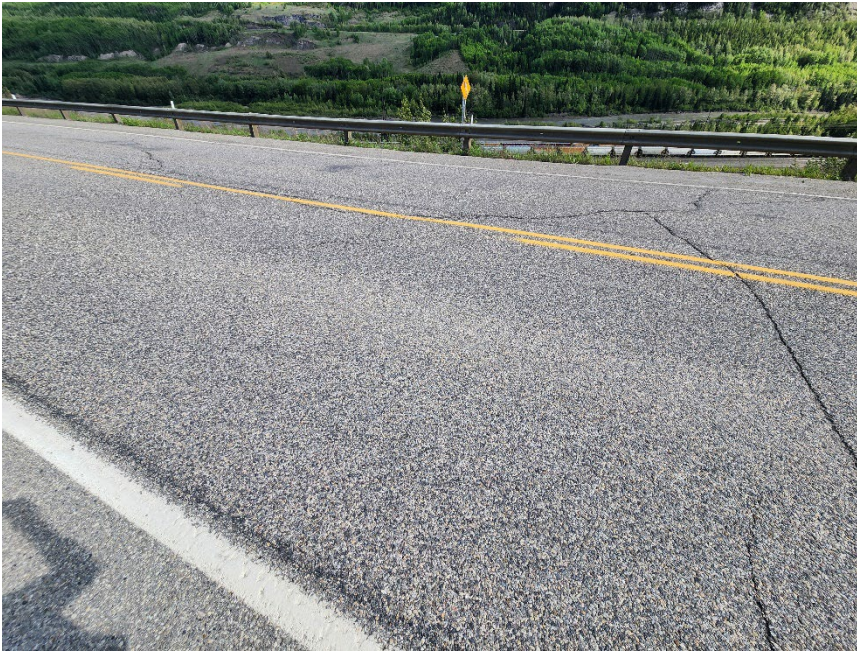
Middle Slide (Photos 3 and 4):

- Pavement cracking and subtle dip at middle slide is about 15 m wide with a roughly circular pattern that extends from highway centerline to northbound shoulder. The width of the slide as indicated by pavement cracking does not appear to indicate a large failure that extends far down the slope. The surface of the slope below the middle slide appears to be stable with the possibility of a toe bulge approximately 10 m downslope in the bushes that could also be a remnant from poor slope grading.

Photo 3 Cracking and dip in pavement surface of Hwy 40:36 at middle slide area. Photo taken June 10, 2024, facing southeast.

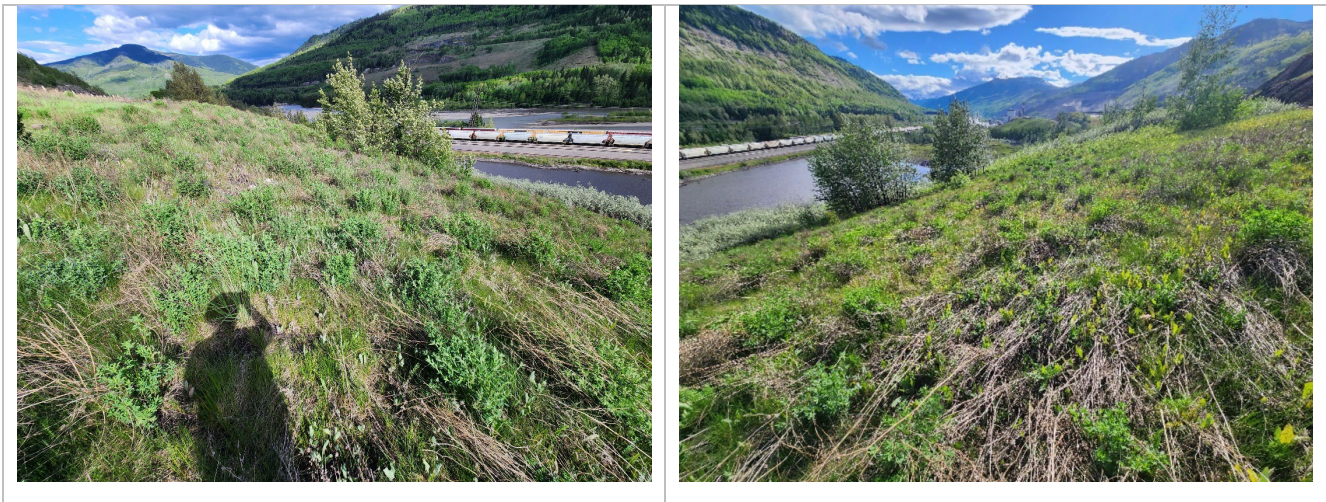
- Material exposed on slope below middle slide appears to be mine-waste material and could be from a former mine-waste fill/dump that predates highway construction. There is several meters distance between the guardrail and the crest of the slope which could also indicate a former mine waste structure as opposed to a highway embankment fill. Mine-waste dumps are typically built-in thick lifts with minimal compaction by end dumping with haul trucks. Settlements of the embankment could occur with time that might explain the movements at the western site limits, as would sliding of the waste dump slopes on thin sloping layers of segregated and/or fine-grained waste-dump materials that become preferential drainage paths.

Photo 4 Slope on south side of Hwy 40:36 at middle slide area. Photos taken June 10, 2024, facing southeast and southwest, respectively.

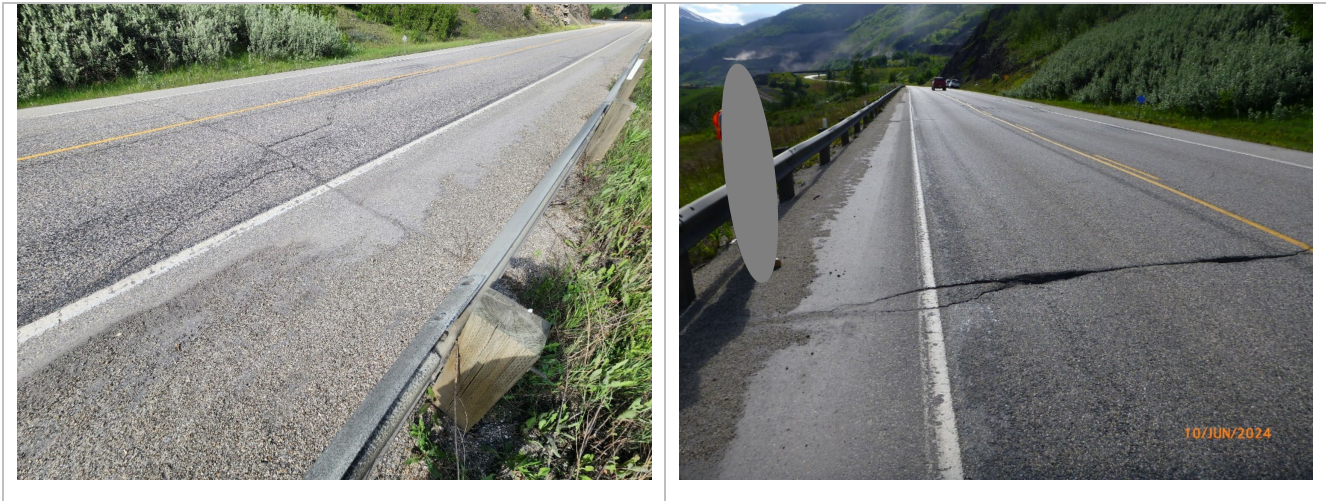
East Slide (Photos 5 and 6):

- Cracking extends across both lanes of highway with a subtle dip in northbound lane. Pieces of pavement missing along one crack that extends roughly perpendicular across highway.
- Brake marks observed in southbound lane near blue-hazard-diamond sign.

Photo 5 Cracking and dip in pavement surface of Hwy 40:36 at east slide area. Photo taken June 10, 2024, facing northeast and west, respectively.

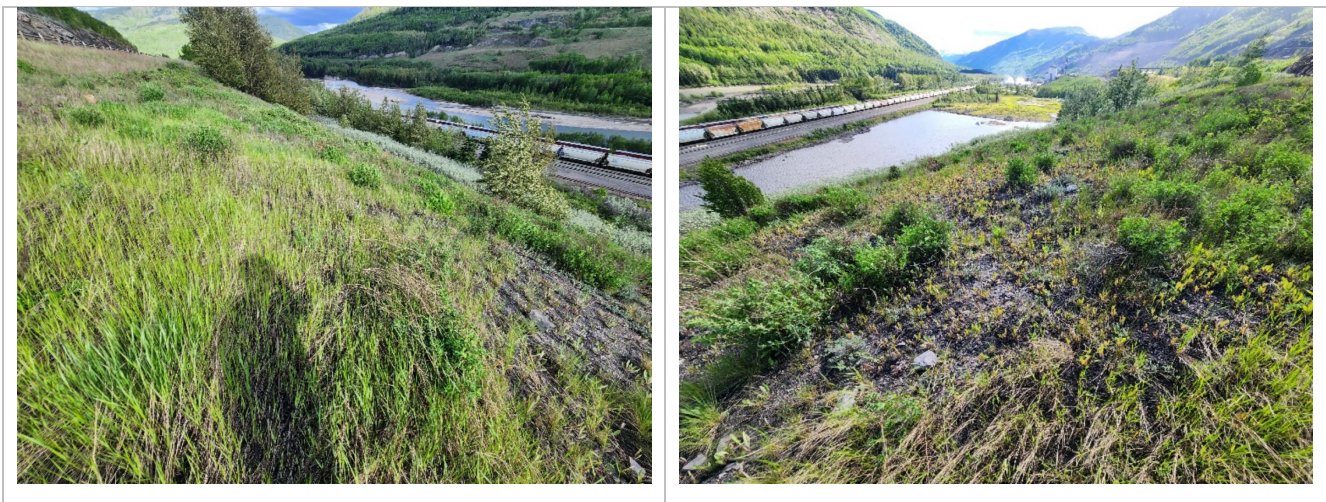
Photo 6 Slope on south side of Hwy 40:36 at east slide area. Photos taken June 10, 2024, facing southeast and southwest, respectively.

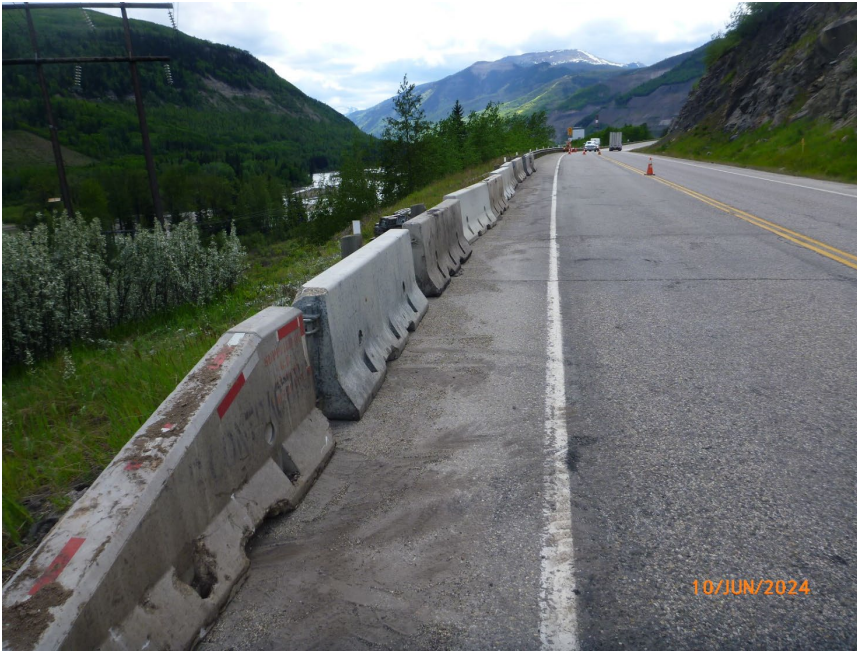
Photo 7 Pavement surface of Hwy 40:36 above ATCO slide. Note contractor in process of mobilizing to site to begin repair work. Photo taken June 10, 2024, facing southwest.

- ATCO constructed a bench for powerline work on the downslope/east side of the highway embankment. The bench was constructed using a cut and sliver fill method, resulting in an over-steepened backslope and fill slope that led to the slide above the bench. Slides movements have resulted in pavement cracking near the shoulder of the northbound lane and a dip in the pavement surface. The stability of the slope below the bench is unknown, and it is immediately above the train tracks. KCB has prepared a repair design for the ATCO slide, which includes excavating and reconstructing the slide with geogrid-reinforced fill and drainage. At the time of the 2024 inspection, a contractor was mobilizing to site to begin repair work which is expected to take approximately two to three weeks to complete. KCB will be on site to monitor repair work. Estimated cost or repair: \$650,000 to \$700,000.

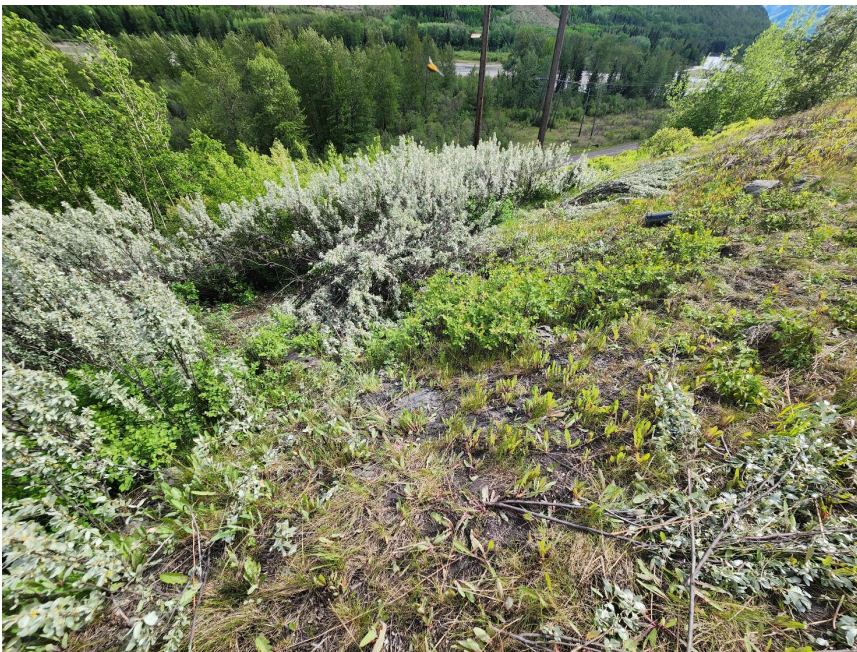
Photo 8 ATCO slide on south side of Hwy 40:36. Note contractor in process of brush removal to begin repair work. Photo taken June 10, 2024, facing southwest.
