July 15, 2024

**CON0022166 Peace Region (Grande Prairie District – South) GRMP Instrumentation Monitoring Site GP008; H40:36, km 16.365 Road Surface Slumping (2.5 km North of McIntyre Mine) Section C – 2024 Spring Readings**

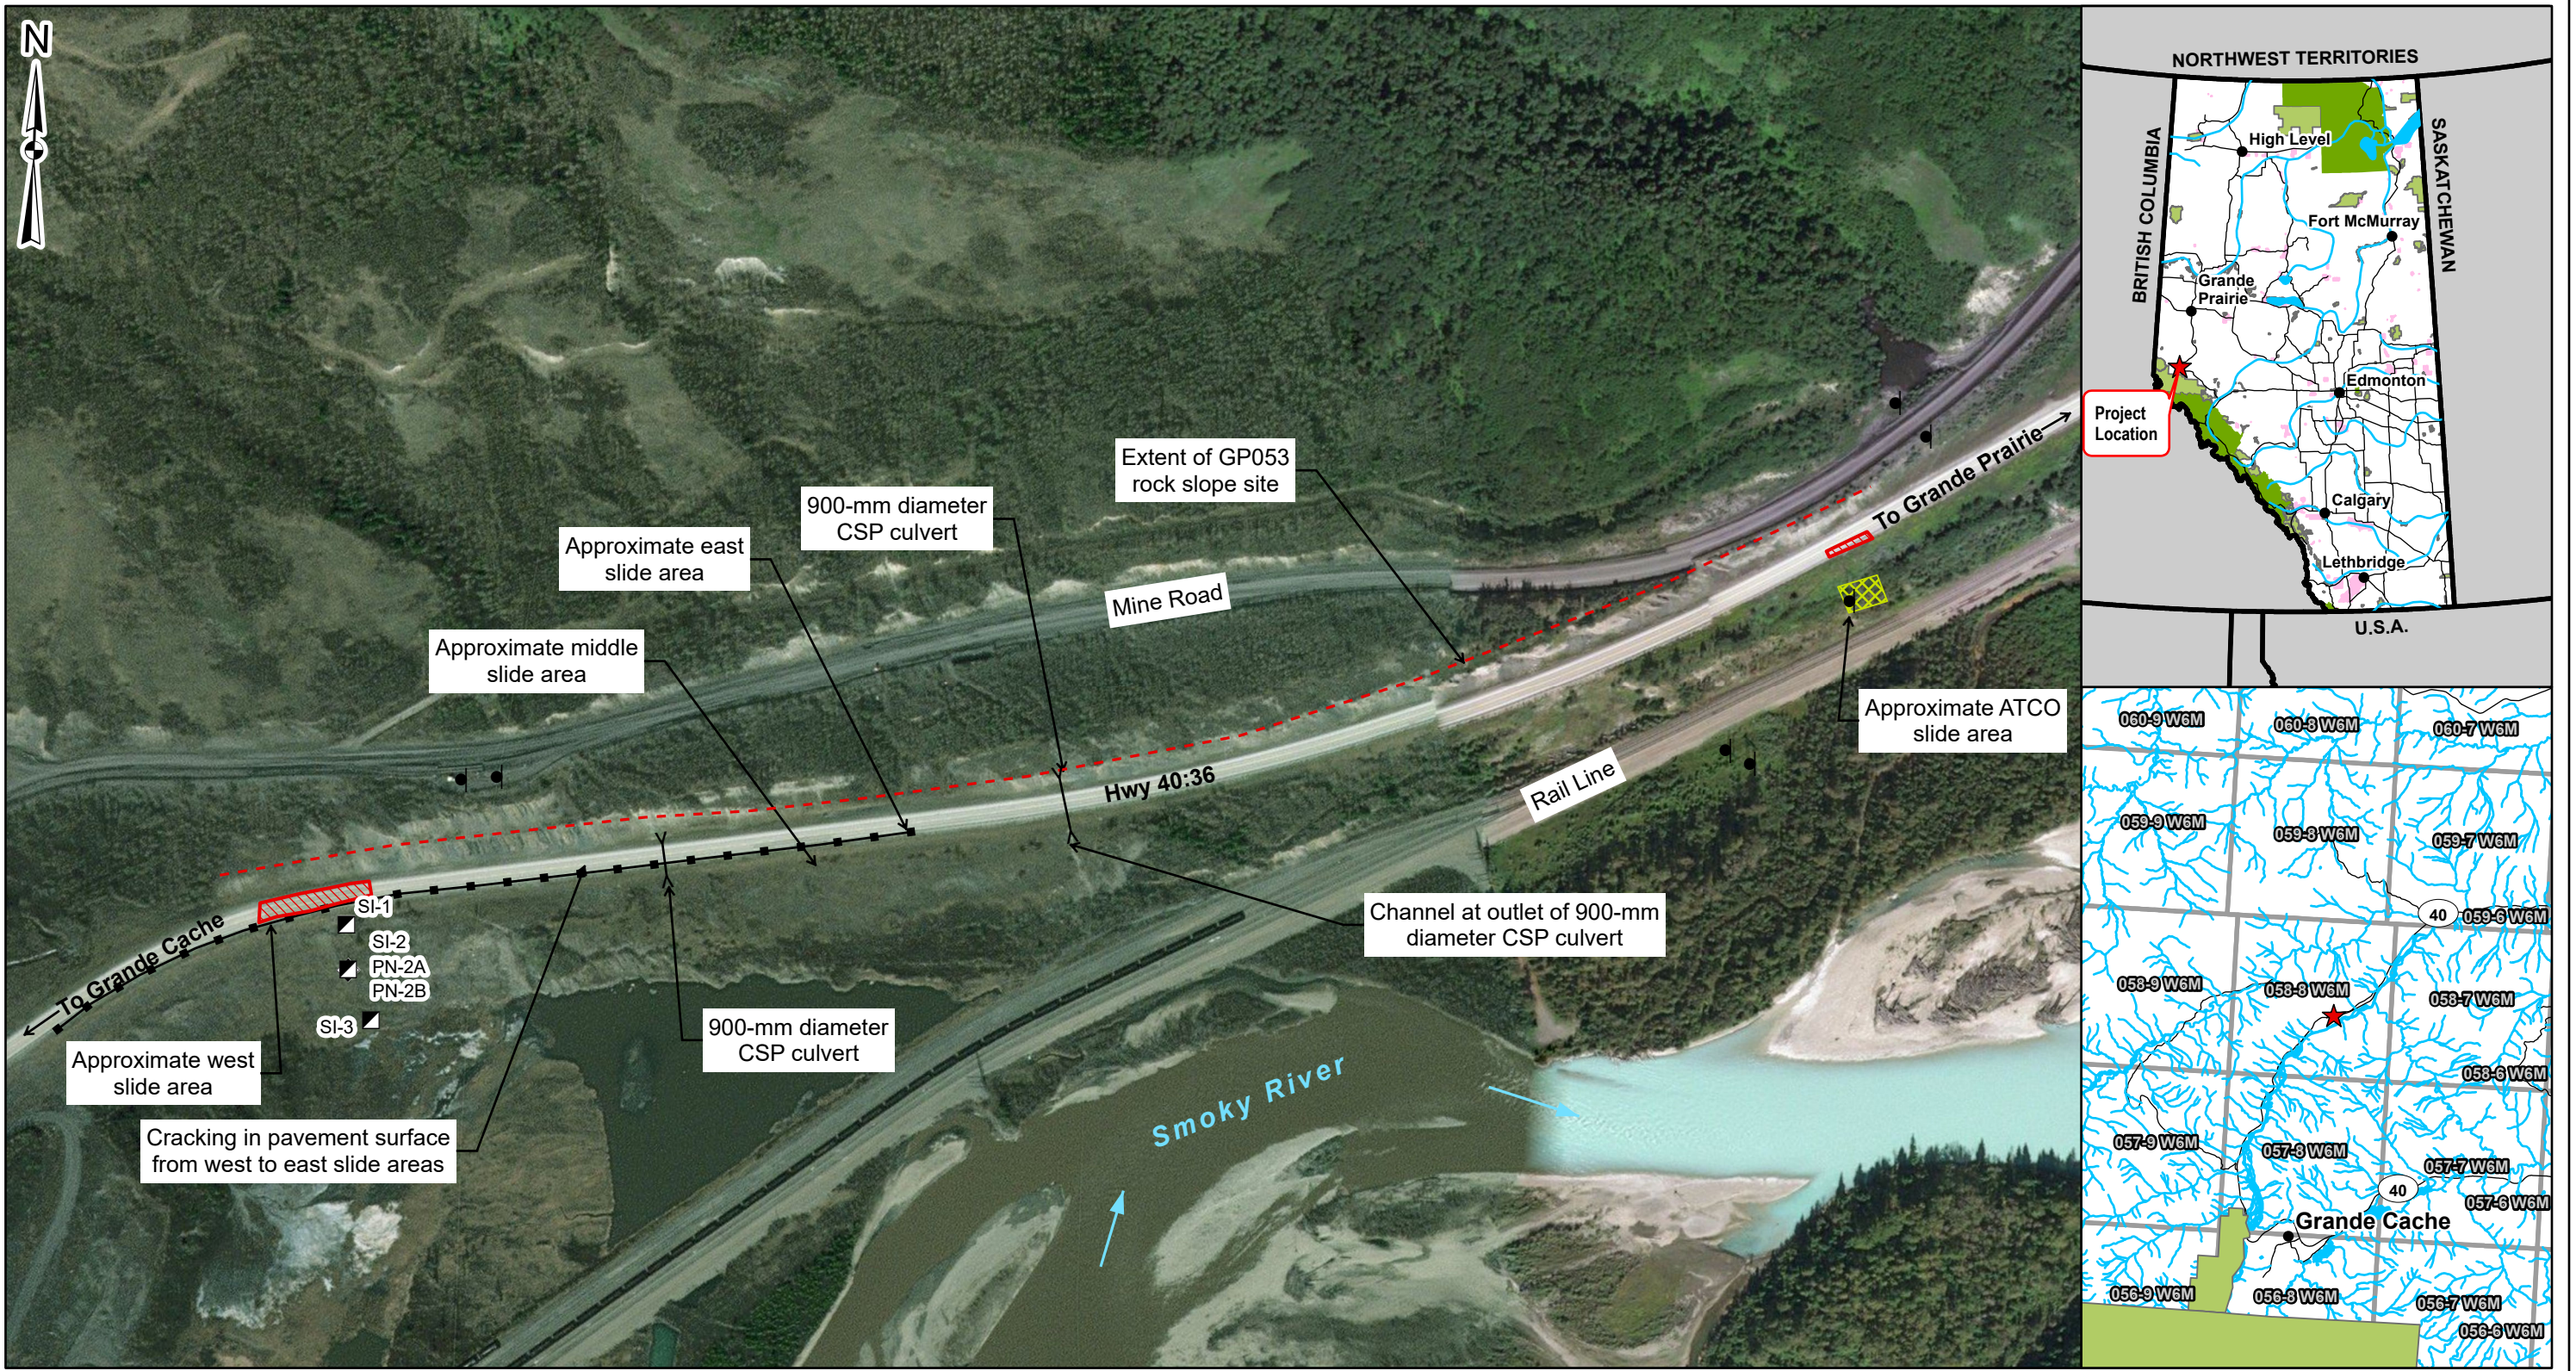
PROJECT	PEACE REGION (GRANDE PRAIRIE DISTRICT-SOUTH) GEOHAZARD RISK MANAGEMENT PROGRAM	
TITLE	Site Plan GP008 - Road Surface Slumping (2.5 km North of McIntyre Mine) Hwy 40:36, km 16.365 and 17.139	
SCALE	PROJECT No.	FIG No.
1:4,000	A05116A01	1

The geohazard at the GP008 site consists of three landslides in a possible mine-waste fill/dump below Hwy 40:36:

- the west slide, which cuts diagonally across the highway;
- the middle slide, which is confined to the northbound lane and shoulder; and
- the east slide, which encompasses both lanes.

In 2004, three SIs (SI-1, SI-2, and SI-3) and three PNs (PN-1 and PN-2A/B) were installed at the west/south slide by a previous consultant to monitor movement and groundwater conditions, respectively. SI-1, SI-2, and SI-3 are installed in the upper one-third of the slope, near the midslope, and at the toe of the slope, respectively. PN-1 is now inoperable.

All operable instruments should continue to be read once per year (spring) unless movements increase and begin to impact the highway. Spring readings should be completed after late-May or early-June, due to the risk of water inside the instrument casings being frozen earlier in the year.

The site should continue to be inspected by the Maintenance Contract Inspector (MCI) and as part of the GP South region GRMP Section B inspections.

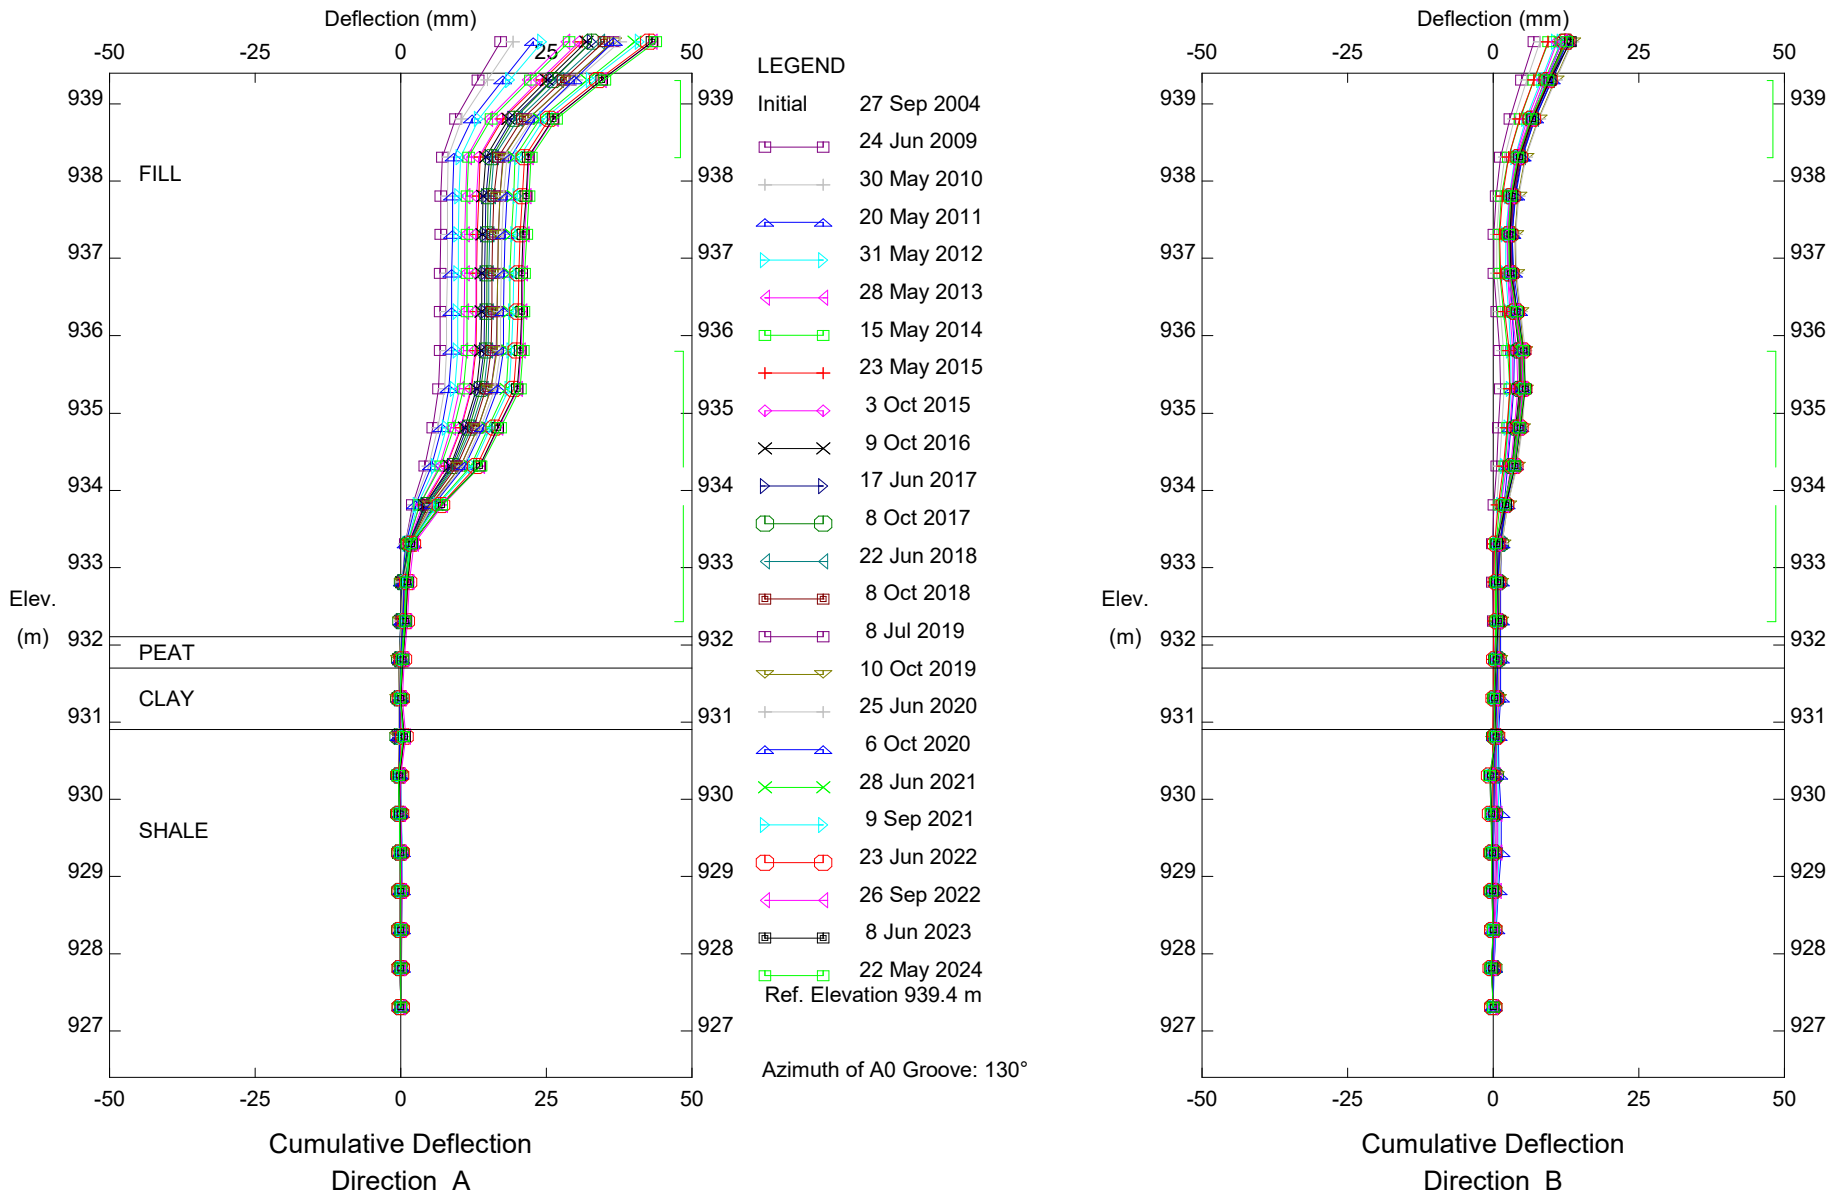
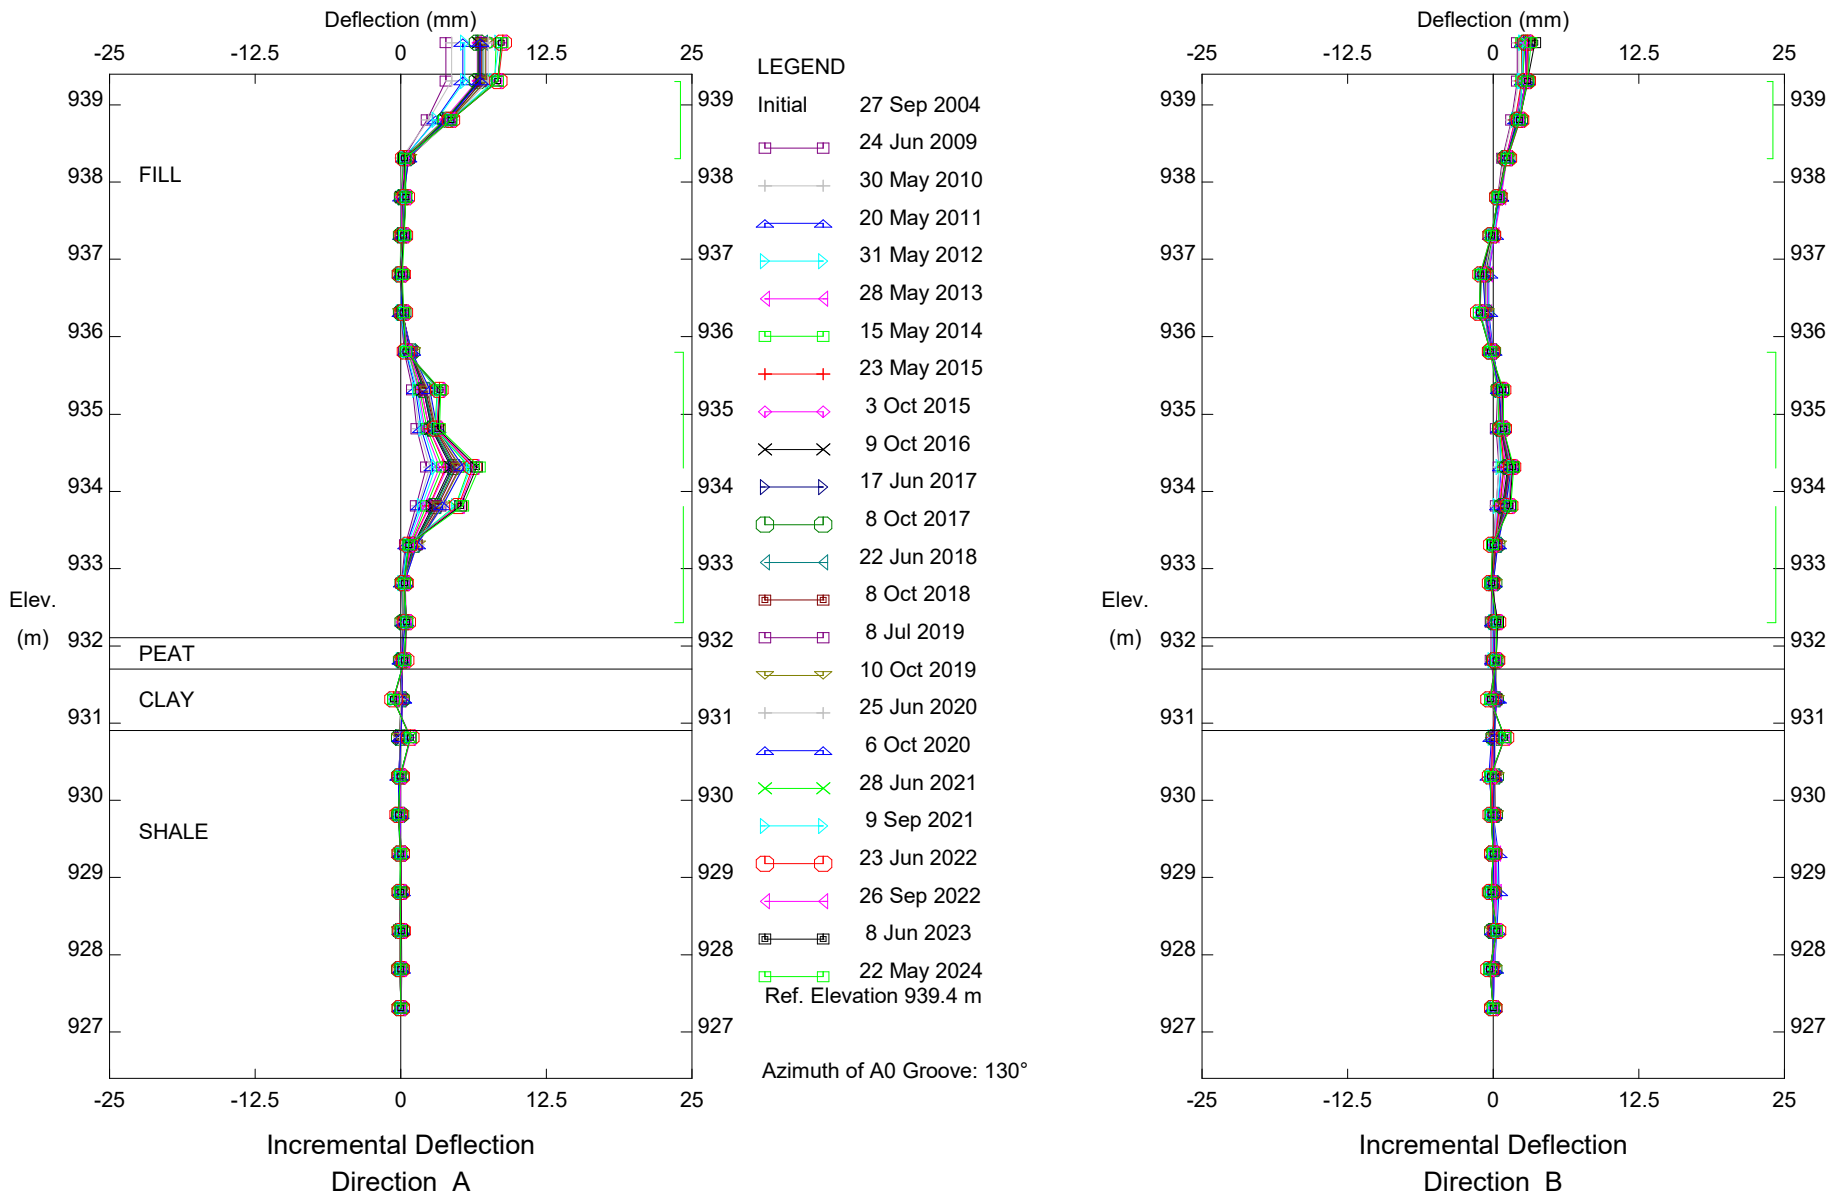
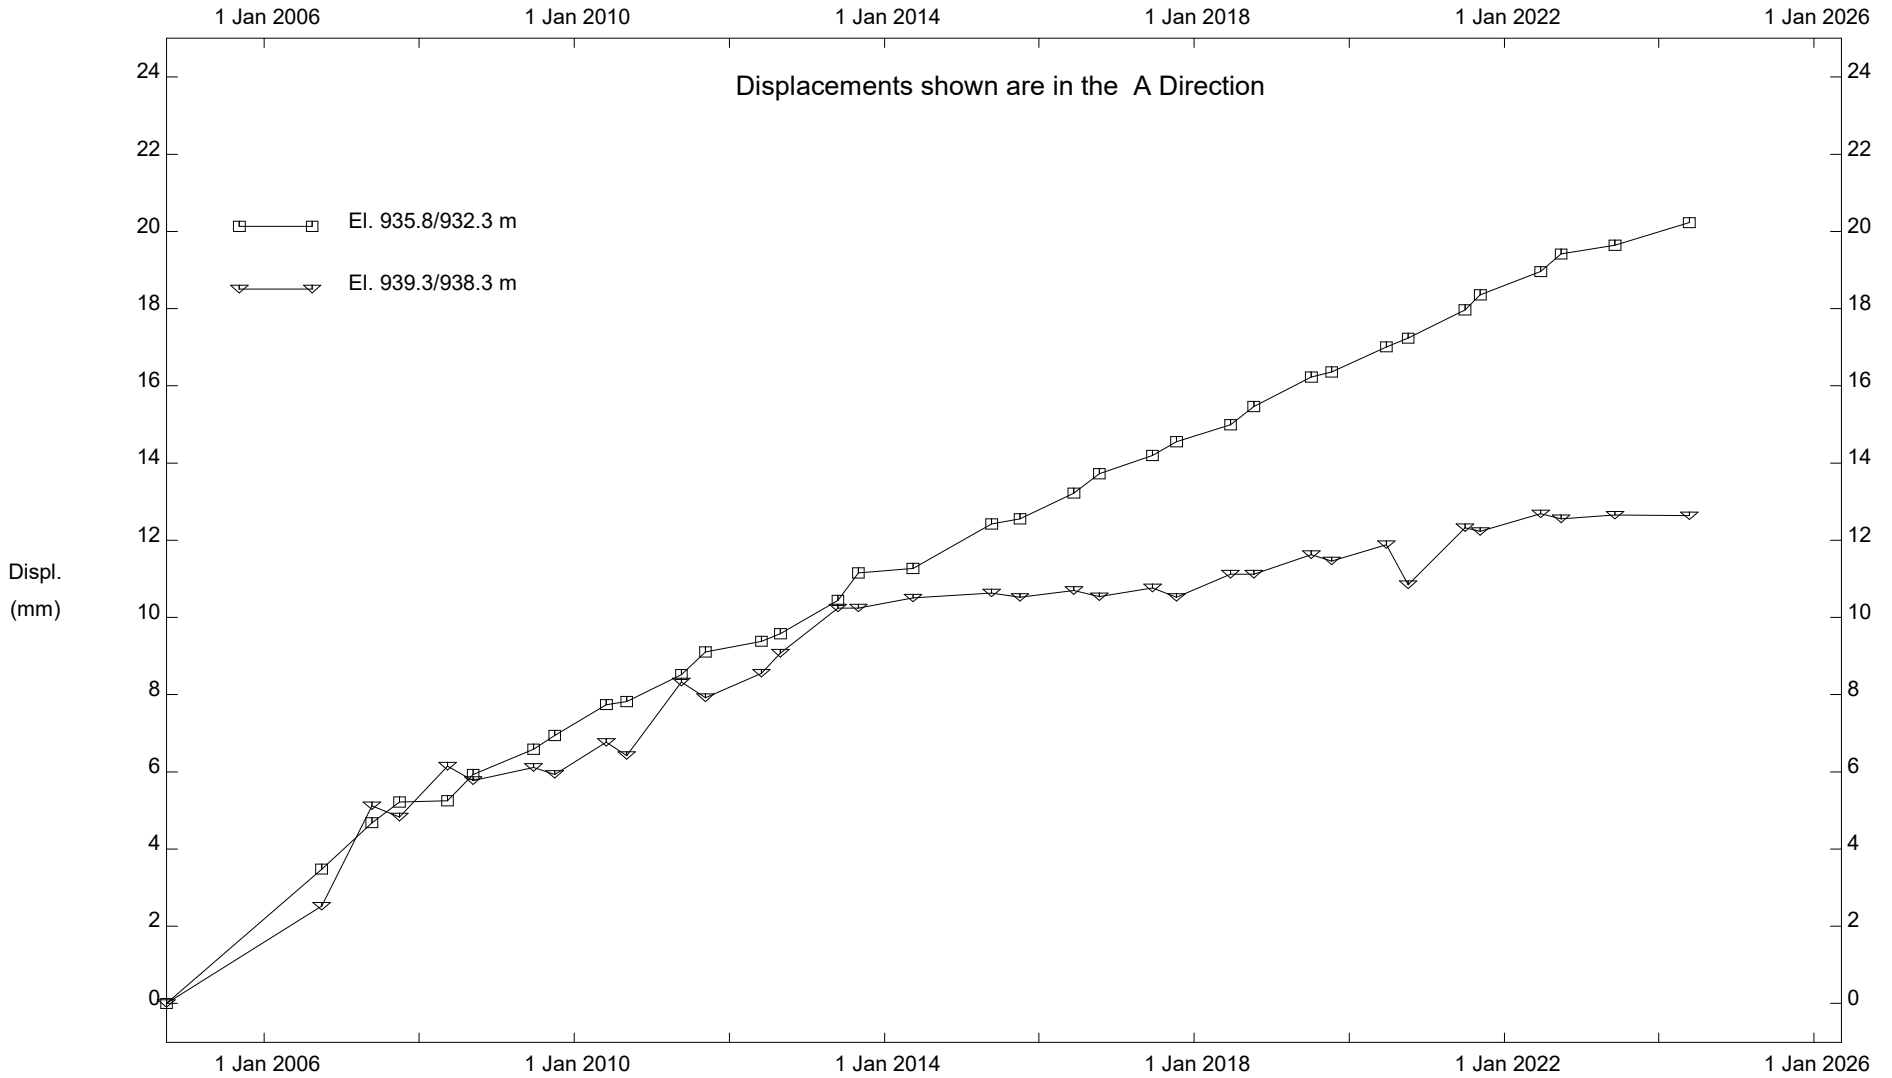
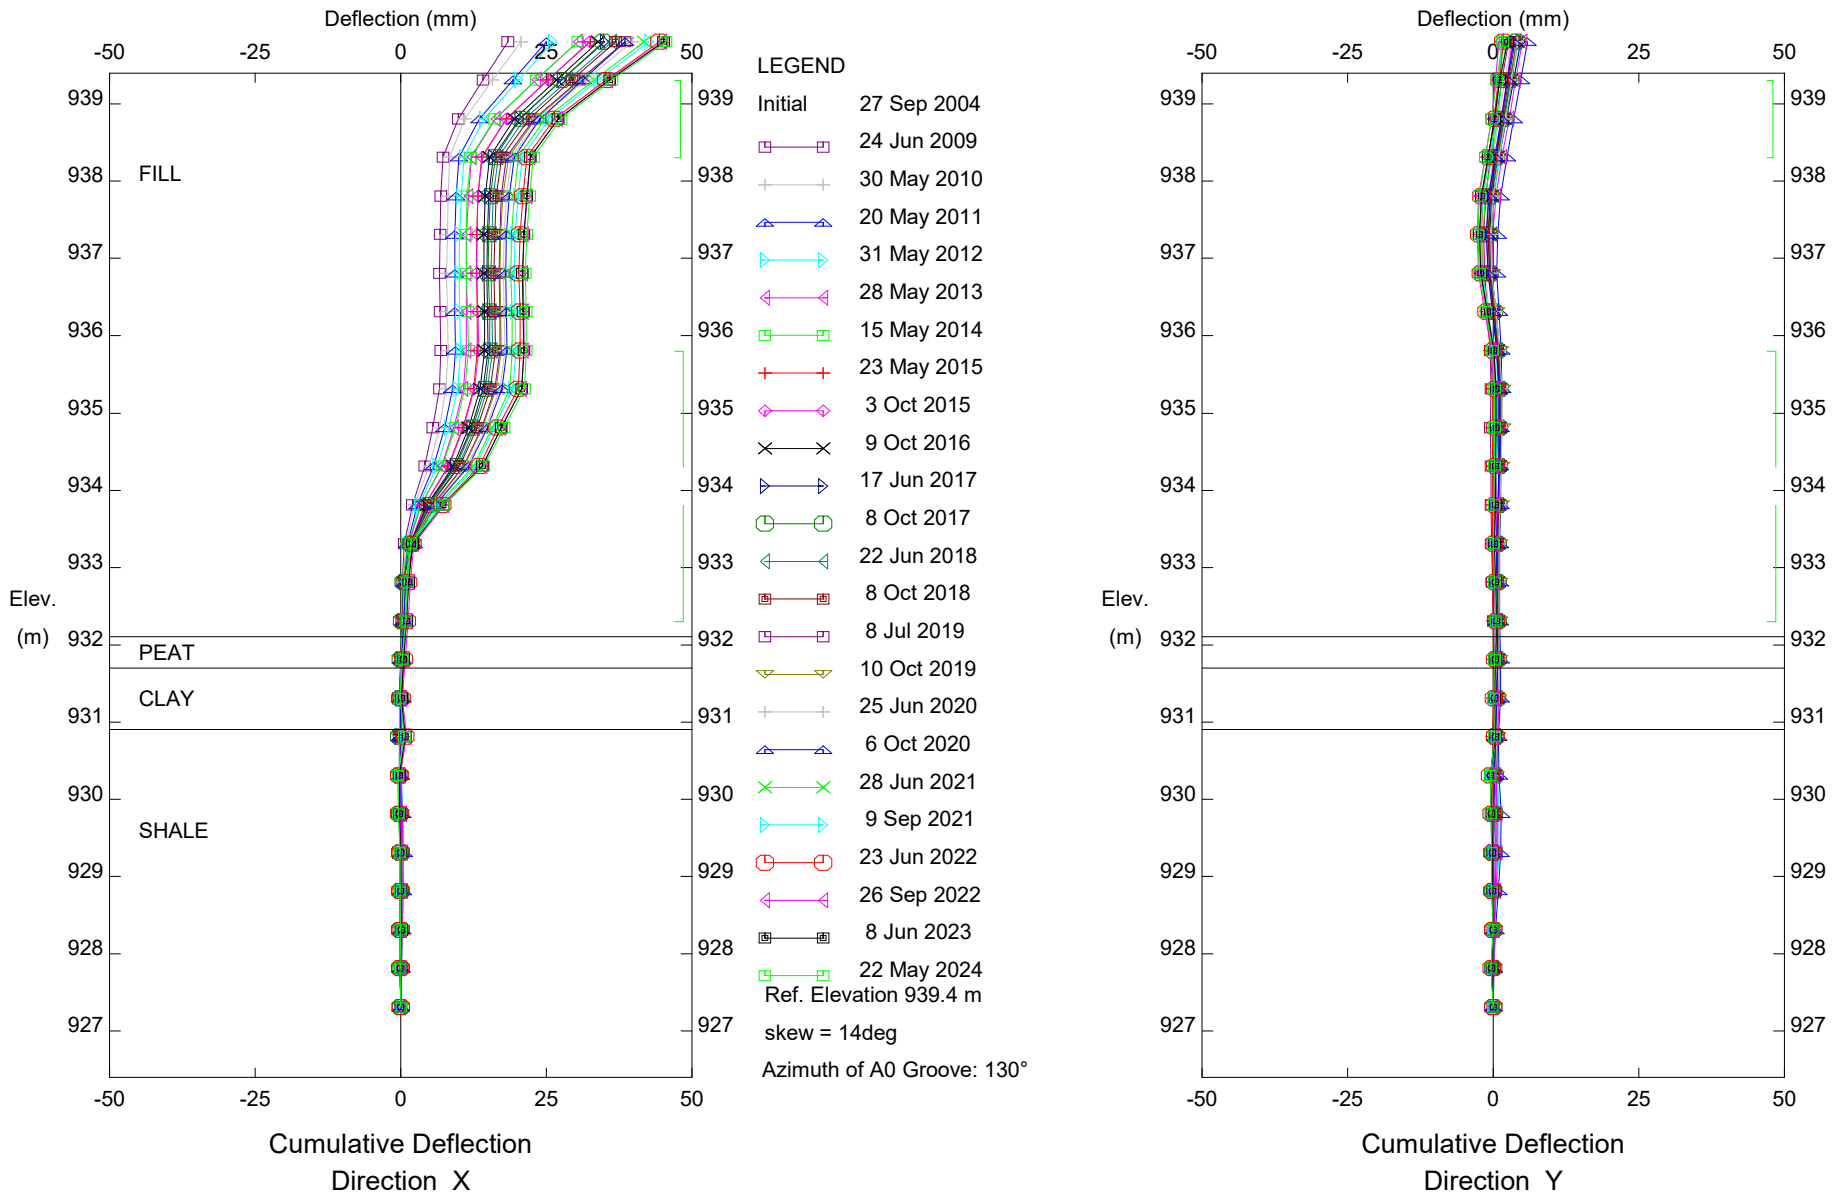
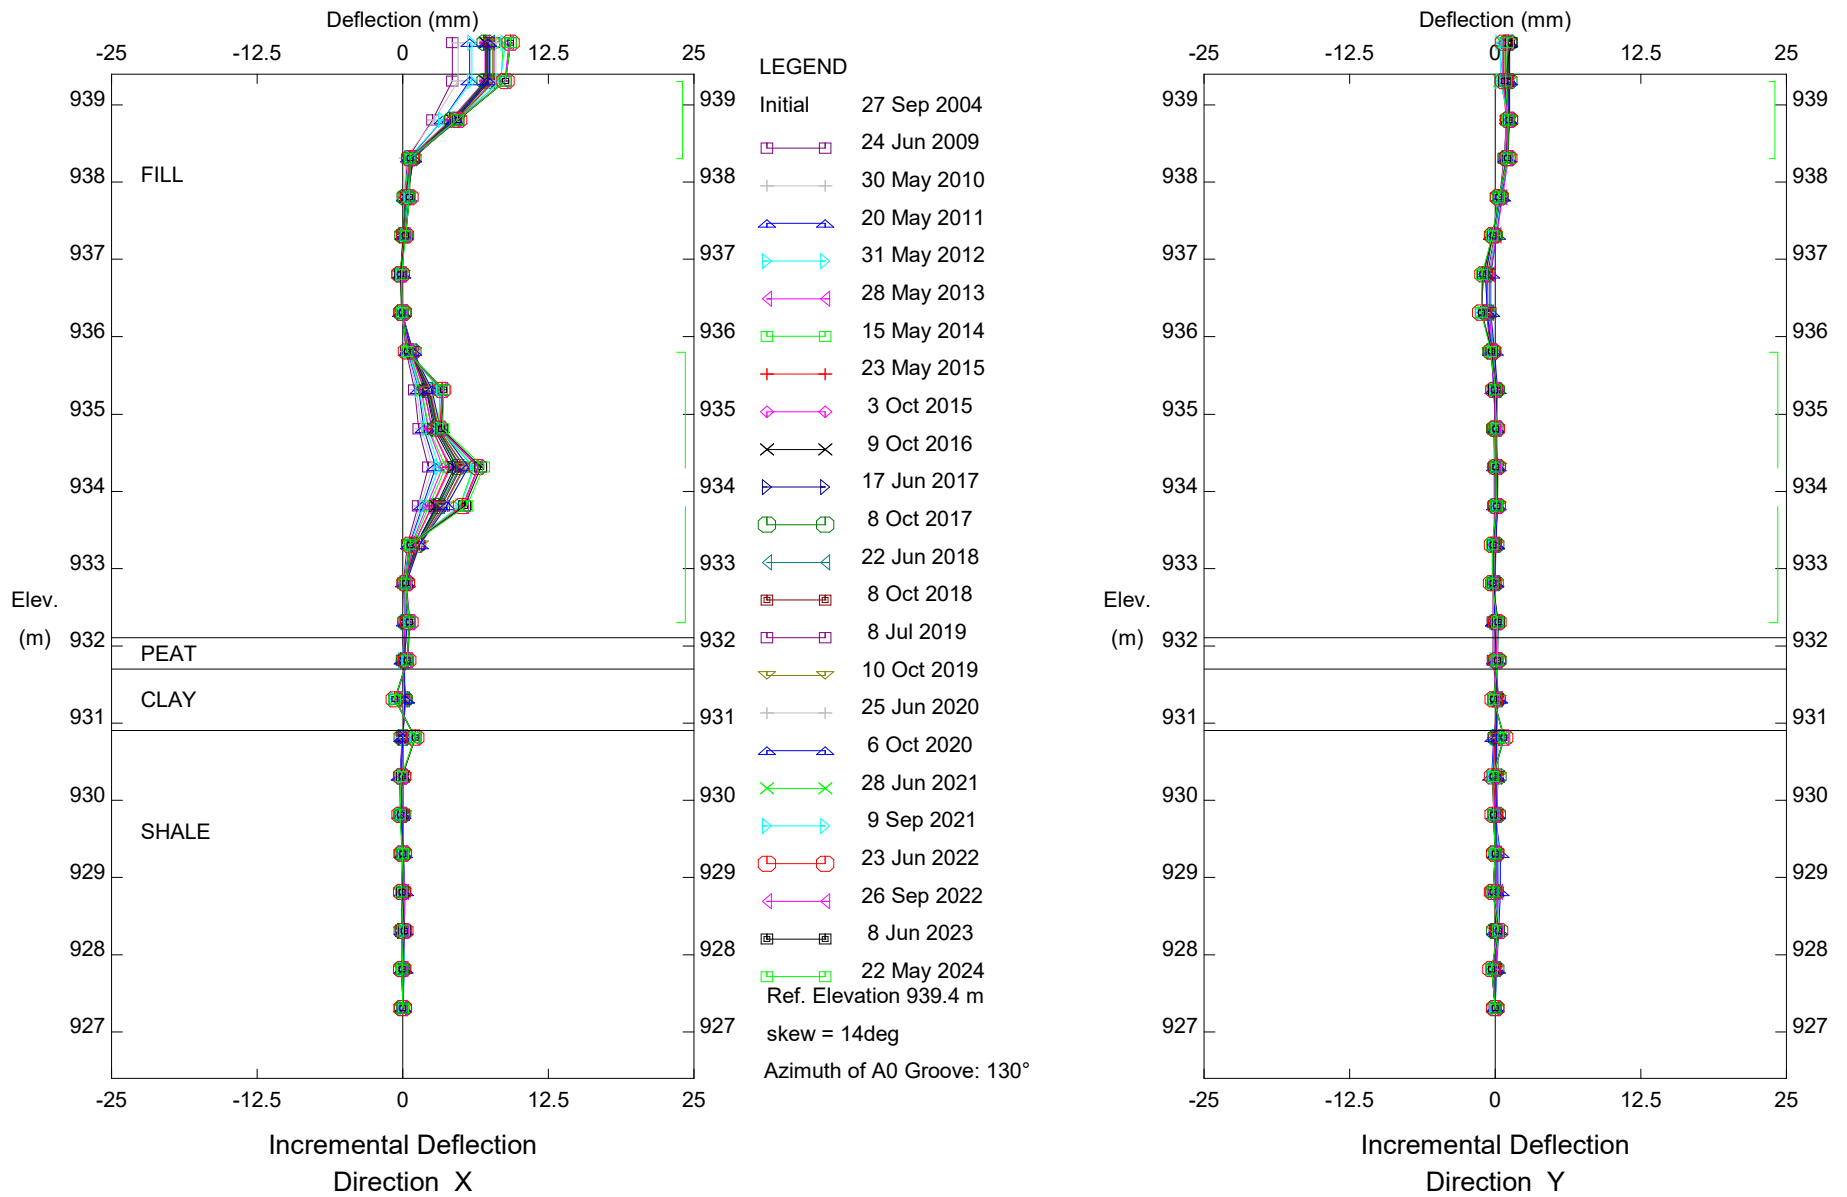
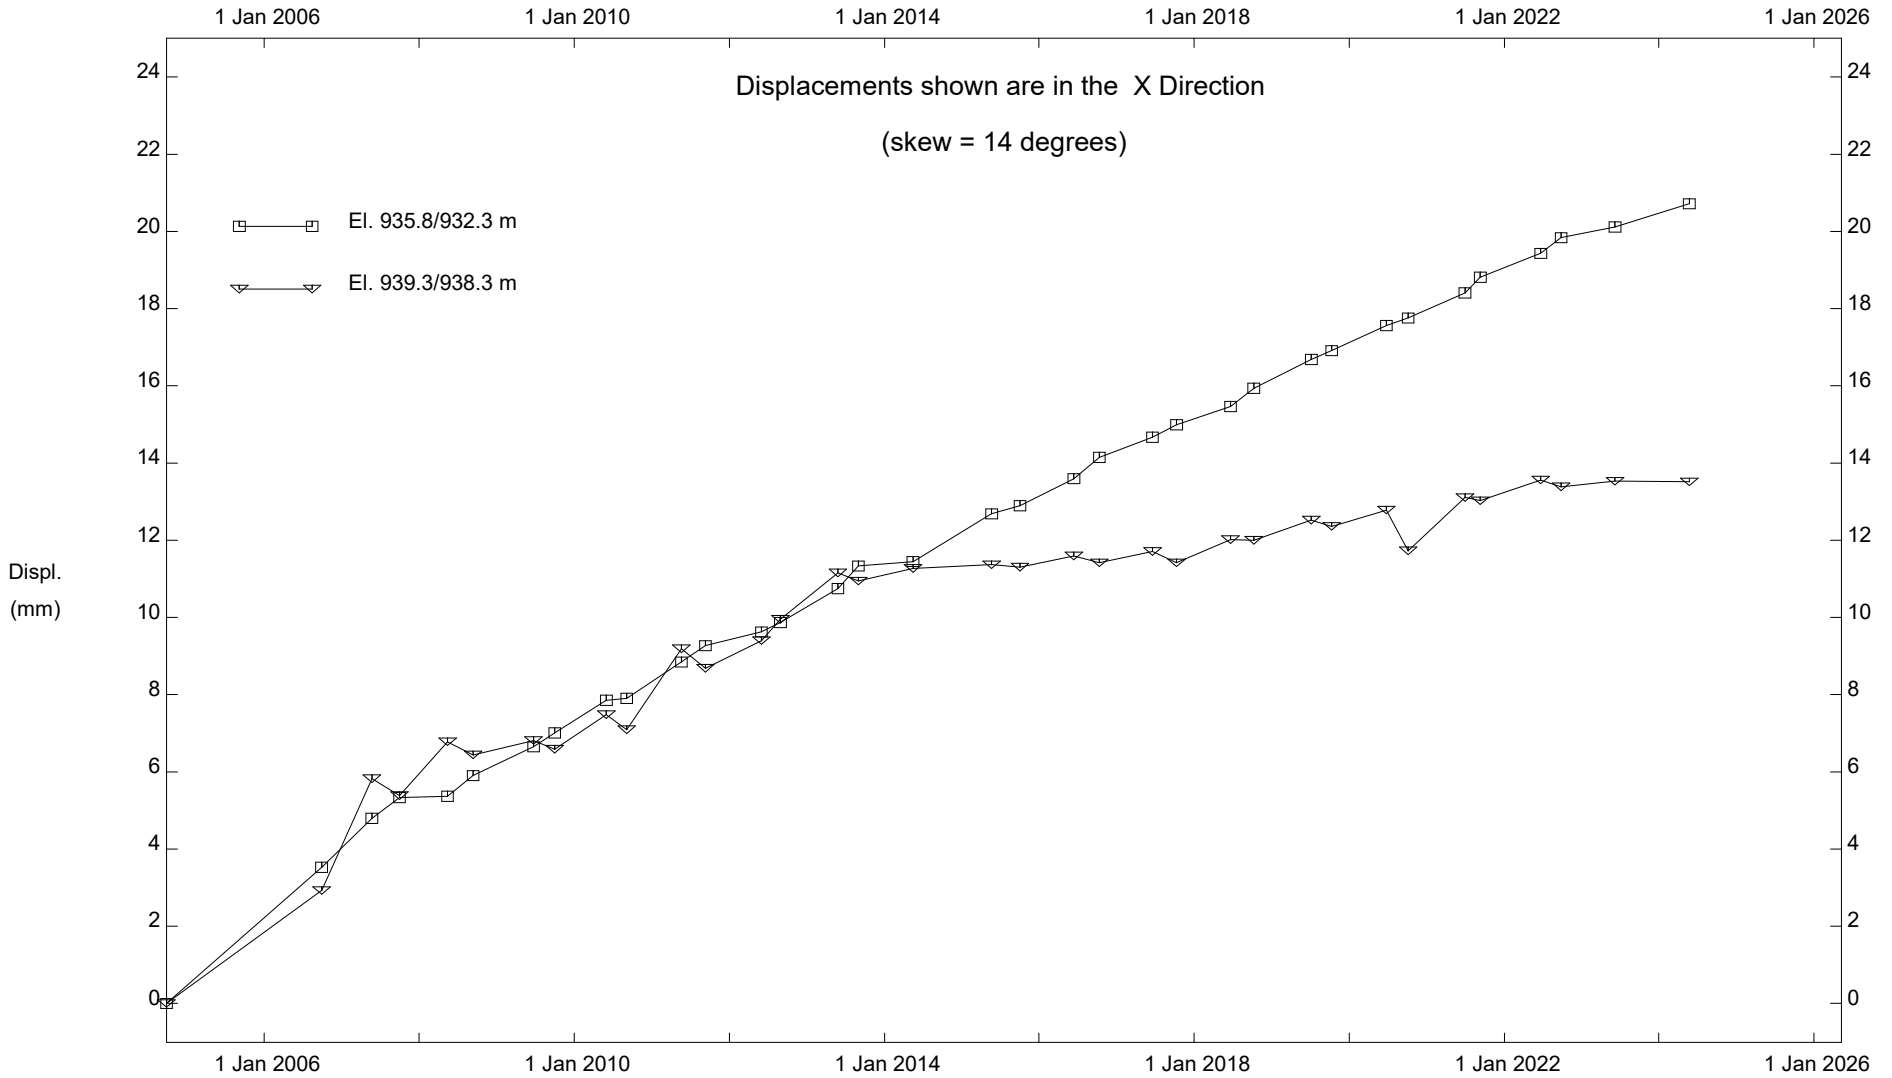
GP008; H40:36, Road Surface Slumping, Inclinometer SI-1

- SI-1 from ground surface to an approximate depth of 1.1 m below ground surface, and from approximately 3.6 m to 7.1 m below ground surface;
- SI-2 from ground surface to an approximate depth of 2.1 m below ground surface, and from approximately 2.0 m to 4.1 m below ground surface; and
- SI-3 from an approximate depth of 1.2 m to 2.1 m below ground surface, with most of the movement being recorded since May 2015.

The movement being recorded in all three SIs is occurring within the fill.

Although a peat layer was identified in the SI data plots, the distributed shearing movements recorded in SI-1 appear to be on a basal plane above the peat layer. The peat layer is most likely the cause of the movement and the SI data points may be shifted upwards due to soil logging or SI stick up issues. Alternatively, there could be a loose zone of fine-grained segregated material near the base of the fill that is straining under embankment load. Observations of the highway embankment slope surface during the 2021 and 2024 Section B inspections indicated that the fill material is likely mine waste that could have been end-dumped in thick lifts (with minimal compaction) before or as part of highway construction. Movements recorded in SI-2 and SI-3 are well above the peat layer, indicating that straining of the embankment along a segregated fine-grained layer in the mine waste fill is more likely.

SI-1 and SI-2 (located near the top of the slope and mid-slope, respectively) are recording movement to the southeast. However, SI-2 (located near the toe of the slope) is recording movement more toward the southwest. This could indicate that the movement pattern for the highway embankment is complex and difficult to assess, given that the highway embankment was constructed in thick lifts with minimal compaction.
