July 15, 2024

**CON0022166 Peace Region (Grande Prairie District – South) GRMP Instrumentation Monitoring Site GP008; H40:36, km 16.365 Road Surface Slumping (2.5 km North of McIntyre Mine) Section C – 2024 Spring Readings**

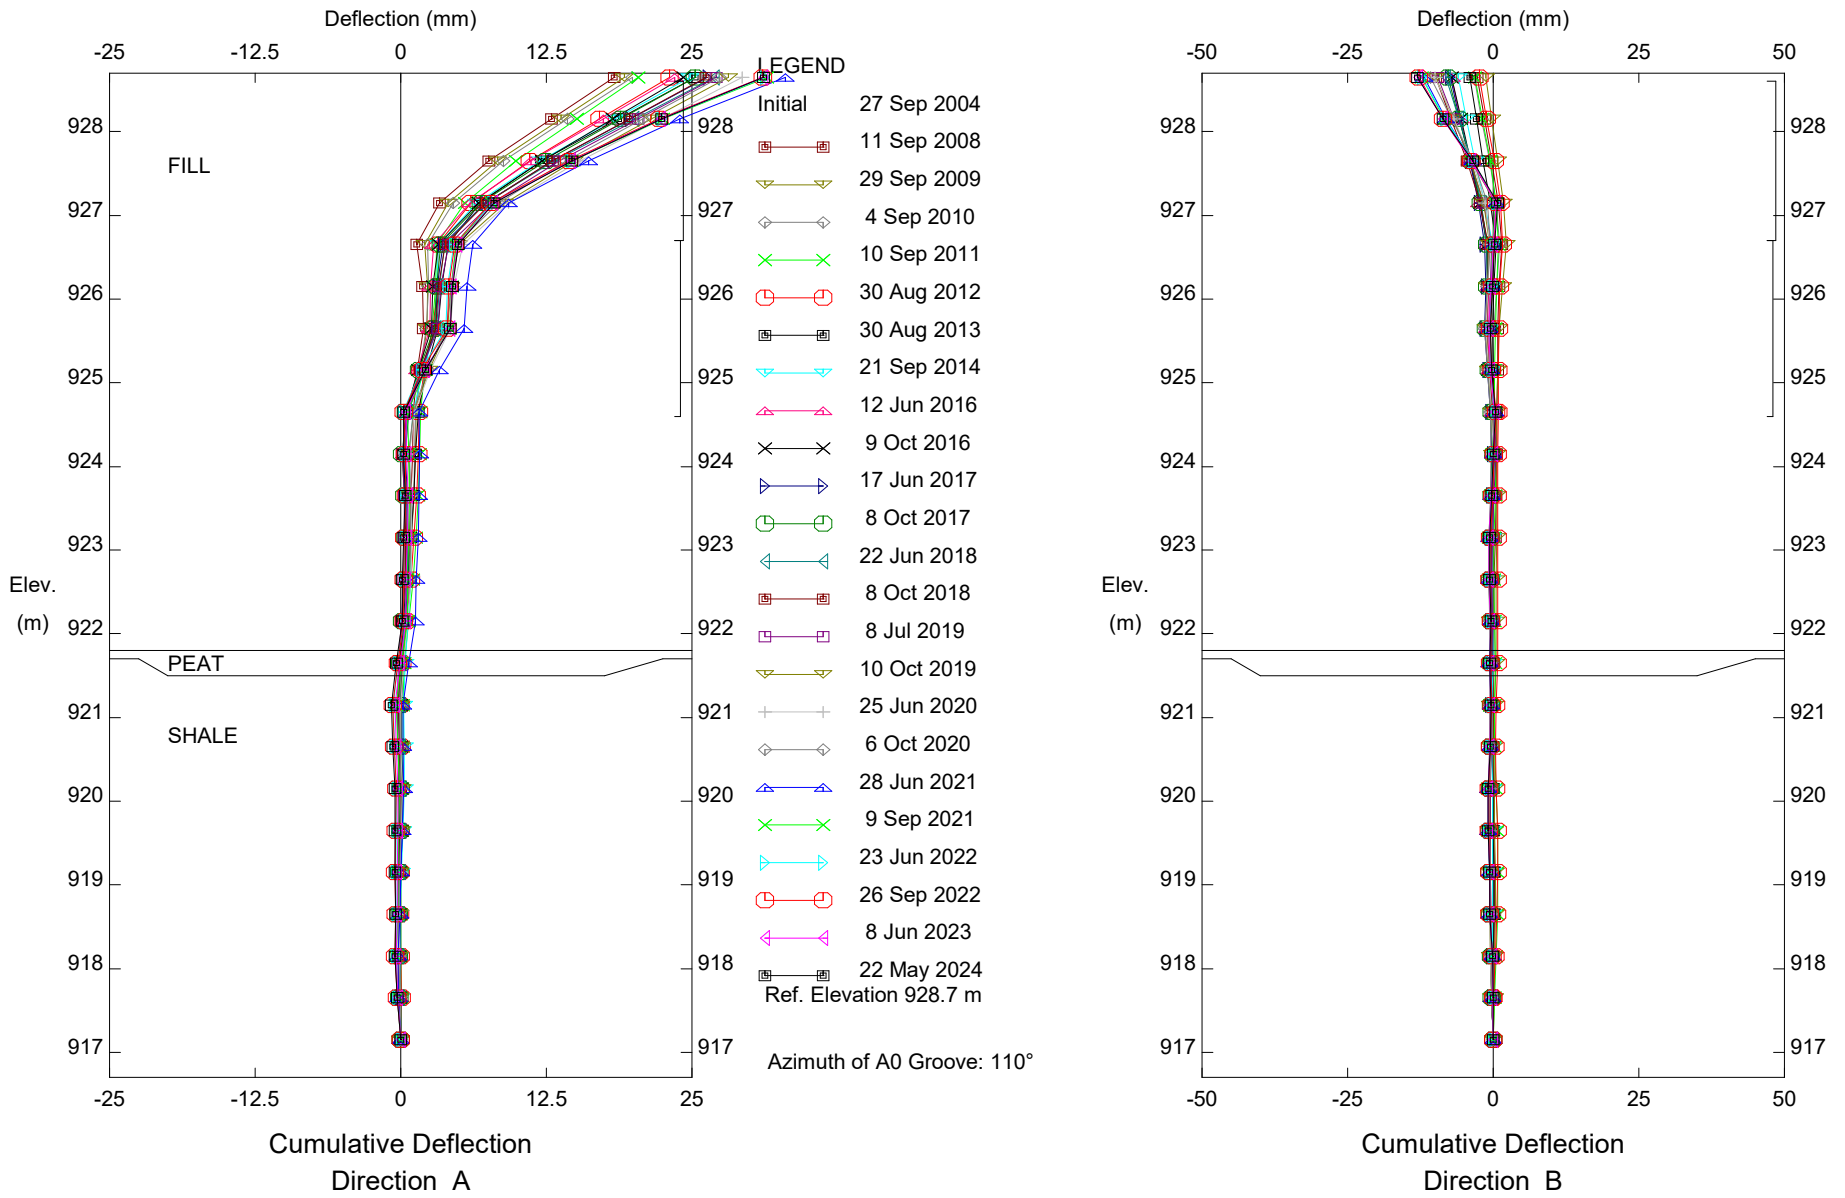
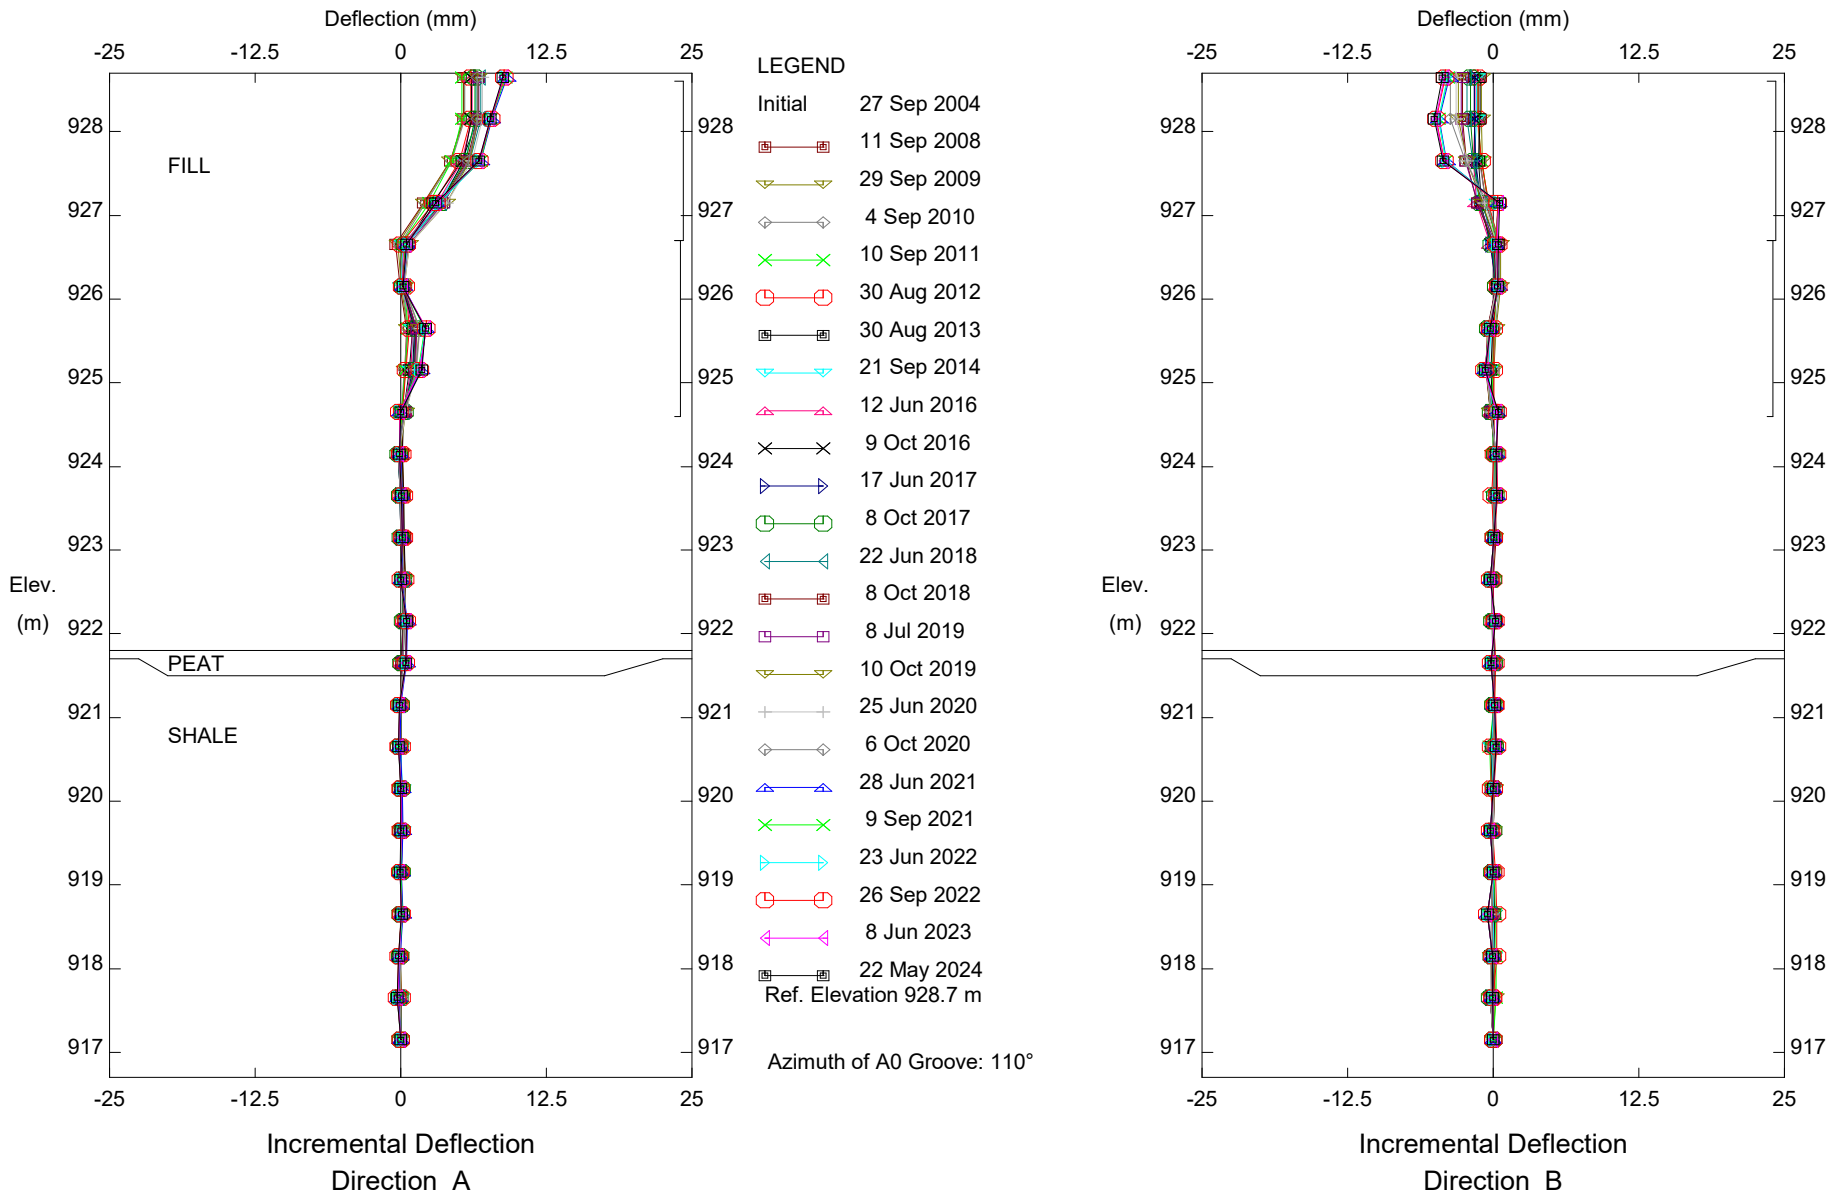
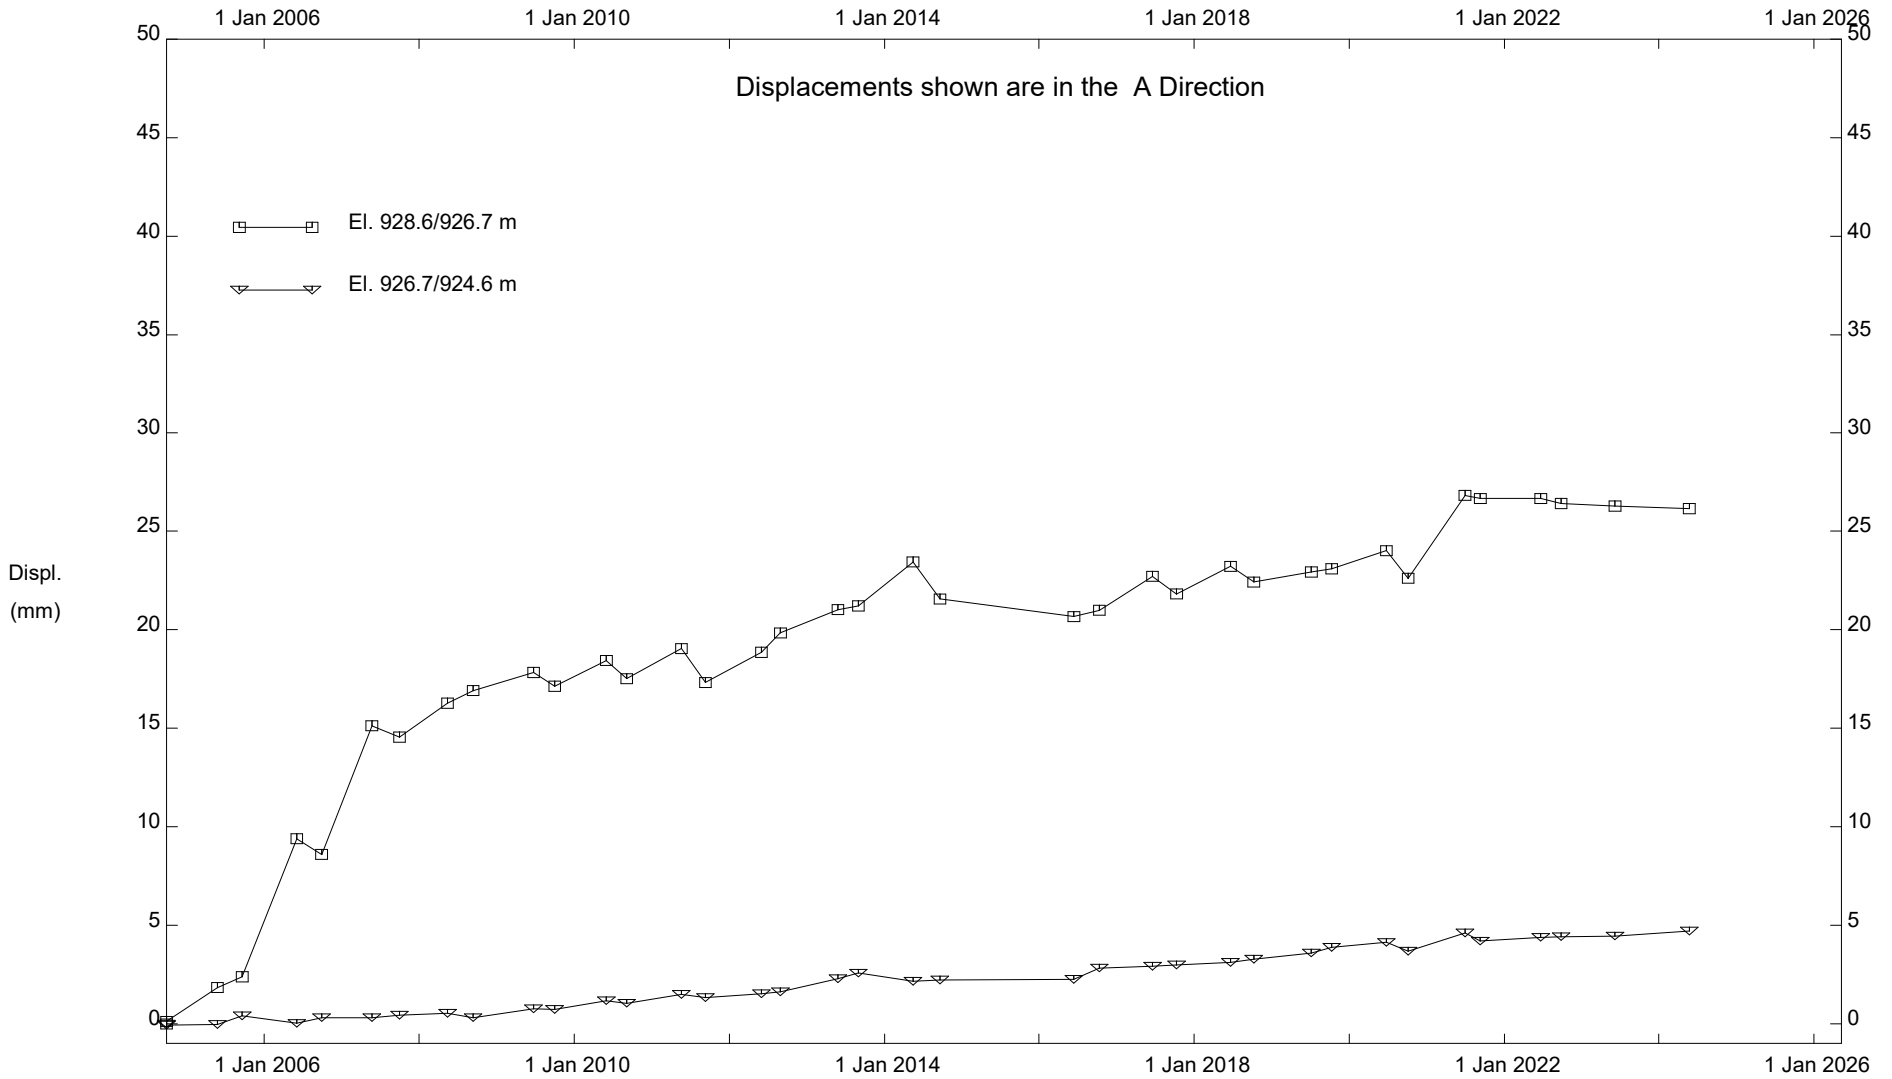
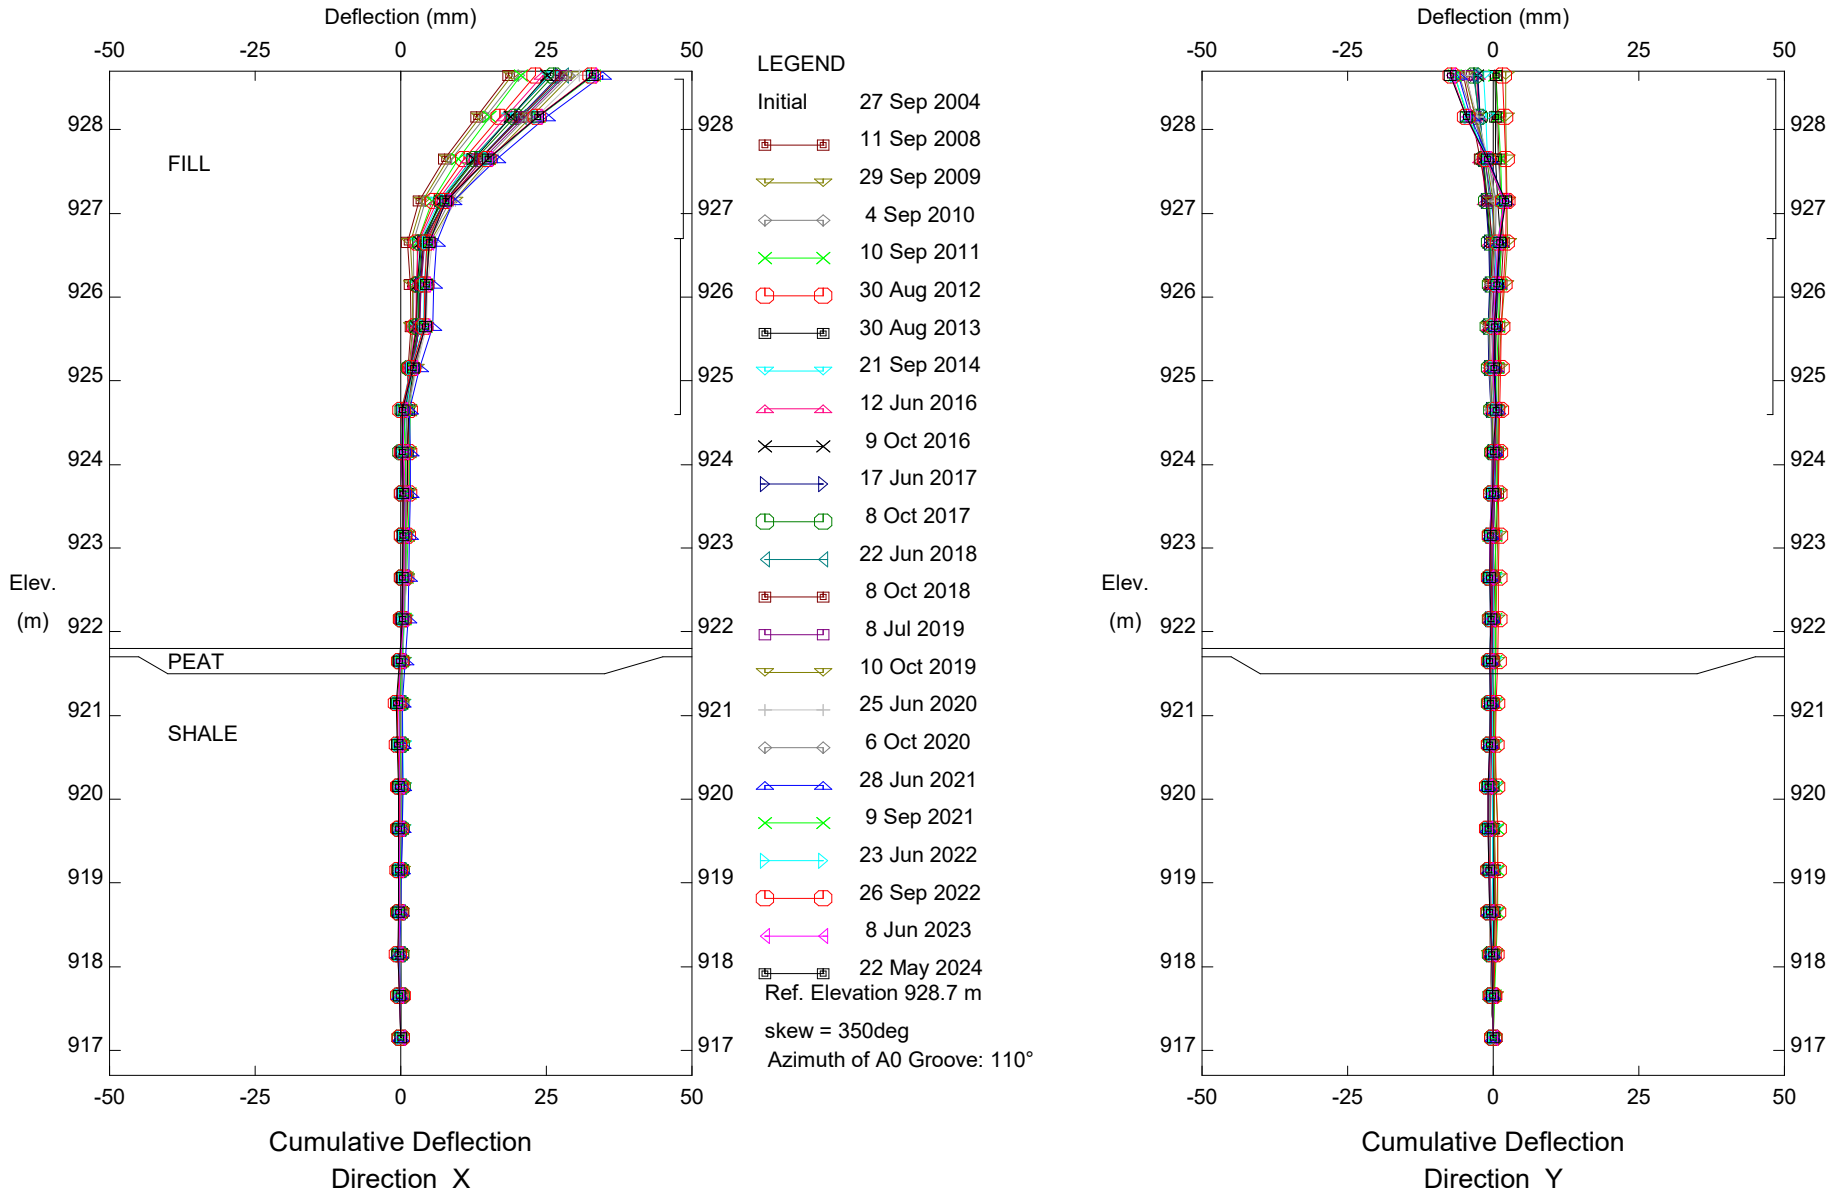
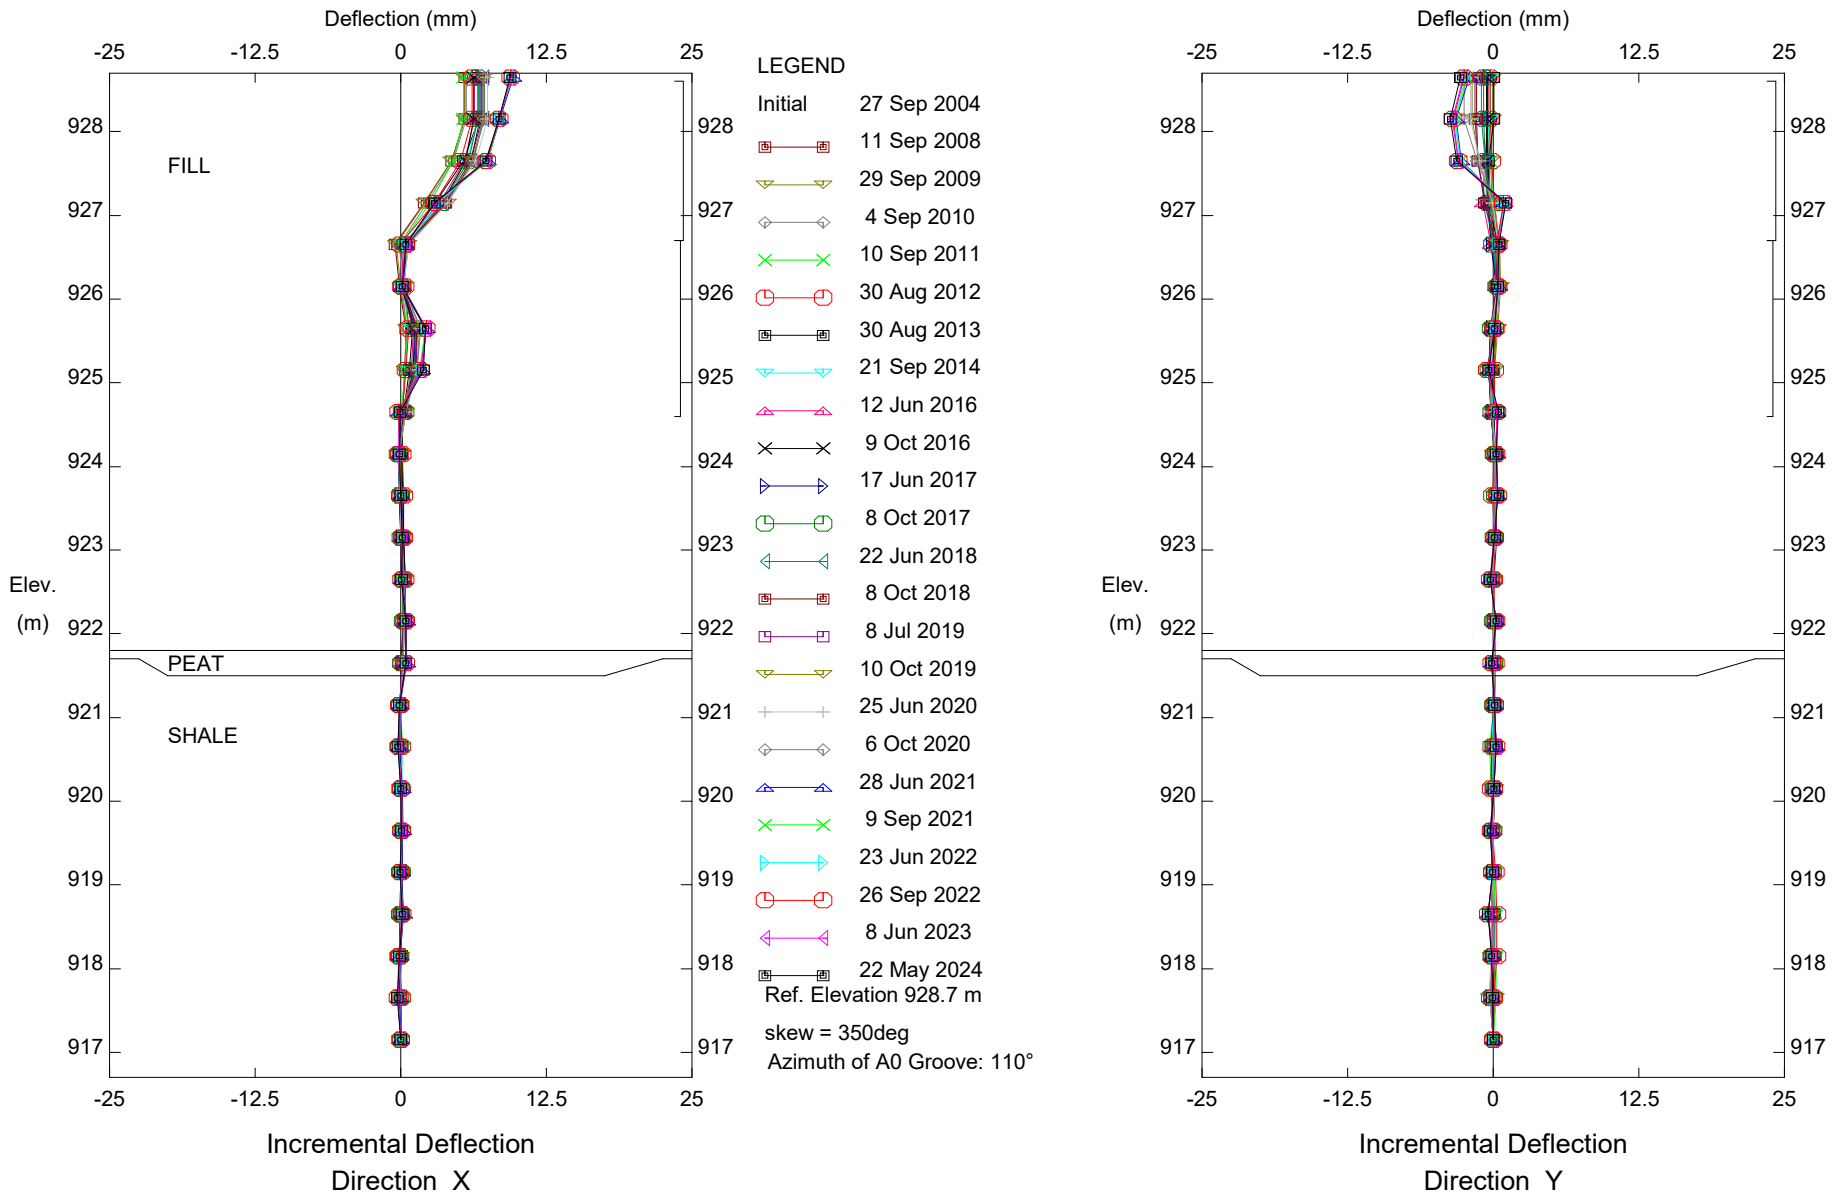
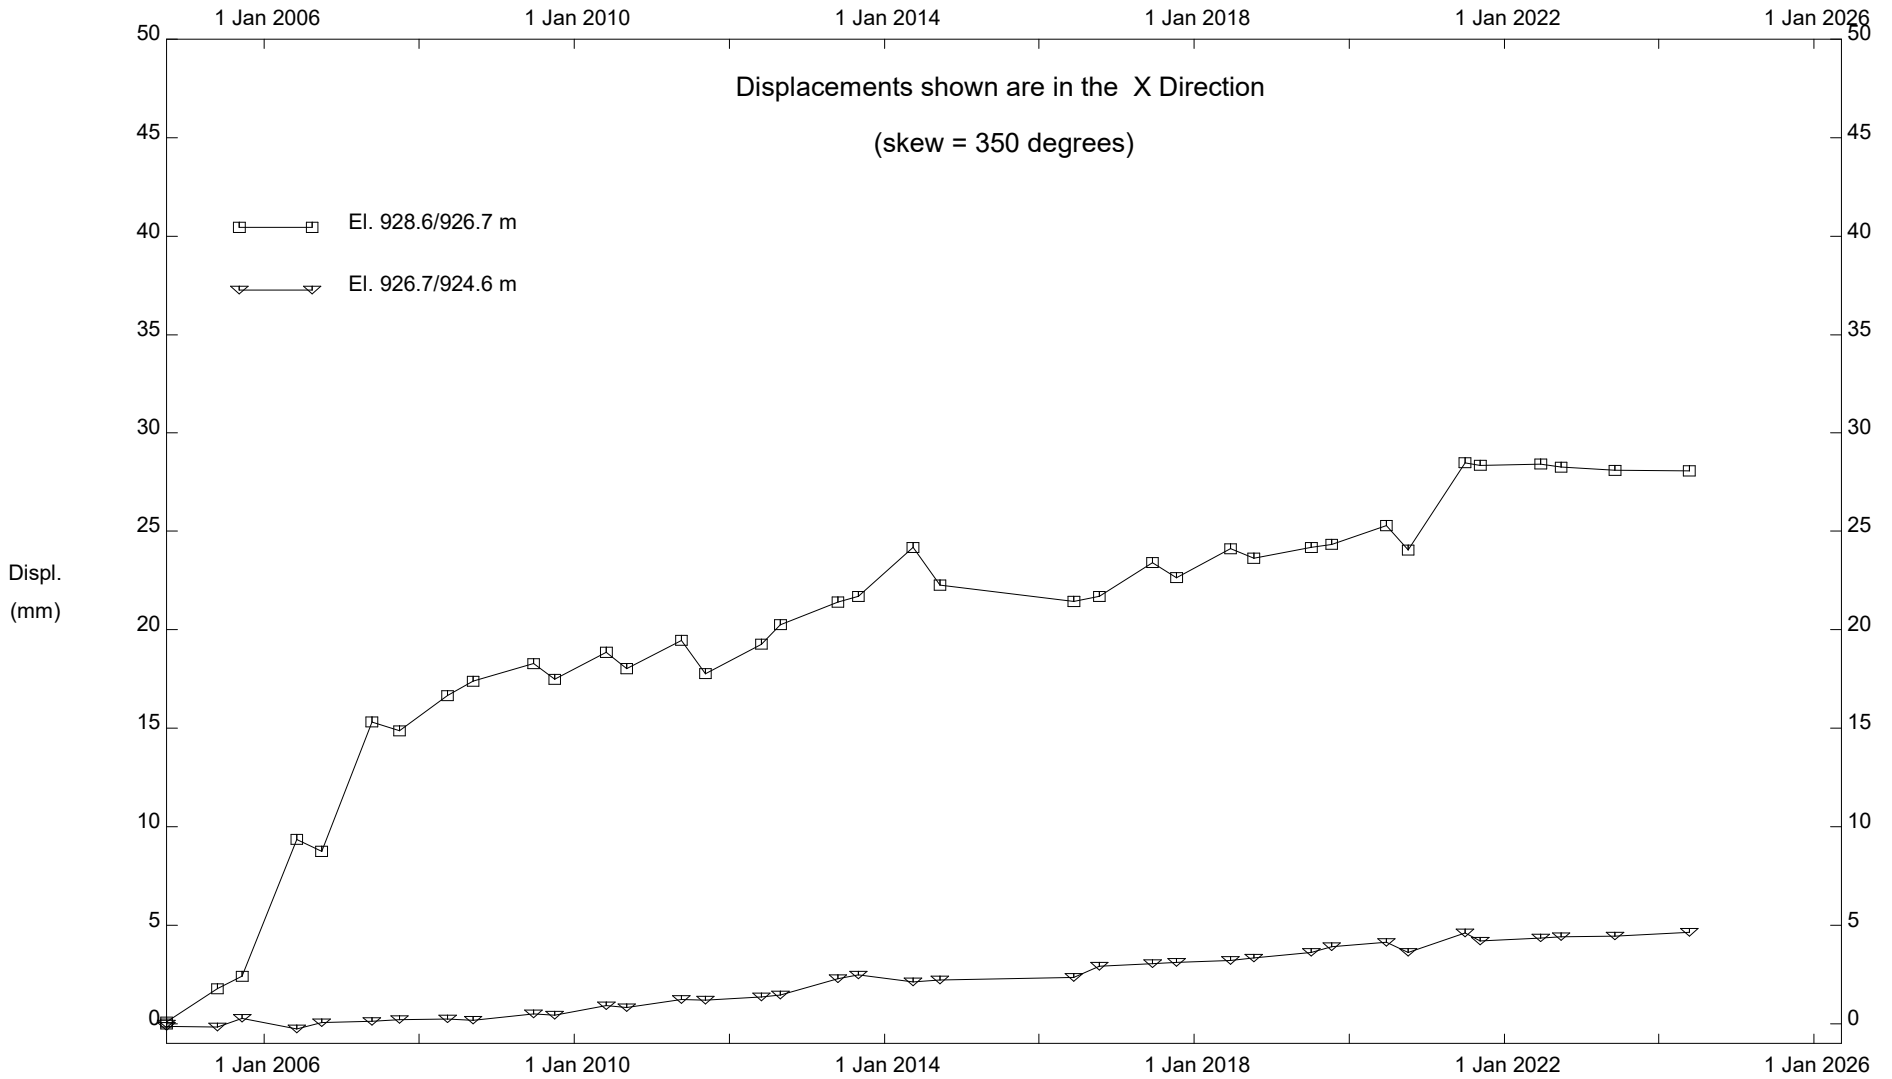
GP008; H40:36, Road Surface Slumping, Inclinometer SI-2

- SI-1 from ground surface to an approximate depth of 1.1 m below ground surface, and from approximately 3.6 m to 7.1 m below ground surface;
- SI-2 from ground surface to an approximate depth of 2.1 m below ground surface, and from approximately 2.0 m to 4.1 m below ground surface; and
- SI-3 from an approximate depth of 1.2 m to 2.1 m below ground surface, with most of the movement being recorded since May 2015.

Since the instruments were installed in 2007, the rate of movement being recorded in SI-1, SI-2, and SI-3 in the fill has been slow (less than 2 mm/year), except for increased movement (up to approximately 6 mm/year) recorded in the X-direction of SI-2 in early 2006 and 2021. In 2021, the increased rate of movement recorded in SI-2 was likely a result of the SI reading equipment being changed when KCB took over the readings in June 2021. Since 2021, the movement rates recorded in SI-2 are once again slow (less than 1 mm/year).

SI-1 and SI-2 (located near the top of the slope and mid-slope, respectively) are recording movement to the southeast. However, SI-2 (located near the toe of the slope) is recording movement more toward the southwest. This could indicate that the movement pattern for the highway embankment is complex and difficult to assess, given that the highway embankment was constructed in thick lifts with minimal compaction.
