July 15, 2024

**CON0022166 Peace Region (Grande Prairie District – South) GRMP Instrumentation Monitoring Site GP008; H40:36, km 16.365 Road Surface Slumping (2.5 km North of McIntyre Mine) Section C – 2024 Spring Readings**

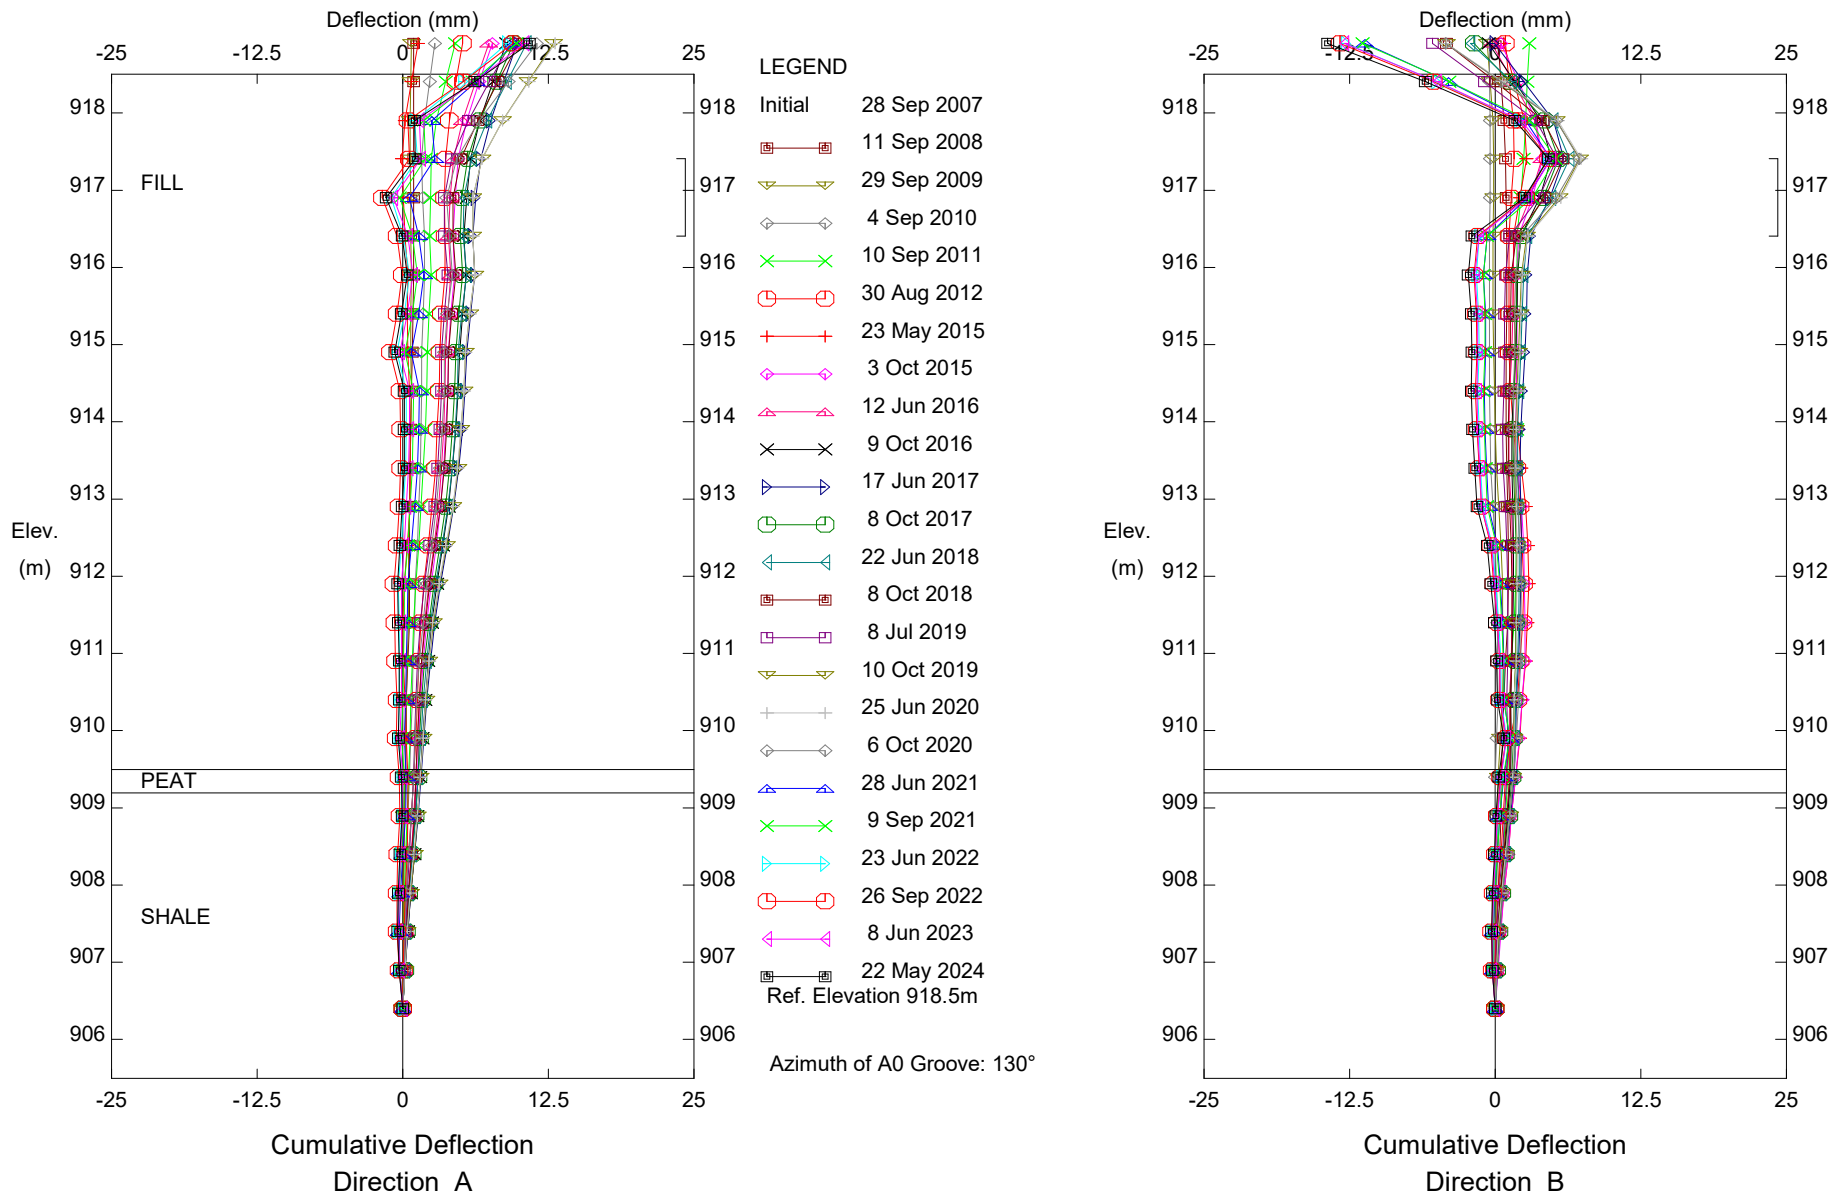
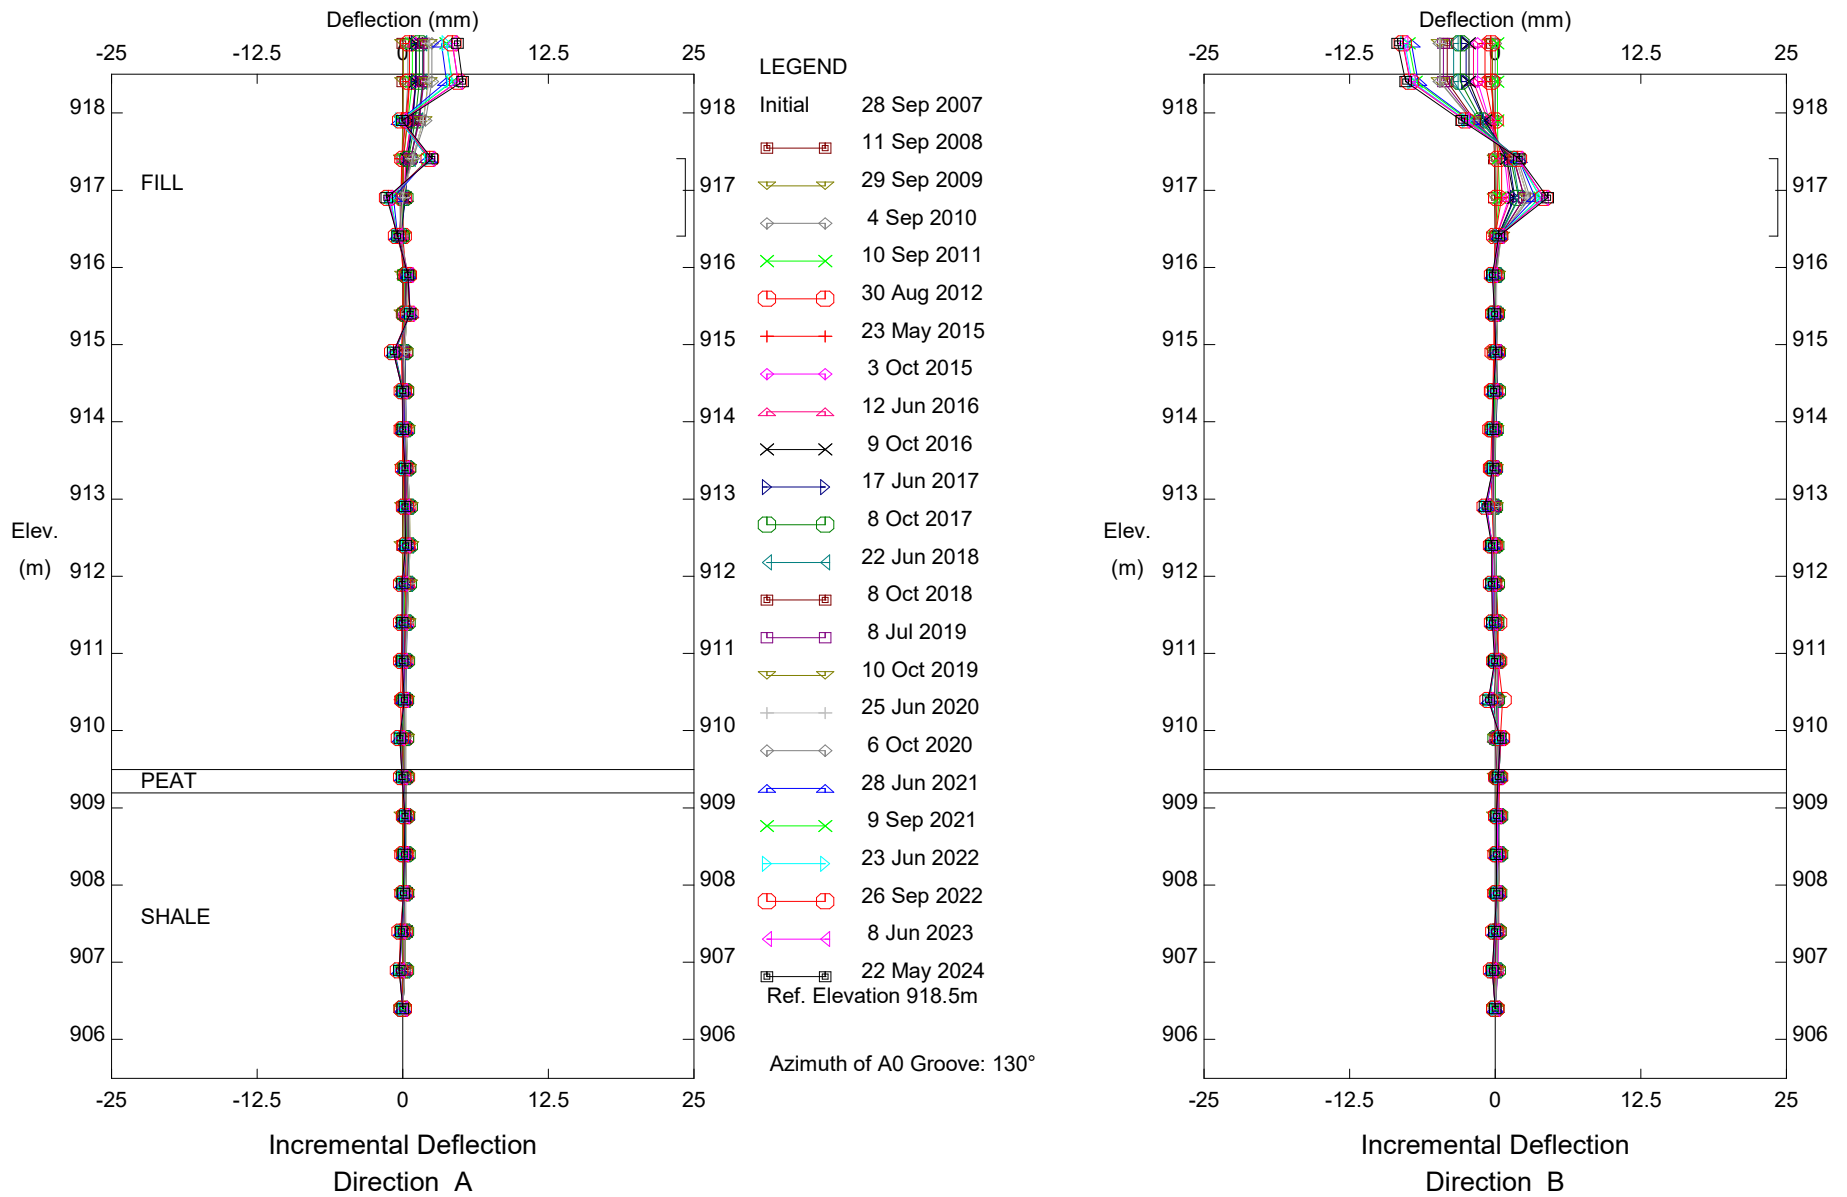
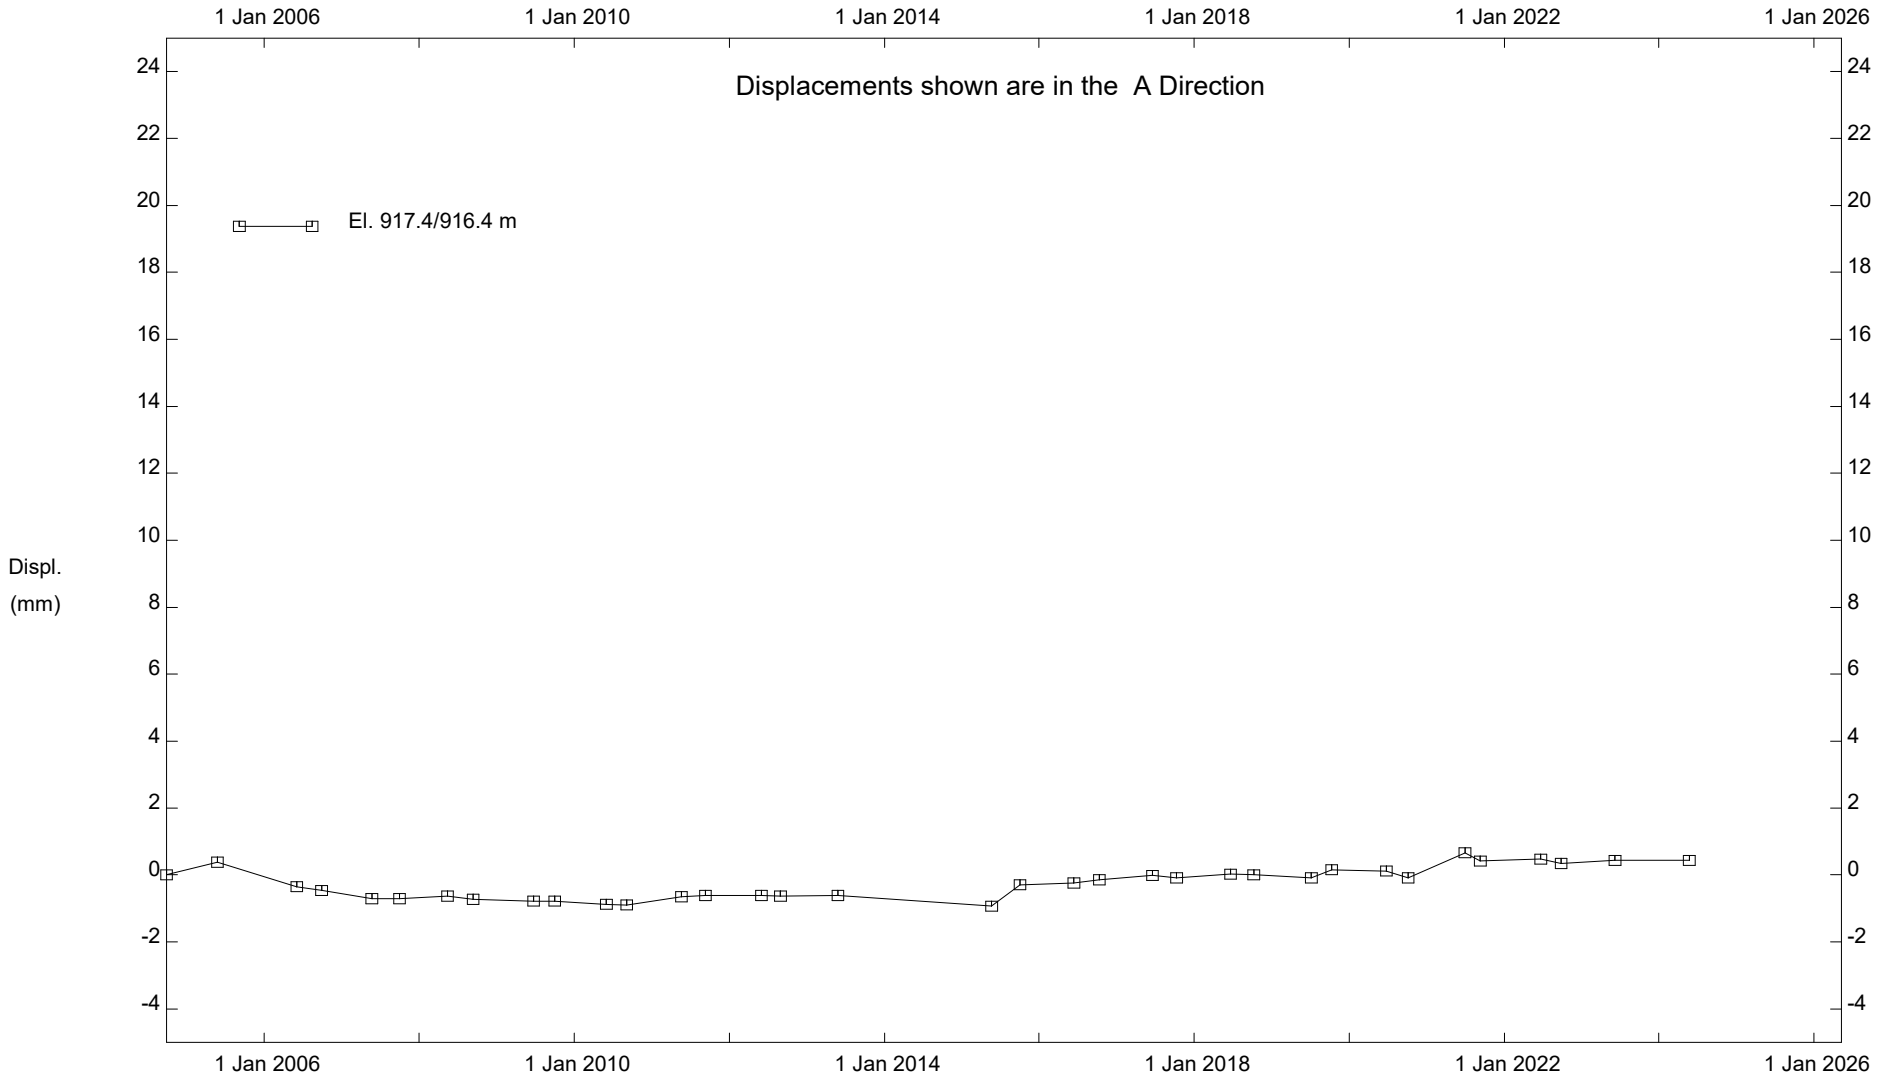
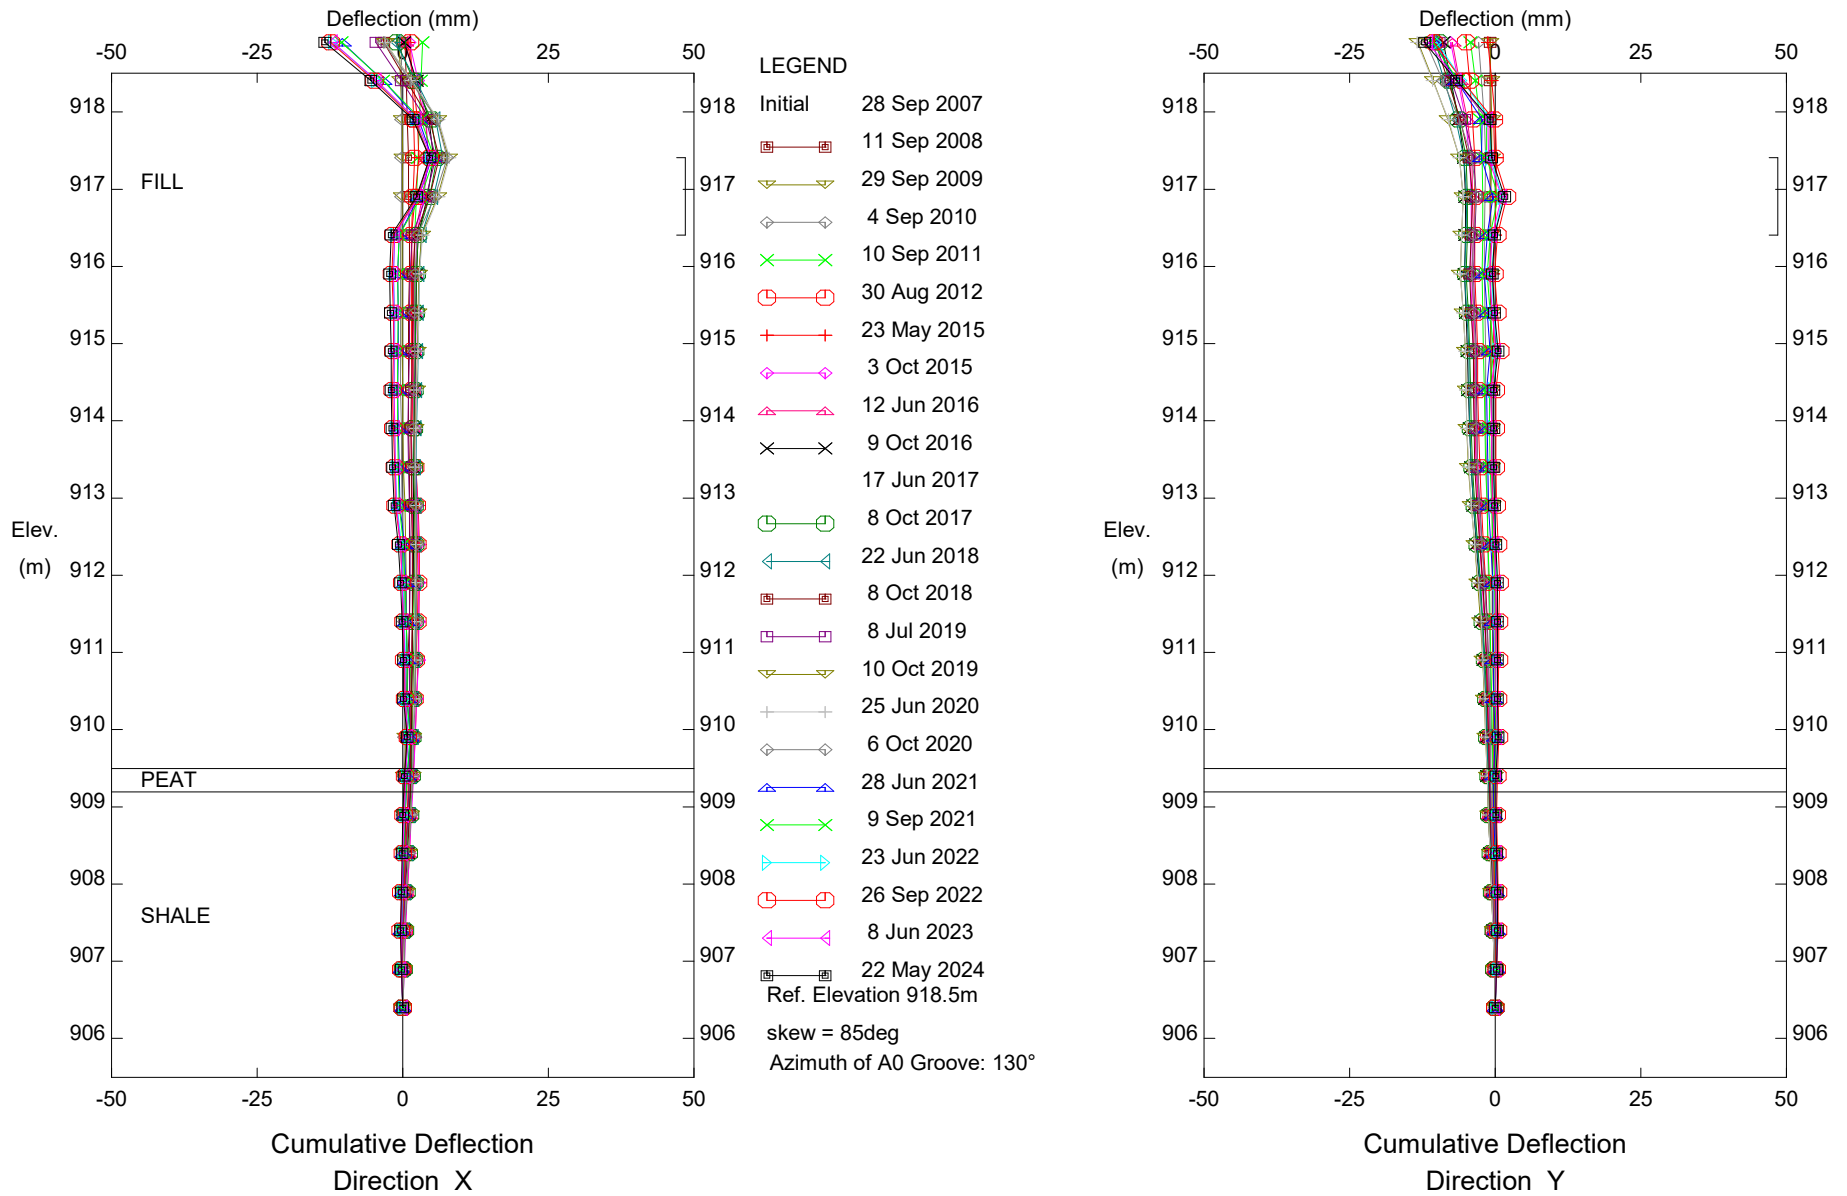
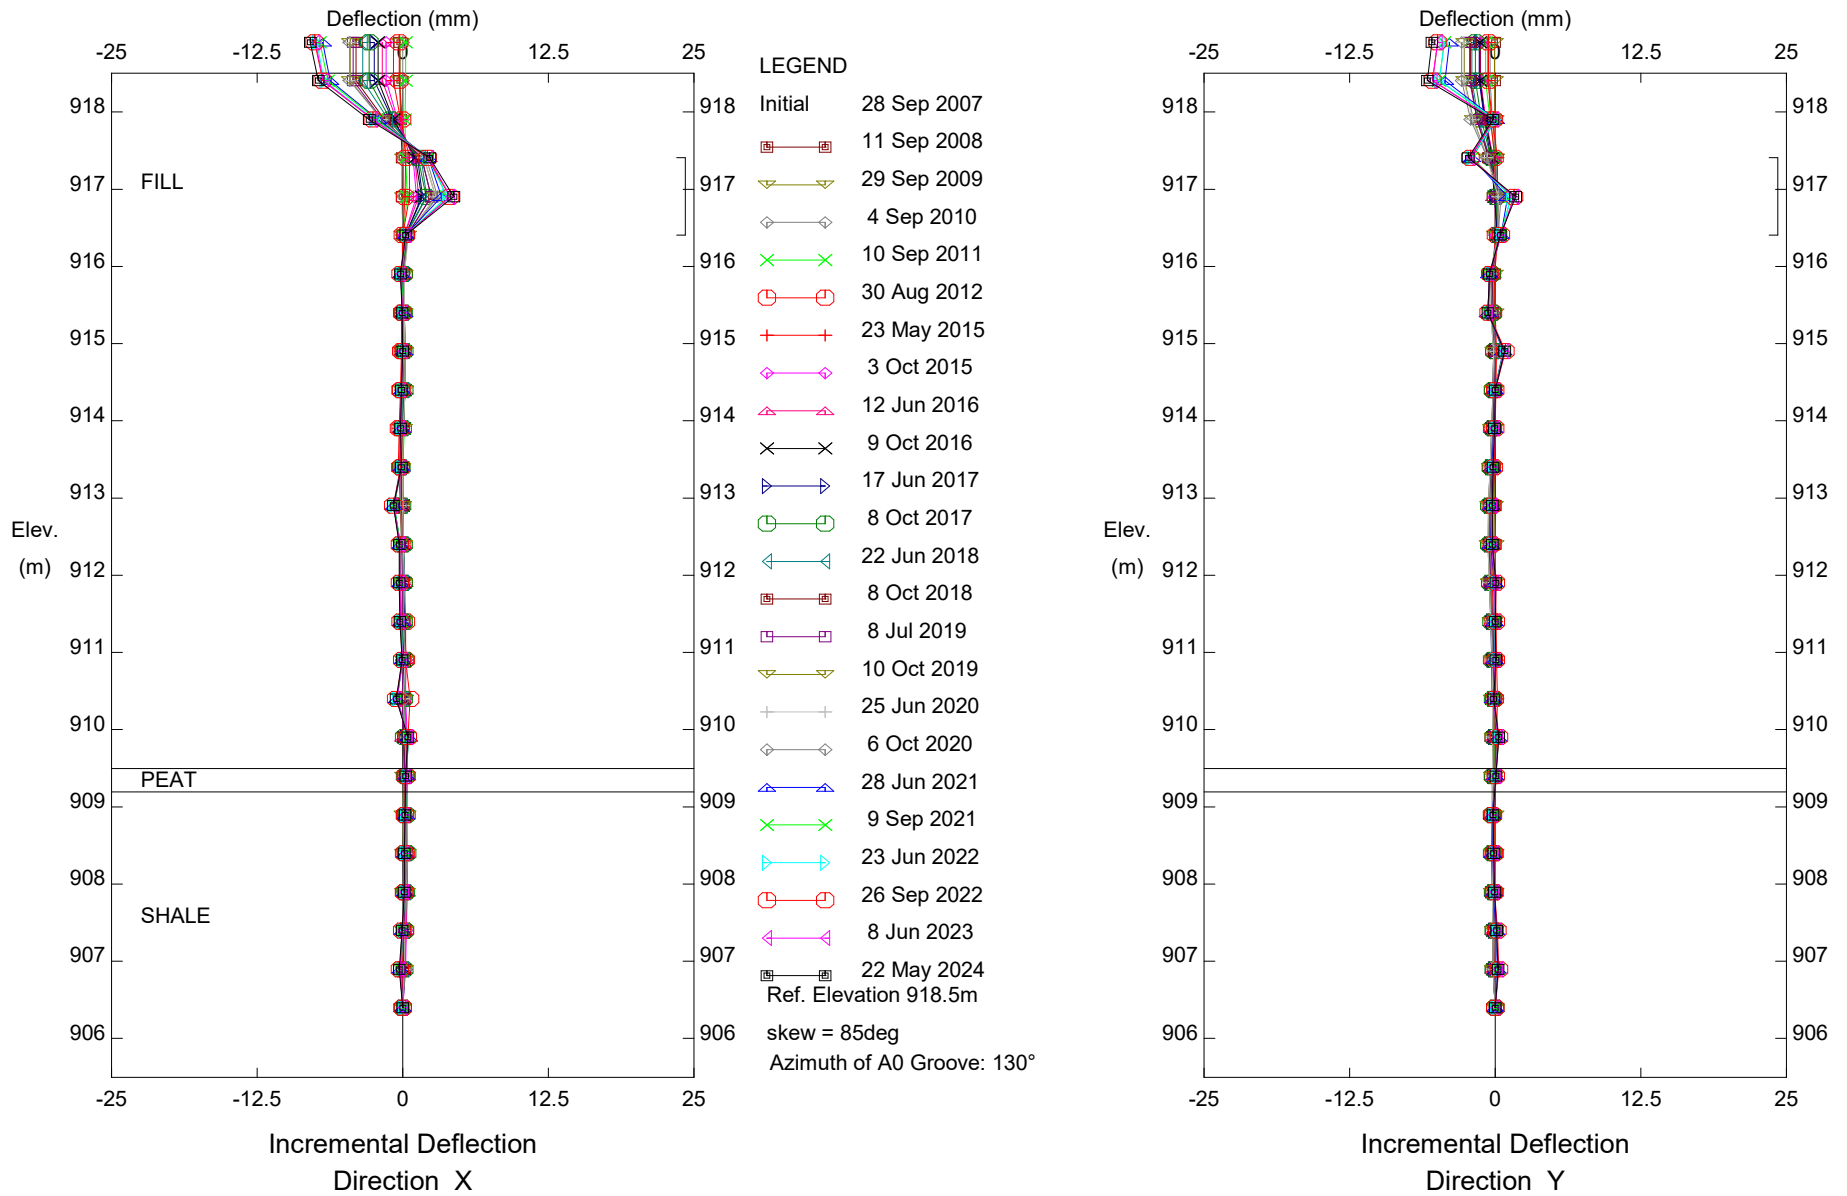
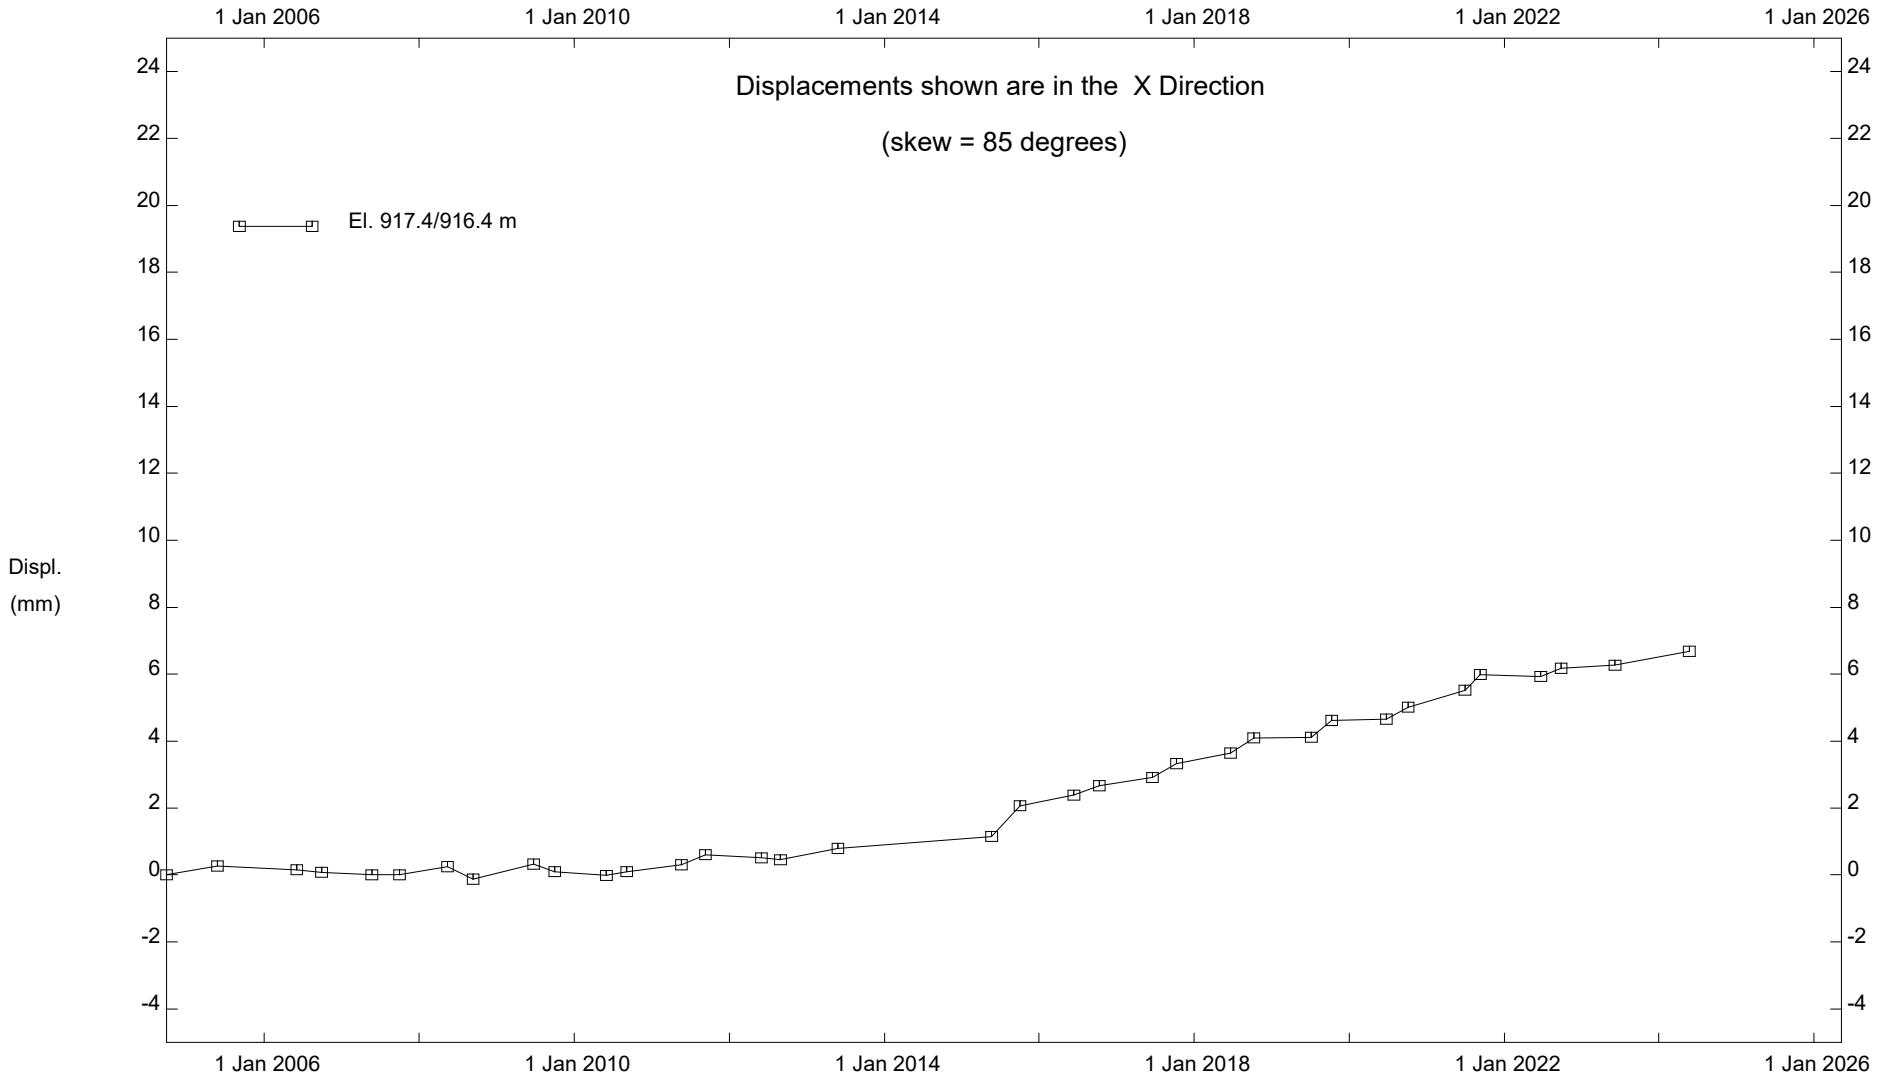
GP008; H40:36, Road Surface Slumping, Inclinator SI-3

- SI-1 from ground surface to an approximate depth of 1.1 m below ground surface, and from approximately 3.6 m to 7.1 m below ground surface;
- SI-2 from ground surface to an approximate depth of 2.1 m below ground surface, and from approximately 2.0 m to 4.1 m below ground surface; and
- SI-3 from an approximate depth of 1.2 m to 2.1 m below ground surface, with most of the movement being recorded since May 2015.

The movement being recorded in all three SIs is occurring within the fill.

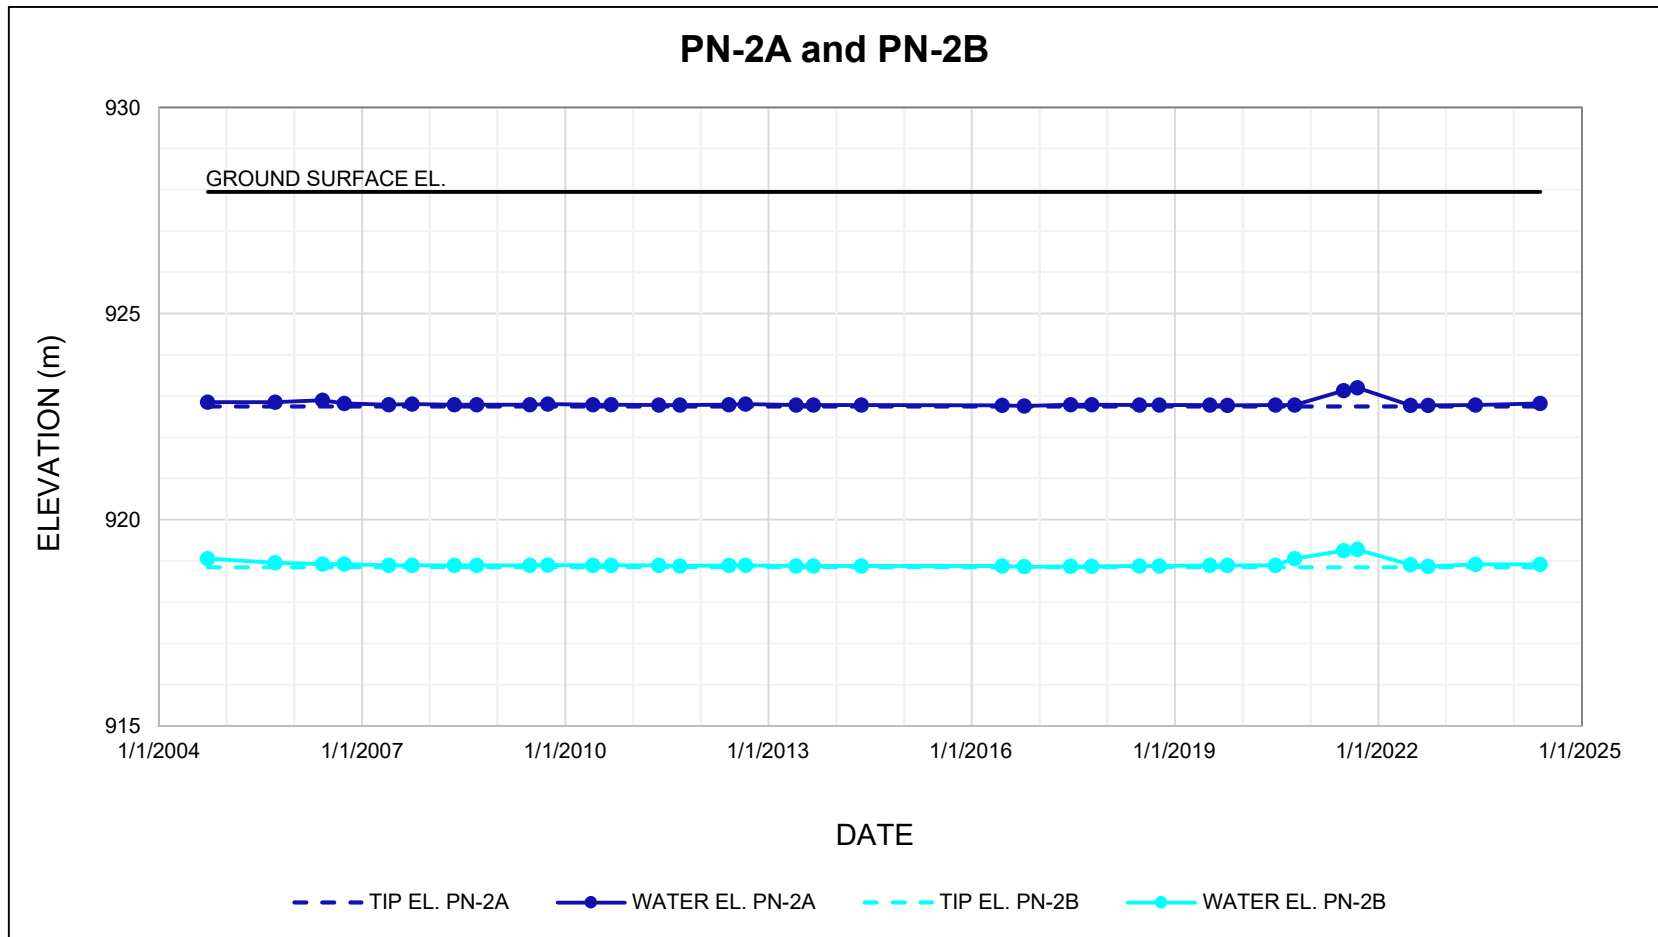
PROJECT PEACE REGION (GRANDE PRAIRIE DISTRICT - SOUTH) GEOHAZARD RISK MANAGEMENT PROGRAM		
	TITLE Piezometer Data GP008 - Road Surface Slumping (2.5 km North of McIntyre Mine) Hwy 40:36, km 16.365

Since the instruments were installed in 2004, water levels recorded in the PN-2A and PN-2B have been near tip elevation (i.e., the instruments have been dry), except during the spring and fall 2021 readings when water levels increased to 0.2 m and 0.4 m above tip elevation, respectively. Since the spring 2022 reading, the instruments have once again been dry.
