**ALBERTA TRANSPORTATION
GEOHAZARD ASSESSMENT PROGRAM
PEACE REGION – GRANDE PRAIRIE DISTRICT
2020 CALL OUT**

Site Number	Location	Name	Hwy	km
Call Outs	North of Grande Cache	Rockfall & 2 Debris Flows	40:36	8.5 to 11.2
Legal Description		UTM Co-ordinates (NAD 83)		
Km 8.55: SW29-57-8-W6		11U N 5,981,420	E 358,460	
Km 10.9: SE5-58-8-W6		11U N 5,983,463	E 359,373	
Km 11.2: SE5-58-8-W6		11U N 5,983,698	E 359,415

Date	PF	CF	Total
Previous Inspection:	July 12, 2019	10	4	40 (km 8.55 - rockfall basis)
		10	5	50 (km 11.2 & 13.75 sites)
Current Inspection:	May 25, 2020	10	4	40 (km 8.55 - rockfall basis)
		10	5	50 (km 10.9 & 11.2 sites)
Road AADT:	1,150	Year:		2018
Inspected By:	Don Proudfoot, Nicole Wilder (Thurber) Ed Szmata, Rishi Adhikari, Dwayne Lowen (AT)			
Report Attachments:	<input checked="" type="checkbox"/> Photographs <input checked="" type="checkbox"/> Plans <input checked="" type="checkbox"/> Maintenance Items

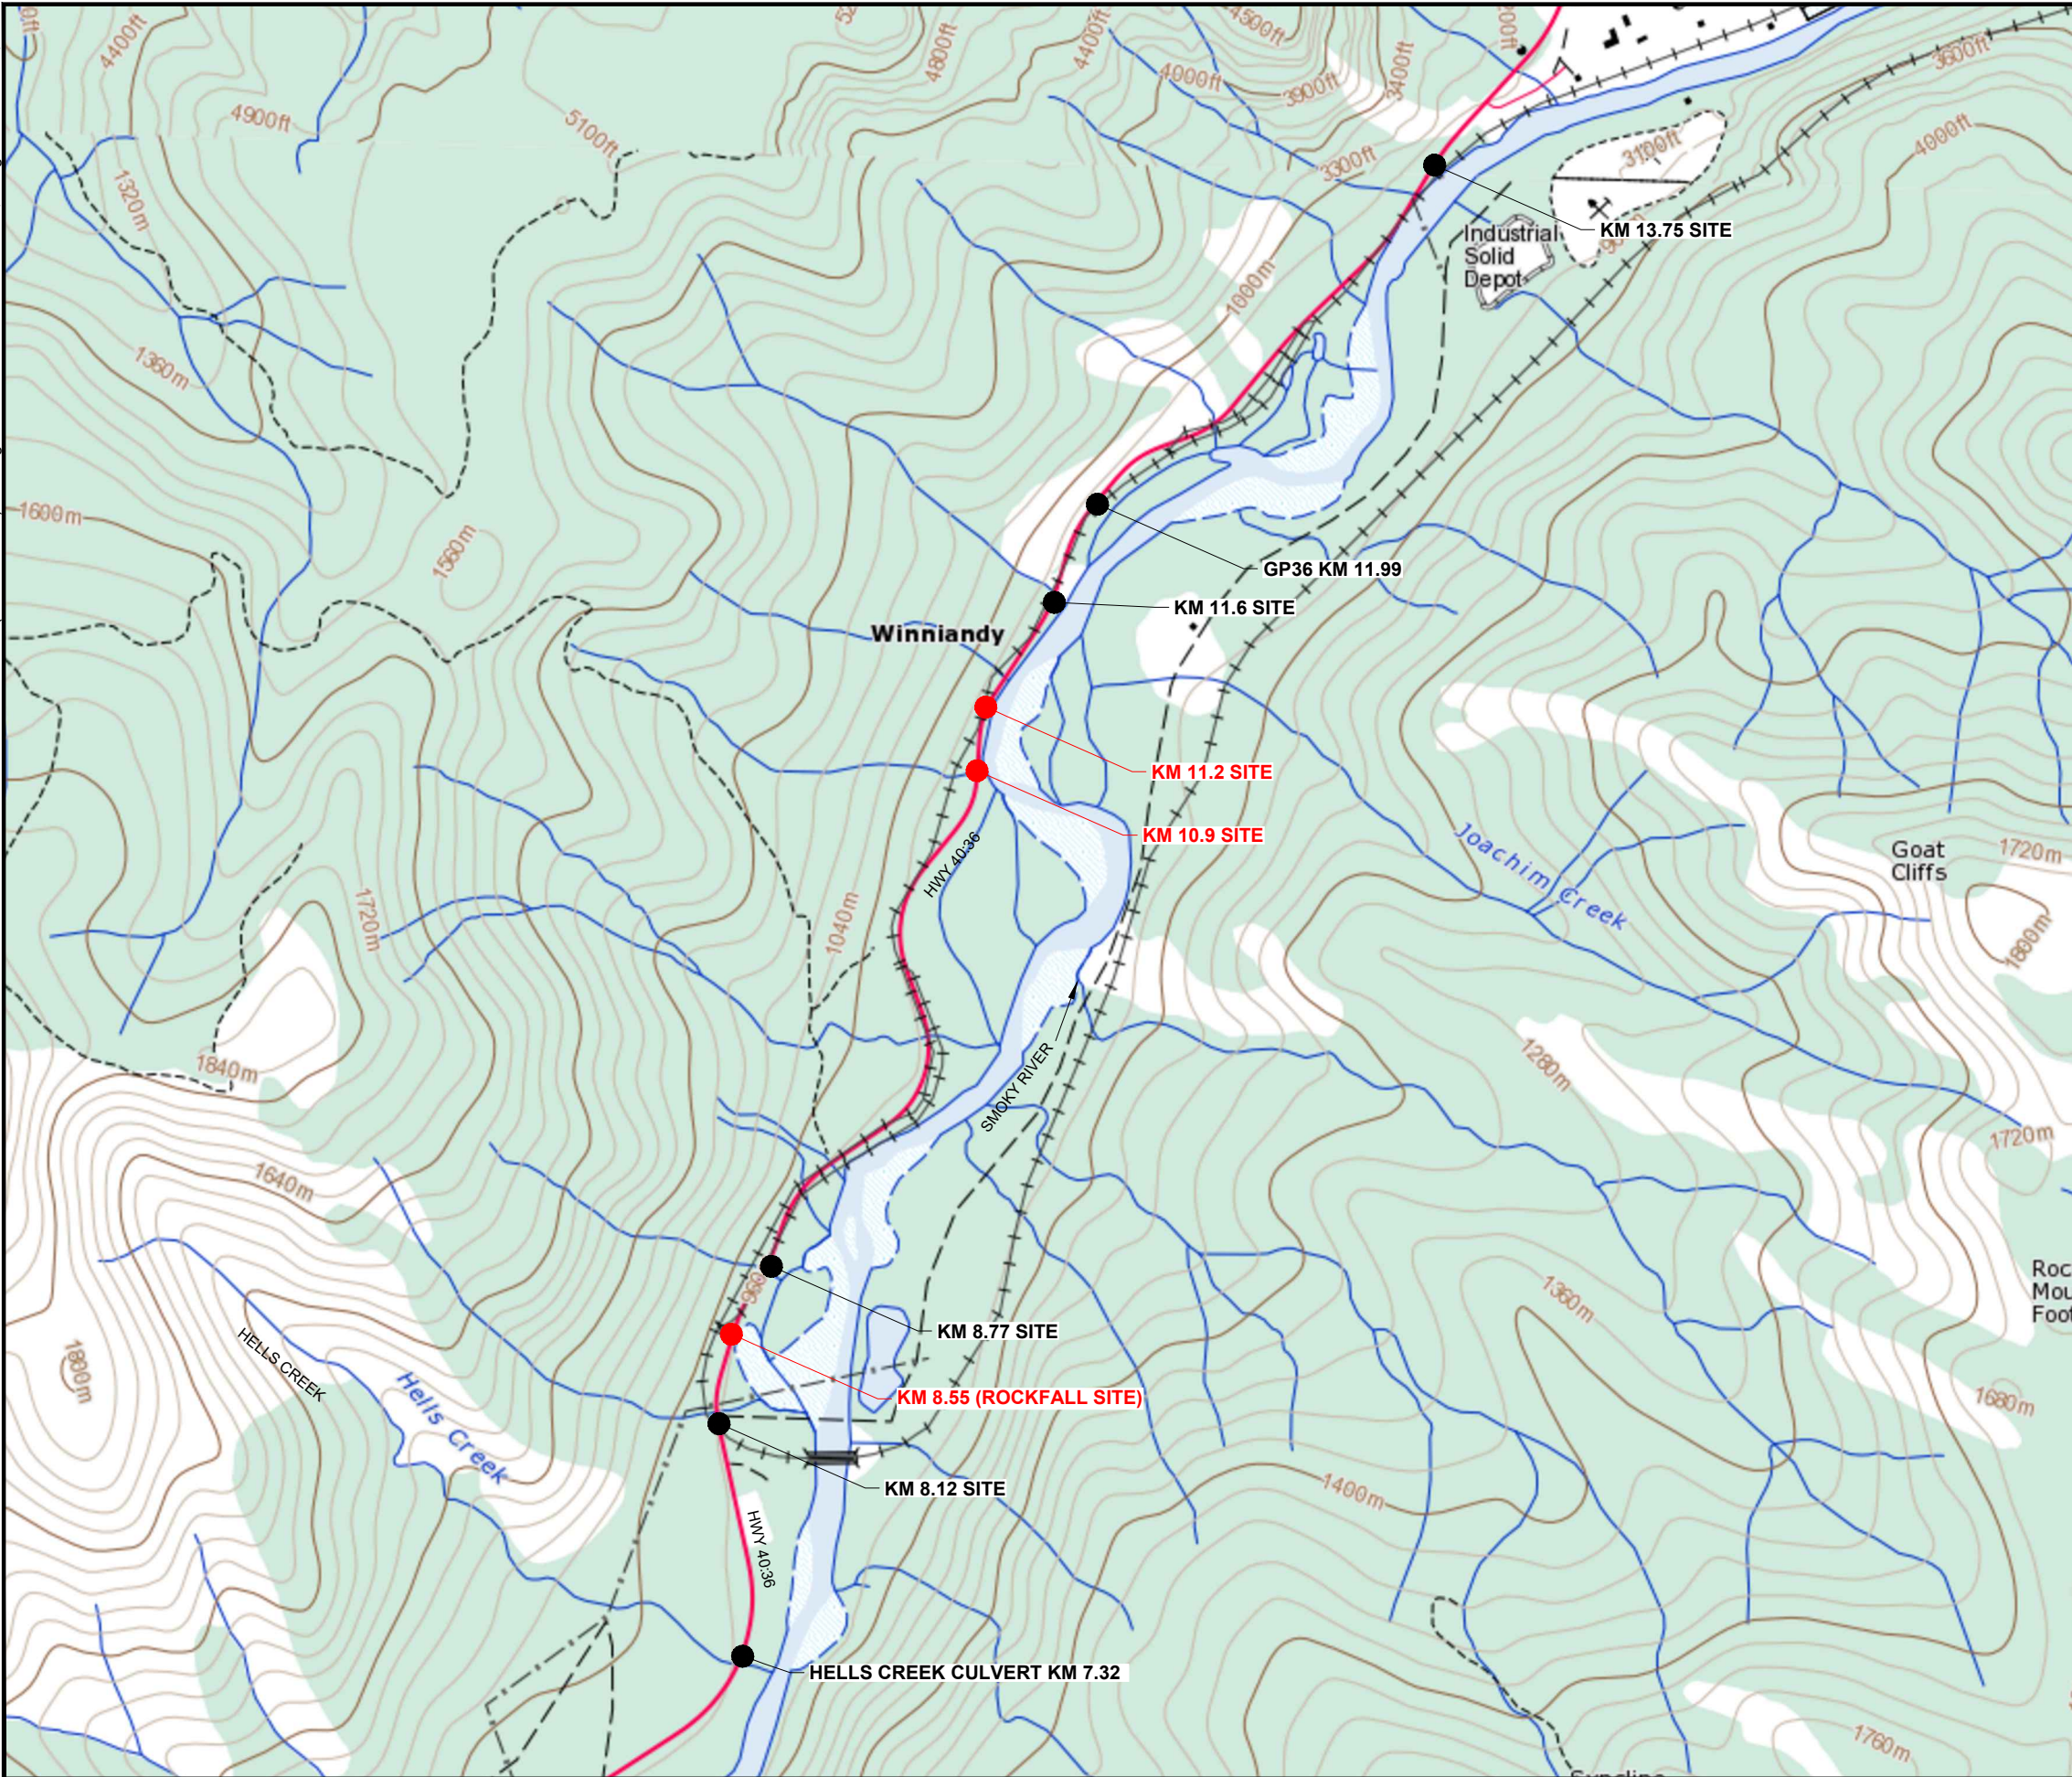
FIGURE 1

At the two debris flow sites, large sudden flow events triggered by heavy rainfall from further up the mountain have travelled along defined channels picking up and depositing debris into the west highway ditch (and across the hwy into the east ditch at both sites). The Alberta Topography Map (Figure 1 attached), the LiDAR drawing (Figure 4 attached), and an excerpt from the Debris Flow Map obtained from AT (Figure 6), documents defined flow channels at or adjacent to these two sites. The debris flow events may possibly have been triggered or complicated by upstream channel blockages that suddenly let loose, unleashing a torrent of water down along the channels. Some portions of the current flow channels above the ditch may have been forced outside of their former channel bed paths at some locations by tree/rock debris barriers created by the sudden flood event, and this re-routing carved out new channel paths. At both debris flow sites the concentrated flows likely saturated the overburden materials and transformed it into more of an earth slide as the flow event progressed.

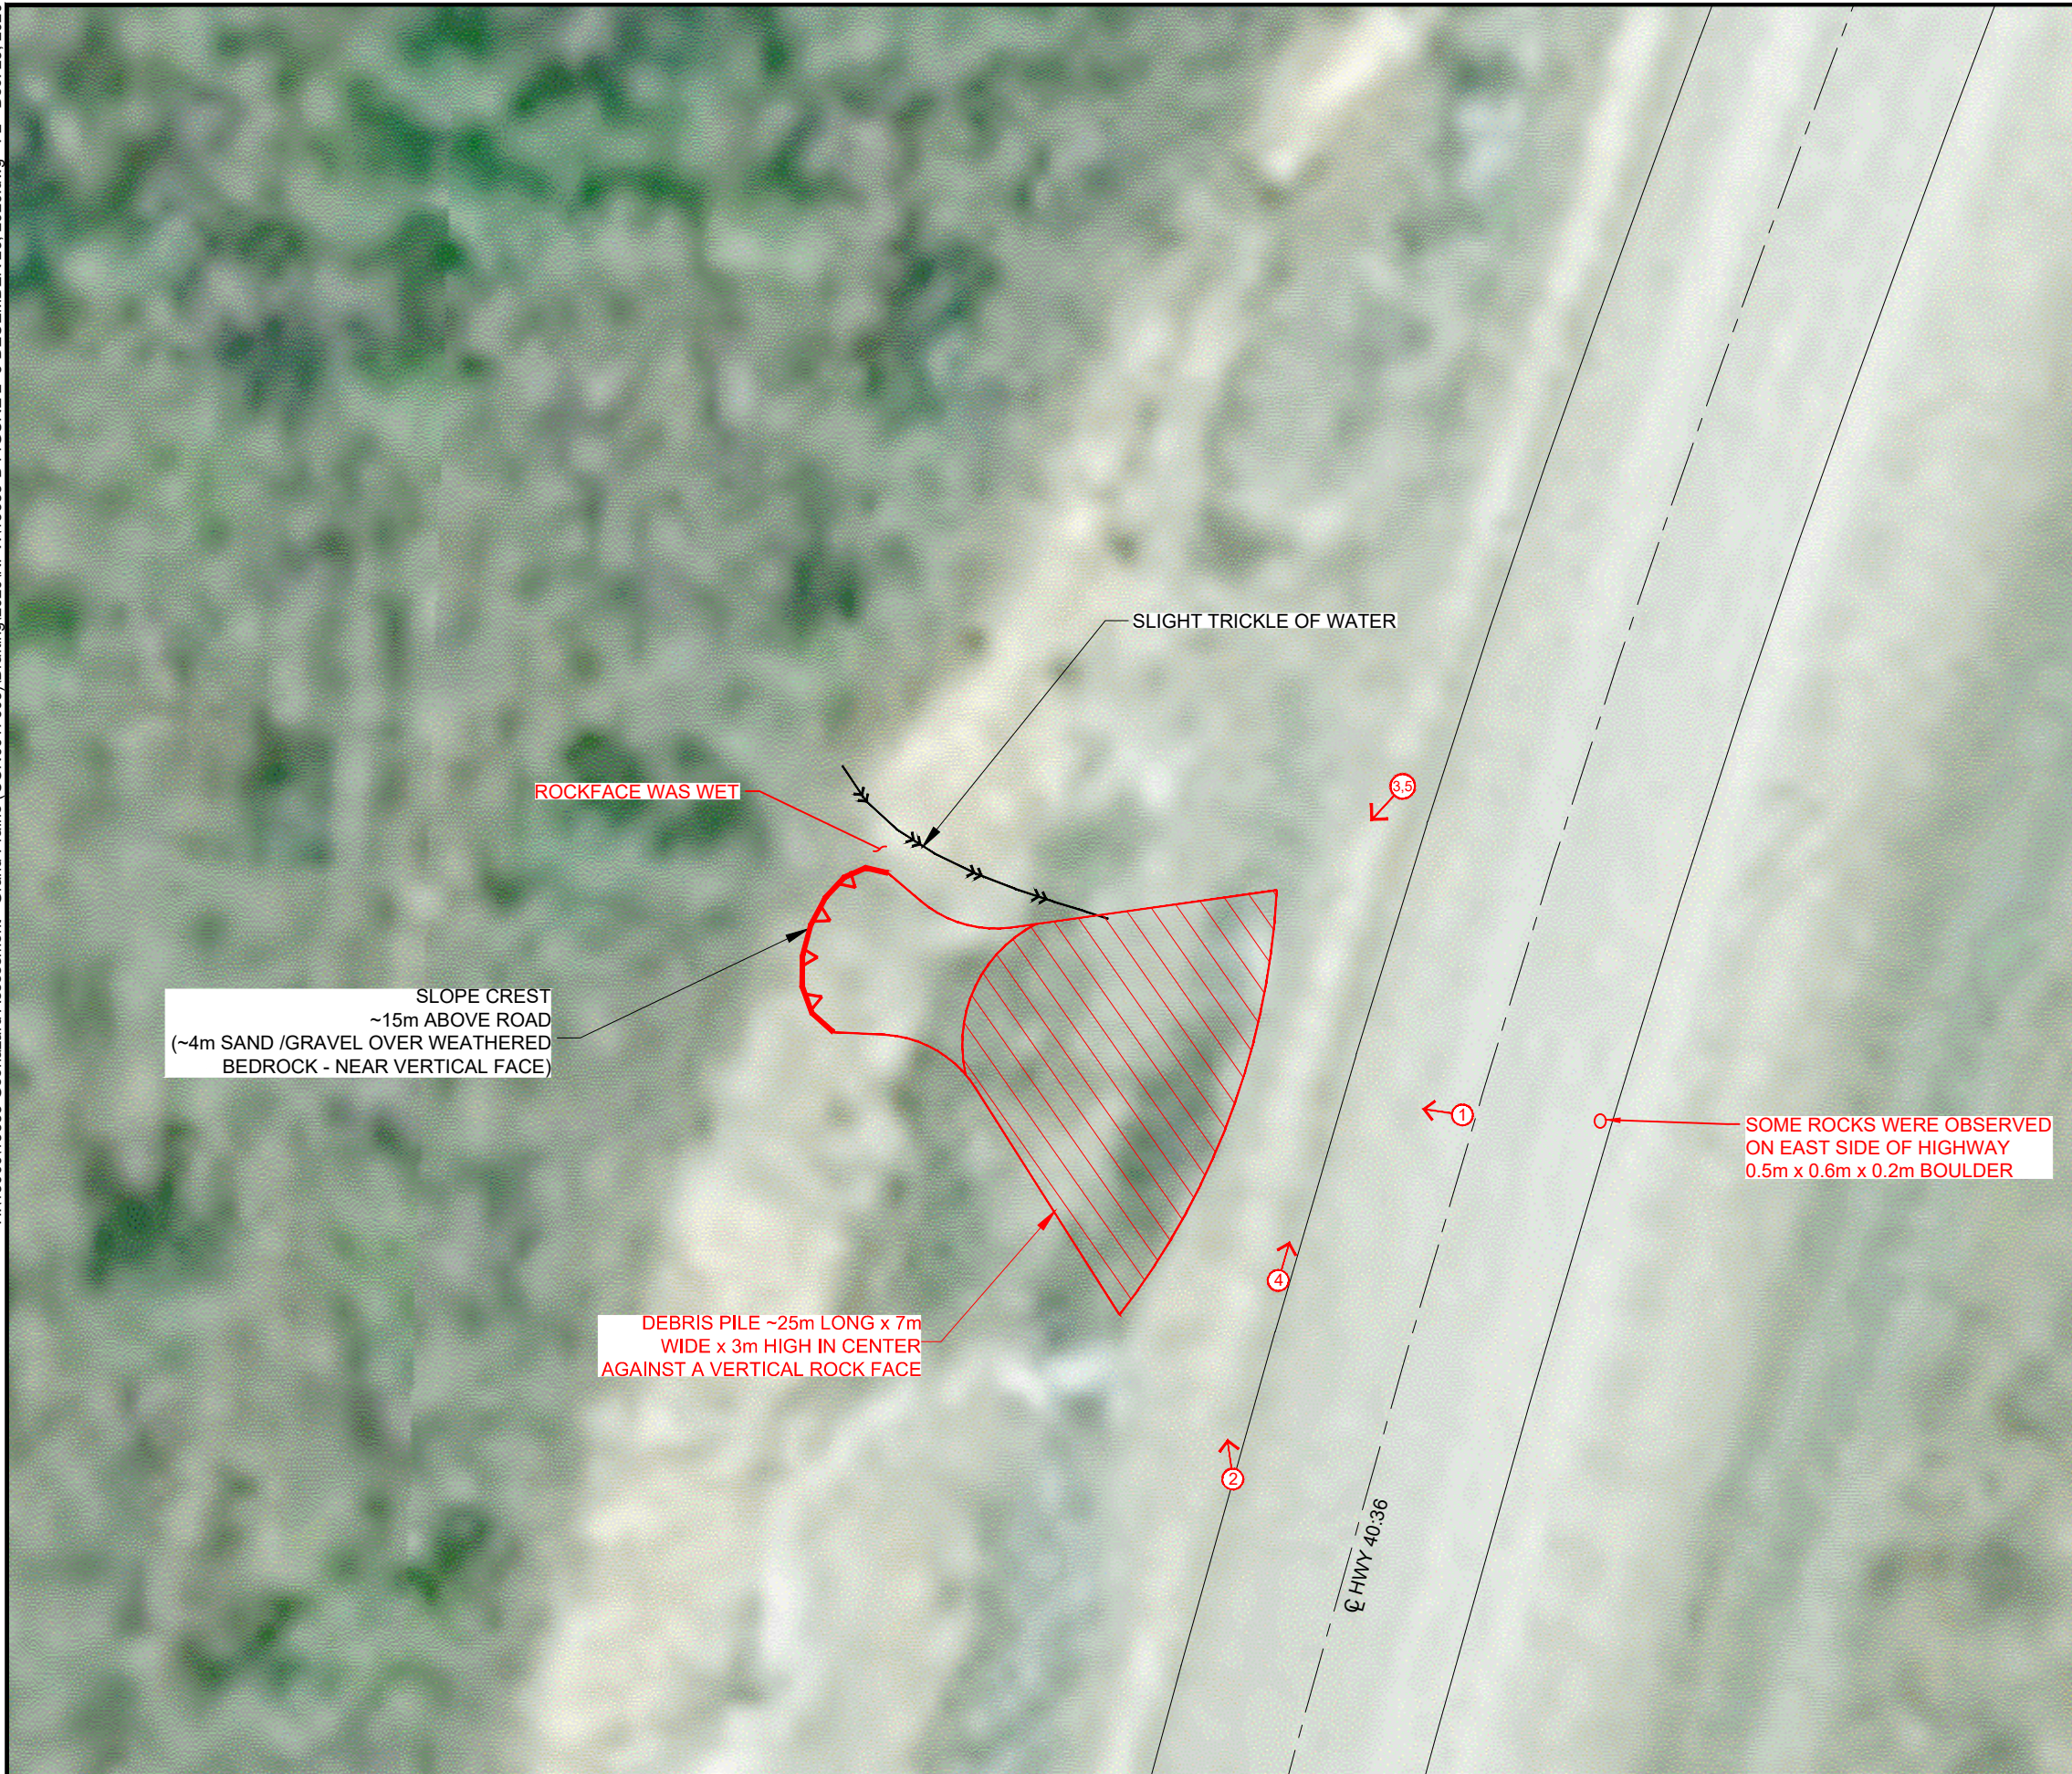
FIGURE 2

At the rock fall site at km 8.55 (Figure 2 attached), there is a backslope cut with a variable thickness (up to 4 m) of granular overburden overlying what appears to be an exposed ledge of weathered sandstone protruding from the top of the bedrock surface, that overlies a near vertical bedrock face. The overburden and the mantle of weathered sandstone directly underlying the overburden fell down along the bedrock face and became deposited in the ditch. The exposed overburden from this slumped area appears to be wet, with a slight trickle of flow running down from the top of the backslope, and overtop the center of the debris build-up in the ditch. It is possible flow from the slope above may have been diverted to this location. It is surmised that the additional weight of the saturated overburden, along with possible aggravation by flow erosion, broke the protruding mantle of weathered sandstone that was supporting it above, which fell down along the lower bedrock face and became deposited in the west ditch.

At this rockfall site, the debris consists of unsorted overburden with some bedrock boulders that ended up as a deposit over a length of about 25 m in the west ditch in a conical shape (estimated at about 130 m³ of material).

The crest of the backslope is about 15 m above the road at this location. The exposed slope face consisting of up to 4 m of overburden material overlying bedrock extends a significant distance in both directions from the rock fall area, and AT is concerned that adjoining areas could similarly fall. It appears that two older gullies with scarring on the backslope face below exist (one a short distance north, and the other a greater distance south, of this existing rock fall location), that may have carried flow in the past.

- Overburden removal/rock scaling (at the km 8.55 site). Access for any equipment or human traffic appears to be difficult, and this would be expensive.

- Catch Fence or Mesh Draping (at the km 8.55 site). A catch fence could possibly be installed along the ditch, while a mesh draping would need to be anchored behind the potential overburden slide scarp to reduce the risk of rocks tumbling onto the highway. Again, access is difficult, but this could be less costly than the excavation/scaling.

For the km 8.55 site, overburden removal/scaling or catch fence/mesh draping could be considered (as mentioned in the **Discussion** section of this report).

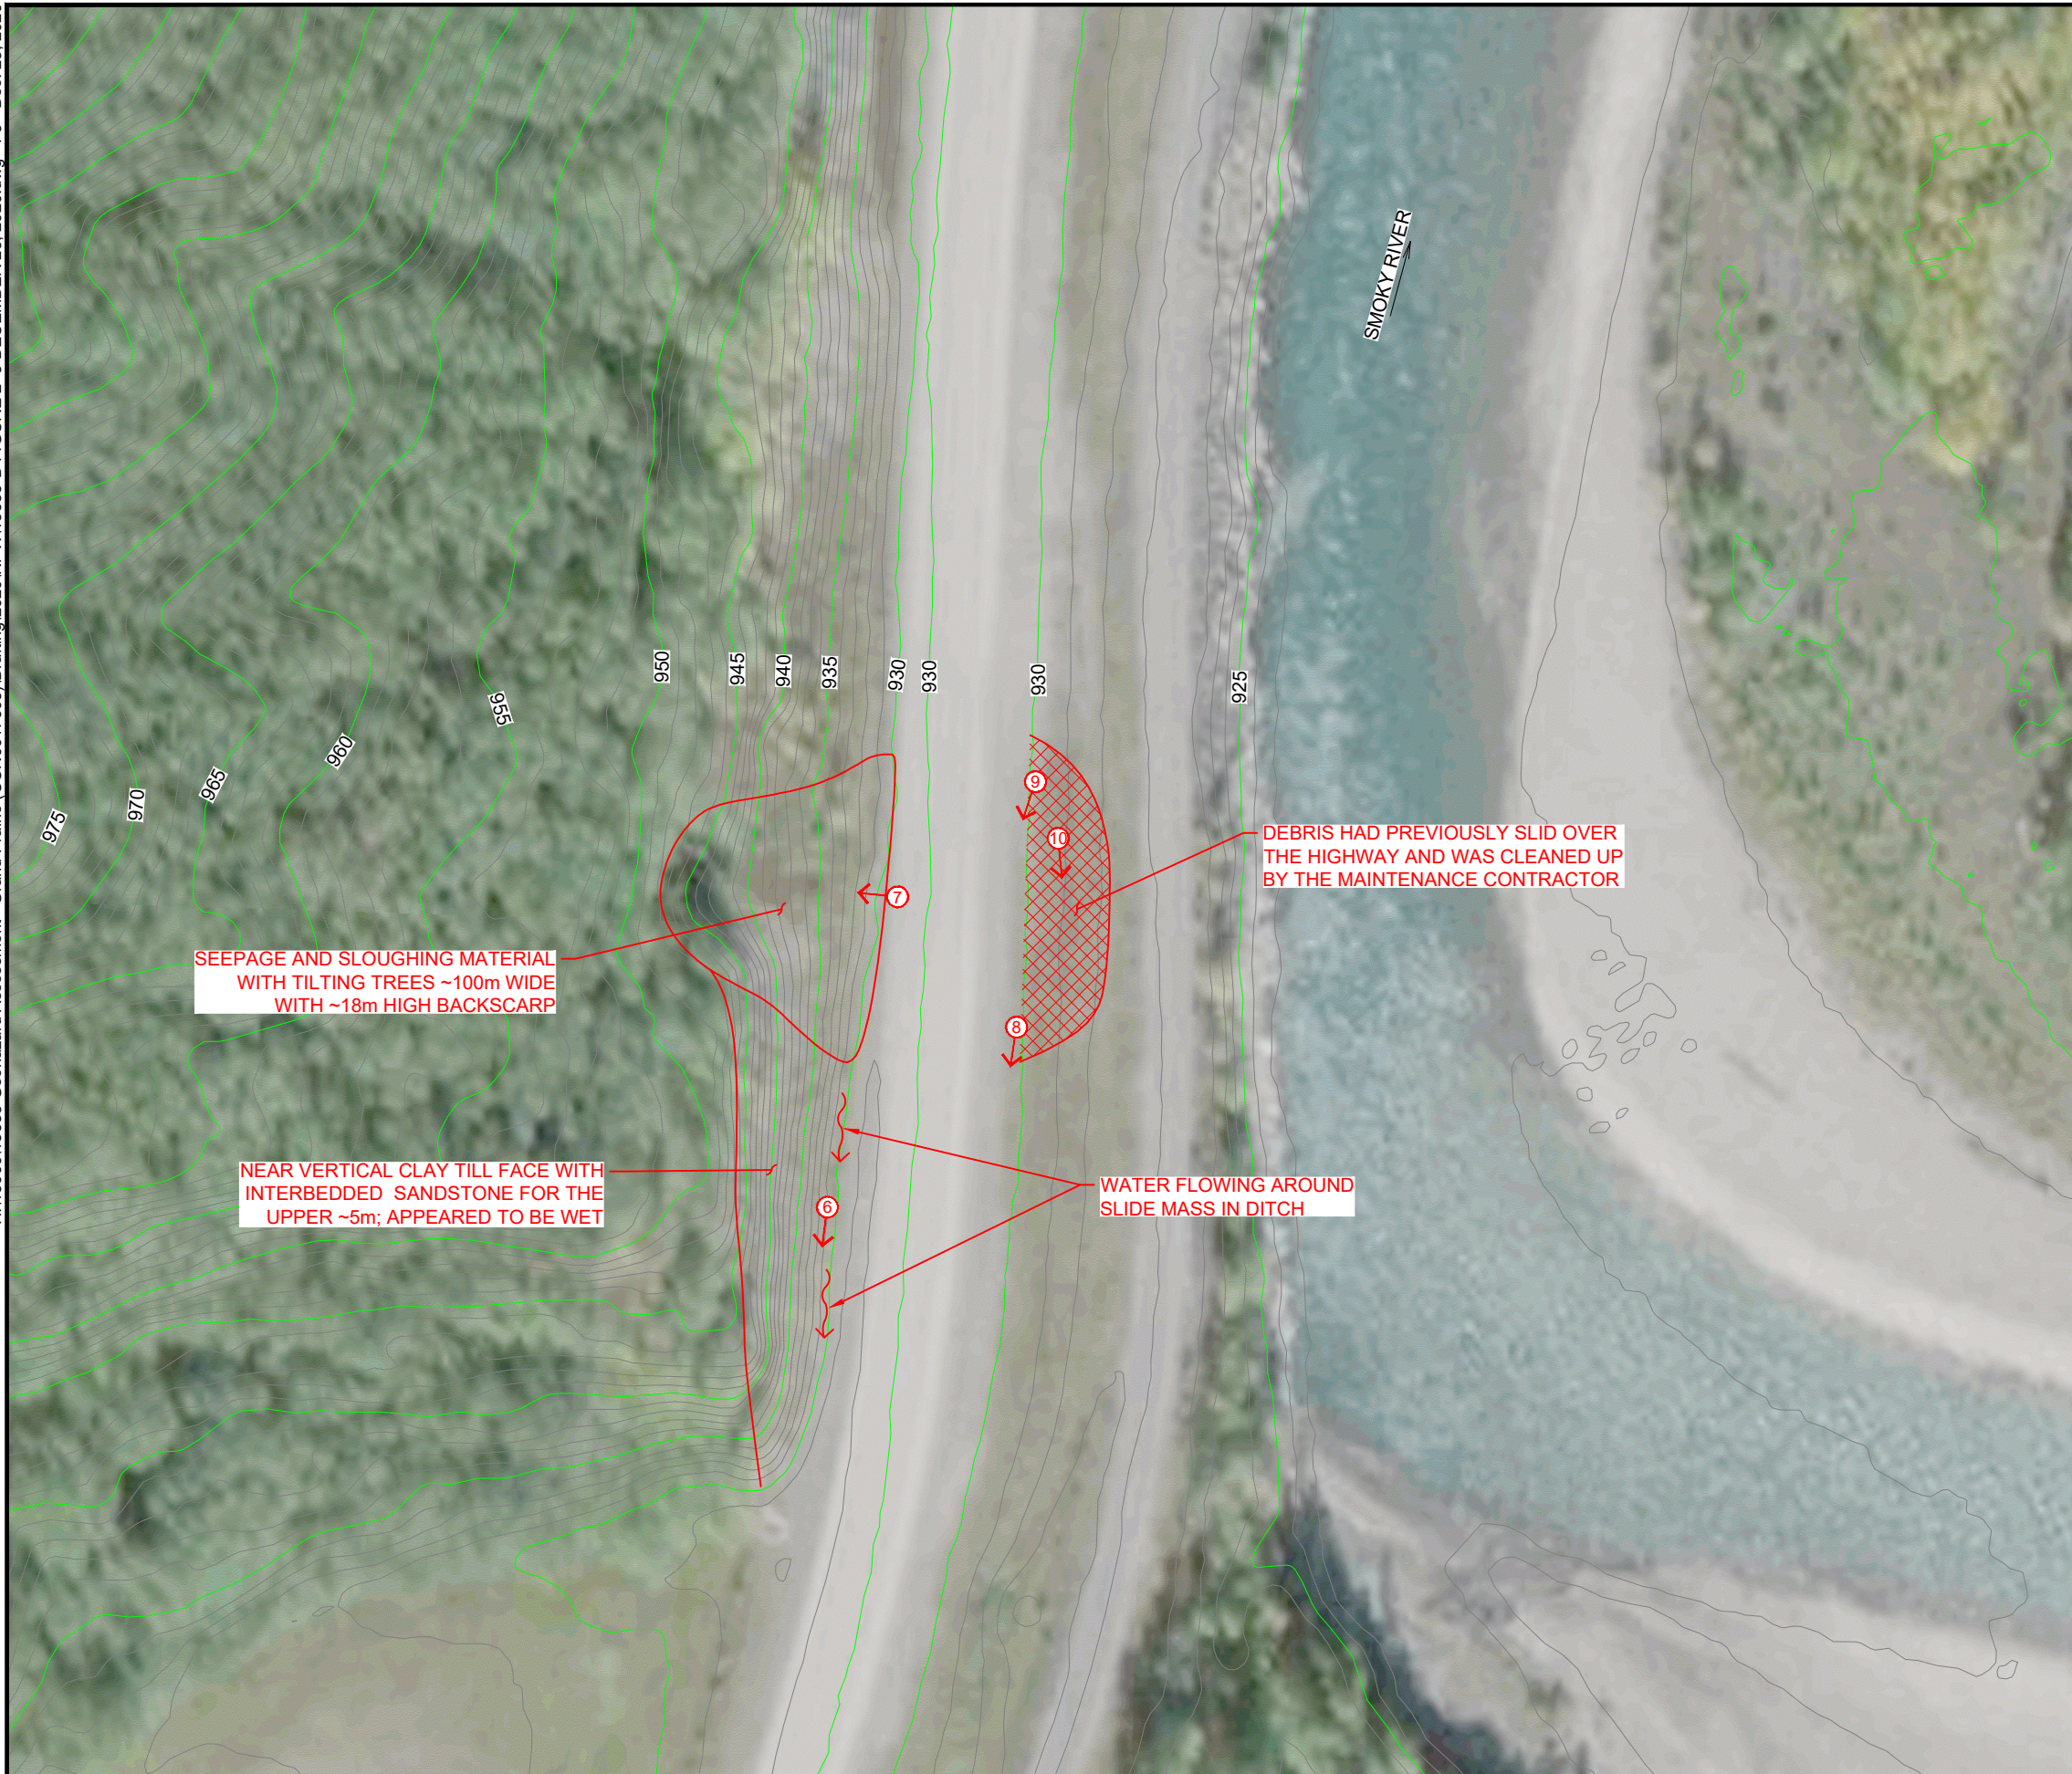
FIGURE 3

At the time of the call out, debris build-up of fine sediments was deposited in the west ditch in a general conical or deltaic fan shape (see Figure 3 attached). The channel flow had appeared to incise an outlet point through the overburden backslope at this location (the top of the backslope of this earth flow scarp was now estimated at about 18 m above the highway and about 50 m from the highway).

One stream of water having low to moderate flow volumes was observed running down the backscarp from further upslope, over the slumped material and debris deposit, and outletting into the west ditch. Predominant fine sediments/debris infilled the west ditch and extended over a length of about 100 m. Some additional sloughing of material should be expected as the stream likely saturated much of the debris and overburden.

SEEPAGE AND SLOUGHING MATERIAL WITH TILTING TREES ~100m WIDE WITH ~18m HIGH BACKSCARP

NEAR VERTICAL CLAY TILL FACE WITH INTERBEDDED SANDSTONE FOR THE UPPER ~5m; APPEARED TO BE WET

DEBRIS HAD PREVIOUSLY SLID OVER THE HIGHWAY AND WAS CLEANED UP BY THE MAINTENANCE CONTRACTOR

WATER FLOWING AROUND SLIDE MASS IN DITCH

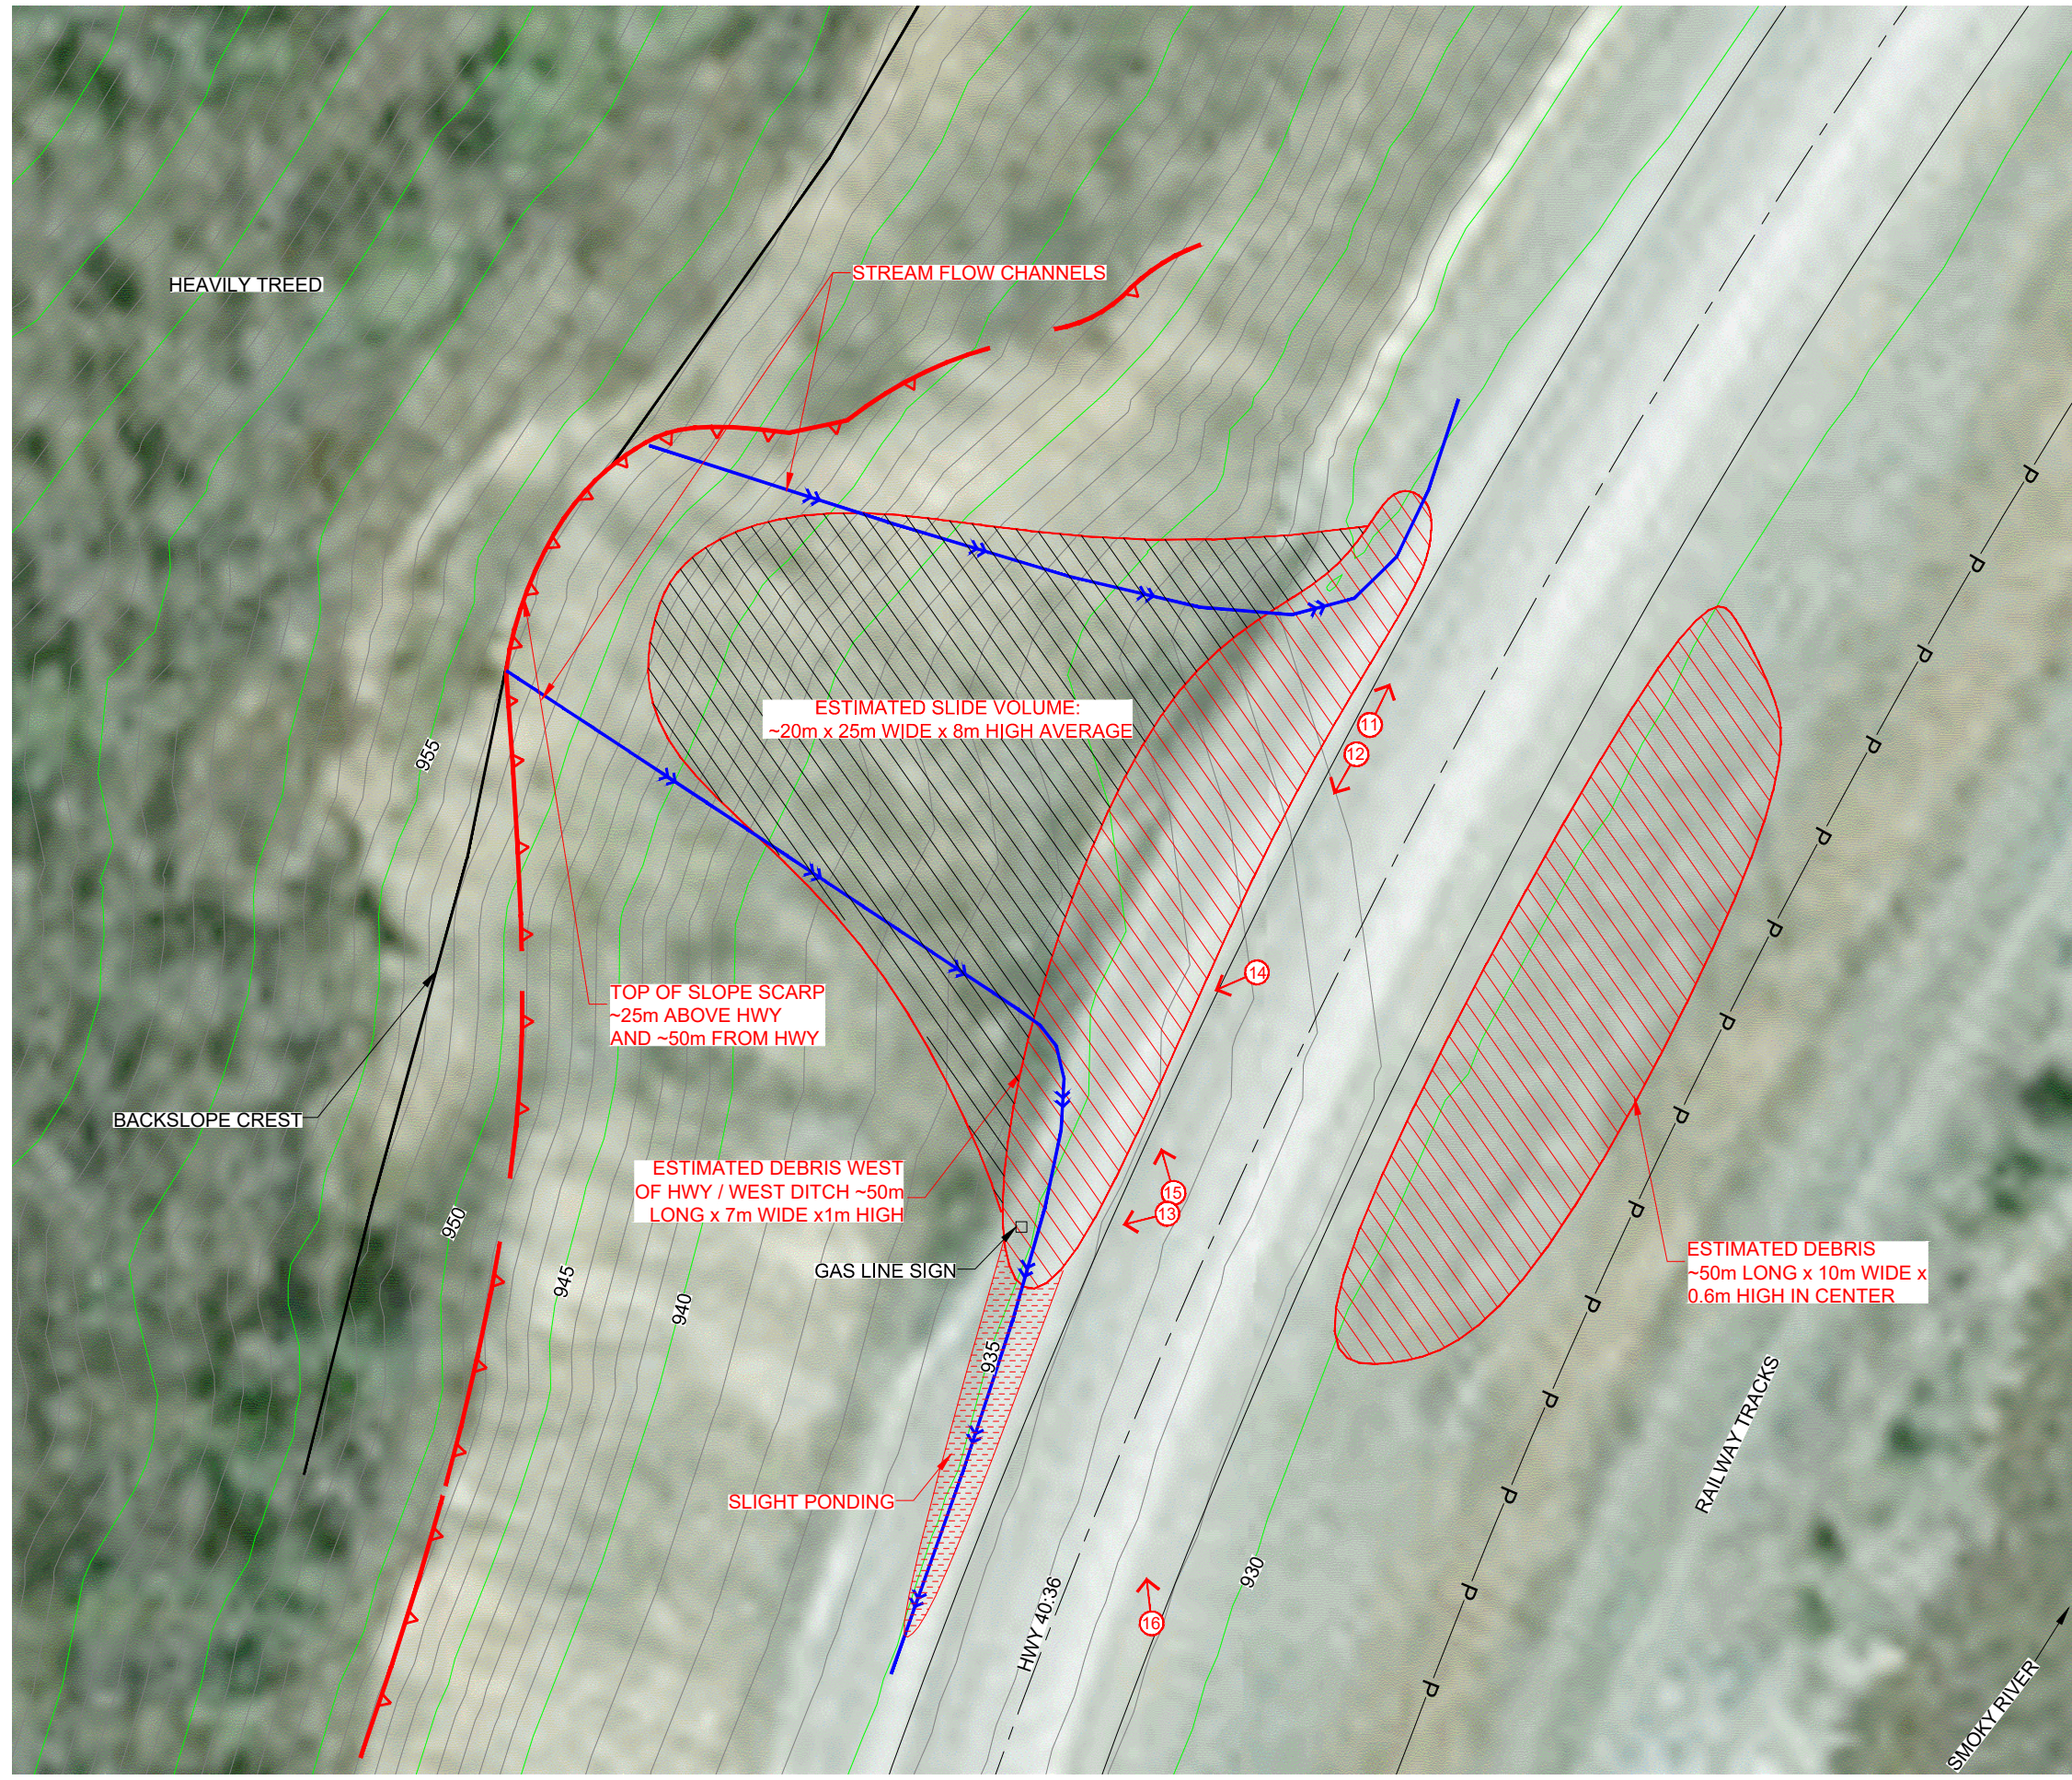
FIGURE 5

At the time of the call out, debris build-up of fine sediments was deposited in the west ditch in a general conical or deltaic fan shape (see Figure 5 attached). The channel flow had appeared to incise an outlet point through the overburden backslope at this location (the top of the backslope of this earth flow scarp was now estimated at about 25 m above the highway and about 50 m from the highway).

Two streams of water having low to moderate flow volumes were observed running down the backscarp from further upslope, over the slumped material and debris deposit, and outletting into the west ditch. The streams ran in opposite directions and were pooling along the west ditch, indicating the ditch at this site was at a relative elevation high. Predominant fine sediments/debris infilled the west ditch and extended over a length of about 50 m (equidistant from the apex center), with an estimated removal volume of about 250 m³. Some additional material could be expected however, as the two streams likely saturated much of the debris, and the existing excavation could mobilize more debris material from the backslope channels above.

Debris had also flowed across the hwy at this location, as evidenced by a windrow of material that had been graded against the east hwy shoulder (an additional ~100 m³).

The backslope of the highway is relatively steep and eroded with shallow ongoing sloughing of soil.

- The backslope could be cut back further to a flatter angle at the km 11.2 site to improve slope stability and create more storage room in the highway ditch.

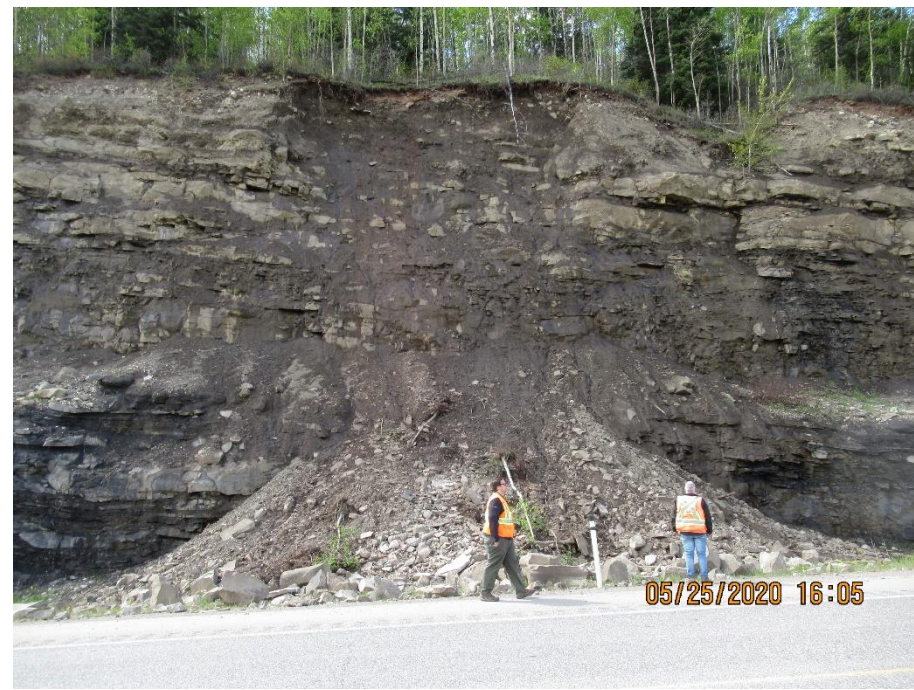
Photo 1.
Hwy 40:36 km 8.5
Looking directly at the face of the west hwy rock backslope and overburden/rock fall deposit in the west ditch.

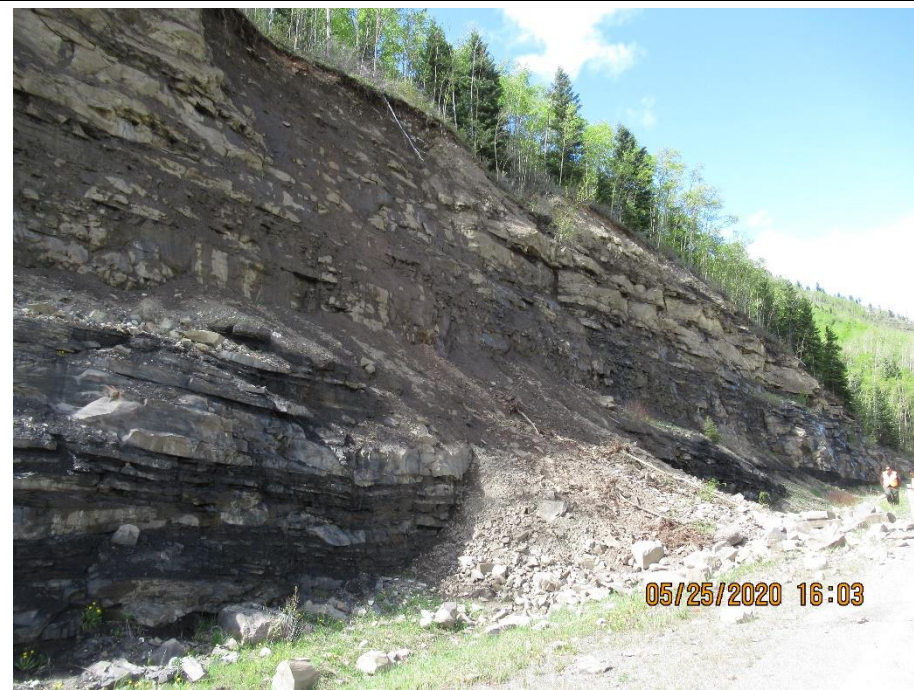
Photo 2.
Hwy 40:36 km 8.5
Looking northwest up at the backslope face just to the north of Photo 1. Note that there appear to be a couple of older, smaller debris deposits that have accumulated in the ditch.

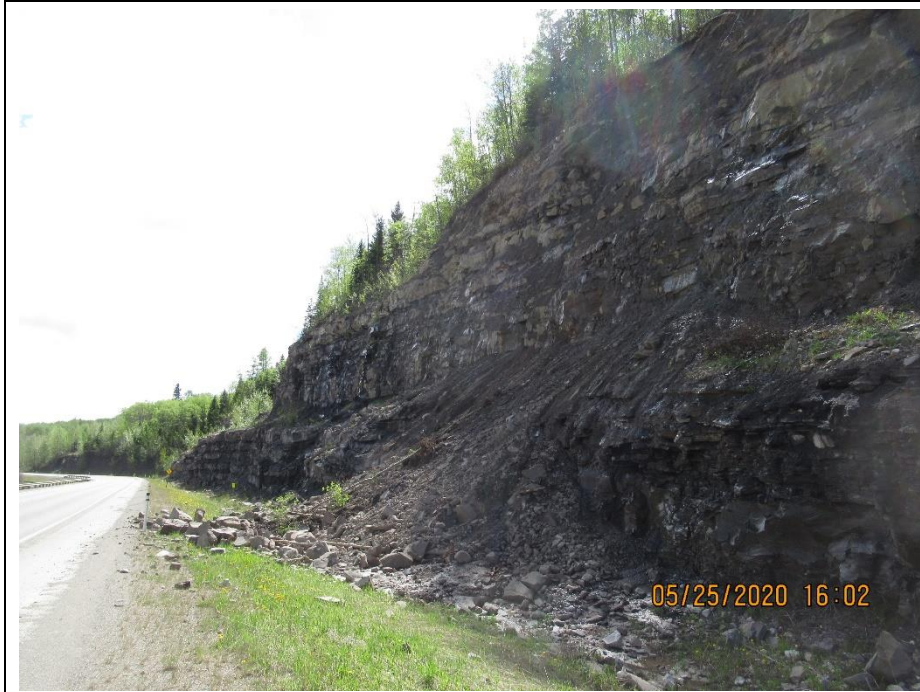
Photo 3.
Hwy 40:36 km 8.5
Looking southwest at the backslope face just to the south of Photo 1. Note that there are a couple of smaller zones of recent rockfalls west of the large one.

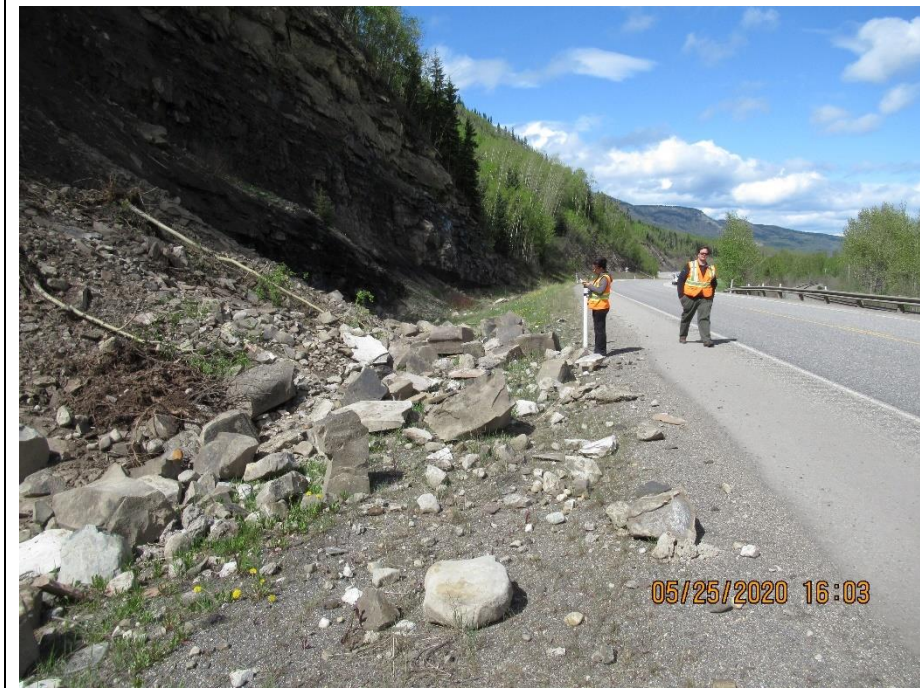
Photo 4.
Hwy 40:36 km 8.5
Looking northeast from the shoulder of the EBL of Hwy 40:36 at the fallen rocks on the highway shoulder.

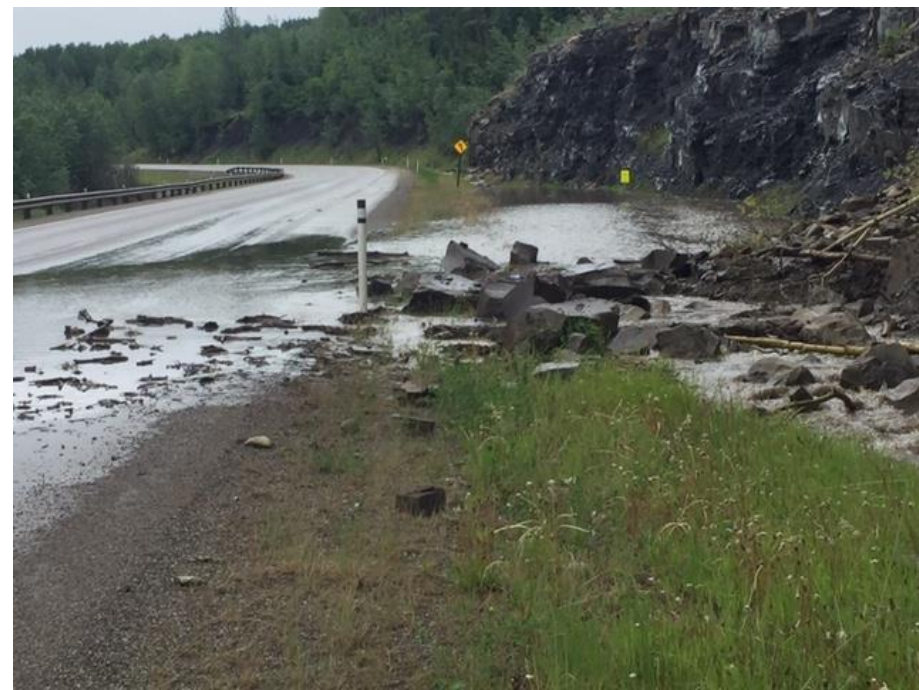
<input checked="" type="checkbox"/> Seepage	On June 14, 2020 the MCI provided a photo of the rockfall site at km 8.55 and the area at the base had pooling water which was flooding and flowing over the highway. Water was also observed trickling down the backslope at the rockfall site.	<input checked="" type="checkbox"/>	
<input type="checkbox"/> Bridge/Culvert Distress		<input type="checkbox"/>	
<input checked="" type="checkbox"/> Other	Sediment build-up of varying extents and sediment sizes were observed in the west ditch at all 3 sites. A windrow of debris existed on the east side of the highway at the km 10.9 and 11.2 sites.	<input checked="" type="checkbox"/>	
Instrumentation: None

Photo 5.
Hwy 40:36 km 8.5
Looking southwest
from the shoulder
of the EBL of Hwy
40:36 taken by AT
on June 14, 2020.

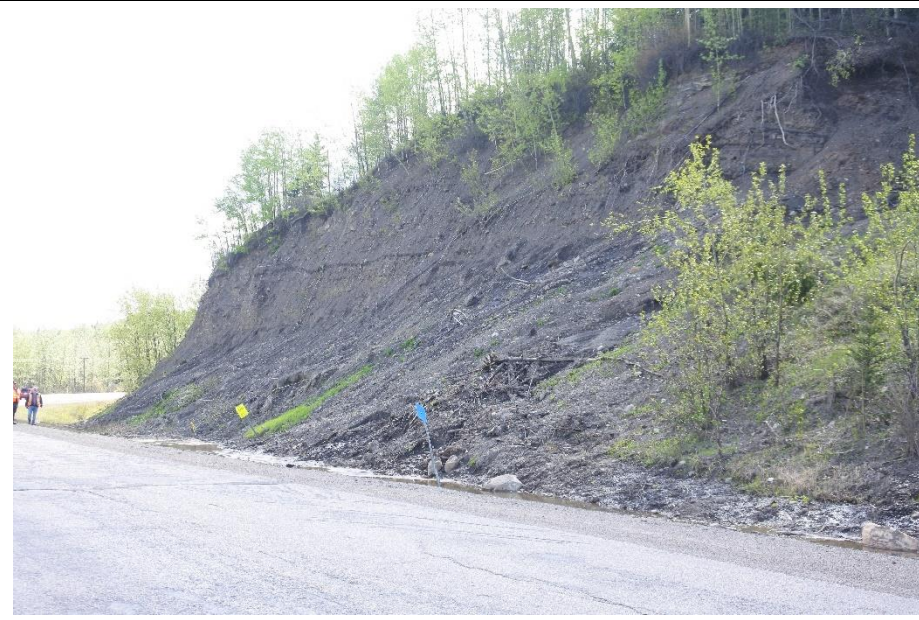
Photo 8.
Hwy 40:36 km
10.9
Looking west from
the shoulder of the
NBL shoulder of
Hwy 40:36 at slide
mass now within
the SBL ditch.

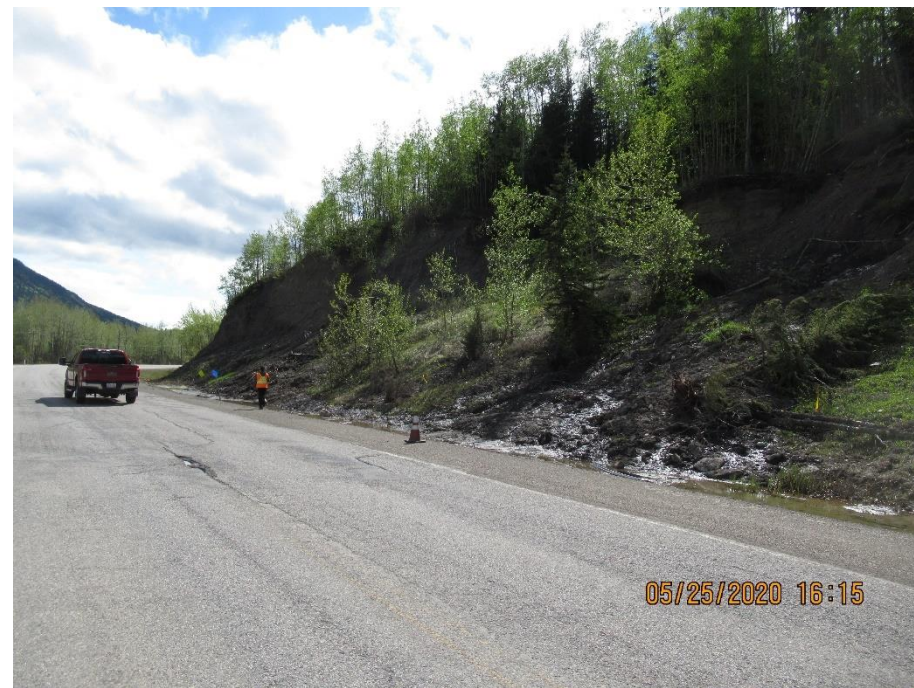
Photo 9.
Hwy 40:36 km
10.9
Looking southwest
from the near the
middle of the Hwy
at slide mass.

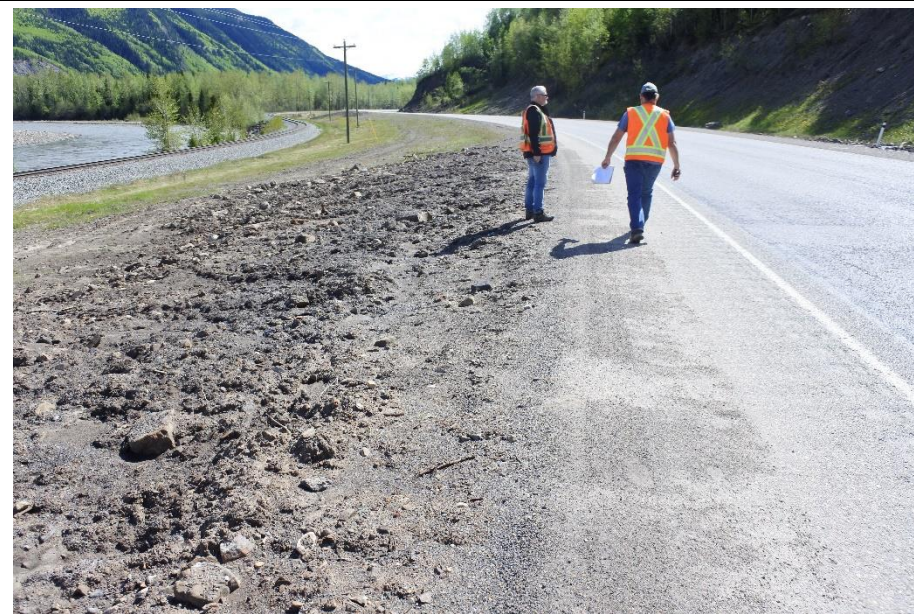
Photo 10.
Hwy 40:36 km
10.9
Looking south from
the shoulder of the
NBL shoulder of
Hwy 40:36 where
slide debris
previously flowed
across the
highway.

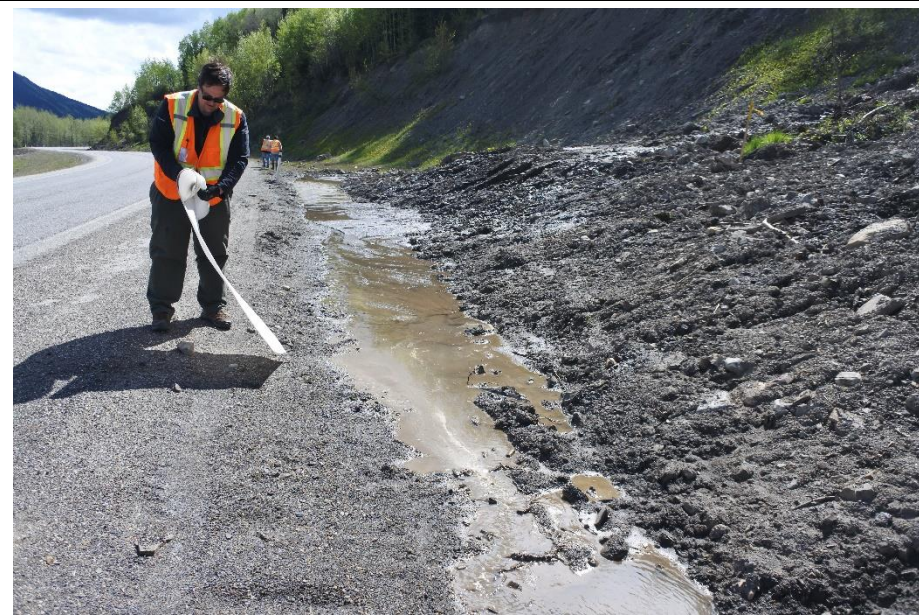
Photo 12.
Hwy 40:36 km
11.2
Looking south from
the shoulder of the
SBL shoulder of
Hwy 40:36 debris in
ditch and water
flowing around
debris along
highway shoulder.
