**ALBERTA TRANSPORTATION
GEOHAZARD ASSESSMENT PROGRAM
PEACE REGION – GRANDE PRAIRIE DISTRICT
2020 CALL OUT**

Site Number	Location	Name	Hwy	km
Call Outs	North of Grande Cache	Rockfall & 2 Debris Flows	40:36	8.5 to 11.2
Legal Description		UTM Co-ordinates (NAD 83)		
Km 8.55: SW29-57-8-W6		11U N 5,981,420	E 358,460	
Km 10.9: SE5-58-8-W6		11U N 5,983,463	E 359,373	
Km 11.2: SE5-58-8-W6		11U N 5,983,698	E 359,415

Date	PF	CF	Total
Previous Inspection:	July 12, 2019	10	4	40 (km 8.55 - rockfall basis)
		10	5	50 (km 11.2 & 13.75 sites)
Current Inspection:	May 25, 2020	10	4	40 (km 8.55 - rockfall basis)
		10	5	50 (km 10.9 & 11.2 sites)
Road AADT:	1,150	Year:		2018
Inspected By:	Don Proudfoot, Nicole Wilder (Thurber) Ed Szmata, Rishi Adhikari, Dwayne Lowen (AT)			
Report Attachments:	<input checked="" type="checkbox"/> Photographs <input checked="" type="checkbox"/> Plans <input checked="" type="checkbox"/> Maintenance Items

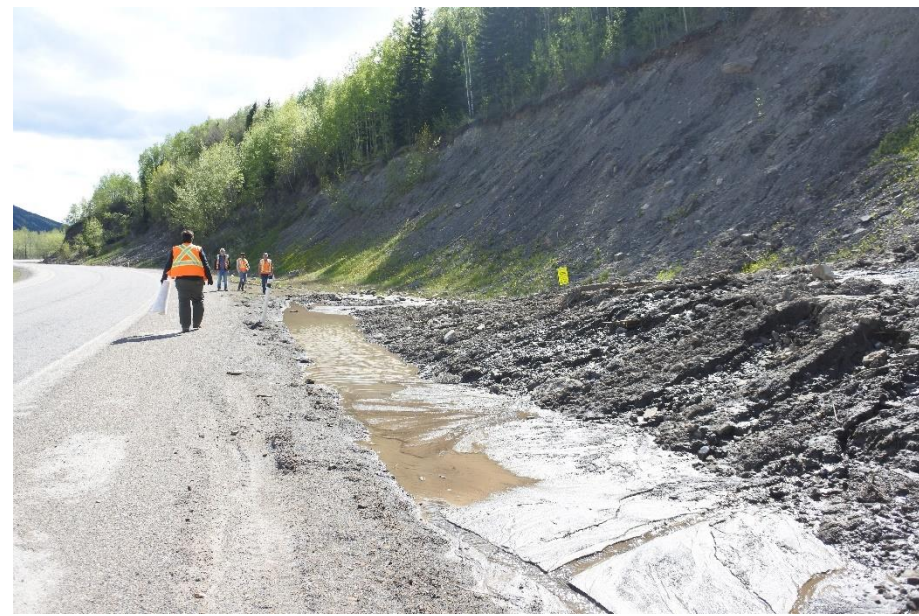
Photo 13.
Hwy 40:36 km
11.2
Looking southwest
at debris which has
slid down into ditch
and water is now
flowing around it.

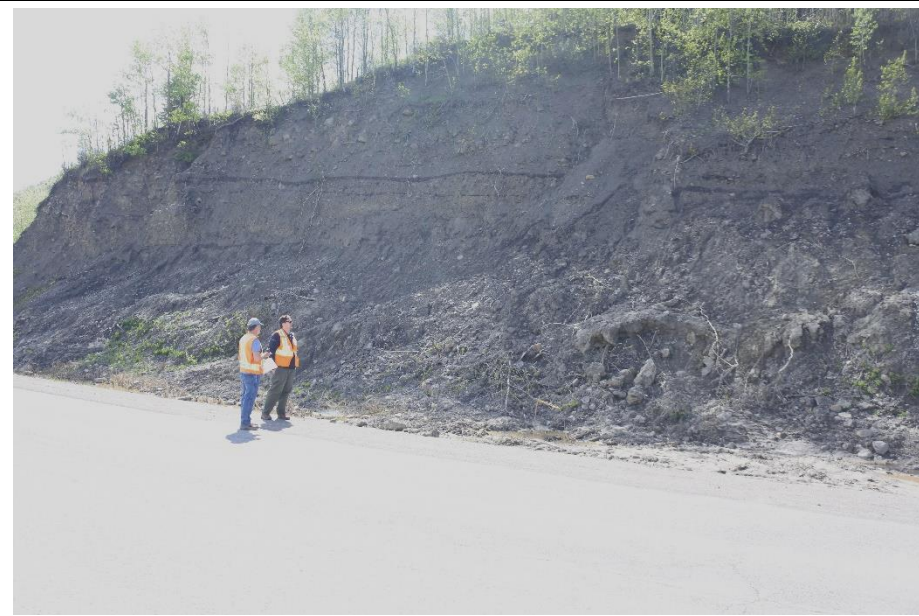
Photo 14.
Hwy 40:36 km
11.2
Looking southwest
across Hwy 40:36
at debris which has
fallen down.

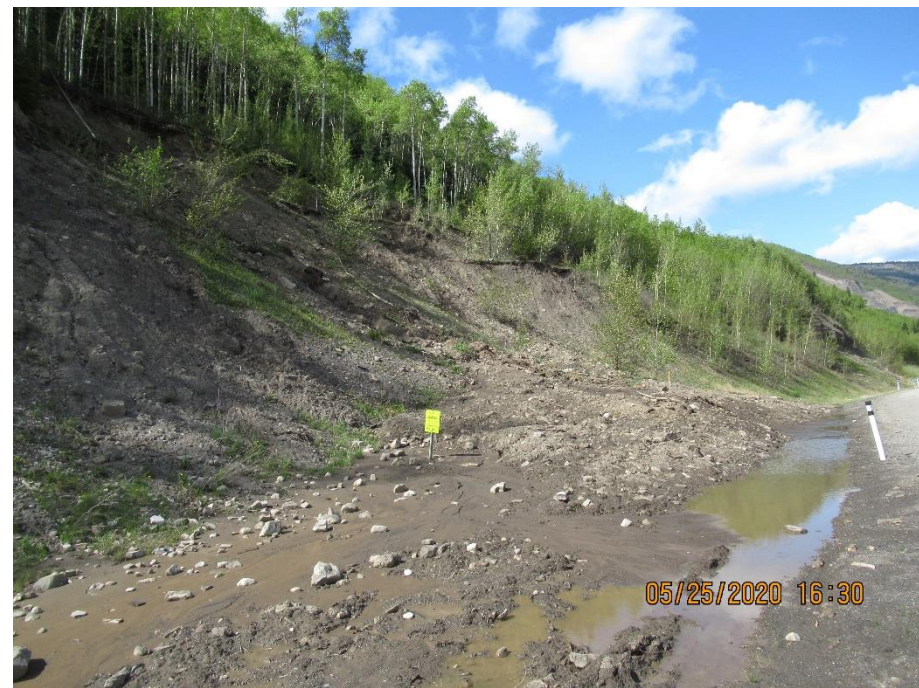
Photo 15.
Hwy 40:36 km
11.2
Looking northwest
from SBL shoulder
at slide mass.

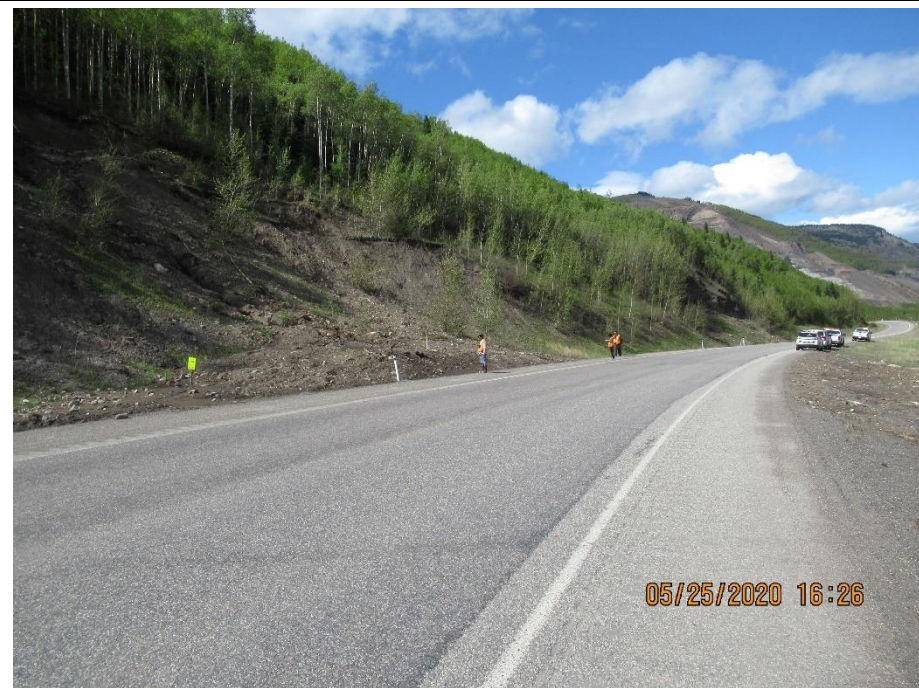
Photo 16.
Hwy 40:36 km
11.2
Looking northwest
from NBL shoulder
across Hwy 40:36
towards slide mass.
