**PEACE REGION  
(GRANDE PRAIRIE DISTRICT – SOUTH) GRMP**

**SITE INSPECTION FORM**

<b>SITE NUMBER AND NAME:</b> GP054 Debris Flow Corridor South of McIntyre Mine		<b>HIGHWAY &amp; KM:</b> 40:36, 8.119 to 12.262	<b>PREVIOUS INSPECTION DATE:</b> July 21, 2021	<b>INSPECTION DATE:</b> <b>June 14, 2022</b>
<b>LEGAL DESCRIPTION:</b>  South NW 29-57-08-W6M North NW 04-58-08-W6M	<b>NAD 83 COORDINATES:</b> UTM    Northing    Easting 11      5981027    358454 11      5984770    360291		<b>RISK ASSESSMENT:</b>  <b>No Recent Occurrence</b> PF: 7 CF: 6 TOTAL: 42 <b>Recent Occurrence</b> PF: 5 CF: 4 TOTAL: 20	
<b>AVERAGE ANNUAL DAILY TRAFFIC (AADT):</b> 820 (north) & 1020 (south) (Reference No. 25592, 2021)			<b>CONTRACT MAINTENANCE AREA (CMA):</b> 504

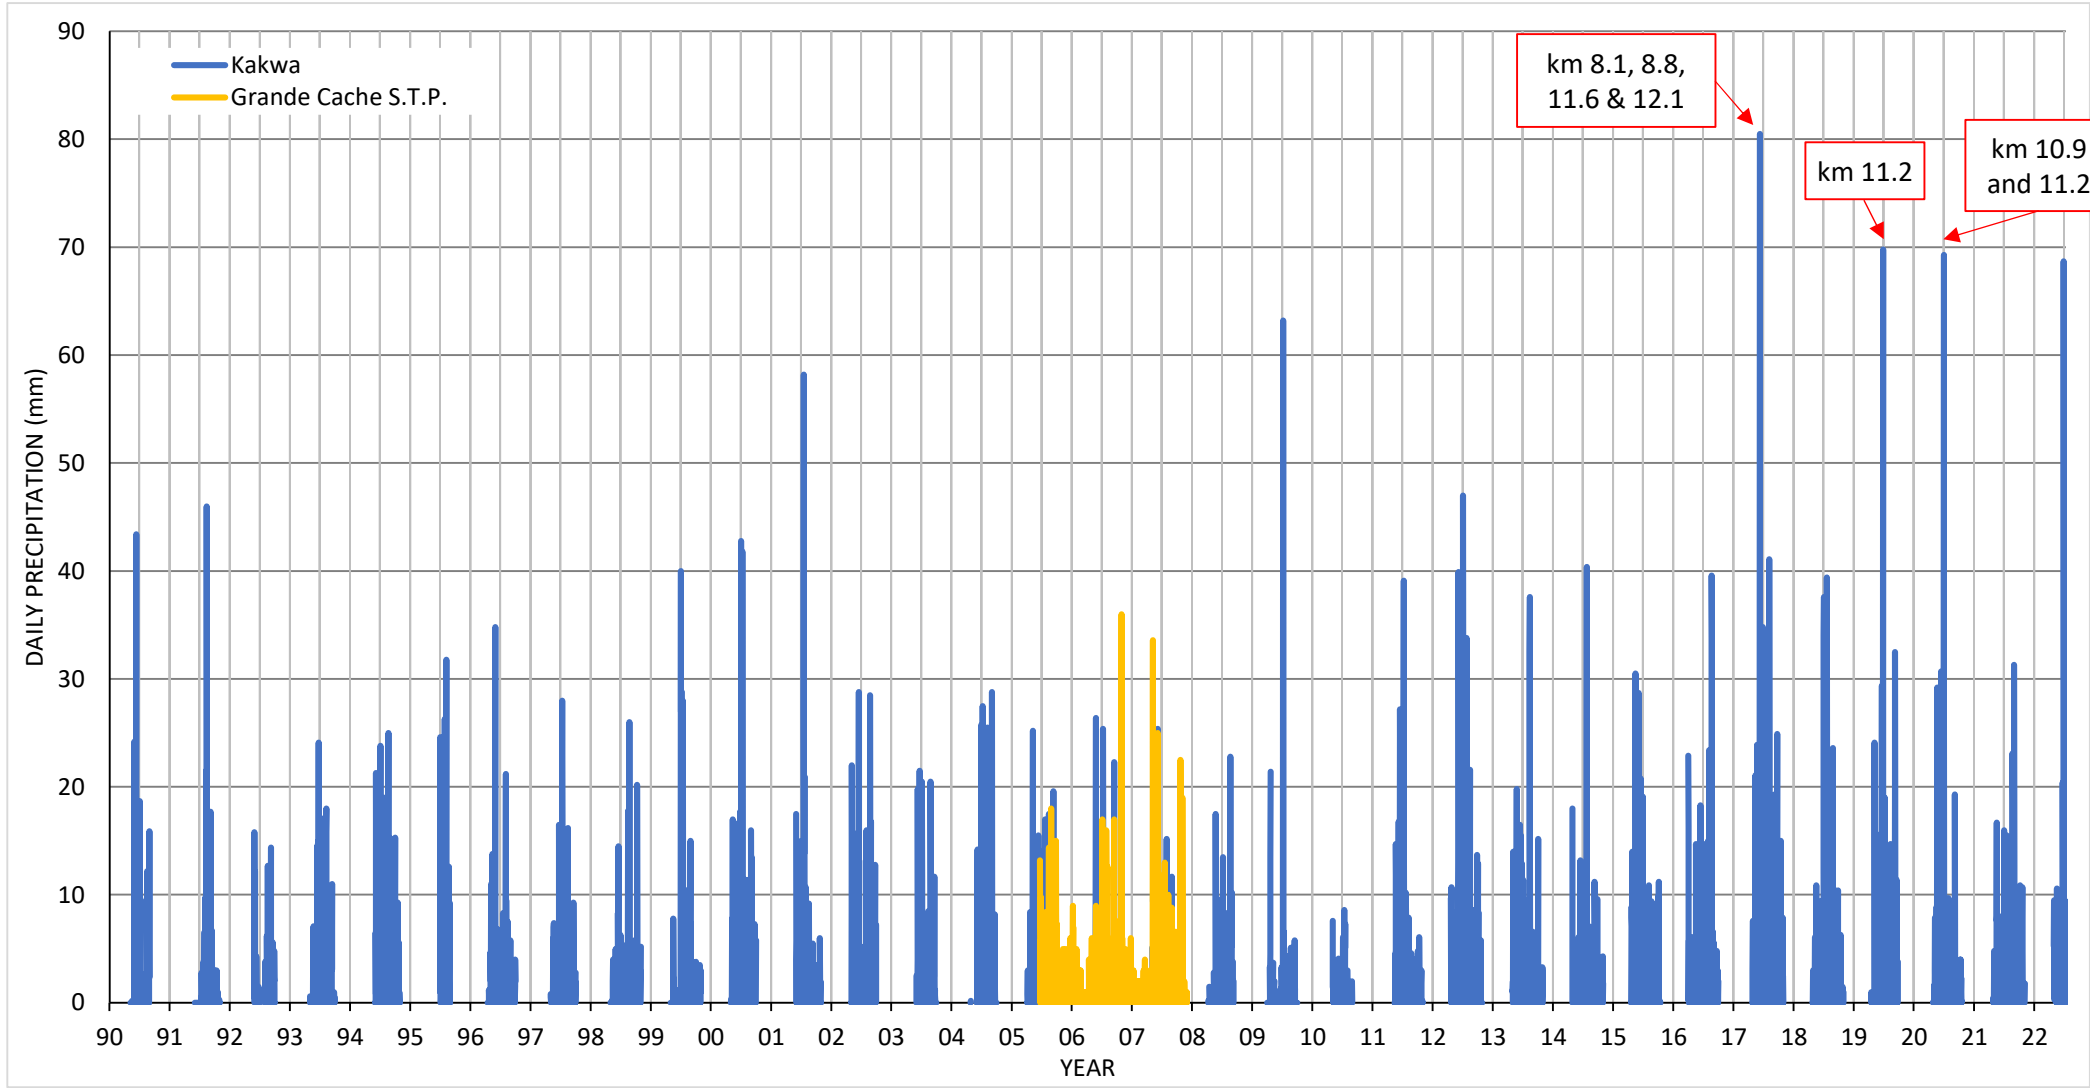
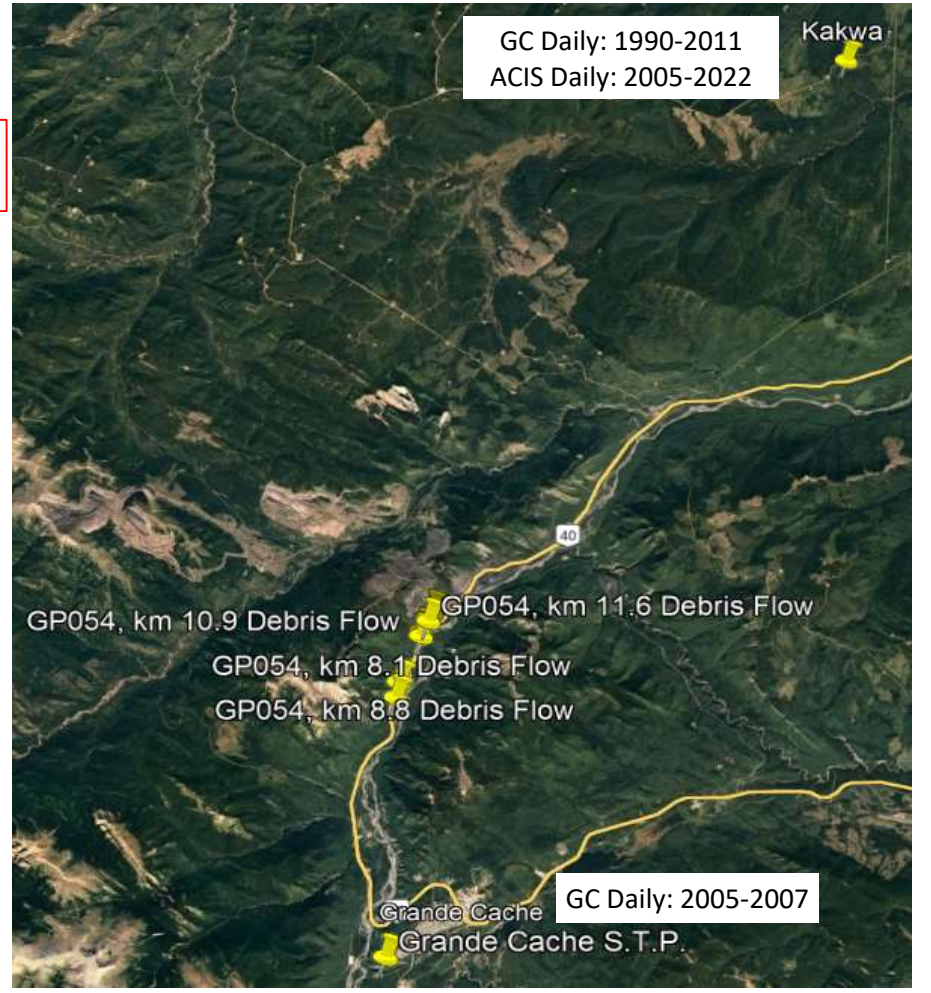
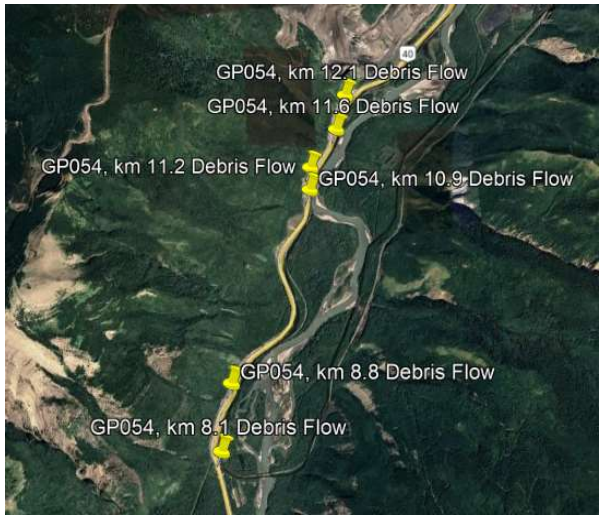
PROJECT		PEACE REGION (GRANDE PRAIRIE DISTRICT - SOUTH) GEOHAZARD RISK MANAGEMENT PROGRAM	
TITLE		Rainfall Data GP054 - Debris Flow Corridor South of McIntyre Mine Hwy 40:36; km 8.119 to 12.262	
SCALE	PROJECT No.	A05116A01	FIG No. 4

KCB reviewed available precipitation data for the site from 1967 to 2022 (record discontinuous before 1990). The rainfall data indicates that the debris flows tabulated in the table above each occurred around the same time as a high-than-average rainfall event as shown in Figure 2. Based on the data from Kakwa station (located approximately 30 km northeast of the site) higher-than-average rainfall events were recorded on June 9, 2017 (approximately 80 mm), June 28, 2019 (approximately 70 mm), July 1, 2020 (approximately 70 mm), and June 29, 2022 (approximately 70 mm). The last time a similar rainfall event occurred was 2009 and before that 2001.

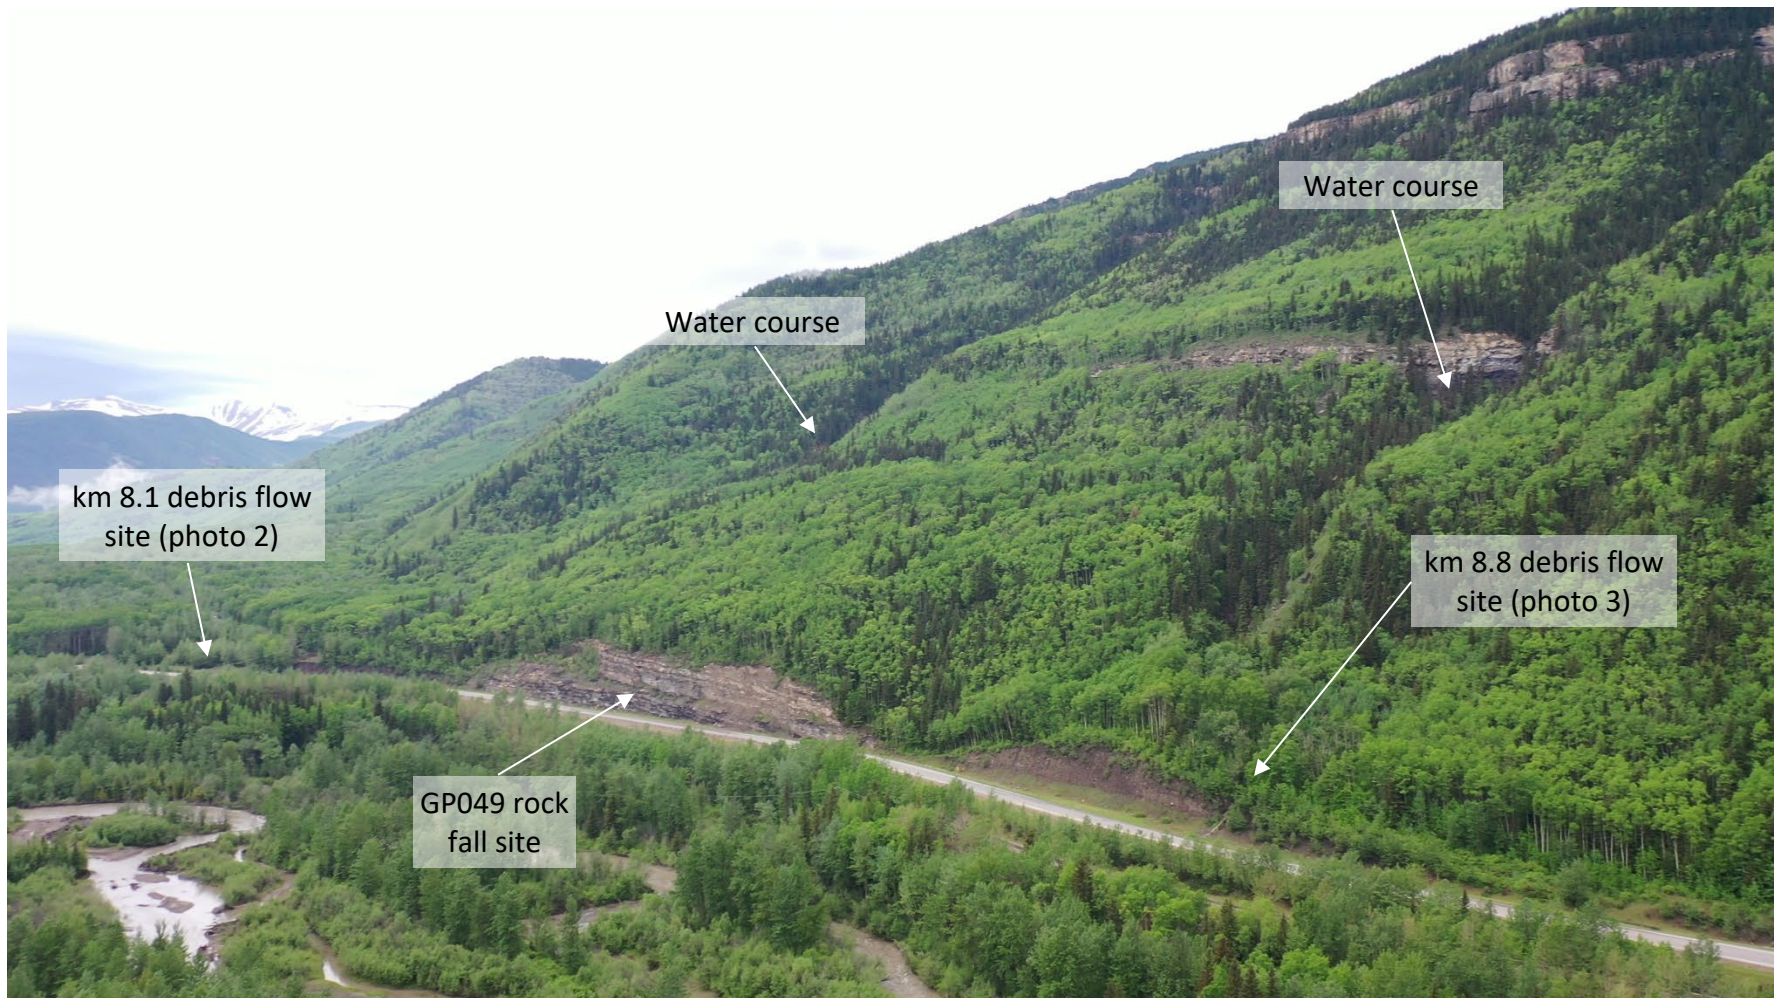
**Photo 1** Debris flows at km 8.1 and 8.8 along backslope on west side of Hwy 40:36. Note water courses above debris flow locations. Photo taken June 14, 2022, facing southwest.

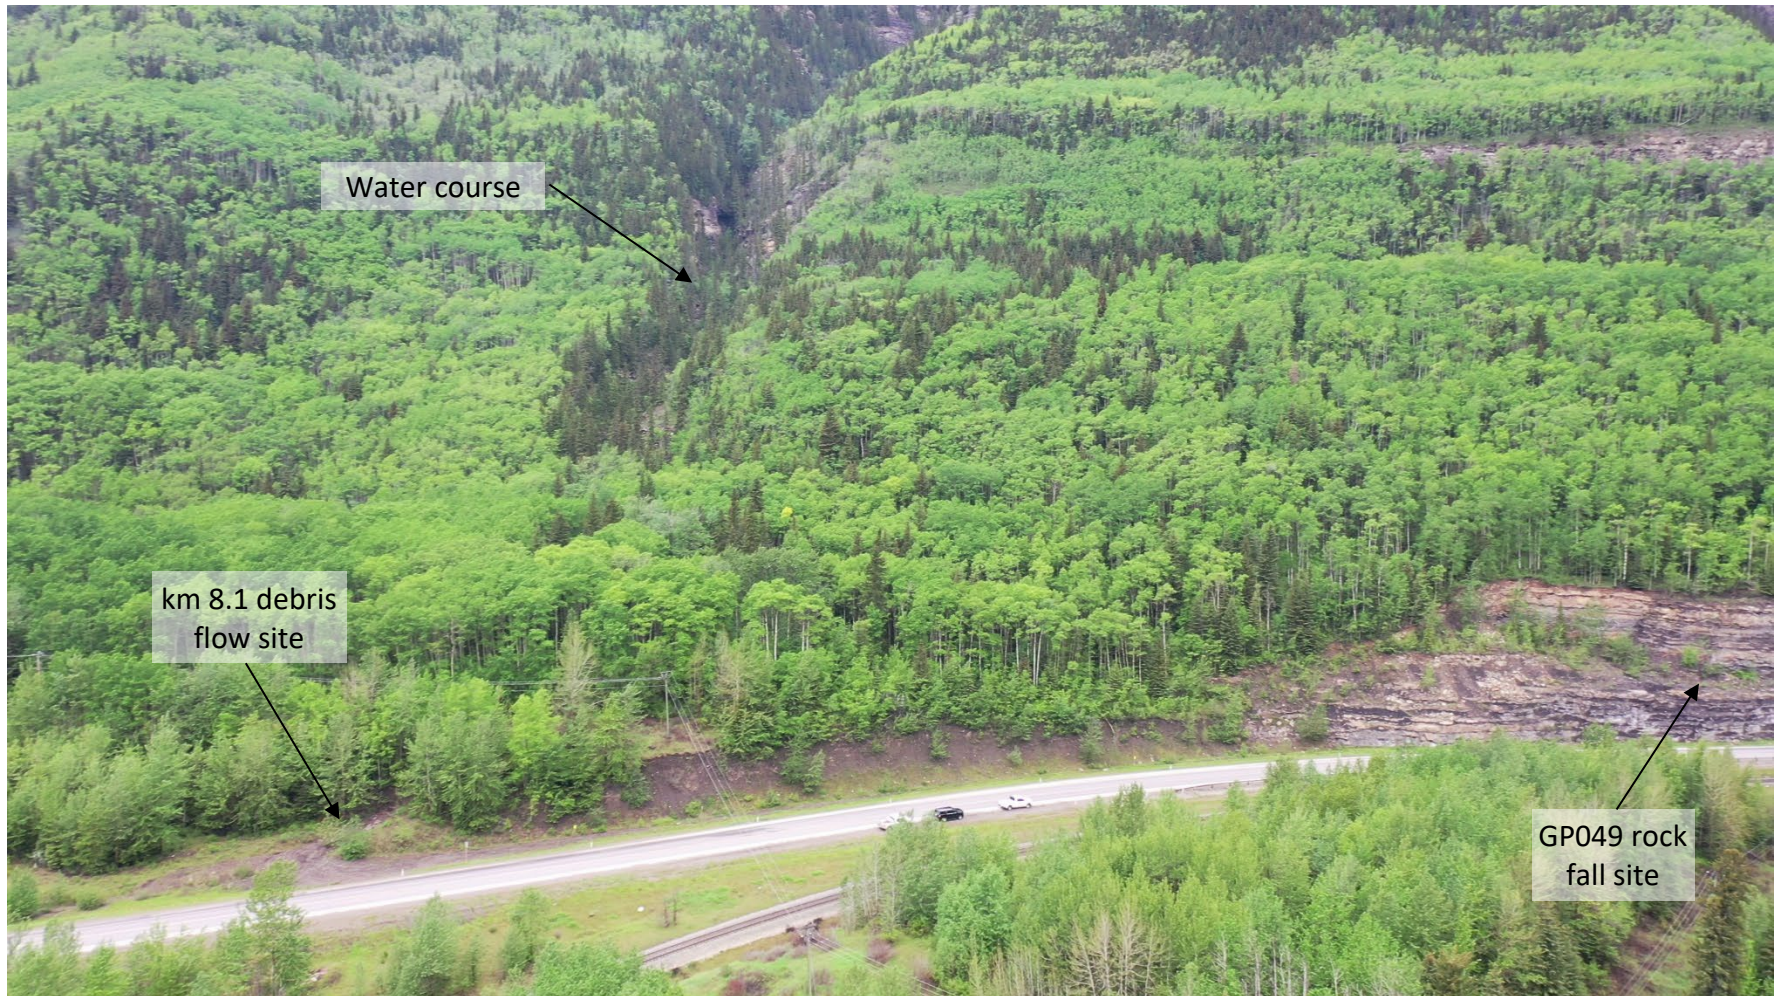
**Photo 2** Debris flow at km 8.1 along backslope on west side of Hwy 40:36. Note water course above debris flow location.  
Photo taken June 14, 2022, facing west.

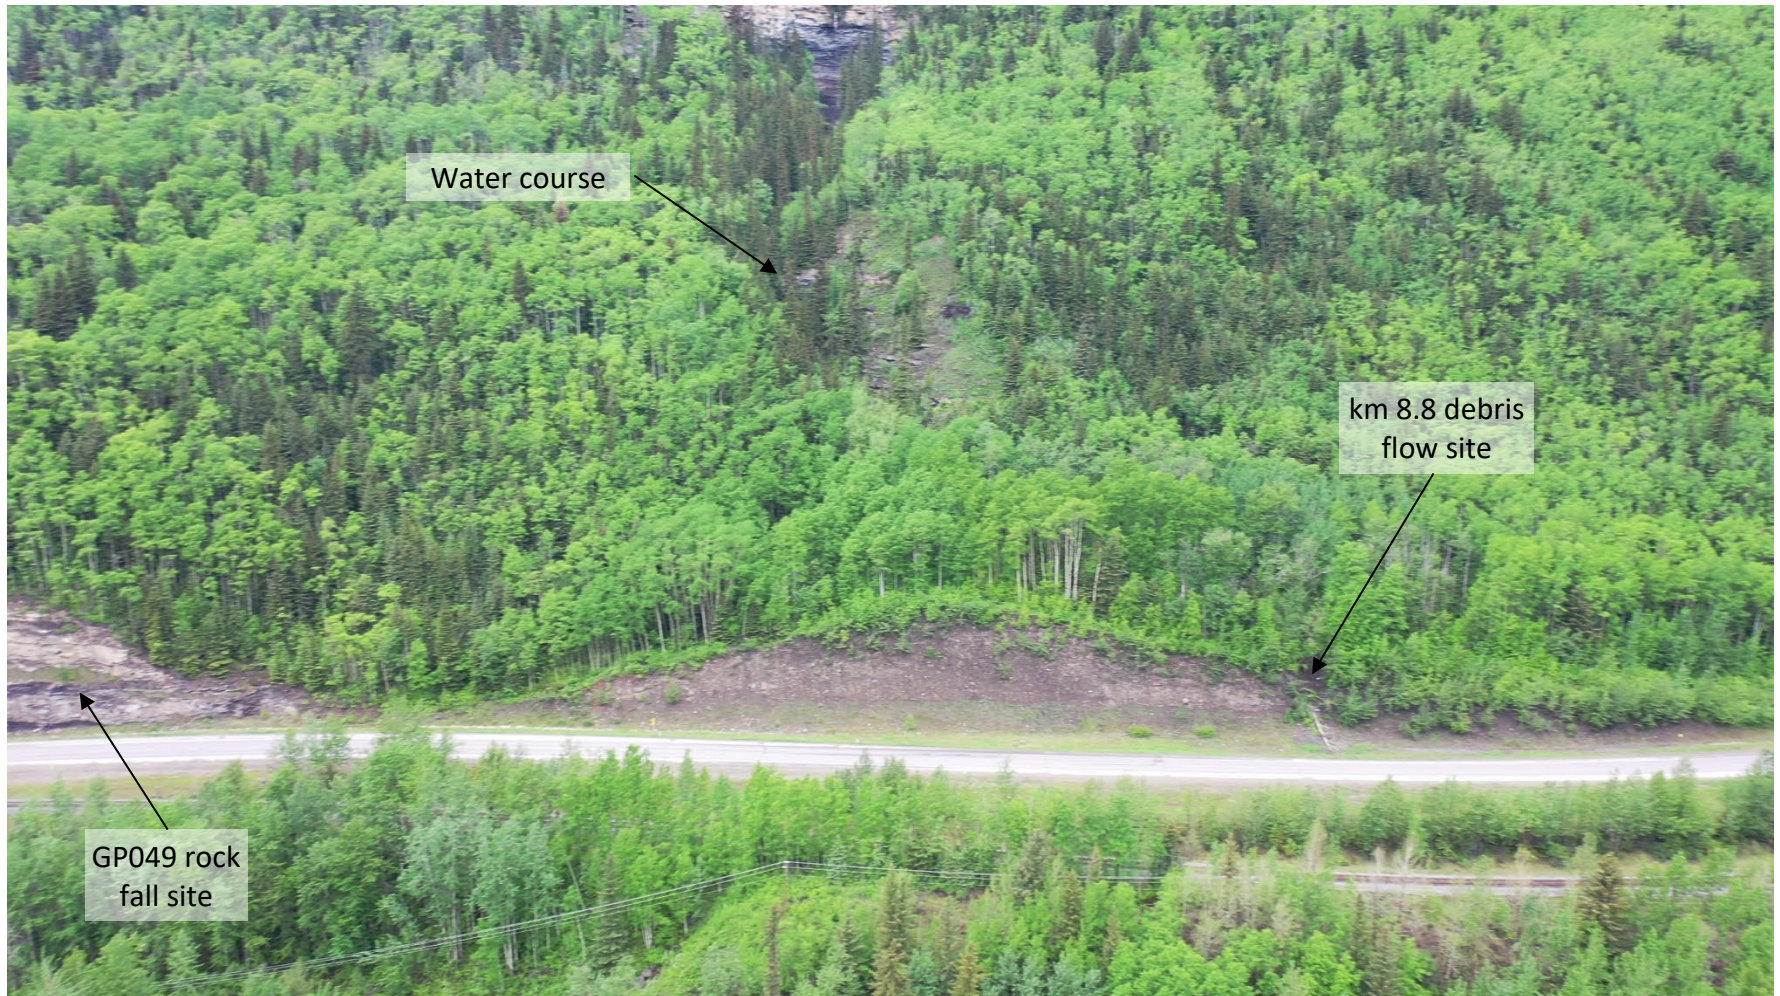
**Photo 3** Debris flow at km 8.8 along backslope on west side of Hwy 40:36. Note water course above debris flow location. Photo taken June 14, 2022, facing west.

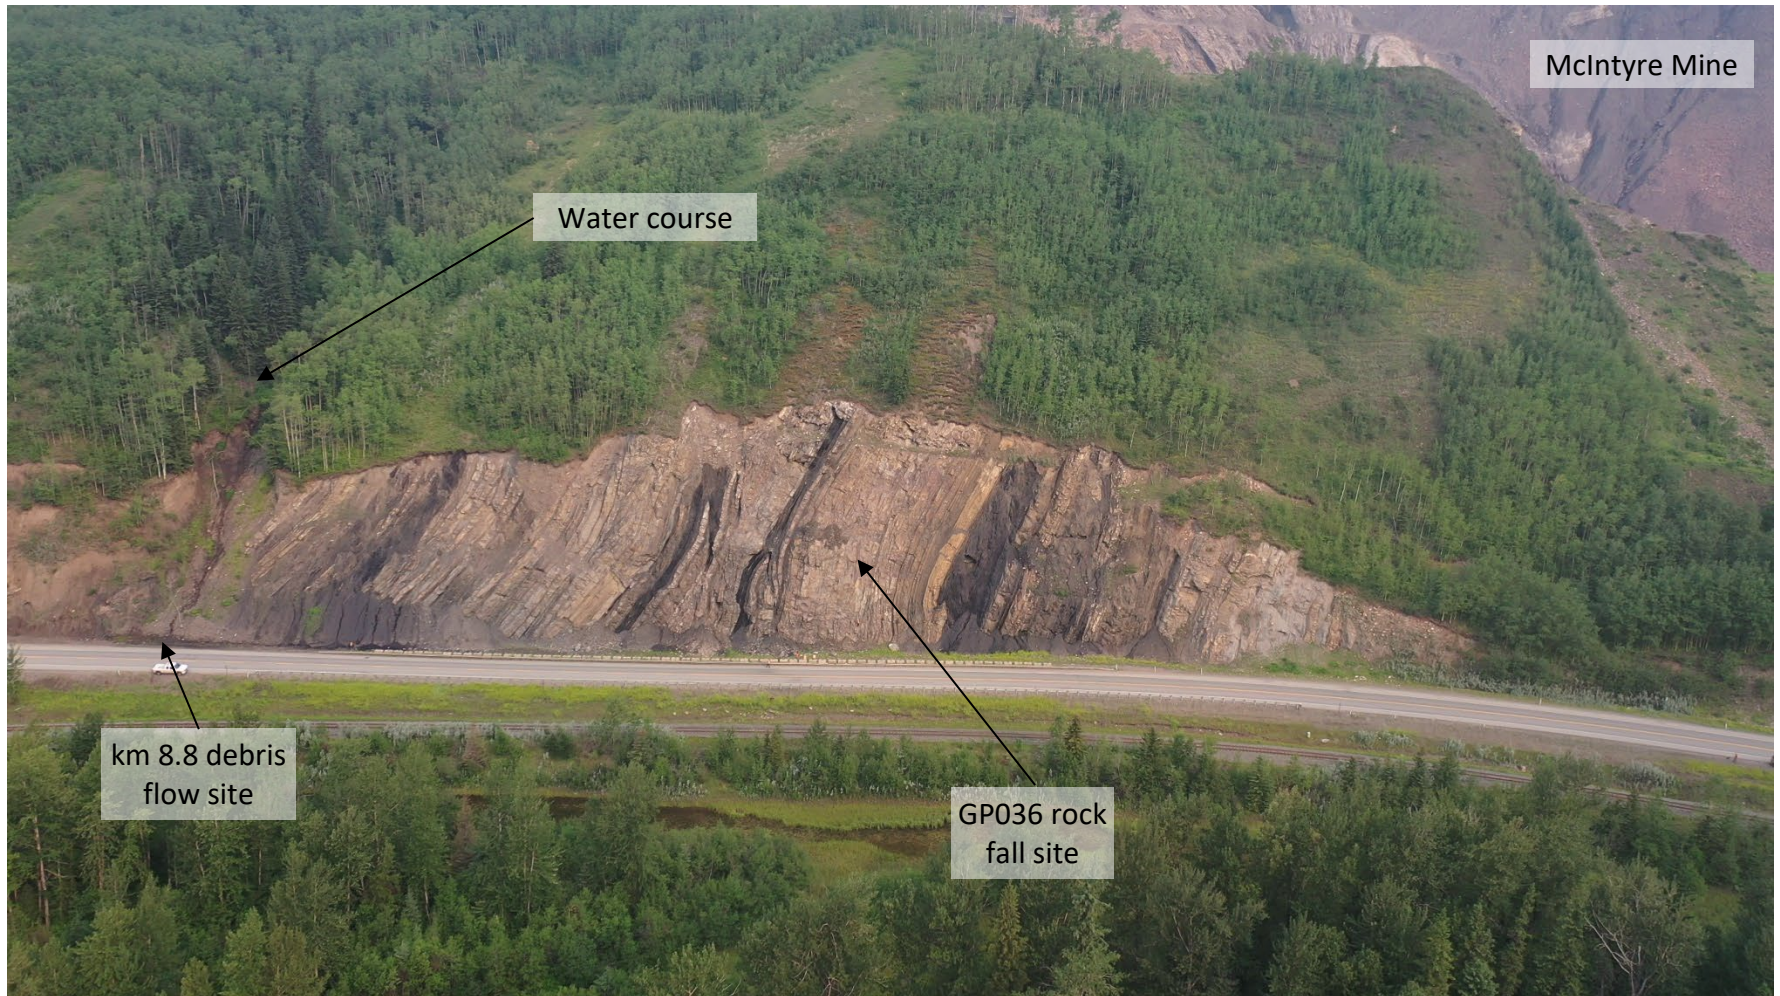
**Photo 4** Debris flow location (km 8.8) along backslope on west side of Hwy 40:36. Note water course above debris flow locations. Photo taken June 14, 2022, facing west.

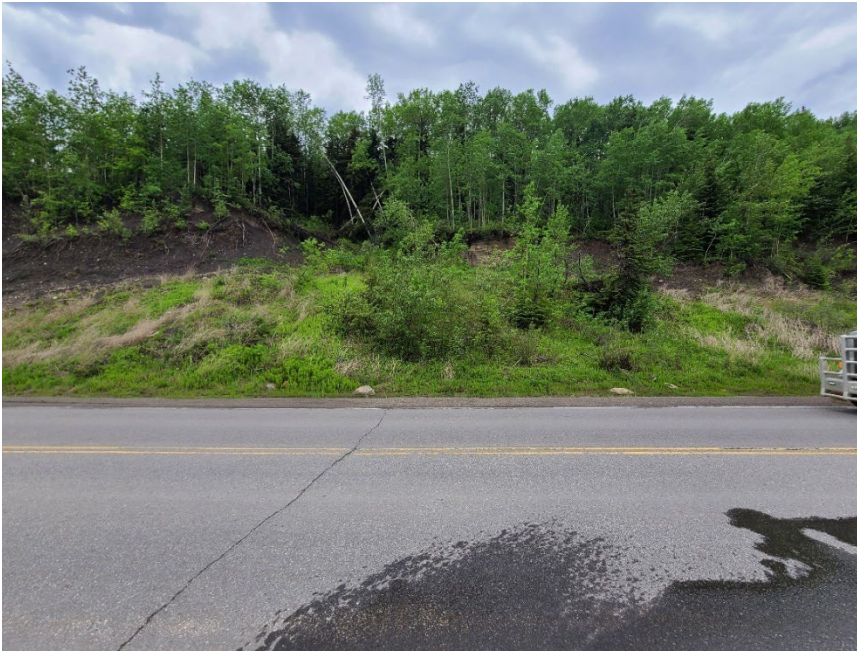
Debris flow at approximately km 10.9 at WP187

- Last debris flow occurred at this location in 2020.
- Fan is well vegetated, indicating no recent debris flow activity.

**Photo 5** Debris flow at km 10.9 along backslope on west side of Hwy 40:36 at WP 187. Photo taken June 14, 2022, facing west.

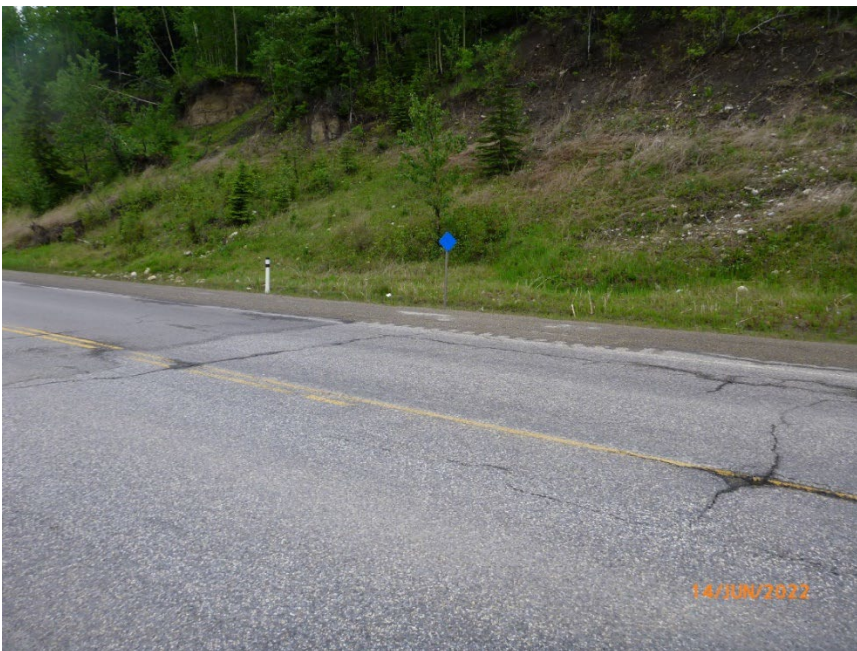
Some ponded water (and cattails) at toe of the km 10.9 site, which could be due to seepage and/or poor ditch drainage. Ice build-up in winter near blue highway marker just north of the km 10.9 site.

**Photo 6** Wet area along backslope on west side of Hwy 40:36 just north of debris flow at WP187. Photo taken June 14, 2022, facing southwest.

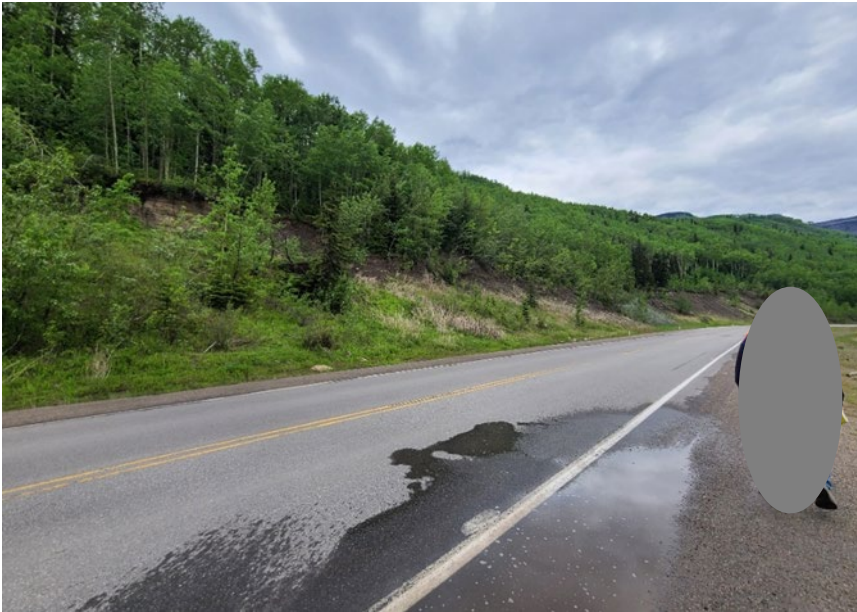
**Photo 7** Backslope on west side Hwy 40:36 between debris flows at km 10.9 and km 11.2 (WP187 and WP188). Photo taken June 14, 2022, facing northwest.

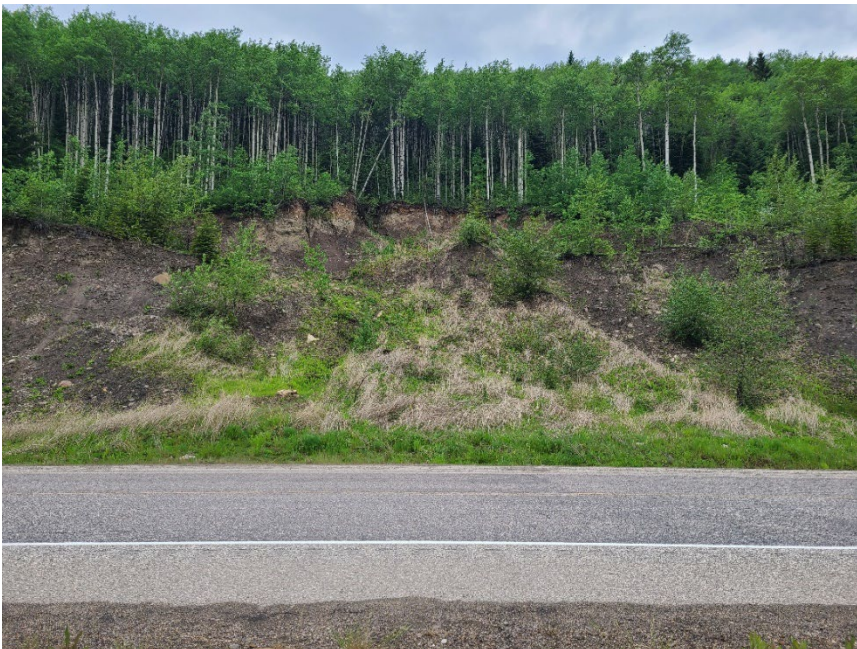
Debris flows at approximately km 11.2 at WP188 sites

- Last debris flows occurred at this location in 2019 and 2020.
- Main debris fan is approximately 20 m wide, but backslope failure around debris fan is approximately 50 m to 60 m. Slope is approximately 10 m high.
- Water observed flowing along south edge of main/largest debris fan.
- Fan is fairly well vegetated, indicating no recent debris flow activity.

**Photo 8** Debris flow at km 11.2 along backslope on west side of Hwy 40:36 at WP188. Photo taken June 14, 2022, facing west.

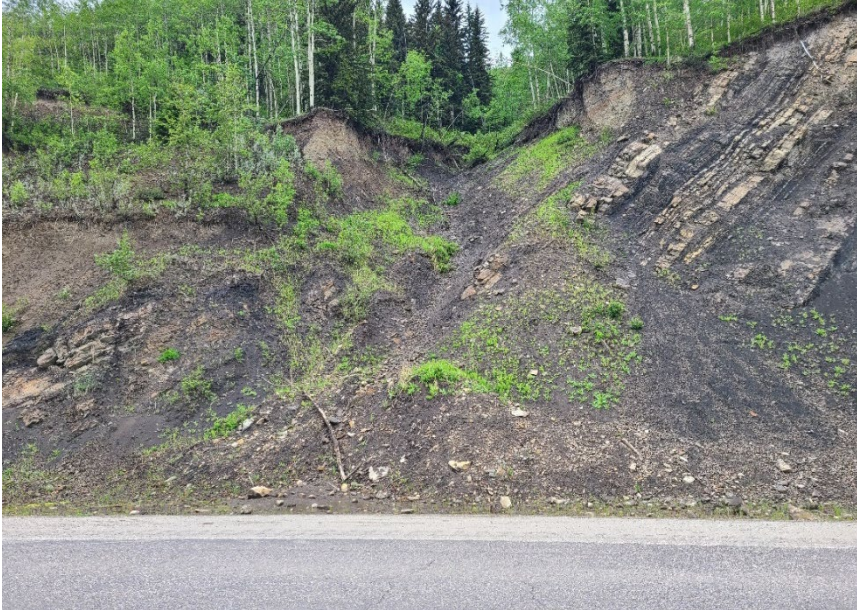
Debris flow at approximately km 12.1 just south of WP189

- Last debris flow occurred at this location in 2017.
- Debris fan is poorly vegetated with erosion gully eroded down center, indicating at least higher water flows at this site that are hindering vegetation growth Debris flow deposit appears wet.

**Photo 9** Debris flow at km 12.1 along backslope on west side of Hwy 40:36 just south of GP036 site and WP189. Note erosion gully down debris fan. Photo taken June 14, 2022, facing west.
