SITE INSPECTION FORM

SITE NUMBER AND NAME: GP054 Debris Flow Corridor South of McIntyre Mine		HIGHWAY & KM: 40:36, 8.119 to 12.262	PREVIOUS INSPECTION DATE: June 14, 2022	INSPECTION DATE: June 12, 2023
LEGAL DESCRIPTION: South NW 29-57-08-W6M North NW 04-58-08-W6M	NAD 83 COORDINATES: UTM Northing Easting 11 5981027 358454 11 5984770 360291		RISK ASSESSMENT: No Recent Occurrence PF: 7 CF: 6 TOTAL: 42 Recent Occurrence PF: 5 CF: 2 TOTAL: 10	
AVERAGE ANNUAL DAILY TRAFFIC (AADT): 780 (north) & 980 (south) (Reference No. 25592, 2022)			CONTRACT MAINTENANCE AREA (CMA): 504

TITLE
 Site Plan
 GP054- Debris Flow Corridor South of McIntyre Mine
 Hwy 40:36, km 8.119 to 12.262

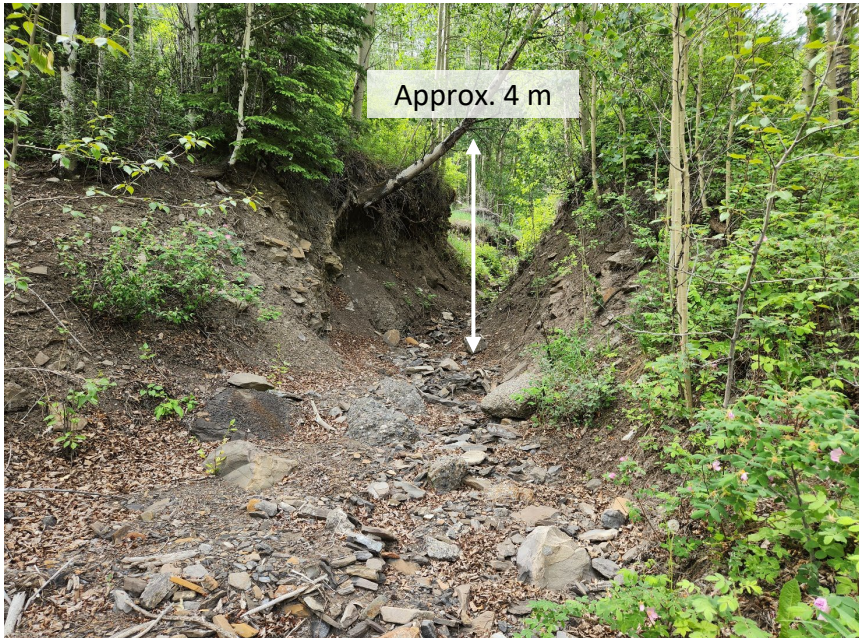
- Last documented debris flow occurred at this location in 2017, but there is evidence of more recent events.
- Debris fan extends from an erosion gully approximately 4 m high into the west (southbound) highway ditch. Debris fan material mostly consists of sand and gravel with some cobbles.

Photo 1 Debris flow at km 8.1 on west side of Hwy 40:36 at WP296. Note erosion gully is approximately 4 m high. Photo taken June 12, 2023, facing northwest.

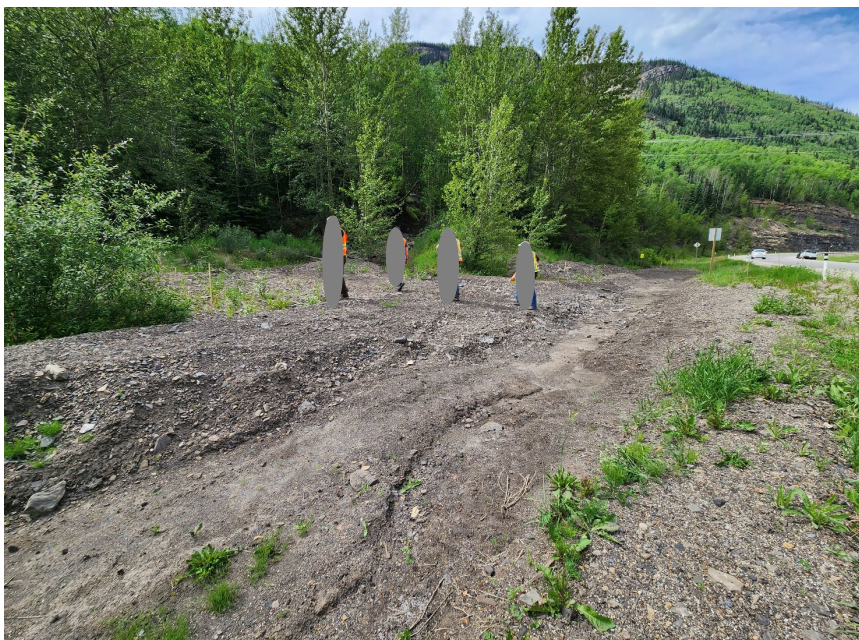
Photo 2 Debris flow at km 8.1 on west side of Hwy 40:36 at WP296. Note debris fan (mostly sand and gravel with some cobbles) in highway ditch. Photo taken June 12, 2023, facing northwest.

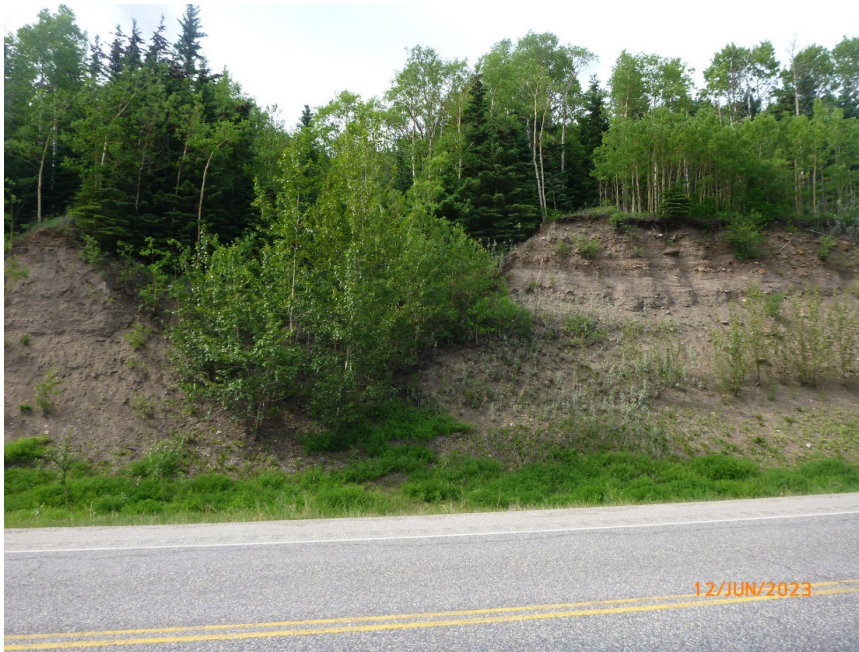
- Fan is fairly well vegetated, indicating no recent debris flow activity.

Photo 3 Debris flow at km 9.3 on west side of Hwy 40:36 at WP297. Photo taken June 12, 2023, facing northwest.

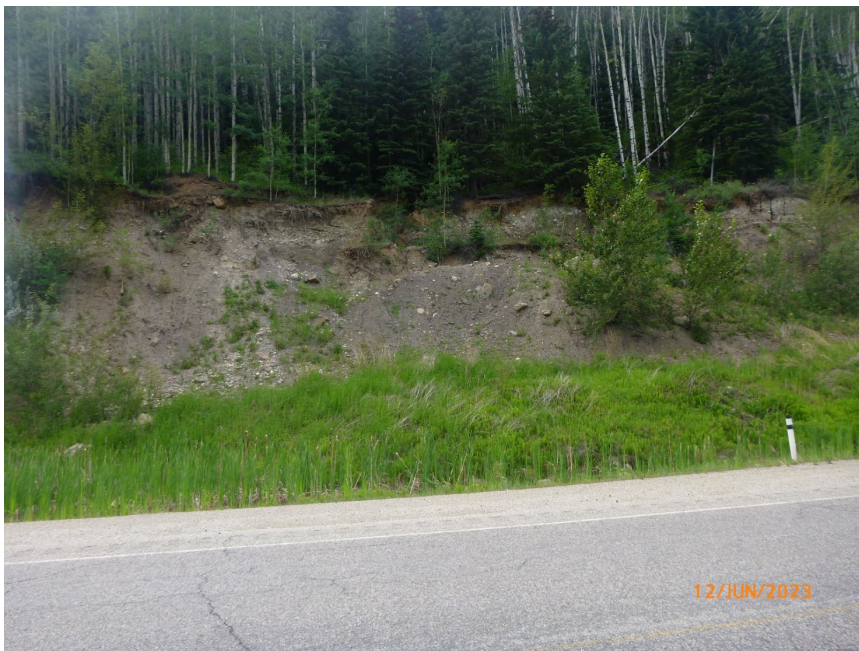
- Debris flow material continues to slump towards highway with slope failure along backslope expanding laterally, parallel to highway likely due to saturation and softening of materials. Backslope failure is approximately 50 m wide. Slope is approximately 10 m high.
- Ponded water and cattails observed in highway ditch at toe of debris flow.

Photo 4 Possible debris flow at km 11.1 on west side of Hwy 40:36 at WP298. Photo taken June 12, 2023, facing west.

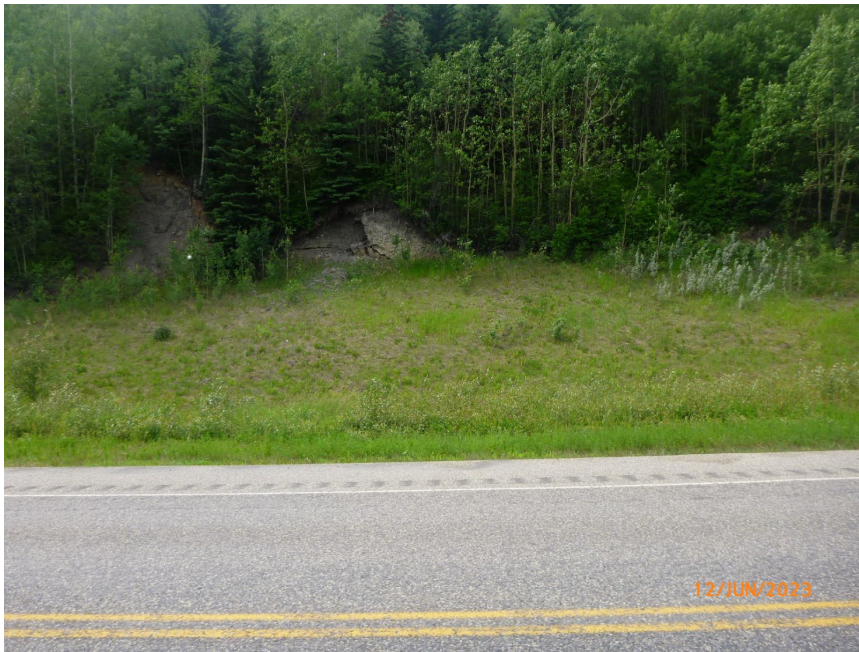
- Area fairly well vegetated, indicating no recent debris flow activity.

Photo 5 Possible debris flow at km 11.4 on west side of Hwy 40:36 at WP299. Photo taken June 12, 2023, facing west.

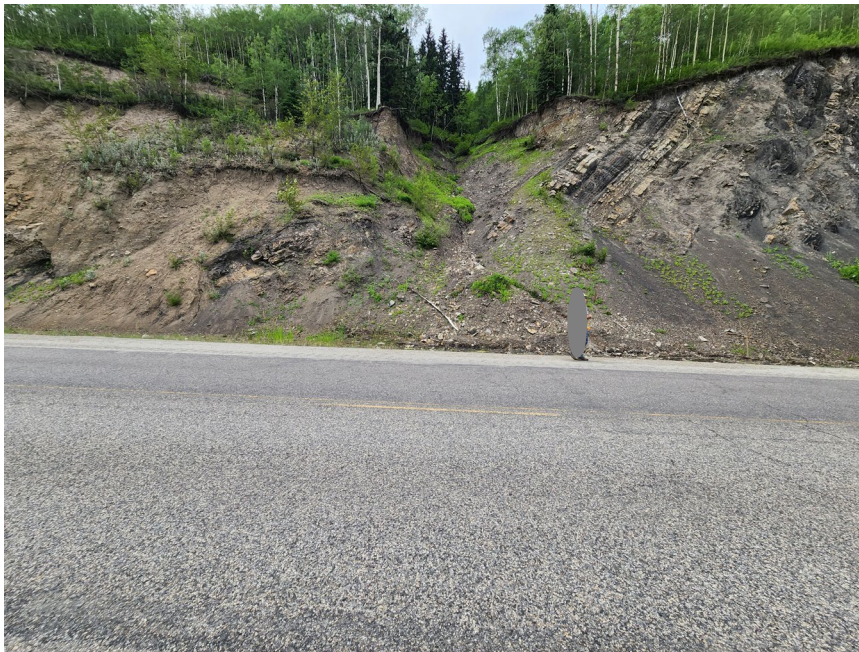
- Last documented debris flow occurred at this location in 2017.
- Debris fan is poorly vegetated with erosion gully eroded down center, indicating higher water flows at this site are possibly hindering vegetation growth.
- Debris flow deposit appears wet, and water visible at toe of debris flow in highway ditch.

Photo 6 Debris flow at km 12.1 on west side of Hwy 40:36 at WP300. Note erosion gully down debris fan and water at toe of debris flow in highway ditch. Photo taken June 12, 2023, facing west.

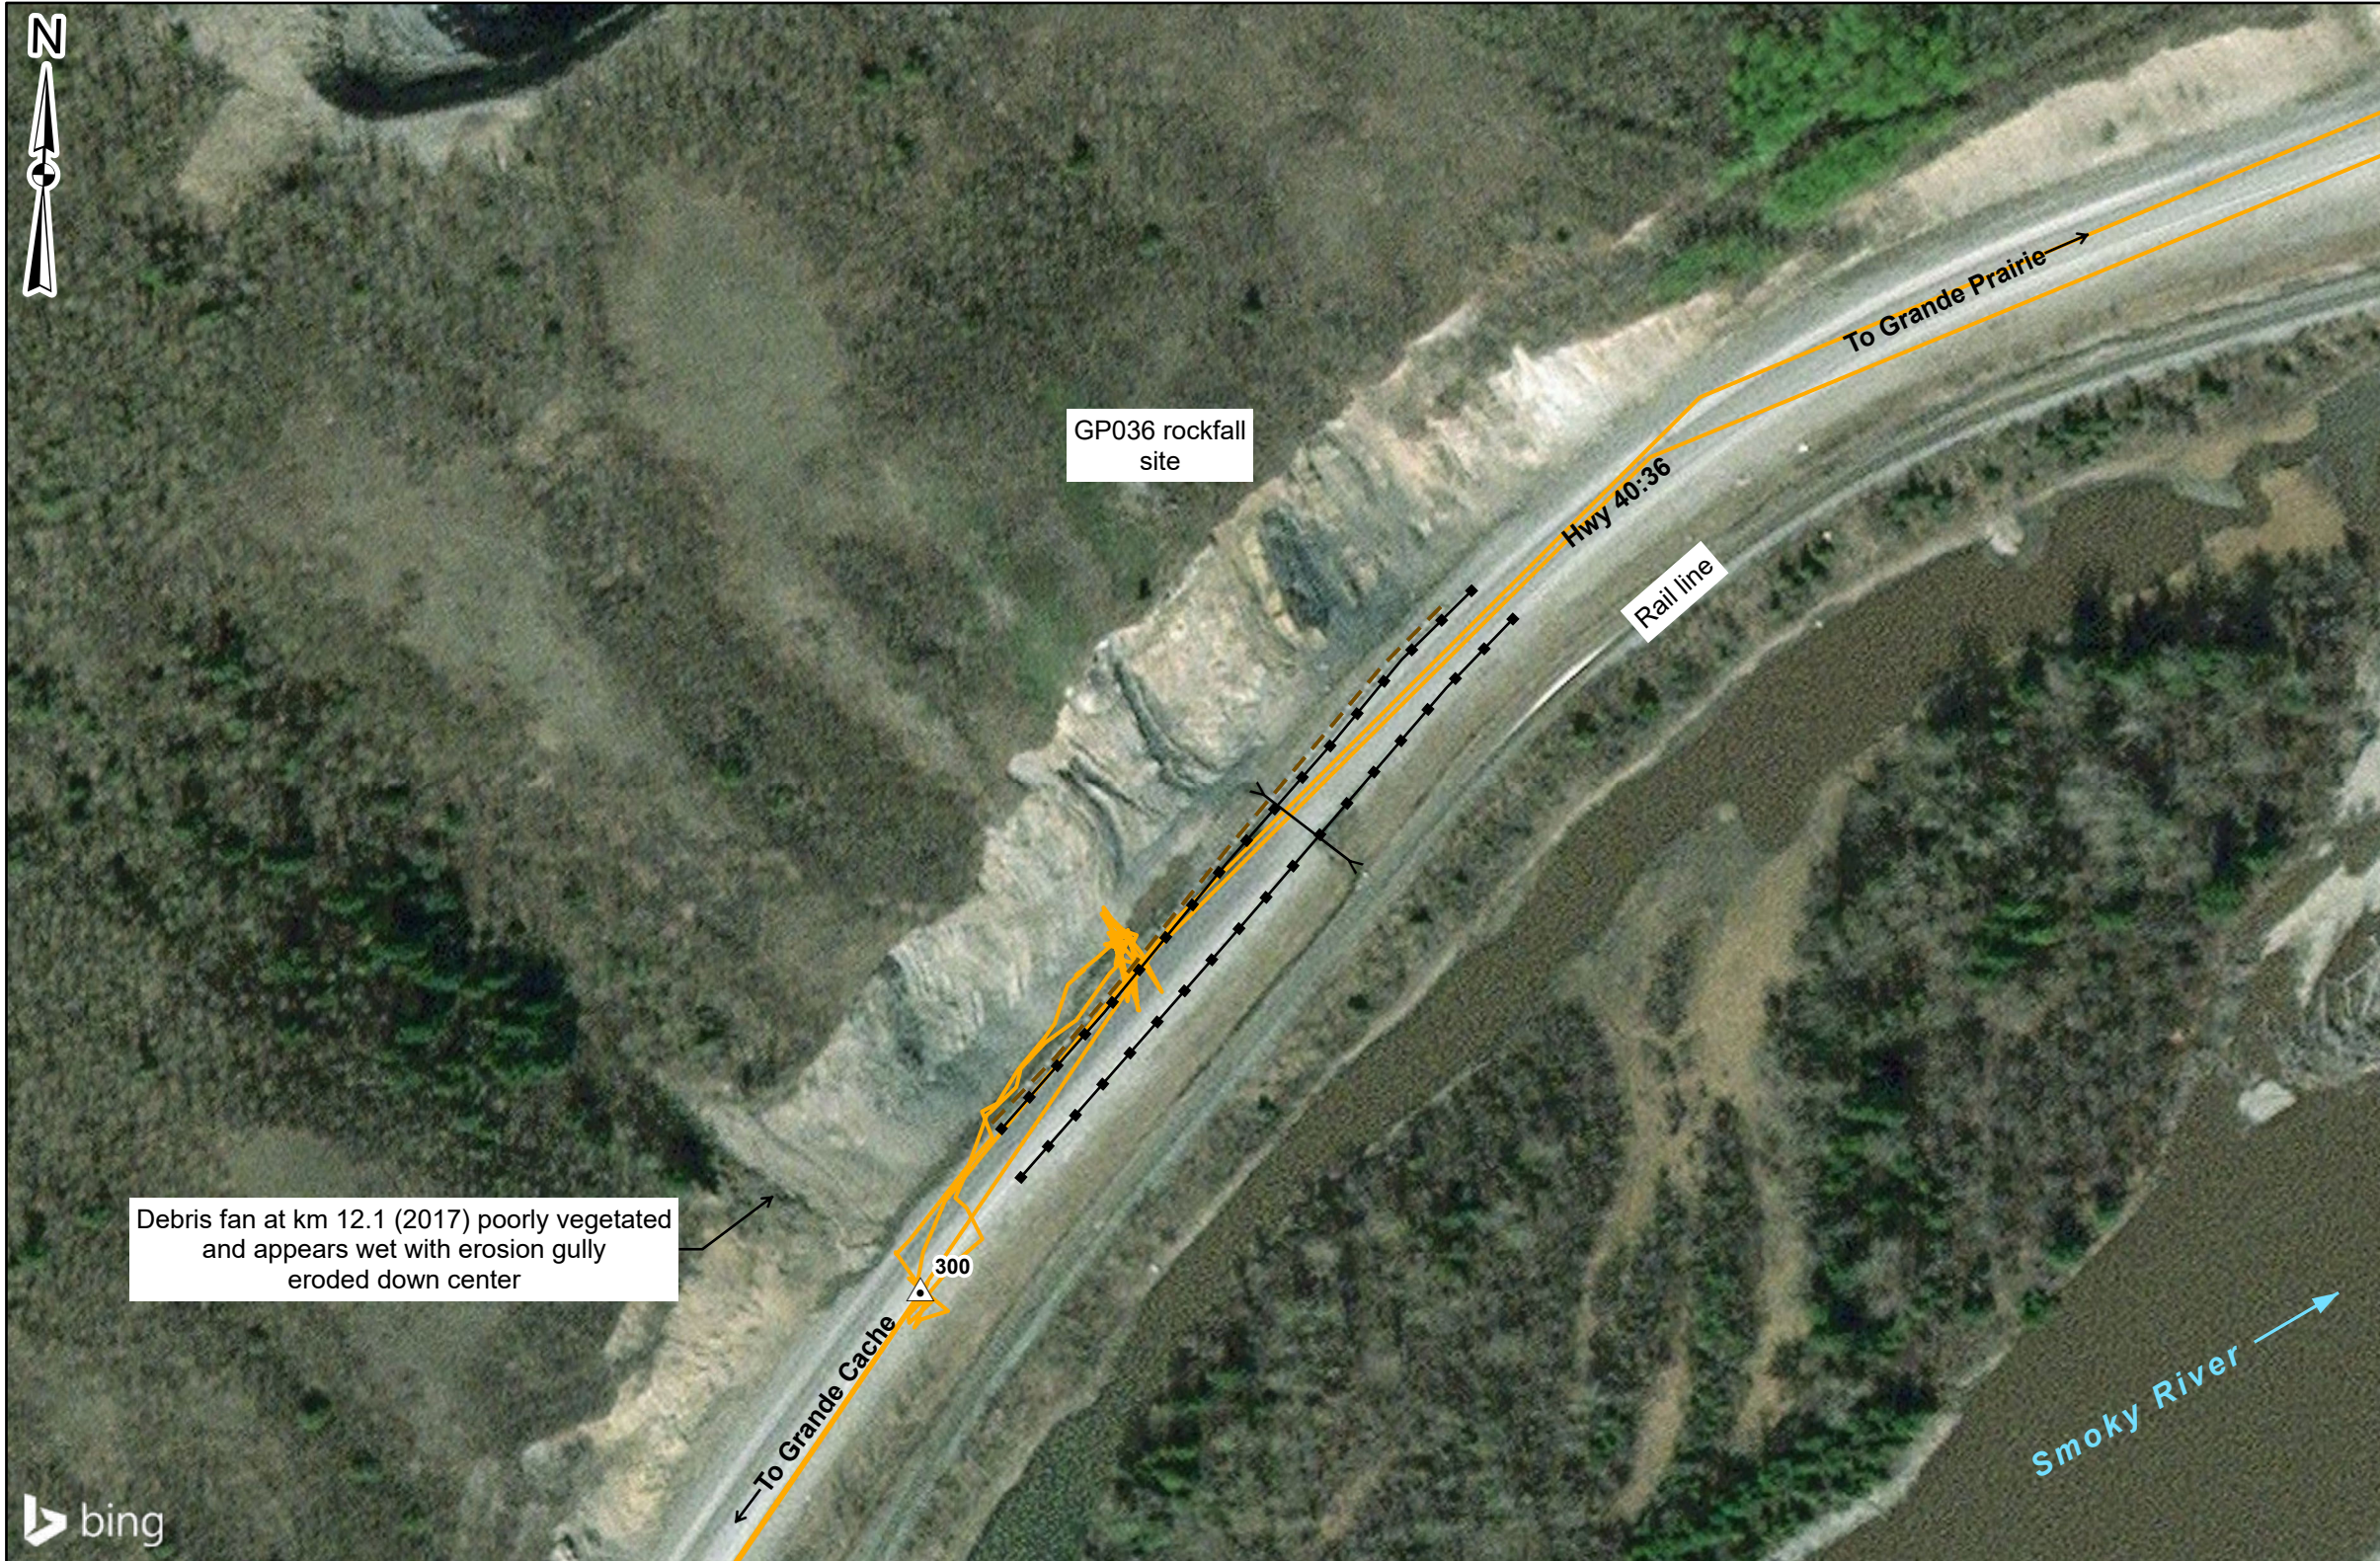
PROJECT PEACE REGION (GRANDE PRAIRIE DISTRICT-SOUTH) GEOHAZARD RISK MANAGEMENT PROGRAM		
TITLE Site Plan GP054 - Debris Flow Corridor South of McIntyre Mine Hwy 40:36, km 12.1		
SCALE 1:1,500	PROJECT No. A05116A01	FIG No. 1

Debris fan at km 12.1 (2017) poorly vegetated and appears wet with erosion gully eroded down center

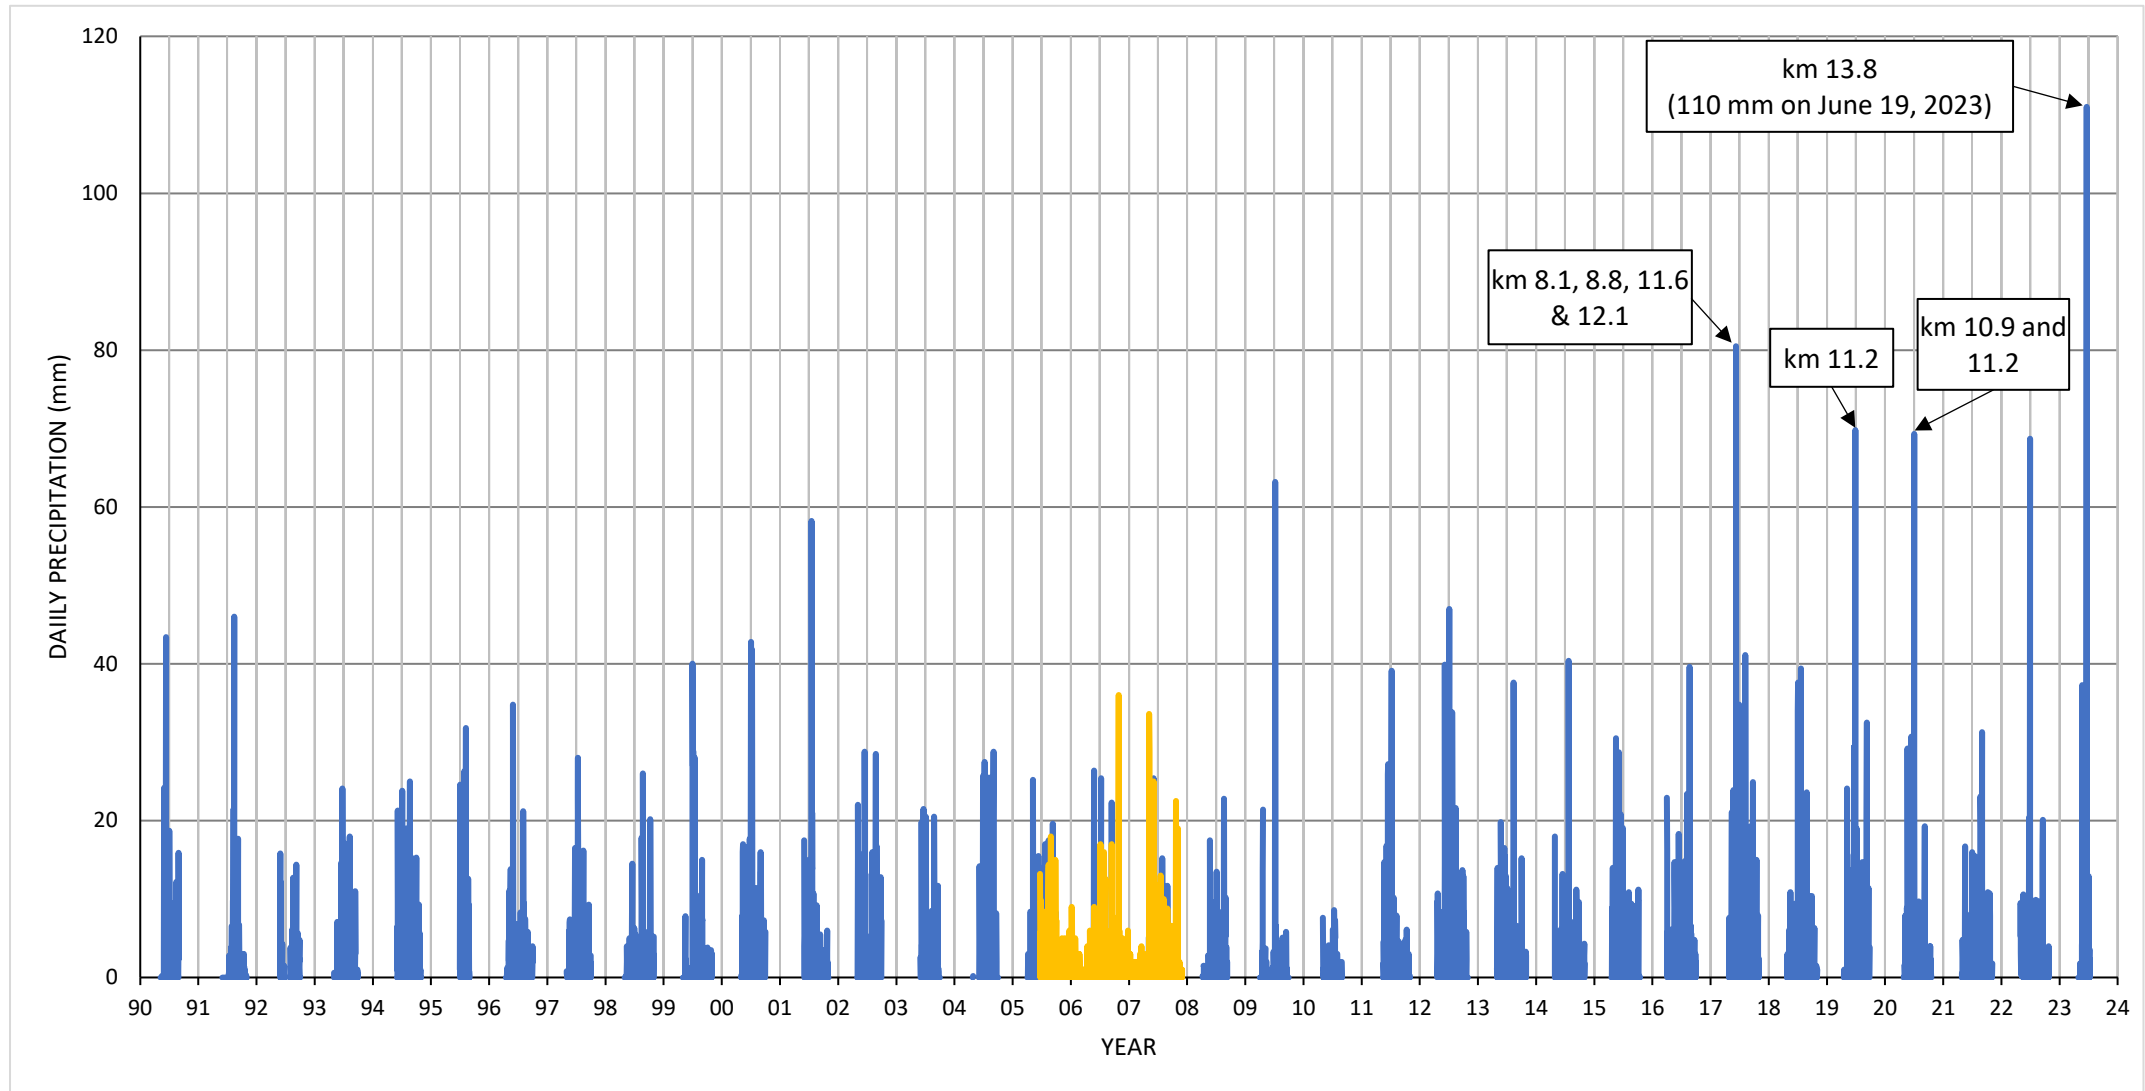
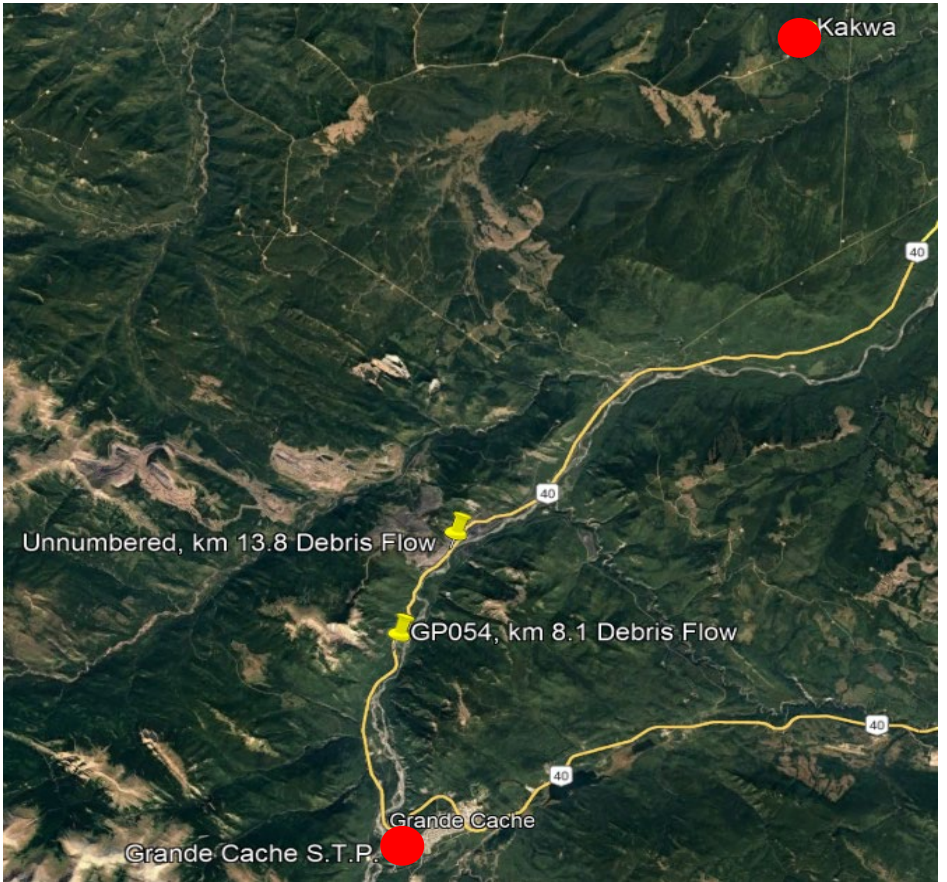
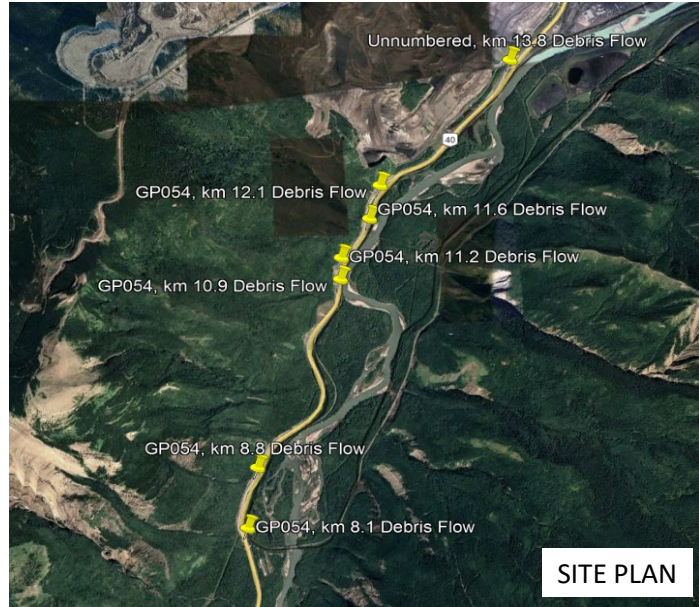
CLIENT 		PROJECT PEACE REGION (GRANDE PRAIRIE DISTRICT - SOUTH) GEOHAZARD RISK MANAGEMENT PROGRAM	
		TITLE Daily Precipitation Data Debris Flow Sites Hwy 40:36	
		SCALE	PROJECT No. A05116A01 FIG No 4

KCB reviewed available precipitation data for the site from 1967 to 2023 (record discontinuous before 1990). The rainfall data indicates that the debris flows tabulated in the table above each occurred around the same time as a high-than-average rainfall event as shown in Figure 2. Based on the data from Kakwa station (located approximately 30 km northeast of the site) higher-than-average rainfall events were recorded on June 9, 2017 (approximately 80 mm), June 28, 2019 (approximately 70 mm), July 1, 2020 (approximately 70 mm), and June 29, 2022 (approximately 70 mm). The last time a similar rainfall event occurred was 2009 and before that 2001. It is noted that despite a higher-than-average rainfall event on June 19, 2023 (approximately 110 mm) no debris flows were reported, except north of the site at km 13.8, indicating the debris flow channels within the current extents of the corridor are likely in the process of recharging following the debris flow events that occurred between 2017 and 2020.
