**PEACE REGION  
(GRANDE PRAIRIE DISTRICT – SOUTH) GRMP**

**SITE INSPECTION FORM**

<b>SITE NUMBER AND NAME:</b> GP054 Debris Flow Corridor South of McIntyre Mine		<b>HIGHWAY &amp; KM:</b> 40:36, 8.119 to 12.262	<b>PREVIOUS INSPECTION DATE:</b> June 12, 2023	<b>INSPECTION DATE:</b> <b>June 10, 2024</b>
<b>LEGAL DESCRIPTION:</b>  South NW 29-57-08-W6M North NW 04-58-08-W6M	<b>NAD 83 COORDINATES:</b> UTM    Northing    Easting 11      5981027      358454 11      5984770      360291		<b>RISK ASSESSMENT:</b>  <b>No Recent Occurrence</b> PF: 7 CF: 6 TOTAL: 42 <b>Recent Occurrence</b> PF: 5 CF: 2 TOTAL: 10	
<b>AVERAGE ANNUAL DAILY TRAFFIC (AADT):</b> 760 (north) & 960 (south) (Reference No. 25592, 2023)			<b>CONTRACT MAINTENANCE AREA (CMA):</b> 504

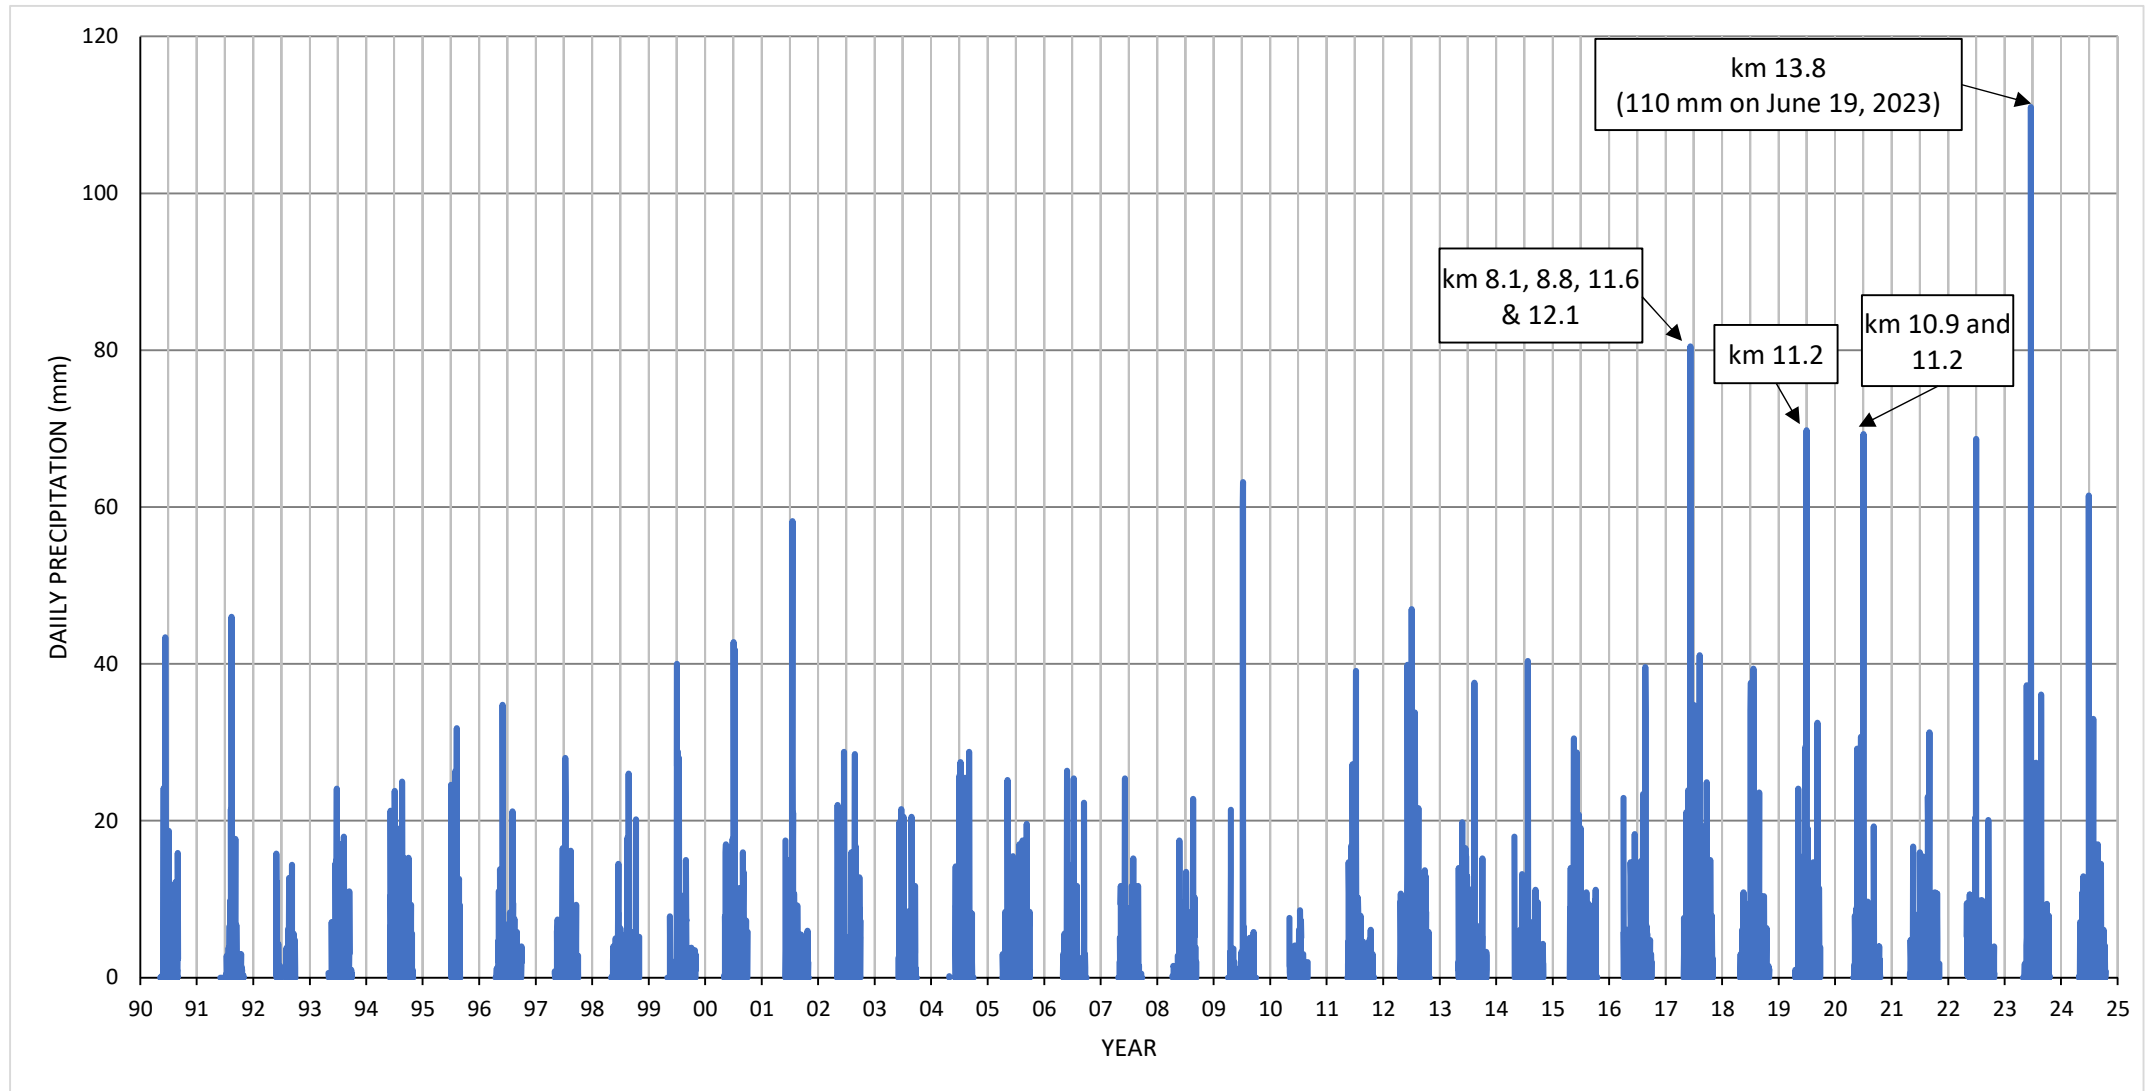
CLIENT		PROJECT	
		PEACE REGION (GRANDE PRAIRIE DISTRICT - SOUTH) GEOHAZARD RISK MANAGEMENT PROGRAM	
		TITLE	
		DAILY PRECIPITATION DATA GP054 DEBRIS FLOW CORRIDOR HWY 40:36	
SCALE	PROJECT No.	A05116A01	FIG No
			4

KCB reviewed available precipitation data recorded at Kakwa weather station (located approximately 30 km northeast of site) from 1967 to 2024. Record discontinuous before 1990, but average daily precipitation data from 1990 to 2024 is shown on Figure 4. The rainfall data indicates that the debris flows tabulated in the table above each occurred around the same time as a high-than-average rainfall events on June 9, 2017 (approximately 80 mm), June 28, 2019 (approximately 70 mm), July 1, 2020 (approximately 70 mm), and June 29, 2022 (approximately 70 mm). The last time a similar rainfall event occurred was 2009 and before that 2001. It is noted that despite a higher-than-average rainfall event on June 19, 2023 (approximately 110 mm) no debris flows were reported, except north of the site at km 13.8, indicating the debris flow channels within the current extents of the corridor are likely in the process of recharging following the debris flow events that occurred between 2017 and 2020.

- Based on the available data the intensity and frequency of heavy precipitation events appears to be increasing in recent years. The study should assess the potential impacts of increased precipitation on debris flow.

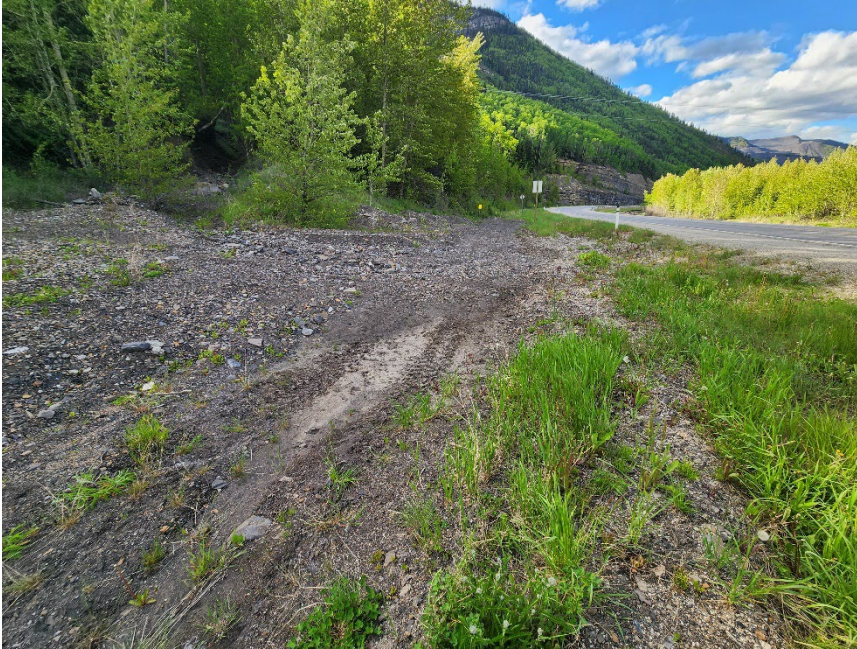
Debris flow at approximately km 8.1 (Photos 1 and 2):

- Last documented debris flow occurred at this location in 2017, but there is evidence of more recent events.
- Debris fan extends from an erosion gully approximately 4 m high into the west highway ditch. Debris fan material mostly consists of sand and gravel with some cobbles.

**Photo 1** Debris flow at km 8.1 on west side of Hwy 40:36. Note debris flow fan (mostly sand and gravel with some cobbles) in highway ditch. Photo taken June 10, 2024, facing north.

- TEC could consider a placing a net over the debris flow channel at the km 8.1 site.
- Debris flow reporting could be improved by maintaining a record of debris flows that reach the highway, including the date of event, approximate location, volume of particles, and maximum particle size. It appears that TEC may already be doing this, but a formal record could be prepared by the HMC or MCI based on e-mails to TEC and the regional geotechnical consultant.

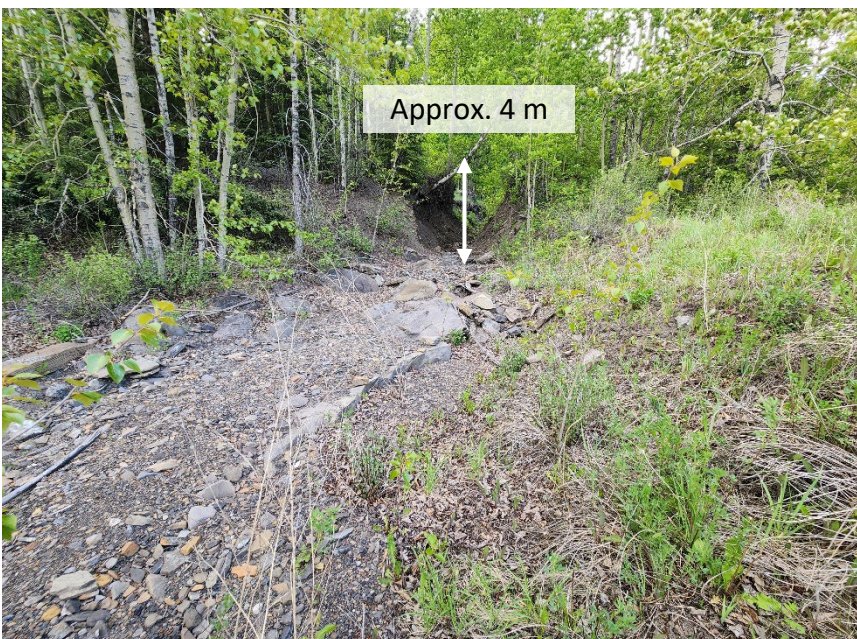
**Photo 2** Debris flow at km 8.1 on west side of Hwy 40:36. Note erosion gully is approximately 4 m high. Photo taken June 10, 2024, facing northwest.

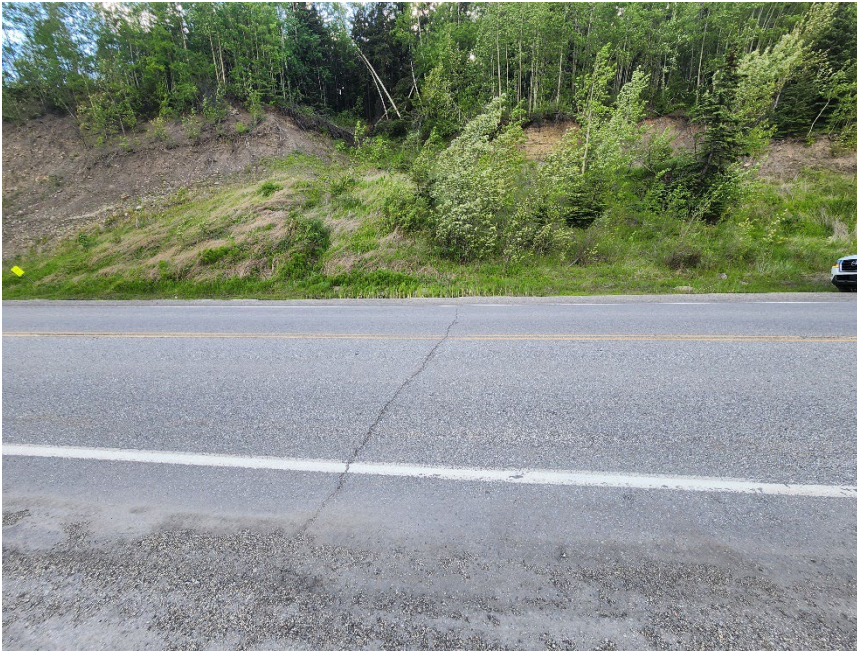
Debris flow at approximately km 10.9 (Photos 3 and 4):

- Ponded water in north highway ditch at toe of debris flow.
- Fan is fairly well vegetated, indicating no recent debris flow activity.
- Debris flow material continues to slump slowly towards highway and is approximately 2.5 m from edge of pavement. Backslope failure is approximately 25 m wide. Slope is approximately 5 m to 8 m high.

**Photo 3** Debris flow at km 10.9 on west side of Hwy 40:36. Photo taken June 10, 2024, facing west.

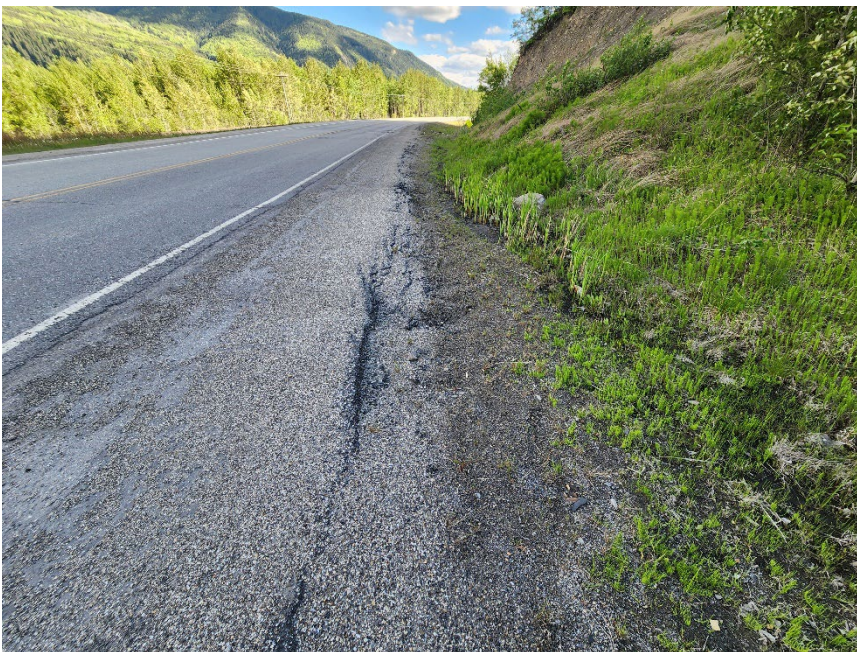
**Photo 4** Toe of debris flow at km 10.9 on west side of Hwy 40:36. Photo taken June 10, 2024, facing southwest.

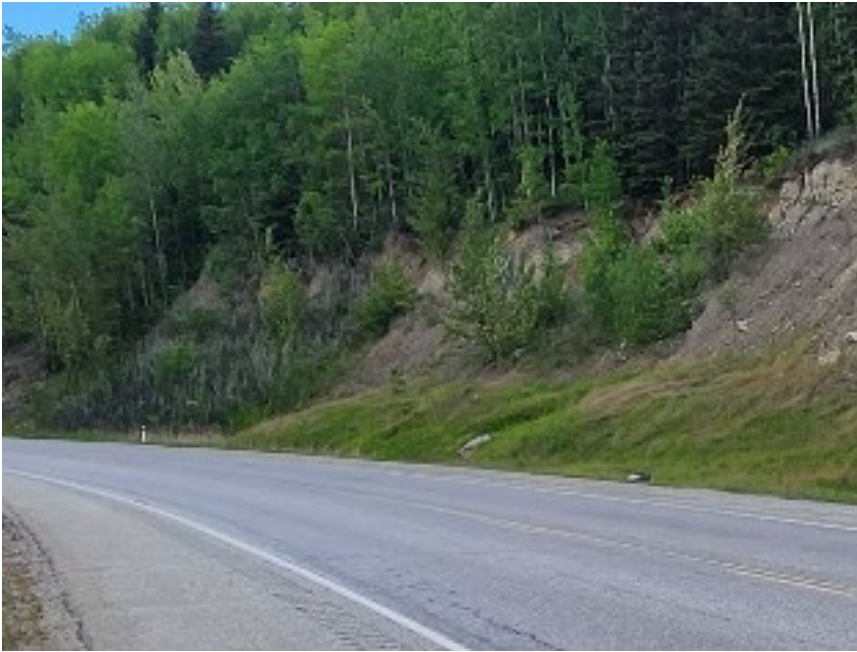
Possible debris flow at approximately km 11.1 (Photo 5):

- Ponded water and cattails in north highway ditch at toe of debris flow.
- Fan is partially vegetated, especially the lower half, indicating no recent debris flow activity.
- Debris flow material continues to slump slowly towards highway with slope failure along backslope likely due to saturation and softening of materials. Backslope failure is approximately 50 m wide. Slope is approximately 5 m to 8 m high.

**Photo 5** Debris flow at km 11.1 on west side of Hwy 40:36. Photo taken June 10, 2024, facing southwest.

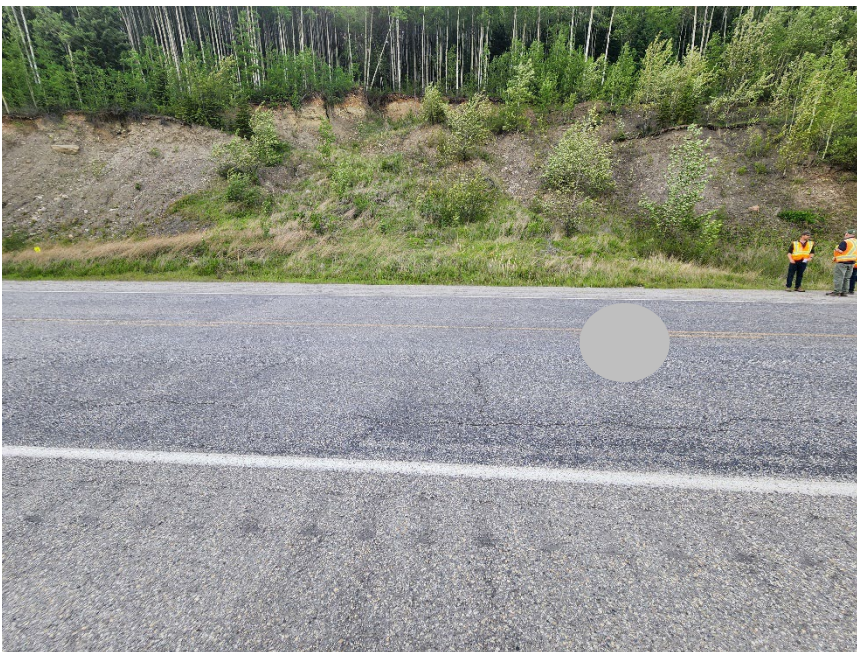
Possible debris flow at approximately km 11.2 (Photos 6 and 7):

- North highway ditch at toe of debris flow dry.
- Fan is partially vegetated, especially the lower half, indicating no recent debris flow activity.
- Debris flow material continues to slump slowly towards highway with slope failure along backslope likely due to saturation and softening of materials. Debris flow material approximately 2.5 m from edge of pavement. Backslope failure is approximately 50 m wide. Slope is approximately 5 m to 8 m high.

**Photo 6** Debris flow at km 11.2 on west side of Hwy 40:36. Photo taken June 10, 2024, facing west.

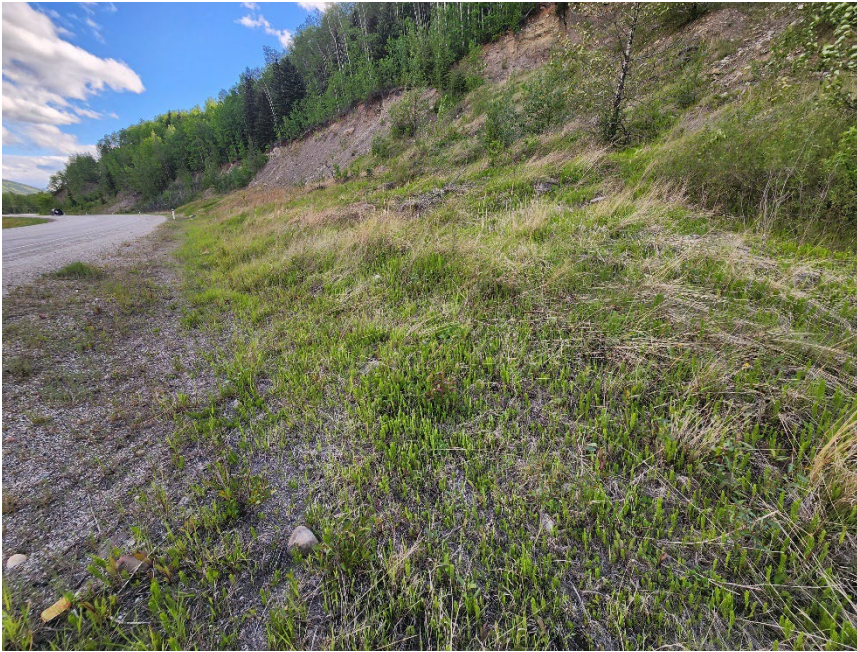
**Photo 7** Toe of debris flow at km 11.2 on west side of Hwy 40:36. Photo taken June 10, 2024, facing south.

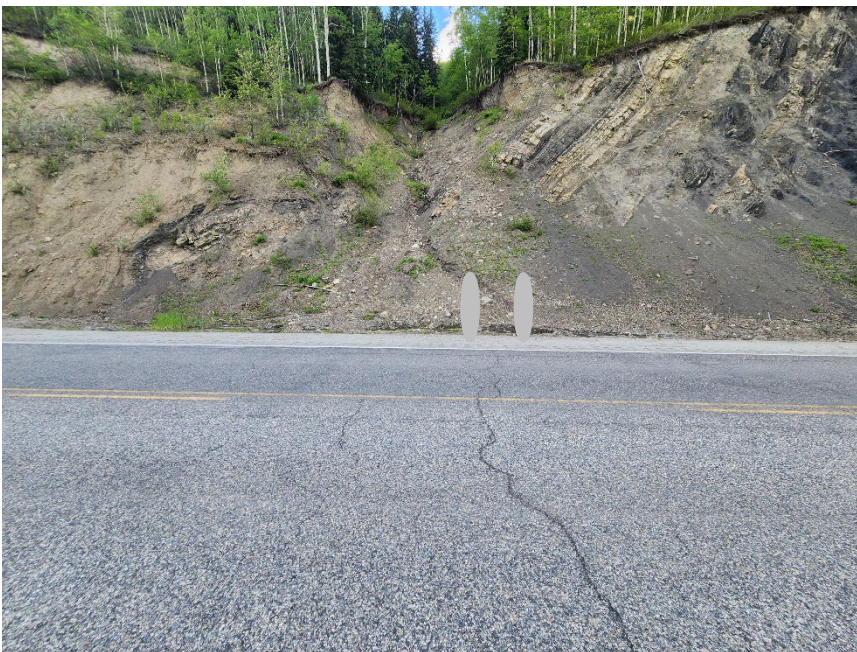
Debris flow at approximately km 12.1 (Photo 8):

- Debris fan is poorly vegetated with erosion gully eroded down center, indicating higher water flows at this site are possibly hindering vegetation growth.
- Debris flow deposit appears wet, and ponded water in west highway ditch at toe of debris flow.

**Photo 8** Debris flow at km 12.1 on west side of Hwy 40:36. Note erosion gully near middle of debris flow fan. Photo taken June 10, 2024, facing northwest.
