Alberta Transportation and Economic Corridors
Main Floor, Provincial Building
9621 96 Avenue
Peace River, Alberta
T8S 1T4

CON0022166 Peace Region (Grande Prairie District – South) GRMP
Hwy 40:36, km 13.700 Debris Flow
Section D – Call-Out Report
Draft

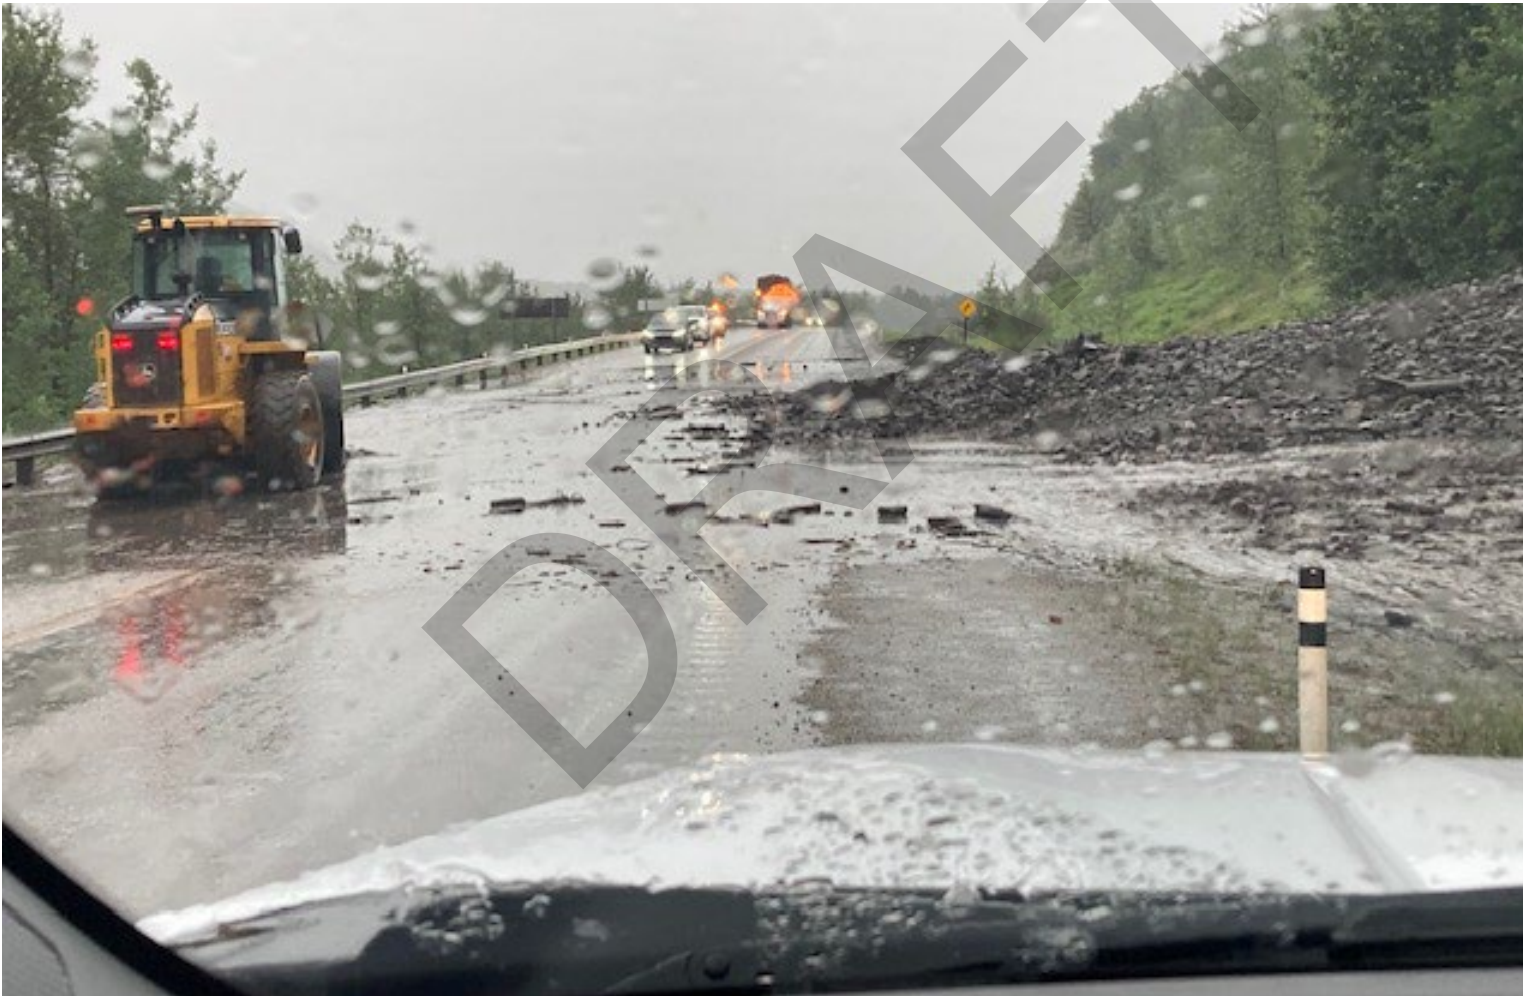
Photo 1 Debris being cleared from highway by front-end loader. Photo taken by Highway Maintenance Contractor (MCI) on June 19, 2023, facing south.

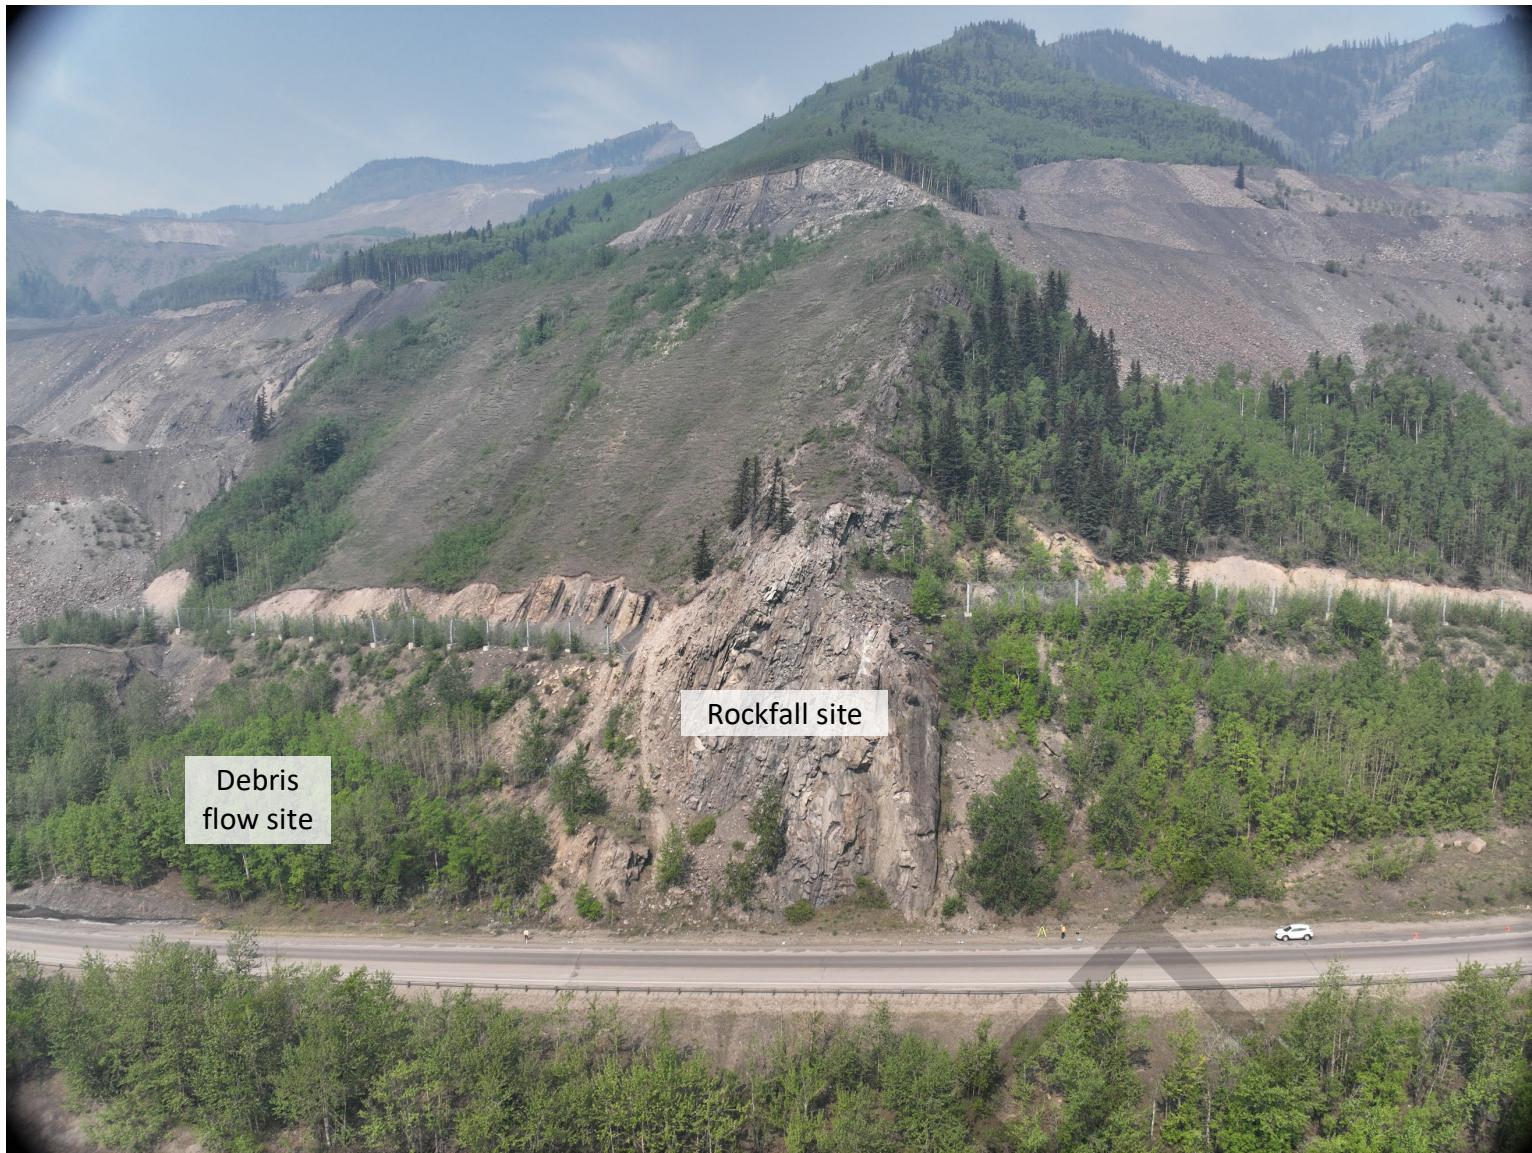
- ◆ Some UAV photos (Photos 2 and 3) taken of the subject site during our May 2023 fieldwork at the adjacent rockfall site are included in Appendix I. In the photos, the two erosion gullies shown in Figure 4 appear to have connected and eroded further downslope below the rockfall fence and through the mine road along the toe of the waste-rock dump. There also appears to be some pond water and debris in the west highway ditch.

Photo 2 UAV photo of the subject debris flow site taken during our field work at the adjacent unnumbered rockfall site in May 2023. Photo taken with UAV on May 17, 2023, facing west.

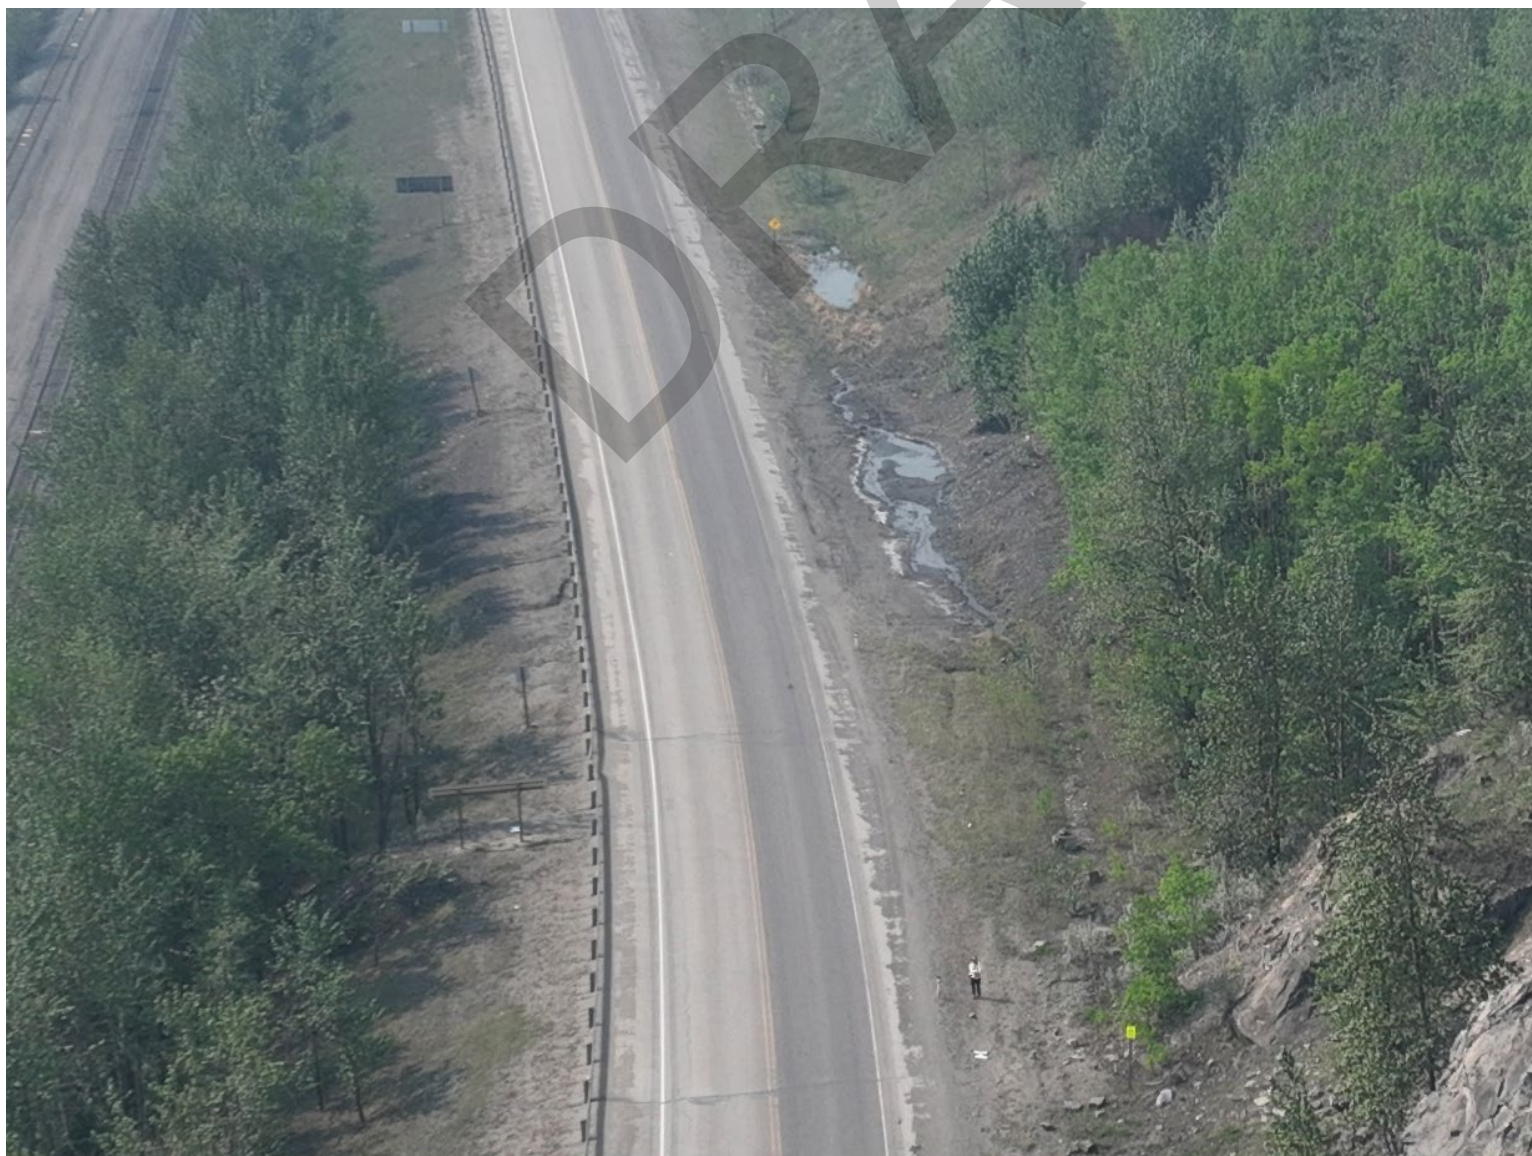
Photo 3 UAV photo of the subject debris flow site taken during our field work at the adjacent unnumbered rockfall site in May 2023. Photo taken with UAV on May 17, 2023, facing southwest.

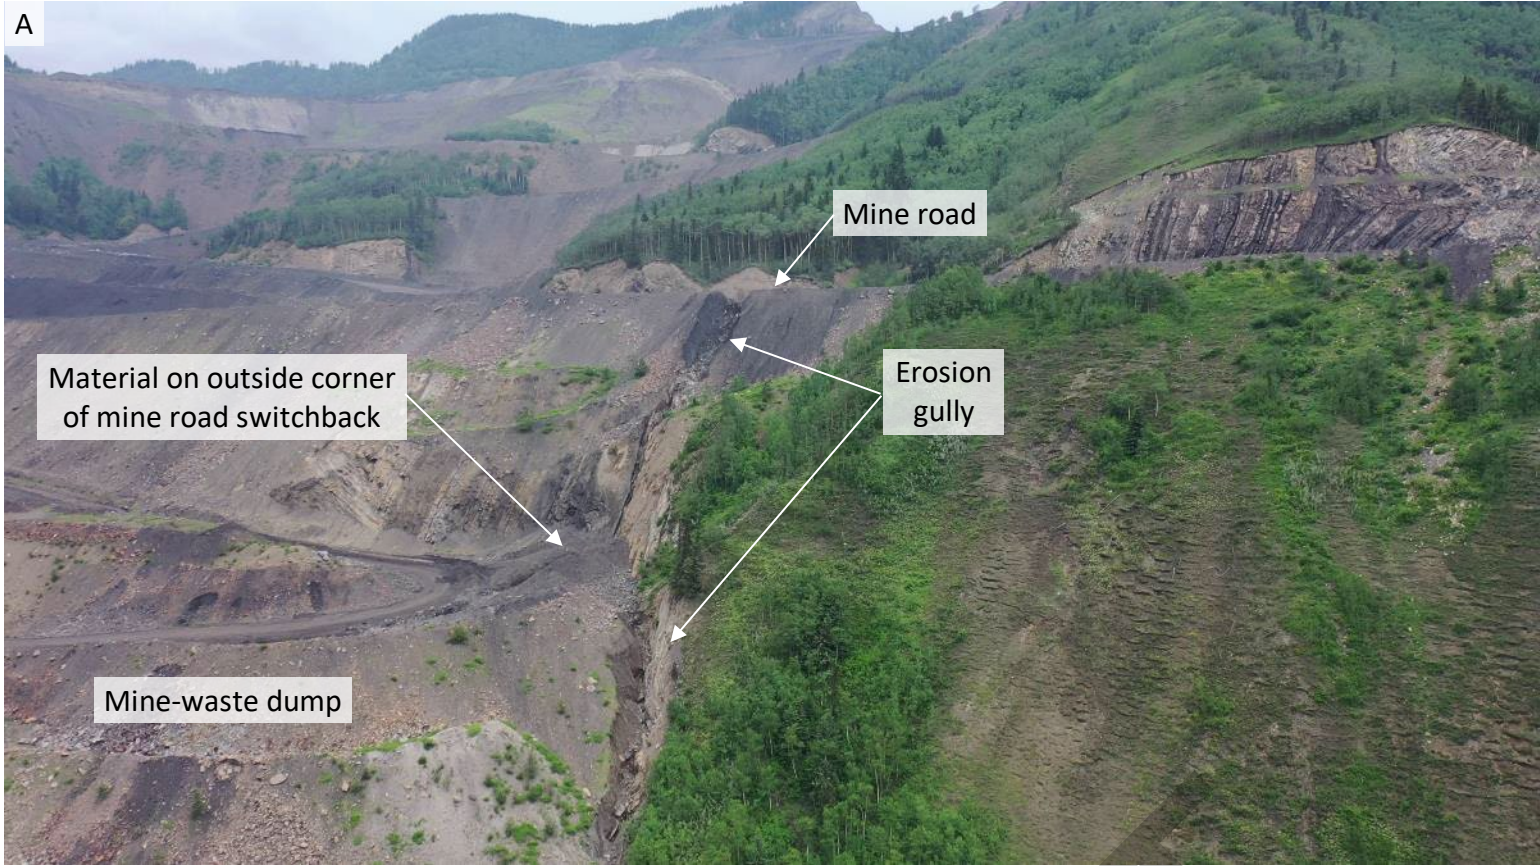
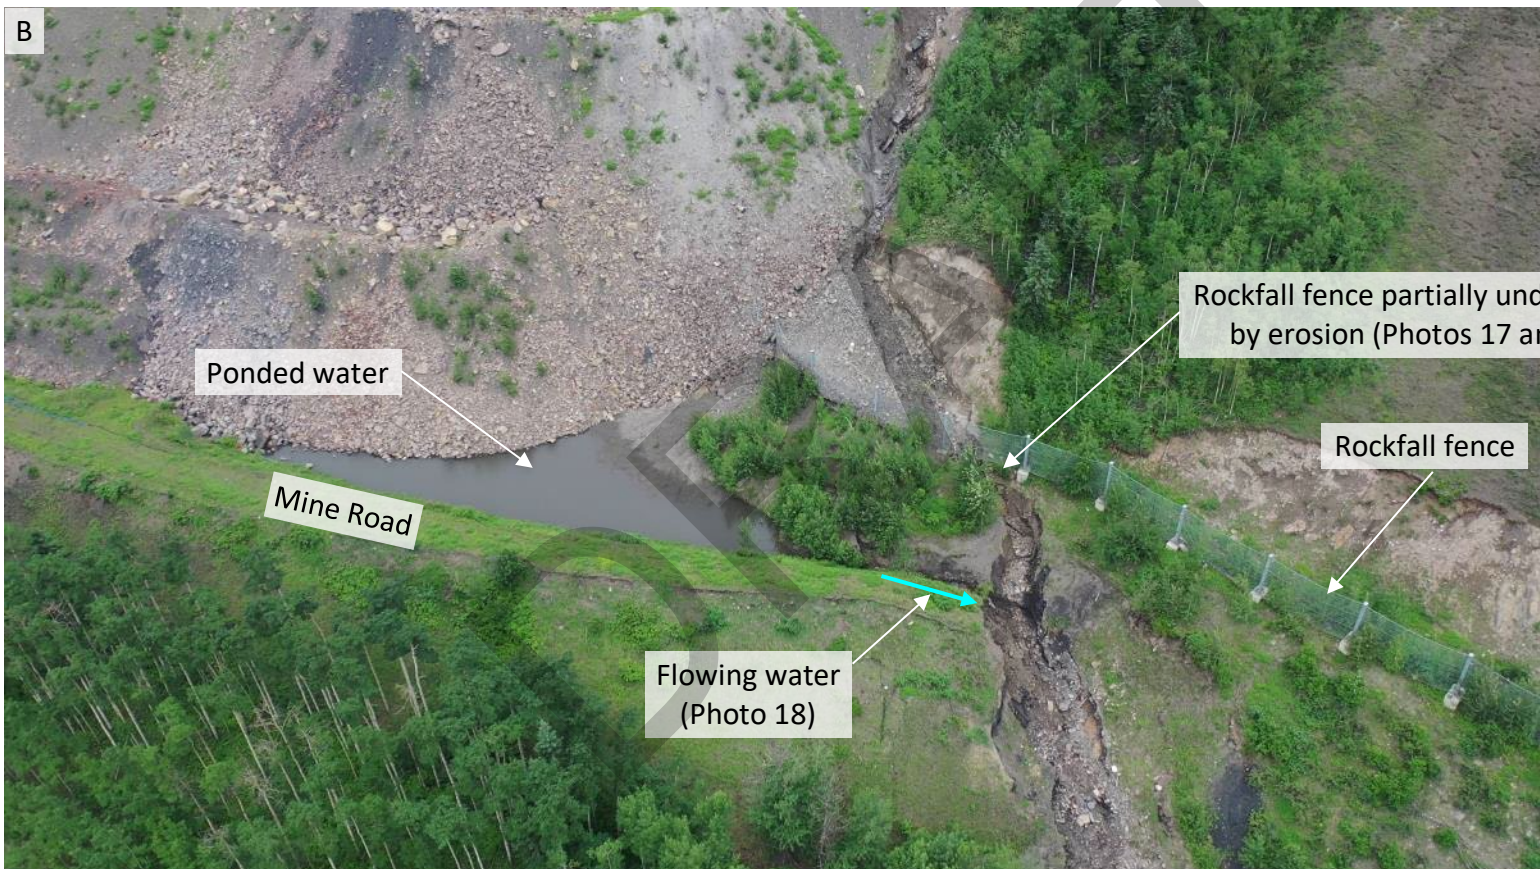
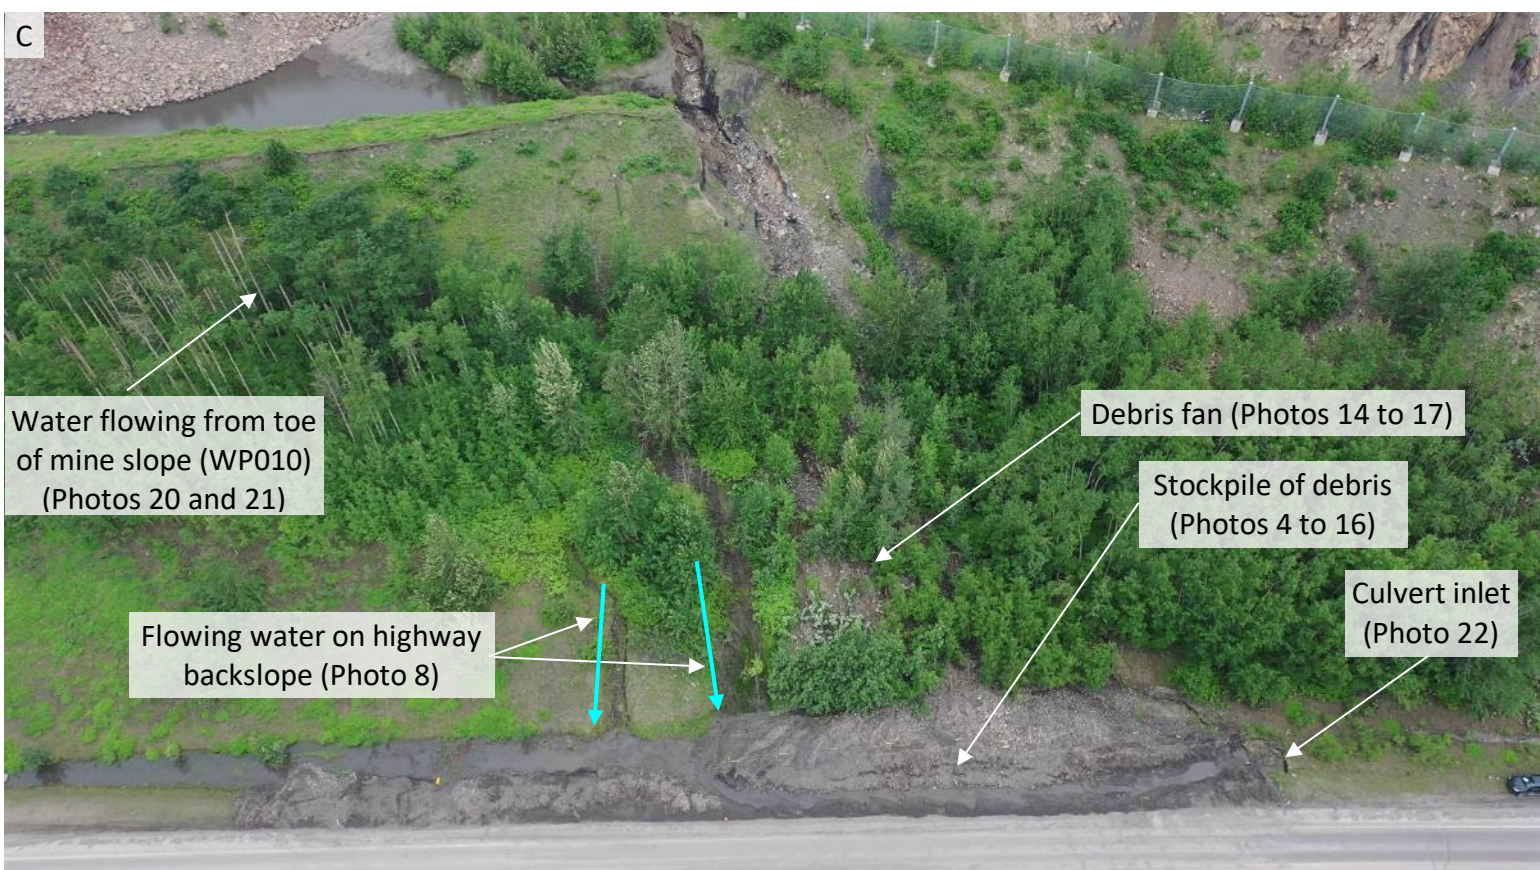
- ◆ A pond of water is located at the northeast corner of the mine-waste dump (Photo 4).
- Debris from the highway removed during/following the June 19, 2023 flow event was temporarily stockpiled along the west side of the highway creating an approximate 60-m long berm between WP003 and WP009 and a smaller 50-m long berm extending south of WP009 (Photo 4 through 13). The width and height of the berms varies, but near WP008 where it is largest it is up to approximately 3 m to 4 m wide and 3 m to 4 m high. **TEC to confirm if the stockpiled material has already been removed.**

- ◆ The erosion gully cuts through some material located on the outside corner of a mine road switchback, below the rockfall fence, and through the lower mine road (Photos 4 through 6, 17, and 18) where it joins the apex of the debris fan (Photos 17).

- ◆ The water flowing through and along either side of the debris fan appears to be flowing from further upslope, including the erosion gully and the pond of water located at the northeast corner of the mine-waste dump (Photos 4 and 18).

Photo 4 Overview of site. Note erosion gully between north flank and toe of mine-waste dump through some material located on outside corner of mine road switchback, below rockfall fence, and through lower mine road. Also note water flowing from water ponded at northeast corner of waste-rock dump and along highway backslope (indicated with blue arrows), and stockpile of debris material along west highway ditch. Photo taken with UAV on June 22, 2023 facing west and down.

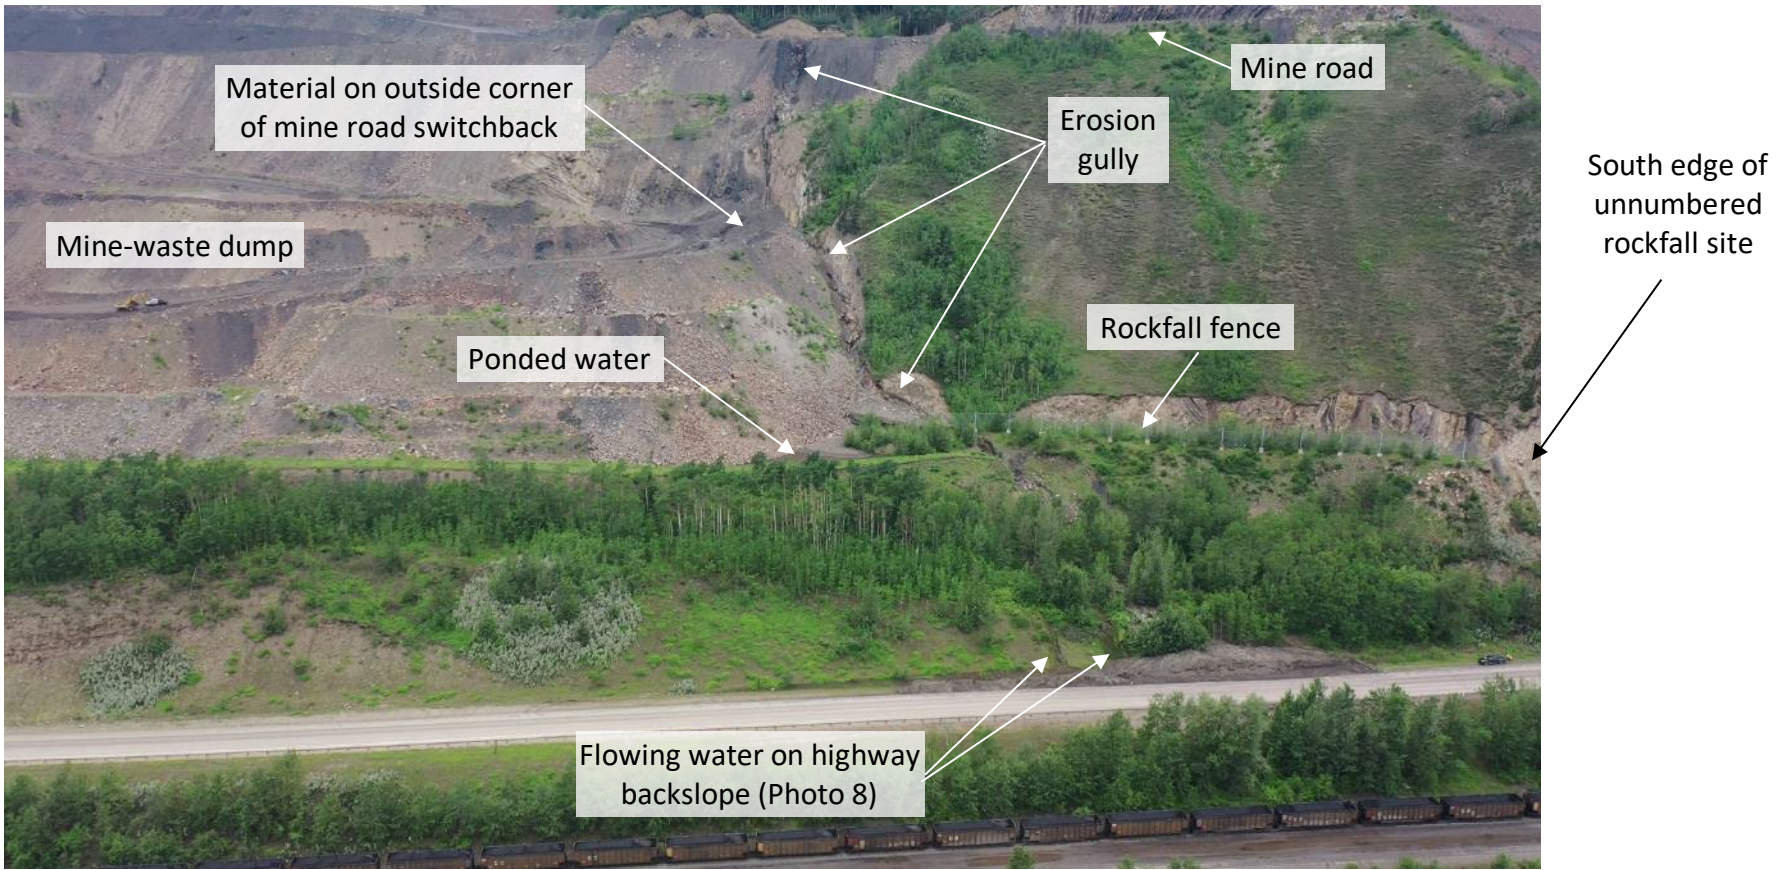
- Water was observed flowing from the highway backslope near WP009 (Photos 4, 5, and 8) and through and along either side of the debris fan into the west highway ditch (Photo 13).

Photo 5 Overview of site. Photo taken with Unmanned-Aerial Vehicle (UAV) on June 22, 2023, facing northwest.

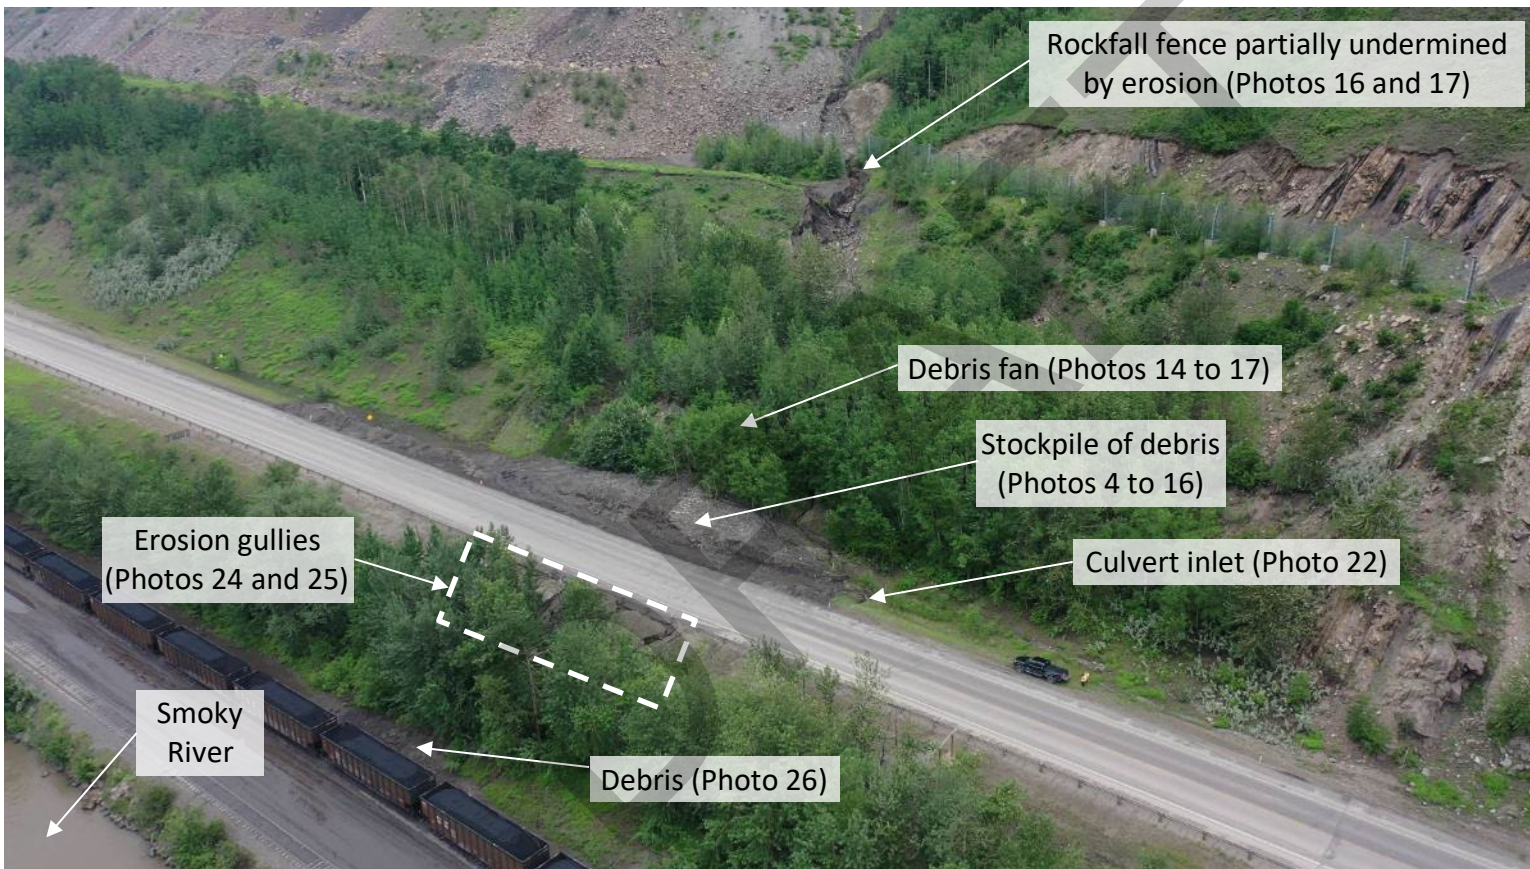
- KCB was unable to cross the railway tracks to assess if material or turbid water from the debris flow had reached the Smoky River but based on photos taken with our UAV (Photo 6) it does not appear that it did.

Photo 6 Overview of site. Photo taken with UAV on June 22, 2023, facing southwest.

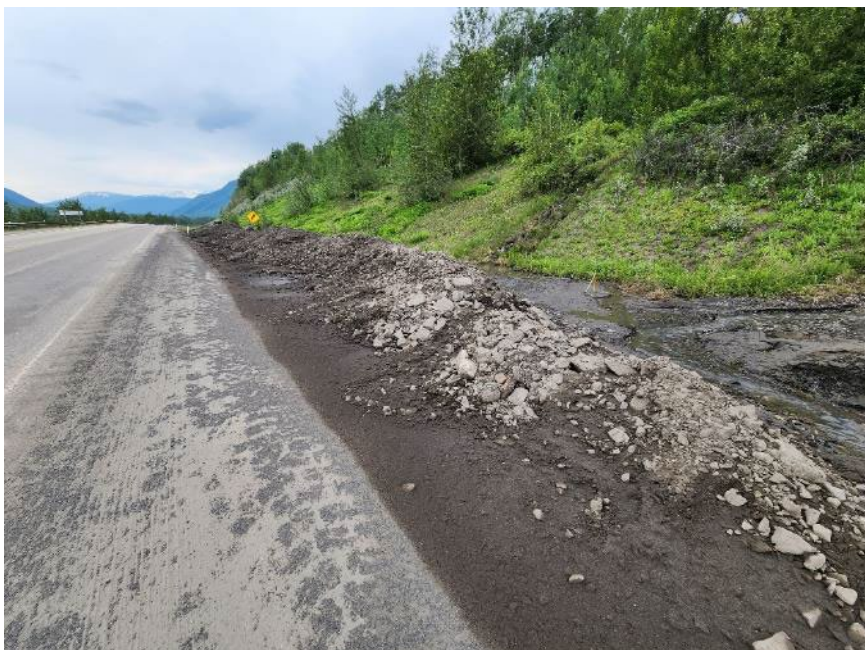
Photo 7 Temporary stockpile of debris along west side of highway south of WP009. Photo taken on June 22, 2023, near WP009 facing southwest.

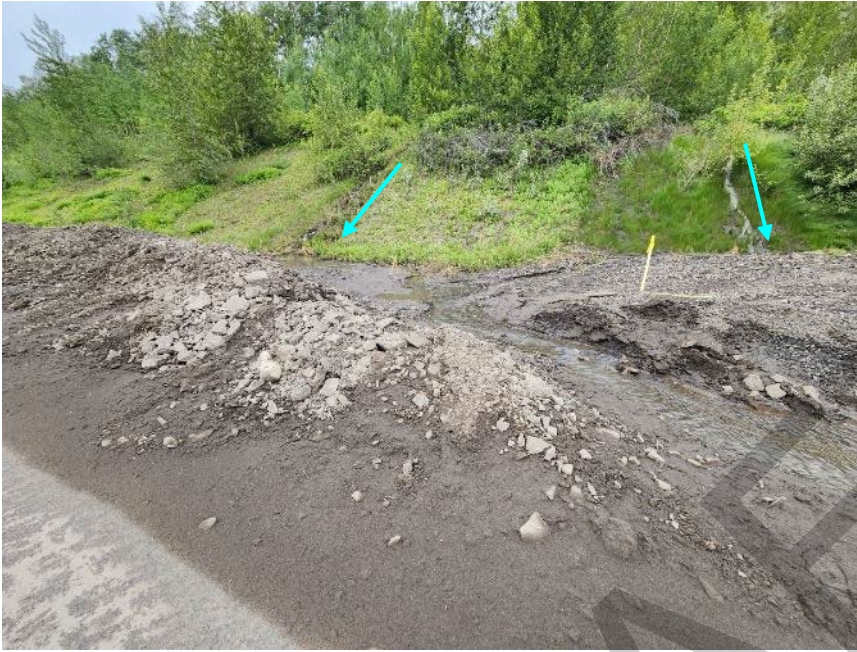
Photo 8 **Flowing water on highway backslope (indicated with blue arrows). Photo taken on June 22, 2023, near WP009 facing west.**

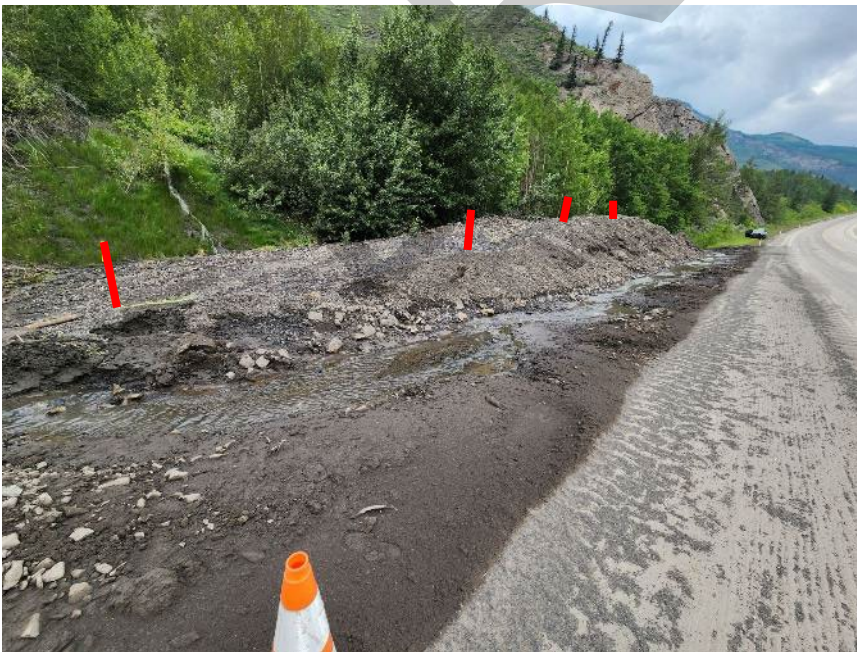
- ◆ Along the temporary stockpile of debris, a row of survey stakes marks the location of a high-pressure natural-gas line (photos 9 and 12).
- Behind the temporary stockpile of debris, a debris fan extends back through the trees approximately 60 m to the toe of the lower mine road and northeast corner of the mine-waste dump where it is approximately 20 m wide (Photos 4 through 6, and 14 through 17). The material in the debris fan mainly consisted of coarse-grained material, including some cobbles and a few boulders, in a matrix of fine-grained material. The coarse-grained material varied from angular to subrounded. Generally, the material in the debris fan appeared coarser than the material removed from the highway. **TEC to confirm if coarser material from the debris flow was removed and stockpiled elsewhere.**

Photo 9 **Temporary stockpile of debris along west side of highway between WP003 and WP009. Note survey stakes marking location of high-pressure natural-gas pipeline (indicated with red lines). Photo taken on June 22, 2023, near WP009 facing northwest.**

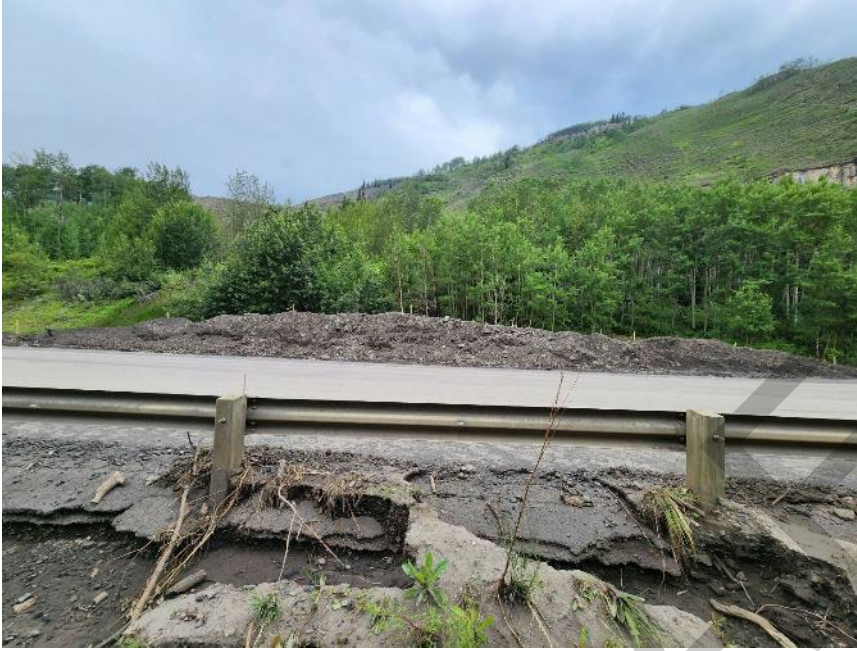
Photo 10 Temporary stockpile of debris along west side of highway between WP003 and WP009 and erosion gullies along east side of highway. Note pavement subgrade exposed along west side of highway, and guardrail posts partially undermined. Photo taken on June 22, 2023, facing west.

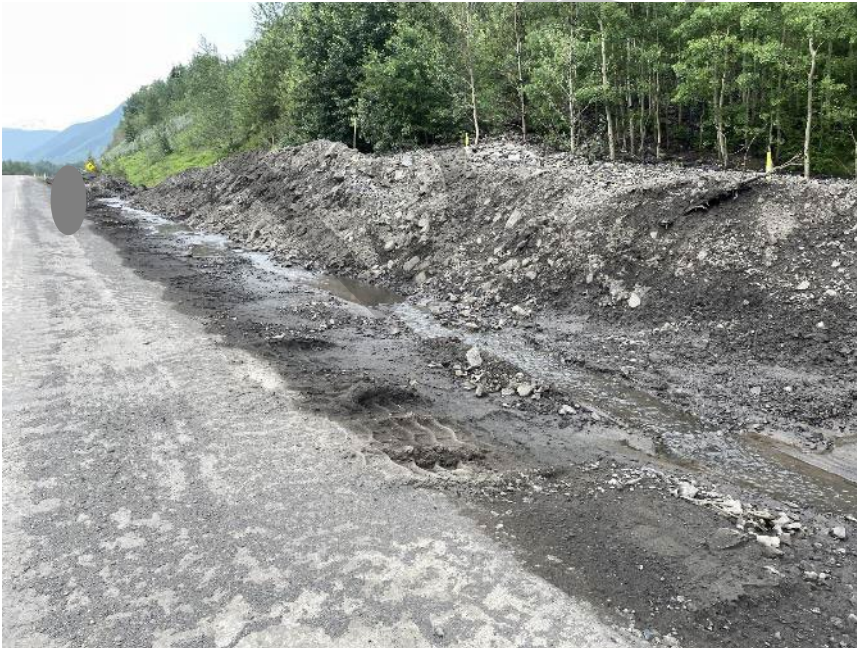
Photo 11 Temporary stockpile of debris along west side of highway. Photo taken on June 22, 2023, facing southwest.

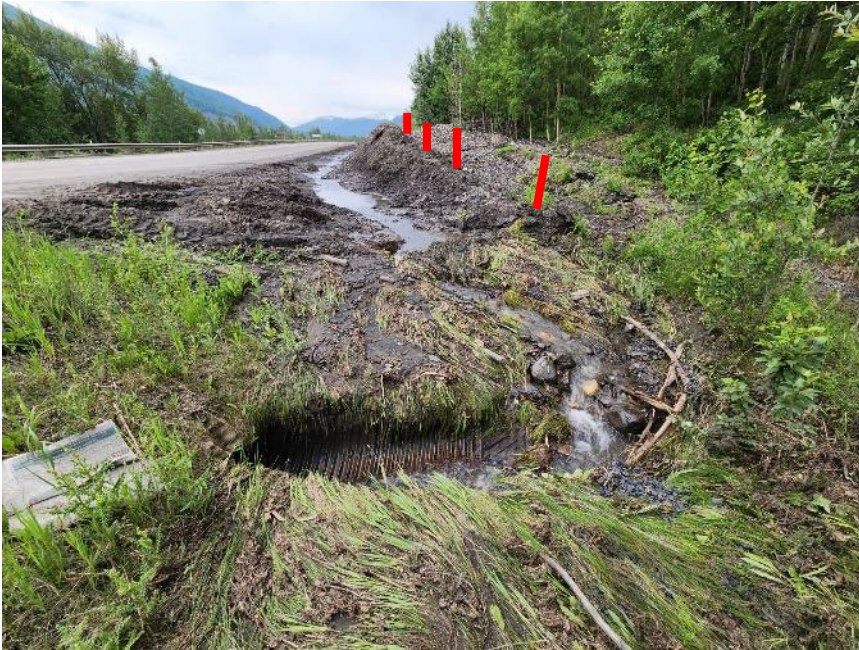
Photo 12 Temporary stockpile of debris along west side of highway. Note survey stakes marking location of high-pressure natural-gas pipeline (indicated with red line), water flowing in west highway ditch, and culvert inlet. Photo taken on June 22, 2023, near WP003 facing south.

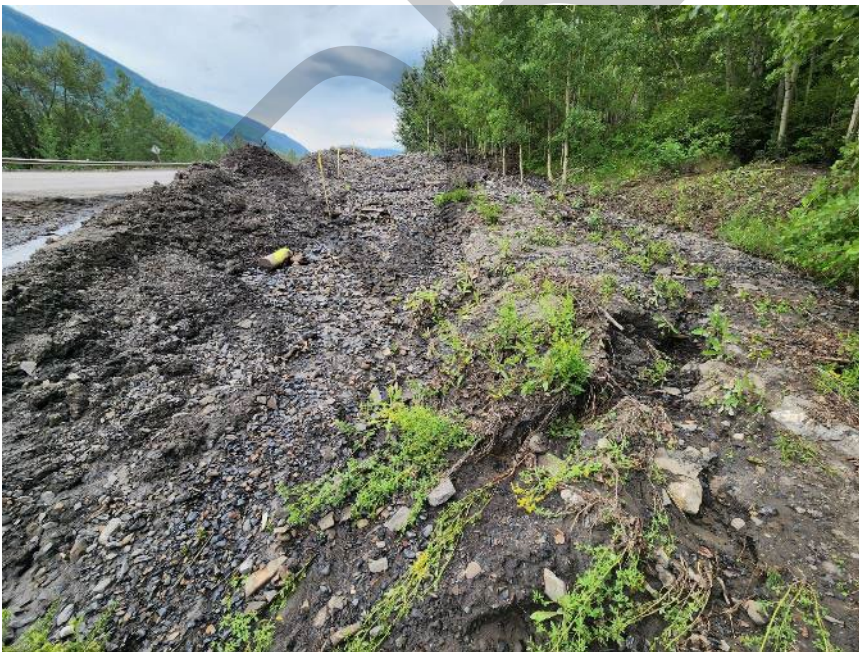
Photo 13 Top of temporary stockpile of debris along west side of highway. Photo taken on June 22, 2023, facing south.

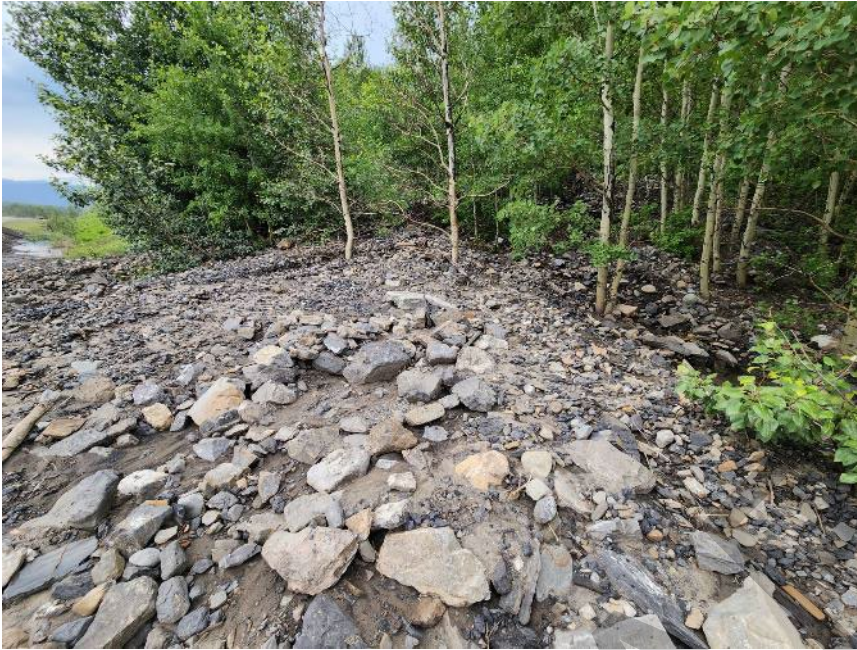
Photo 14 Debris fan behind temporary stockpile of debris along west side of highway. Photo taken on June 22, 2023, facing southwest.

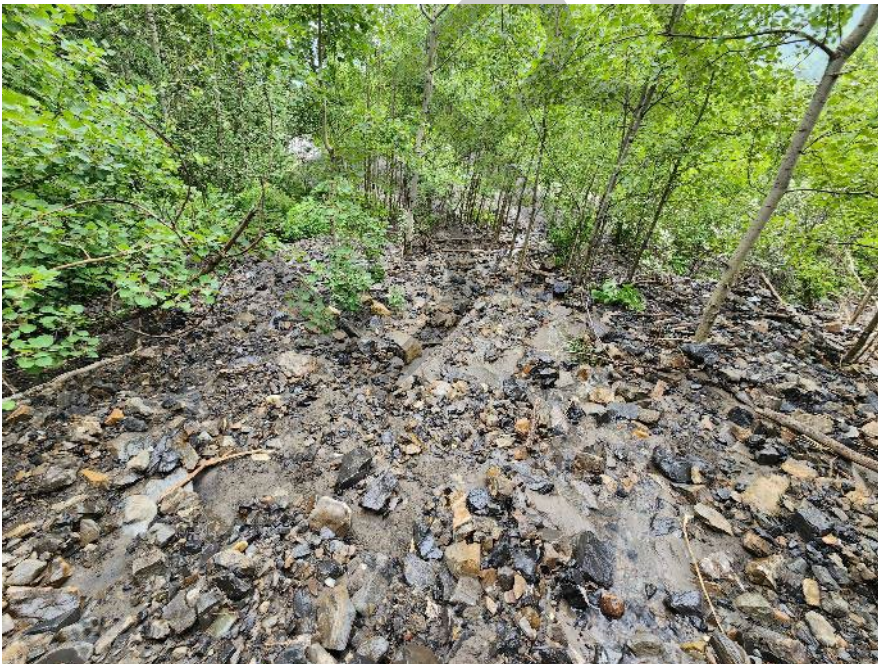
Photo 15 Debris fan and flowing water in trees between WP008 and WP005. Photo taken on June 22, 2023, facing east.

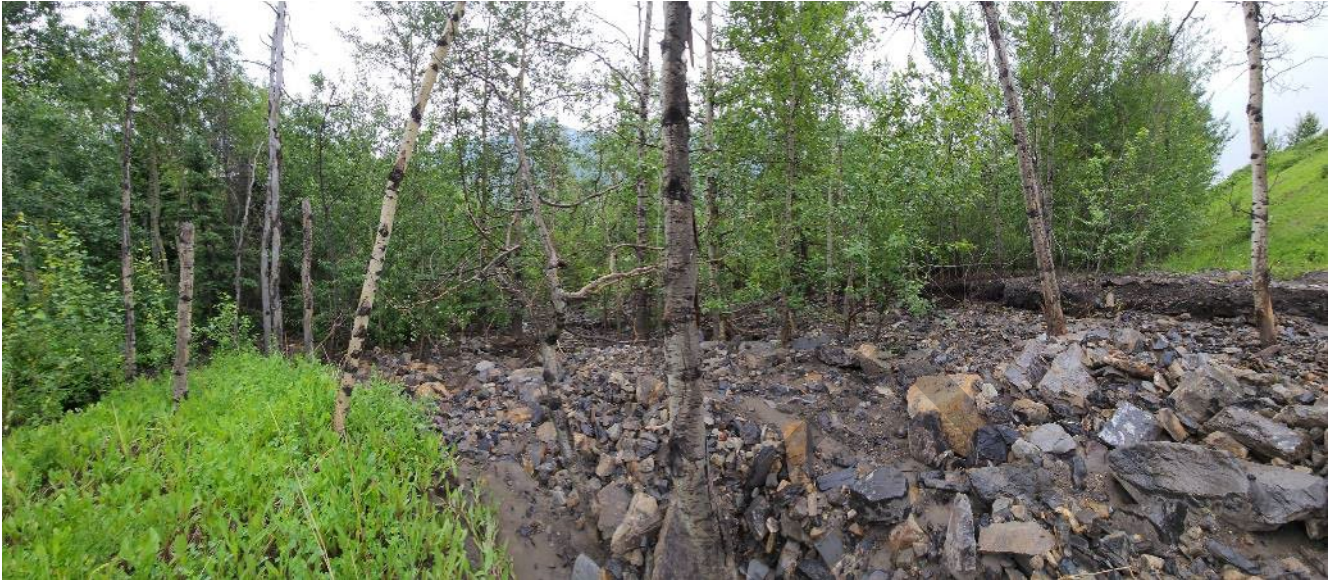
Photo 16 Debris fan through trees. Panoramic photo taken on June 22, 2023, near WP006 facing southeast.

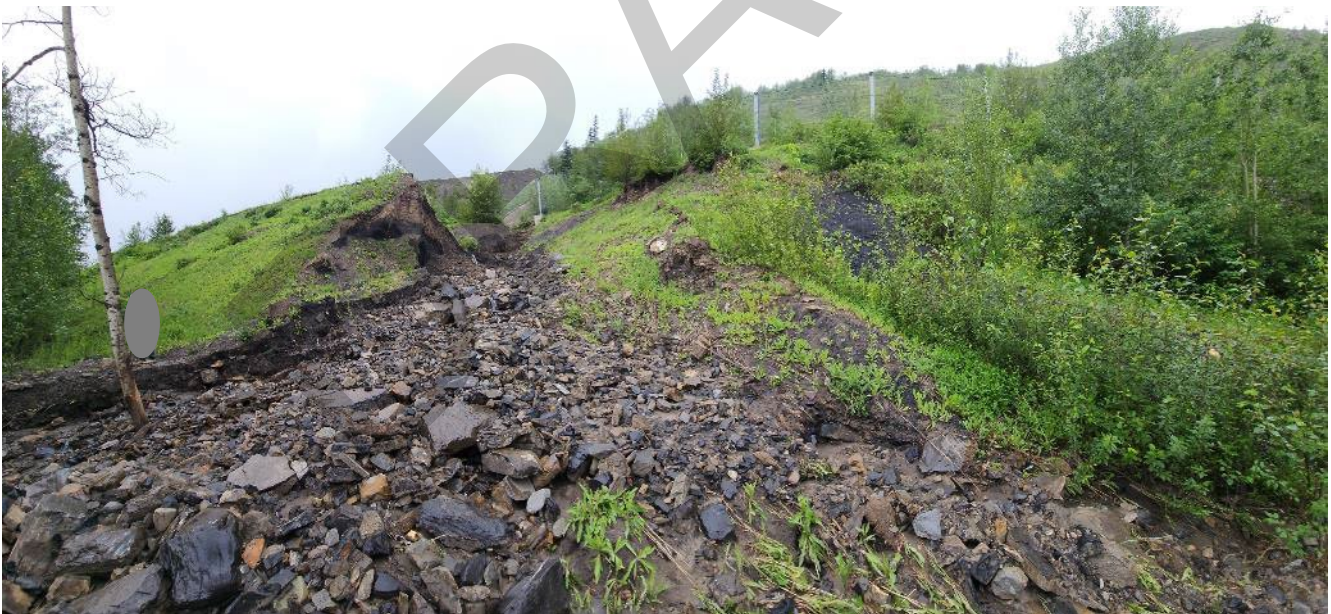
- An approximate 20-m wide by 15-m high section of the lower access road has been eroded at the northeast corner of the mine-waste dump (photos 17 and 18).

Photo 17 Transition between upslope erosion gully and debris fan on west side of highway. Panoramic photo taken June 22, 2023, near WP005 facing southwest.

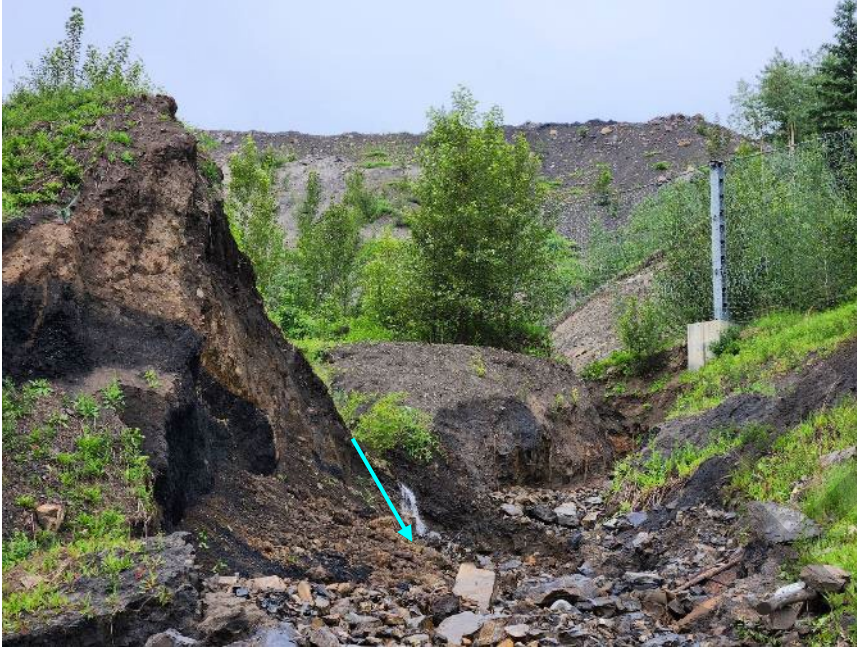
- The entire length of rockfall fence undercut was not visible (obscured by trees and outside TEC's right-of-way), but an approximate 5-m high near-vertical face has been eroded below one of the visible rockfall fence posts (Photo 18). The section of rockfall fence to the north appeared to be in good condition with little to no debris retained behind it (Photo 19).

Photo 18 Rockfall fence partially undermined by erosion. Note water flowing from ponded water at northeast corner of mine-waste dump (indicated with blue arrow). Photo taken June 22, 2023, near WP005 facing southwest.

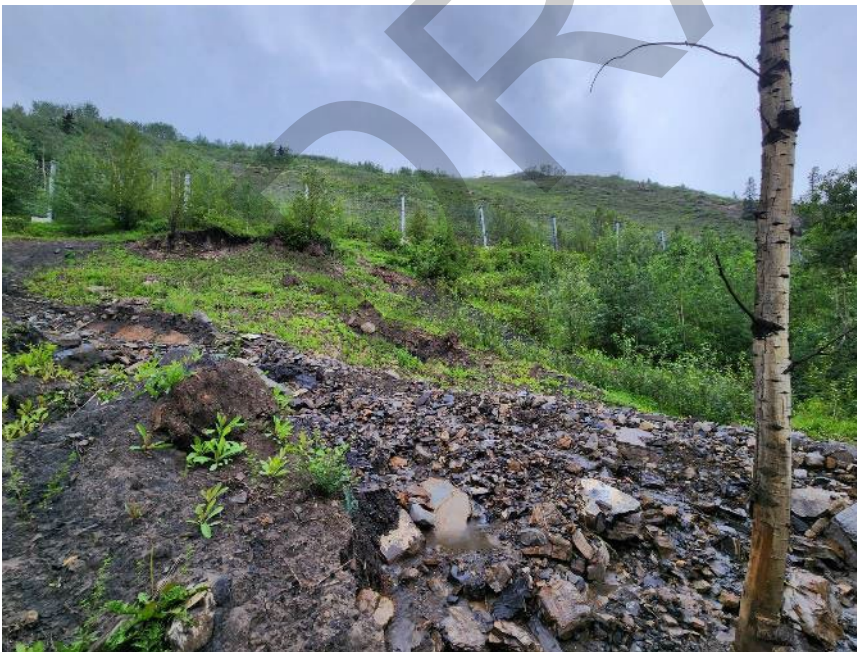
Photo 19 Portion of rockfall fence to north unaffected by erosion gully. Photo taken June 22, 2023, near WP005 facing northwest.

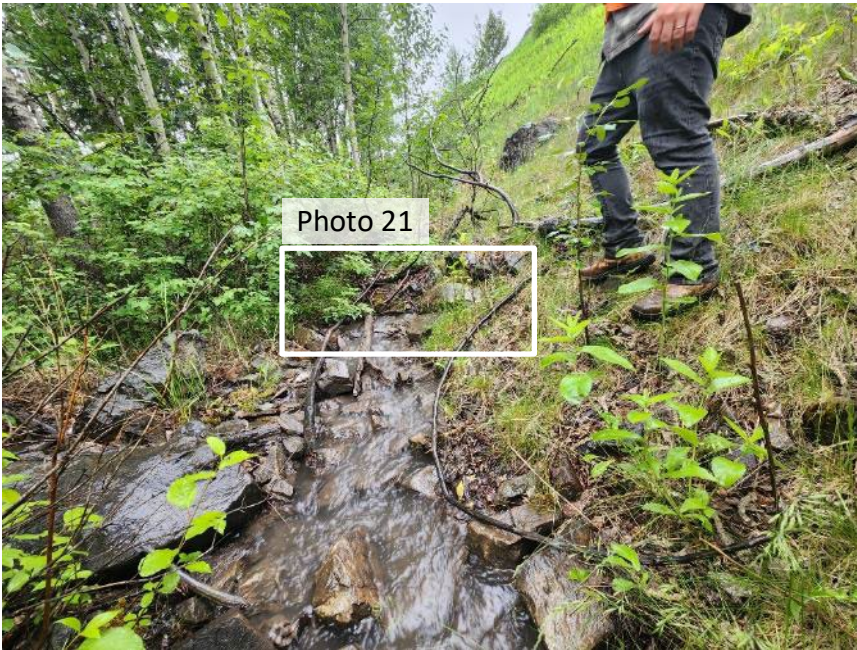
- ◆ The water flowing from the highway backslope near WP009 accounts for approximately 50% of the ditch flow and appears to be flowing from a leakage point located at the downstream toe of the mine slope at WP010 (Photos 20 and 21). Based on the 2012 and 2013 call-out reports prepared by KEC, this maybe the location of a possible drain below the mine-waste dump.

Photo 20 **Flowing water along downstream toe of mine slope at WP010. Photo taken June 22, 2023, facing southwest.**

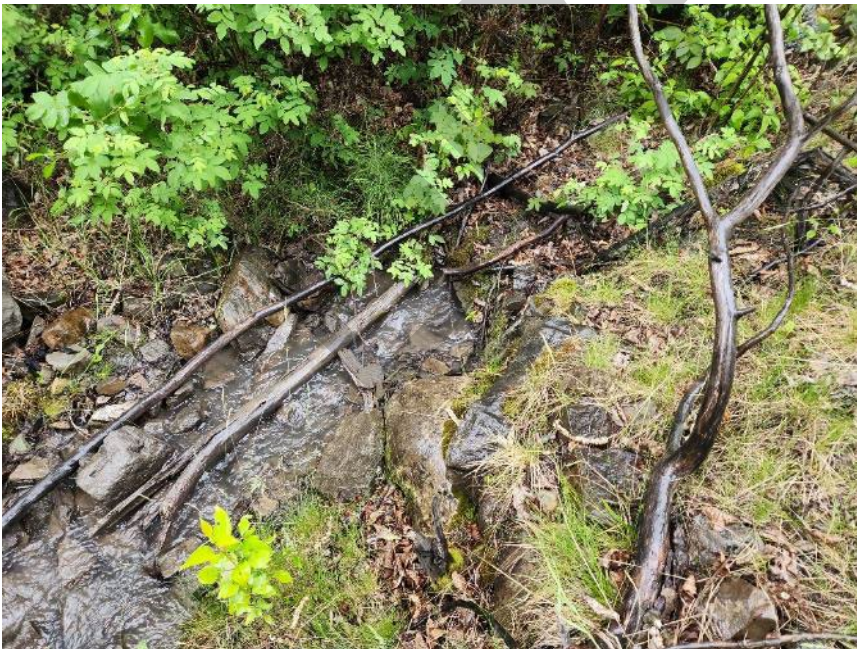
Photo 21 **Flowing water exiting at downstream toe of mine slope at WP010. Photo taken June 22, 2023, facing southeast.**
