Alberta Transportation and Economic Corridors
Main Floor, Provincial Building
9621 96 Avenue
Peace River, Alberta
T8S 1T4

CON0022166 Peace Region (Grande Prairie District – South) GRMP
Hwy 40:36, km 13.700 Debris Flow
Section D – Call-Out Report
Draft

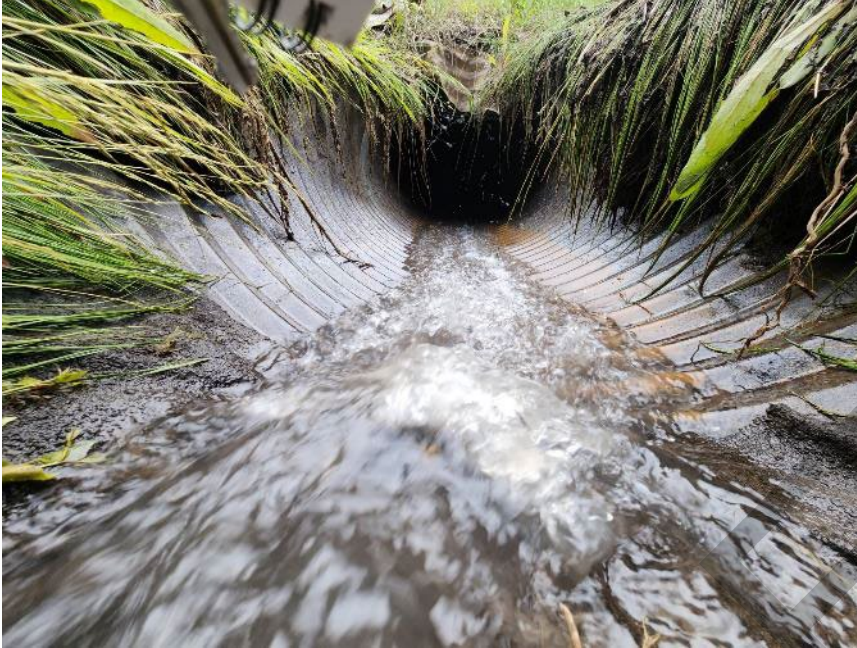
- Water in the west highway ditch flows through a centerline culvert below the highway to discharge downslope adjacent to the railway tracks. The culvert inlet (WP003) (Photos 4, 5, and 22) consists of an approximate 900-mm-diameter piece of corrugated-steel-pipe (CSP), which is dented at the obvert, and the culvert outlet (WP004) (Photo 23) consists of an approximate 900-mm-diameter piece of corrugated-plastic-pipe. Both the culvert inlet and outlet were clear and open.

Photo 22 Inlet of centreline culvert at WP003. Photo taken on June 22, 2023, facing southeast.

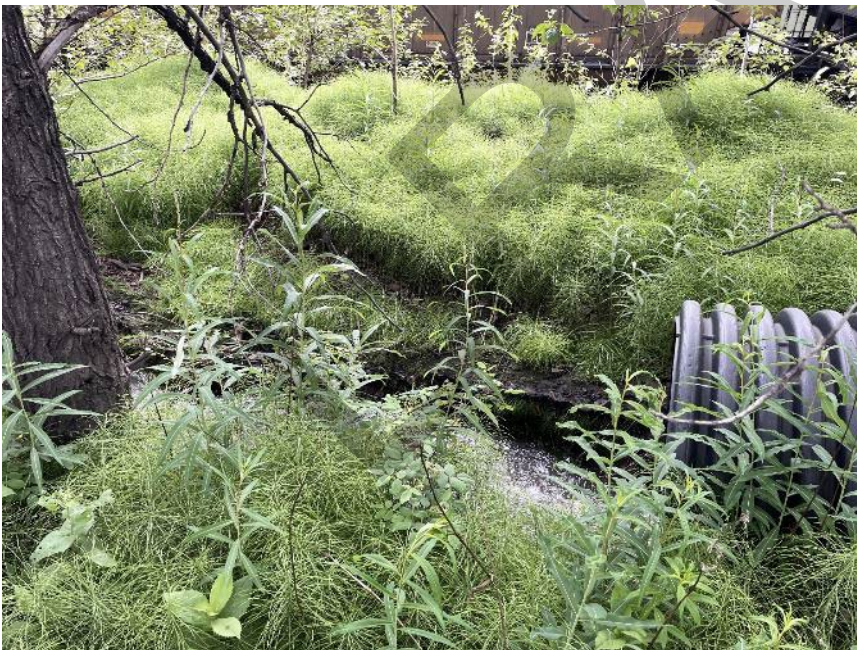
Photo 23 Outlet of centreline culvert at WP004. Photo taken on June 22, 2023, facing east.

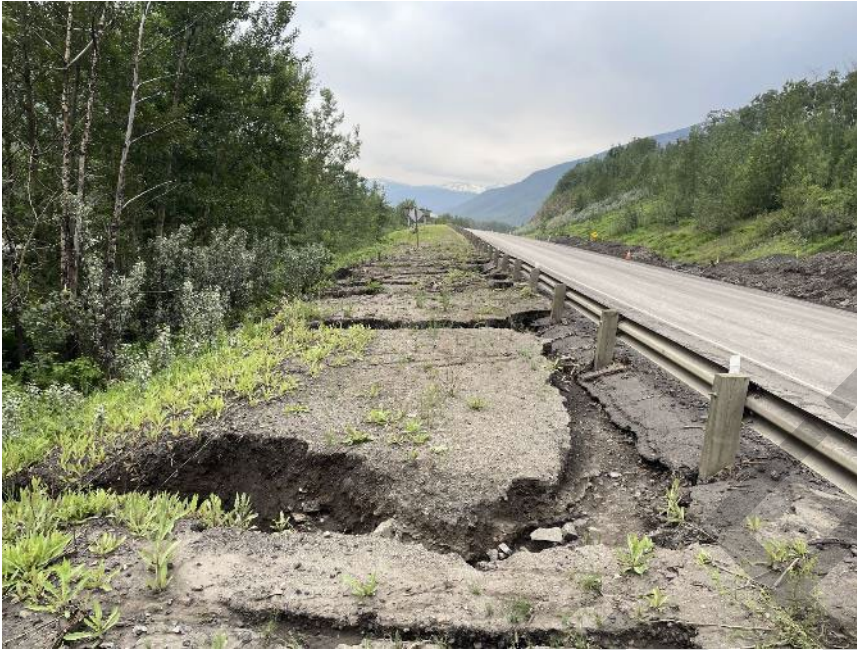
- Surface water overflow across the highway has resulted in erosion gullies along the east side of the highway over an approximate 35-m long section between WP001 and WP002 (Photos 6, 24, and 25). Some of the erosion gullies were up to approximately 2 m wide by 1 m deep. In some locations the pavement subgrade consisting of sand and gravel was exposed, and some of the w-beam guardrail posts were partially undermined up to approximately 0.3 m (Photos 24 and 25). **TEC to confirm if the erosion gullies have already been backfilled.**

Photo 24 Erosion gullies along west side of highway between WP001 and WP002. Photo taken June 22, 2023, facing southwest.

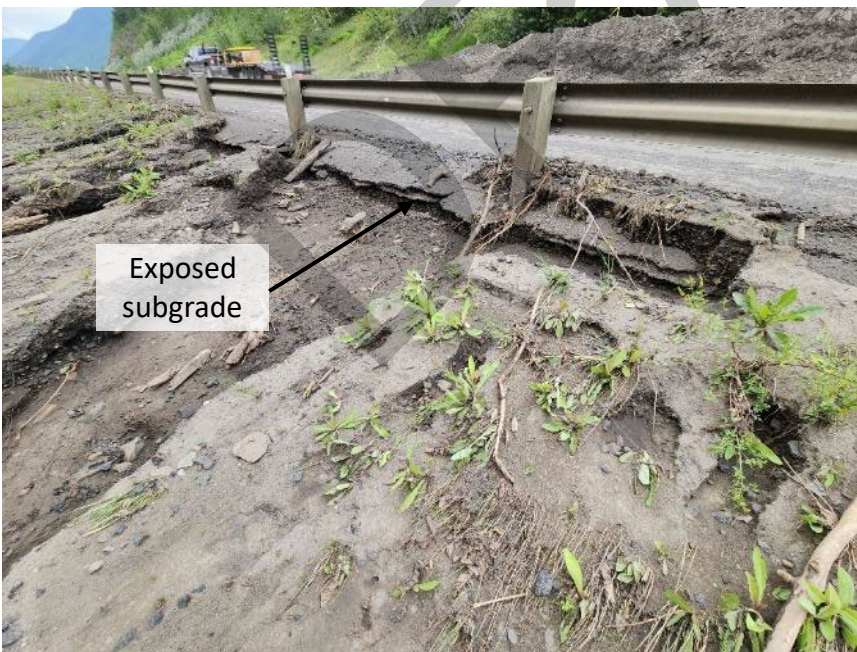
Photo 25 Pavement subgrade exposed along west side of highway, and guardrail posts partially undermined. Photo taken June 22, 2023, between WP001 and WP002 facing southwest.

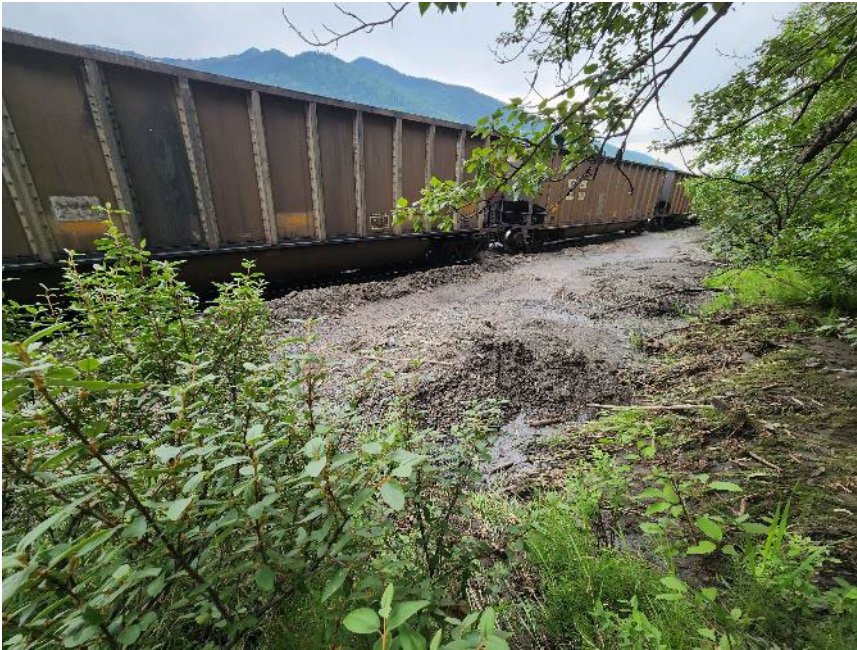
- Debris washed downslope of the site was observed along the CN tracks where a train was parked at the time of the inspection (Photos 4 and 24). A small berm up to 0.3 m high was observed along the track indicating CN has done some clean-up.

Photo 26 Debris along railway tracks. Photo taken June 22, 2023, facing southeast.
