**PEACE REGION  
(GRANDE PRAIRIE DISTRICT – SOUTH) GRMP**

**SITE INSPECTION FORM**

SITE NUMBER AND NAME: <b>NEW SITE Debris Flow near McIntyre Mine</b>		HIGHWAY & KM: 40:36, 13.700	PREVIOUS INSPECTION DATE: June 22, 2023	INSPECTION DATE: <b>June 10, 2024</b>
LEGAL DESCRIPTION: NE 09-58-08-W6M	NAD 83 COORDINATES: UTM Northing Easting 11 5985608 361022		RISK ASSESSMENT: PF: 8 CF: 5 TOTAL: 40	
AVERAGE ANNUAL DAILY TRAFFIC (AADT): 760 (north) & 960 (south) (Reference No. 25592, 2023)			CONTRACT MAINTENANCE AREA (CMA): 504

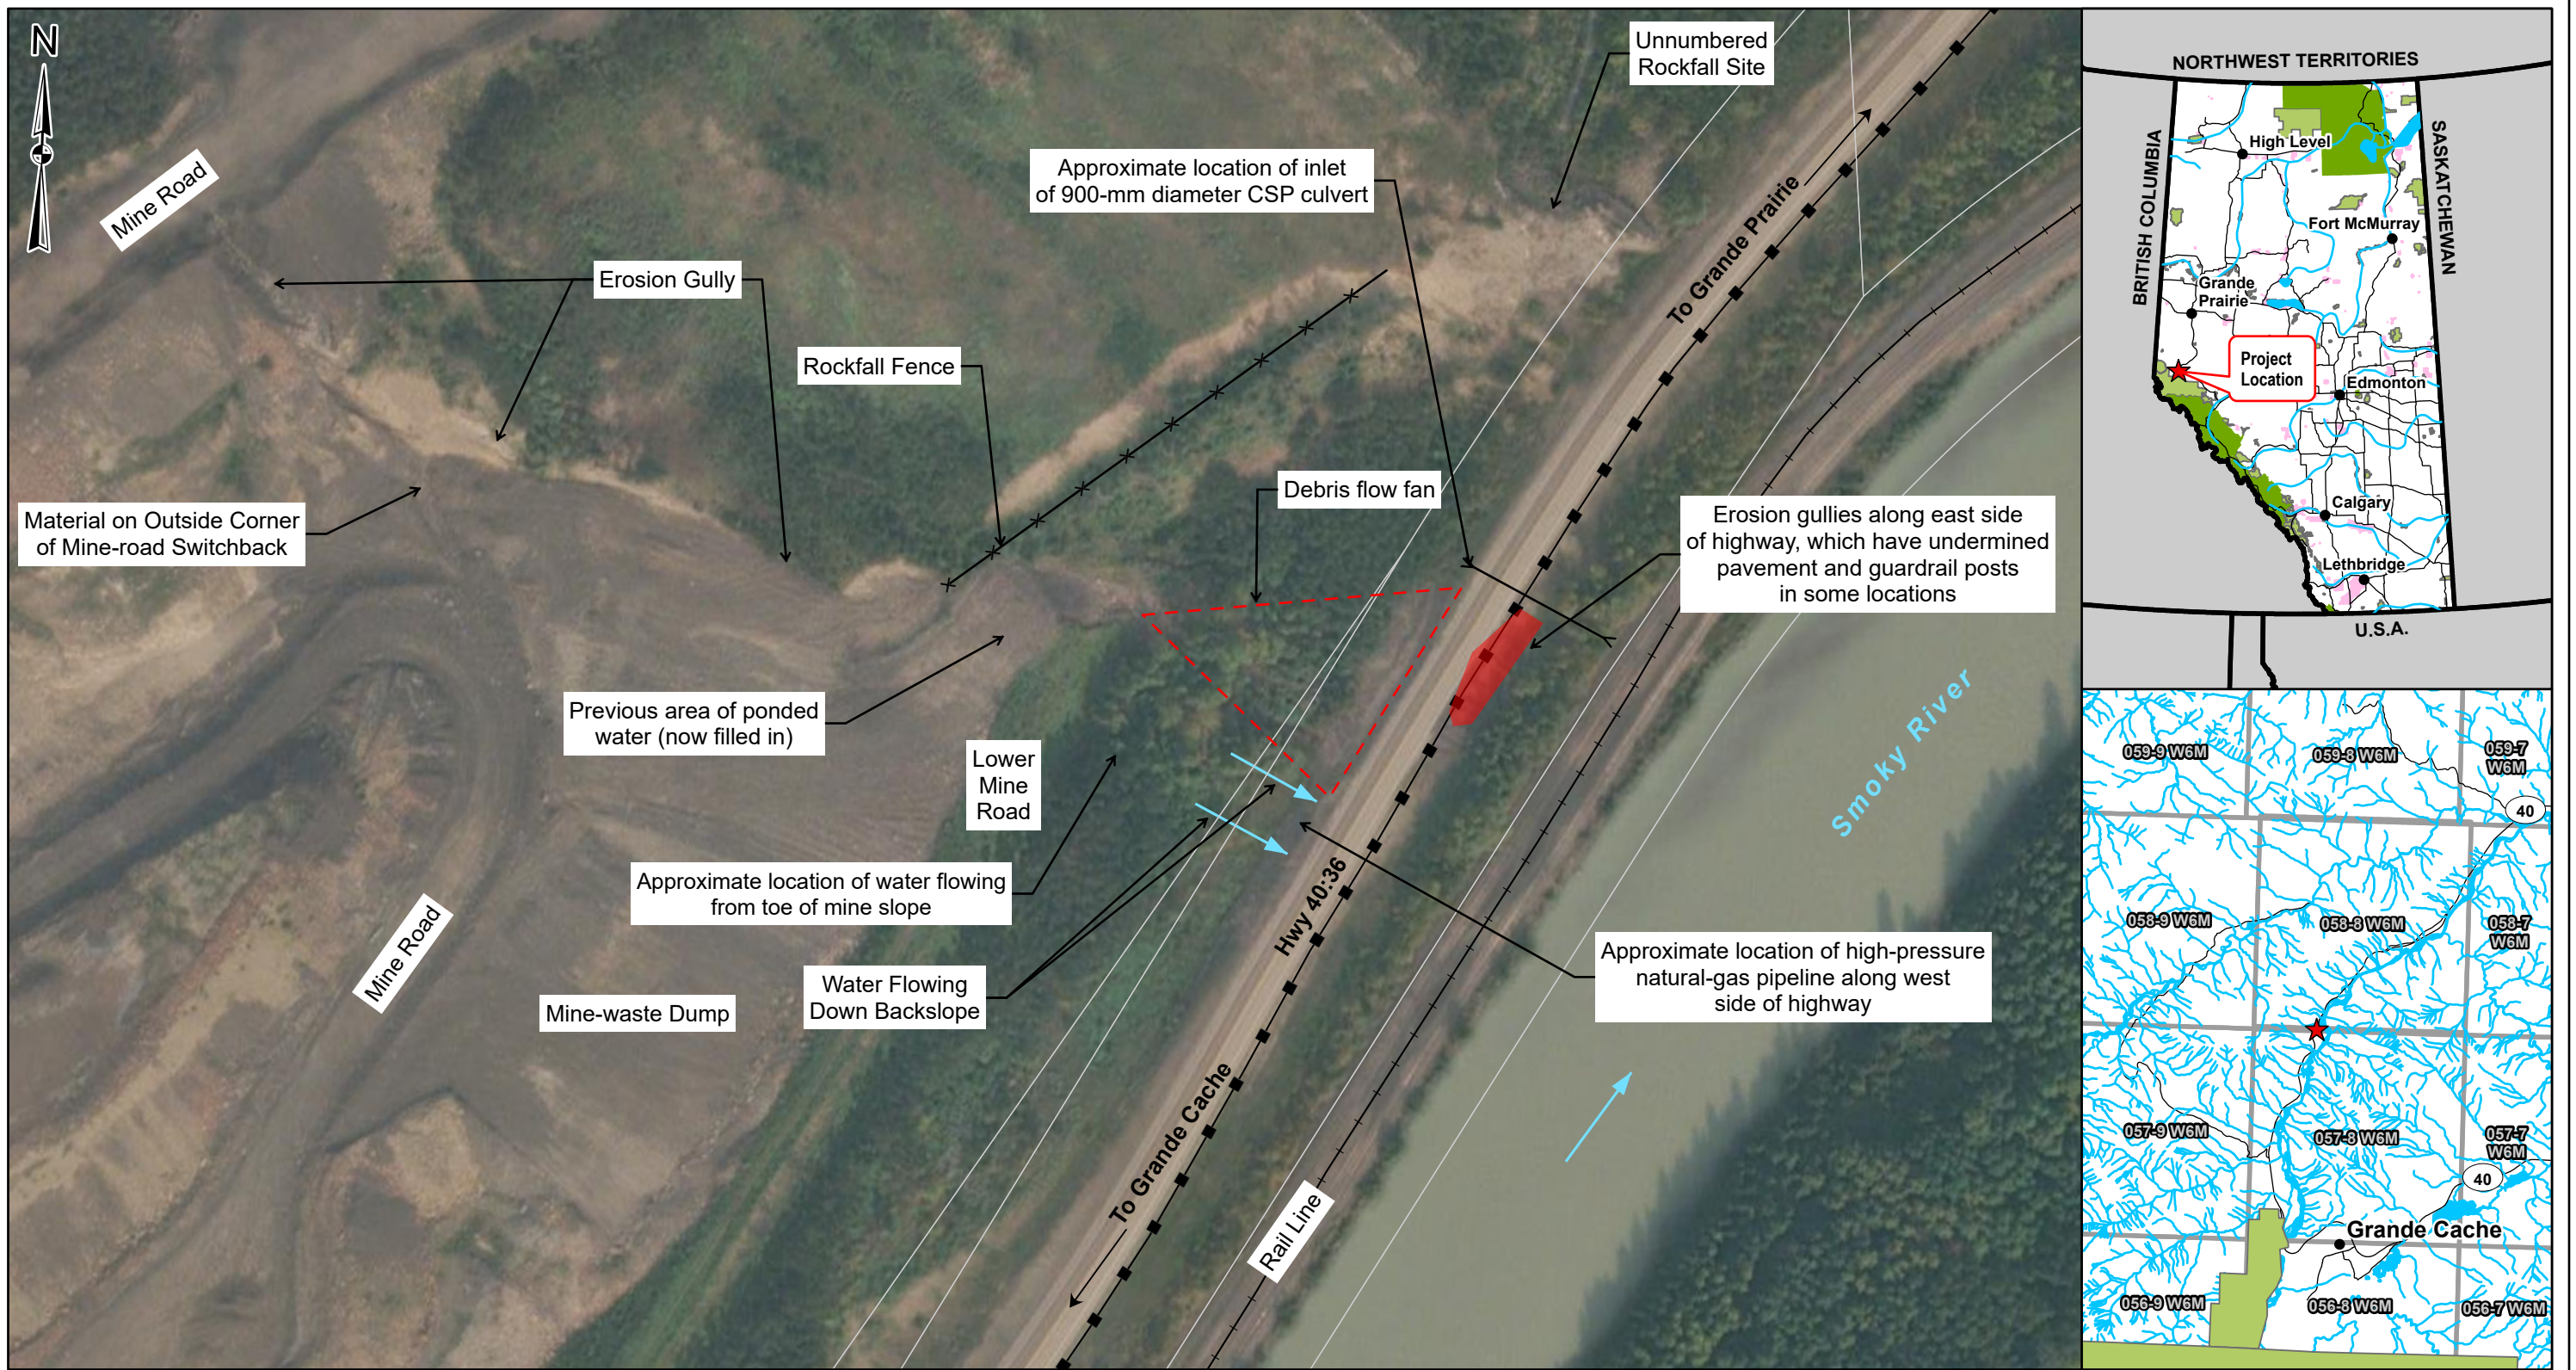
SCALE 1:1,700 PROJECT No. A05116A01 FIG No. 1

TITLE  
 Site Plan  
 New Site - Debris Flow Near McIntyre Mine  
 Hwy 40:36, km 13.7

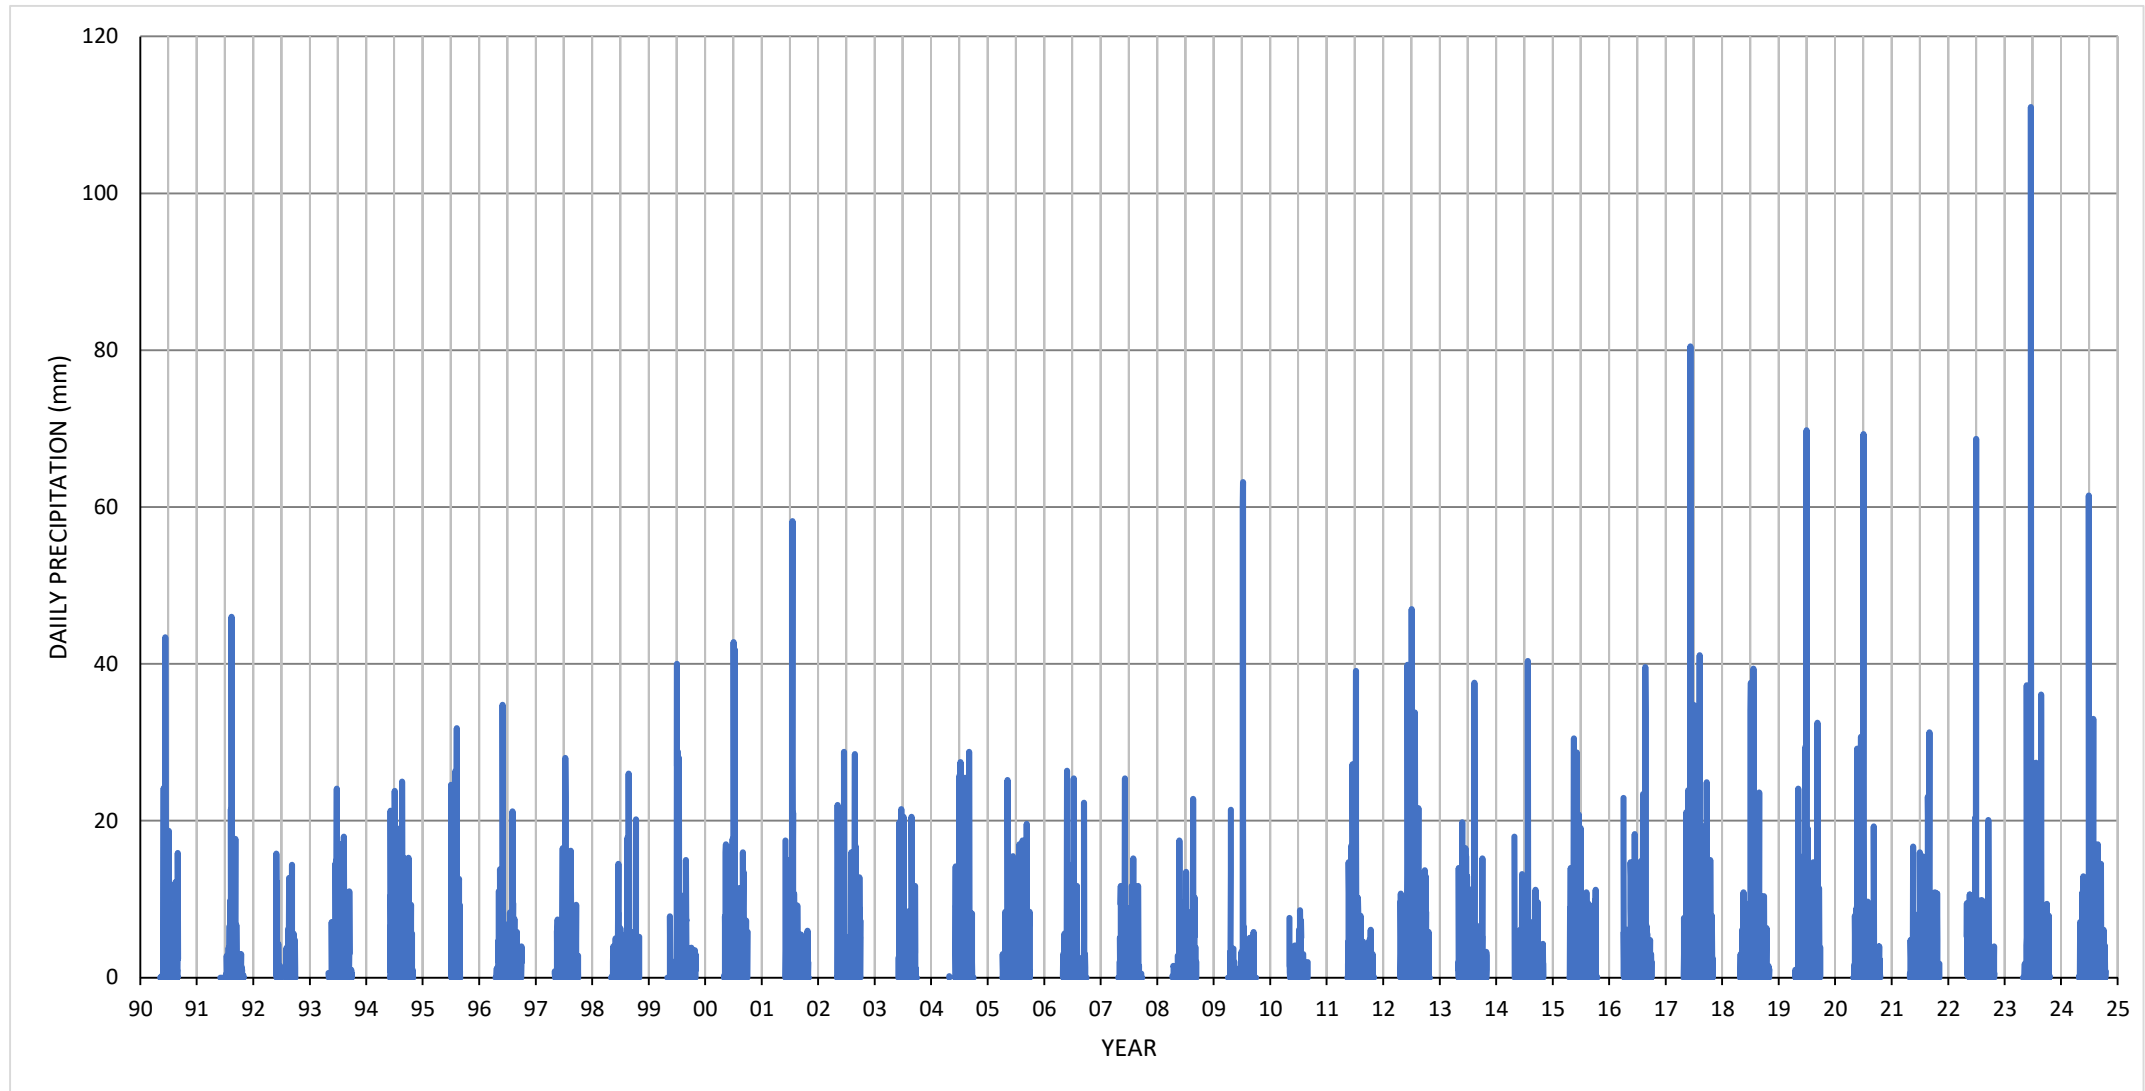
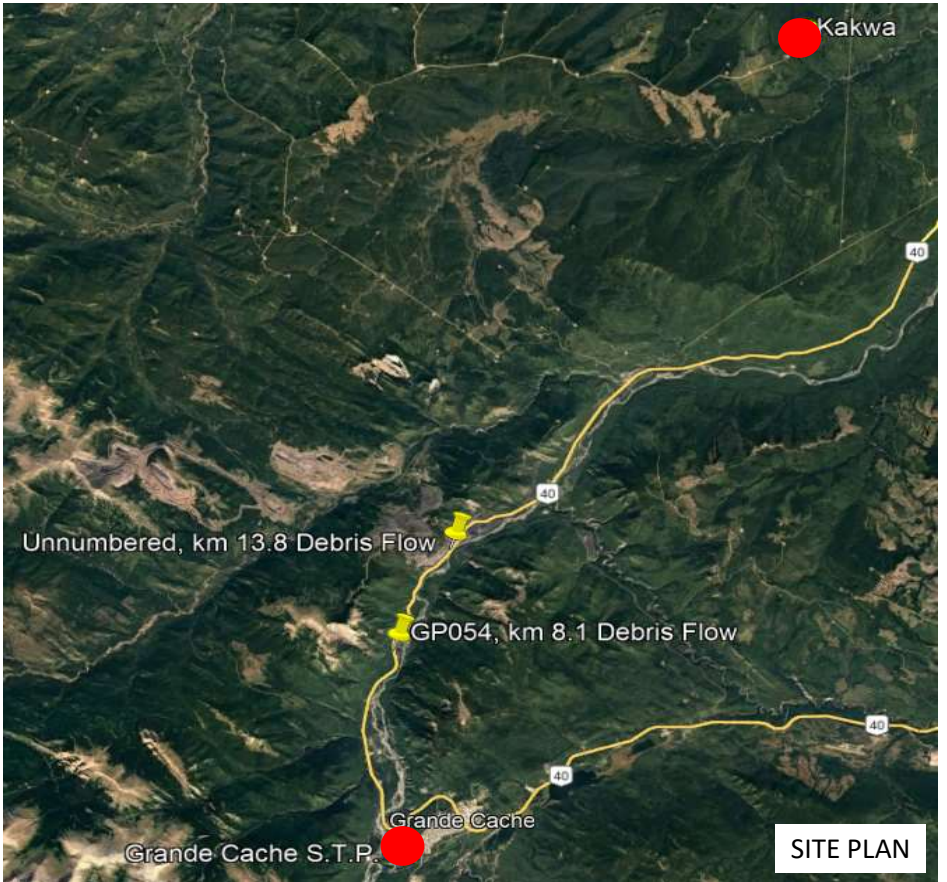
KCB reviewed available precipitation data recorded at Kakwa weather station (located approximately 30 km northeast of site) from 1967 to 2024. Record discontinuous before 1990, but average daily precipitation data from 1990 to 2024 is shown on Figure 2. Based on data from Kakwa weather station higher-than-average rainfall events were recorded on June 9, 2017 (approximately 80 mm), June 28, 2019 (approximately 70 mm), July 1, 2020 (approximately 70 mm), June 29, 2022 (approximately 70 mm), and June 19, 2023 (approximately 110 mm). Based on available data intensity and frequency of heavy precipitation events appears to be increasing in recent years.

CLIENT		PROJECT	
		PEACE REGION (GRANDE PRAIRIE DISTRICT - SOUTH) GEOHAZARD RISK MANAGEMENT PROGRAM	
		TITLE	
		Daily Precipitation Data Debris Flow Site Hwy 40:36	
SCALE	PROJECT No.	A05116A01	FIG No
			2

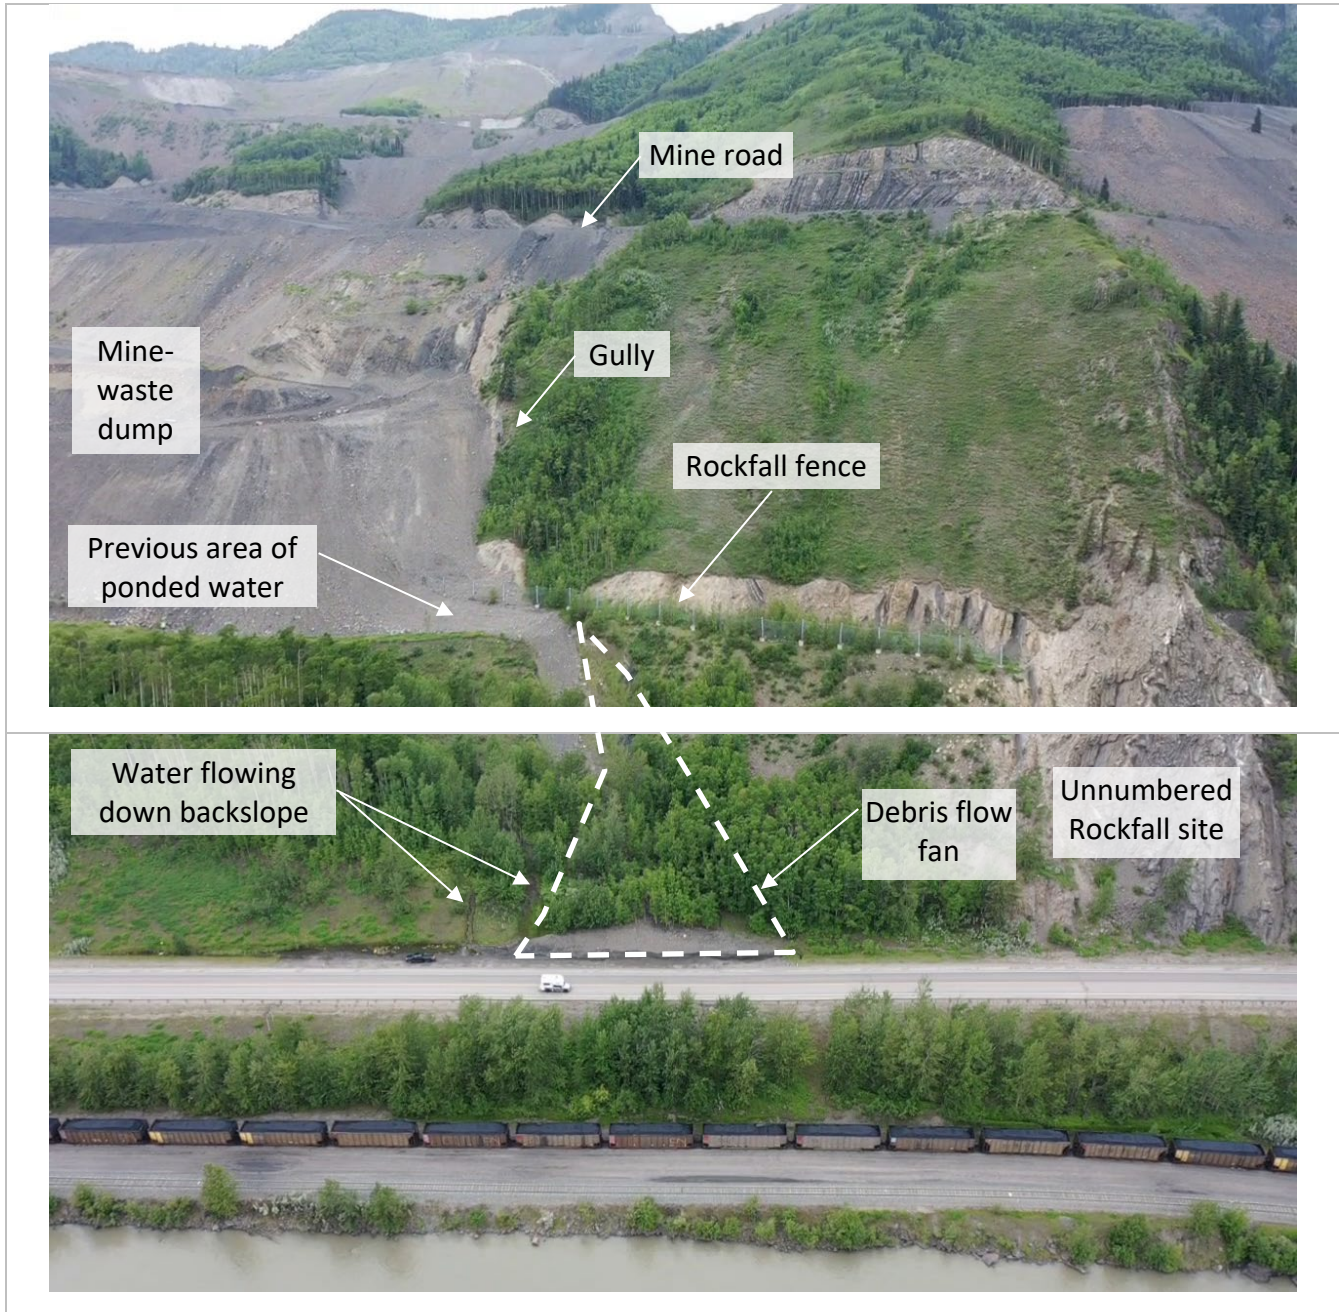
**Photo 1** Overview of debris flow site. Photos taken with Unmanned Aerial Vehicle (UAV) on June 26, 2024, facing northwest.

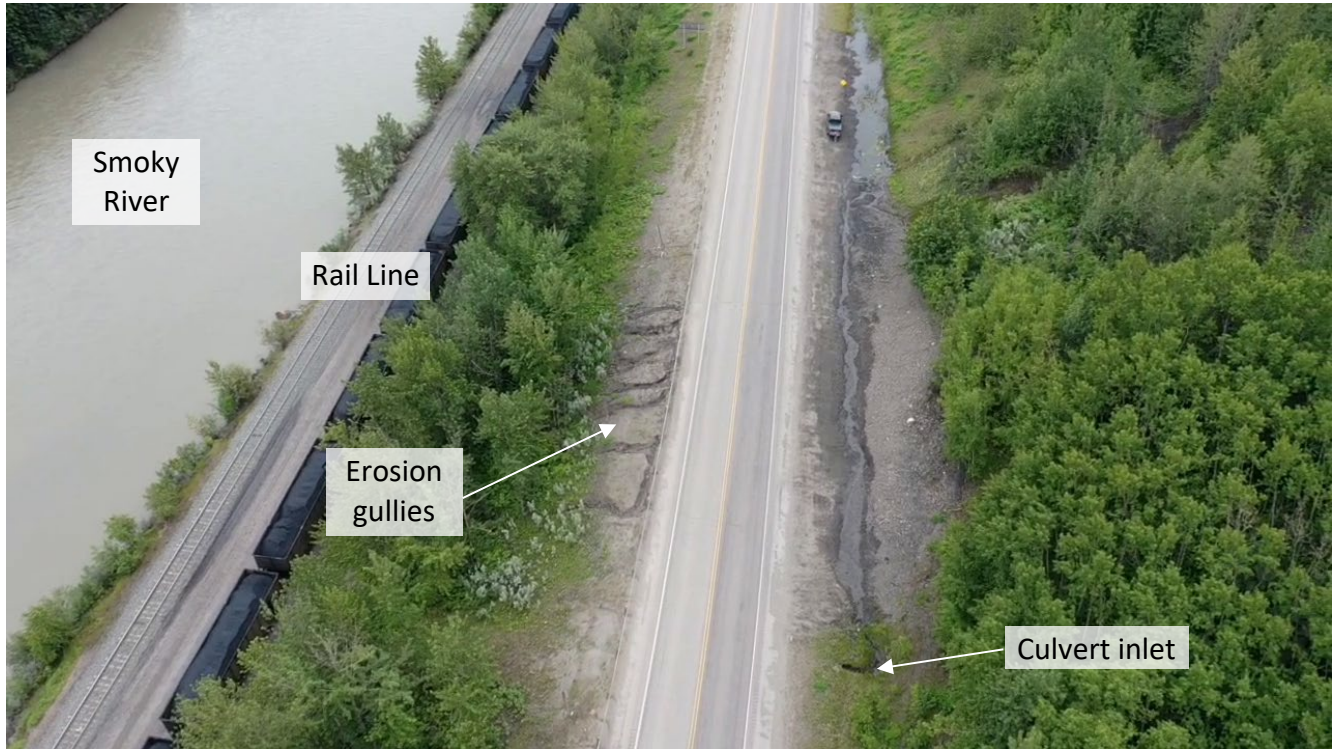
**Photo 2** Overview of debris flow site. Photo taken with UAV on June 26, 2024, facing southwest.

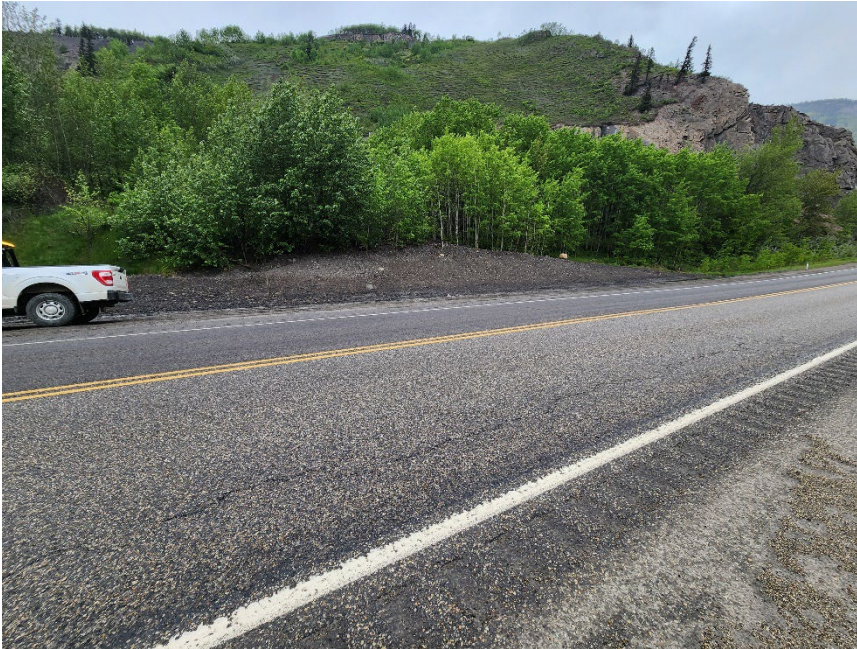
**Photo 3** Debris flow material remaining after clean-up along west side of Hwy 40:36. Photo taken June 11, 2024, facing northwest.

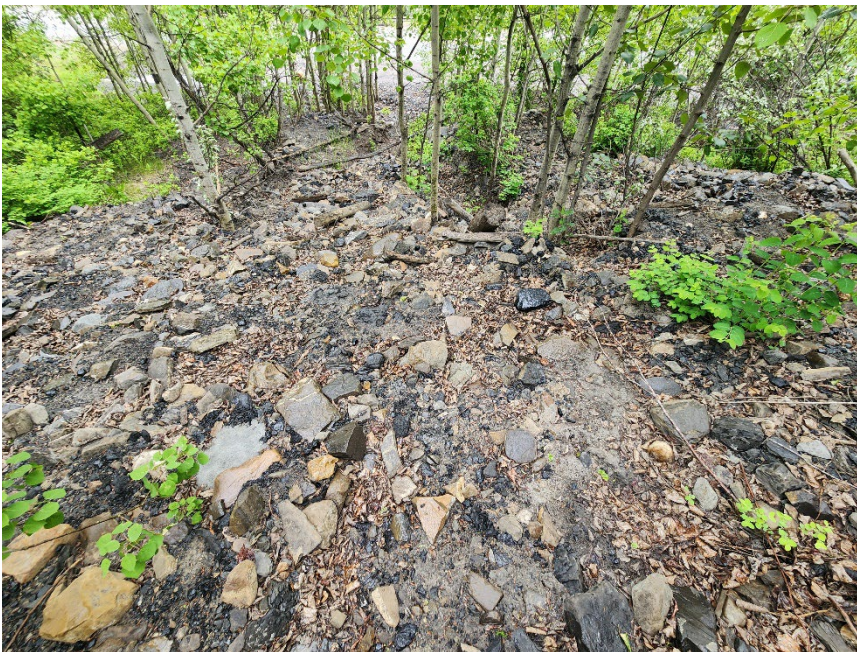
**Photo 4** Debris flow material within trees on west side of Hwy 40:36. Photo taken June 11, 2024, facing southeast.

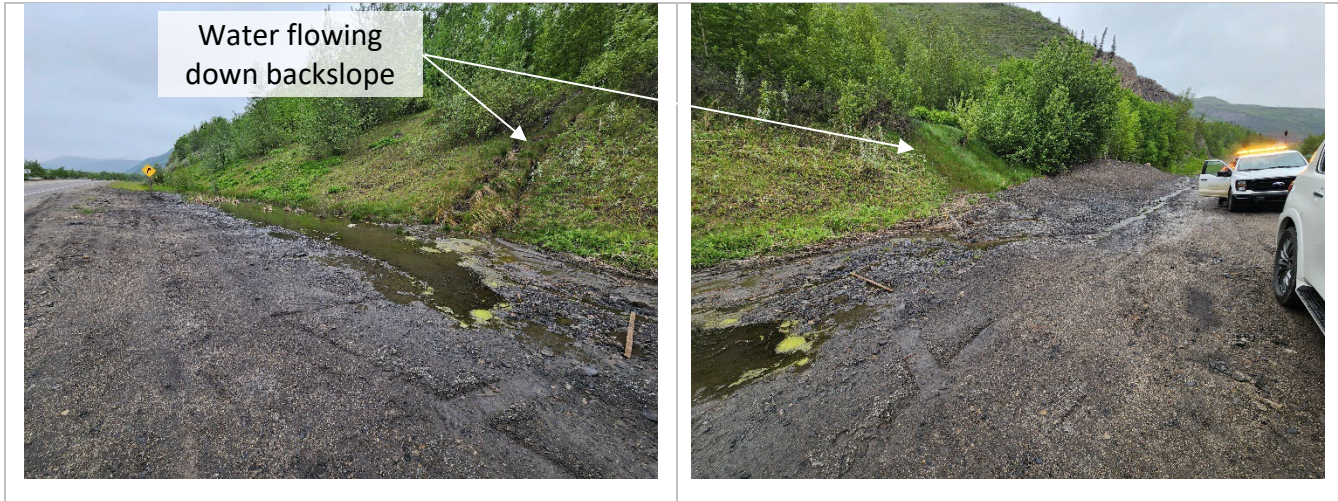
**Photo 5** Water flowing down backslope on west side of Hwy 40:36. Photos taken June 11, 2024, facing southwest and northeast, respectively.

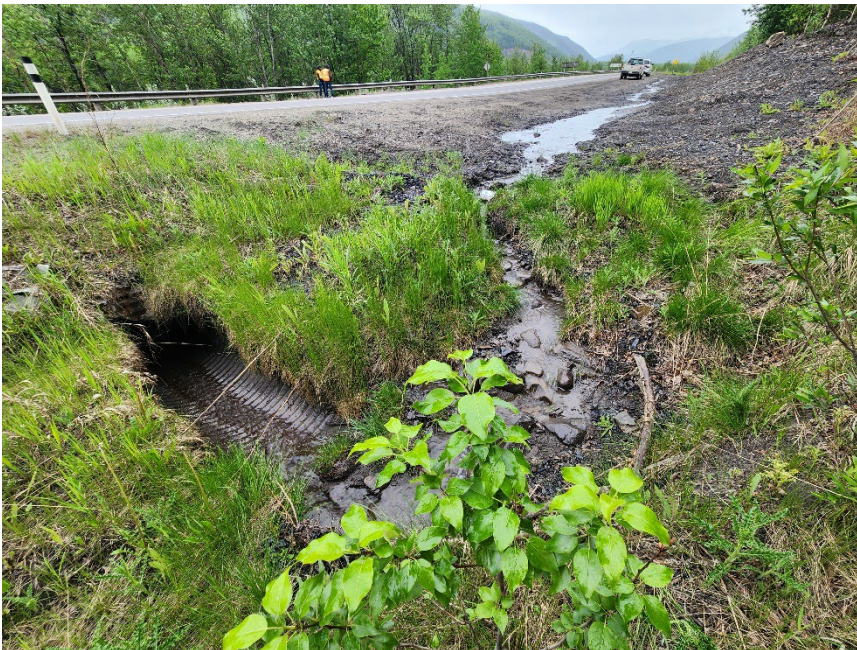
**Photo 6** Inlet of culvert that conveys flow from west side to east side of Hwy 40:36. Photo taken June 11, 2024, facing south.

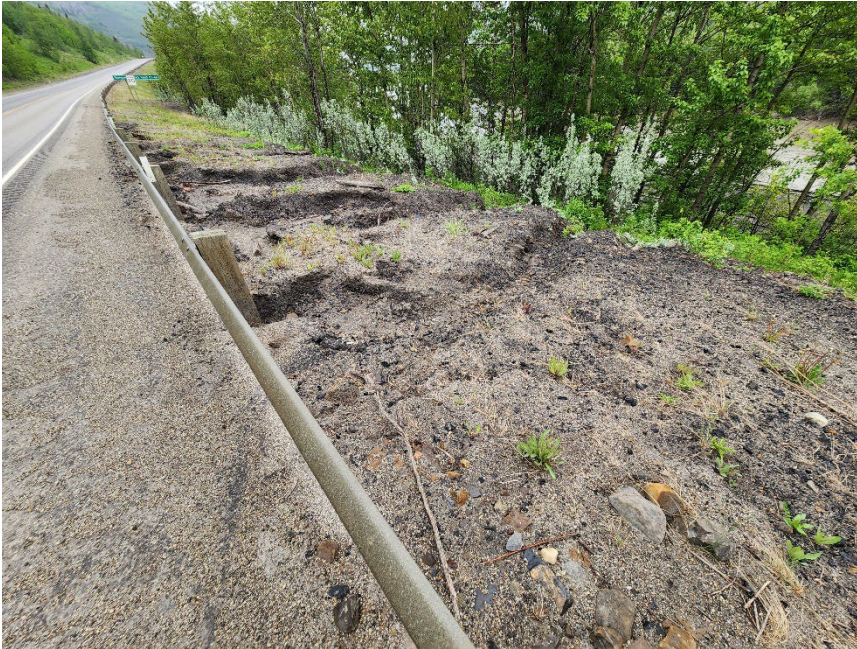
**Photo 7** Erosion gullies along east side of Hwy 40:36. Photo taken June 11, 2024, facing northeast.

- Short-term:
  - Debris flows crossing highway have eroded channels on east side of highway, partially exposing highway subgrade, partially undermining pavement, and leaving some w-beam guardrail posts unsupported along east highway shoulder. The erosion gullies on the east side of the highway should be backfilled to provide support to the highway pavement, subgrade, and guardrail posts where exposed. The estimated cost for the HMC to complete this work is between \$20,000 and \$40,000.

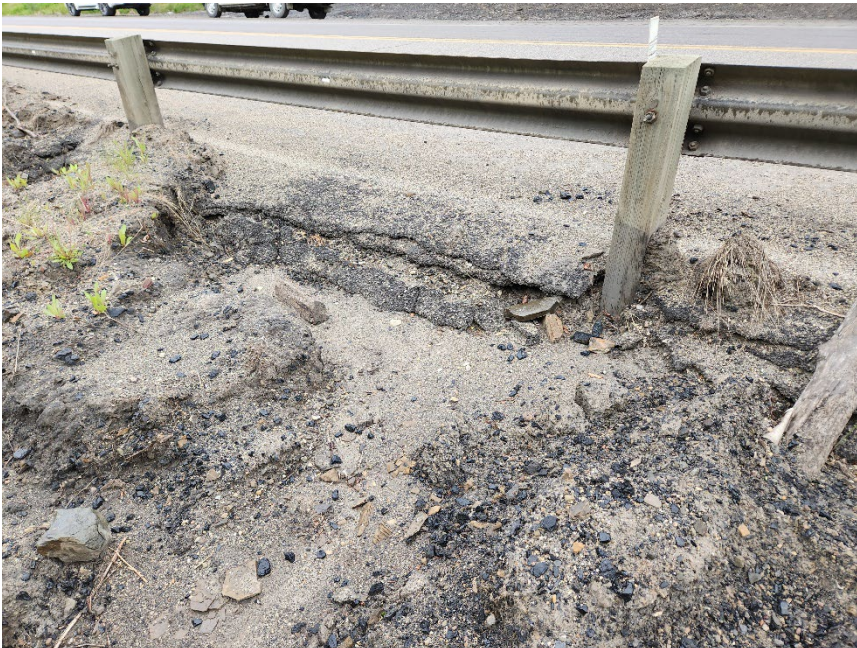
ITEM	CONDITION EXISTS		DESCRIPTION AND LOCATION	NOTICABLE CHANGE FROM LAST INSPECTION	
	YES	NO		YES	NO
Pavement Distress	X		Subgrade exposed and pavement partially undermined on west south side of highway due to erosion (Photo 8).		X
Slope Movement		X	None observed at time of 2024 inspection.		X
Erosion	X		Debris flow material/fan along west side of highway (approximately 110 m long) (Photos 1 to 4). Erosion gullies on east side of highway (approximately 35 m long) (Photos 2 and 7), which appear deeper and wider since previous inspection.	X	
Seepage	X		Seepage from toe of mine-waste dump flows through treed area down backslope into west highway ditch, which flows to culvert at north end of site across highway (Photos 1, 5, and 6). Seepage location may be a possible drain below mine-waste dump.		X
Culvert Distress		X	None observed at time of 2024 inspection (Photo 6).		X

**Photo 8** Subgrade exposed and edge of pavement partially undermined on east side of Hwy 40:36. Some guardrail posts also unsupported. Photo taken June 11, 2024, facing west.
