CON0022166 Peace Region (Grande Prairie South) GRMP
Hwy 40:36 rockfall, km 8.395 to 17.161
Call-Out Report

1 INTRODUCTION

As part of the Geohazard Risk Management Program (GRMP) contract for the Grande Prairie South region, Klohn Crippen Berger Ltd. (KCB) was requested by Alberta Transportation (AT) to conduct a call-out inspection for rockfalls along multiple GRMP sites along Hwy 40:36 between km 8.395 to km 17.161. The site is located on the west side of Hwy 40 with the south limit of the call-out area being approximately 8 km north of Grande Cache, Alberta. The call-out area includes the GP049, GP036, an un-numbered site near a rockfall fence erected by a third party, and the newly (in 2022) created GP053 (formerly part of GP008A) GRMP rock slope sites.

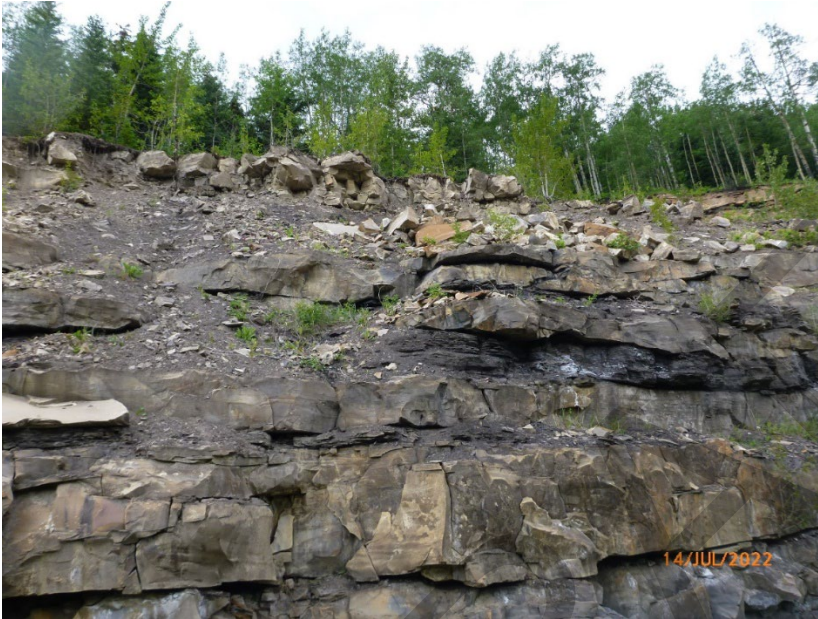
- At the south end of the slope (Photo GP049-I-1) the rock slope below the bench (4 to 8 m above the highway is deteriorating to an approximate 45°-degree slope with several pieces overhanging. The formation of a scree (sand and gravel surfacing on the rock slope has obscured the type of bedrock that is weathering) might be allowing energy dissipation for some rockfall blocks to be attenuated, but some particles (non-"platy" particles) are rolling off the slope and down into the ditch.

Photo GP049-I – 1 Rock mass at GP049-I site is has near horizontal bedding planes. Brow of rock slope has overhanging blocks that should be scaled. Photo taken July 14, 2022, facing west.

- ◆ *The slope could be scaled to remove loose particles.*
- Rockfall particles were observed within 1 m of the edge of pavement (Photo GP049-I-2). There are some rockfall particles in the ditch but the ditch bottom is not blocked yet.

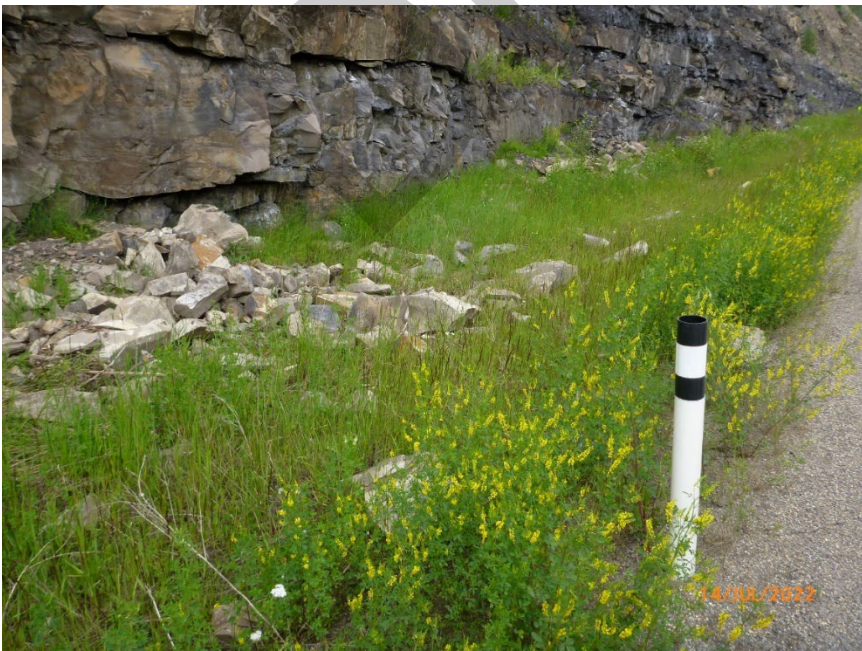
Photo GP049-I – 2 Rockfall in ditch has reached the edge of the highway. Photo taken July 14, 2022, facing northwest.

- ◆ *The ditch should be cleaned of rockfall particles, scree, and talus.*
- Not all of the upper slope above the mid-slope bench could be viewed from the highway, but it appears in the drone videos taken in spring 2022 to be of similar quality to the rest of the upper slope. Overhanging blocks of bedrock and loose particles were visible in the upper slope (Photo GP049-I-3). The upper slope appeared to be a dilated, weak rock mass.

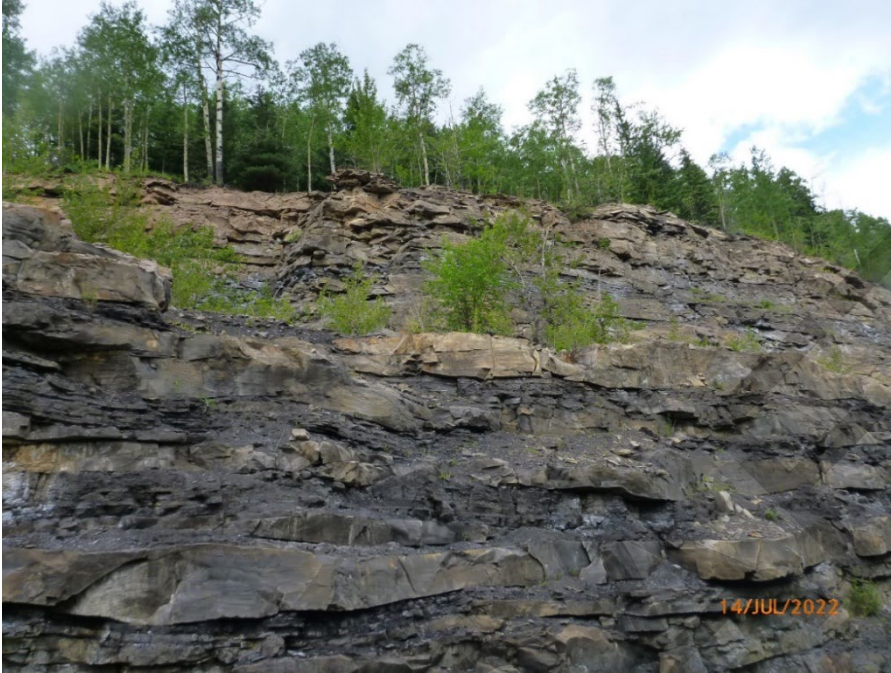
Photo GP049-I – 3 Higher portion of rock slope above mid-slope bench sparsely vegetated with small trees. Note overhanging blocks on upper slope above bench that should be scaled. Photo taken July 14, 2022, facing west.

- ◆ *The upper rock slope should be scaled to remove loose particles. However, we believe the entire rock slope will continue to deteriorate so regular scaling will be required in the future. An attenuation drape (i.e., fine mesh covering of the slope) would confine the path of rockfall and dissipate energy through drape friction and promoting contact with the rock slope.*

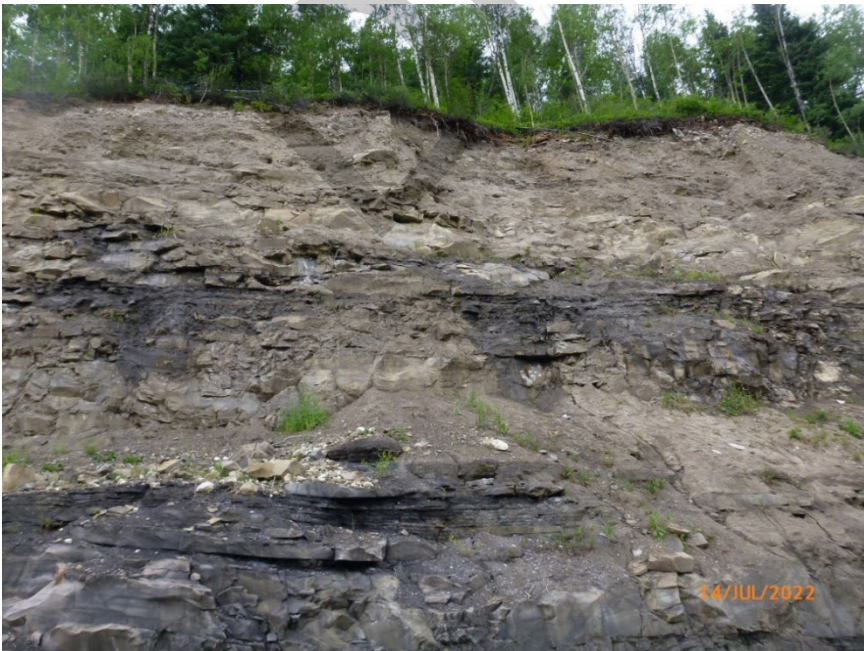
- Soil is exposed at the brow of the slope (Photo GP049-I-4) and appears to be a till material that contains cobbles and boulders which presents additional rockfall hazards.

Photo GP049-I – 4 Soil at brow of slope at north end of -I site contains cobbles and rock mass looks reasonably competent. This location could be addressed with an attenuating drape. Photo taken July 14, 2022, facing west.

- ◆ *An attenuation drape could mitigate the rockfall hazard from the soil at the brow of the slope.*

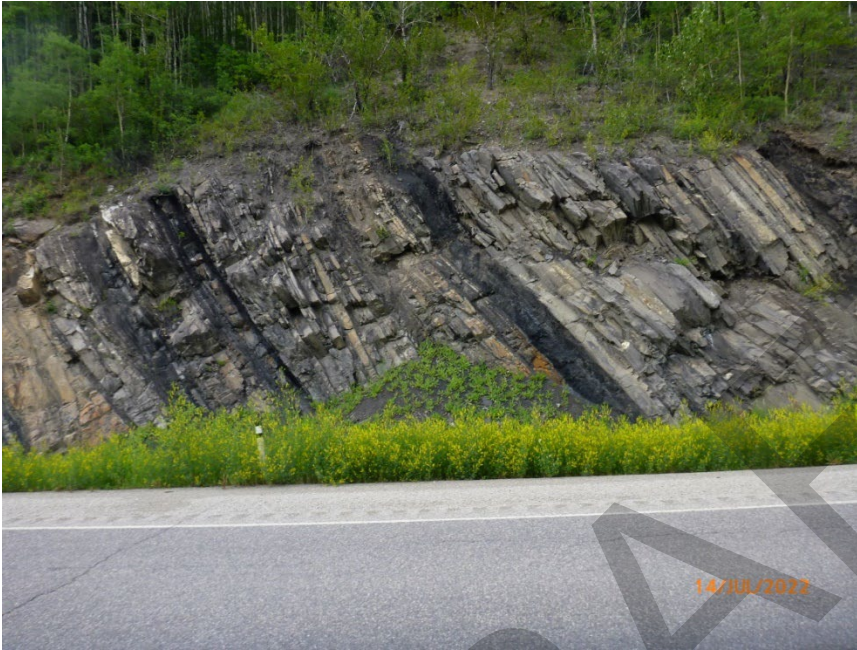
Photo GP049-II – 1 Rock mass structure is different than at GP049-I site (inclined bedding, 45° to 60°), 400 m to the north of the GP049-I site. Photo taken facing west on July 14, 2022.

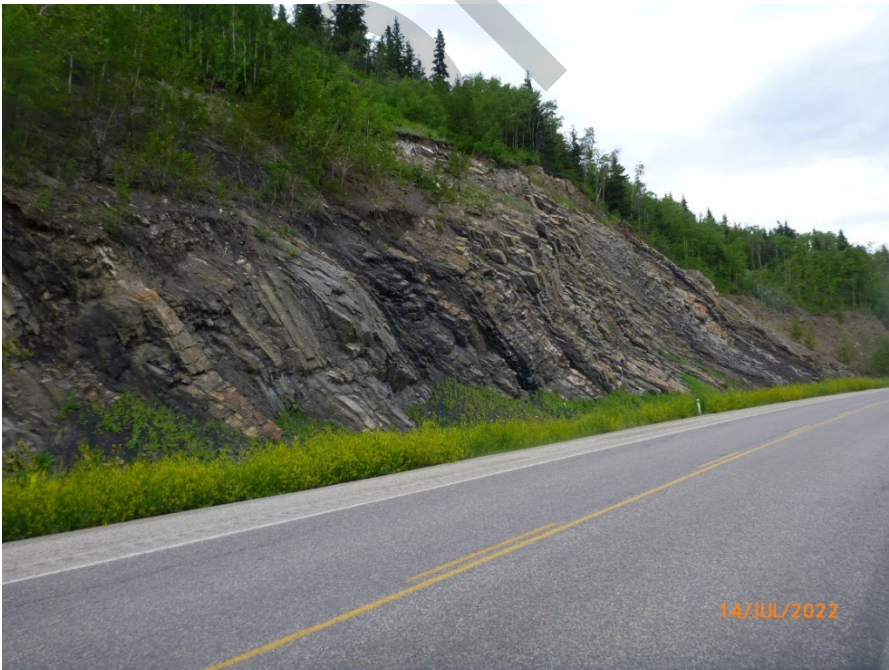
Photo GP049-II – 2 Higher rock slope at north end of GP049-II site. Some overhanging particles where inclined bedding planes have been undermined by historical rock falls or construction blasting. Photo taken facing northwest on July 14, 2022.

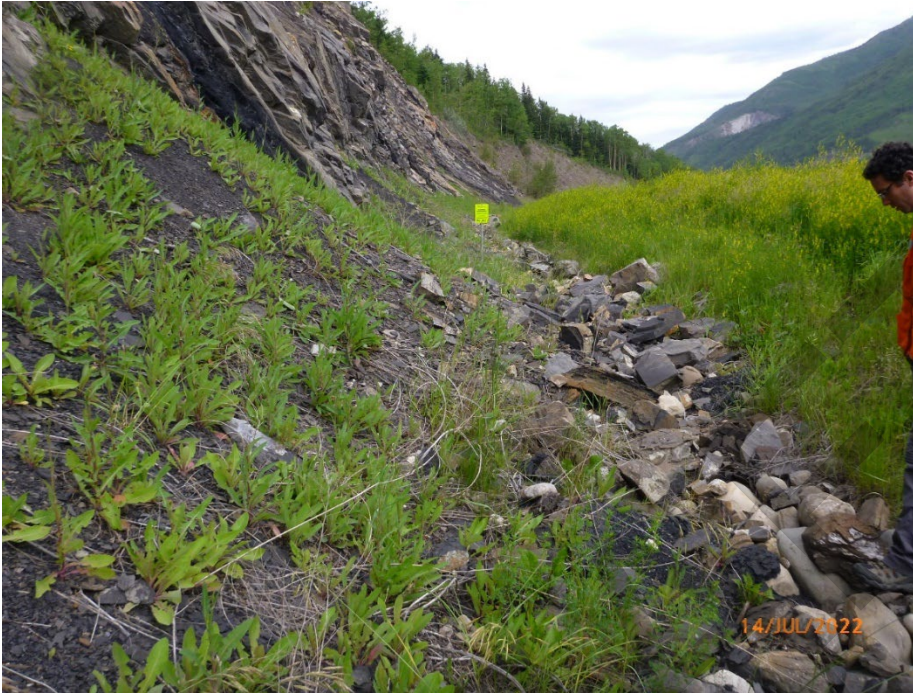
- The coal seams appear to be weathering faster than the adjacent bedrock seams which causes undermining of the overlying bedrock which then generates rockfall (Photo GP049-II-3 and -4). The talus slopes of deteriorated coal and fine-grained particles allows some rockfall particles to roll to the toe of the talus slope and up the highway slope towards the pavement.

Photo GP049-II – 3 Ditch at GP049-II is approximately 10 m wide and 1.5 m deep and appears to be containing most rock fall particles. Tall vegetation obscures seeing rockfall particles near edge of pavement. Note buried pipeline marker in ditch. Photo taken facing north on July 14, 2022.

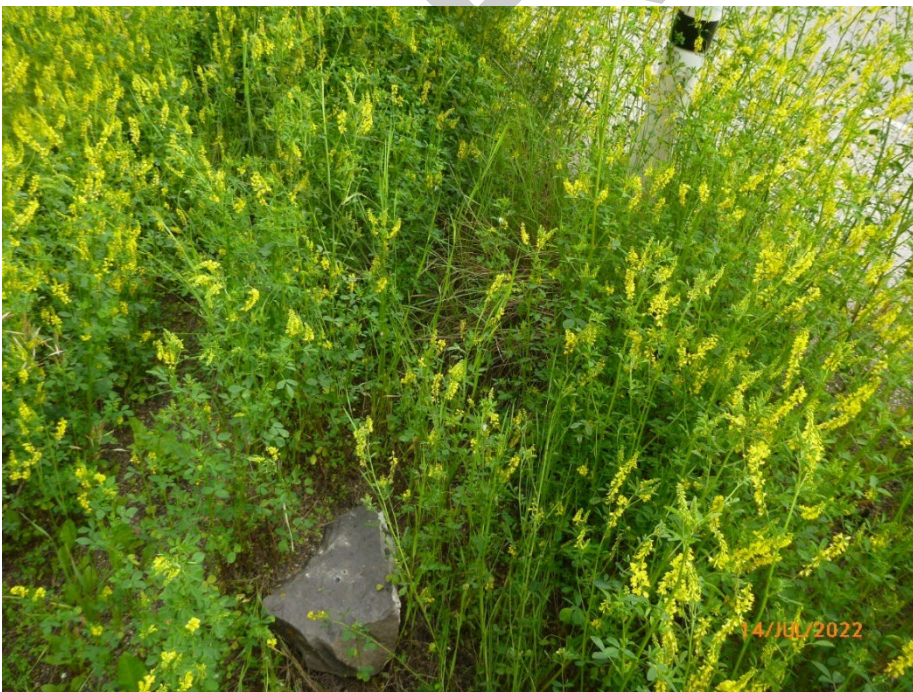
Photo GP049-II – 4 One of three observed rockfall particle 0.3 m x 0.2 m x 0.1 m located within 1.0 m from edge of pavement.

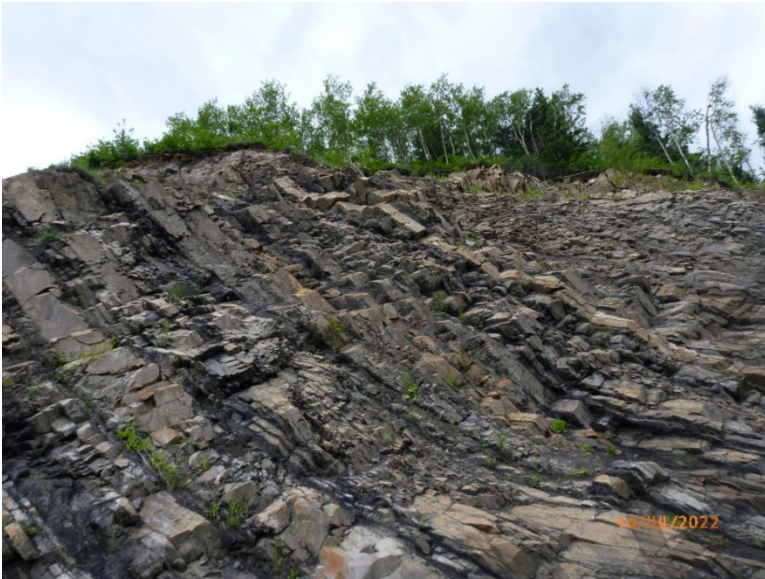
- The orientation of bedding planes and the orientation of the slope is such that weathering of more fractured and thinly bedded layers of bedrock lead to undermining of more competent, thicker layers of bedrock, creating potential for future rockfall events (GP049-II-5).

Photo GP049-II – 5 Undermining of more competent bedrock layers created by weathering and erosion of less competent bedrock layers creates rockfall hazard on the entire slope. One source of rockfall blocks is located near brow of slope, located above a large rockfall block (1.2 m x 1.2 m x 0.3 m) located 3 m from pavement edge. Brow of slope has bedrock that has dilated joints and potential for large blocks of rock to detach. Photo taken July 14, 2022, facing west.

- ♦ *The slope should be scaled to remove the hazard posed by loose particles that could become future rockfall events.*
- The brow of the slope at its highest point appears to be bedrock with more widely spaced discontinuities with dilated joints, with potential to generate rockfall events. This part of the slope is immediately above where a rockfall particle 1.2 m x 1.2 m x 0.3 m was located within 1.0 m of the edge of pavement (Photo GP049-II-5)

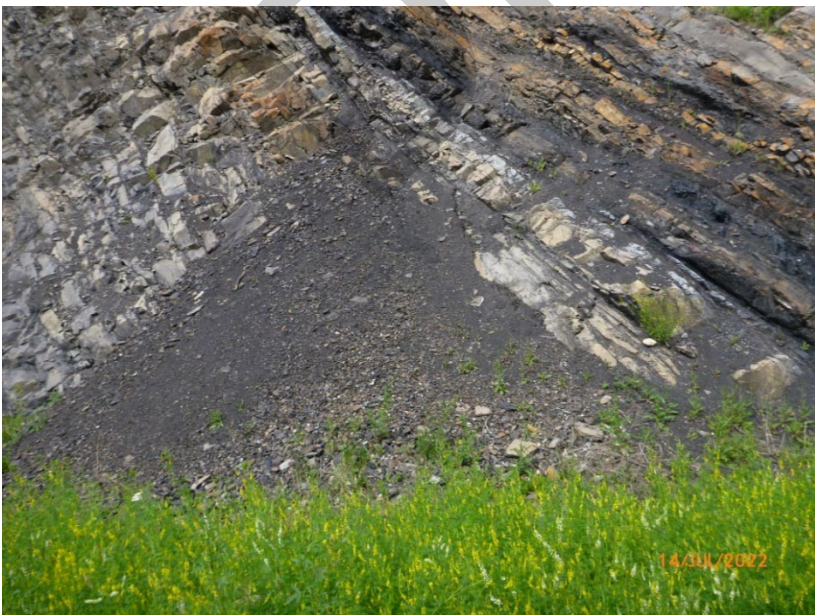
- ♦ *The brow of the slope should be scaled.*
- The fracturing of the bedrock may have been worsened by construction blasting.
- Zones of bedrock interbedded with coal seams are also weathering faster than surrounding bedrock which appears to be removing confinement for larger rock blocks (Photo GP049-II-6).

Photo GP049-II – 6 Talus cone located below zone of interbedded highly fractured rock and coal. Coal appears to weather/erode creating a talus cone, leaving overlying bedding planes of more competent rock unsupported, creating some rockfall hazard. Photo taken July 14, 2022, facing west.

- ♦ *The coal seams could be shotcreted to mitigate weathering and exacerbation of existing rockfall hazard.*

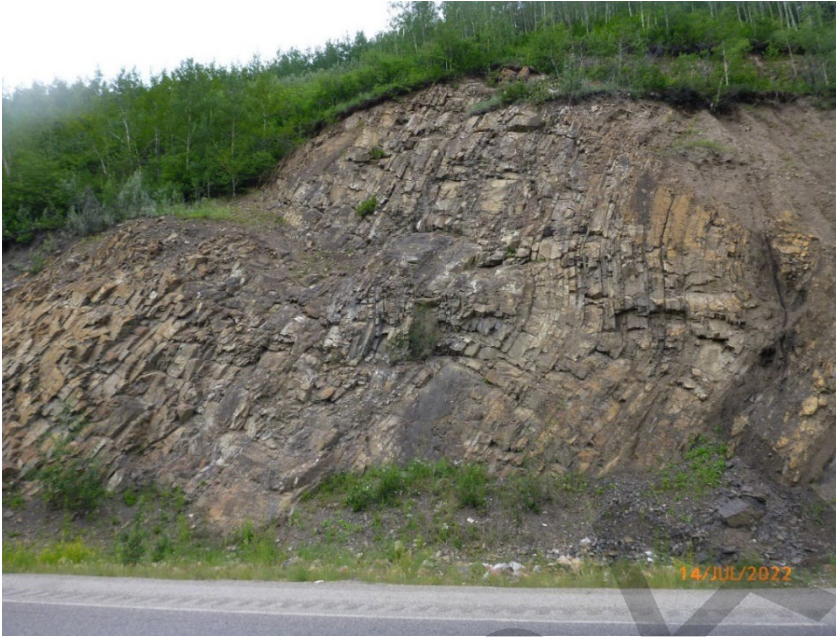
Photo GP036 – 1 Rock slope at south end of GP036 site. Rockfall activity does not reach the road at this site. Note soil infilling of possible fault feature at right of photo. Photo taken July 14, 2022, facing northwest.

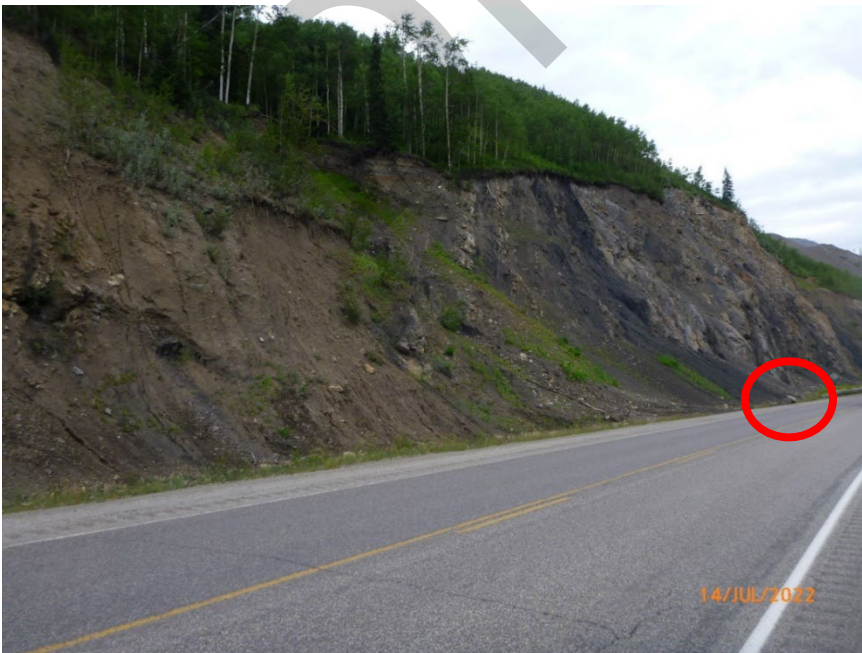
Photo GP036 – 2 Soil-infilled possible fault structure between rock slopes. South end of north part of site shown in this photo. Largest rock fall in July 2022 rainfall and rockfall event is shown by red circle. Photo taken July 14, 2022, facing northwest.

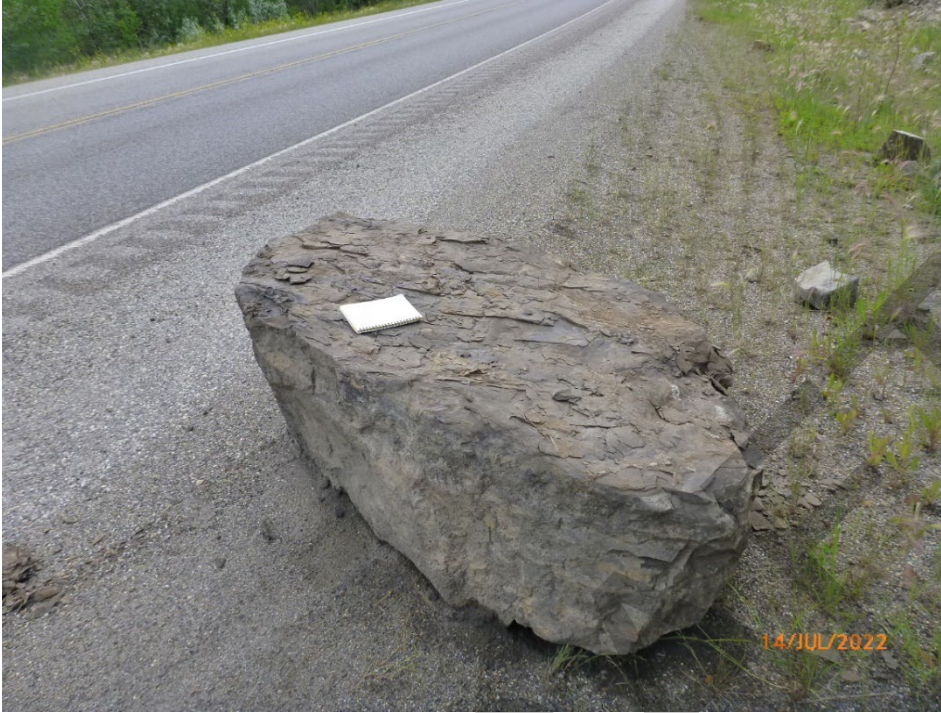
- ♦ *The ditch should be cleaned of rockfall particles and talus cones.*
- Evidence of surface water drainage over the slope face was observed. Small rills were eroded into fine-grained talus cones (Photo GP036-3).

Photo GP036 – 3 Largest rockfall particle from July 2022 rainfall event (0.6 m x 1.5 m x 1.2 m). Rockfall particle fell at southern limit of guardrail and was pushed to this location off road. Photo taken July 14, 2022, facing southwest.

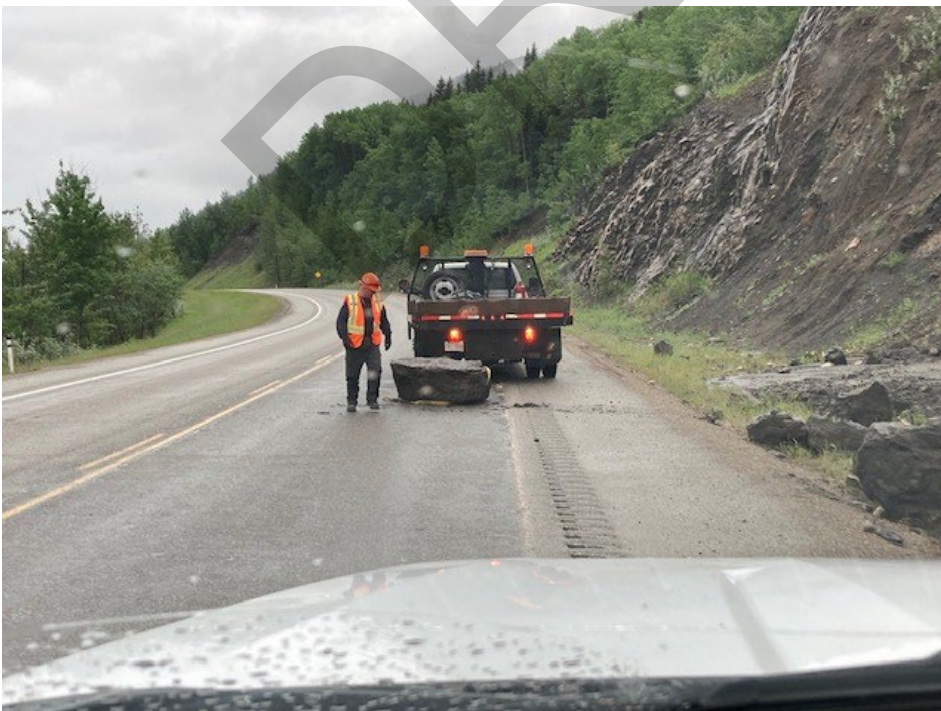
Photo GP036 – 4 June 29, 2022 rockfall on the highway. Photo taken July 29, 2022, facing southwest by AT.

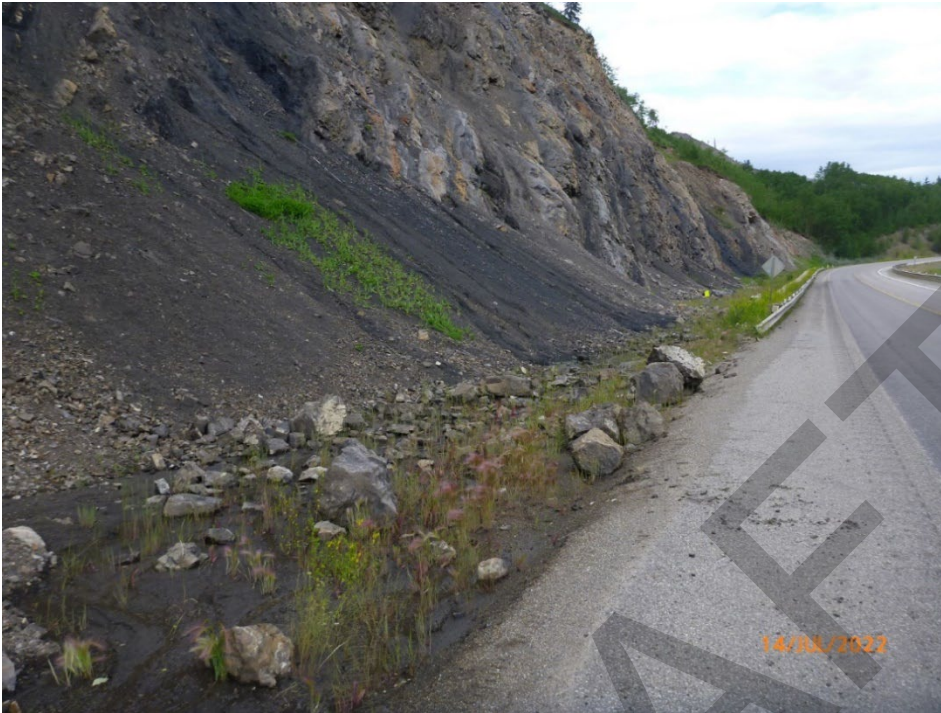
Photo GP036 – 5 **Collection of rockfall blocks at south limit of north rock slope near southern limit of guard rail. Photo taken July 14, 2022, facing northeast.**

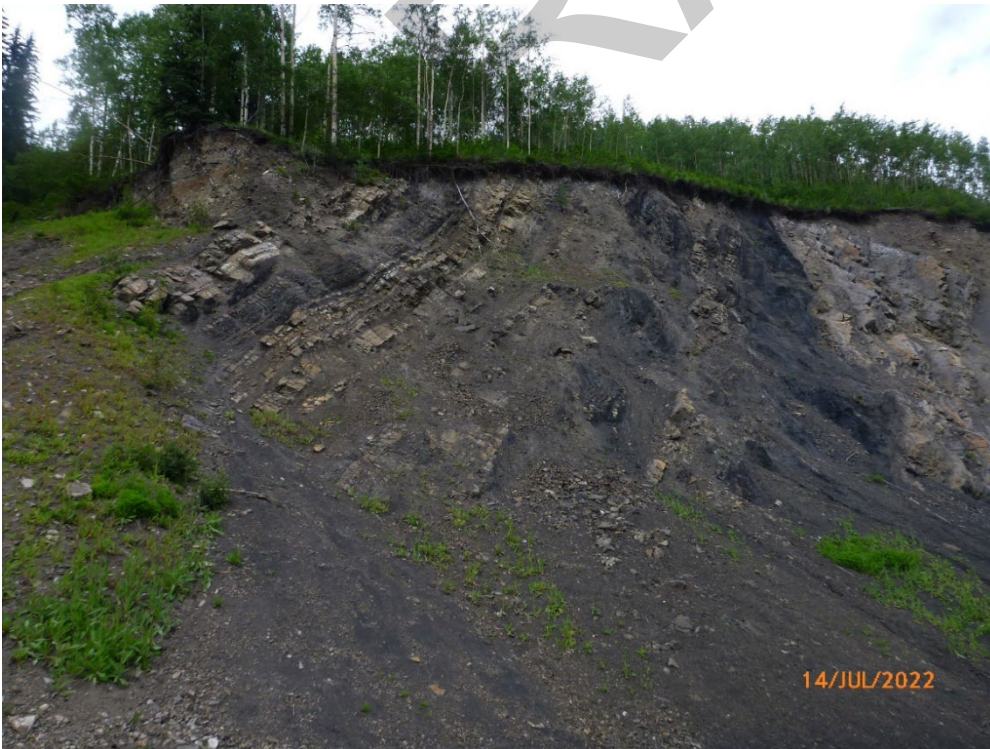
Photo GP036 – 6 **Upper part of north slope above June 29, 2022 rockfall event show in Photo GP036 – 4. Photo taken July 14, 2022, facing northwest.**

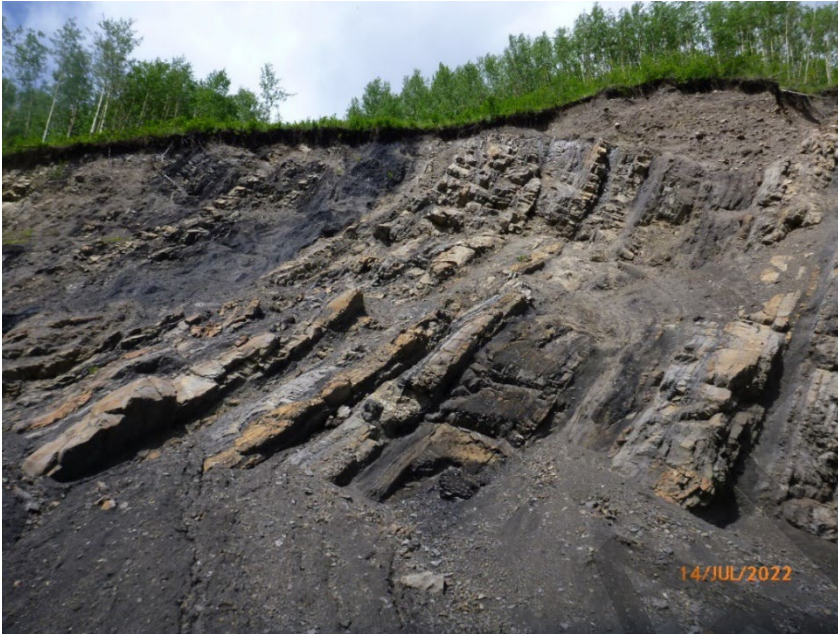
- Weaker bedrock units (such as coal, but also more closely fractured or weak bedrock) are eroding faster than the surrounding more competent bedrock. In some cases the weathering has created deep channels (0.5 m to 1.0 m deep) in the bedrock surface. These “channels” become preferential pathways for smaller particles (sand, gravel, cobbles) to be funneled down. Talus slopes are accumulating at the base of the weathered “channels” (Photos GP036-7, -8, -10, and -11).

Photo GP036 – 7 Upper slope, progressing to the north. Note gravel deposit at brow of slope. Note also weathering and removal of weaker rock units (such as coal) which is creating some overhangs and loss of confinement for the rock slope face, leading to rockfalls. Photo taken July 14, 2022, facing northwest.

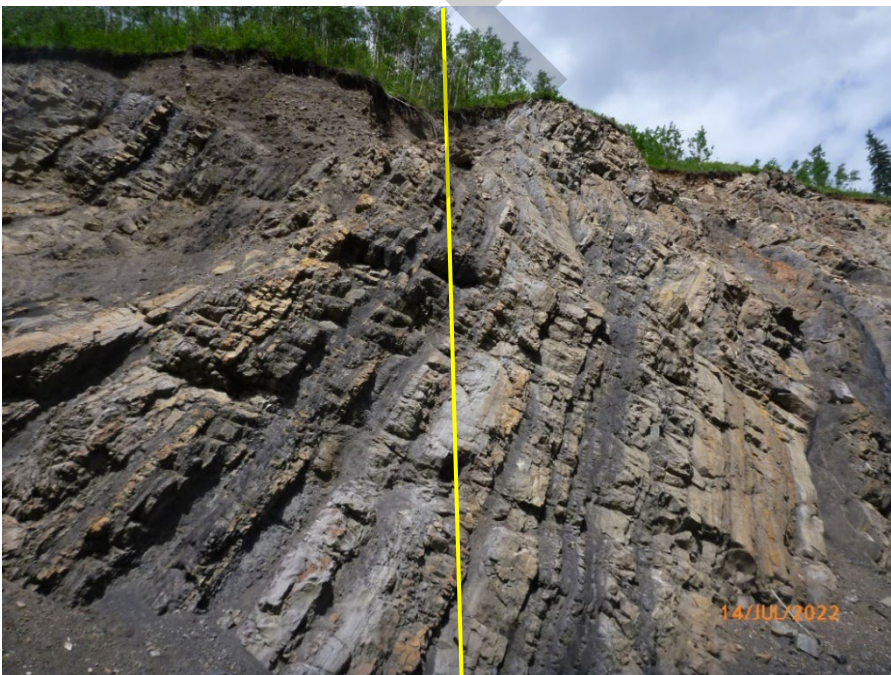
Photo GP036 – 8 Upper slope. Yellow line shows north limit of photo -6. Note uneven weathering of rock slope face which is creating overhangs and rockfall potential as well as preferential fall paths for smaller rockfall particles. Photo taken July 14, 2022, facing northwest.

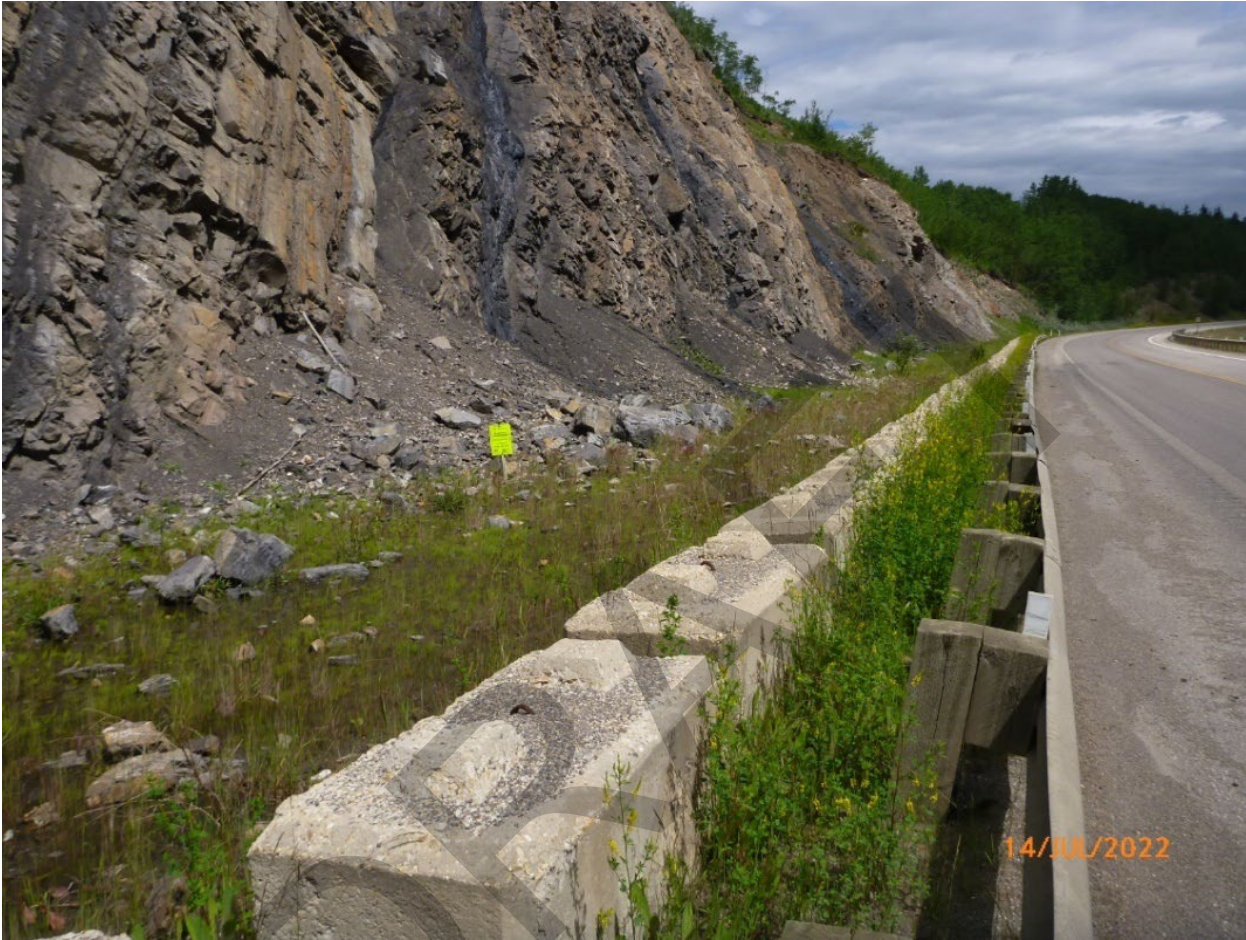
- Historic rockfall activity at the GP036 site resulted in AT installing a row of lock blocks at the edge of the highway and then installing a guardrail to address the hazard associated with the lock blocks (Photo GP036-9). The guardrail has been impacted by direct strikes of rockfall events indicating the combination of lock/block height, ditch width, and ditch depth is not adequate to contain rockfalls from hitting the highway surface.

Photo GP036 – 9 **Portion of slope with deteriorating lock blocks and guard rail at edge of pavement. Note weathering coal seams, rockfall particles in ditch, and pipeline marker at toe of slope. Photo taken July 14, 2022, facing northeast.**

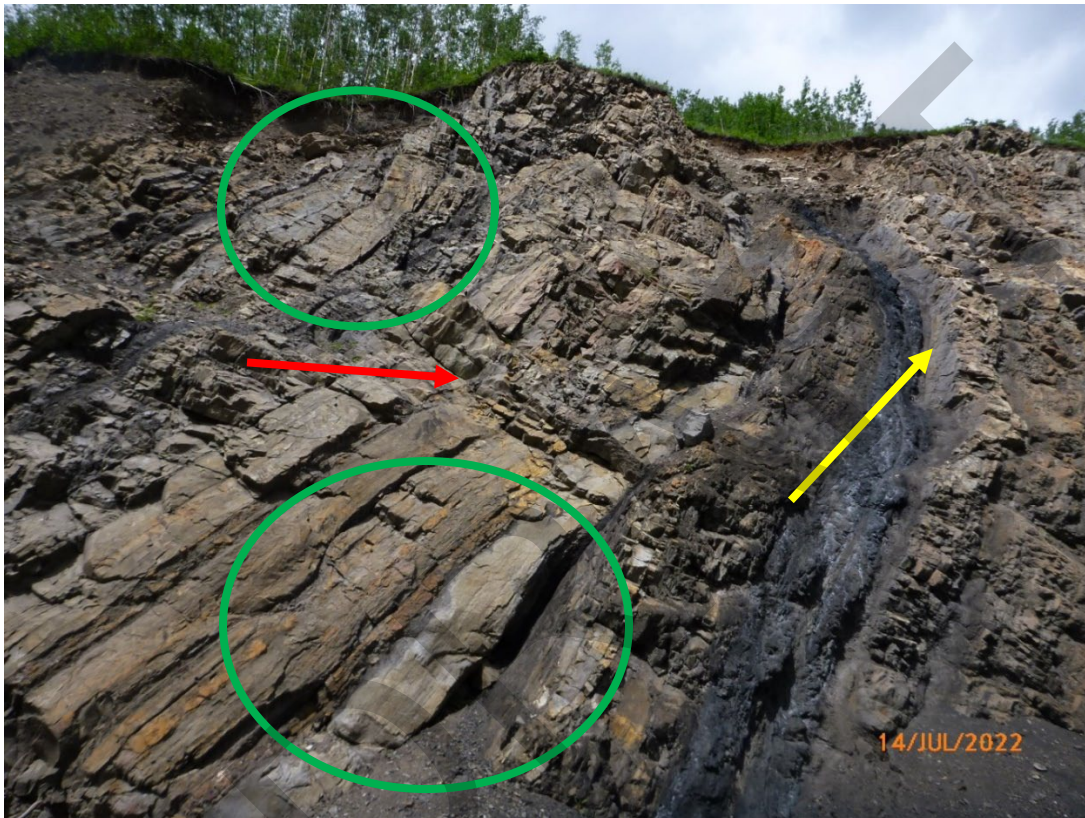
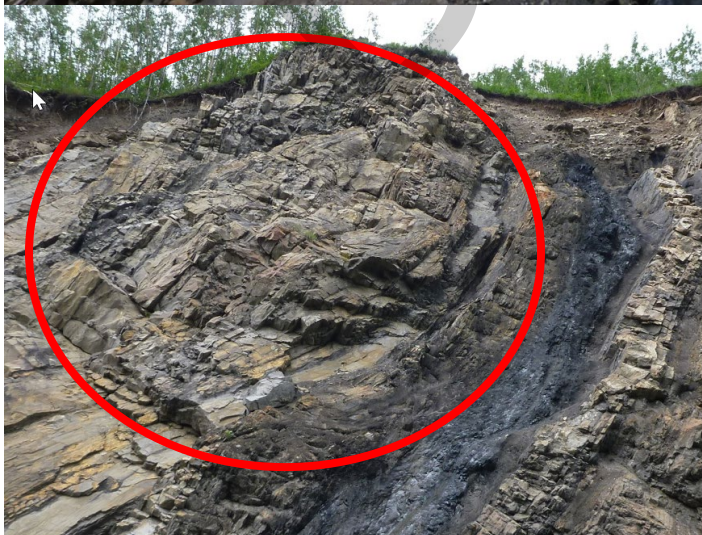
- A potentially large rock block that could be a future rockfall hazard was identified on the slope (Photo GP036-10). A bedrock discontinuity “plane” (distorted and non-planar, as

previously discussed) appears to underlie a large block of rock with some overhang. The north side of the large rock block is a layer of fractured rock and a seam of coal which is weathering faster than the rest of the slope. The discontinuity between the undulating discontinuity and the block of rock appears to be dilated. Continued weathering of the coal seam could result in loss of confinement, resulting in overstressing the remainder of the attachments for the large block to the slope, causing a large rockfall event that would likely bury the entire highway.

Photo GP036 – 10 Potential rock block on upper slope that could be further undermined by weathering of soft rock and coal seams. Some dilated (open) joints at toe. Red arrow indicates dilated joint. Green circles indicate bedrock joint or shear plane on left and below the rock block that could be behind the rock block. Yellow arrow indicates soft rock and coal seams that are weathering and eroding which could unload the north side of the rock block and cause a large rockfall event. Red circle in inset photo shows extent of rock block. Photo taken July 14, 2022, facing northwest.

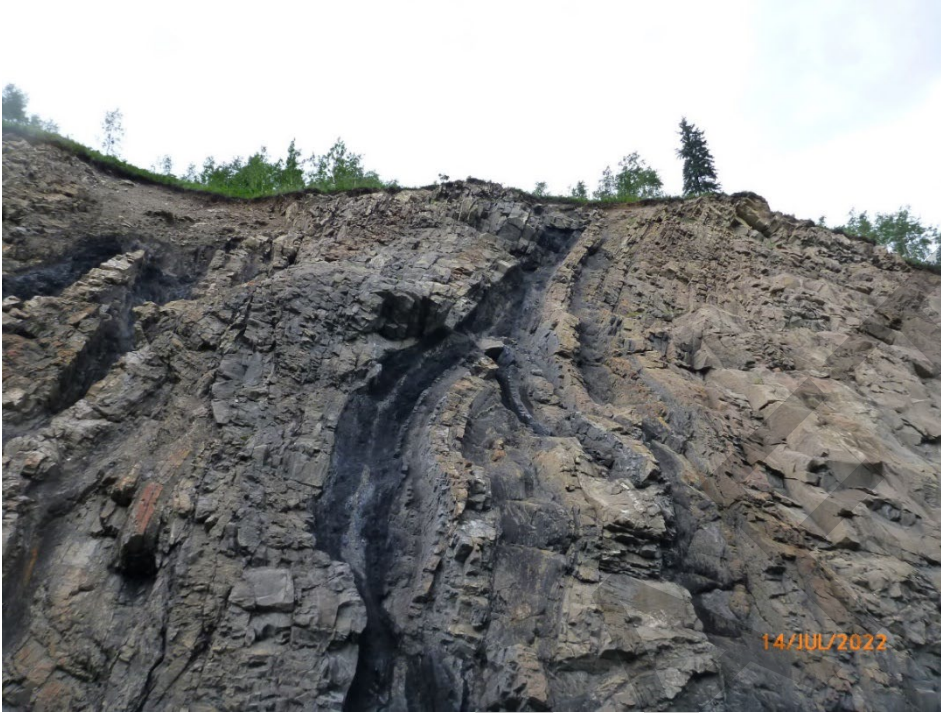
Photo GP036 – 11 Additional coal seams and soft rock layers that have weathered and eroded, leaving blocks of rock unsupported. Photo taken July 14, 2022, facing northwest.

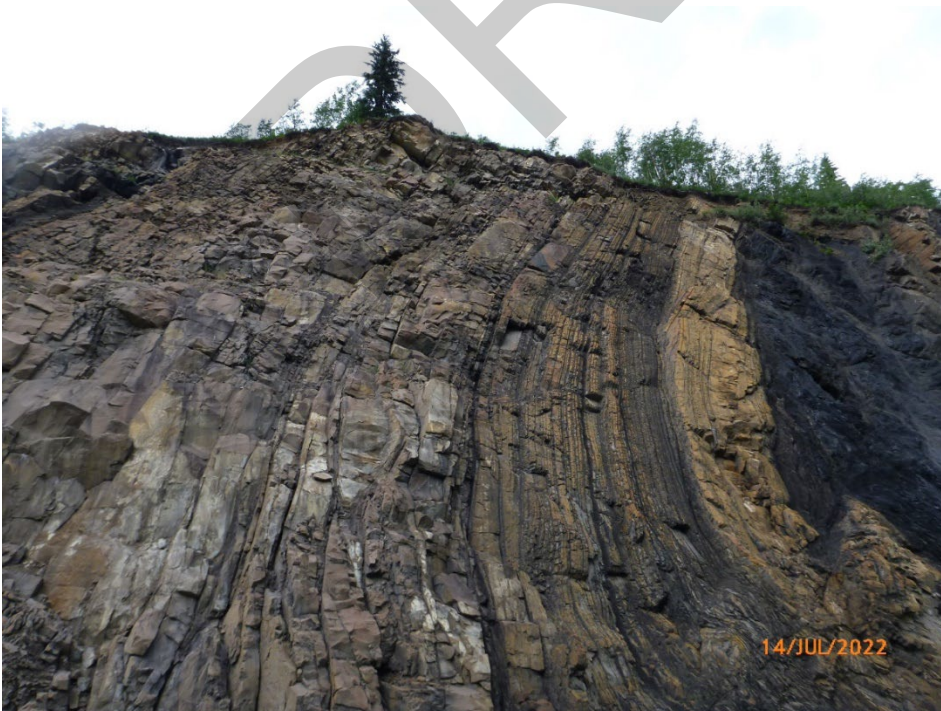
- The north part of the slope appears to be more competent bedrock with less weathering and deterioration. The coal seam with the adit exposed mid-point of the slope also appears to be more competent and is not weathering at the same rate as other coal seams on the GP036 slope (Photo GP036-12 and -13).

Photo GP036 – 12 More competent section of rock slope between coal seams (adit coal seam is to the right (north)). Photo taken July 14, 2022, facing northwest.

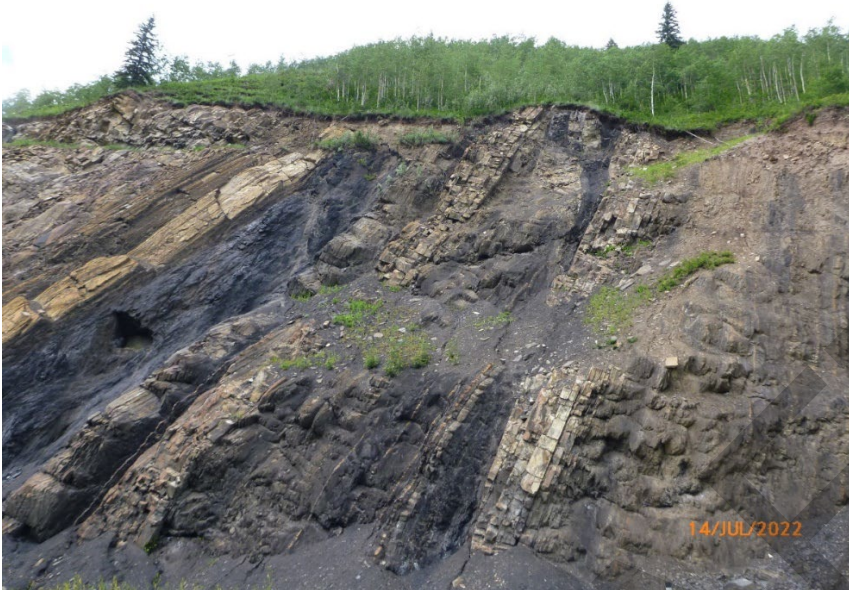
Photo GP036 – 13 Rock slope to the north of coal seam adit. Photo taken July 14, 2022, facing northwest.

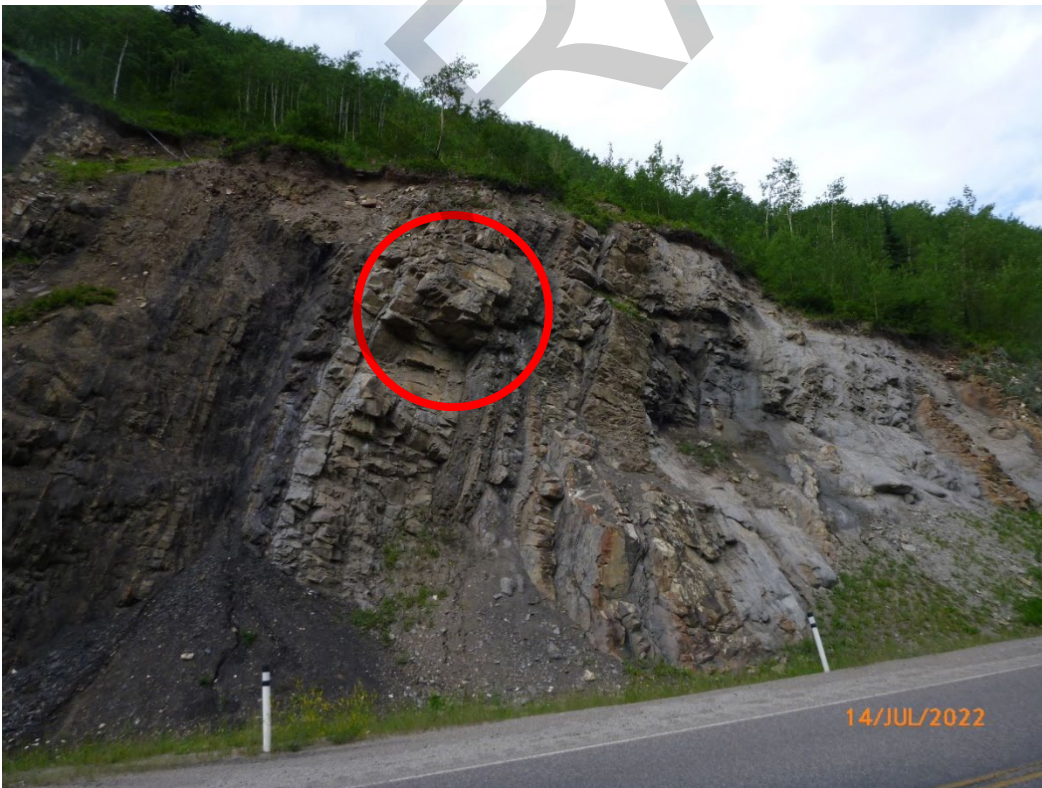
Photo GP036 – 14 Rock slope at north limit of rock cut slope. Red circle indicates overhang in upper third point of slope (shown in Photo -15). Photo taken July 14, 2022, facing northwest.

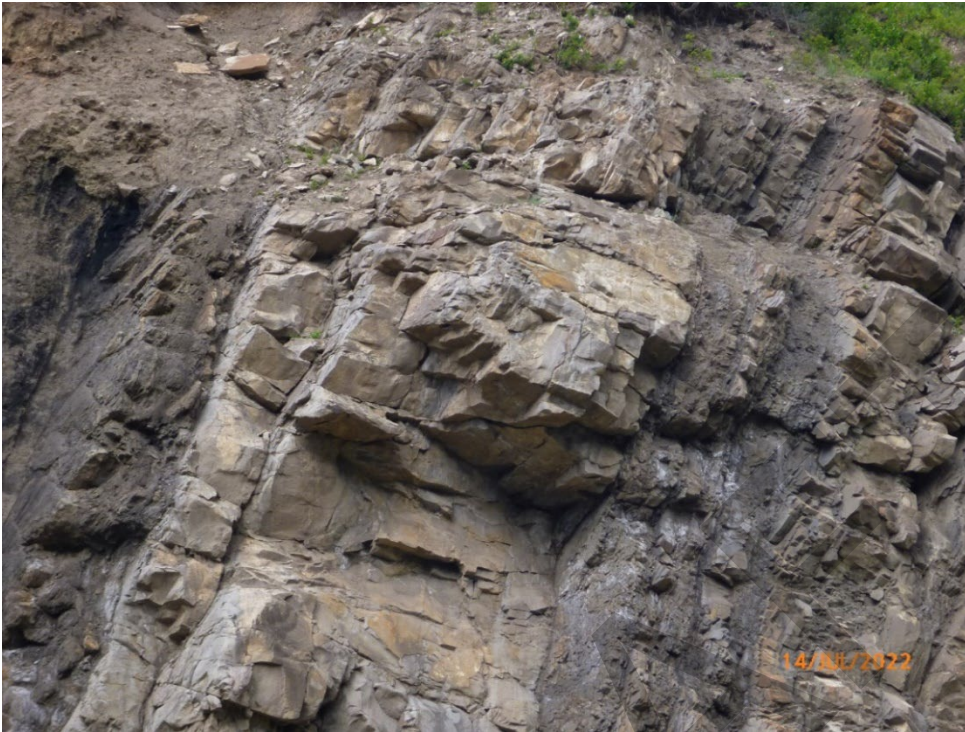
Photo GP036 – 15 Overhang at upper third of slope shown in Photo 13. Photo taken July 14, 2022, facing northwest.

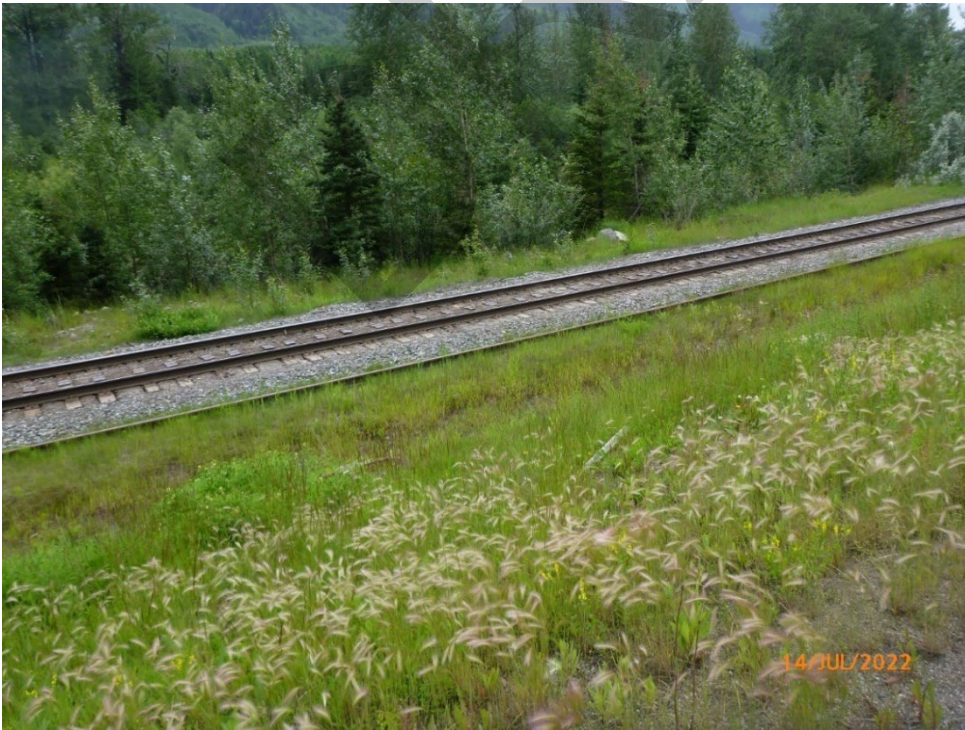
Photo GP036 – 16 Large blocks of rock that appear to have rolled downhill past the railway tracks. Photo taken July 14, 2022, facing south.

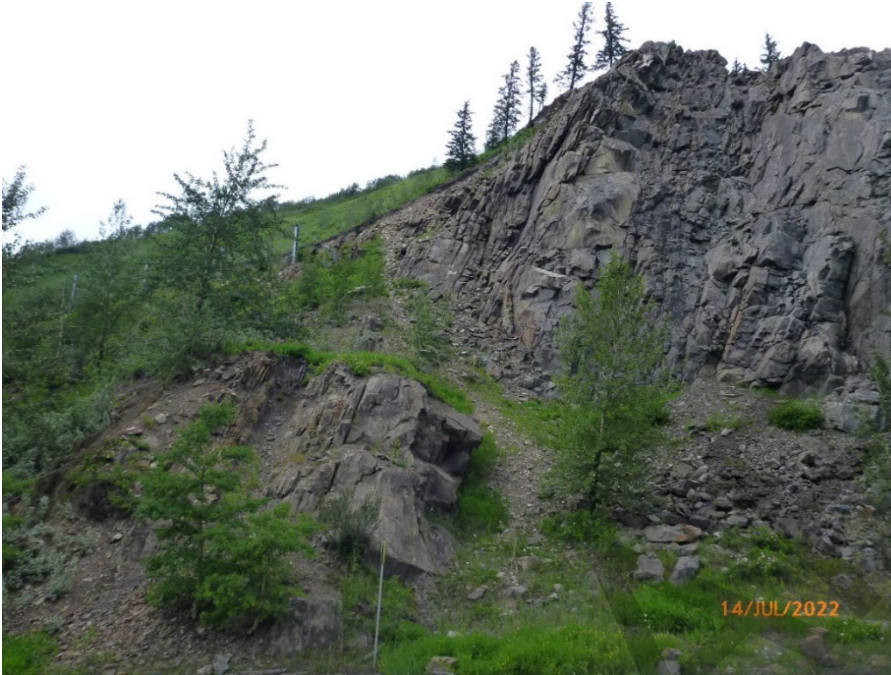
Photo Rockfall Fence Site 1

- Some rockfall blocks were noted in the ditch below a zone of closely bedded and fractured bedrock that has preferentially weathered with time (Photos Rock Fall Fence -1 and -2).
 - ♦ *The slope should be scaled and the ditch cleaned of rockfall blocks.*

**Rock slope north of GP049 downslope of mine rockfall fence.
Photo taken July 14, 2022, facing northwest.**

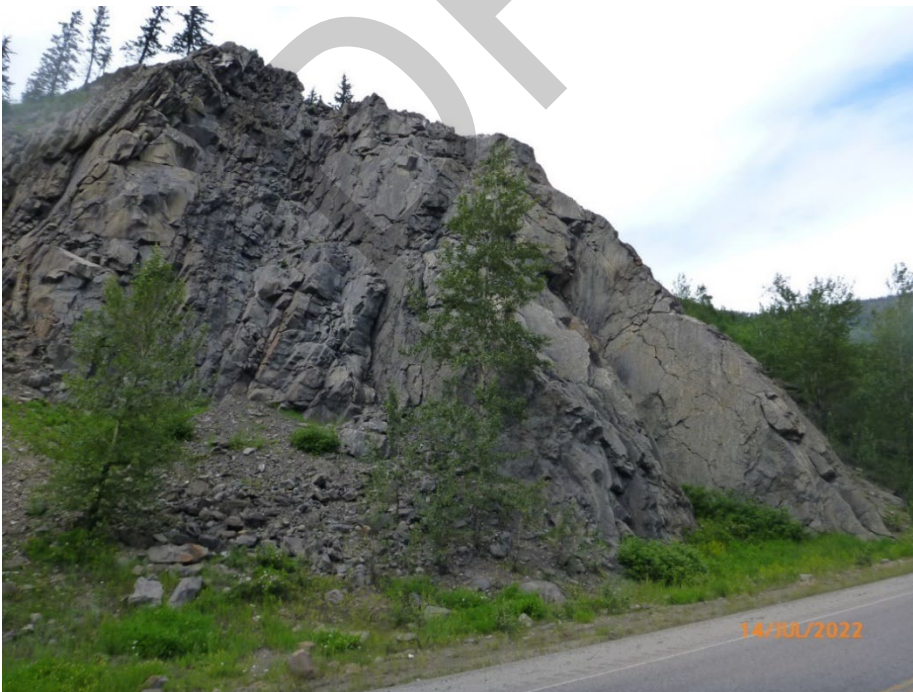
Photo No Site Number 2

Rock slope north of GP049 downslope of mine rockfall fence. Several overhanging rock blocks are present on the more fractured zones of this rock slope. Photo taken July 14, 2022, facing north.

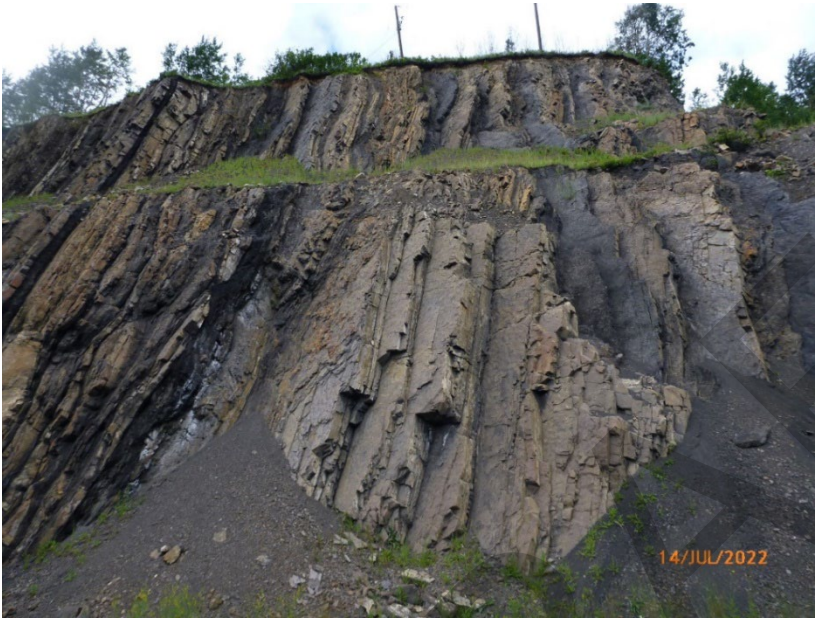
- The bedrock structure at this site consists of near vertical bedding planes (dip estimated between 70° to 80°) dipping to the south to southwest (Photo GP053-I-1 and -2). The rock mass appears to have relatively tight bedding planes but the rock mass is fractured perpendicular to the bedding planes which generates rockfall events.

Photo GP053-I – 1 Typical rock slope with uneven weathering of bedding planes. Weathering of weak, fractured or coal seams is causing stronger seams to be undermined. Deeper troughs preferentially funnel rockfall particles into talus cones. Note talus cones on mid-slope bench which could launch rockfall from upper part of slope. Photo taken July 14, 2022 facing northwest.
