CON0022166 Peace Region (Grande Prairie South) GRMP
Hwy 40:36 rockfall, km 8.395 to 17.161
Call-Out Report

1 INTRODUCTION

As part of the Geohazard Risk Management Program (GRMP) contract for the Grande Prairie South region, Klohn Crippen Berger Ltd. (KCB) was requested by Alberta Transportation (AT) to conduct a call-out inspection for rockfalls along multiple GRMP sites along Hwy 40:36 between km 8.395 to km 17.161. The site is located on the west side of Hwy 40 with the south limit of the call-out area being approximately 8 km north of Grande Cache, Alberta. The call-out area includes the GP049, GP036, an un-numbered site near a rockfall fence erected by a third party, and the newly (in 2022) created GP053 (formerly part of GP008A) GRMP rock slope sites.

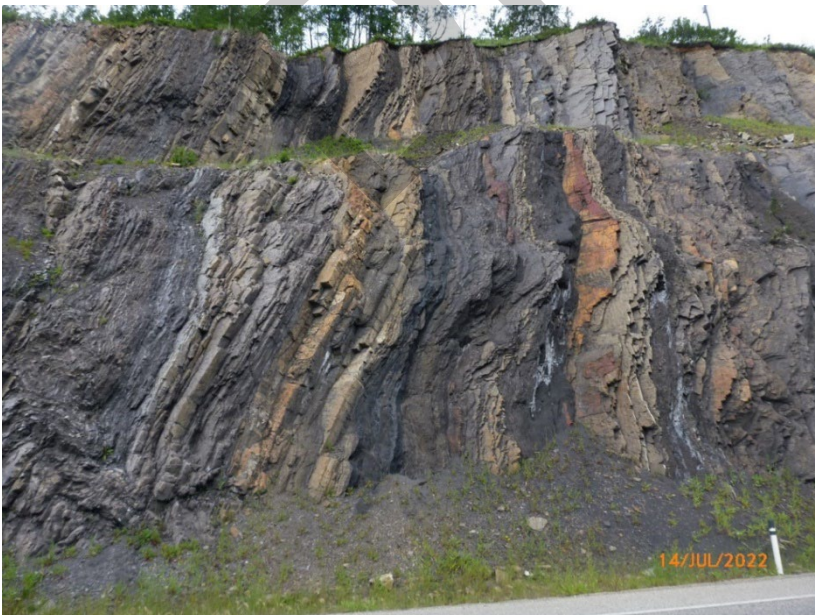
Photo GP053-I – 2 Rock slope with relatively even weathering of bedding planes. Note talus cones on mid-slope bench which could launch rockfall from upper part of slope. Photo taken July 14, 2022, facing northwest.

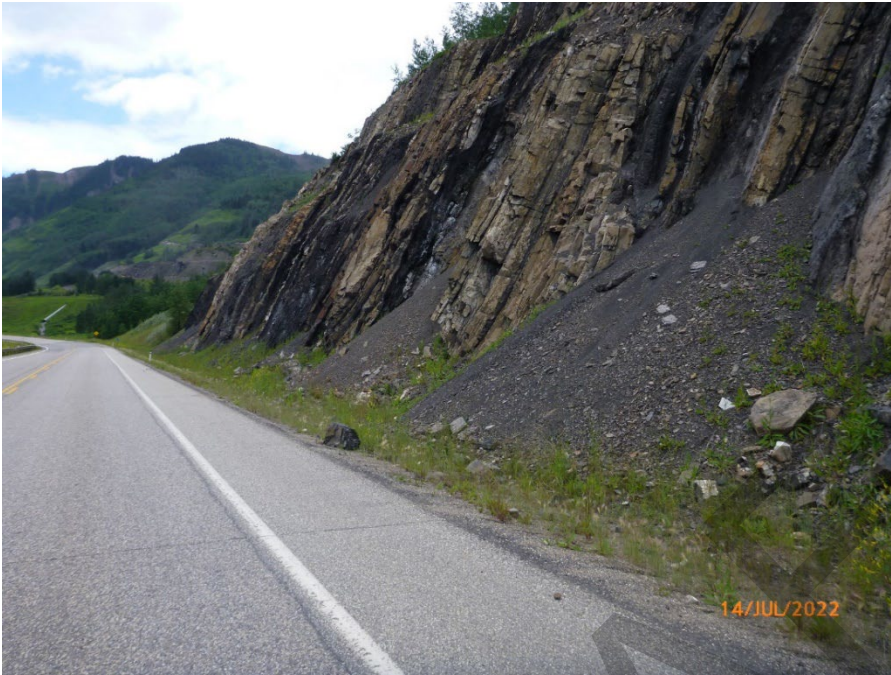
- Talus cones of fine-grained material (sand and gravel) and rockfall particles were observed in the ditch (Photo GP053-I-3).
- The bedrock structure changes in the north part of the -I slope to a gentle fold with dip of approximately 20°, dipping to the southeast towards the highway (Photo GP053-I-4).

**Photo GP053-I – 3 Talus cones and rockfall particles in ditch and close to edge of pavement.
Photo taken July 14, 2022, facing southwest.**

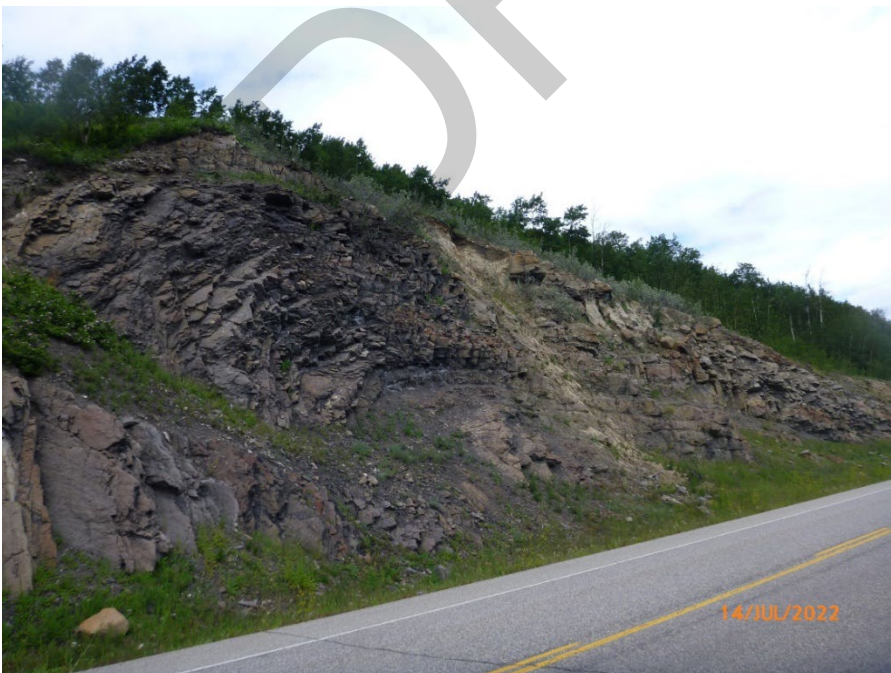
Photo GP053-I – 4 Different (second) structure of bedrock with different orientation of bedding planes. Note non-planar distortion of bedding planes in a gentle fold. The near vertical bedding plane bedrock structure shown in Photos GP053-2 is located at the lower lefthand corner of this photo. Photo taken July 14, 2022, facing northwest.

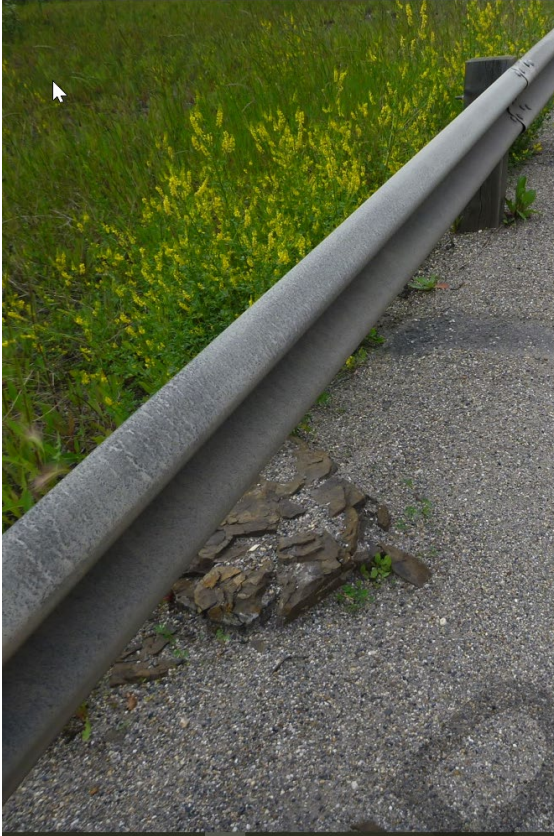
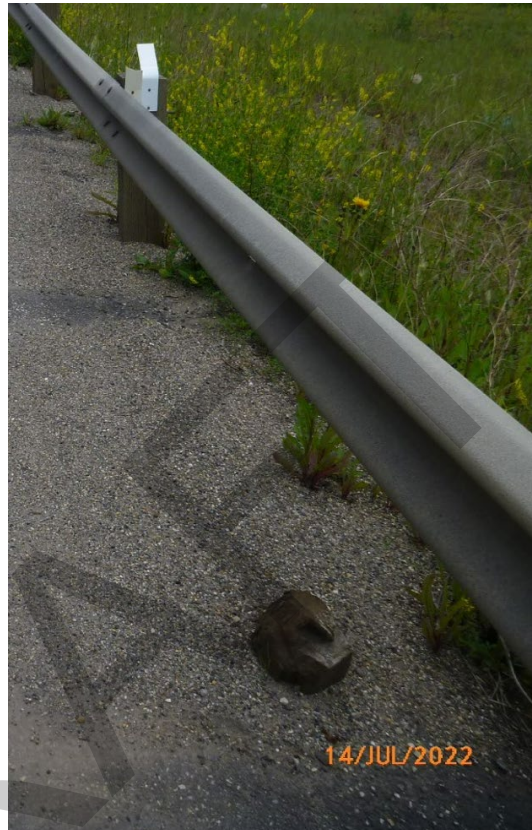
Photo GP053-I – 5 Rockfall particles under guardrail on opposite side of the highway from rock slope. Photos taken July 14, 2022, facing southwest and northeast respectively.

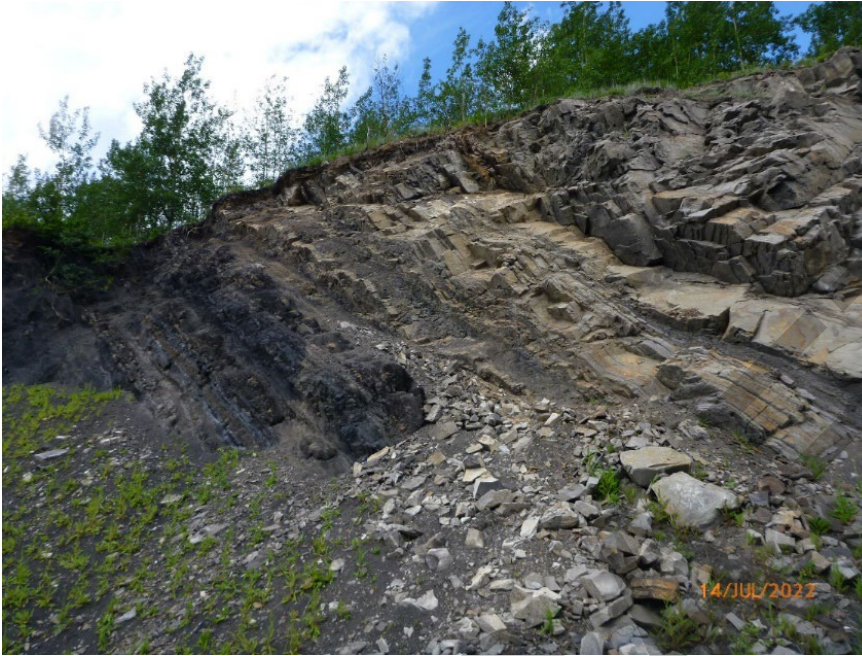
Photo GP053-II – 1 Different structure (third) of bedrock with different orientation of bedding planes. Note overhangs forming on south side of bedding planes caused by previous rockfall. Photo taken July 14, 2022, facing northwest.

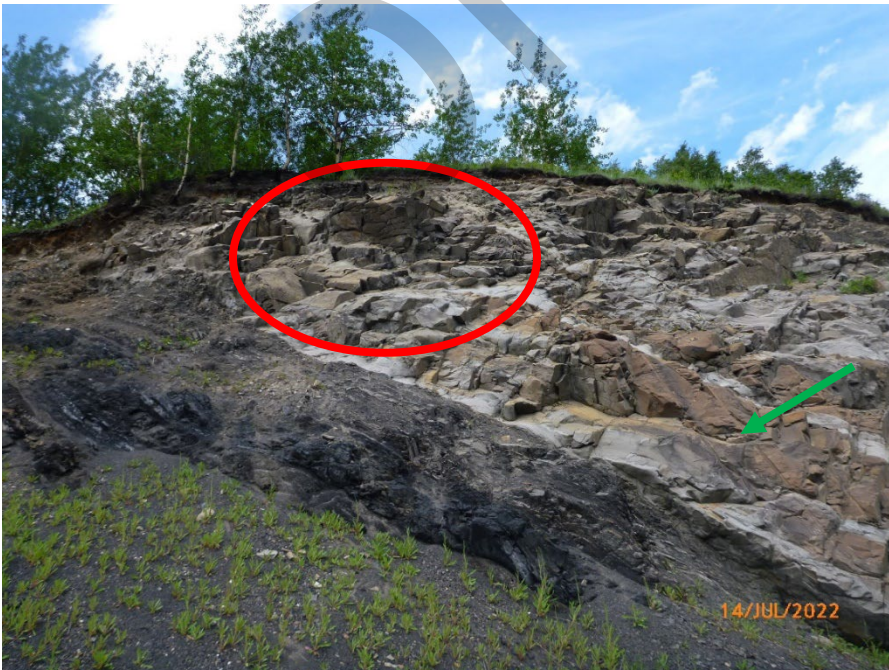
Photo GP053-II – 2 Rock slope with half barrels (green arrows) from rock cut blasting. Red circle indicates dilating bedrock joints in an overhang near top of slope. Photo taken July 14, 2022, facing northwest.

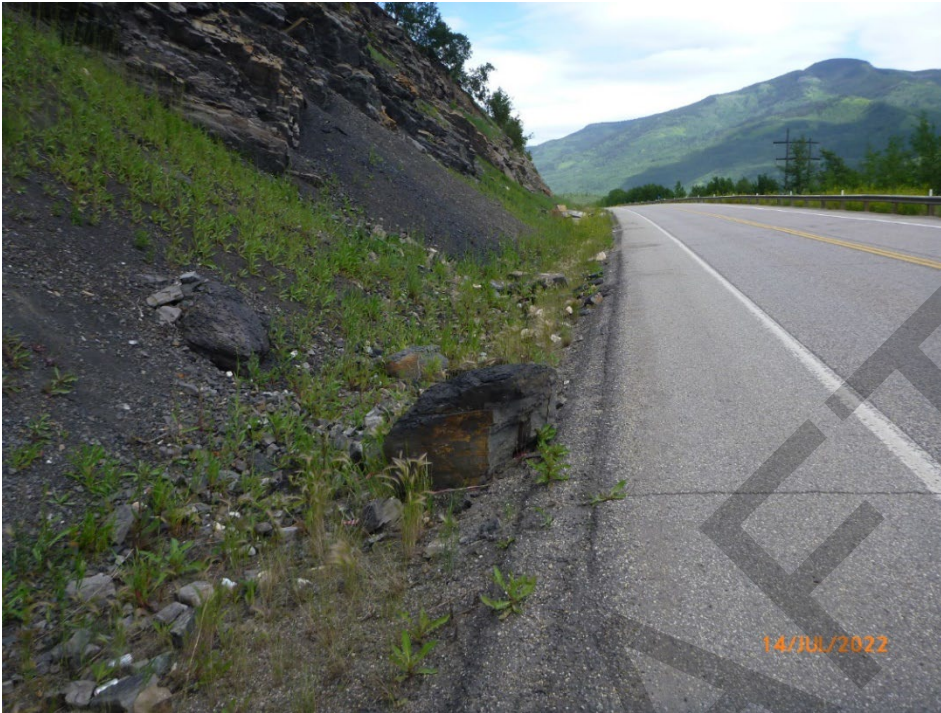
Photo GP053-II – 3 Ditch with talus slopes and rockfall particles. Photo taken July 14, 2022, facing northeast.

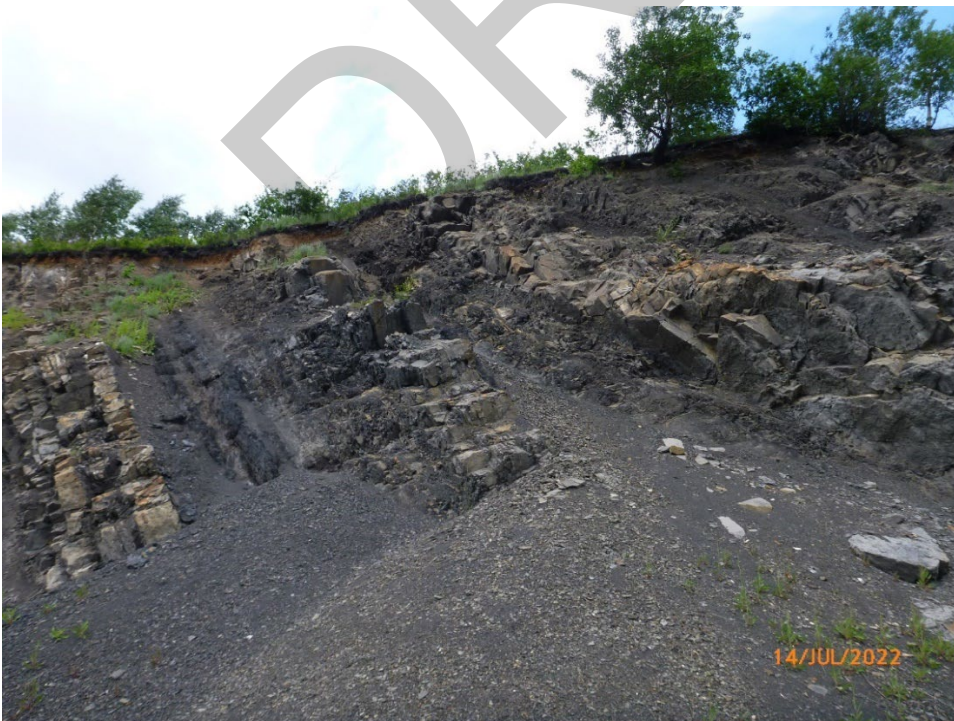
Photo GP053-II – 4 Weathered and eroded soft or highly fractured rock and coal seams are being eroded to create overhanging rock blocks which then become rock fall. Note trees at brow of slope. Photo taken July 14, 2022, facing northwest.

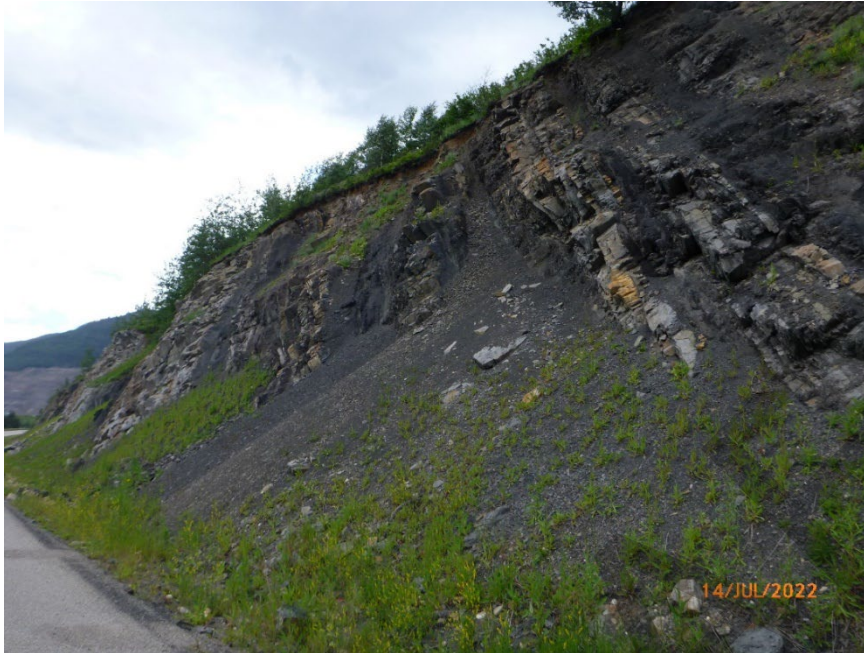
- Small rockfill particles, 0.5 m or less, were observed near the guardrail on the opposite side of the highway (Photo GP053-II-5).
 - ♦ *The slope should be scaled and the ditch cleaned of rockfall blocks and talus material.*

Photo GP053-II – 5 Section of slope that is weathering and eroding with zones of more competent rock elevated above the slope. The loss of support for the more competent rock layers eventually leads to rockfall. Photo taken July 14, 2022, facing southwest.

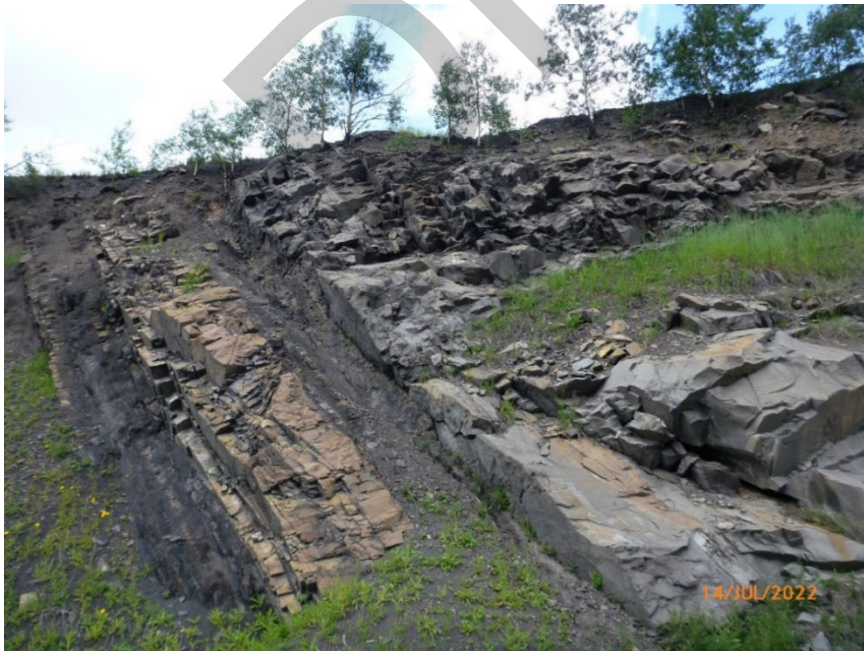
Photo GP053-II – 6 More competent, more massive layers of bedrock that are undermined do not experience as much rockfall or slope deterioration upon erosion of soft rock and coal seams. A mine access road is located behind the crest of the slope as shown in Figure 7. Photo taken July 14, 2022, facing northwest.

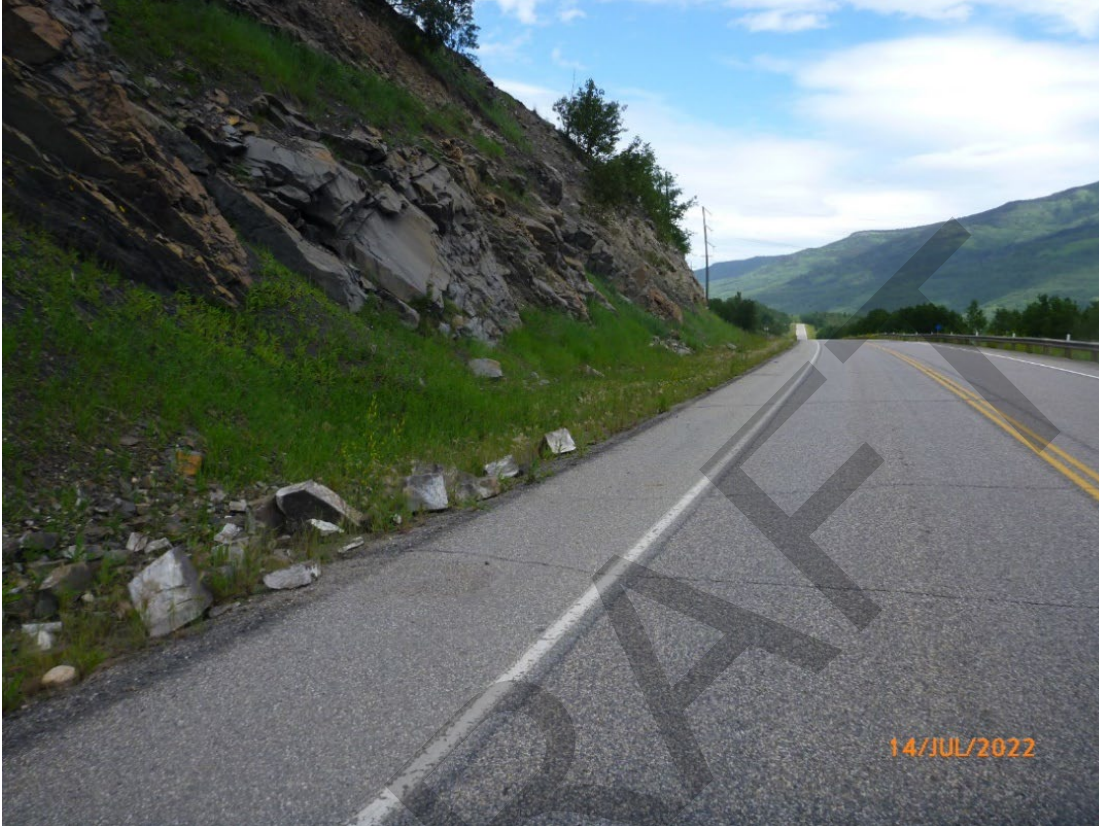
Photo GP053-II – 7 Talus slopes and rock blocks in the ditch. The rock blocks in the ditch appear to get closest to the highway by rolling down the talus slope. Photo taken July 14, 2022, facing northeast.

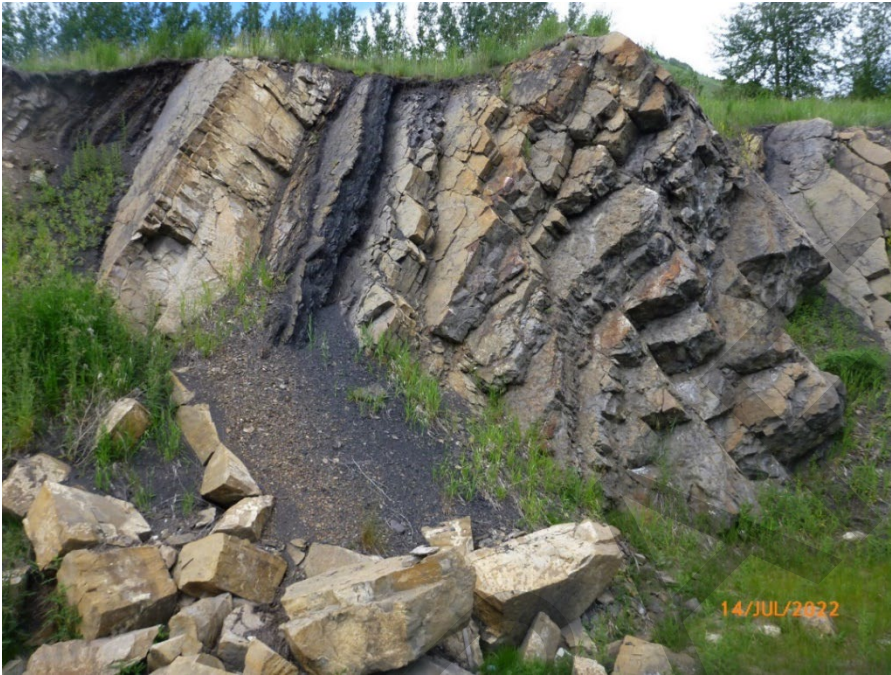
- The rock slope is approximately 100 m long and approximately 4 m to 5 m high.
- The bedrock structure is different at this site from the previous sites with steeply dipping bedding planes (estimated 60 to 70°) dipping to the south. The bedding planes vary from a few centimeters thick to over 1 m thick. More fractured or possibly blast damaged zones appear to have been removed, likely during construction, leaving an uneven slope surface (Photos GP053-III-1 and -2).

Photo GP053-III – 1 Low rock cut at north end of GP053 site. Rock slope is generating rockfall but height of slope and depth and width of ditch are containing rockfall particles. Note that orientation of bedding planes is different from previous zones of the GP053 site. Photo taken July 14, 2022, facing northwest.

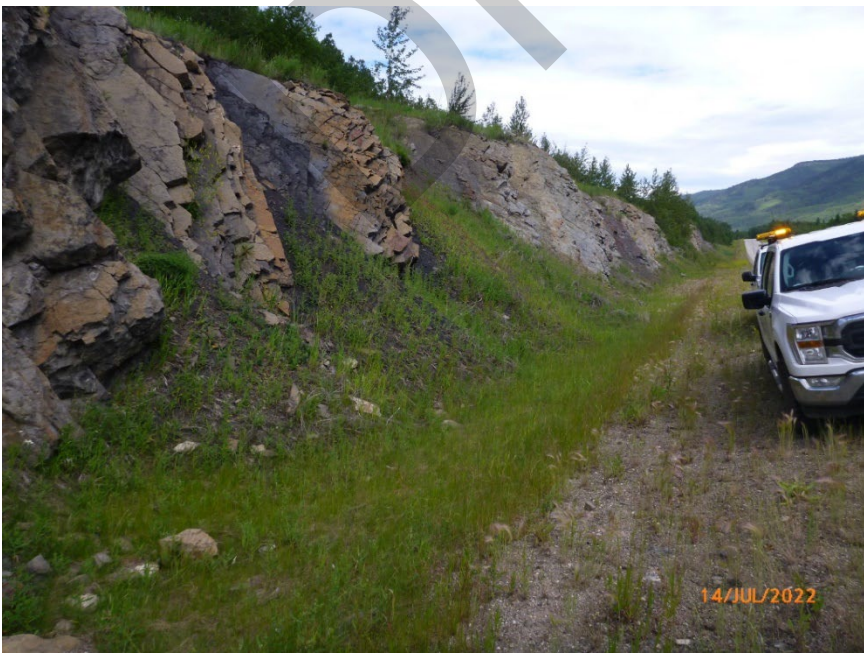
Photo GP053-III – 2 Rock slope and ditch with few rockfall particles. Photo taken July 14, 2022, facing northeast.
