**SITE INSPECTION FORM**

<b>SITE NUMBER AND NAME:</b> GP053 Rock Slope North of McIntyre Mine		<b>HIGHWAY &amp; KM:</b> 40:36, 16.295 to 17.161	<b>PREVIOUS INSPECTION DATE:</b> June 14, 2022	<b>INSPECTION DATE:</b> <b>June 12, 2023</b>
<b>LEGAL DESCRIPTION:</b> West SE 15-58-08-W6M East NW-14-58-08-W6M	<b>NAD 83 COORDINATES:</b> UTM Northing Easting 11 5986971 362772 11 5987248 363835		<b>RISK ASSESSMENT:</b> PF: 12 CF: 5 TOTAL: 60	
<b>AVERAGE ANNUAL DAILY TRAFFIC (AADT):</b> 840 (north) & 840 (south) (Reference No. 70000788, 2022)			<b>CONTRACT MAINTENANCE AREA (CMA):</b> 504

**PRIMARY SITE ISSUE:** Series of rockfall hazards from rock slope along/above west side of Hwy 40:36. Talus deposits and rockfall particles from rock slope constrict north highway ditch and falling rocks are a traffic hazard. The site is located along the west valley slope of the Smoky River. This site is the rockfall component of the former GP008A site that has been made into a separate site with three subsites in 2022 for rockfalls only. GP008 site is now for road surface slumping and slides only.

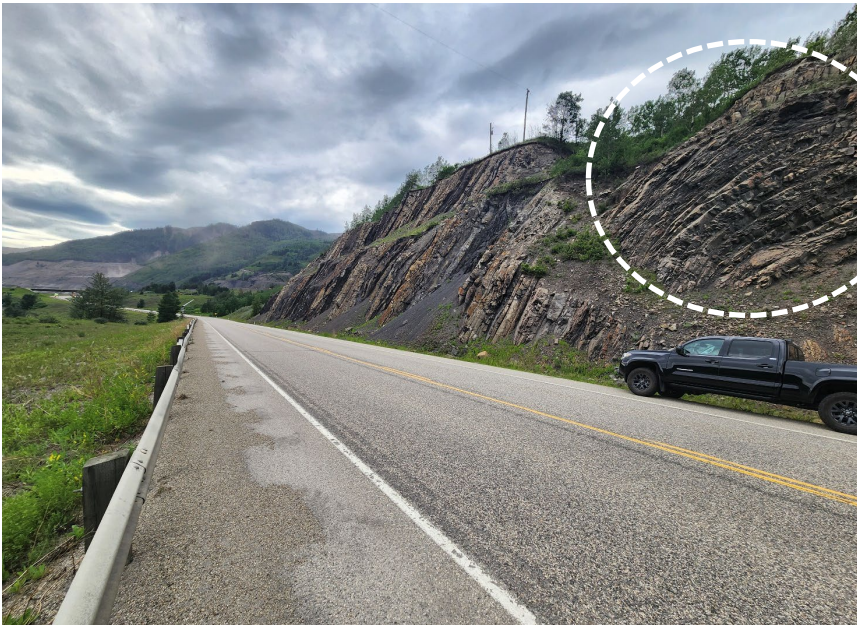
- Photo 1** Rock slope along north side of Hwy 40:36 at GP053-I site. Note change in orientation of bedrock structure at fold (circled in white) and talus material mainly from coal seams in highway ditch. Photo taken June 12, 2023, facing northwest.

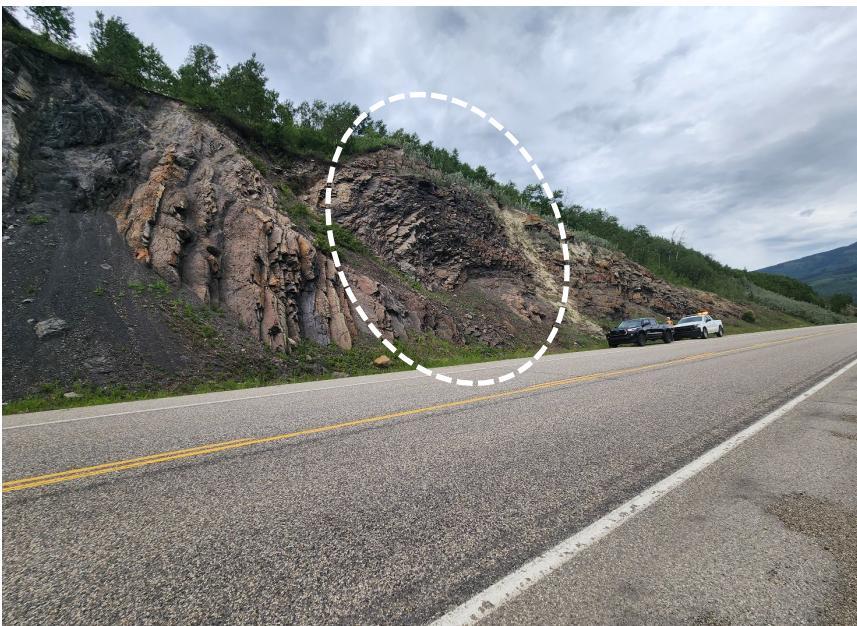
- Photo 2** Rock slope along north side of Hwy 40:36 at GP053-I site. Note change in orientation of bedrock structure at fold (circled in white). Photo taken June 12, 2023, facing northeast.

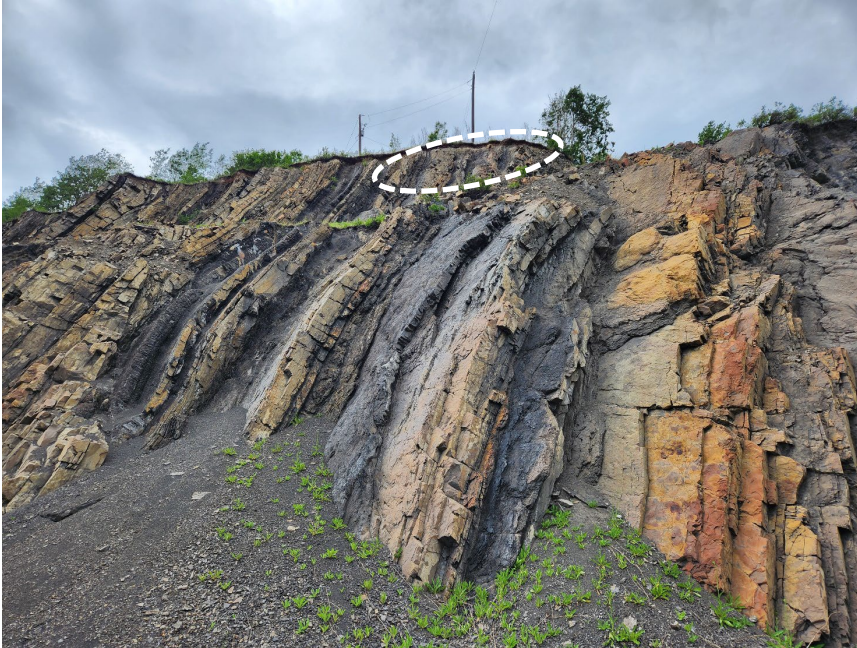
**Photo 3** Rock slope along north side of Hwy 40:36 at GP053-I site. Note near-vertical bedding orientation of bedrock, bench which could launch rockfall particles from upper slope, rock blocks on mid-slope ledge/bench (circled in white, see photo below). Photo taken June 12, 2023, facing north.

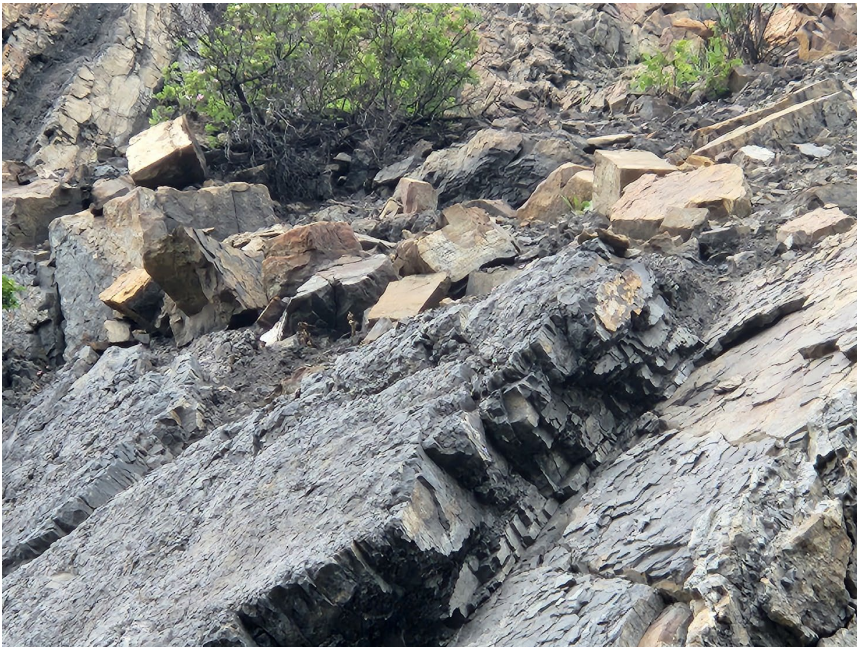
**Photo 4** Rock blocks on mid-slope ledge/bench shown in previous photo. Photo taken June 12, 2023, facing north.

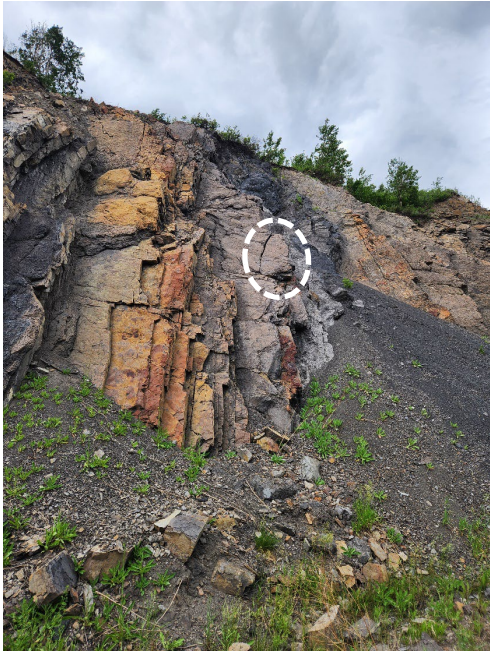
**Photo 5** Rock slope along north side of Hwy 40:36 at GP053-I site. Note near-vertical bedding orientation of bedrock, hanging and jointed rock blocks (one circled in white), and talus material mainly from coal seams in highway ditch. Photo taken June 12, 2023, facing northeast.

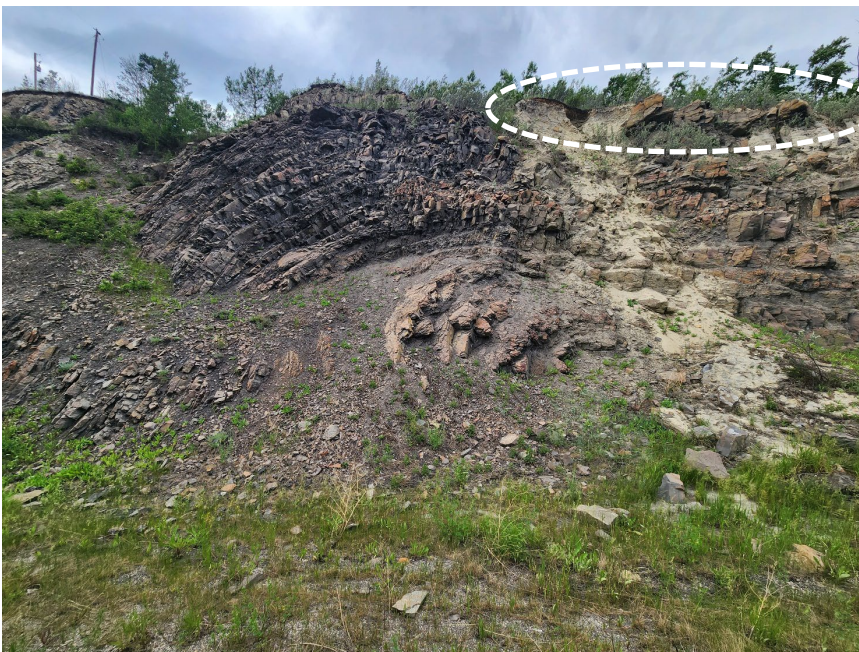
**Photo 6** Fault/fold in bedrock along north side of Hwy 40:36 at GP053-I site. Note erosion and hanging rock blocks at crest of slope (some circled in white, see photo below). Photo taken June 12, 2023, facing north.

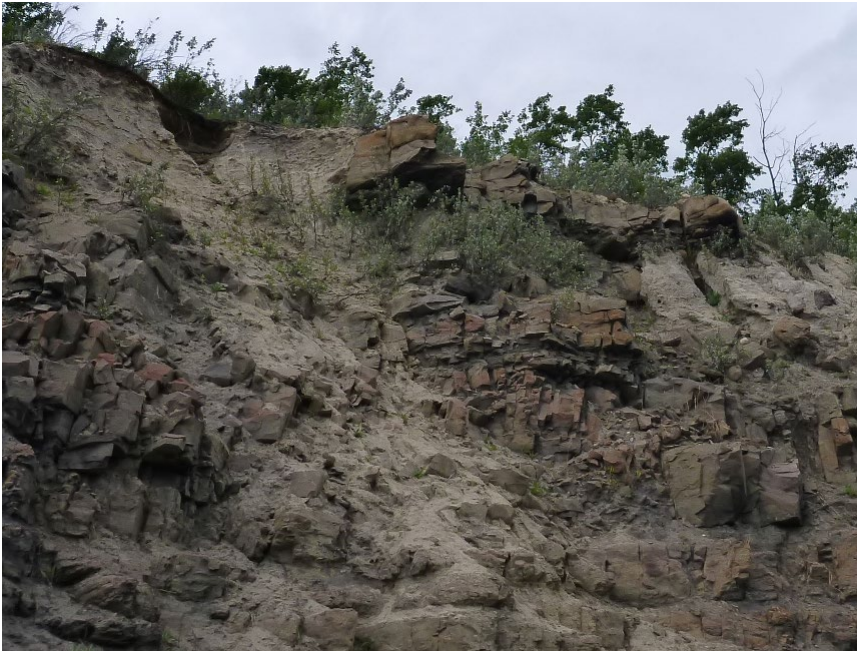
**Photo 7** Erosion and hanging rock blocks at crest of slope shown in previous photo. Photo taken June 12, 2023, facing northeast.

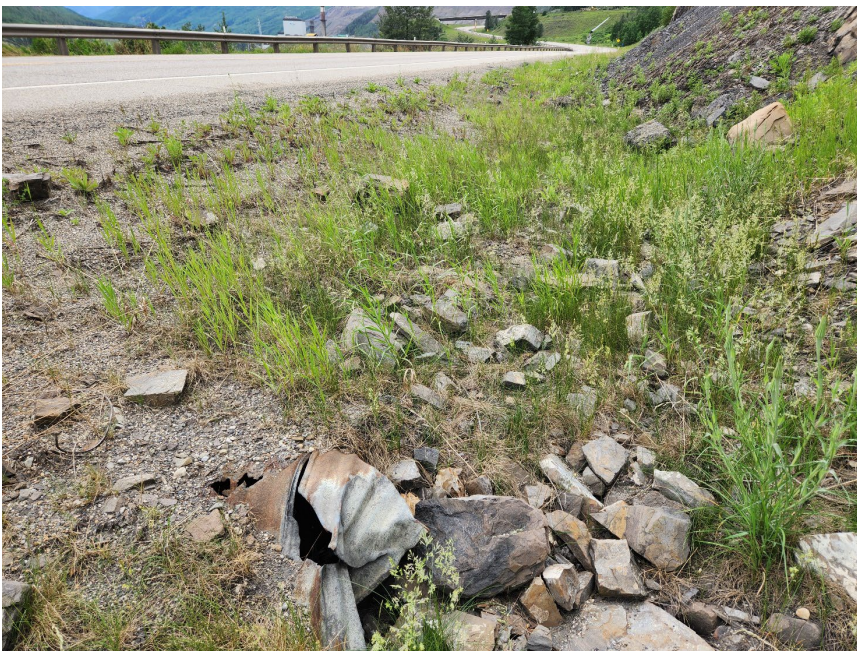
ITEM	CONDITION EXISTS		DESCRIPTION AND LOCATION	NOTICABLE CHANGE FROM LAST INSPECTION	
	YES	NO		YES	NO
Pavement Distress	X		Majority of pavement distress along corridor due to GP008A slide movements. No change in pavement distress from rockfall hazards observed.		X
Slope Movement	X		Previously fallen rockfall particles (up to 1.0 m x 1.0 m x 1.0 m) and talus materials between toe of slope and pavement edge.	X	
Erosion	X		Differential weathering, freeze thaw, ice jacking, and seepage eroding rock mass. Some erosion along crest of slope.		X
Seepage		X	None observed at time of 2022 inspection.		X
Culvert Distress		X	Culvert inlet crushed in north (westbound) highway ditch.		X

**Photo 8** Crushed culvert inlet in north ditch of Hwy 40:36 at GP053-I site. Photo taken June 12, 2023, facing west.

<p><u>GP053-III:</u></p> <ul style="list-style-type: none"> <li>• Bedrock structure is different at this site from the previous sites with bedding planes dipping from the east to the southwest (dip estimated between 55° to 60°). The bedding planes vary from a few centimeters thick to over 1 m thick. More fractured or possibly blast damaged zones appear to have been removed, likely during construction, leaving an uneven slope surface.</li> </ul>
Several hanging rock blocks observed at the subsites with some close to falling.
TEC says that some rock particles make it to the highway, and some are large enough to require a front-end loader to remove. TEC also reported that there has been more rockfall from the rock slope in recent years. Mine development upslope/north of the rock slope could be influencing the performance of the slope.
<p><u>Maintenance/Repair/Monitoring Recommendations:</u></p> <ul style="list-style-type: none"> <li>• Short-term:               <ul style="list-style-type: none"> <li>○ “Watch for fallen rock” signs already installed on either side of site, on the east shoulder before the site for northbound traffic and on the west shoulder before the site for southbound traffic. Additional signage (e.g., “watch for fallen rock, no parking) should be installed along the site to further warn motorists of rockfall hazards.</li> <li>○ Clean highway ditch regularly to maintain rockfall storage volume (i.e., keep the ditch as wide and deep as possible to retain material within the ditch) and reduce the potential for material reaching the highway. TEC reported that there are no utilities below the ditch at this site, but AbaData indicates there may be a pipeline (depth unknown) that crosses the highway from south to north near the GP053-I site. Estimated cost: approximately \$25,000 to \$40,000.</li> <li>○ Inlet of culvert which is crushed should also be repaired to maintain ditch flow.</li> </ul> </li> </ul>

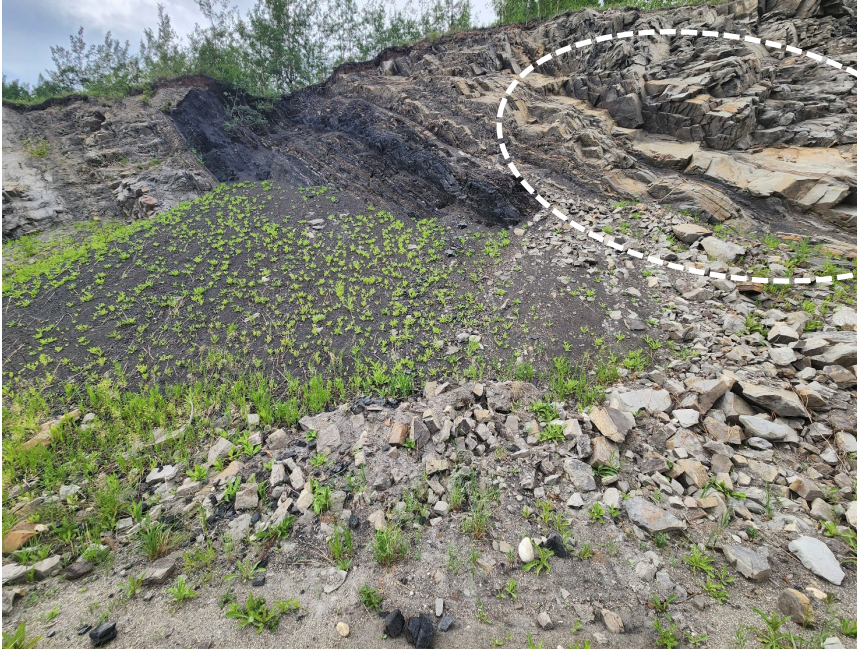
**Photo 9** Rock slope along north side of Hwy 40:36 at GP053-II site. Note talus material mainly from coal seams and rockfall particles in highway ditch, and overhanging rock blocks (circled in white, see photo below). Photo taken June 12, 2023, facing north.

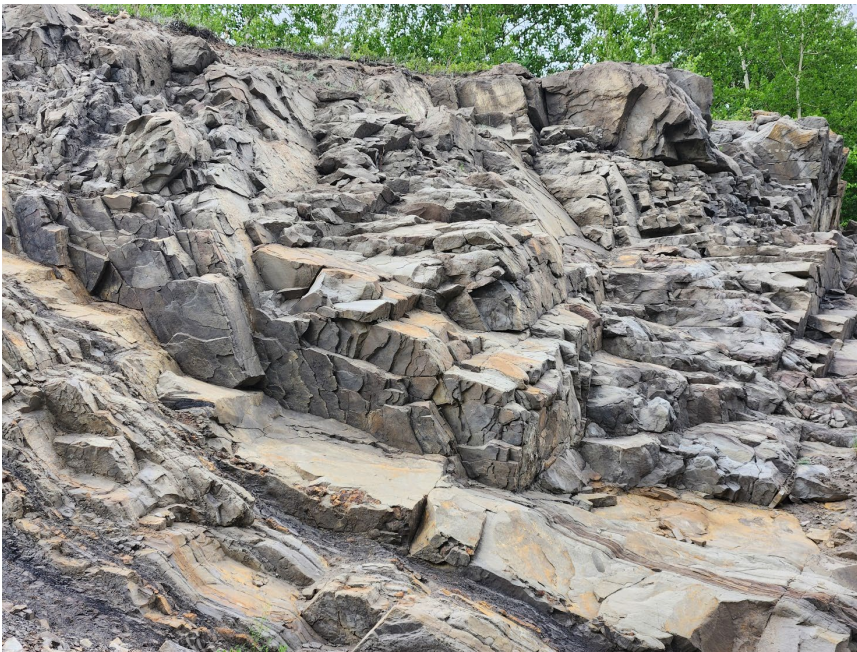
**Photo 10** Hanging rock blocks shown in previous photo. Photo taken June 12, 2023, facing north.
