SITE INSPECTION FORM

SITE NUMBER AND NAME: GP053 Rock Slope North of McIntyre Mine		HIGHWAY & KM: 40:36, 16.295 to 17.161	PREVIOUS INSPECTION DATE: June 12, 2023	INSPECTION DATE: June 10, 2024
LEGAL DESCRIPTION: West SE 15-58-08-W6M East NW-14-58-08-W6M	NAD 83 COORDINATES: UTM Northing Easting 11 5986971 362772 11 5987248 363835		RISK ASSESSMENT: PF: 12 CF: 5 TOTAL: 60	
AVERAGE ANNUAL DAILY TRAFFIC (AADT): 820 (east) & 820 (west) (Reference No. 70000788, 2023)			CONTRACT MAINTENANCE AREA (CMA): 504

PEACE REGION
(GRANDE PRAIRIE DISTRICT – SOUTH) GRMP
SITE INSPECTION FORM

TITLE
 Site Plan
 GP053 - Rock Slope North of McIntyre Mine
 Hwy 40:36, km 16.295 to 17.161

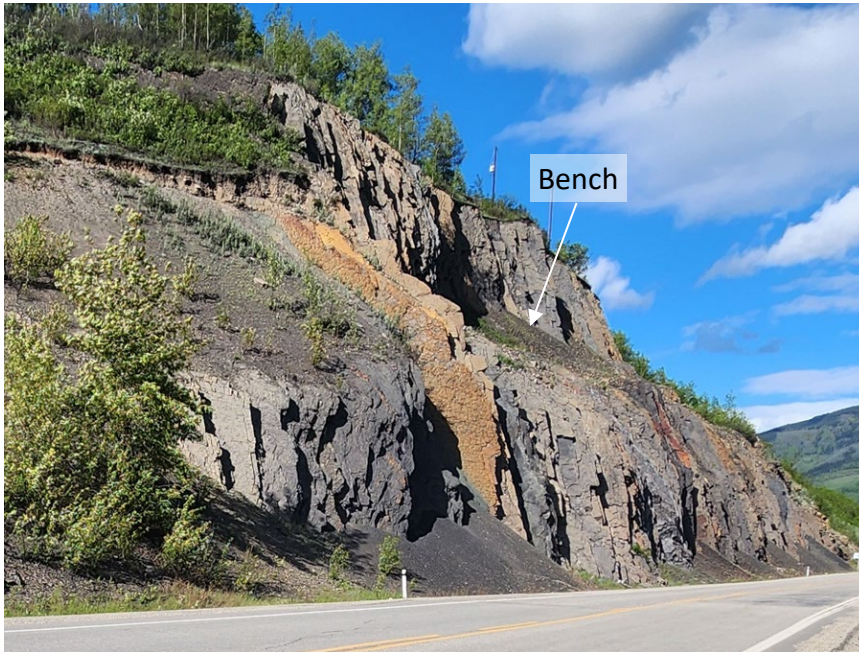
- Bedrock structure consists of bedding planes dipping from the south to southwest (dip estimated between 59° to 86°). The rock mass appears to have relatively tight bedding planes, but the rock mass is fractured perpendicular to the bedding planes which generates rockfall events. The bedrock structure changes in the east part of the slope to a gentle fold with dip of approximately 20° (Photos 3 and 4), dipping to the southeast towards the highway.
- Mid-slope bench that has talus cones/slopes, which could potentially bounce/launch/roll rockfall particles out onto the highway (Photo 1). A pile of rock blocks was also observed along this bench.

- Photo 1** Rock slope along north side of Hwy 40:36 at GP053-I site. Note bench which could launch rockfall particles from upper slope. Photo taken June 10, 2024, facing northeast near west end of site.

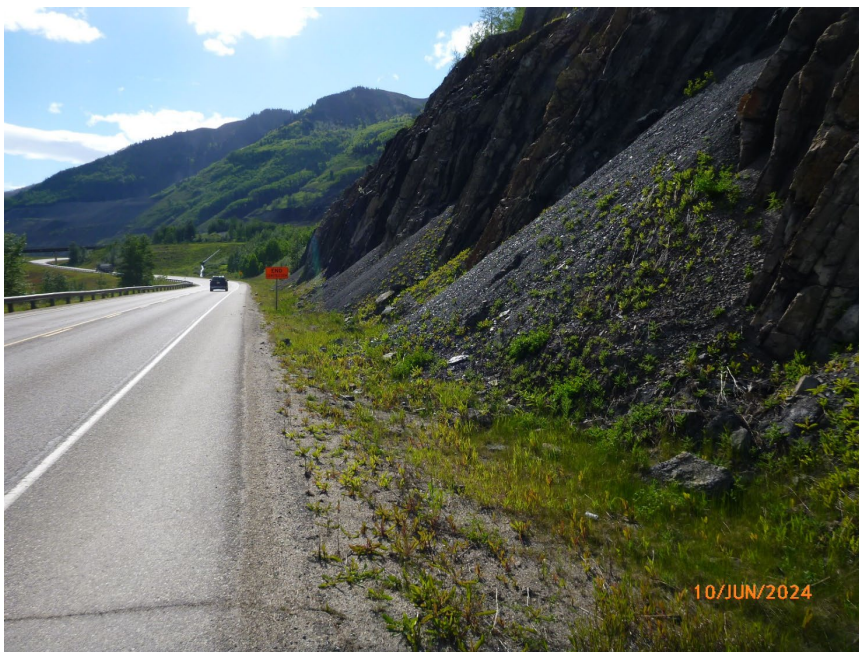
- Photo 2** Rock slope along north side of Hwy 40:36 at GP053-I site. Note talus material mainly from coal seams in ditch. Photo taken June 10, 2024, facing west.

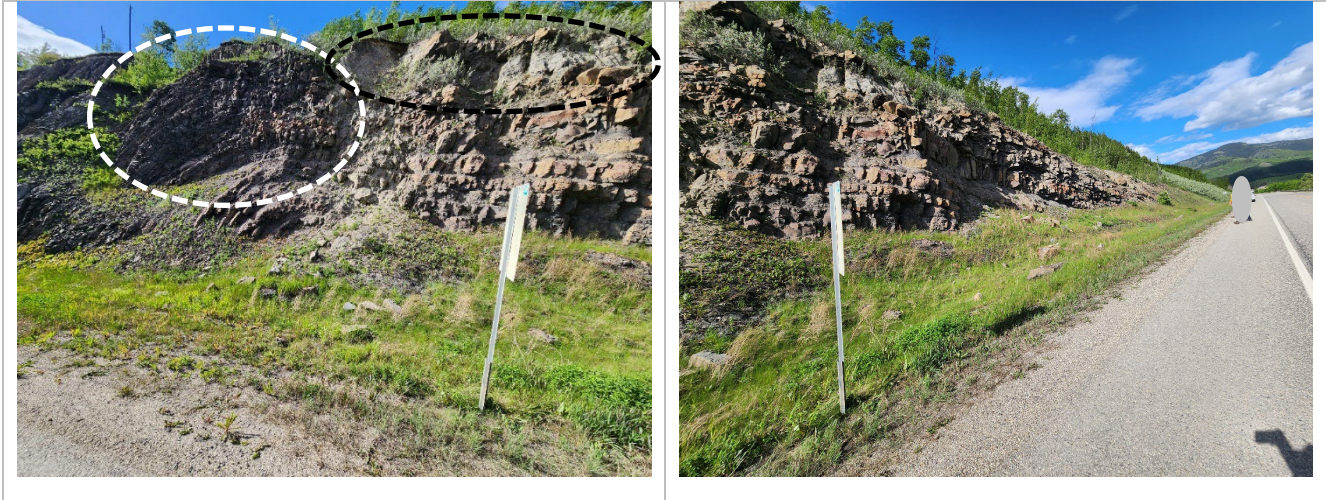
Photo 3 Rock slope along north side of Hwy 40:36 at GP053-I site. Note change in orientation of bedrock structure at fold (circled in white, see next photo), and erosion and hanging rock blocks at crest of slope (some circled in black). Photo taken June 10, 2024, facing northwest.

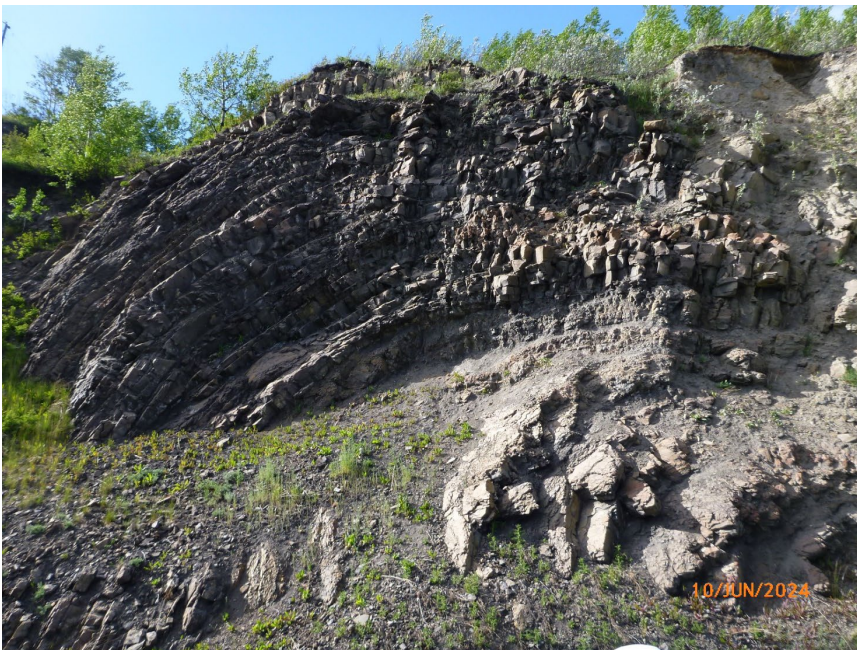
Photo 4 Fault/fold in bedrock shown in previous photo. Photo taken June 10, 2024, facing north.

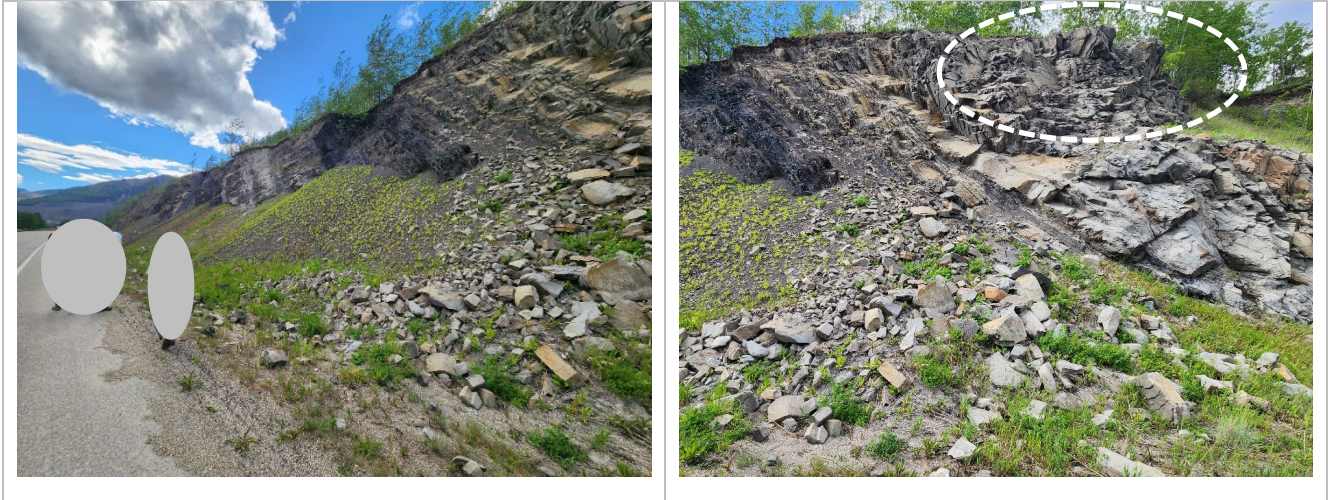
Photo 5 Rock slope along north side of Hwy 40:36 at GP053-II site. Note talus material mainly from coal seams and rockfall particles in highway ditch, and overhanging rock blocks (circled in white, see photo below). Photos taken June 10, 2024, facing northwest and north, respectively, near middle of site.

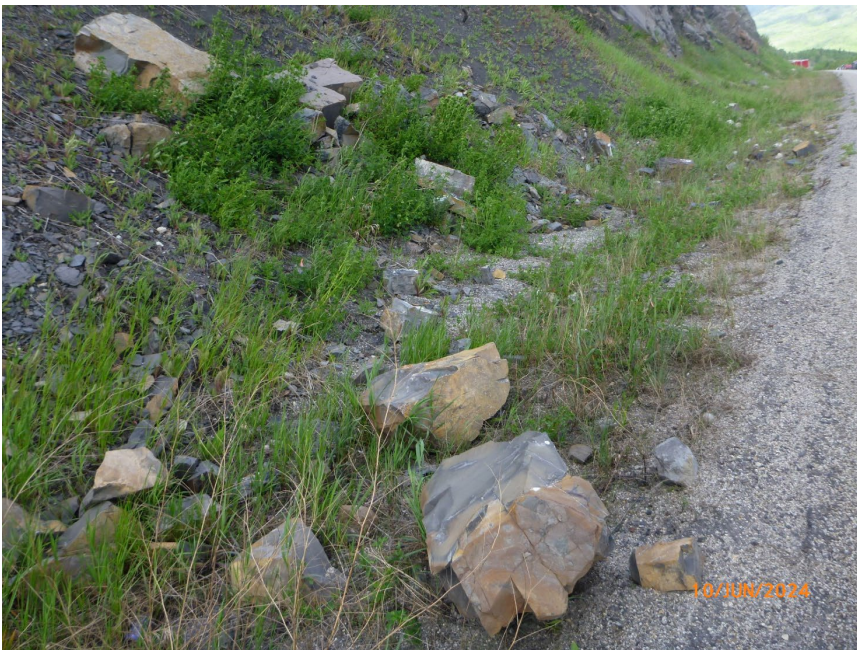
Rock mass consists of bedded and sheared sedimentary rocks, with coal seams which are weathering faster. Faster weathering of the coal results in the undermining of more competent rocks, which results in overhanging blocks and particles with little support that eventually fall, and the deposition of talus cones/slopes at the toe of the coal seams with occasional adjacent lateral rock block piles/cones (Photos 1 to 3, and 5 to 8). Cubical shaped rockfall particles appear to be rolling and bouncing down the talus cones bringing them closer to the highway (i.e., the talus cones act like chutes for rockfall particles) (Photo 6). Whereas flat platy shaped rockfall particles appear to get hung up in the talus.

Photo 6 Rockfall particles in ditch on north side of Hwy 40:36 at GP053-II site. Photo taken June 10, 2024, facing northeast.

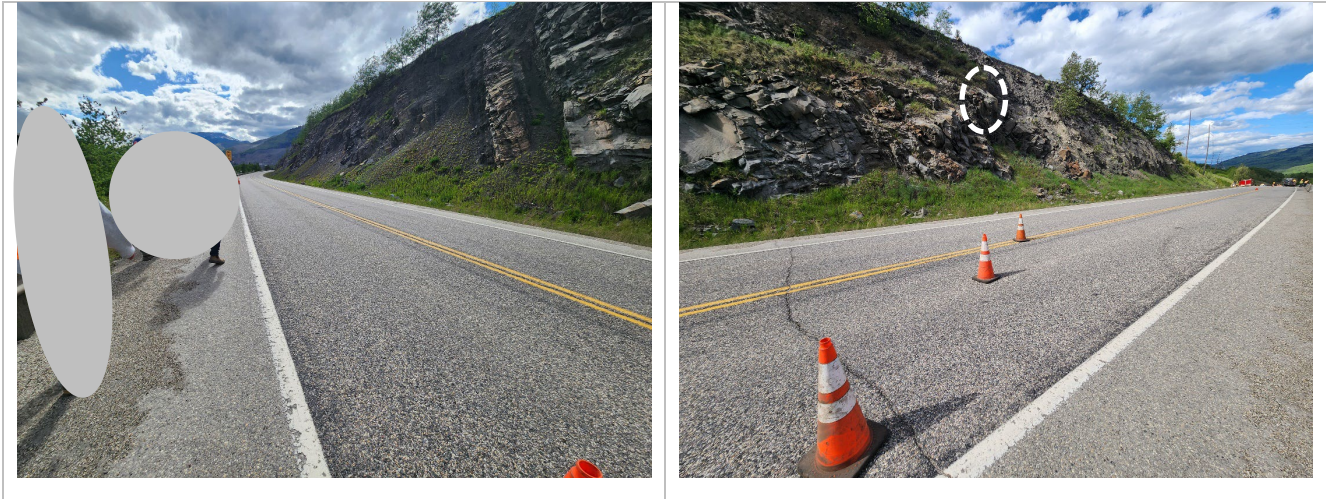
Photo 7 Rock slope along north side of Hwy 40:36 at GP053-II site. Note large overhanging rock block (circled in white, see next photo). Photos taken June 10, 2024, facing northwest and northeast, respectively, near east end of site.

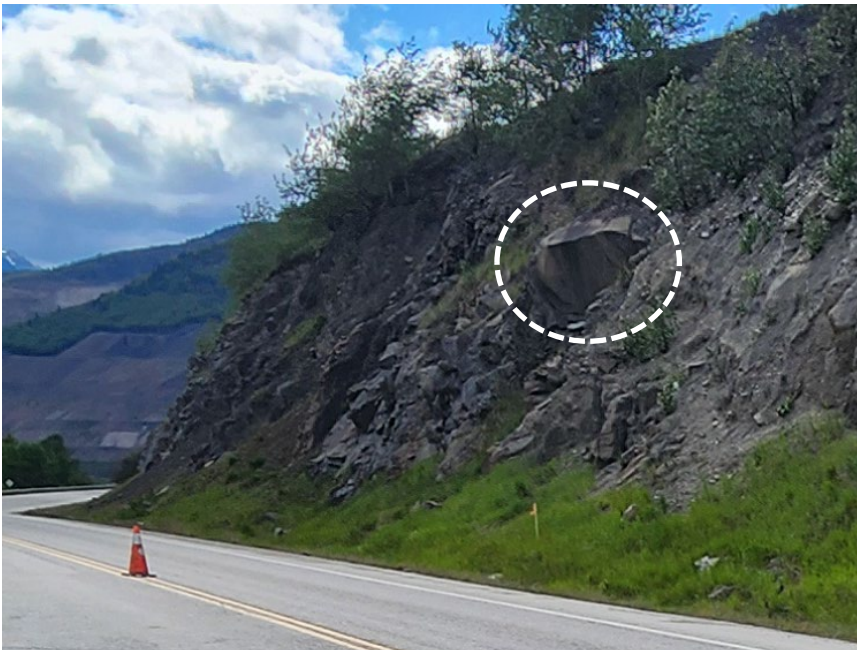
Photo 8 Large overhanging rock block (circled in white) shown in previous photo. Photo taken June 10, 2024, facing northwest.

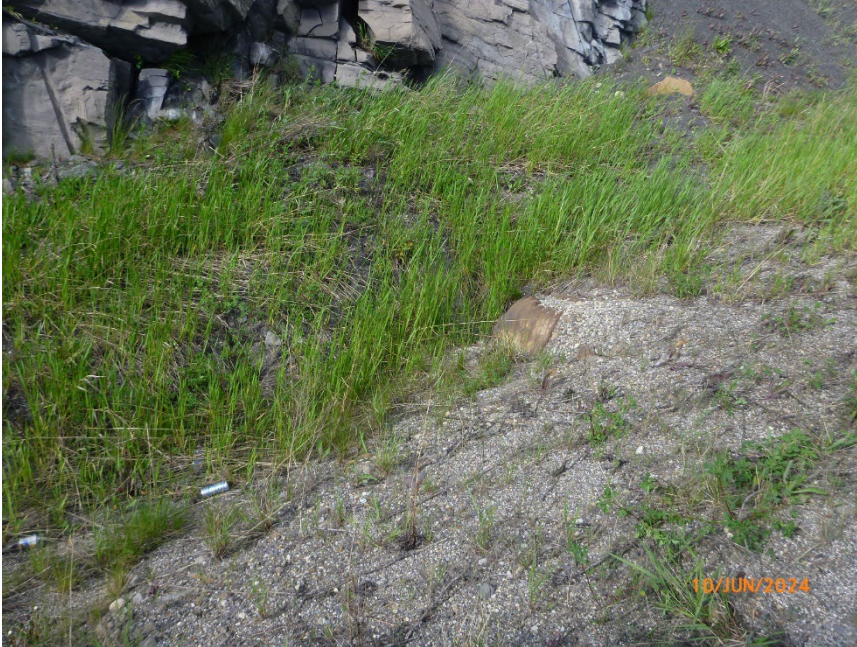
Seepage		X	None observed at time of 2024 inspection.		X
Culvert Distress	X		Culvert inlets crushed and/or partially blocked by rockfall particles in north highway ditch (Photo 9 and 10).		X

Photo 9 Culvert inlet in ditch on north side of Hwy 40:36 at GP053-I site. Culvert inlet damaged and partially blocked by rockfall particles. Photo taken June 10, 2024, facing northeast.

- Repair and/or clean-out culvert inlets which are damaged and partially covered by rockfall particles to maintain ditch flow.
- Long-term:
 - KCB submitted a final preliminary engineering report (PER) in August 2024, which included design of rockfall hazard mitigation actions, for four sites along Hwy 40:36 between km 8.395 to km 17.161, including this site. In the PER the following options were presented:

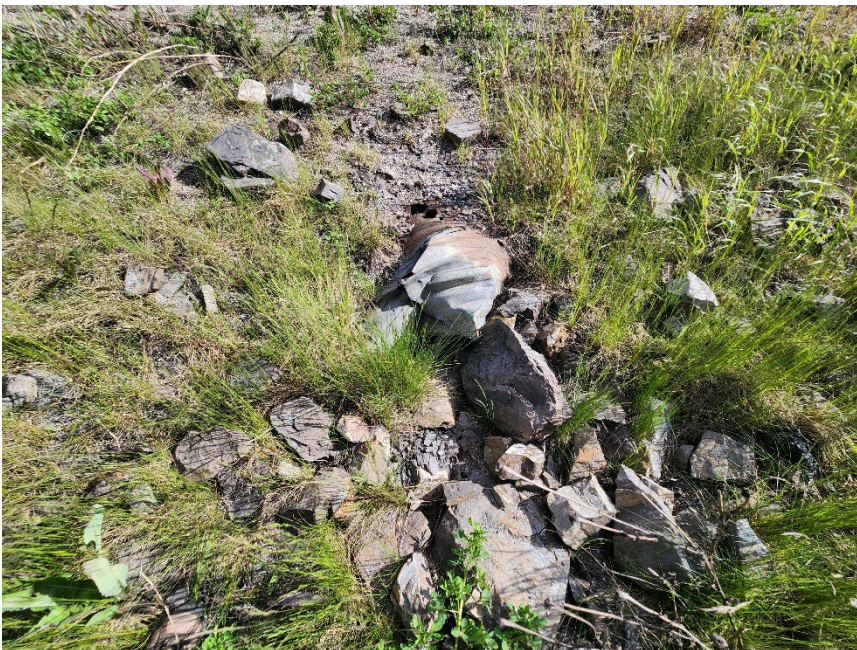
Photo 10 Culvert inlet in ditch on north side of Hwy 40:36 at GP053-I site. Culvert inlet damaged and partially blocked by rockfall particles. Photo taken June 10, 2024, facing south.
