**ALBERTA TRANSPORTATION  
GEOHAZARD ASSESSMENT PROGRAM  
PEACE REGION – GRANDE PRAIRIE DISTRICT  
2020 CALLOUT**

Site Number	Location	Name	Hwy	km
GP53 Call Out	NW of Grande Cache	Candle Road Slide	40:38	7.5
Legal Description		UTM Co-ordinates (NAD 83)		
NE20-61-4-W6		11U N 6,017,112	E 398,940

**2020 INSPECTION PLAN**

**DWG No. 13353-GP53-1**

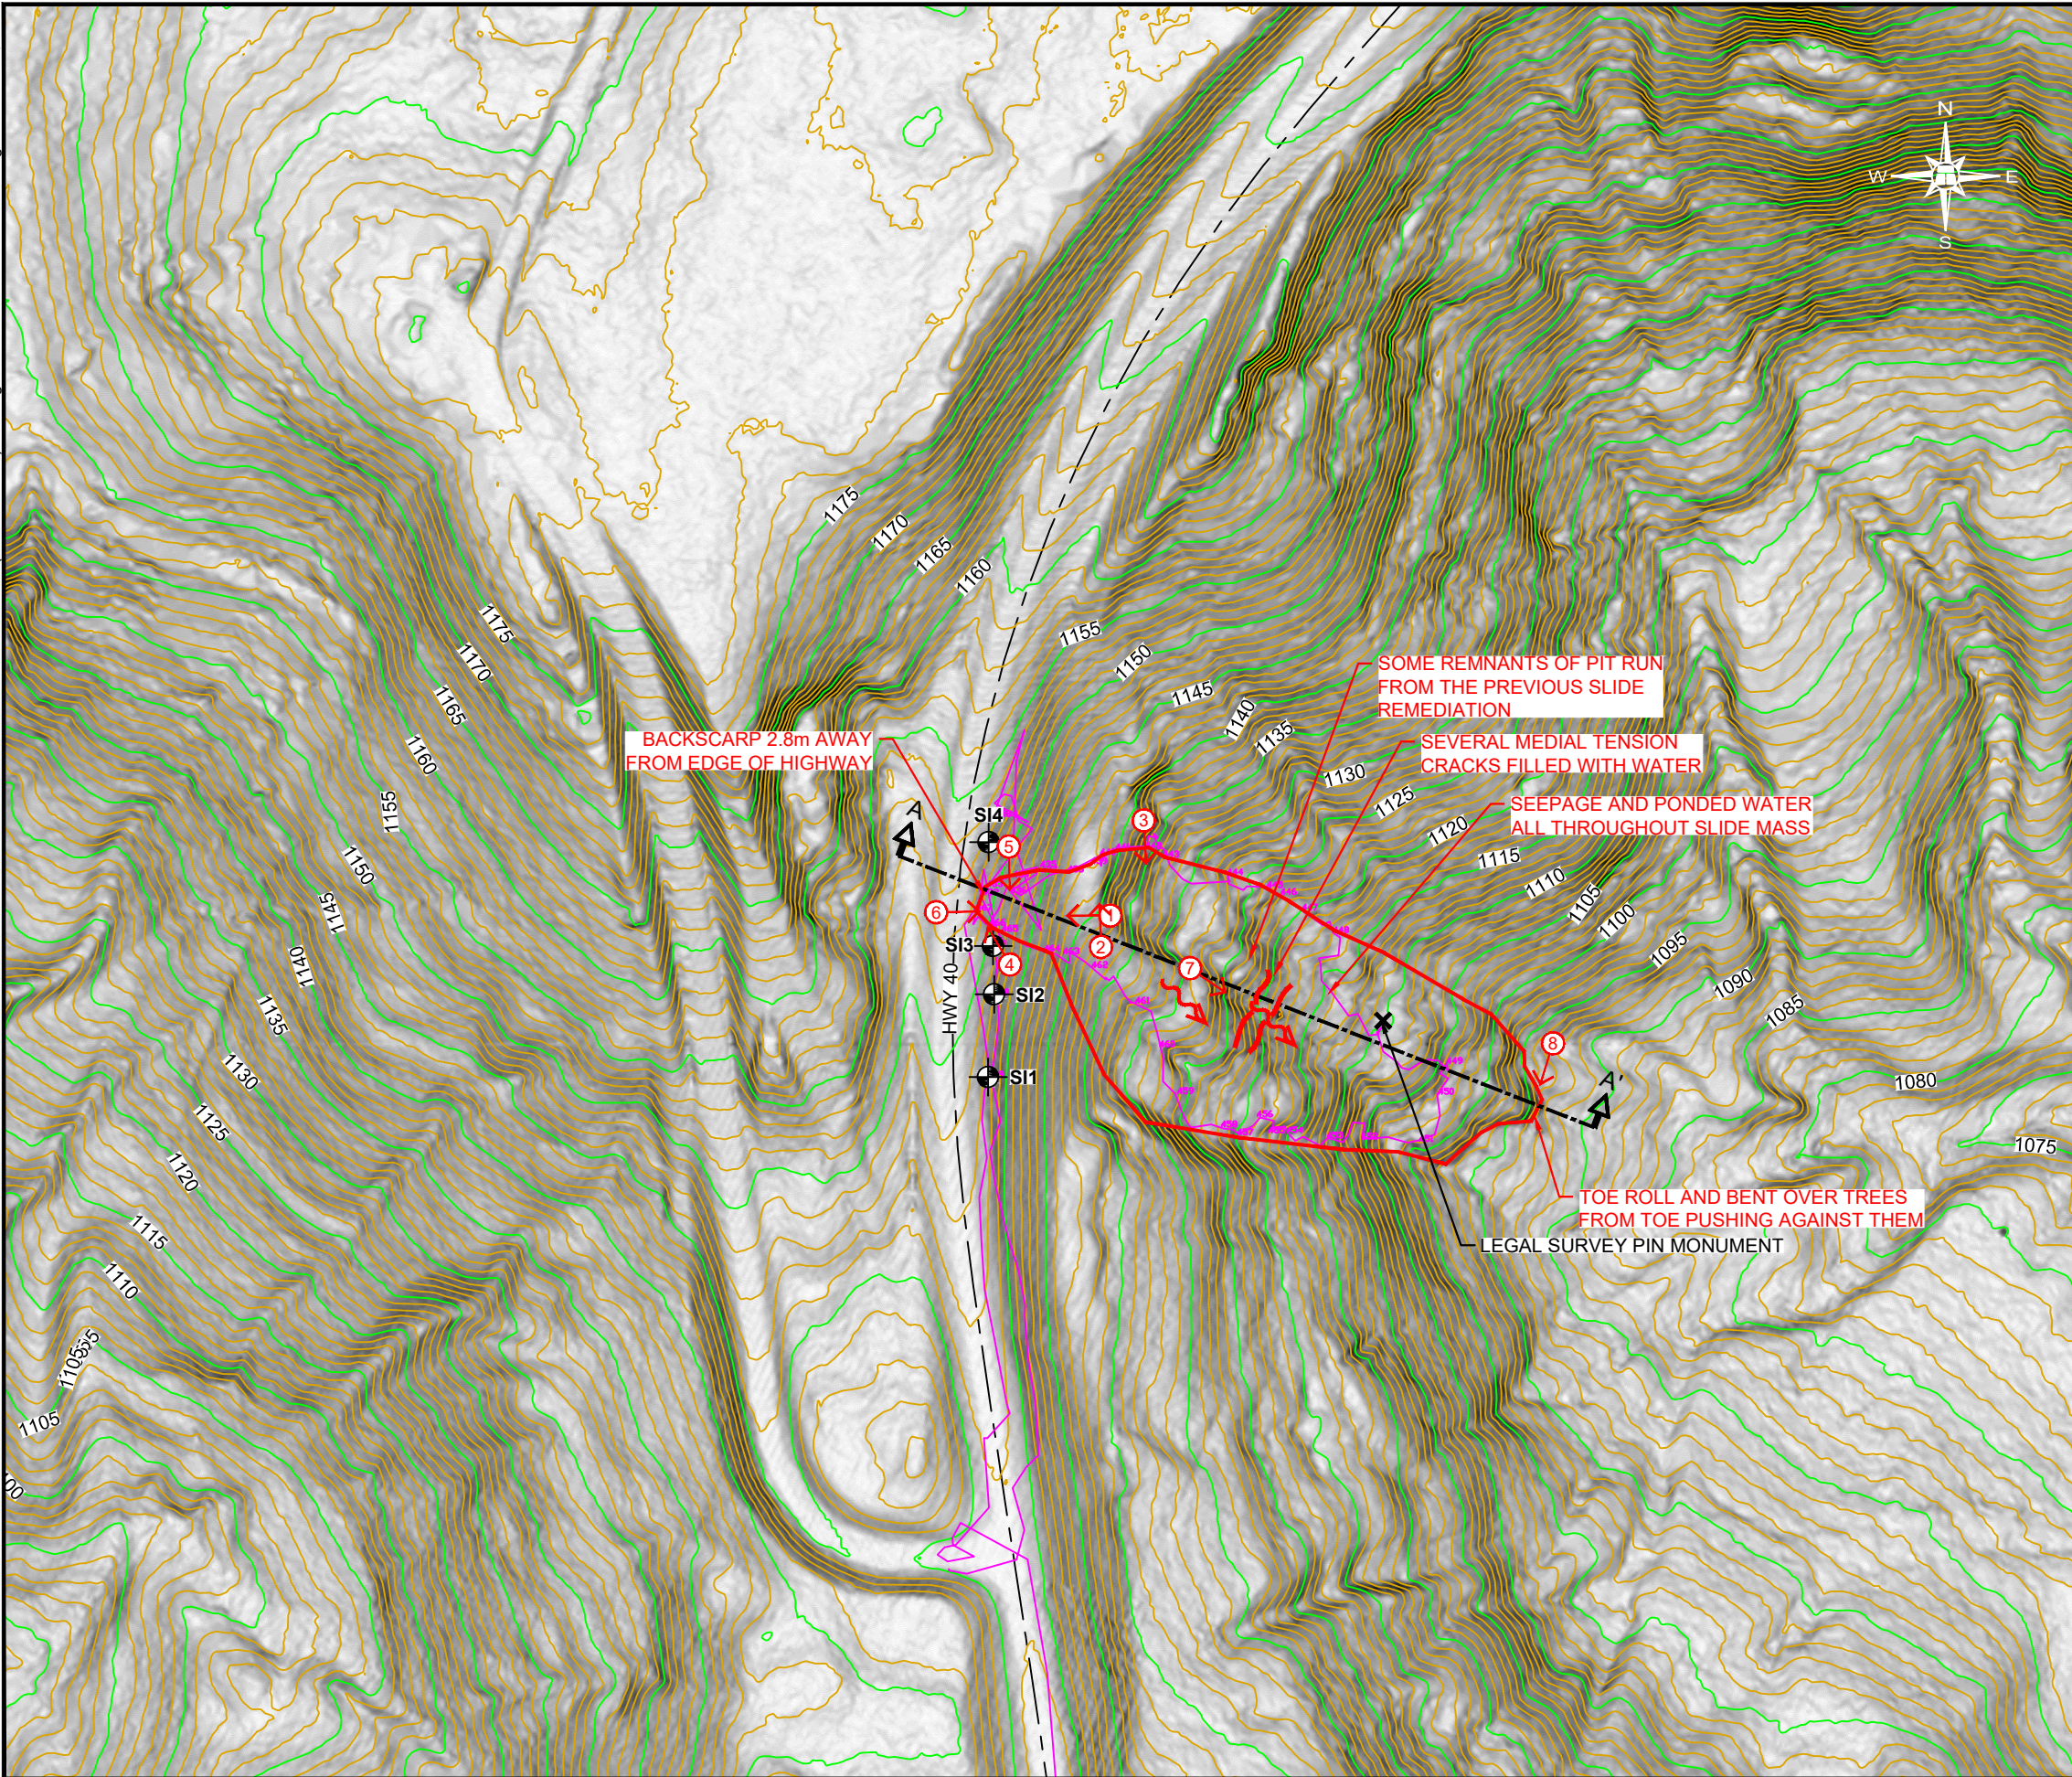
Based on LiDAR (See Dwg. No.13353-Hwy-40:38 Callout-1) the slope affected by the landslide is about 60 m high and inclined at about 3.8H:1V.

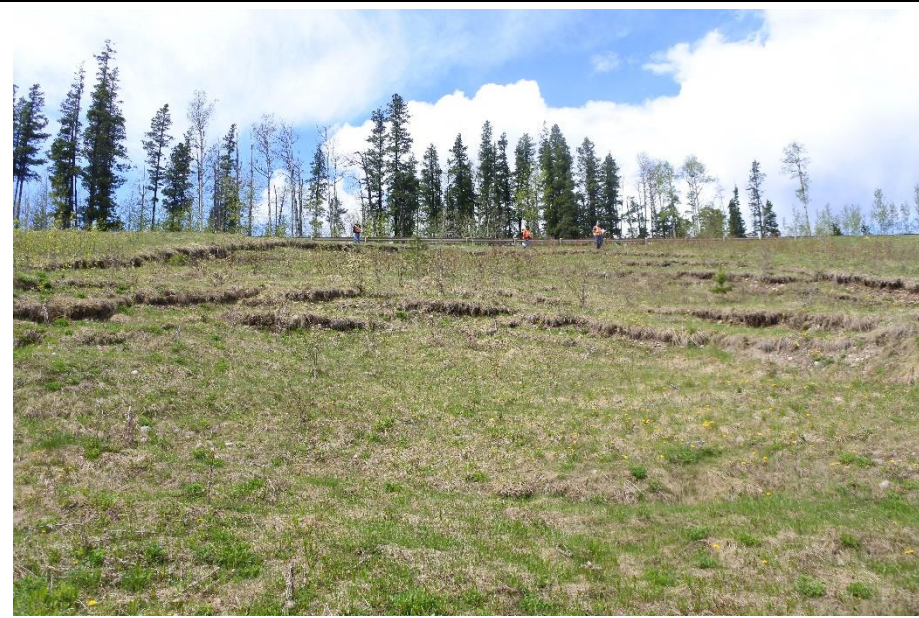
**Photo 1.**  
Looking west up at  
main back scarp.

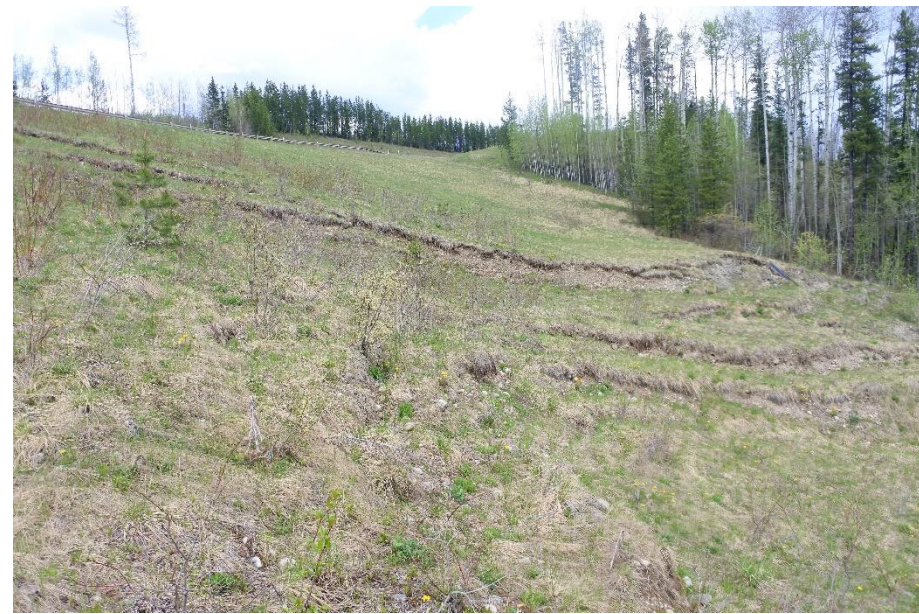
**Photo 2.**  
Looking north  
towards the north  
flank of the  
landslide.

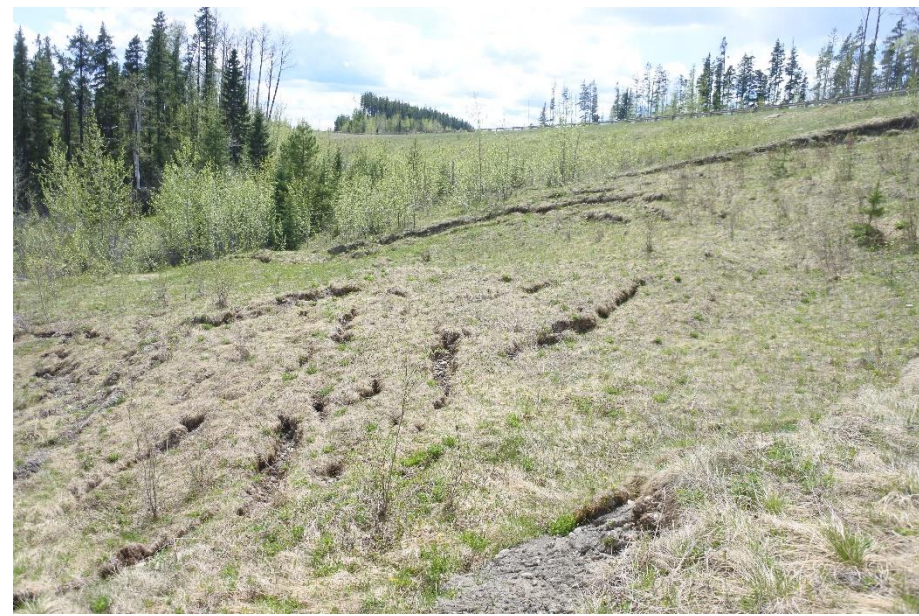
**Photo 3.**  
Looking south  
towards south flank  
of the landslide and  
medial tears.

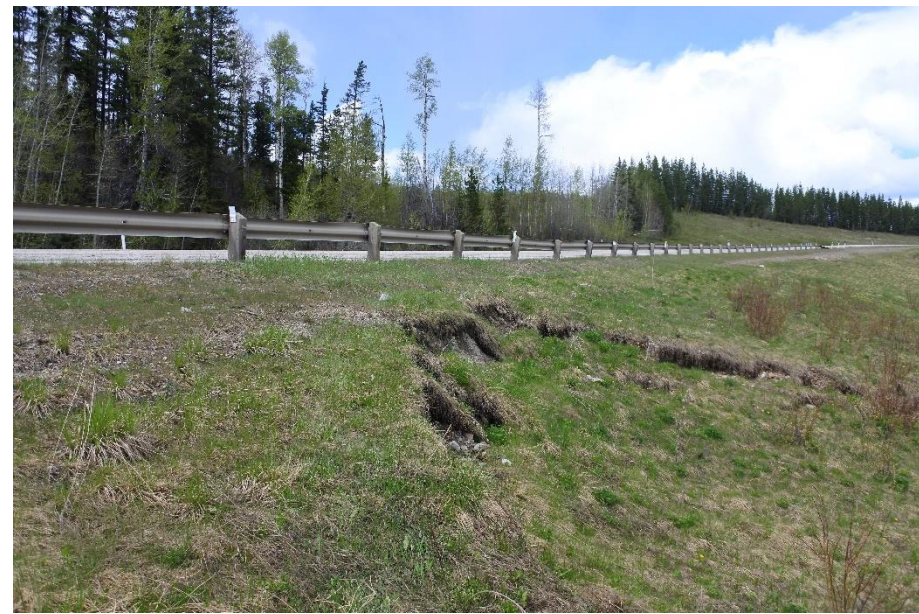
**Photo 4.**  
Looking northwest  
at backscarp  
nearing the  
highway.

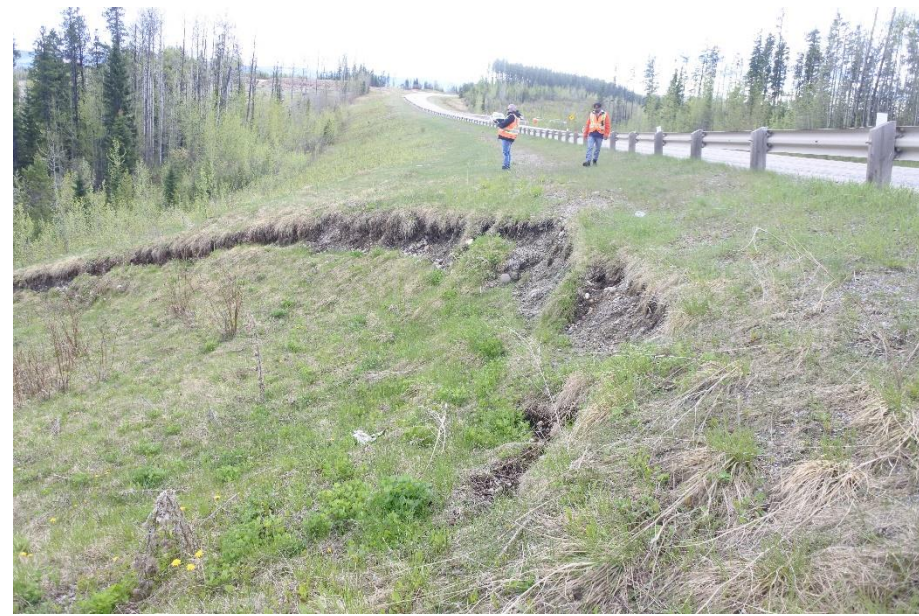
It is anticipated that the slide is based in clay shale and was triggered by water seepage. Poor embankment materials and a steep embankment slope may also have contributed to causing the slide. The main scarp appears to be retrogressing further back towards the highway (measured at 2.8 m from the highway) and could eventually begin to affect the highway. The depth of the slip surface and details of the previous slide repair are not fully known as it is not known whether the excavation of the failed mass was stepped or if they placed the pit run along a sloped plane. If details are available this would be valuable information to obtain.

**Photo 5.**  
Looking south at backscarp which is now 2.8 m away from the highway edge.

In the short term, the slide should be regularly monitored for regression of the slide scarp, which could necessitate adequate signage and traffic control marking one lane driving lane closure if the slide retrogresses into the highway.

Construct a pile wall between the slide and the highway, consisting of steel H piles, or possibly concrete piles with a subdrain installed in the west ditch to help drain subsurface water before it enters the slide area. Also, a portion of the guardrail will have to be removed during construction and a temporary detour will likely have to be constructed on the west side of existing highway to allow two-way traffic.

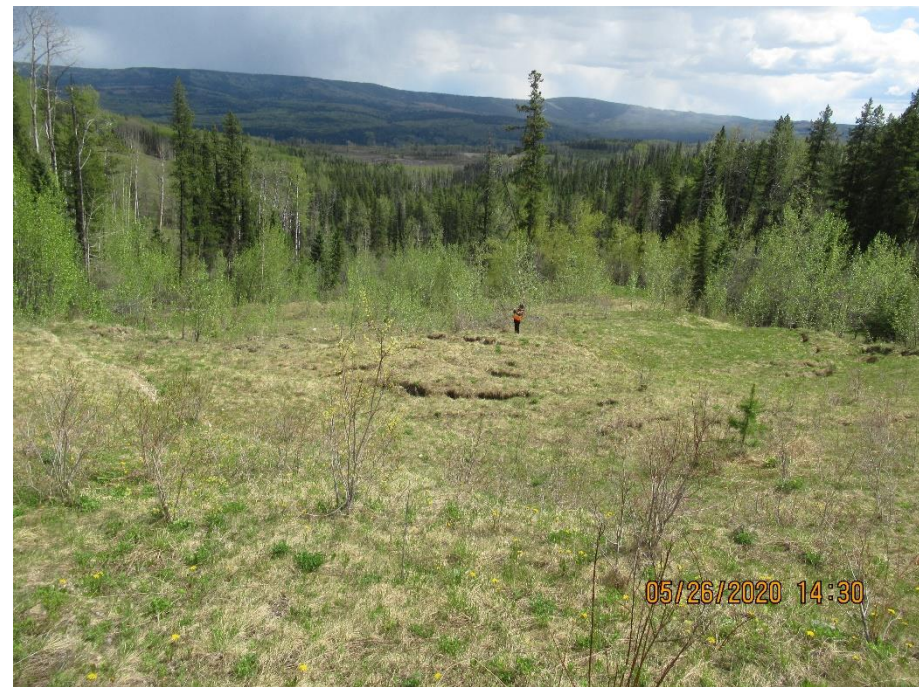
**Photo 6.**  
Looking east down at slide mass and medial tears.

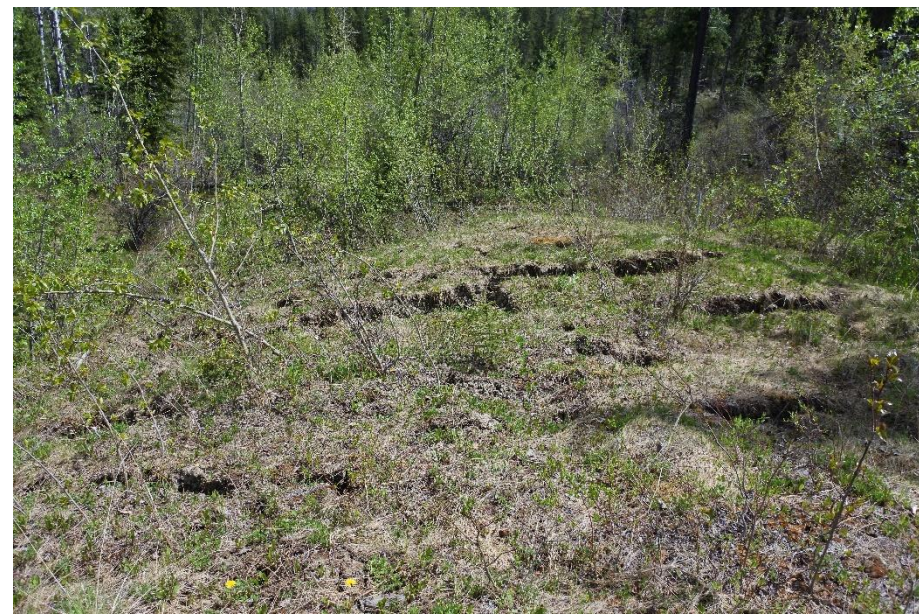
**Photo 7.**  
Looking southeast  
at open tension  
cracks that were  
filled with water.

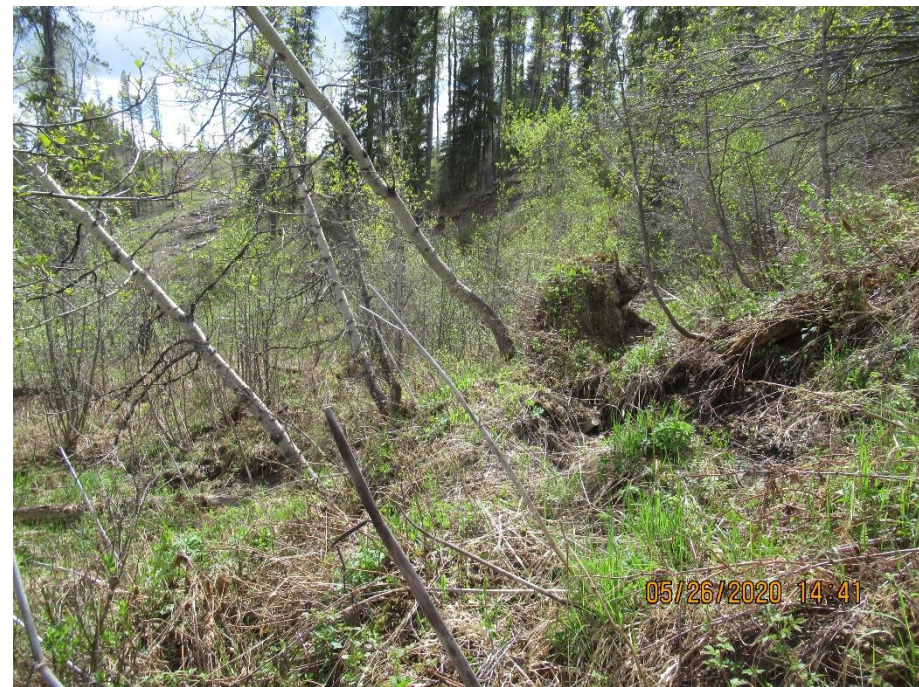
The slide is approximately 215 m long and varies from 25 to 90 m in width. The soils exposed in the slide scarp appeared to consist of gravel fill over clay till. Within the slide mass there were remnants of non-woven geotextile and pit run indicative of a previous slide repair. The toe bulge of the slide was approximately 0.5 m high, with many tilted/bent trees, which suggests prior, continuous movements.

**Photo 8.**  
Looking south at  
toe roll where the  
toe has pushed  
over some trees.
