**SITE INSPECTION FORM**

<b>SITE NUMBER AND NAME:</b> GP002 Candle Road Slide		<b>HIGHWAY &amp; KM:</b> 40:38, 7.439	<b>PREVIOUS INSPECTION DATE:</b> July 20, 2021	<b>INSPECTION DATE:</b> <b>June 13, 2023</b>
<b>LEGAL DESCRIPTION:</b> NE 20-61-04-W6M	<b>NAD 83 COORDINATES:</b> UTM Northing Easting 11 6017104 39852		<b>RISK ASSESSMENT:</b> PF: 7 CF: 2 TOTAL: 14	
<b>AVERAGE ANNUAL DAILY TRAFFIC (AADT):</b> 840 (north) & 800 (south) (Reference No. 70000673, 2022)			<b>CONTRACT MAINTENANCE AREA (CMA):</b> 504

PROJECT  
 PEACE REGION (GRANDE PRAIRIE DISTRICT-SOUTH)  
 GEOHAZARD RISK MANAGEMENT PROGRAM

TITLE  
 Site Plan  
 GP002 - Candle Road Slide  
 Hwy 40:38 km, 7.439

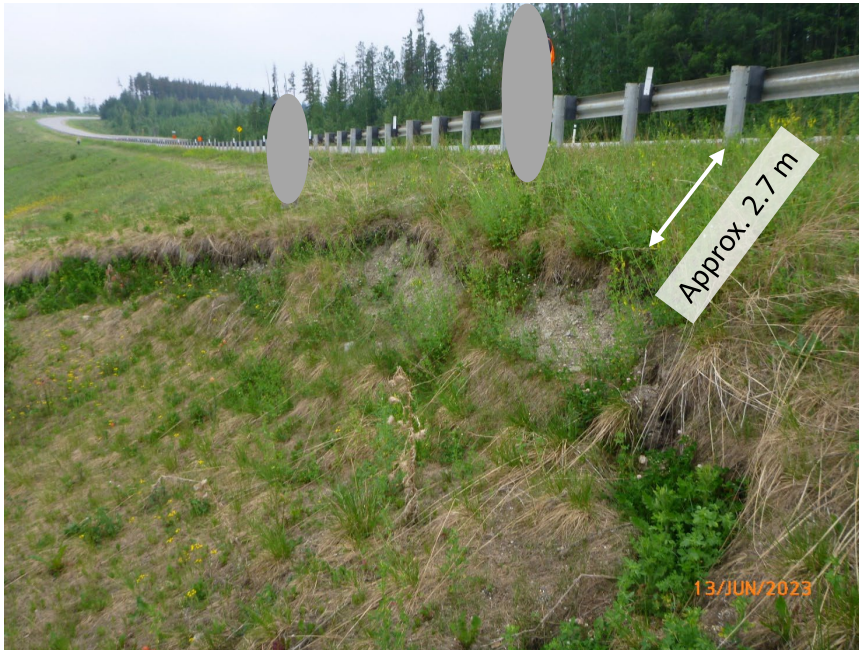
**Photo 1** Slide backscarp on east side of Hwy 40:38 approximately 2.7 m away from guardrail. Photo taken June 13, 2023, facing southwest.

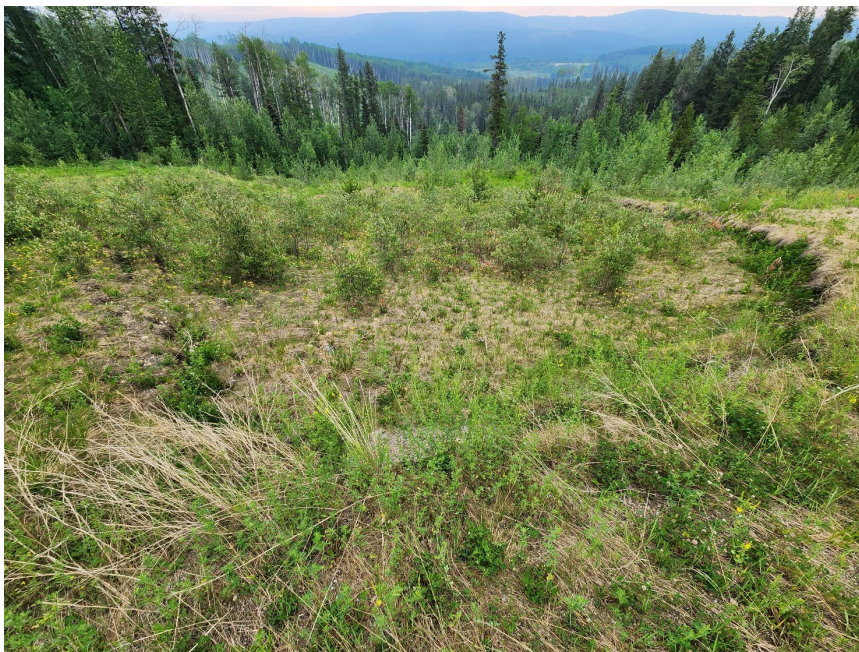
**Photo 2** Slide viewed from crest of slope. Photo taken June 13, 2023, facing east.

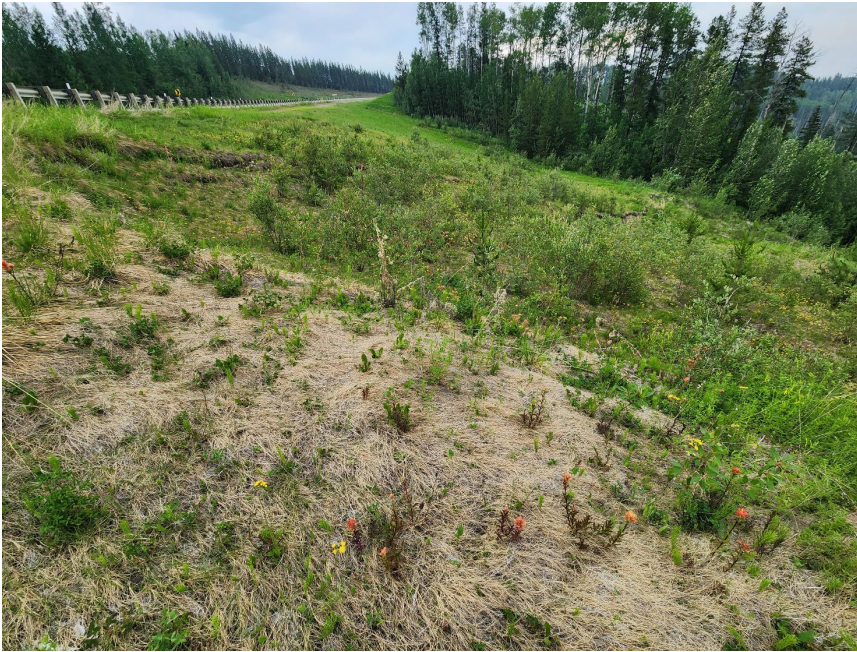
**Photo 3** Looking across top of slide from south/right flank. Photo taken June 13, 2023, facing north.

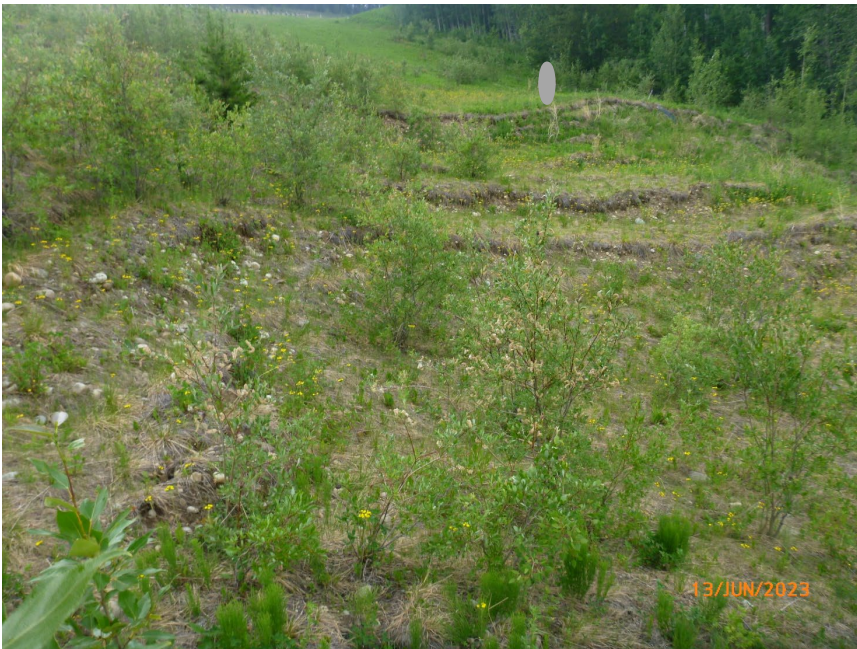
**Photo 4** Looking across middle of slide from south/right flank near WP303. Note subrounded to rounded gravel and cobbles exposed on slope. Photo taken June 13, 2023, facing north.

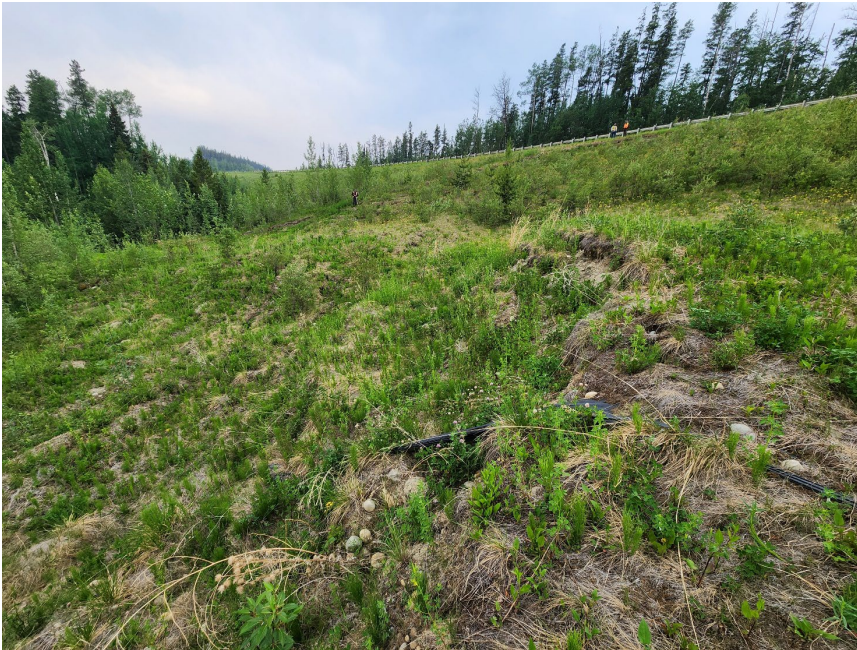
**Photo 5** Looking across middle of slide from north/left flank. Photo taken June 13, 2023, facing southwest.

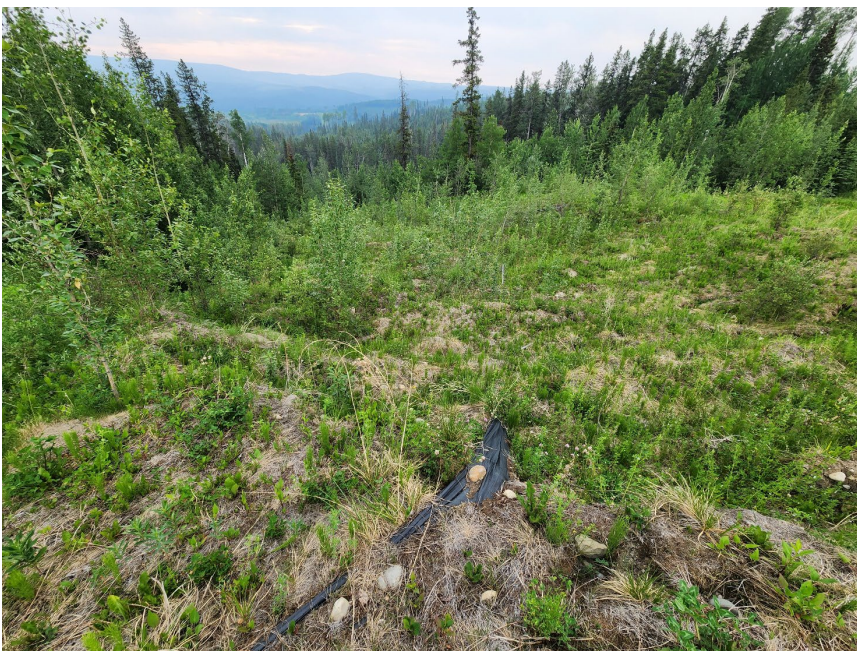
**Photo 6** Exposed silt fencing near toe of slide at north/left flank. Photo taken June 13, 2023, facing southeast.

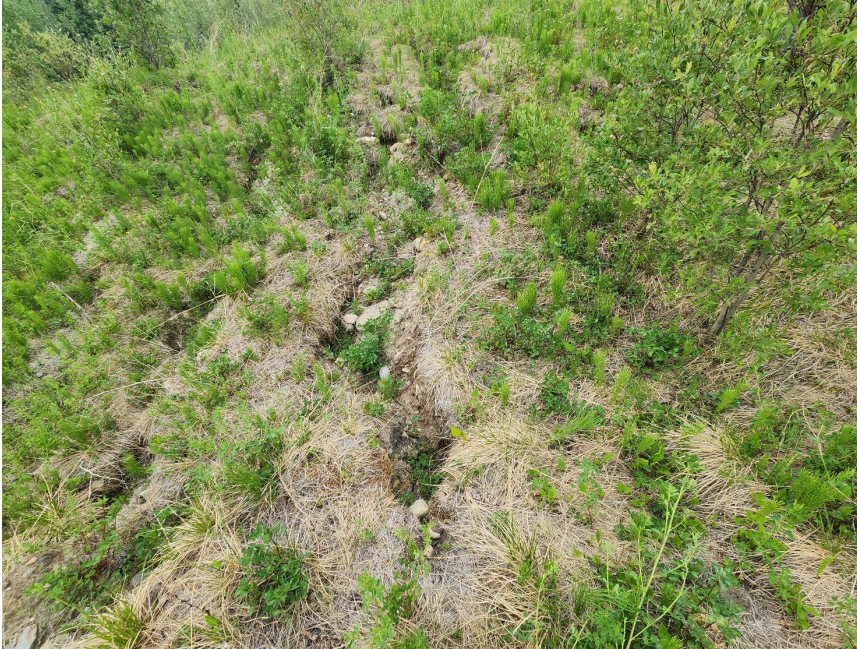
**Photo 7** Cracking within lower slide area. Photo taken June 13, 2023, facing down.

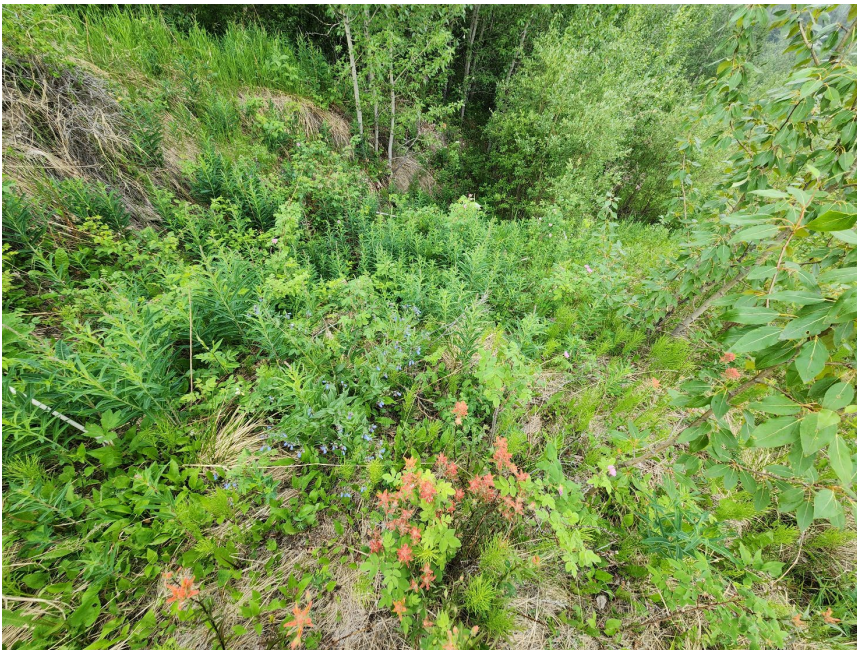
**Photo 8** Gully near north side of slide. Photo taken June 13, 2023, facing east.

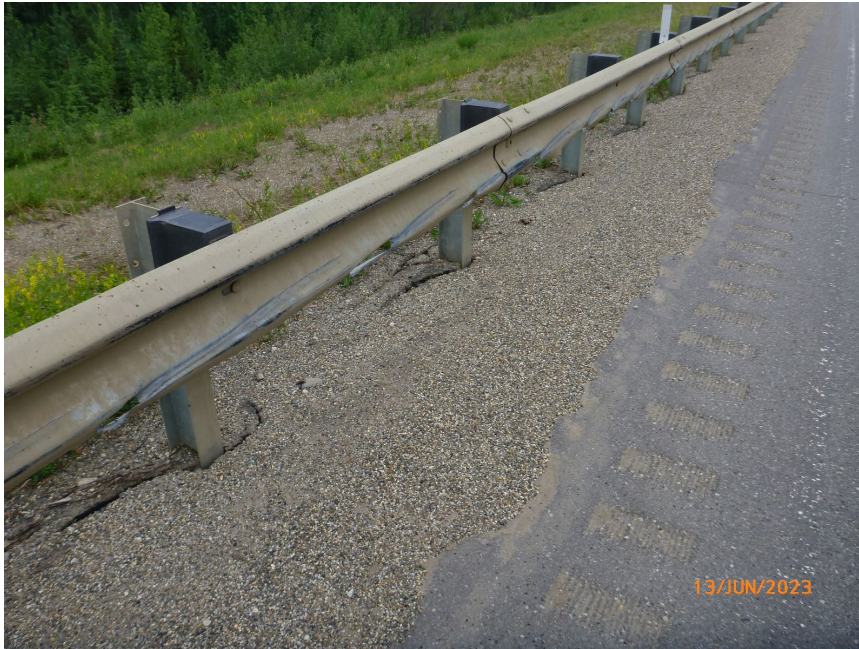
**Photo 9** Section of guardrail which was struck and damaged south of site. Note guardrail posts shifted damaging pavement around posts. Photo taken June 13, 2023, facing southeast.

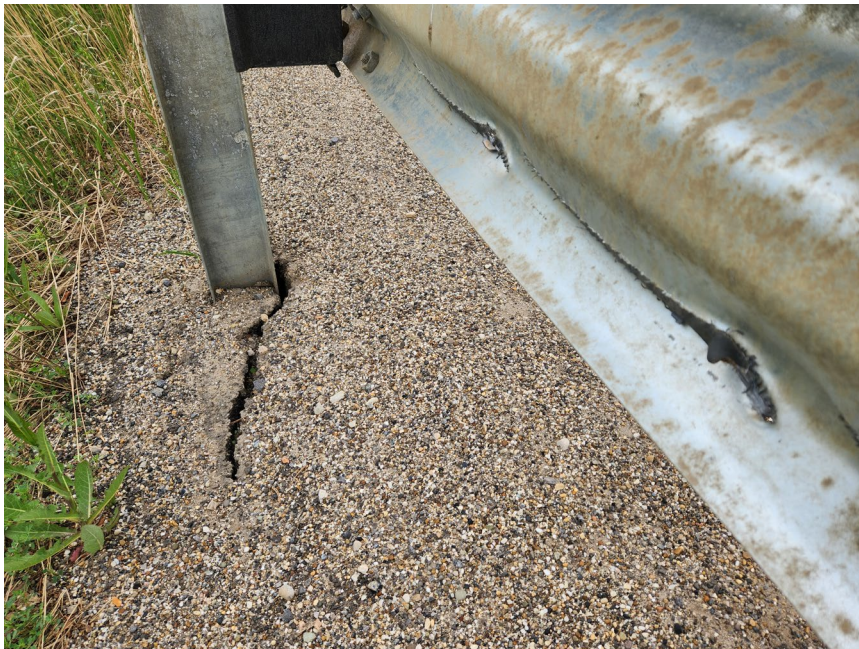
**Photo 10** Section of guardrail which was struck and damaged south of site. Photo taken June 13, 2023, facing south.
