**PEACE REGION  
(GRANDE PRAIRIE DISTRICT – SOUTH) GRMP**

**SITE INSPECTION FORM**

<b>SITE NUMBER AND NAME:</b> GP003-I and II Cutbank River Slides (South) (Roseham Creek)		<b>HIGHWAY &amp; KM:</b> 40:38, 52.134	<b>PREVIOUS INSPECTION DATE:</b> June 15, 2022	<b>INSPECTION DATE:</b> <b>June 11, 2024</b>
<b>LEGAL DESCRIPTION:</b> NE 16-65-05-W6M SE-16-65-05-W6M	<b>NAD 83 COORDINATES:</b> UTM Northing Easting 11 6054593 391085		<b>RISK ASSESSMENT:</b> PF: 11 CF: 4 TOTAL: 44	
<b>AVERAGE ANNUAL DAILY TRAFFIC (AADT):</b> 2,300 (north) & 2,280 (south) (Reference No. 7000761, 2023)			<b>CONTRACT MAINTENANCE AREA (CMA):</b> 504

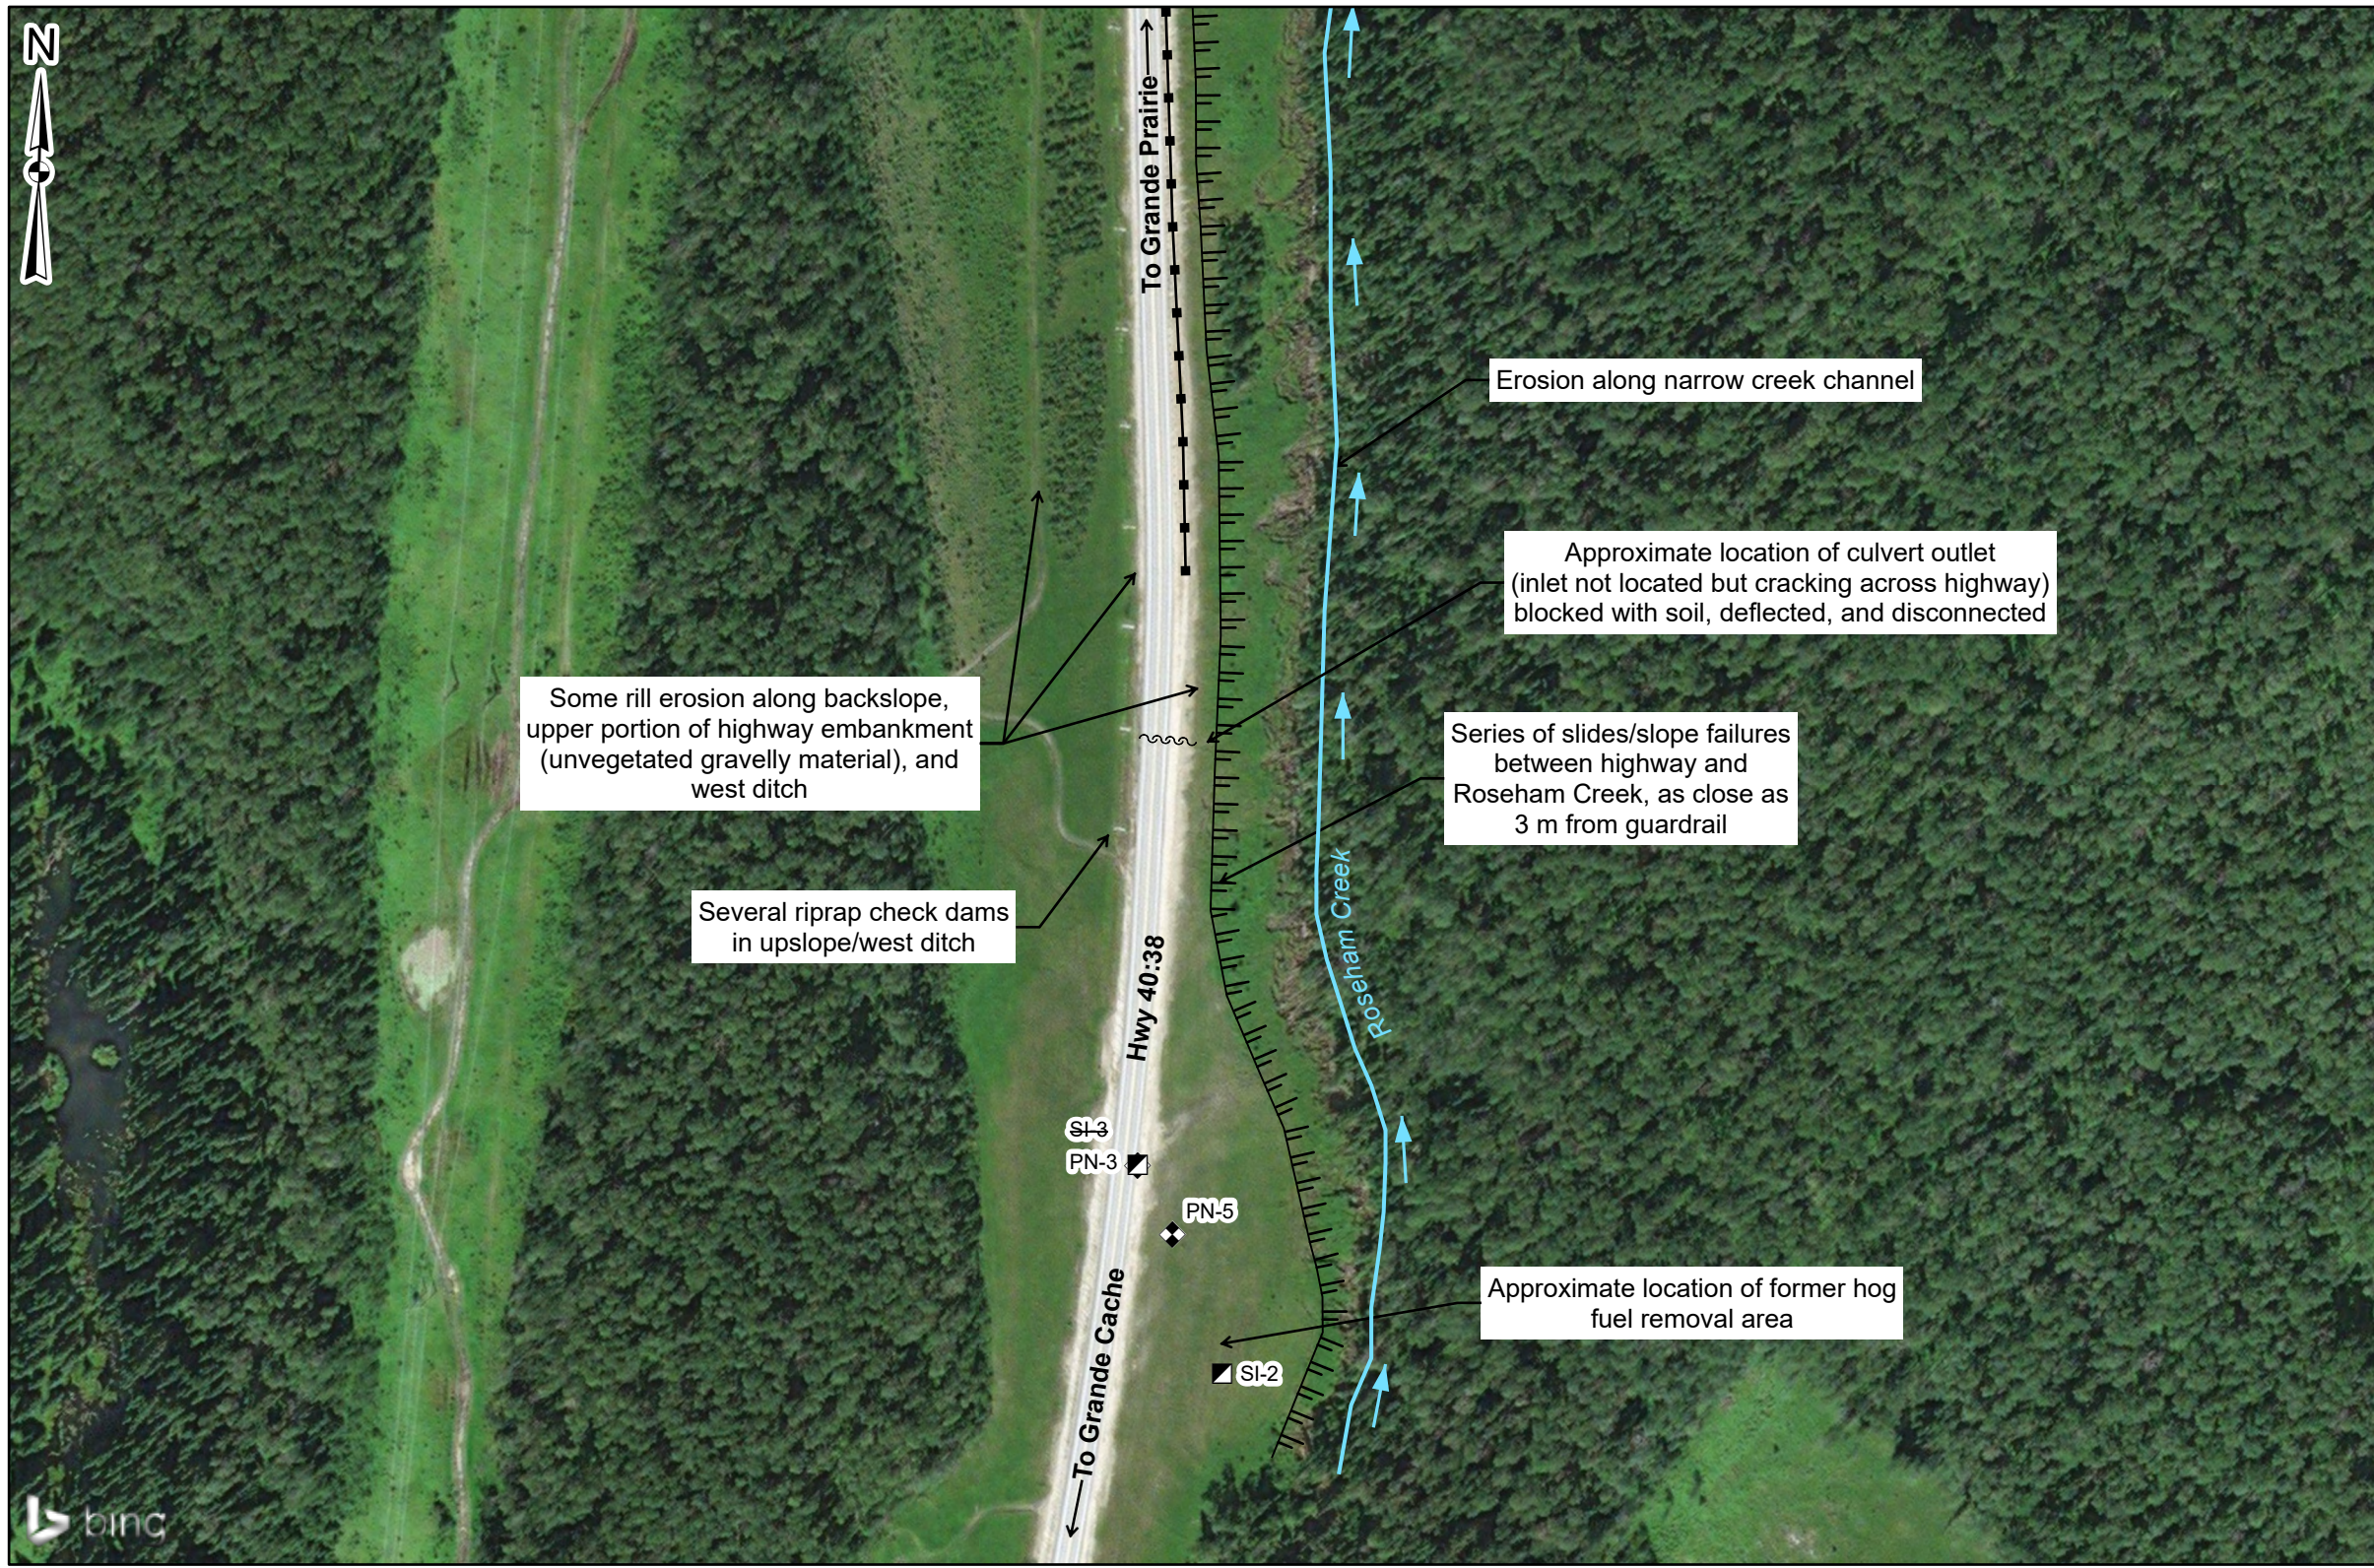
PROJECT	PEACE REGION (GRANDE PRAIRIE DISTRICT-SOUTH) GEOHAZARD RISK MANAGEMENT PROGRAM	
TITLE	Site Plan GP003-I and -II - Cutbank River Slides (South) Hwy 40:38, km 52.134	
SCALE	PROJECT No. A05116A01	FIG No. 1

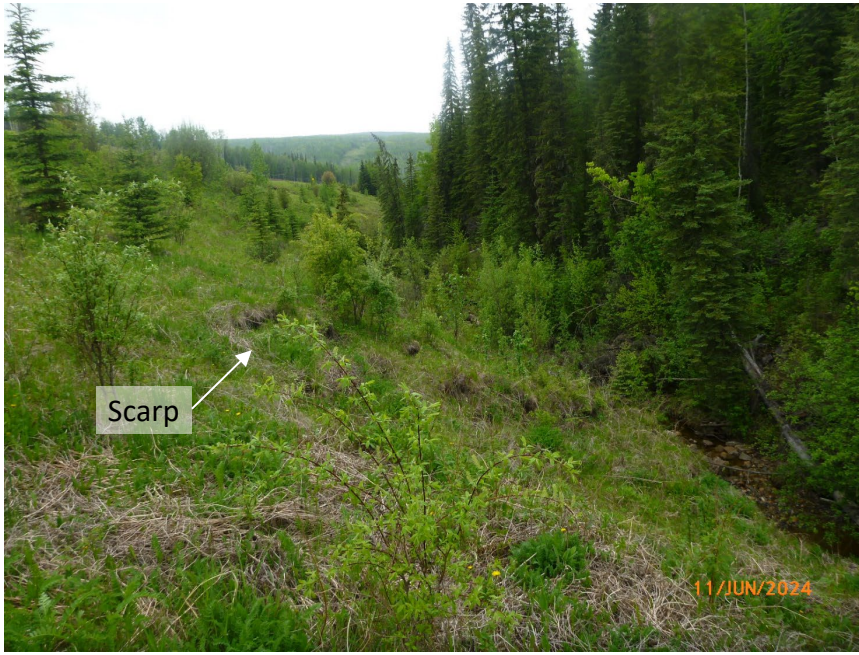
**Photo 1** Slope failure and slide scarps near creek on east side of Hwy 40:38. Photo taken June 11, 2024, facing north.

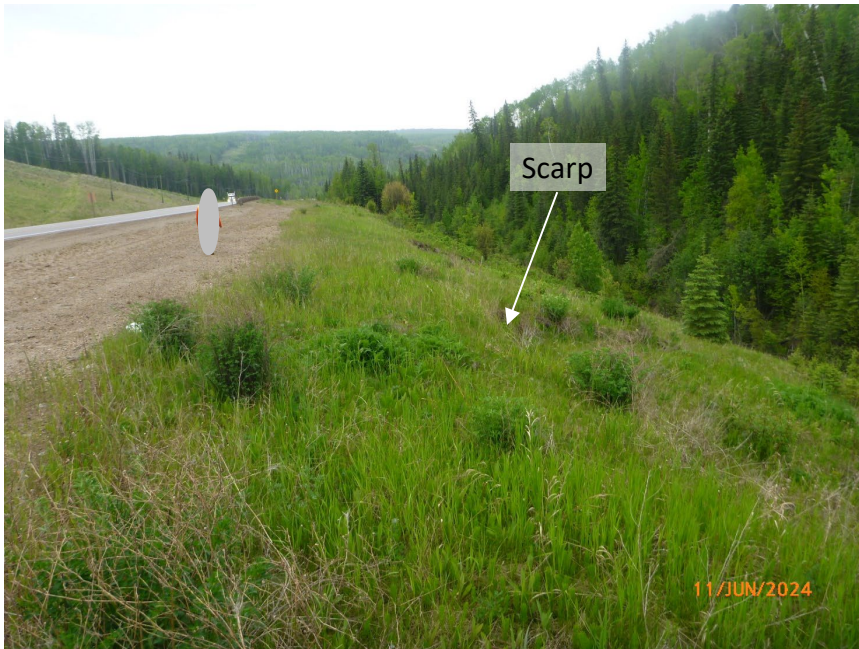
**Photo 2** Slope failure and slide scarps between Hwy 40:38 and Roseham Creek. Photo taken June 11, 2024, facing north.

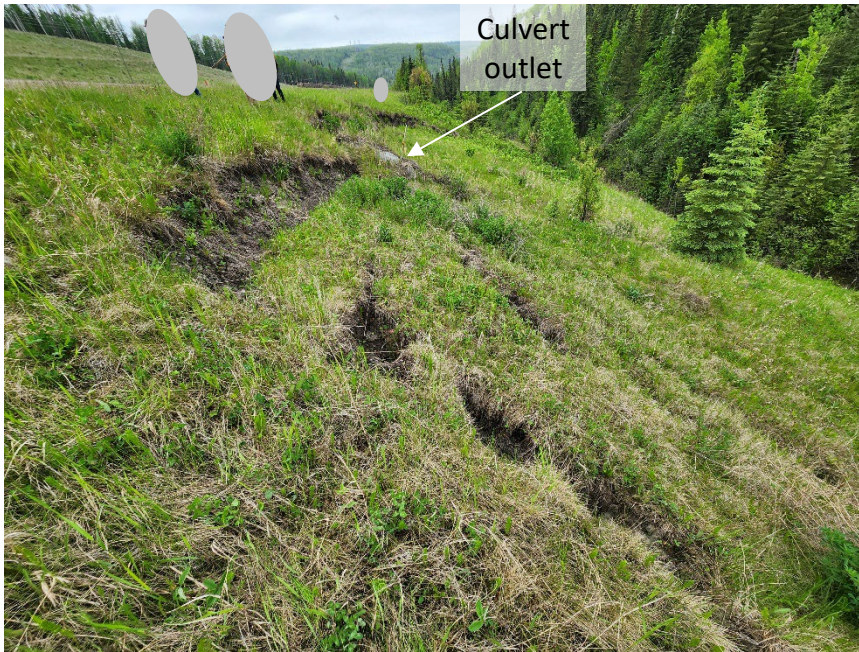
**Photo 3** Slope failure and slide scarps between Hwy 40:38 and Roseham Creek. Note culvert outlet, see next photo. Photo taken June 11, 2024, facing north.

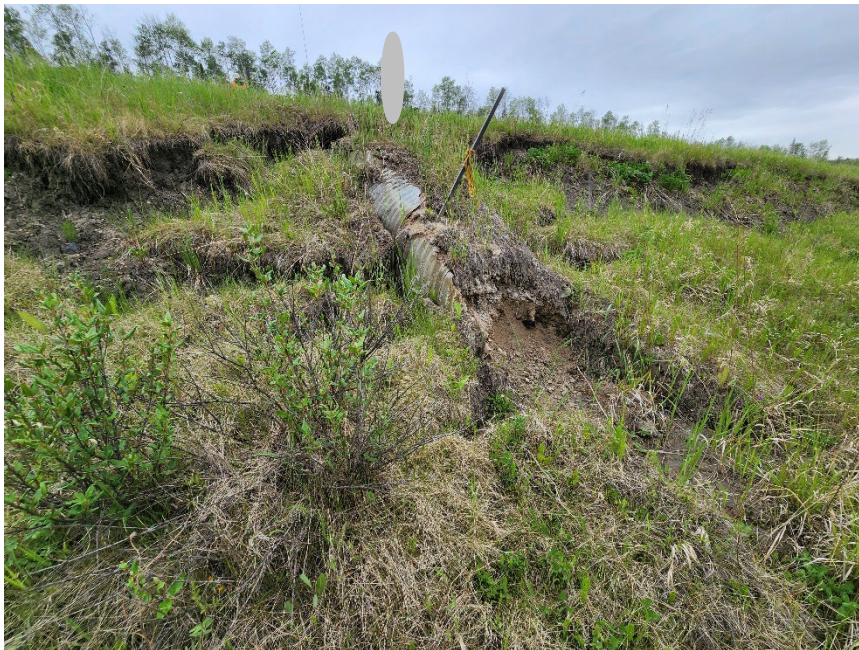
**Photo 4** Culvert outlet on east side of Hwy 40:38 deflected, disconnected, and blocked with soil. Culvert inlet not visible in ditch on west side of highway. Photo taken June 11, 2024, facing northwest.

- Continue to maintain and clean existing subdrain system.
- Monitor seepage around culvert outlet on east side of highway. Monitor for signs of sinkhole activity in west highway ditch where inlet of culvert could be buried.

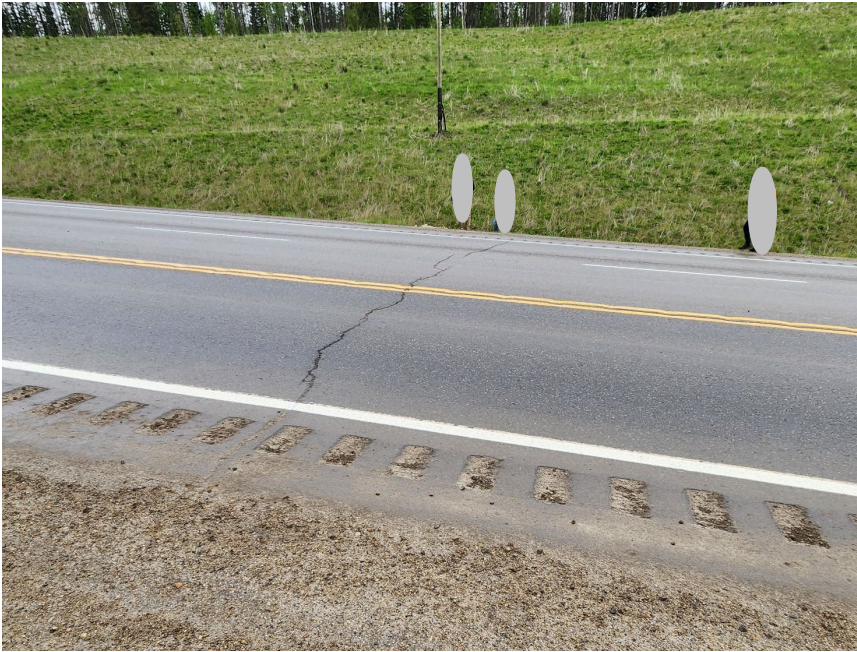
**Photo 5** Culvert inlet not visible in ditch on west side of highway, but pavement surface cracked above likely culvert alignment. Photo taken June 11, 2024, facing northwest.

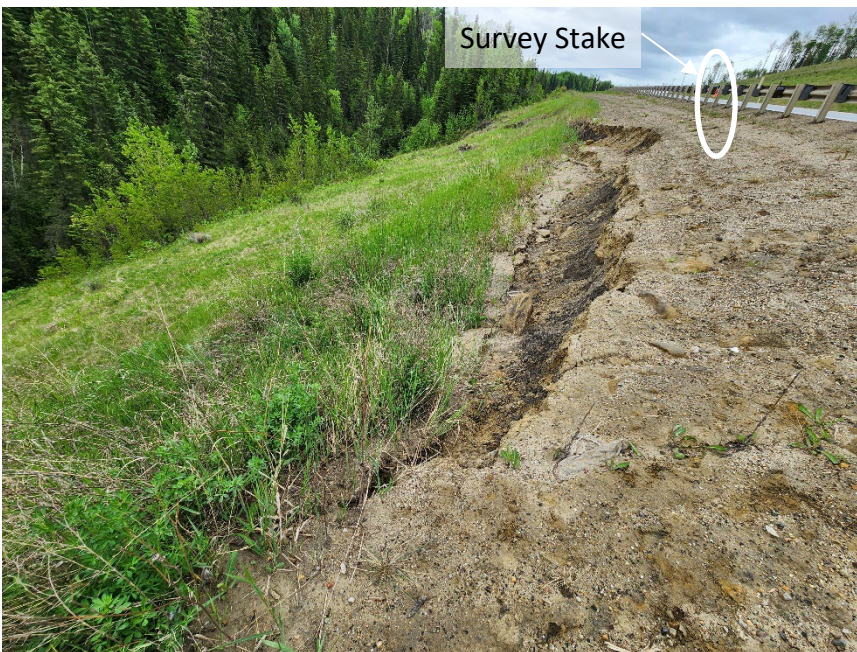
- Closest slide scarp approximately 3 m from guardrail.
- Reference/survey stake with flagging placed approximately 1 m from slide scarp and 2 m from guardrail to monitor slide retrogression towards highway. Previous reference/survey stake placed in 2022 had fallen down and could not be found.

**Photo 6** Slope failure and slide scarps between Hwy 40:38 and Roseham Creek. Note rill erosion on upper portion of slope (unvegetated gravelly material) and reference/survey stake with flagging (circled in white) to monitor retrogression of slide scarp. Photo taken June 11, 2024, facing south.

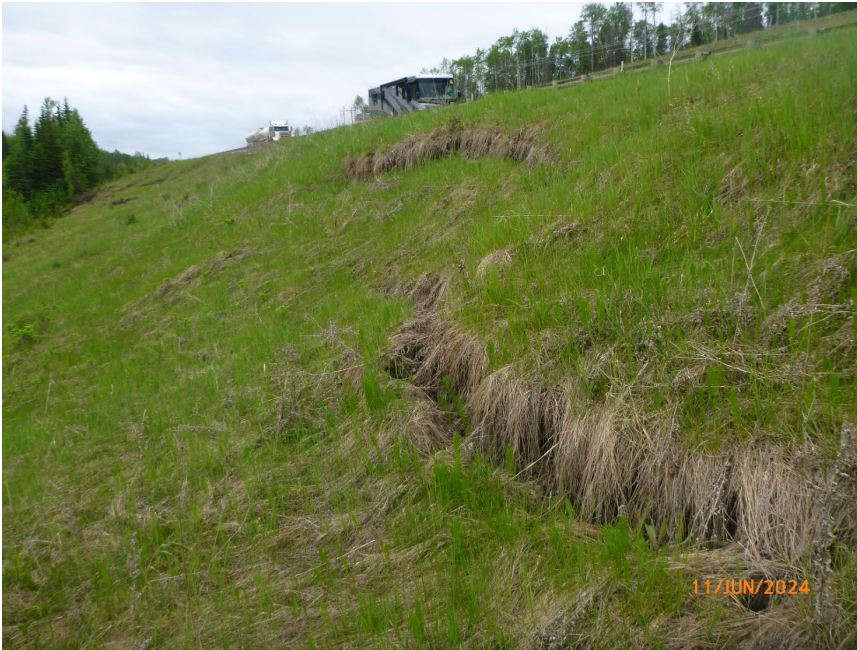
Base of creek channel narrow with slopes squeezing in from either side, and in some locations partially blocked by fallen trees (Photo 7). Active erosion occurring along creek channel, resulting in steep sides slope (approximately 5 m high) adjacent to creek. Many leaning trees near base of creek channel.

**Photo 7** Slope failure and slide scarps between Hwy 40:38 and Roseham Creek. Photo taken June 11, 2024, facing south near north end of site.

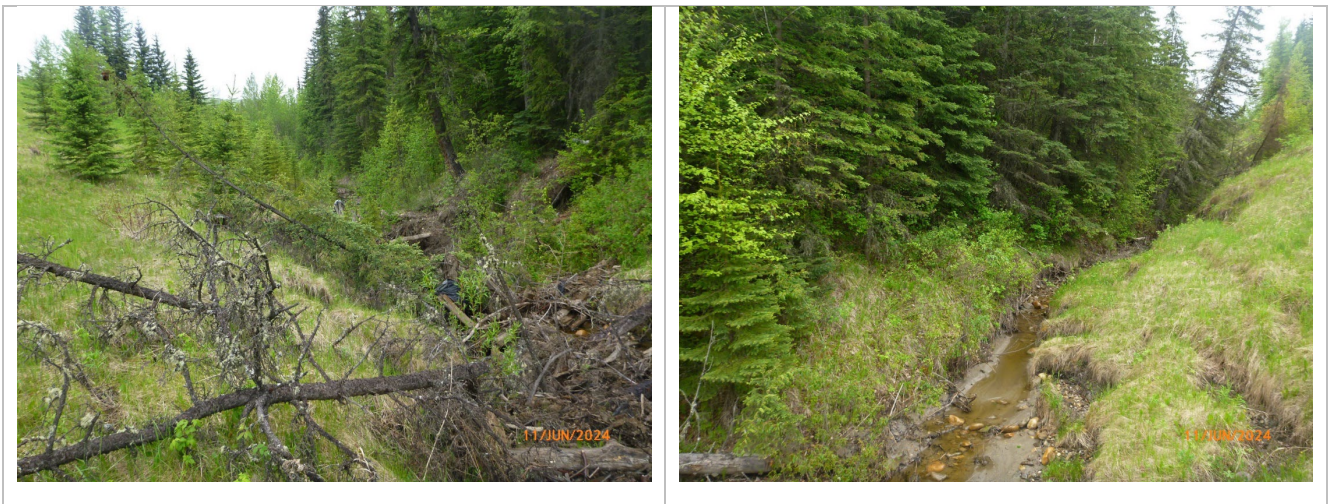
- Former hog fuel removal area well vegetated with no signs of movement, except along creek channel (Photos 8 and 9).

**Photo 8** Roseham Creek. Note narrow channel width and slopes squeezing in from either side. Photos taken June 11, 2024, facing north and south, respectively.

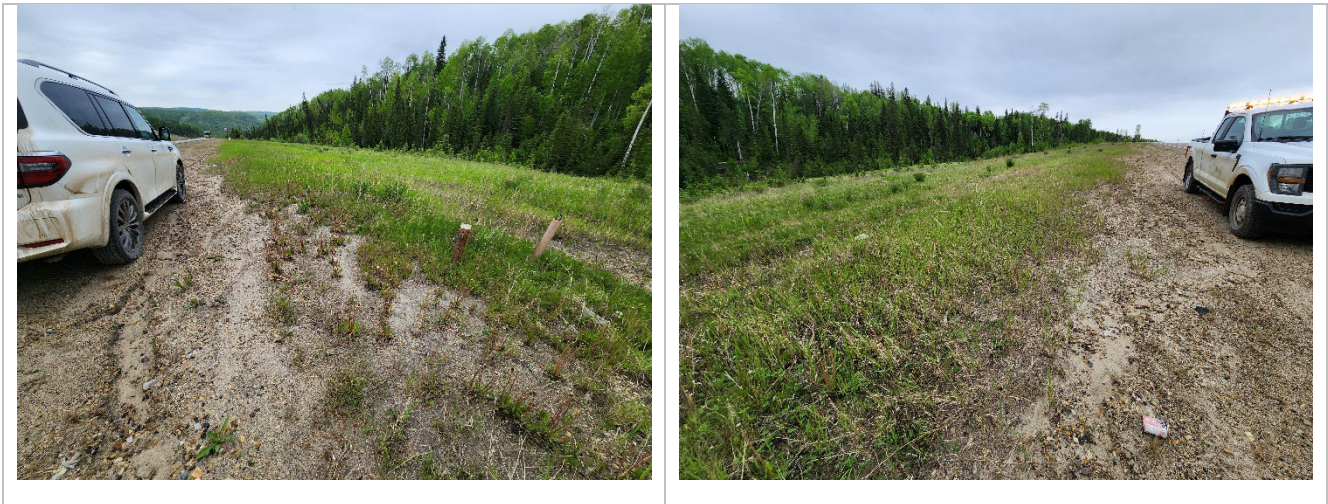
**Photo 9** Former hog fuel removal area at south end of GP003 site. Photos taken June 11, 2024, facing north and south, respectively.

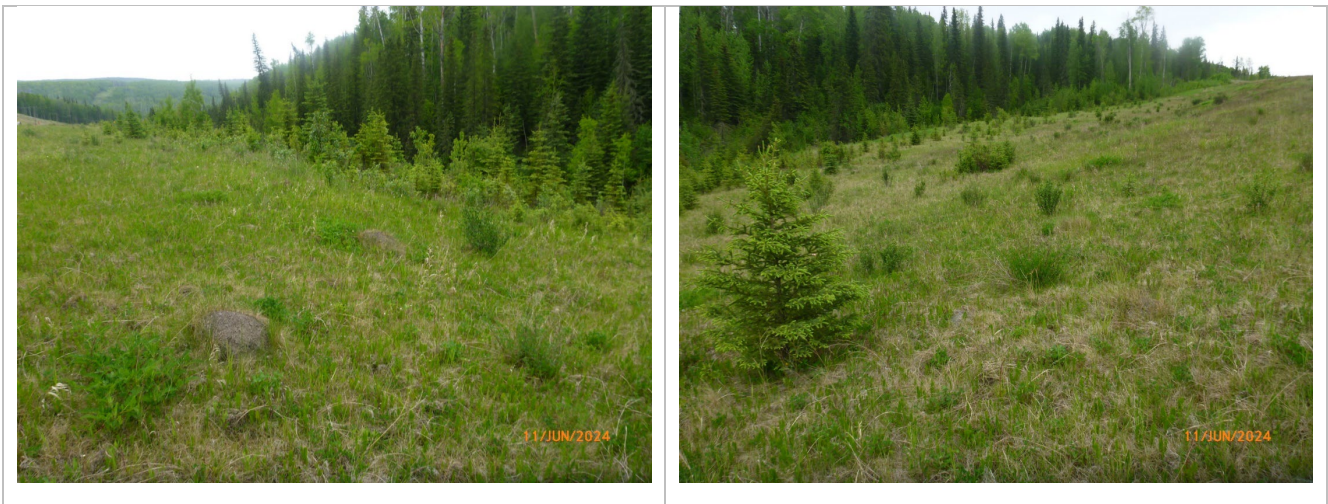
**Photo 10** Former hog fuel removal area at south end of GP003 site. Photos taken June 11, 2024, facing north and south, respectively.

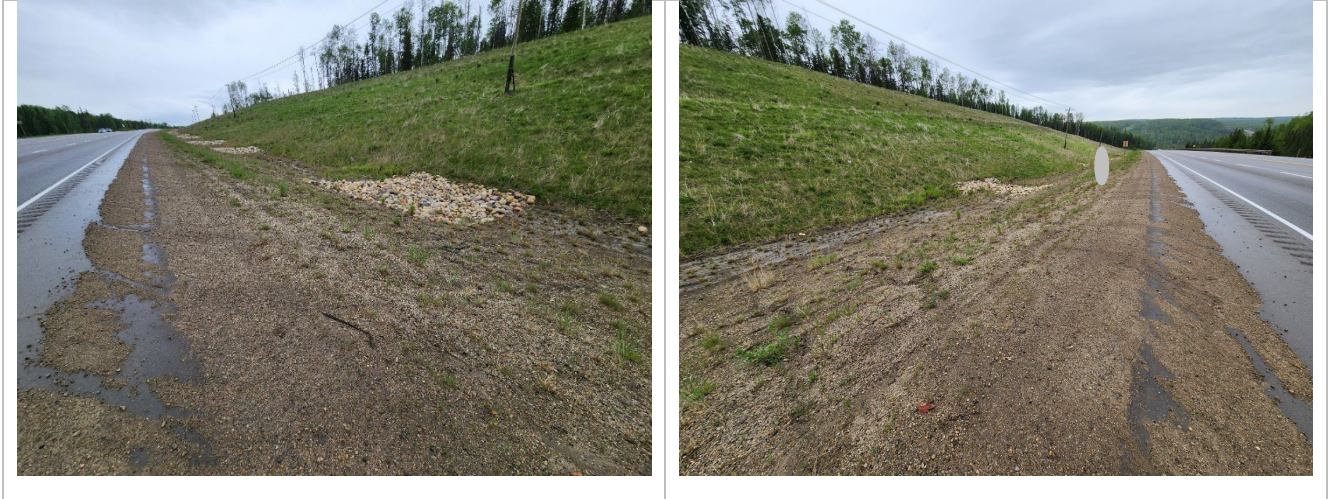
**Photo 11** Backslope on west side of Hwy 40:38. Note riprap check dams and rill erosion in/along ditch channel. Photos taken June 11, 2024, facing southwest and northwest, respectively.

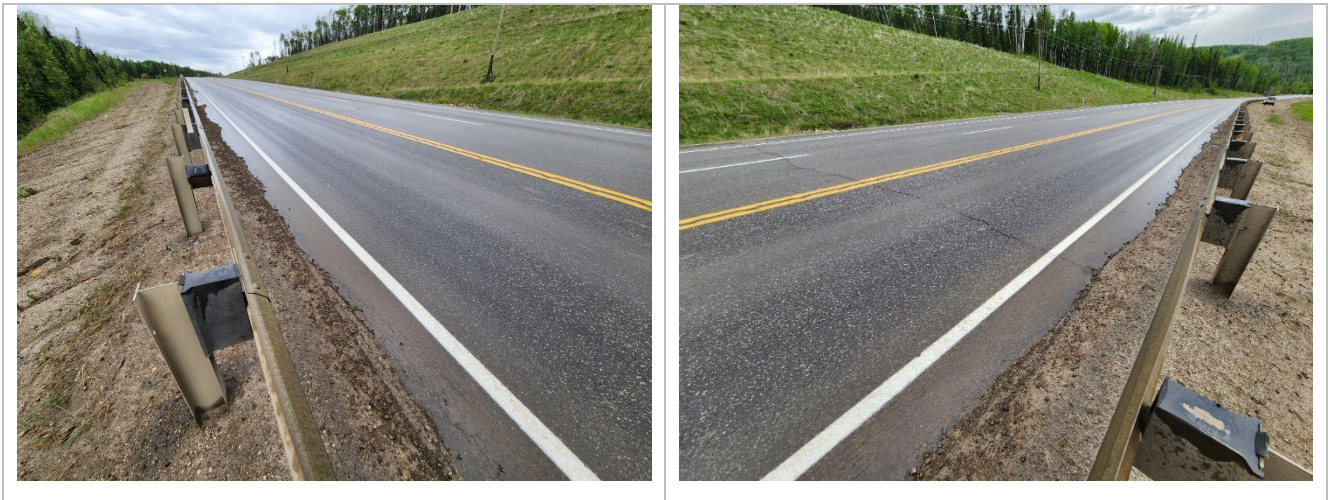
**Photo 12** Pavement surface of Hwy 40:38. Note rill erosion on upper portion of slope (unvegetated gravelly material). Photos taken June 11, 2024, facing southwest and northwest, respectively.
