July 15, 2024

CON0022166 Peace Region (Grande Prairie District – South) GRMP Instrumentation Monitoring Site GP003; H40:38, km 52.134 Cutbank River (South) Roseham Creek Section C – 2024 Spring Readings

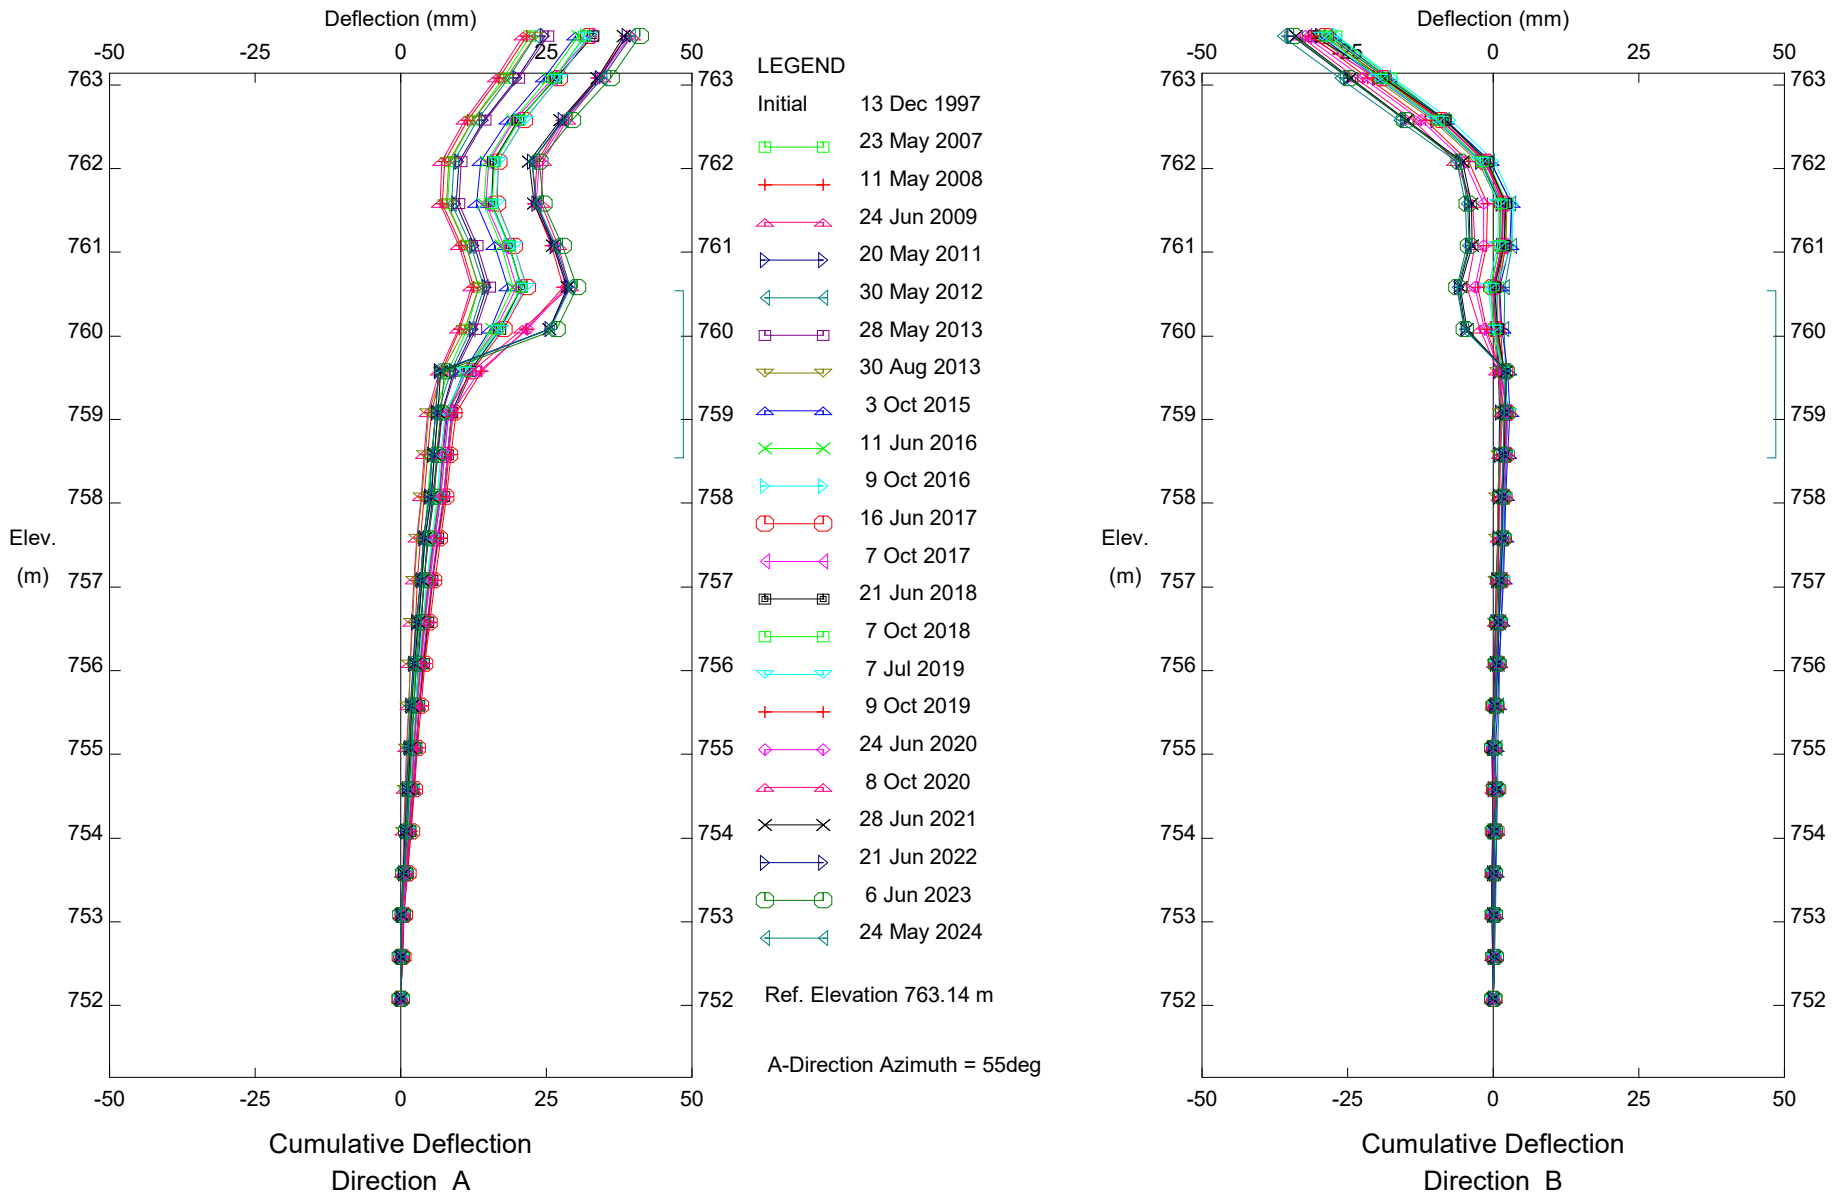
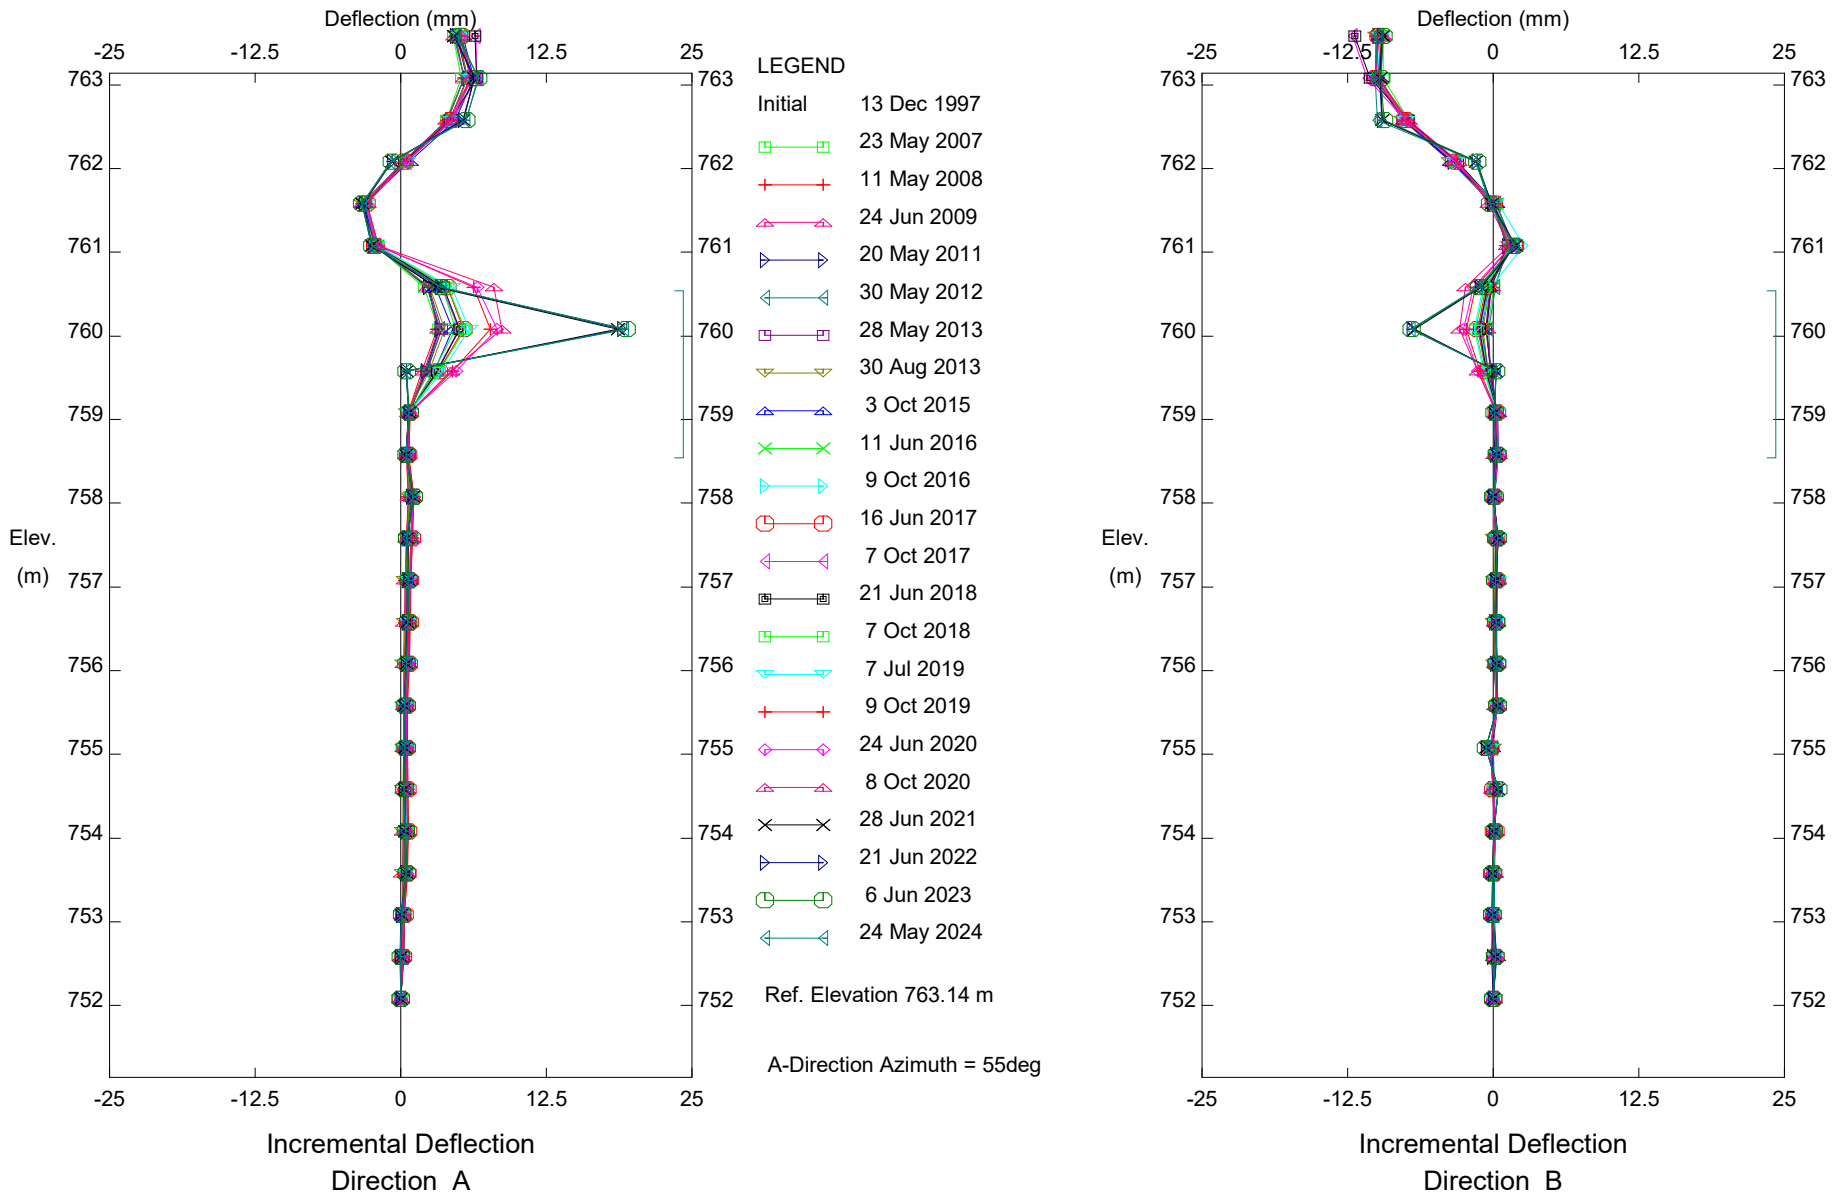
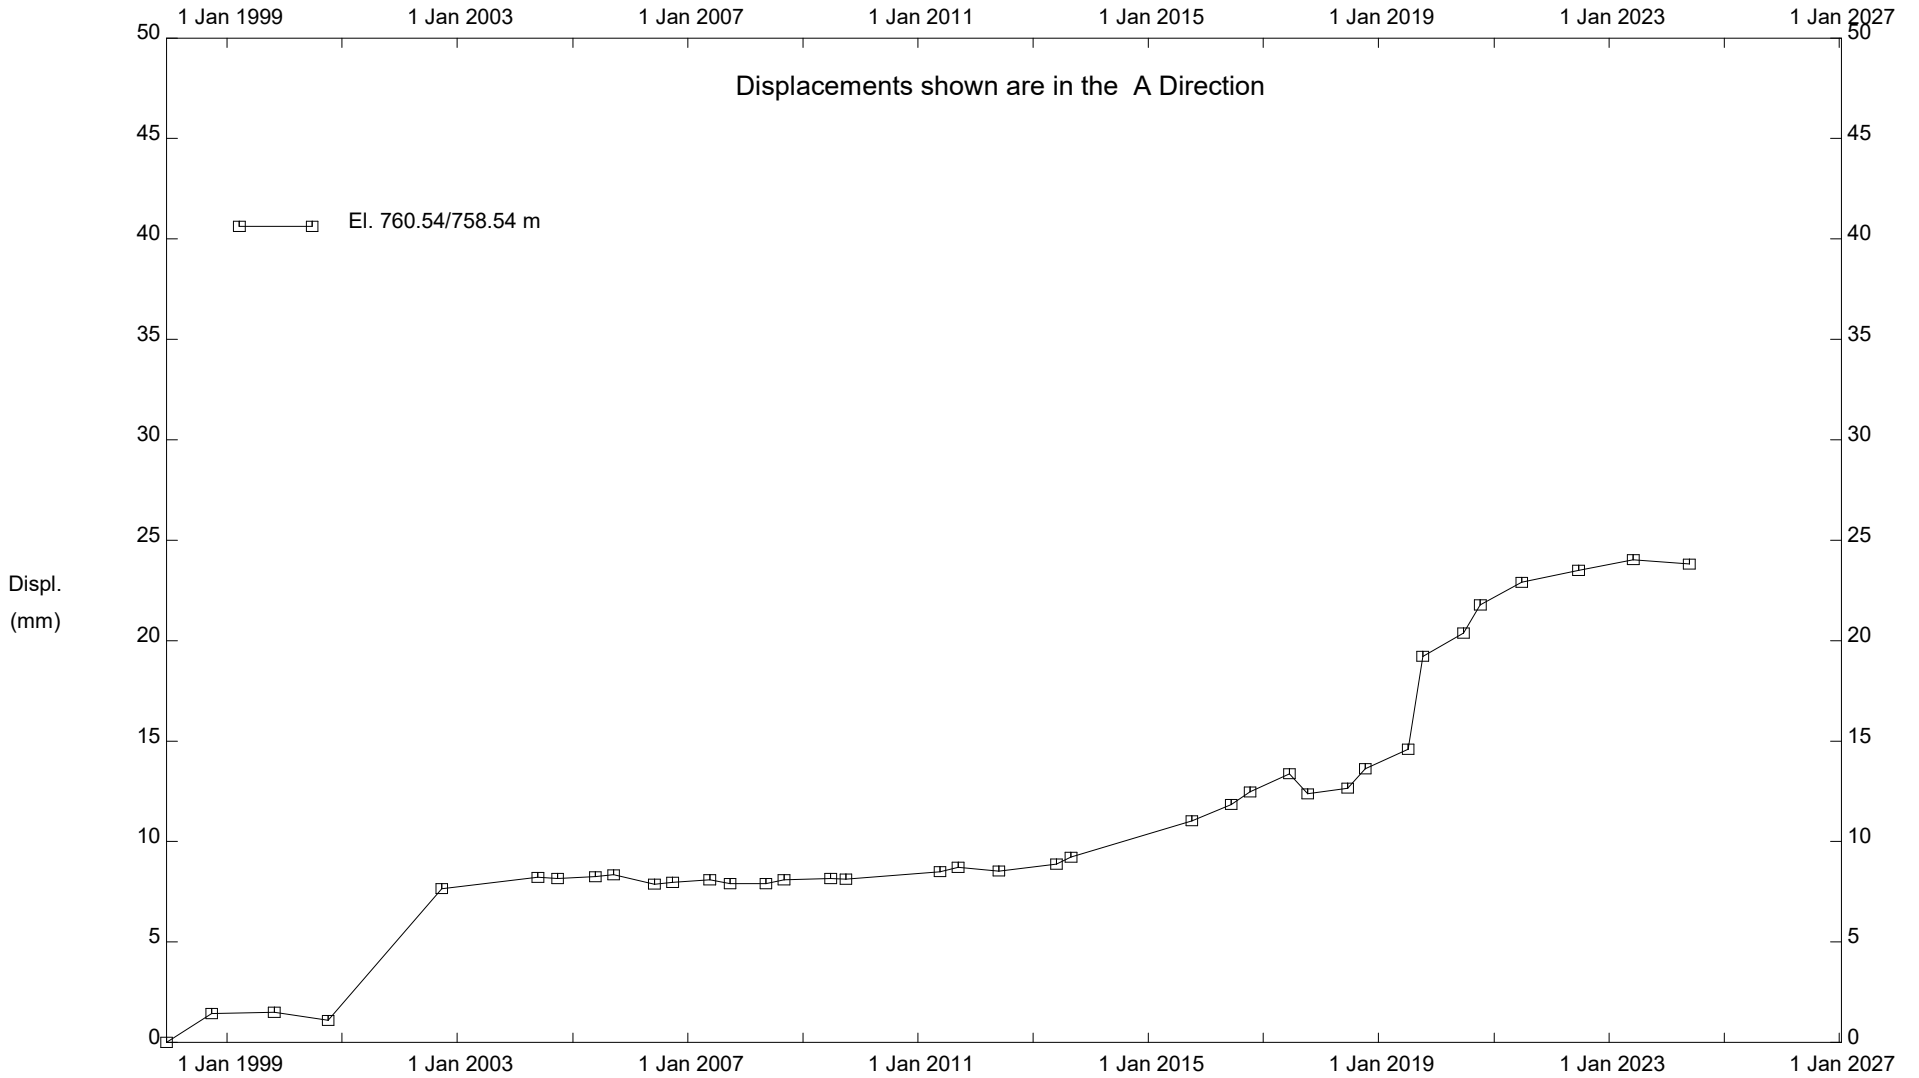
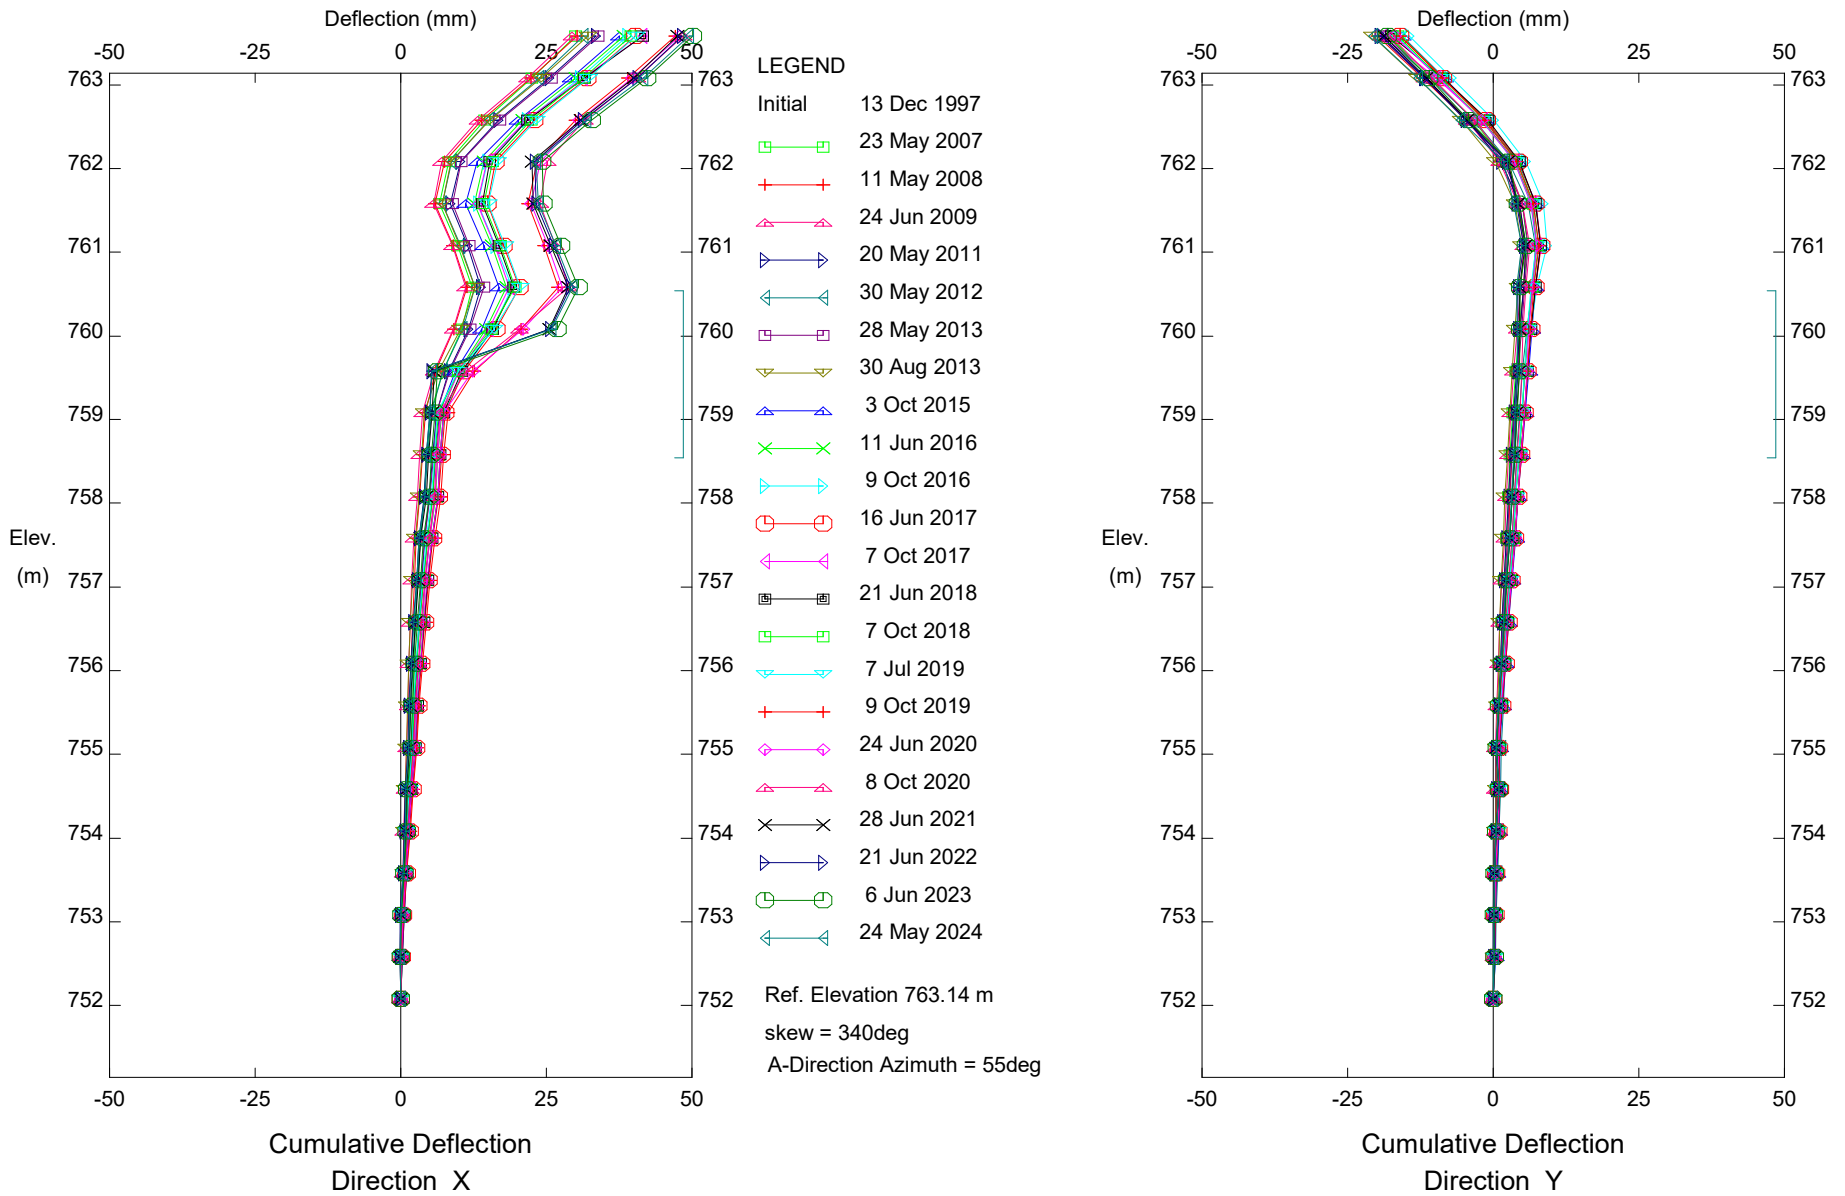
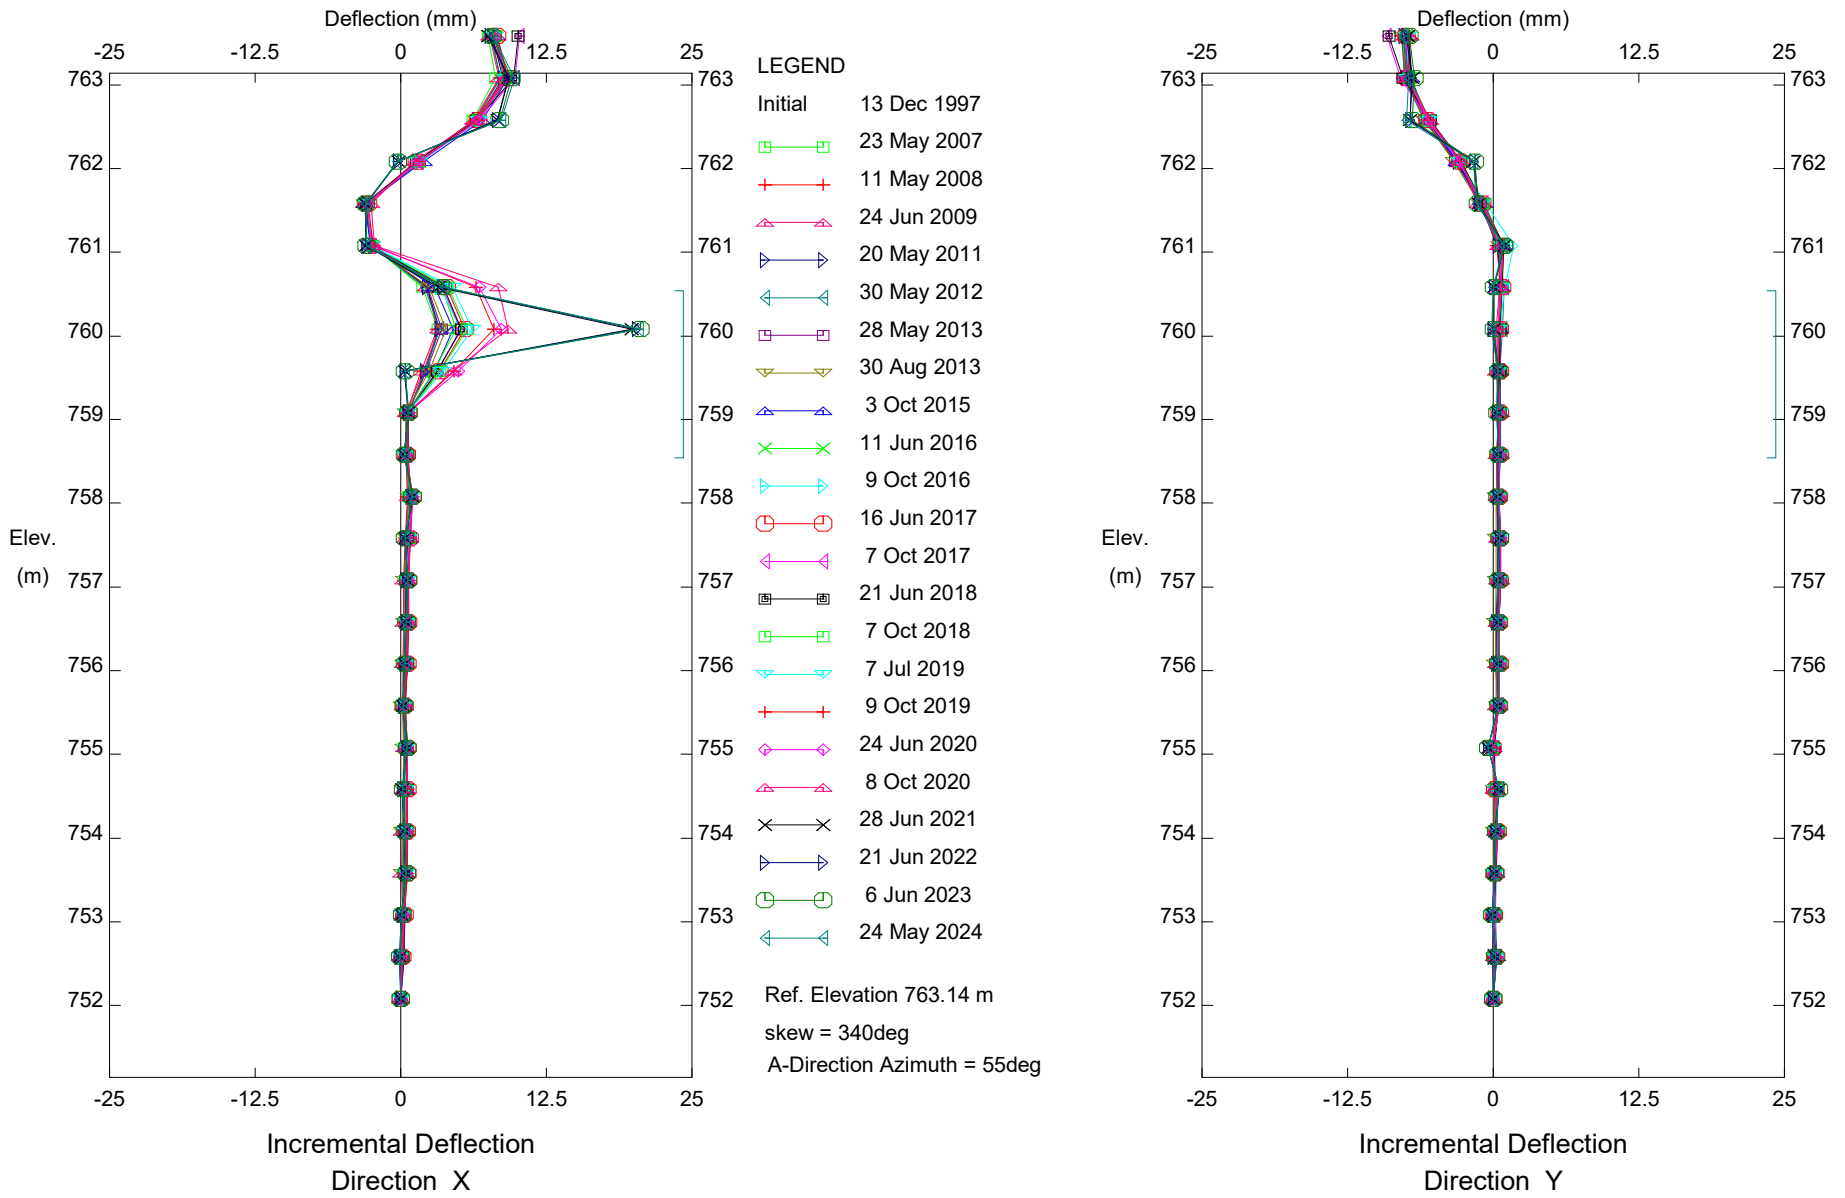
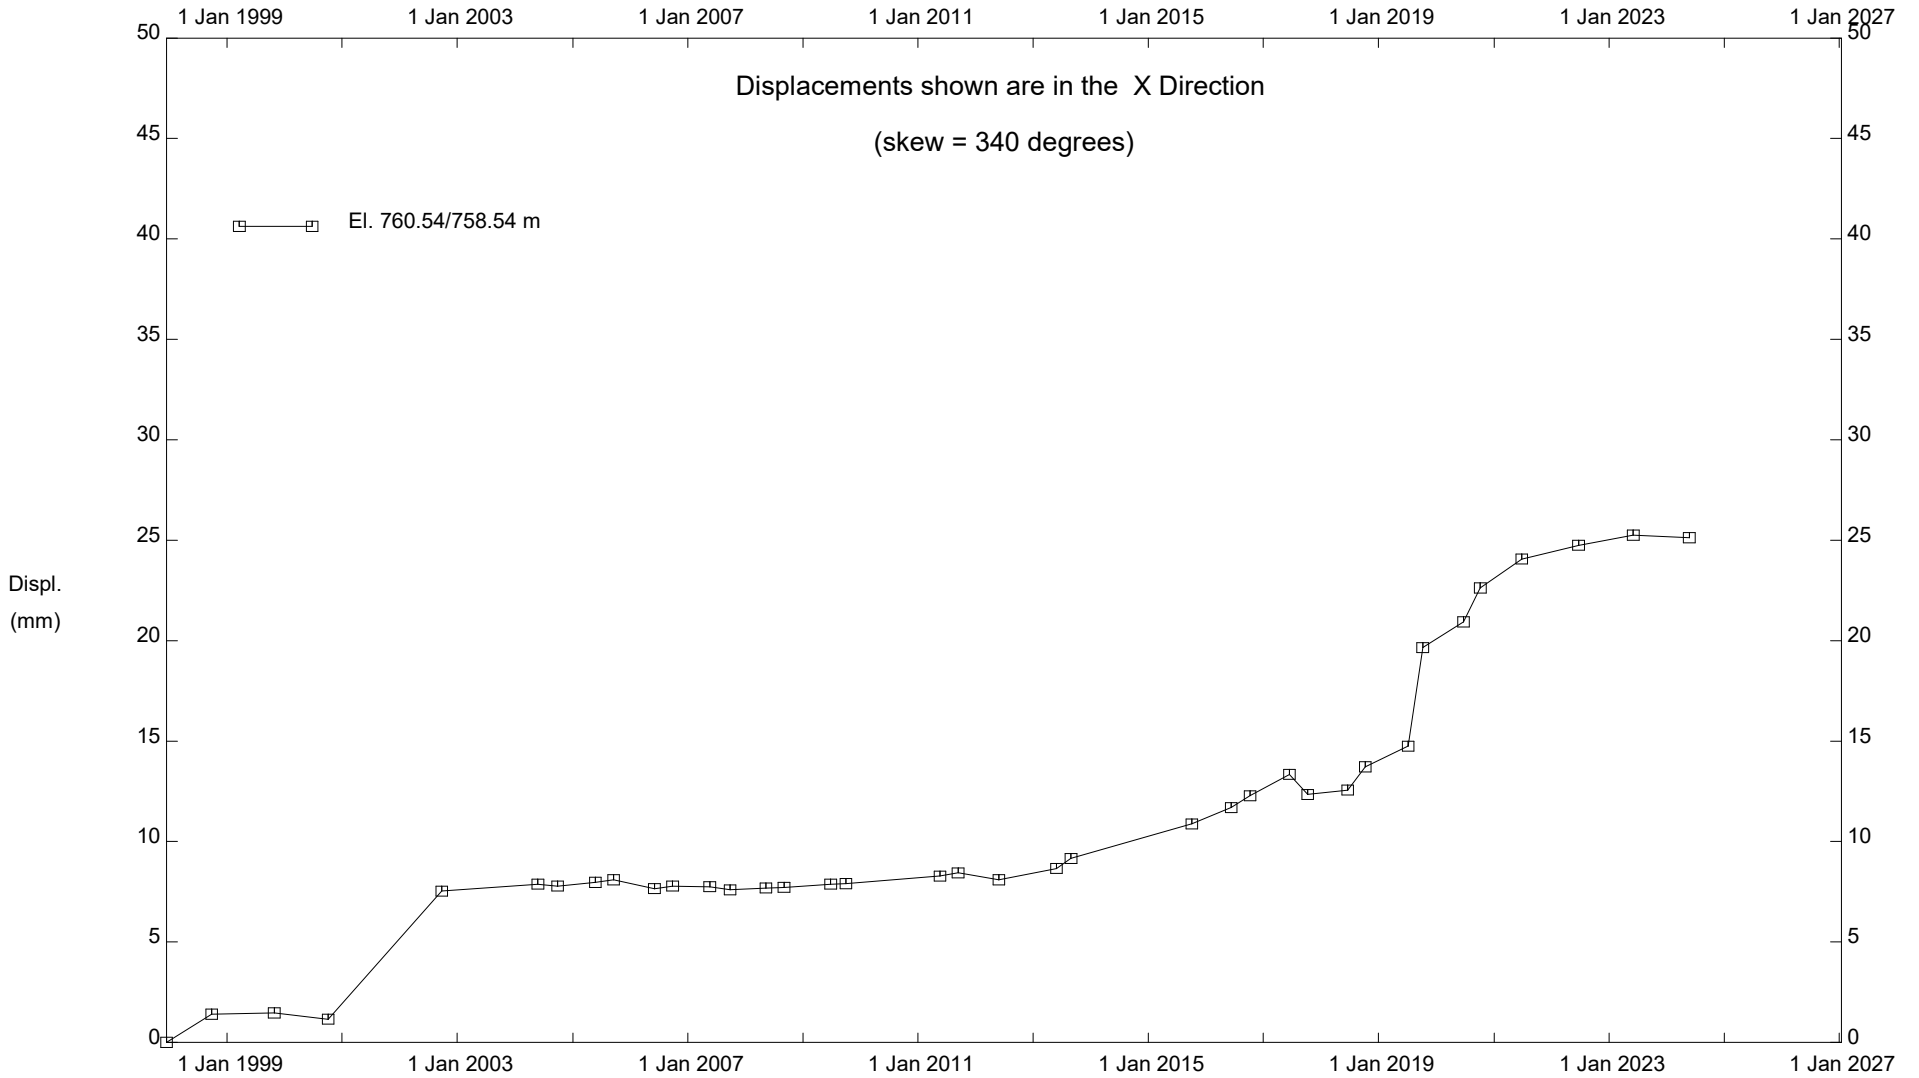
In SI-2, distributed movement is recorded from ground surface to an approximate depth of 3.6 m below ground surface (elevation 763.1 m to 759.6 m). Distributed movement is also being recorded in this instrument at an approximate depth of 4 m to 11 m below ground surface (elevation 759 m to 752 m).

The bottom of distributed movement recorded in SI-2, which is located approximately 30 m from the toe of the highway embankment, is at approximately the same elevation as Roseham Creek, which is located at the toe of the highway embankment.

The rate of movement being recorded in SI-2 was relatively slow (less than 1 mm/year) between 1997 and 2015 before increasing to an approximate rate of 20 mm/year in late 2019. The increased rate of movement was also observed on site when a larger-than-typical asphalt crack was observed during the 2015 Section B inspection. The increased rate of movement may have been caused by creek erosion at the toe of the highway embankment and groundwater seeping through the embankment fill.

All operable instruments should continue to be read once per year (spring). Spring readings should be completed after late-May or early-June, due to the risk of water inside the instrument casings being frozen earlier in the year.

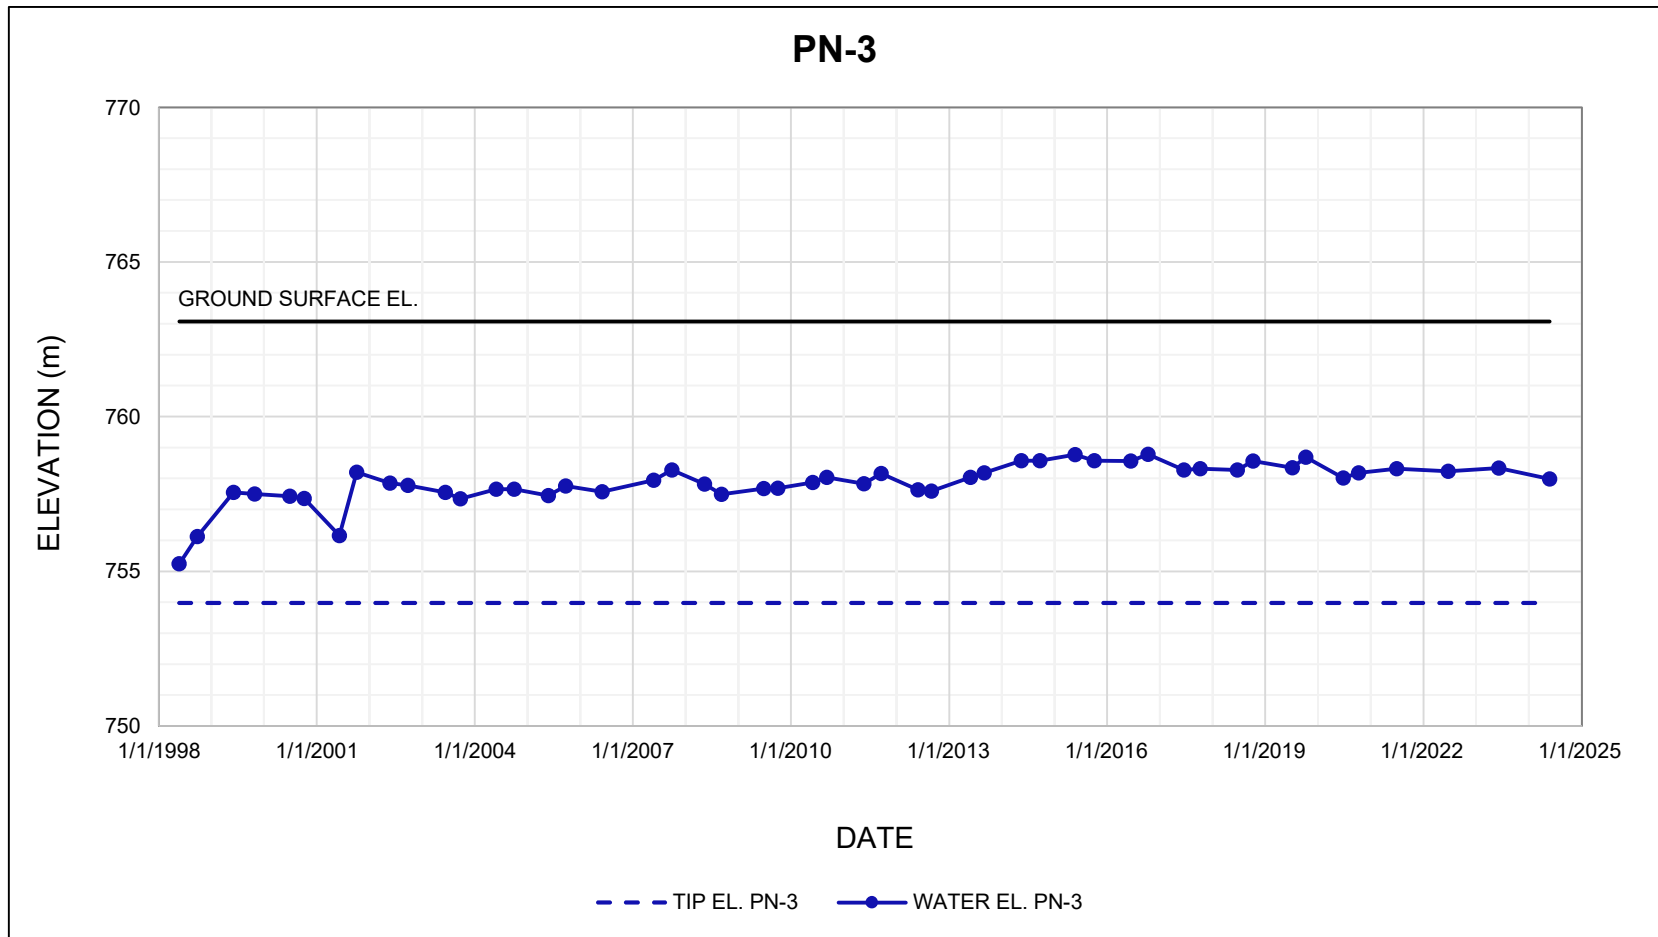
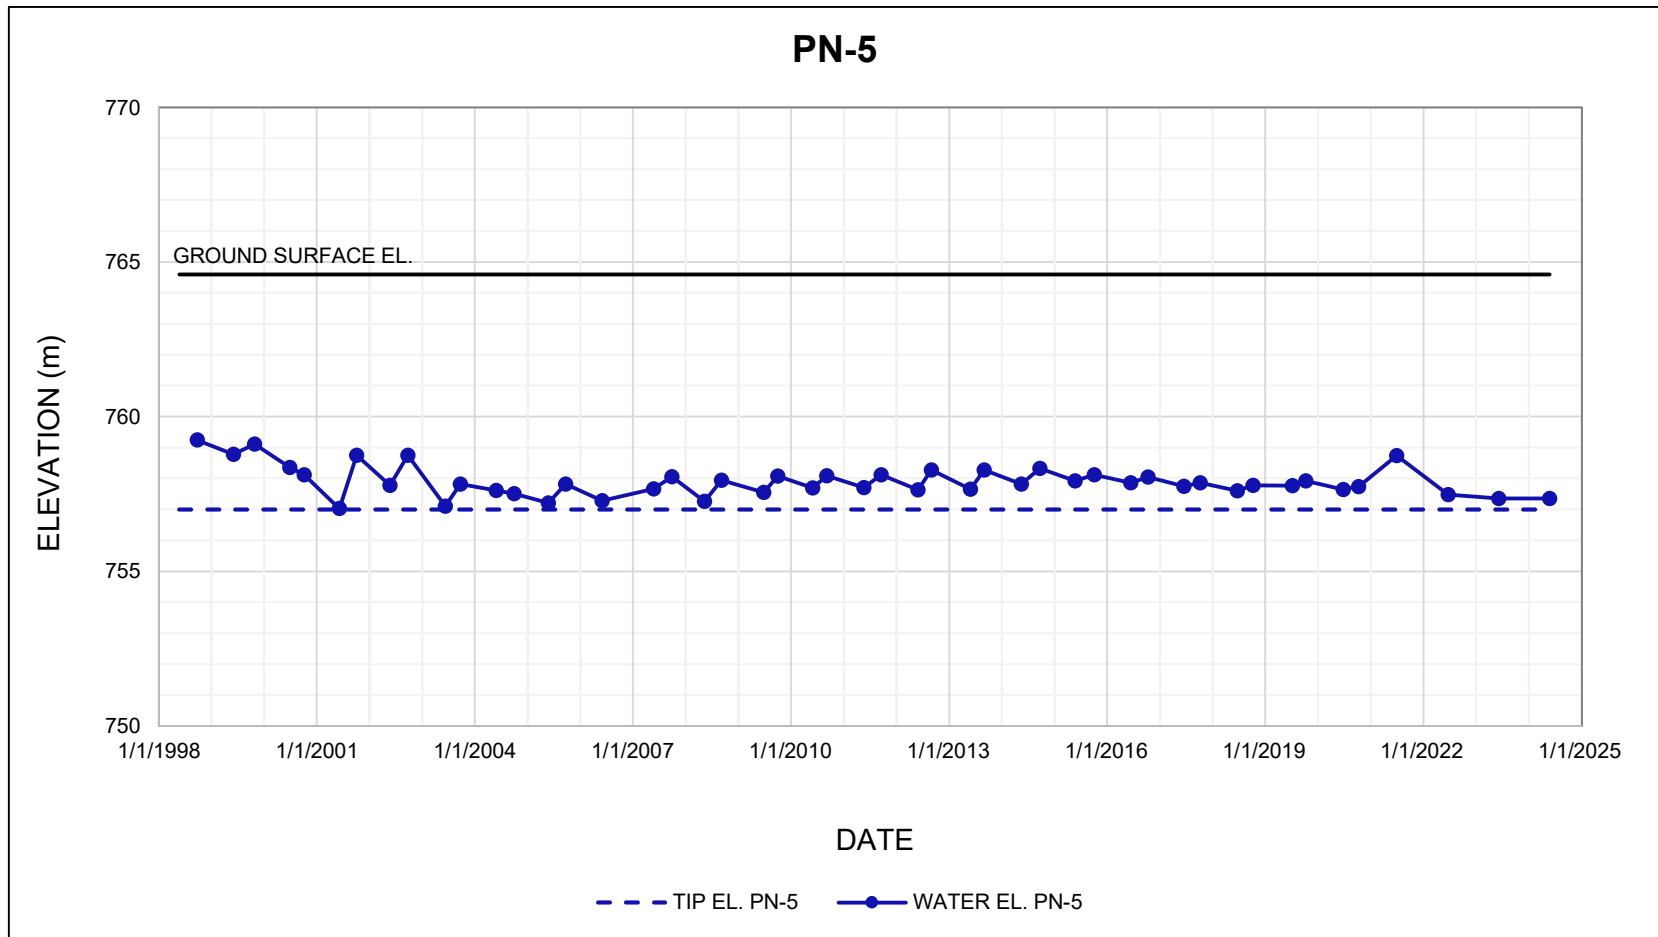
PROJECT PEACE REGION (GRANDE PRAIRIE DISTRICT - SOUTH) GEOHAZARD RISK MANAGEMENT PROGRAM		
	TITLE Piezometer Data GP003 - Cutbank River (South) Roseham Creek Hwy 40:38, km 52.134

In the mid-2010s, an approximate 0.5 m to 1.0 m increase in porewater pressure was recorded in PN-3 and PN-5, and the rate of movement recorded in SI-2 correspondingly increased from less than 1 mm/year to an approximate rate of 20 mm/year. Since the mid- to late-2010s, an approximate 0.8 m decrease in porewater pressure has been recorded in PN-3 and PN-5. The rate of movement recorded in SI-2 also began to decrease in 2019/2020 and, since June 2022, has been less than 1 mm/year. This decrease in porewater pressures and movement rates, could be attributed to:

- possible seasonal variation in precipitation or freshet infiltration, or runoff or creek flow eroding the toe of the slope;
- cutting back the backslope to widen the highway for a passing lane in 2019 and 2020, reducing infiltration into the highway embankment and foundation and decreasing shear stresses applied to the foundation; and/or
- improving highway drainage to more effectively convey water downslope away from the slide.
