**SITE INSPECTION FORM**

<b>SITE NUMBER AND NAME:</b> GP034 Slide South of Kakwa River		<b>HIGHWAY &amp; KM:</b> 40:38, 21.016	<b>PREVIOUS INSPECTION DATE:</b> September 08, 2021	<b>INSPECTION DATE:</b> <b>June 13, 2023</b>
<b>LEGAL DESCRIPTION:</b> NW 28-62-04-W6M	<b>NAD 83 COORDINATES:</b> UTM Northing Easting 11 6028755 399896		<b>RISK ASSESSMENT:</b> PF: 5 CF: 4 TOTAL: 20	
<b>AVERAGE ANNUAL DAILY TRAFFIC (AADT):</b> 780 (north) & 980 (south) (Reference No. 25592, 2022)			<b>CONTRACT MAINTENANCE AREA (CMA):</b> 504

**PEACE REGION  
(GRANDE PRAIRIE DISTRICT – SOUTH) GRMP  
SITE INSPECTION FORM**

TITLE  
 Site Plan  
 GP034 - Slide South of Kakwa River  
 Hwy 40:38, km 21.016

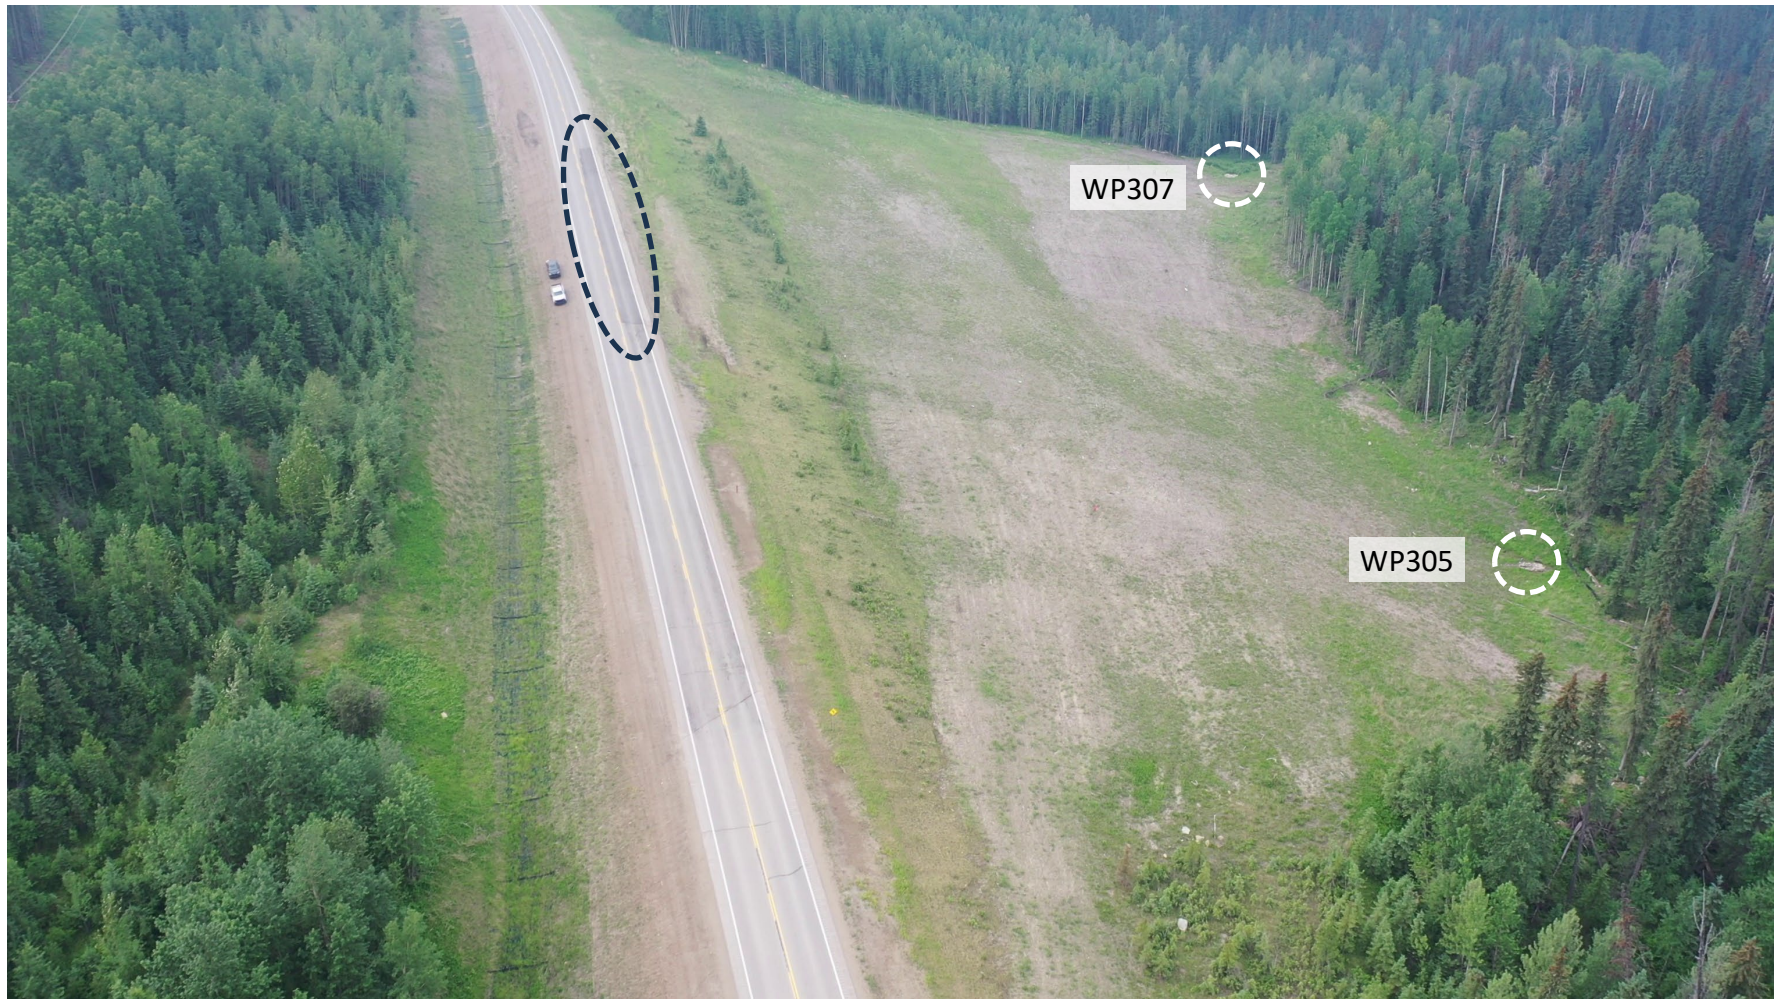
**Photo 1** Overview of GP034 site. Note pavement patch placed after 2021 overlay in west (southbound) lane of Hwy 40:38 (circled in black) and drain outlets at WP305 and WP307 (circled in white). Photo taken June 13, 2023, facing southwest.

- Continue to patch and pave this section of highway as needed.
- If movements continue and further repair/stabilization work is required, TEC should consider a mitigation method that improves the stability of the highway surface but does not change the state of stress of the slope and trigger more deep-seated movements. Possible repair options could include construction of deep cast-in-place piles through the toe berm and across the failure surface, or construction of a driven-steel wall or a soil nail-reinforced-earth-retaining wall below the edge of pavement to stabilize the small wedge of soil that is moving below the west (southbound) lane of the highway. Estimated cost: approximately \$2,000,000 to \$4,000,000 (deep cast-in-place piles), \$800,000 to \$1,500,000 (100-m-long driven-steel wall), and \$400,000 to \$600,000 (100 soil nails), respectively.

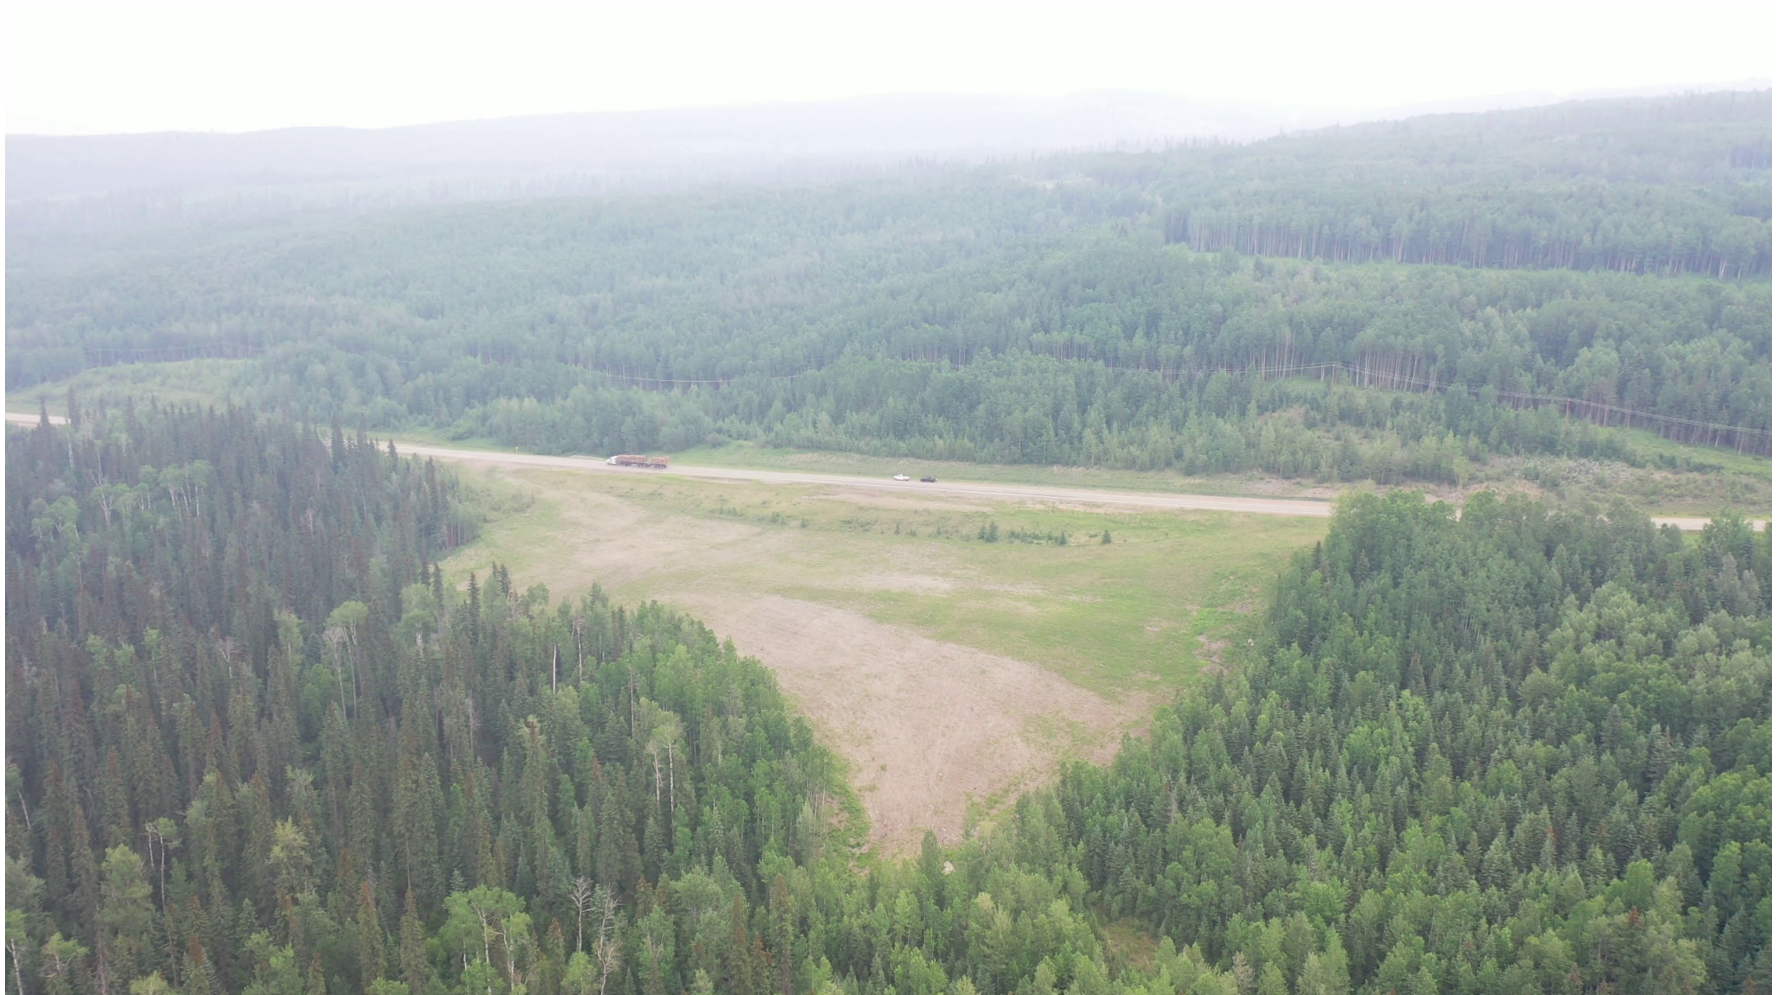
**Photo 2** Overview of GP034 site. Photo taken June 13, 2023, facing northeast.

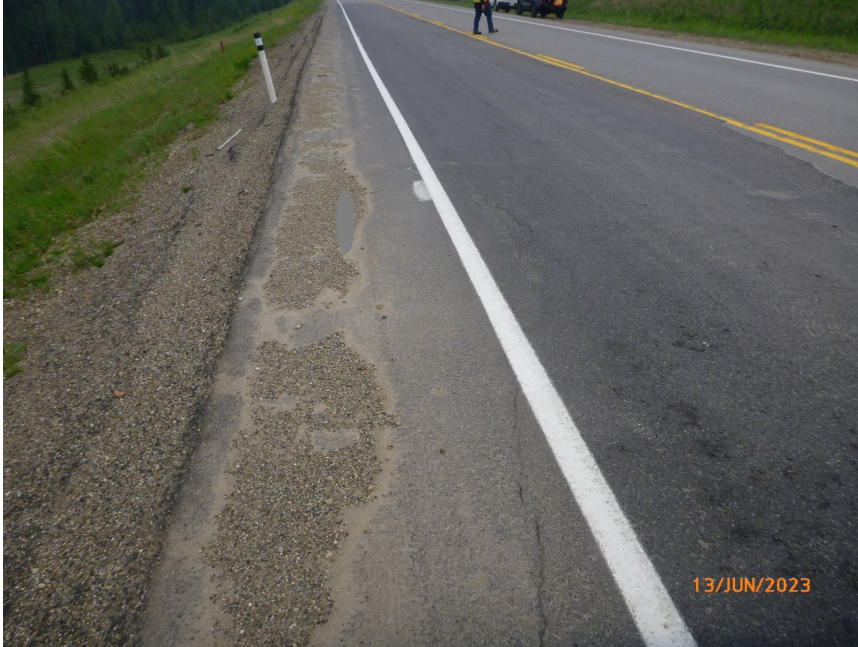
ITEM	CONDITION EXISTS		DESCRIPTION AND LOCATION	NOTICABLE CHANGE FROM LAST INSPECTION	
	YES	NO		YES	NO
Pavement Distress	X		Pavement patch placed after 2021 overlay has settled, but minimal to no cracking observed.	X	
Slope Movement	X		Settlement and cracking in recent pavement patch and SI data indicates ongoing slide movements.	X	
Erosion		X	None observed at time of 2023 inspection.		X
Seepage	X		Conditions during 2023 inspection were drier compared to conditions during 2021 inspection as described below.	X	
Culvert Distress		X	No culverts observed by KCB but drain outlets at WP305 and WP308 appeared in good condition. Drain outlet at WP307 not visible.		X

Shallow movement recorded in S117-3 is believed to be causing the pavement cracking observed on site and may be an extension upwards along a backscarp, associated with deeper movement. Otherwise, deep movements recorded in S117-2 and S117-3 have slowed since early 2021.

**Photo 3** Pavement patch placed after 2021 overlay in west (southbound) of Hwy 40:38 has settled, but minimal to no cracking observed. Photo taken June 13, 2023, facing north.

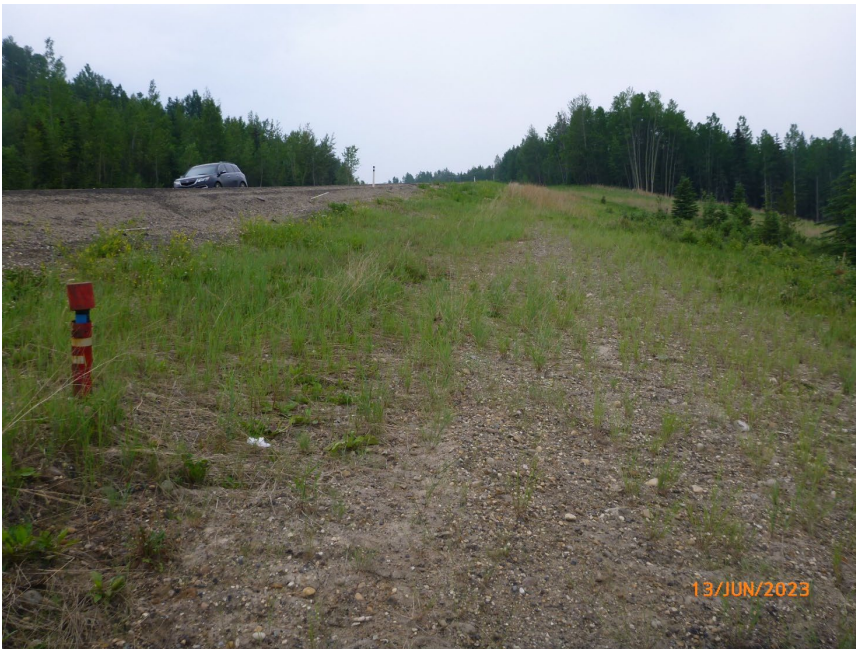
Highway shoulder is steep along west (southbound) lane of Hwy 40:38.

**Photo 4** Steep shoulder along west (southbound) lane of Hwy 40:38. Photo taken June 13, 2023, facing south.

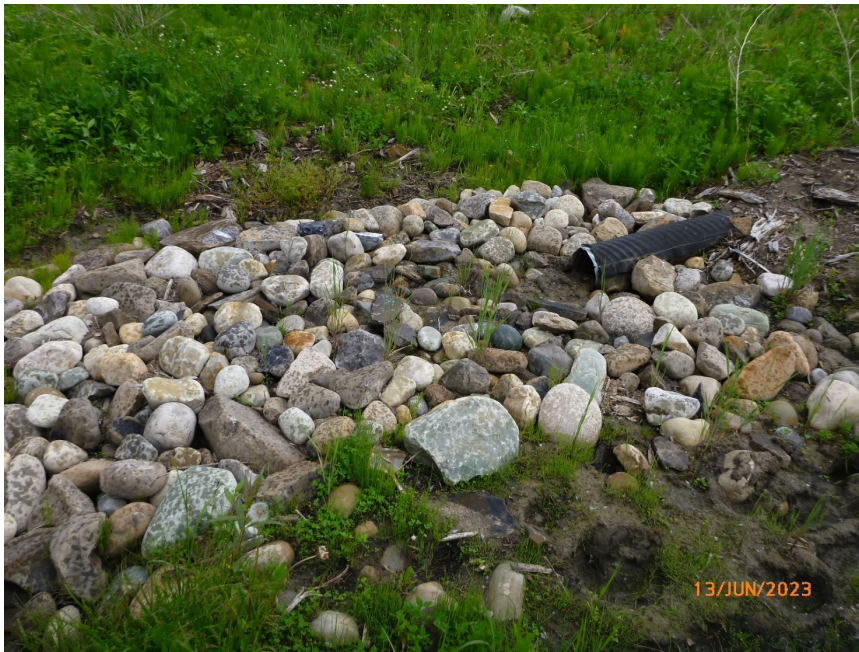
- some water around the drain outlet at WP305;
- a possible former wet area at WP306; and
- dense vegetation around the drain outlet at WP307 although the drain outlet appeared dry.

**Photo 5** Wet area surrounding drain outlet at WP305. Photo taken June 13, 2023, facing northeast.

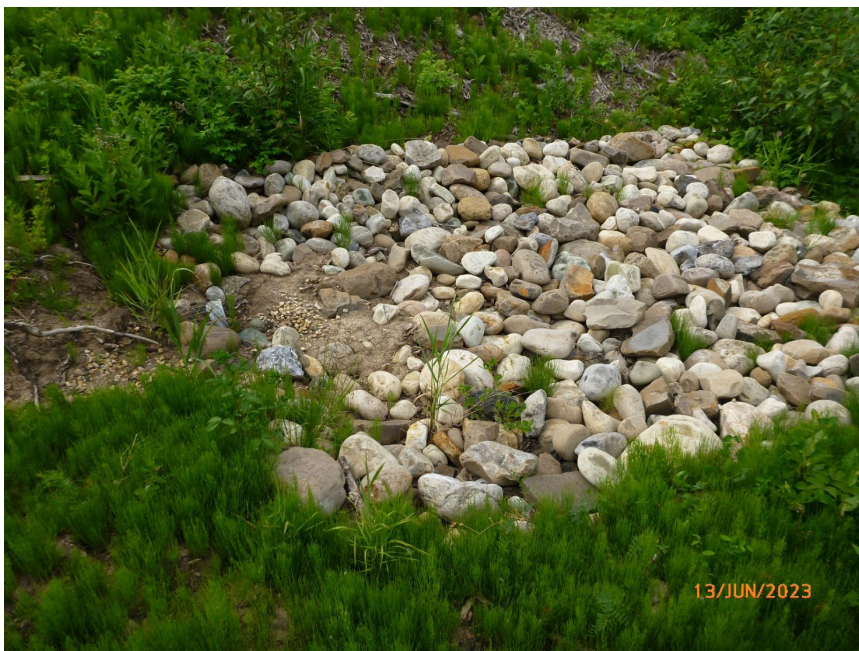
**Photo 6** Dense vegetation surrounding drain outlet at WP307 but area otherwise appeared dry. Photo taken June 13, 2023, facing east.

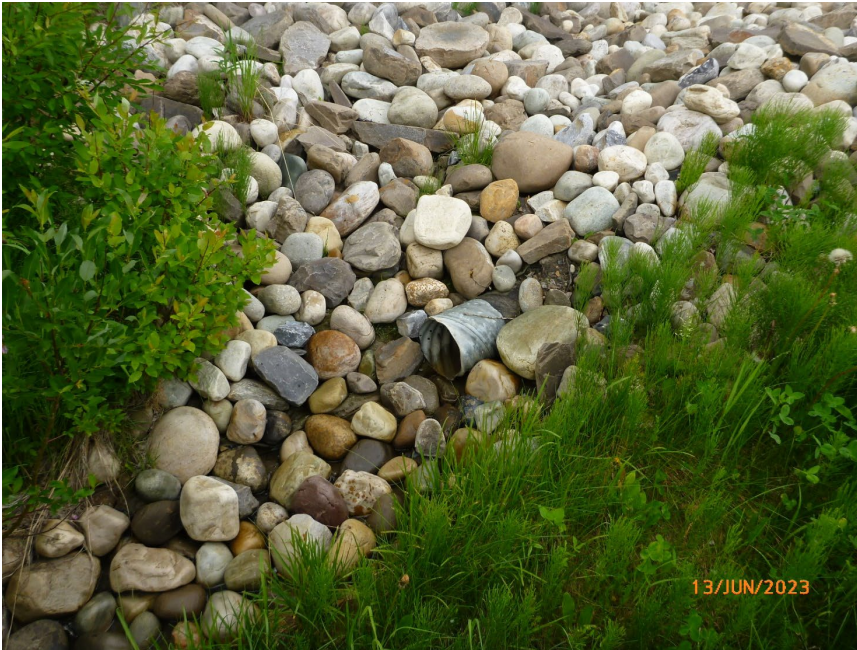
In 2020, a groundwater interception trench consisting of non-woven geotextile surrounding granular filter materials and a perforated collection pipe was installed approximately 4 m below the east (northbound) highway ditch. At the time of the 2023 inspection, water was discharging from the collection pipe outlet at WP308 at an estimated rate of 1 L per 5 seconds to 10 seconds.

**Photo 7**      **Flowing drain outlet in east (northbound) ditch of Hwy 40:38 at WP308. Photo taken June 13, 2023, facing southeast.**
