July 15, 2024

CON0022166 Peace Region (Grande Prairie District – South) GRMP Instrumentation Monitoring Site GP034; H40:38, km 21.016 Slide South of Kakwa River Section C – 2024 Spring Readings

TITLE
 Site Plan
 GP034 - Slide South of Kakwa River
 Hwy 40:38, km 21.016

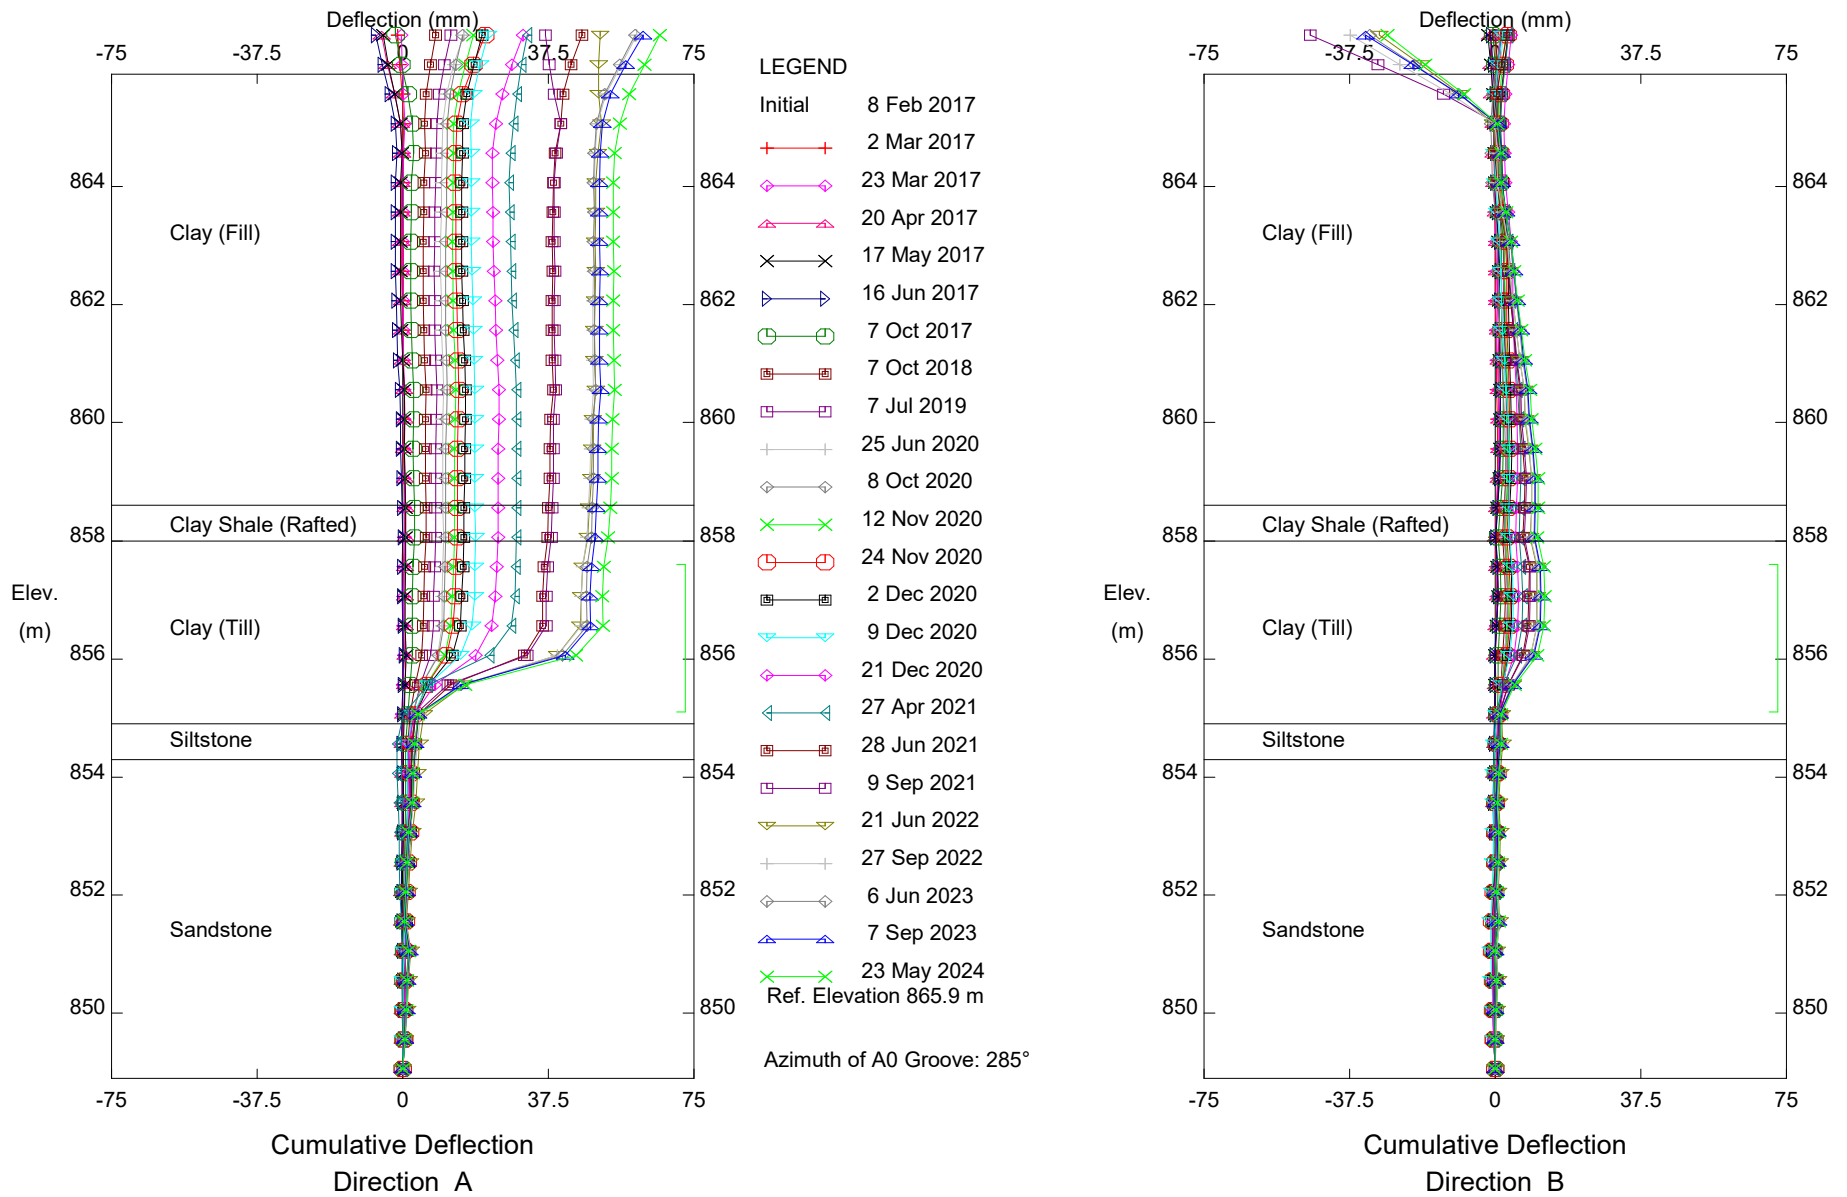
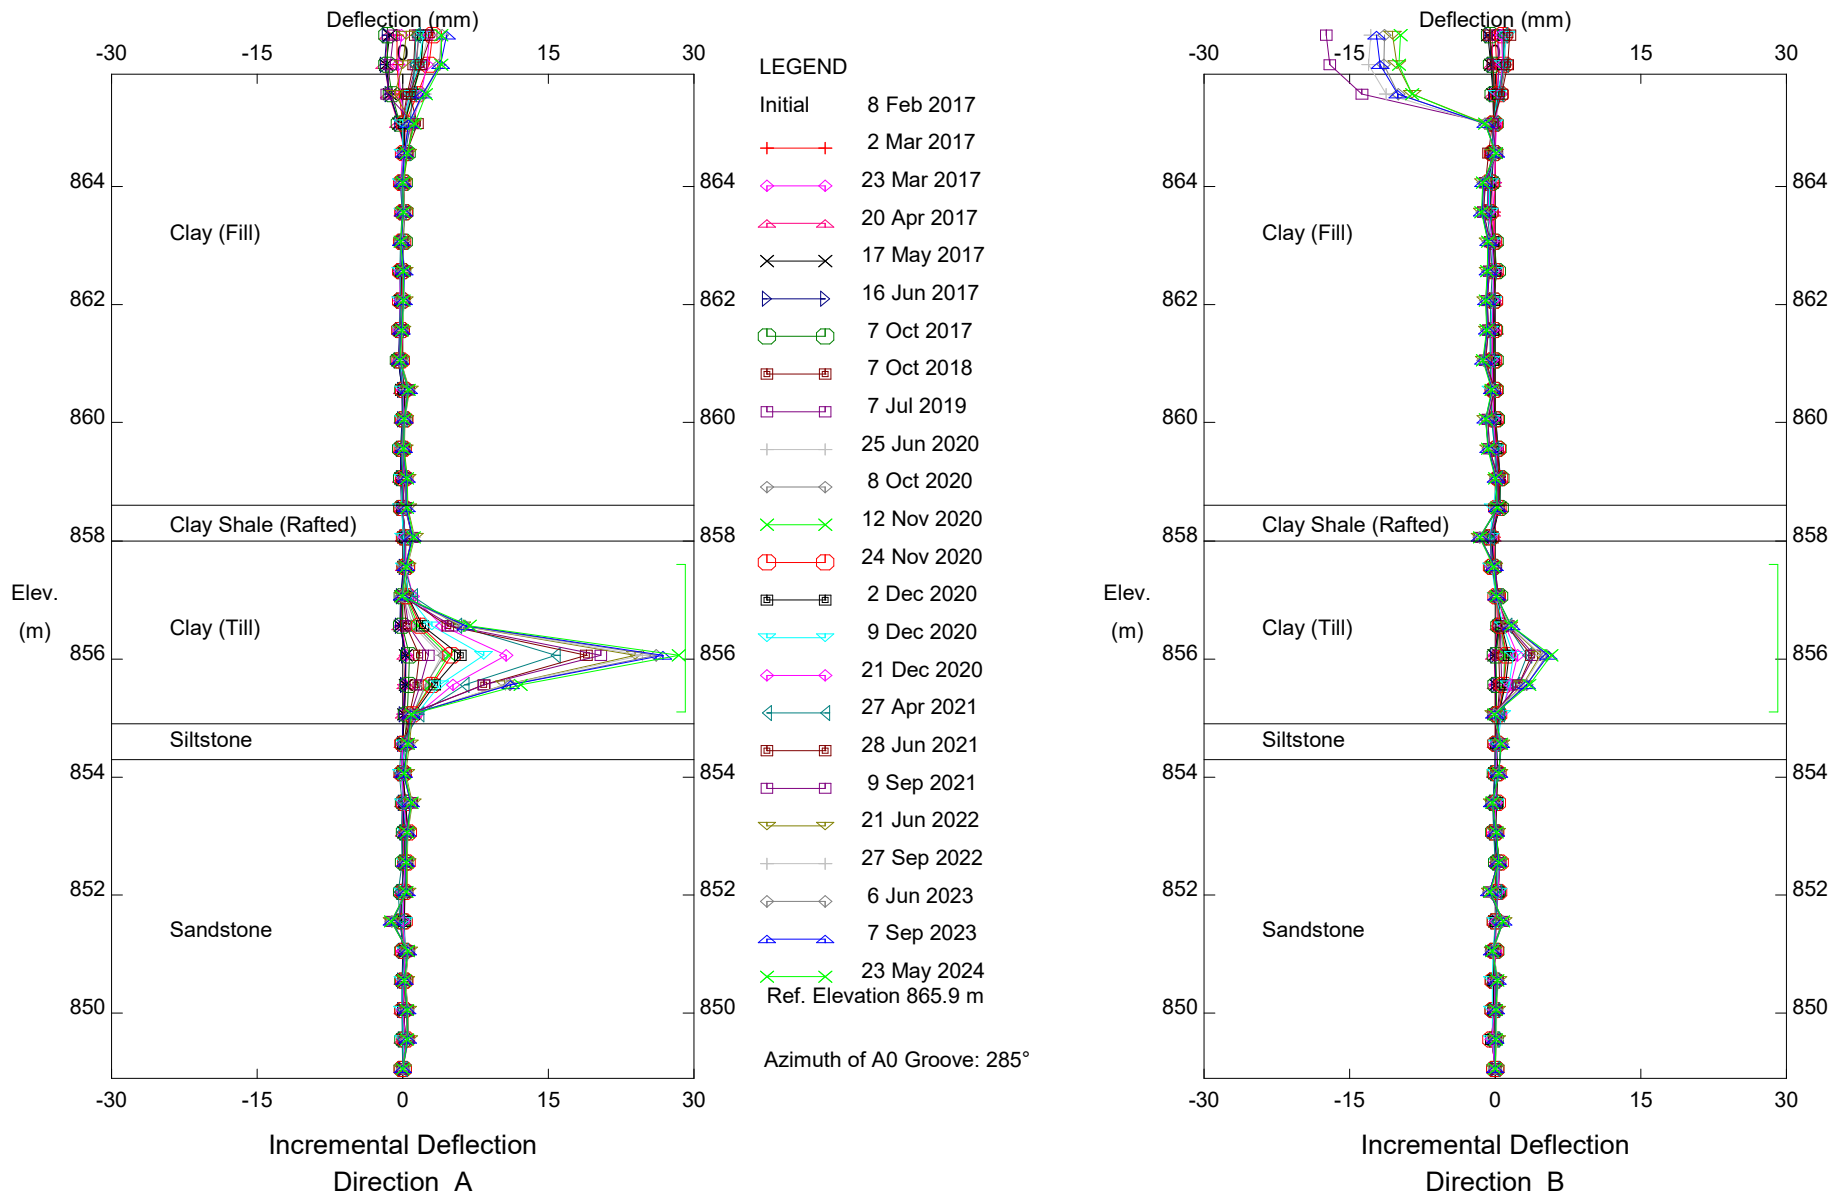
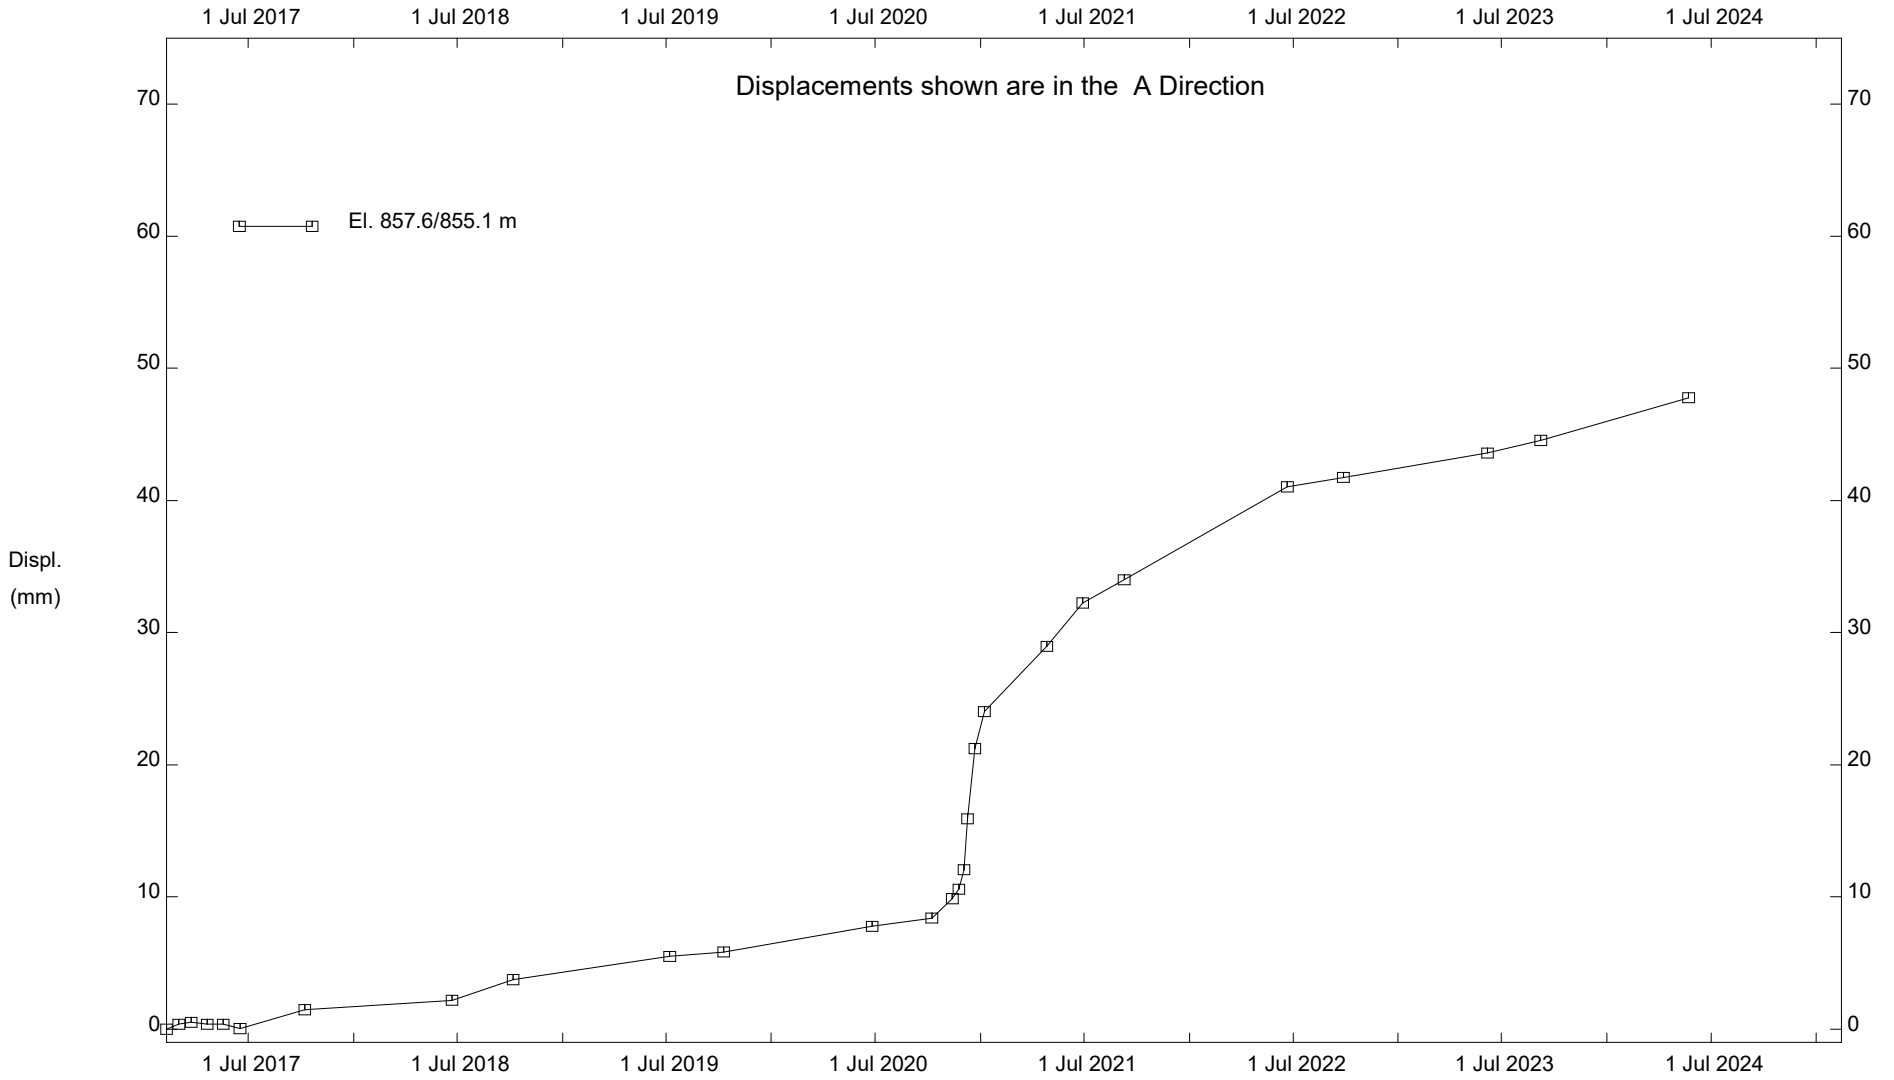
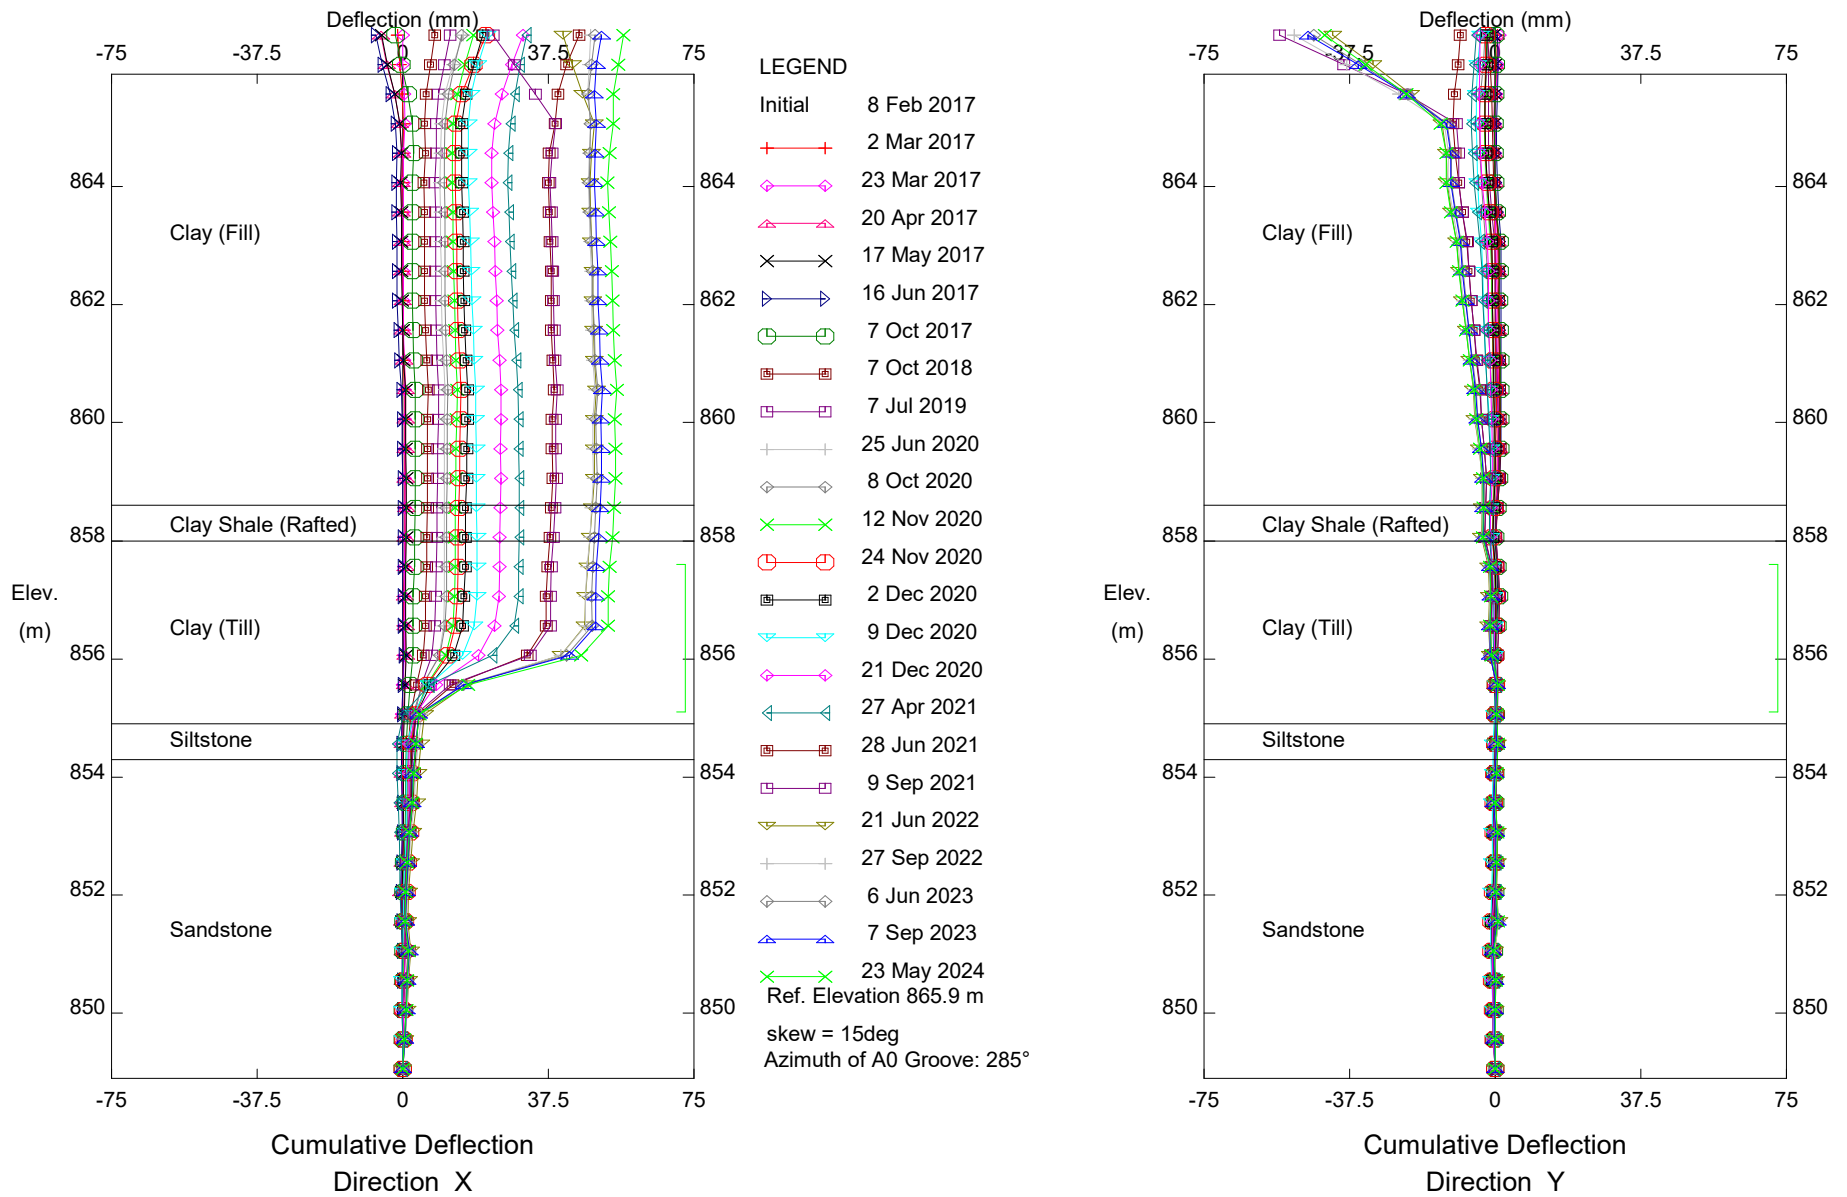
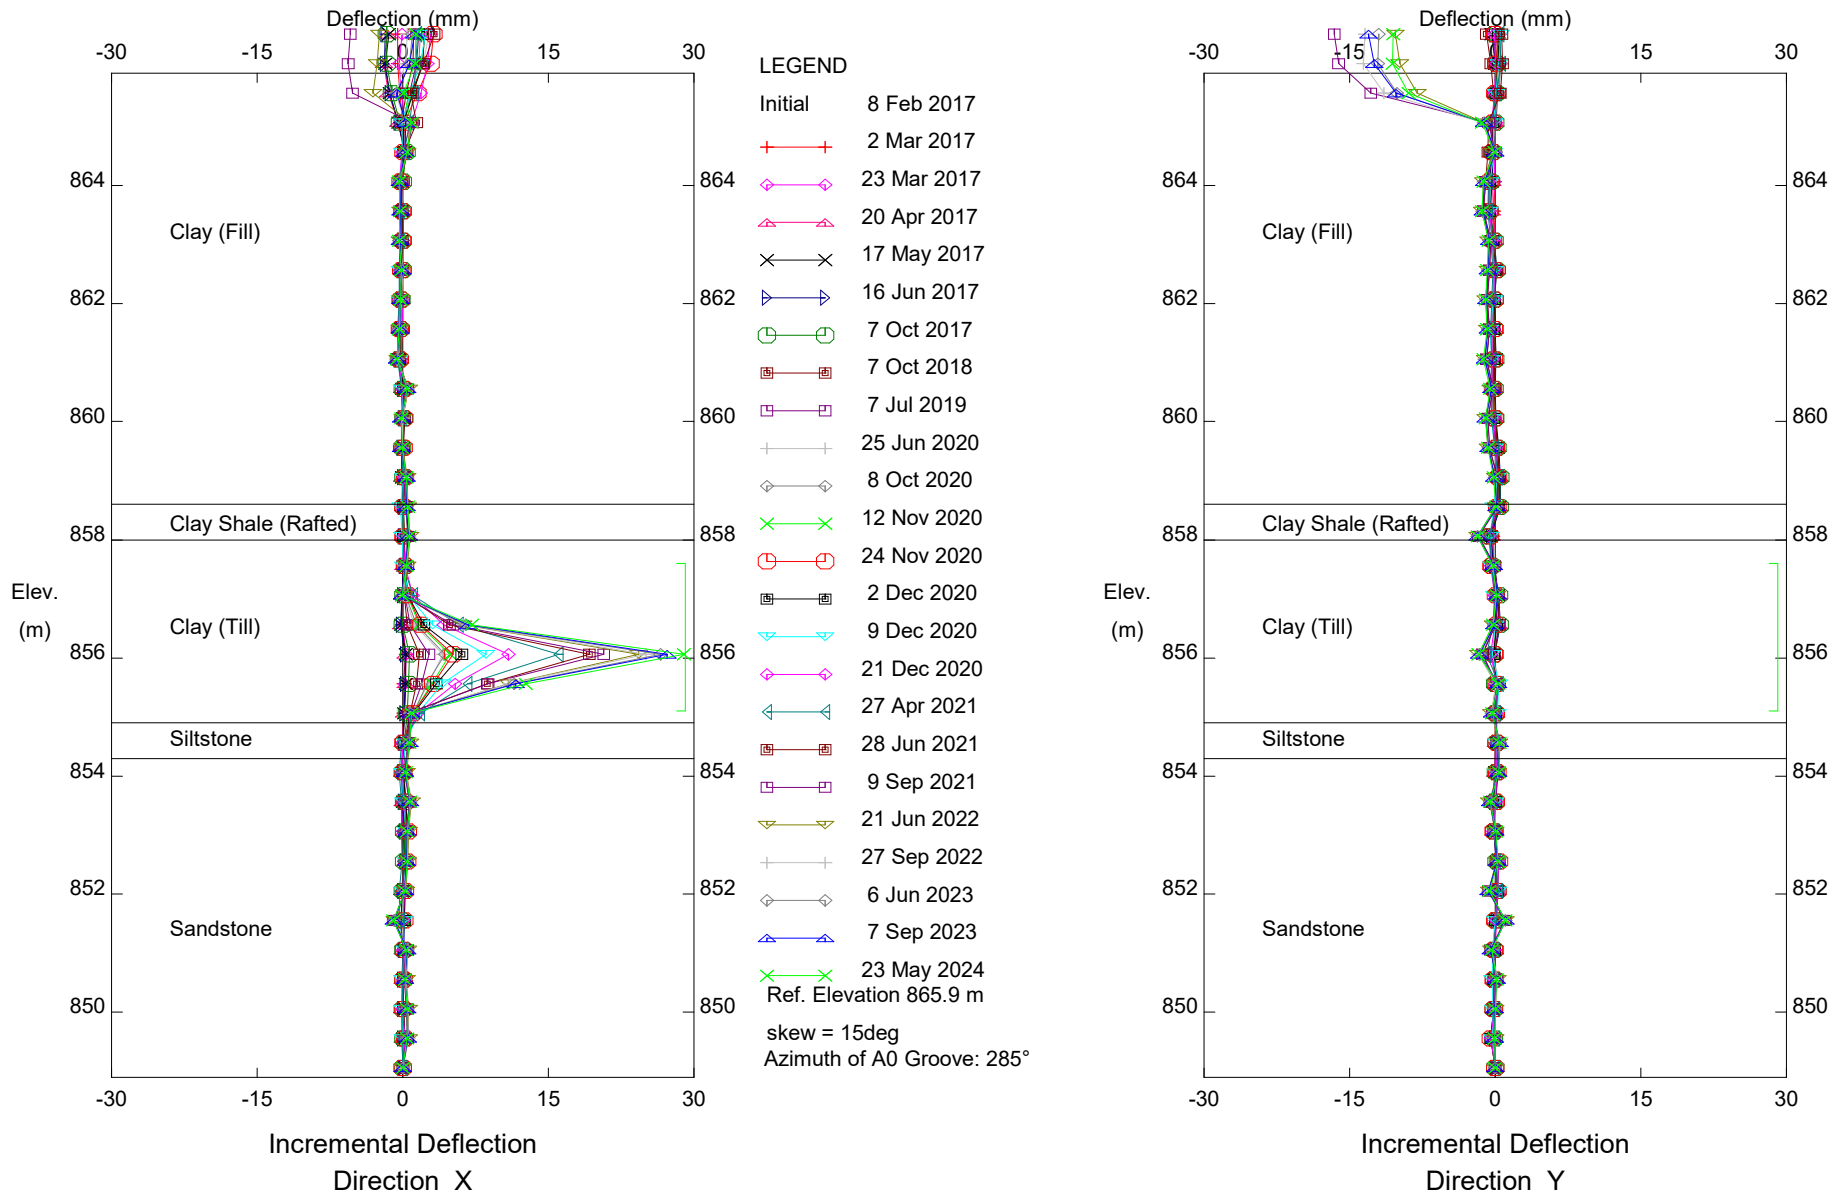
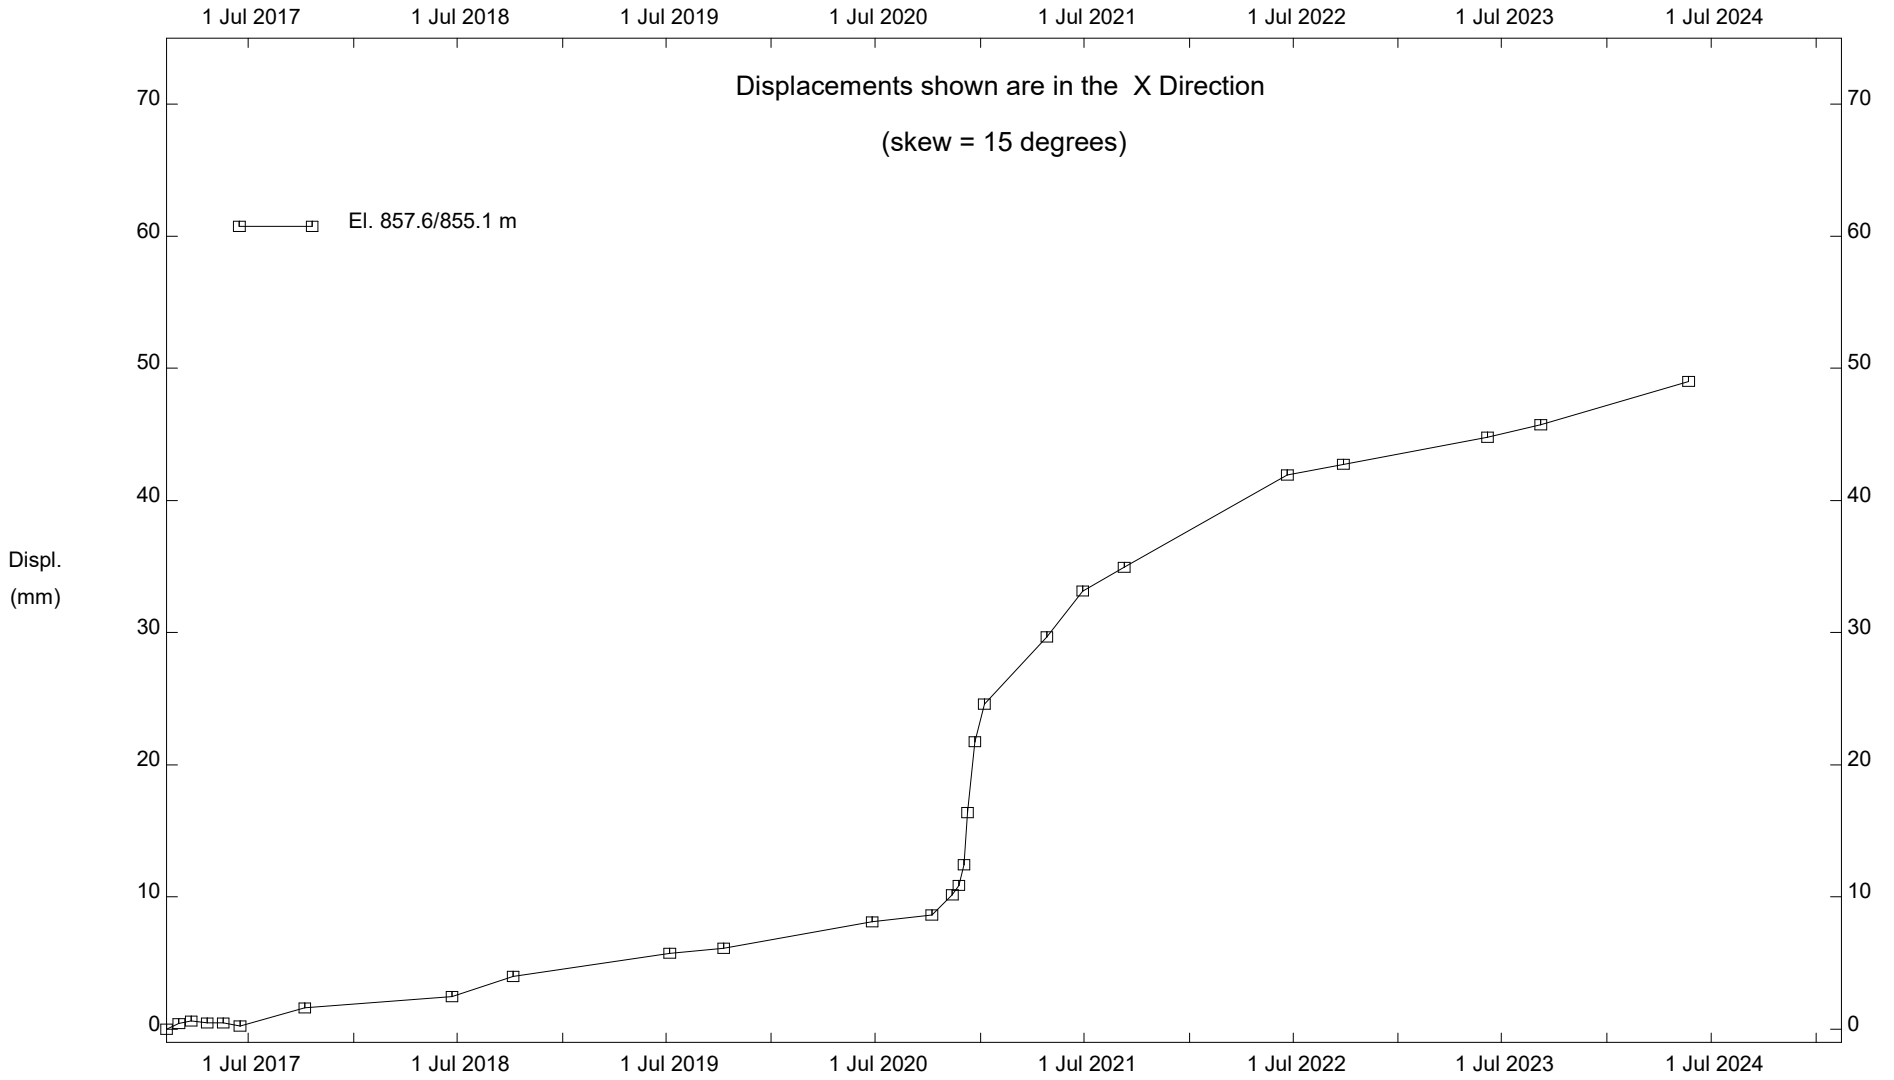
GP034; H40:38, Inclinator SI17-2

- SI17-2 between an approximate depth of 9.3 m and 10.8 m below ground surface (elevation 856.6 m to 855.1 m) at the bottom of a clay till foundation unit overlying bedrock (siltstone); and
- SI17-3 between an approximate depth of 13.0 m and 14.5 m below ground surface (elevation 841.6 m to 840.1 m) in a clay foundation unit overlying bedrock (clay shale).

The rate of foundation movement being recorded in SI17-2 and SI17-3 was relatively slow and steady (less than 5 mm/year) between February 2017 (installation date) and October 2020, but increased up to approximately 212 mm/year and 5,519 mm/year, respectively, when construction began in late-2020. Since January 2021, the rate of foundation movement recorded in SI17-2 and SI17-3 (recorded in the clay till and clay units between two clay shale layers, respectively) has decreased significantly and is currently less than 5 mm/year. Increased movement, which could impact the highway, may occur in response to periods of heavy or prolonged rainfall, resulting in higher groundwater conditions.
